Sonoma Creek Enhancement Project; Creating Functionality in a Centennial Marsh of Sonoma, California
Grant Agreement No. P1475008
Project Final Report
07/30/14-5/31/16

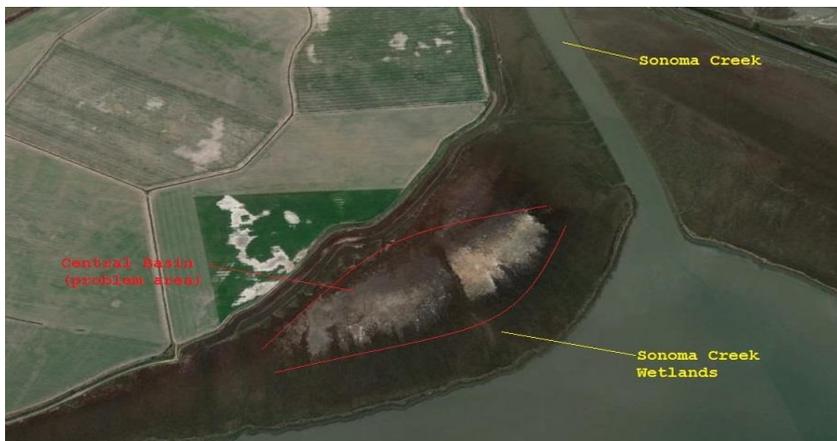
Figure 1. Aerial image of 400-acre Sonoma Creek marsh with 260-acre inundated “dead zone.”

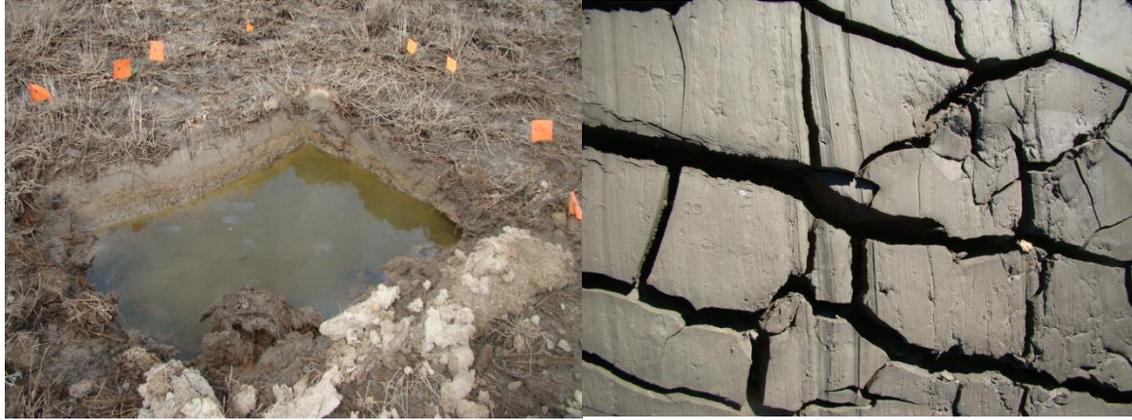
Figure 4 and 5. Show the extremely difficult conditions of the Sonoma Creek Enhancement Project. The Project team adapted quickly to difficult, flooded marsh conditions as well as unexpected soil shrinking rates to complete the project.

levee enlarging material (Figure 4). After de-watering, sediment was found to shrink by 50-60% of its excavated square footage (Figure 5). The Project team used this knowledge to guide adaptations to the original plans and specifications. Changes were made to the original design to account for the shrinkage while staying within permit requirements and project footprint.

Difficulties also arose because of the flooded marsh conditions. Marsh mound parameters were expanded to account for both soil shrinkage as well as allow Hanford to dispose of material quickly in the “dead zone” where marsh conditions could not safely allow multiple vehicle trips to load and unload the material in further drop locations.

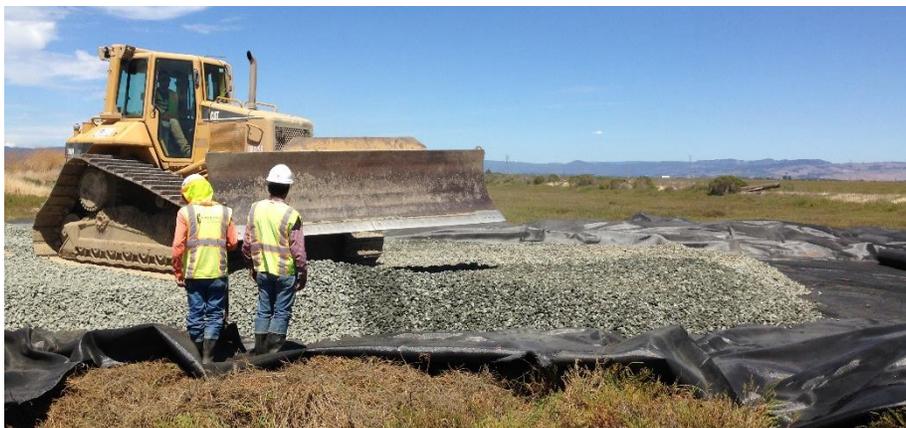
Figure 11. Hanford crew create an 18in-36in thick permeable access

As 30ft segments of tarp was laid, the construction crew placed ample loads of drain rock onto the tarp 18-24in deep to ensure vehicles would stay above the marsh plane. Once drain rock was placed, geogrid was lain on top of the rock, after which the tarp ends were wrapped around the drain rock and brought together, creating a “burrito” effect. A subsequent layer of geogrid and 6in deep drain rock was then placed on top of the tarping for additional stability.

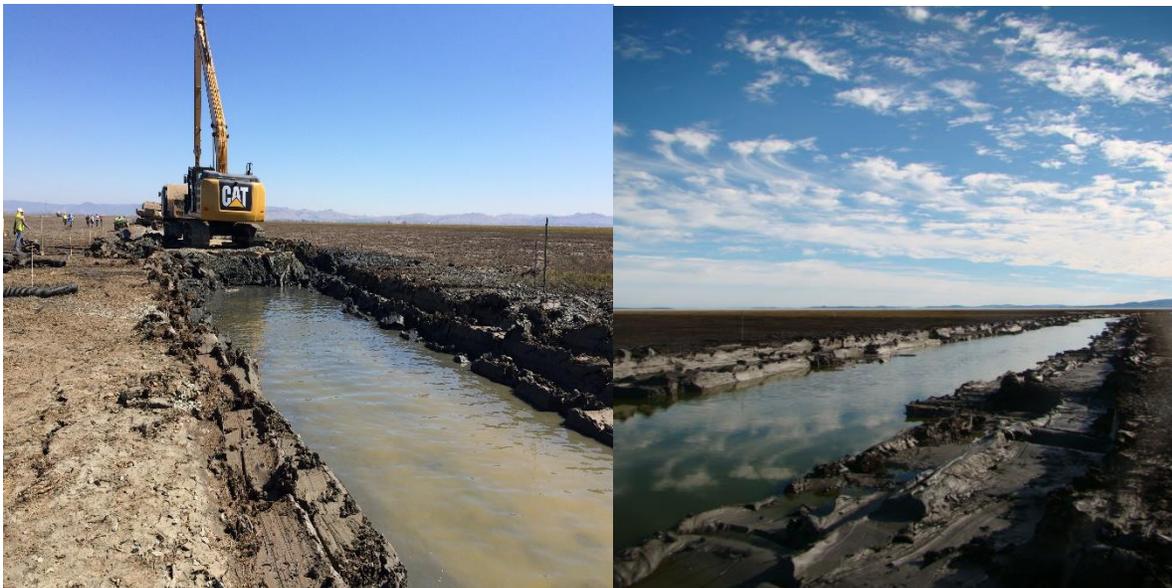
Figure 12 and 13. Show the completed excavation of the southern half of the channel, points 22+00 to 45+60. Note the stair-step/bench effect shown in figure 12 to relieve slumping pressure of unstable marsh soils. Water shown filling the channel in these images has leached from the central basin top and marsh soil, this channel is not yet open to Sonoma Creek's natural tidal flow.

Once the access road was built overlaying the construction footprint of the main channel alignment, Hanford's team simultaneously excavated and transported away drain rock and tarping road material, then continued to excavate the channel as designed in the project plans and specifications. Throughout excavation of the channels, Hanford also constructed raised features both along the channel alignment (marsh mounds) and along the levee (transition ramp). The southern end of the channel is the narrowest portion of the main channel, and was excavated to a top of about 20ft at the top of the channel. Hanford then excavated the channel down to a depth of 0ft NAVD88 (elevation) and shaped a bench into the channel banks at a 1ft high: 1ft long (1:1) ratio, as designated in the project plans (Figure 12). The bench is a stair-step contour of the channel side banks to improve side stability with these extremely soft soils; thus reducing side bank slumping into the channel which could possibly block water flow through the channel. The Project team quickly realized, however, that even with the stepping effect, the channel banks were not stable enough to hold a 1:1 ratio. ESA engineers assisted Hanford in adjusting the channel geometry so that the side banks could be constructed at more stable ratios. With the adjustments, slopes of the channel bank ranged from 1:3 to 1:6. Final adjustments brought the channel bottom elevation down to -1ft NAVD88. Those two measurements were fixed excavation guidelines while channel top width varied along the main channel alignment from 20ft across at its tapered end at (point 45+60) to 30ft across at the channel's center point (24+00, Figure 13) and up to 50ft across at the channel's mouth where it connects to Sonoma Creek (point 0+00) (Figure 7). This process was continued for most of the channel excavation. When the two connection points were reached, Hanford connected the northern ½ channel alignment to Sonoma Creek, connected the northern and southern channel alignments and connected the main channel alignment to the access road channel.

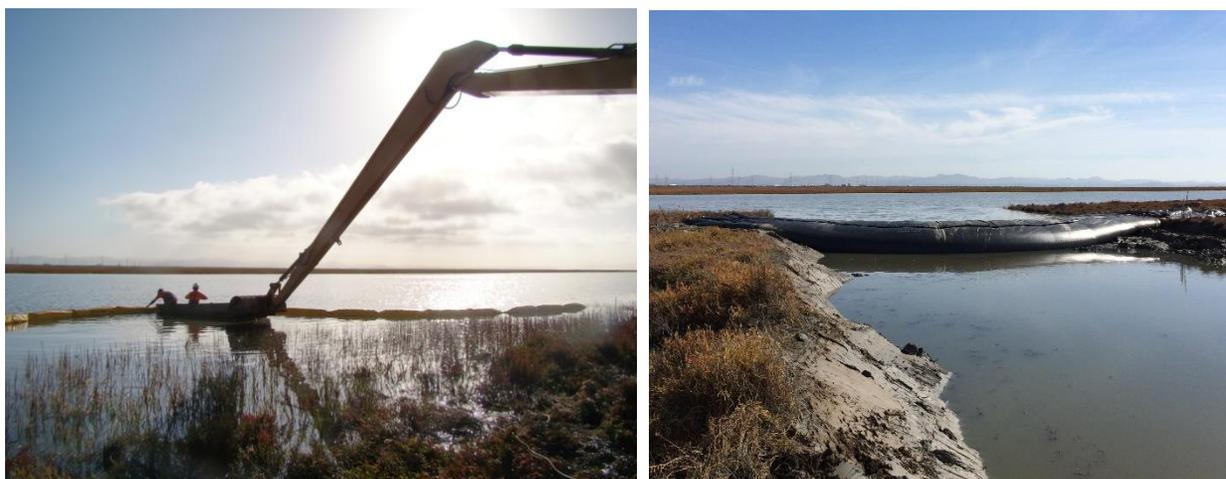
Figure 14 and 15. Connecting the northern half of SCEP channel to Sonoma Creek was a feat requiring many installments including the set-up of an exclusionary curtain, excavating the first 70 ft of channel mouth, and then the placement of a temporary Aquadam. Both the curtain and Aquadam (pictured here) prevent wildlife from entering the worksite during construction, a biological monitor was onsite for the entirety of the installation.

When Hanford had finished excavation on the southern end of the channel and the northern half of the access road (which was now safely out of rail nesting season) they began excavation of the channel mouth at Sonoma Creek. To ensure that no wildlife would enter or become trapped within the construction zone, a 100ft long turbidity curtain was installed, arcing across the 50ft wide, 7ft deep channel mouth entrance. Once the turbidity curtain was installed, the excavator began to remove soil material from the low tidal marsh habitat along the Sonoma Creek marsh/Sonoma Creek bank. The excavator removed over 70ft of channel material, 50 ft wide and 7 ft deep, placing material at the nearest marsh mounds before the 100ft long, 10,000 gallon Aquadam was installed. This water-filled damn was chosen and installed by Hanford as the best way to discourage wildlife entrapment while allowing malleability when the channel banks, bottom sediment and tides were constantly changing. An additional hope was that the construction team would be able to pump some water out of the channel to enhance the visibility of digging in the creek. Unfortunately they channel banks proved too soft to securely hold the Aquadam in place without equal water pressure holding the dam between Sonoma Creek and the channel. A wildlife biologist monitored exclusion efforts for 3 days while the curtain was placed (Figure 14), channel connection dug and the temporary Aquadam installed (Figure 15). Once the Aquadam was successfully installed and secured, Hanford continued to excavate the main channel alignment back from the channel mouth to the center point at 22+00 (Figure 7).

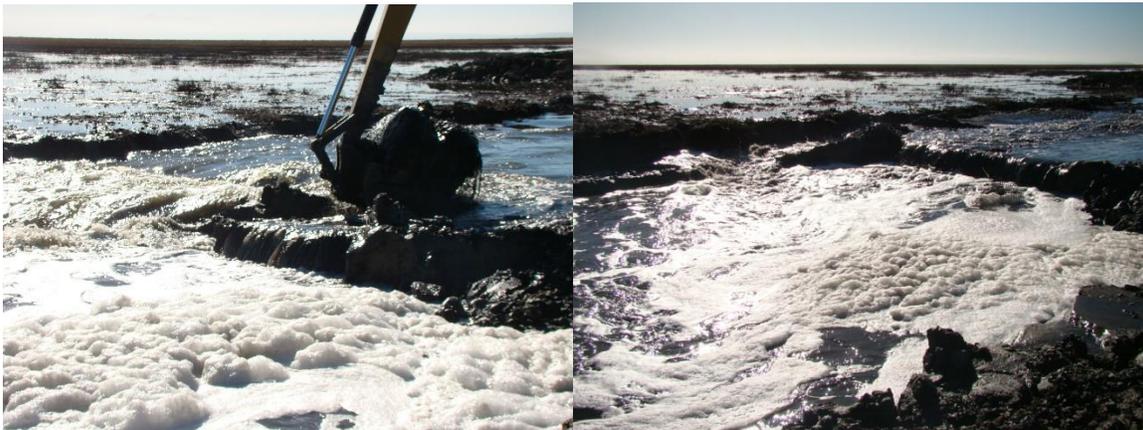
Figure 16 and 17 show the final excavation component of the channel. A 20ft soil plug was carefully removed to unite the southern and northern channel halves and allow trapped water from the central basin and southern channel half to finally flow out to Sonoma Creek. The team had to work carefully to regulate water release as the 1,000s of gallons of water could have forced through the plug, distributing the sediment into the channel and caused impediments to flow.

Within a month, Hanford had excavated the northern half of the main channel alignment from 0+00 south to 21+80 (Figure 7). At this point, a 20ft wide plug of channel material was kept as a dividing line between the freely flowing tide water of the northern end of the channel and the stagnant, entrapped water table leaching from the southern end of the channel (Figure 16 and 17). In early November, Hanford's skilled excavators slowly began to remove the top 2ft soil plug that trapped remaining water in the channel. Once the plug was removed, for the first time water from trapped on Sonoma Creek marsh and in the sediment entered the channel. The last remaining soils were removed, and within a day of channel connection, the channel began draining the marsh and circulating tidal in-flows.

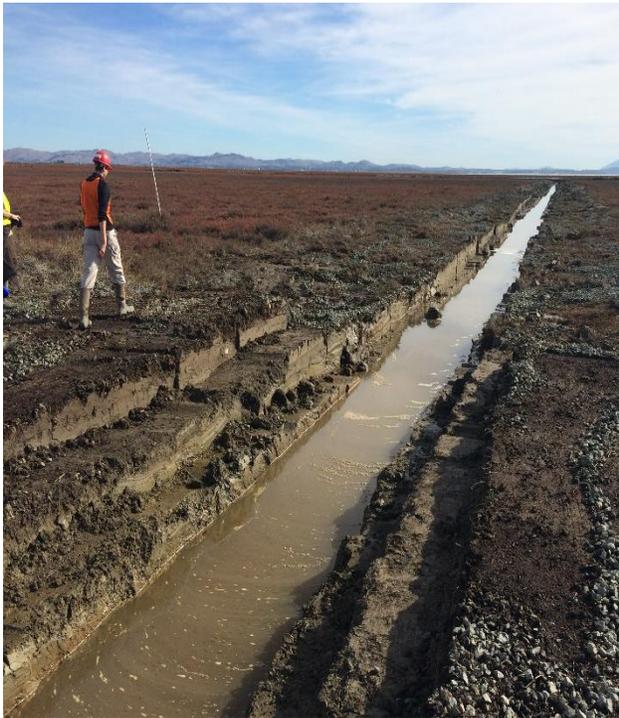
Figure 18. Staff walk along the lateral access road channel created to mitigate the depressions the weeks of heavy machinery traffic caused under the access road. This channel now stretches from the levee to the mid-way point of the main channel and ties in pre-existing MSMVCD channels to create an enhanced drainage network.

The access road section leading back to the levee left a deep depression in the marsh after months of heavy vehicle traffic from the center point of the main channel at 22+00 (Figure 7). The project team decided it best to excavate a small, lateral channel in its place. This channel would connect to the main channel, and run back towards the levee. A channel no wider than 20 ft top width, with a maximum depth of 5ft was excavated within a week (Figure 18). This access road channel also assisted in uniting and draining in 3 man-made channels that ran lateral to the levee between relic berms. These small channels had been cut in previous years by MSMVCD but had since filled with sediment and vegetation, and inhibited the flow of water off of the marsh once flooded. Uniting old channels with new, larger channels, has encouraged the drainage of vast areas of ponding water away from the levee and off of the marsh. To dispel wave and storm water activity coming up the access road channel towards the levee, Hanford left one relic berm in place to lessen the water's impact 100ft from the levee, just behind the very end of the lateral channel. A high marsh lift between this relic berm and the levee discourages water ponding and pressure on the levee and gently slopes southward into the transition ramp

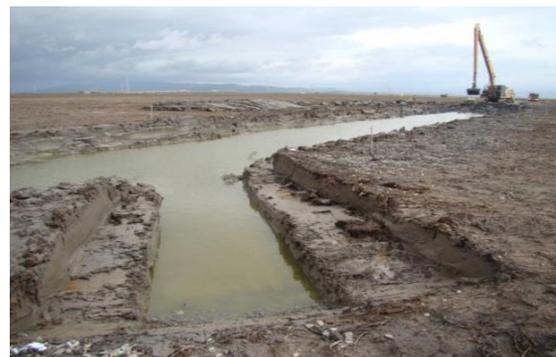
Figure 19. Seven, 20ft long lateral starter channels are expected to naturally extend into the marsh with annual tidal flow. These will be monitored for future development.

As material was excavated along the channel alignment, Hanford also excavated 7 lateral connector channels off of the main channel. These lateral starter channels will allow additional drainage of water off the basin and are expected to naturally progress into the marsh with future tidal action. Lateral channels alternated along both sides of the 4, 560ft main channel at points 37+00, 34+00, 25+00, 20+00, 15+00, 10+00, and 5+00

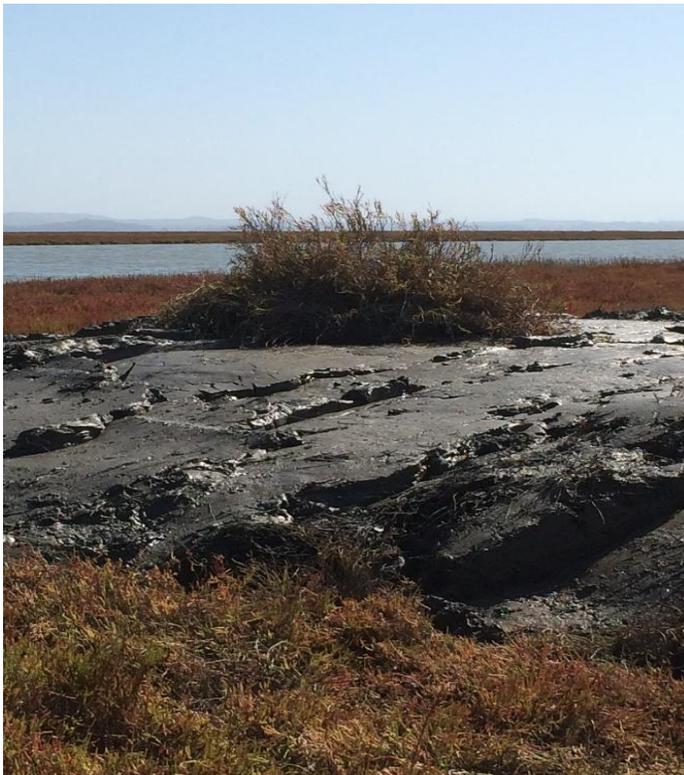
Figure 20. In areas of living vegetation (not the “dead zone”) marsh mounds were adorned with pickleweed, scrapped from the channel footprint. With vegetation placement such as this, marsh mounds are expected to fully re-vegetate faster than the 2 year expectancy for areas and features without pickleweed matts.

SCEP was permitted up to 2 acres of high marsh fill within the marsh basin in the form of marsh mounds (Figure 20). These marsh mounds are expected to provide wildlife habitat and refuge from daily high tide events that consistently flood over 260 acres of the marsh, extreme high tide and storm events (such as King Tides), and eventual sea level rise. These 2 acres of marsh mounds, though elevated off of the marsh plane (which ranges in elevation of 6.0 NAVD88 to 6.4 NAVD88) were required to reach heights no greater than 8.4 NAVD88 after material shrinkage. Limiting mound heights to 8.4 NAVD88 ensures that they maintain their marsh habitat status and are not a conversion of tidal marsh to upland habitat.

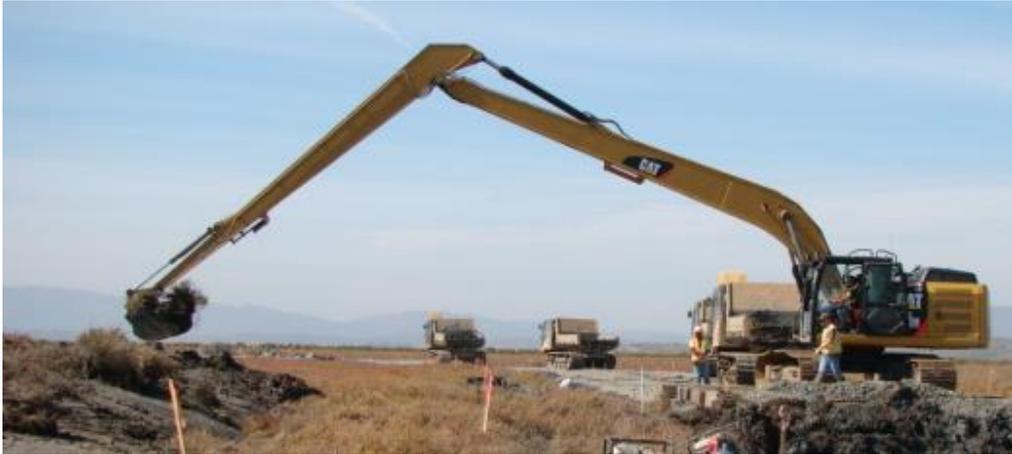
Figure 21. Marsh mounds were placed approximately 20ft from the edge of the channel, noted by wood stakes with orange tops. Mounds are expected to shrink about 50% with sun/air exposure and winter storm events and tidal flow.

Twenty marsh mounds were placed no closer than 20 ft from the edge of the main channel. These marsh mounds were originally planned to be 25ft wide by 50ft long. With these dimensions, the accumulated footprint of these mounds would impact approximately 1 acre of poorly functioning tidal marsh. The marsh mounds at the southern end of the channel were the first to be constructed from the freshly excavated soil. Measurements were taken on the day of construction and every few days to determine soil shrinkage rates. The Project team originally estimated 30% soil shrinkage as water drained from the material and winter weather leveled out the mounds. Within the first two weeks of construction or team found that there was up to 50-60% shrinkage depending on soil saturation and external climate. This information, combined with the need to dispose of soil quickly in difficult construction environments (flooding in the central basin, high tides, saturated soil, and road sinking) and our 2 acres of permitted in-marsh high tide refuge, lead the decision to expand marsh mound dimensions. With this adaptive management plan, marsh mounds ranged from 50ft to 100 ft long with an accumulative footprint of just

under 1 acres of tidal marsh. Each mound maintained the 25ft width as a limitation of excavator reach from the access road (Figure 21).

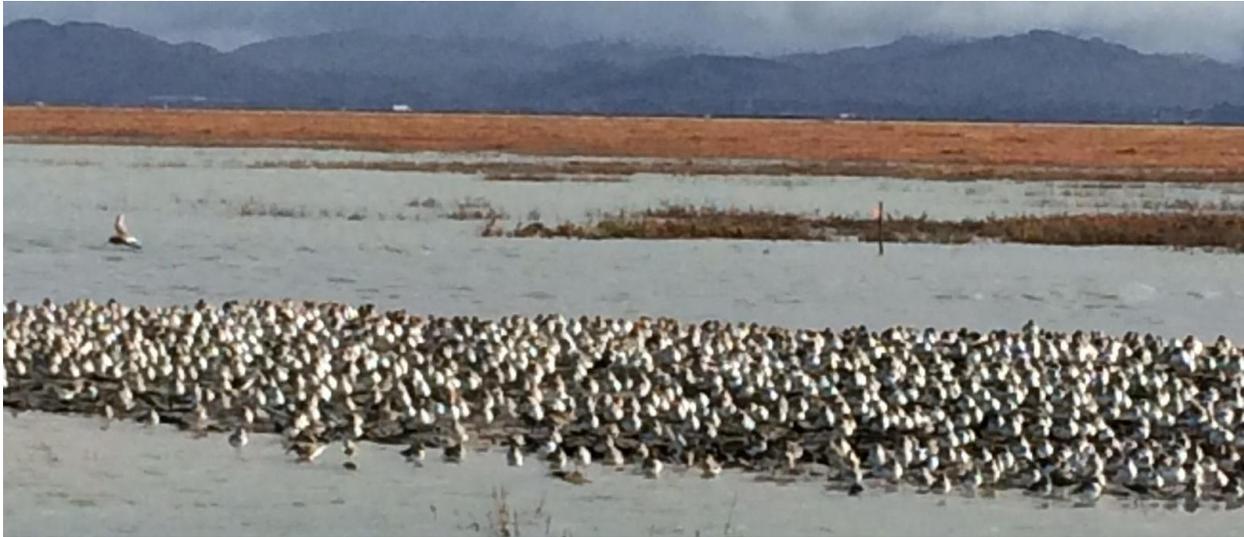
Figure 22. November 24-26, 2015 put Sonoma Creek Enhancement Project's channel and high tide refuge to the test as tides reached record highs of 9ft NAVD88. At this level of sea level rise, only the top portion of the newly constructed marsh mounds remained above water as the rest of the marsh was flooded through to the adjacent levee at 9.2-10.0ft NAVD88. This is a critical problem facing the Bay Area marshes with respect to Climate Change.

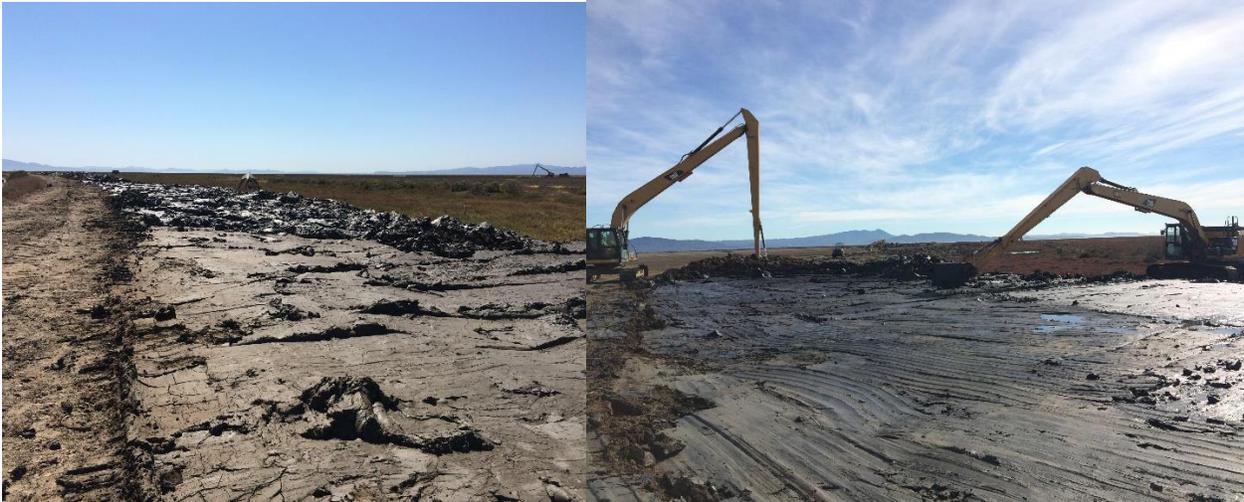
Figure 24 and 25. The left figure shows the original placement of the transition ramp's material. Material was placed as far as the excavator arm could extend from the levee on the left. The photo on the left shows the work done through Hanford's contract extension, originally proposed for 2017. With the help of a second excavator pulling from within the marsh, material is drug down 100-120ft from the levee creating a gently sloping habitat ramp which has already begun to naturally revegetate. High marsh revegetation by STRAW begins fall 2016.

Hanford completed all features described in their contract by November 15th, 2015. Marsh access and work for this project was permitted until November 30th, 2015. With an excess of two weeks of construction time, Audubon and SPBNWR staff decided it favorable to fundraise and complete the first shaping of the transition ramp while machinery was still onsite, operators available, and Hanford under contract (Figure 24 and 25).

The pre-existing marsh plane elevation in this area ranged between 6 and 6.5ft NAVD88, thus causing over 260 acres of water entrapment, prime mosquito breeding zones, and degraded wildlife habitat along marsh side of the levee. Between November 15th and 30th 2015, Hanford was able to shape material placed in the transition zone, disassemble the first interior relic berm, and connect the area between the two berms with a gentle slope. When complete, the transition ramp reached a consistent elevation of 9ft NAVD88 high (2.5-3ft above pre-existing marsh plane) and an average width of 100ft (and occasionally wider or narrower depending on material availability). The final slope along the transition ramp on average reached 40:1 (40ft wide: 1ft high). This ratio is the optimum transition ramp slope for small mammals and secretive marsh birds of concern in San Francisco Bay marshes (Baylands Ecosystem Habitat Goals Science Update, 2015). These parameters were carried out for approximately 2,000 linear feet of the originally proposed 3,200 linear foot transition ramp, from the access road channel to the south. Due to unexpectedly high material shrinkage rates and the need to dispose of material in the marsh to relieve road pressure, the full 3,200ft length of the transition ramp was not achieved. Where less material was

available, at the southern end of the transition ramp, Hanford gently transformed the available material into approximately 600 linear ft of “high marsh lift” to discourage water ponding in problematic areas and bring sunken areas along the levee back up to surrounding marsh plane height of 6-6.5ft NAVD88 (Figure 7).

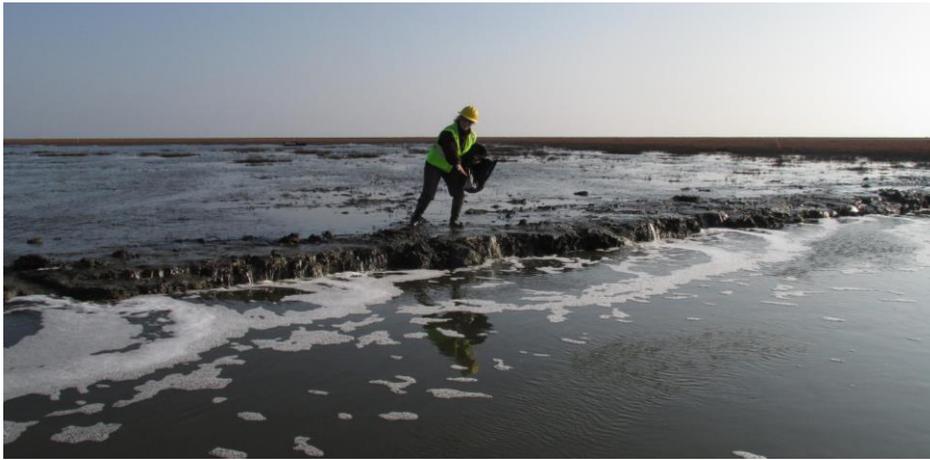
Figure 26. USFWS Biologist Meg Marriott is ecstatic about the immediate response of the new channel as 1,000s of gallons of trapped water now flow, uninhibited, into the channel and out to Sonoma Creek and San Pablo Bay.

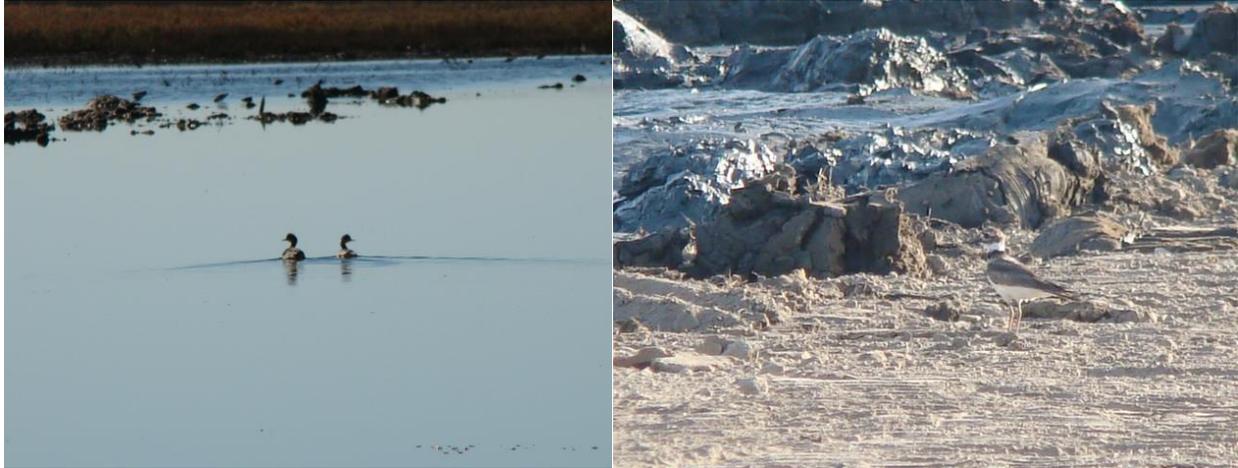
Figure 27 and 28. Photos taken during construction of Grebes locomoting and foraging in the new 7-acre channel and Killdeer inspecting the transition ramp shortly after material was placed. These two new habitats will be monitored as part of the post-construction monitoring plan.

Numerous birds as well as other wildlife have been found using new and enhanced habitats other than the marsh mounds such as the Grebes pictured below locomoting and diving in the new channel and the Killdeer found wandering along the new transition ramp (Figure 27 and 28). In one of this spring’s songbird surveys, a Rock Wren

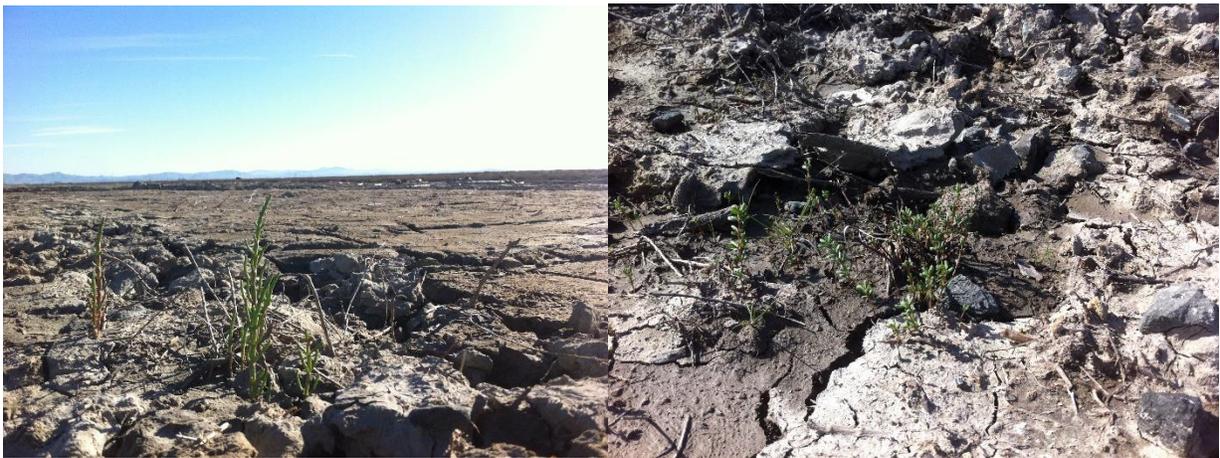
Figure 29 and 30. Vegetative regrowth of low marsh species in constructed transition ramp and channel edges.

Just a few weeks after construction ceased on the project site December and January winter rains brought fresh water to the marsh, new growth of Pickelweed and Alkaline heath (*Sarcacornia pacifica* and *Frankenia salina*) became visible in many exposed habitats. By January, areas where vegetation had been cleared to lay access road and excavate the main channels as well as the newly placed material of the marsh mounds and the transition ramp have already begun to show signs of life (Figure 29 and 30).

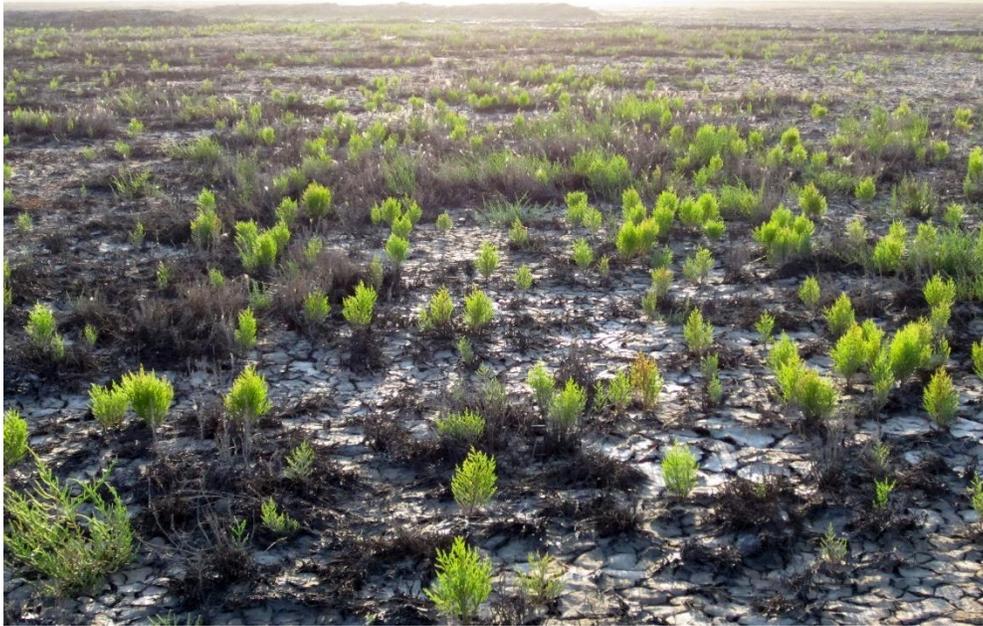
Figure 31. Pickleweed comes back to life after months of inundation as the new SCEP tidal channel drains once stagnant water off the basin, flushing out the algal mats and allowing the central basin’s soil to dry.

In May this year, while completing songbird surveys, Audubon and Refuge staff were bedazzled by the resilience of the interior marsh “dead zone.” Just six months after construction completion, old Pickleweed, thought to be dead, began to burst back to life in the desecrated central basin (Figure 31). Showing the first vibrant signs of life and great hope for the 260 acres of exposed material.

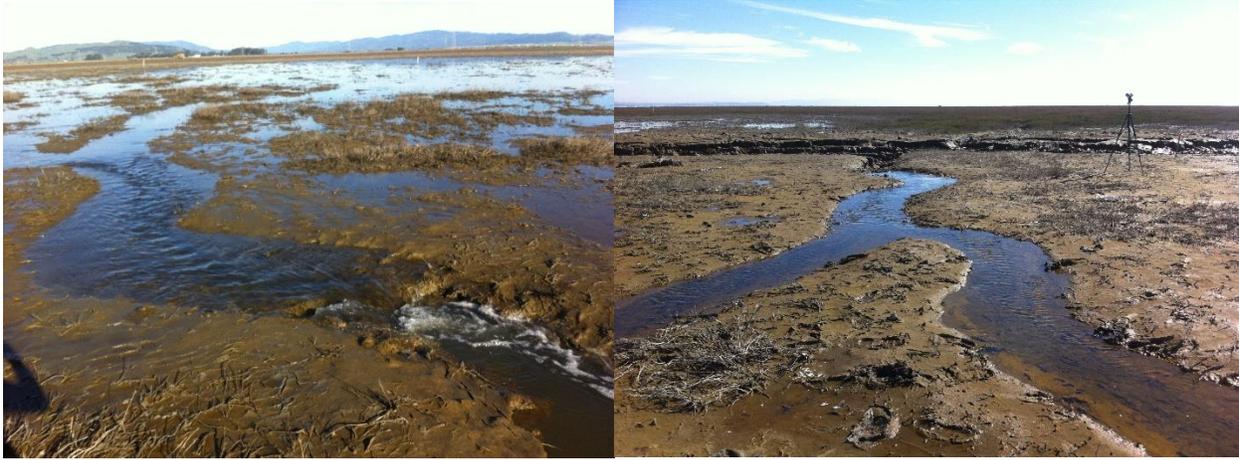
Figure 32 and 33. The formation of new, natural channels becomes obvious as water drains off of the central basin through select pathways. These will continue their sinuous progression further into the marsh, relieving ponding water further away from the excavation site.

Above photos taken February 16, 2016 (only two and a half months post- construction) exhibit newly formed channels on the Sonoma Creek marsh from the SCEP. The left photos clearly shows the abundance of water that is flowing off of the plane and the progression of the toe further into the marsh (Figures 32 and 33).

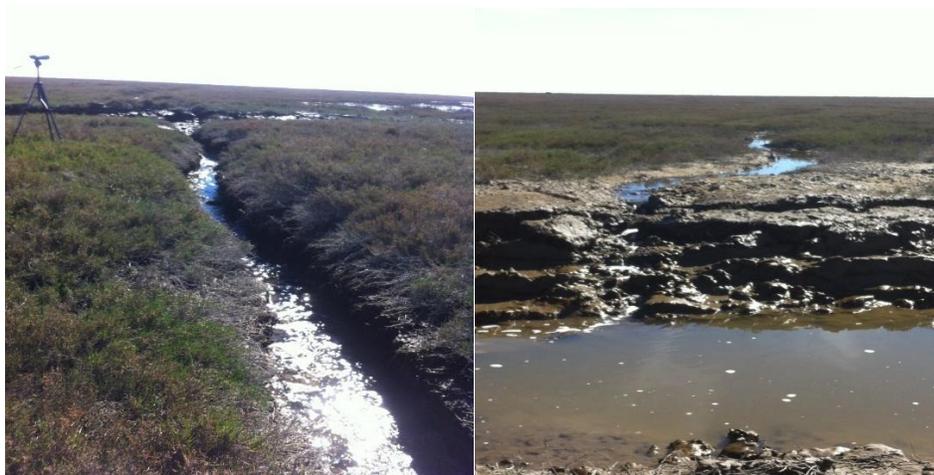
Figures 34 and 35. These revitalized MSVCD made channels have begun to expand and lengthen back into the marsh now that they are tied into the main channel.

Photos below show the importance of these channels in relieving flood conditions on the plane, allowing the mud flats to aerate and dry out which was impossible before the Project.

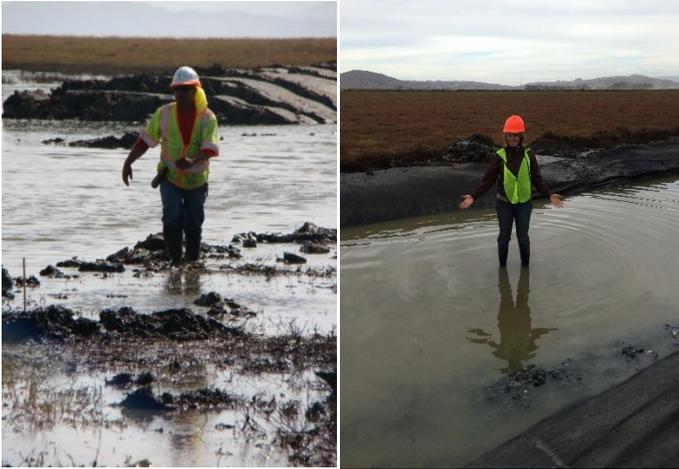
Figures 38 and 39 show the flooded marsh plane conditions the Hanford and project partner crew experienced throughout the construction timeline. At one point, the road sank up to 3ft below the marsh plane, luckily this compaction was within the footprint of the channel.

- High Water Table- The natural water table of Sonoma Creek marsh was extremely high because of years of inundation from entrapped tides and fresh rain water. This posed an extra challenge to Hanford’s excavators who were removing soil from the main channel as water leached off of the central basin and out from the soil into the channel.

- Unexpected material shrinkage- Once excavated, material was found to shrink when exposed to dry air, heat and constant tidal and rain flushing. Marsh mound parameters were expanded to account for 50-60% material shrinkage.
- Daily high tides and seasonal king tides- Tides were the most challenging variable in the completion of this project (Figures 36 and 37). Daily tides made general work conditions difficult for Hanford on the ground and in maintaining their access road. Excavation of the channel was delayed by one week to allow repairs to the road way to ensure that work conditions were safe, machinery was not at jeopardy and that the project could be completed.
