**State of California**  
**Department of Fish and Wildlife**

**Re:** 2017 Kelsey Creek Fish Ladder Enhancement

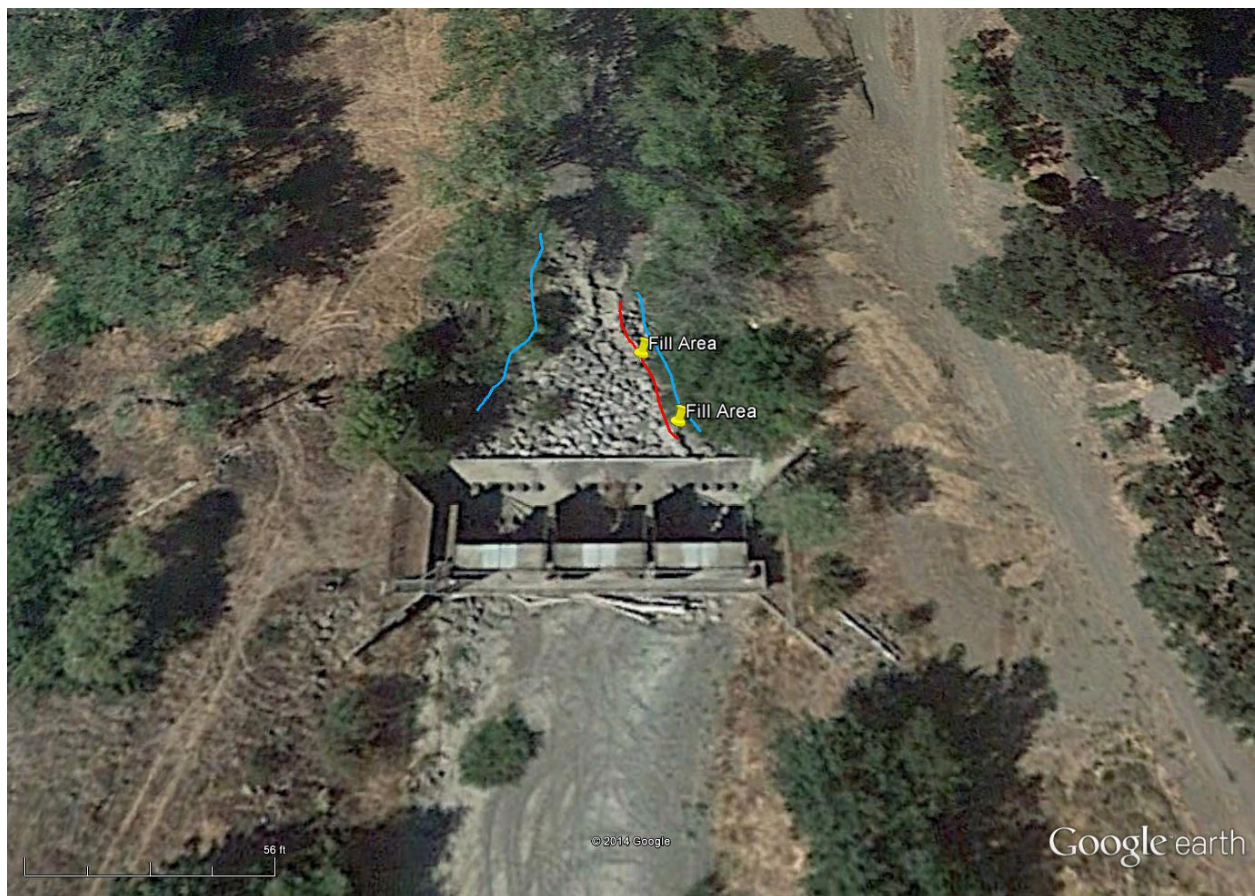
Figure 2. Area below detention structure on Kelsey Creek, Lake County.

Beginning on September 20, 2017 and ending on September 21, 2017, California Department of Fish and Wildlife (Department) employees completed a fish ladder enhancement project on Kelsey Creek (Lake County) (Figure 1). The purpose of the project was to improve one of the two existing fish ladders at the Kelsey Creek Detention Structure for the Clear Lake hitch (*Lavinia exilicauda chi*) (hitch). The hitch is currently listed as threatened under the California Endangered Species Act (CESA). According to Lake County Water Resources staff, hitch only used the west ladder to migrate upstream during their spawning season. The Department is hoping that by improving the east fish ladder which is highlighted in red in Figure 2, that hitch will be able to use it in order to make it to their spawning grounds.

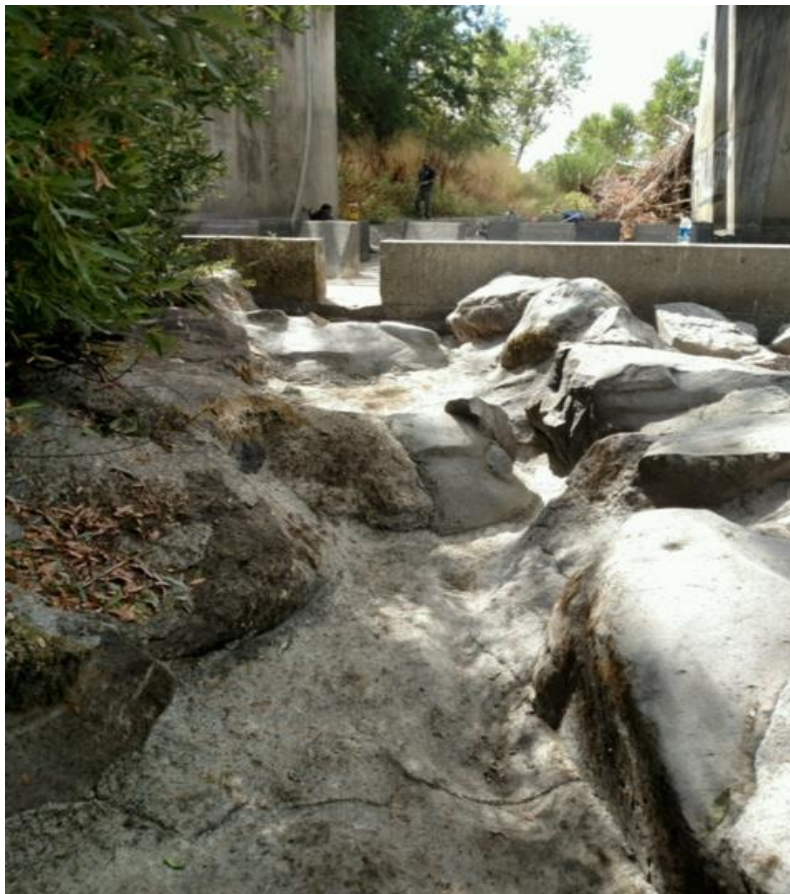
Figure 3. Kelsey Creek Detention Structure East Fish Ladder looking upstream towards detention structure (September 20 and 21, 2017).

Figures 3 – 6 are pictures documenting the reconstruction of the east fish ladder. The ladder changes included putting in holding pools for hitch to rest in during the upstream migration as well as breaks to help slow the current down. In the spring of 2018 and future spring seasons, Department staff will monitor how well the ladder improvements impacted the migration of hitch.

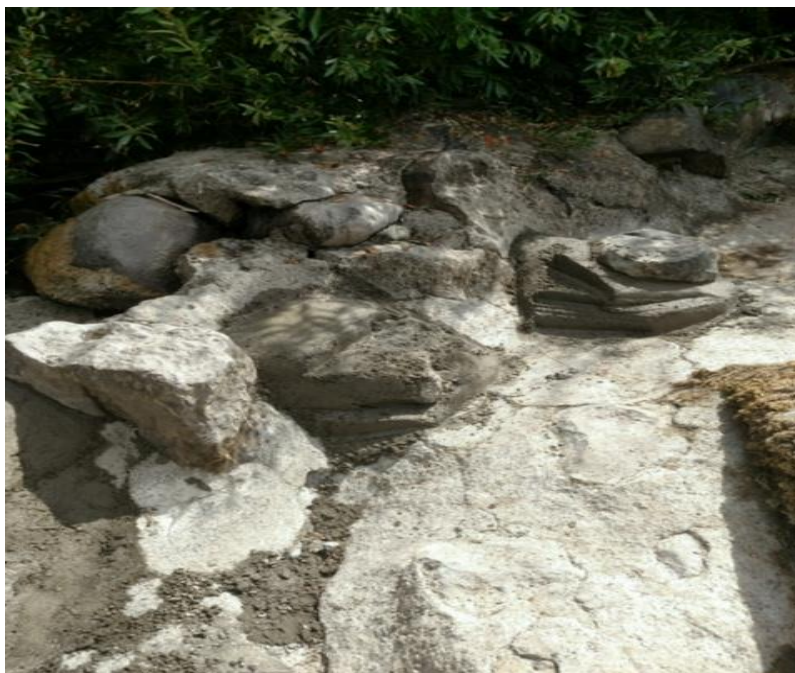
Figure 4. Kelsey Creek Detention Structure East Fish Ladder after concrete was added in order to slow down flows exiting detention structure (September 20 and 21, 2017).

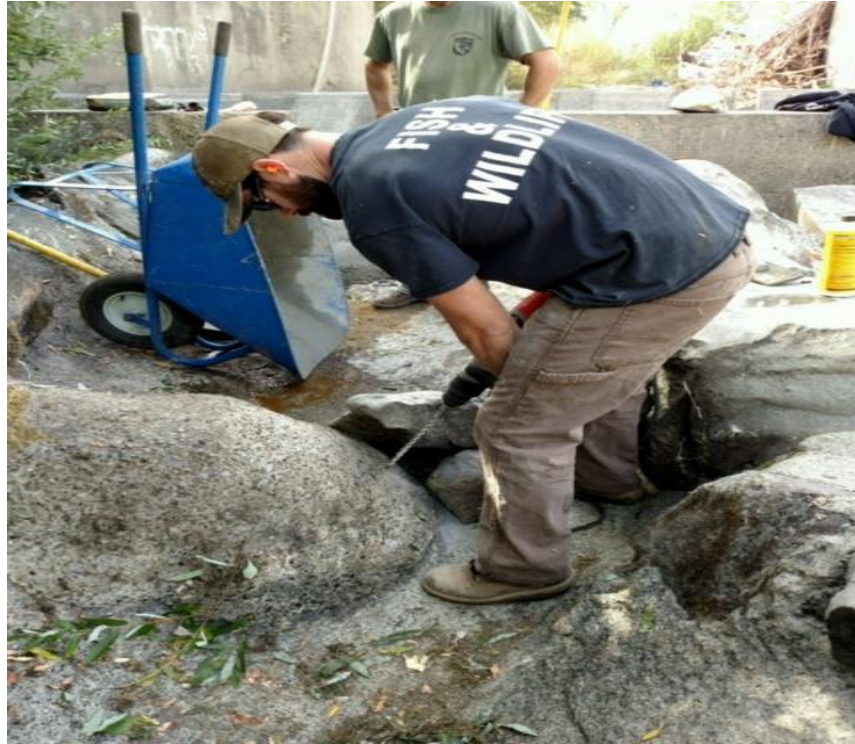
Figure 5. California Fish and Wildlife staff building up a wall on the Kelsey Creek Detention Structure East Fish Ladder in order to form a resting pool for hitch (September 20 and 21, 2017).

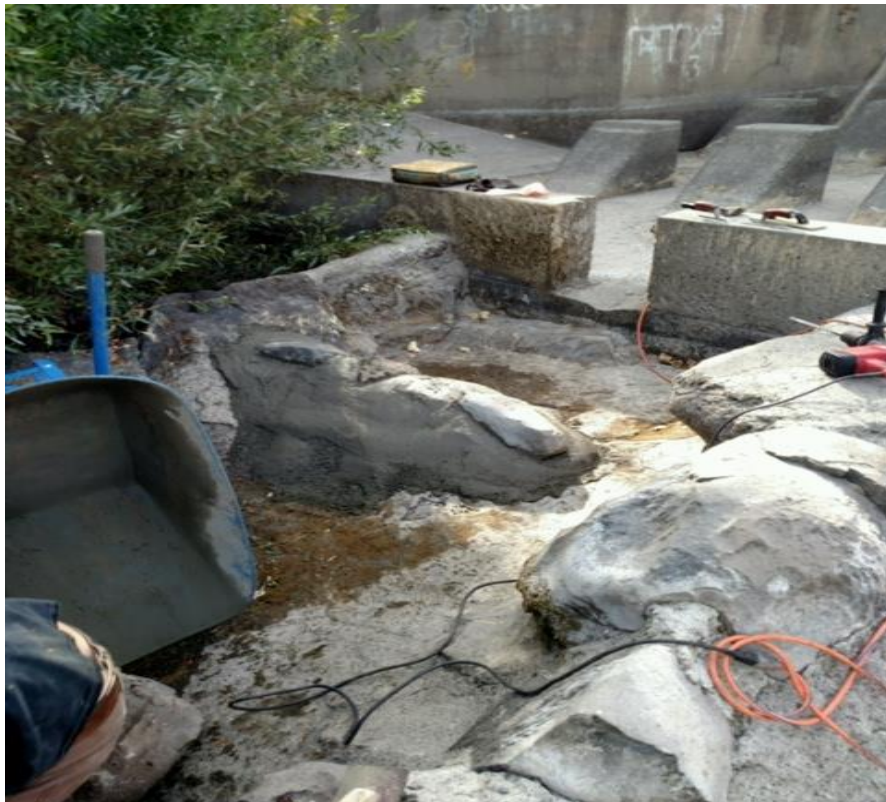
Figure 6. Finished wall, forming a resting pool for hitch on Kelsey Creek Detention Structure East Fish Ladder looking upstream (September 20 and 21, 2017).
