**Summary of Fish Rescues Conducted at the Fremont Weir and Northern Yolo
Bypass
Winter 2016 through Spring 2017**

**Prepared for the United States Bureau of Reclamation
By California Department of Fish and Wildlife
North Central Region
August 2017**

SUMMARY OF 2016-2017 SEASON FISH RESCUES CONDUCTED WITHIN THE YOLO BYPASS

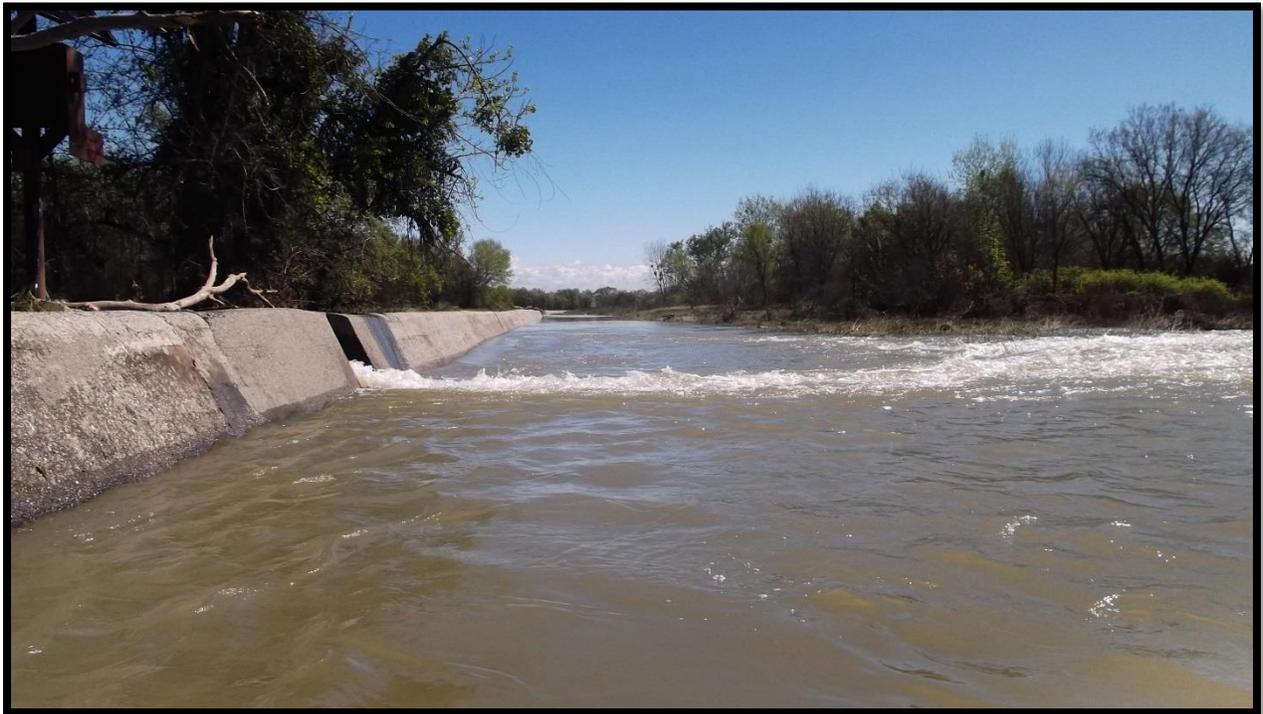
Figure 3. View of Fremont Weir during after cessation of overtopping event in March 2017. Flashboards have been removed to facilitate volitional fish passage to the Sacramento River prior to rescue operations.

A Denil fish ladder was constructed in the east section of Fremont Weir in 1966 to facilitate adult fish passage back into the Sacramento River following several years of Chinook salmon stranding in the Yolo Bypass. The Denil fish ladder is essentially a 1.2 meter-wide, zero percent gradient notch with wood baffles on the bottom of the structure. CDFW opens the fish ladder to initiate volitional fish passage through the weir to the Sacramento River by removing flashboards on the upstream side of the structure. The flashboards are removed upon cessation of weir overtopping events as authorized by Central Valley Flood Protection Board permit number 4899 issued to CDFG on 1 April 1965 (Central Valley Flood Protection Board 2016) (**Figure 3**).

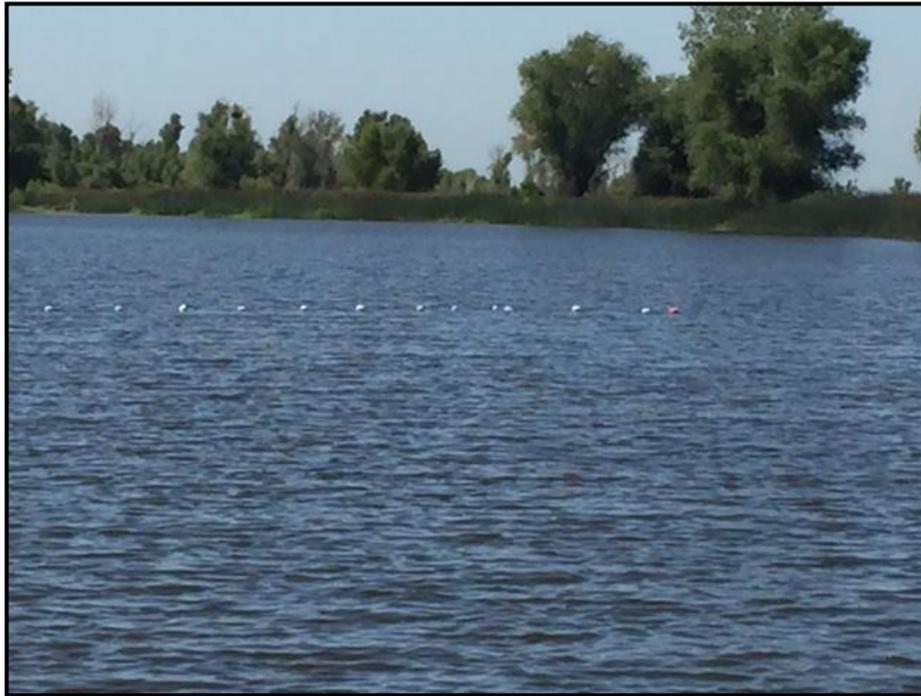
Figure 4. Trammel net deployed in the Tule Pond, June 2017.

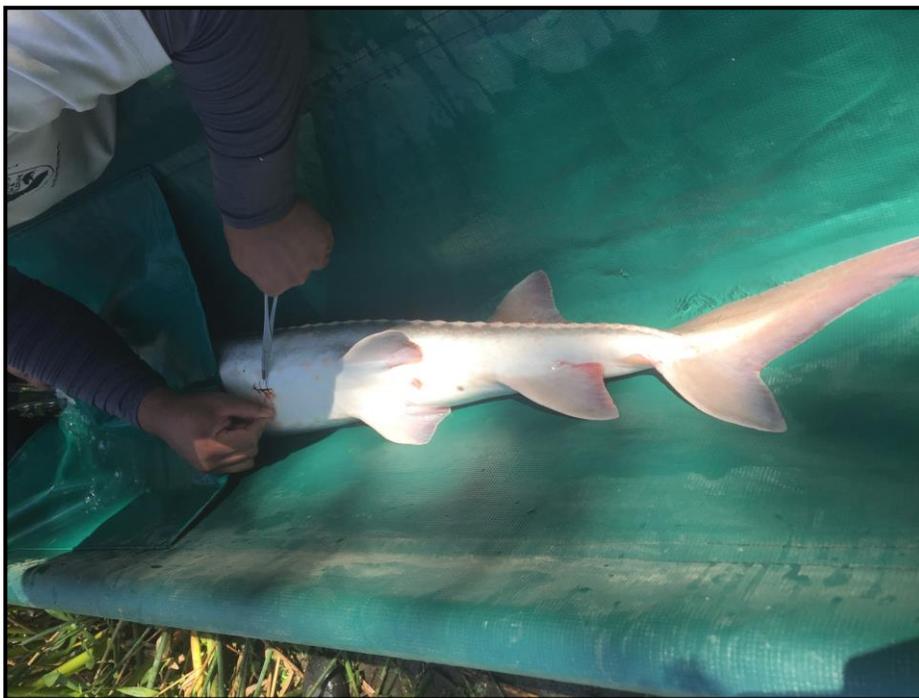
Figure 5. Adult white sturgeon rescued from the Tule Pond receiving an acoustic transmitter.

CDFW staff captured and relocated two adult white sturgeon from the Tule Pond; one adult white sturgeon (193-cm fork length) on 28 June 2017 and one adult white sturgeon (148-cm fork length) on 20 July 2017. Both sturgeon appeared to be in good condition and were tagged and released in the Sacramento River at the Elkhorn Boat Launch Facility. No sturgeon were captured or observed during the three rescue efforts/DIDSON surveys conducted in the Oxbow Pond. Other fish captured in the trammel net during sturgeon rescue efforts included American shad (*Alosa sapidissima*) and brown bullhead (*Ameiurus nebulosus*). Both white sturgeon rescued from the Tule Pond were subsequently detected approximately 20 hours post-rescue detected by a real-time acoustic receiver deployed 11.3 km downstream in the Sacramento River at the Interstate 80 Freeway Bridge (**Table 1**). Daily mean and maximum water temperatures logged by the HOBO® data logger for the Tule Pond during the rescue period are shown in **Figure 6**. The rescue period is defined as the logger deployment date until the last sturgeon was rescued; 20 June to 20 July 2017. The highest daily mean temperature recorded (27.9° C) occurred on 23 and 24 June 2017; and 17 July 2017; while the highest daily maximum temperature recorded (29.5° C) occurred on 22 June 2017. The mean water temperature over the duration of the rescue period was 25.9° C. Water temperatures in the Sacramento River at the Elkhorn Slough release location ranged from 23 °C to 25 °C at the time of release.

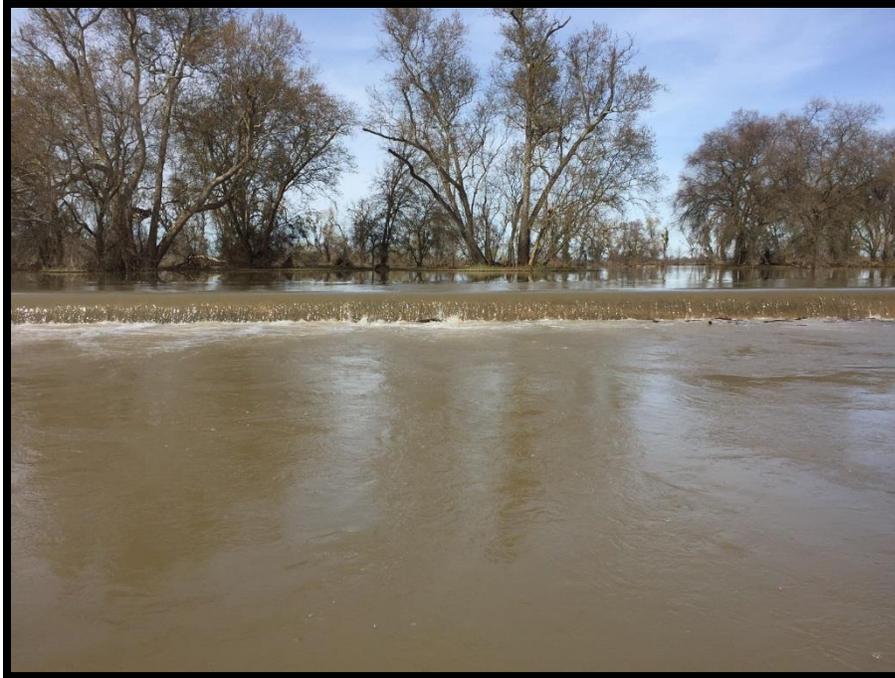
East section of Fremont Weir two days prior to Denil fish ladder flashboard removal. Photograph taken 9 March 2017.

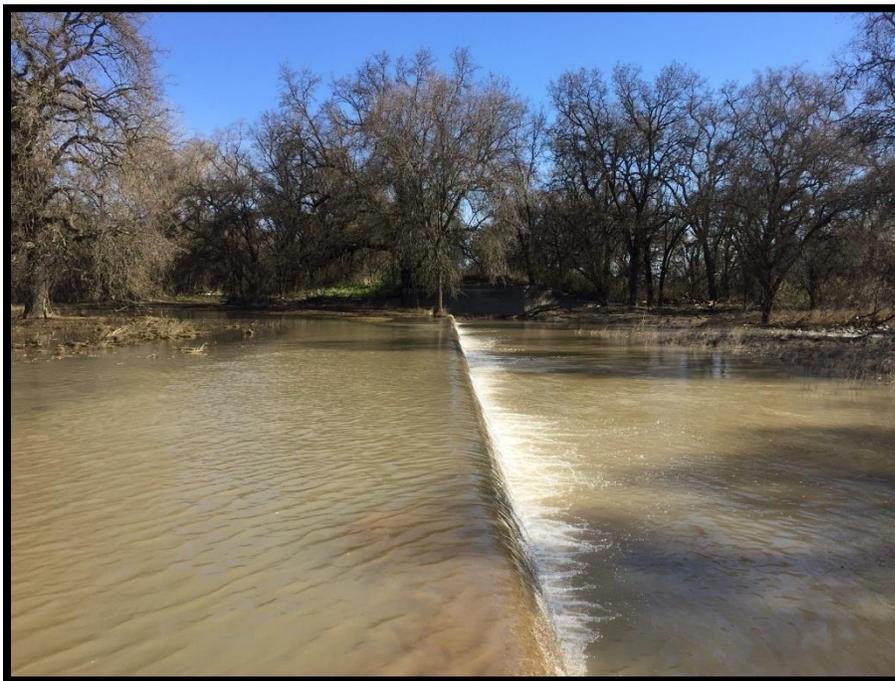
West section of Fremont Weir two days prior to 14 March 2017 fish rescue. Photograph taken 12 March 2017.

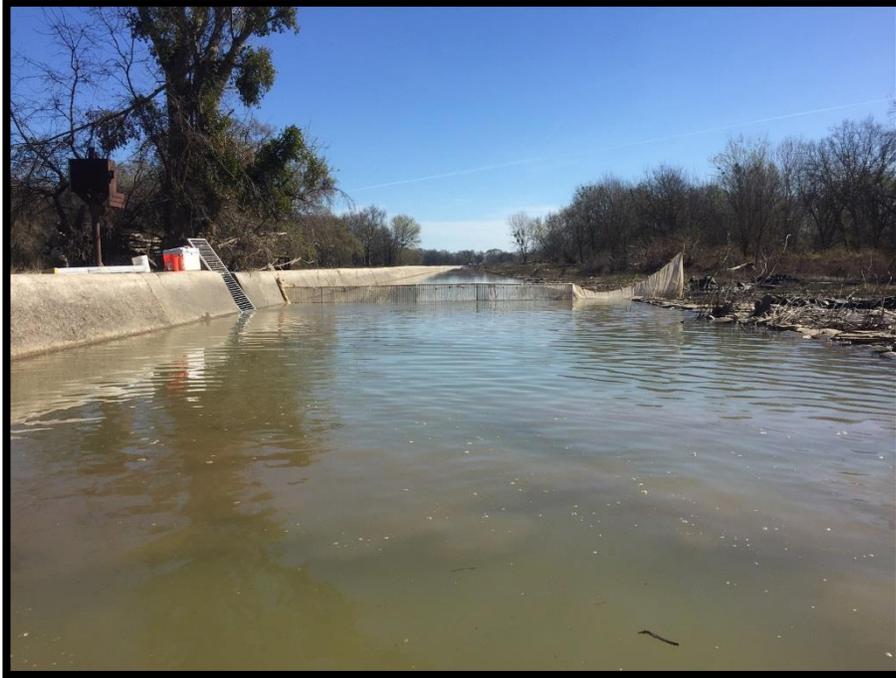
View of temporary fish barrier deployed at the fishway on the east section of Fremont Weir. Photograph taken 14 March 2017.

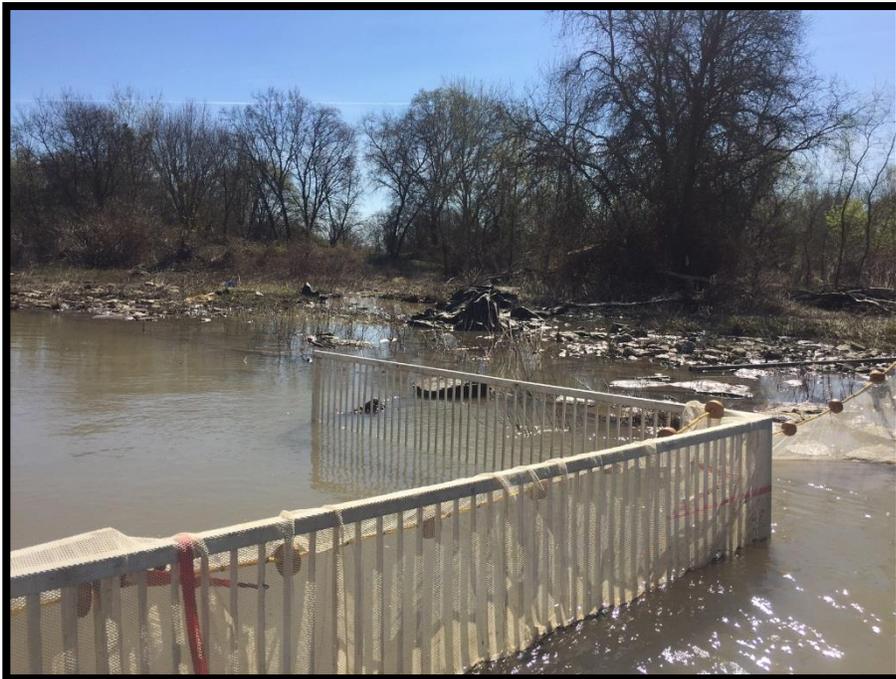
Close-up view of temporary fish barrier deployed at the fishway on the east section of Fremont Weir. The barrier is constructed of specially designed crowder racks and ¼ inch mesh beach seine. Photograph taken 14 March 2017.

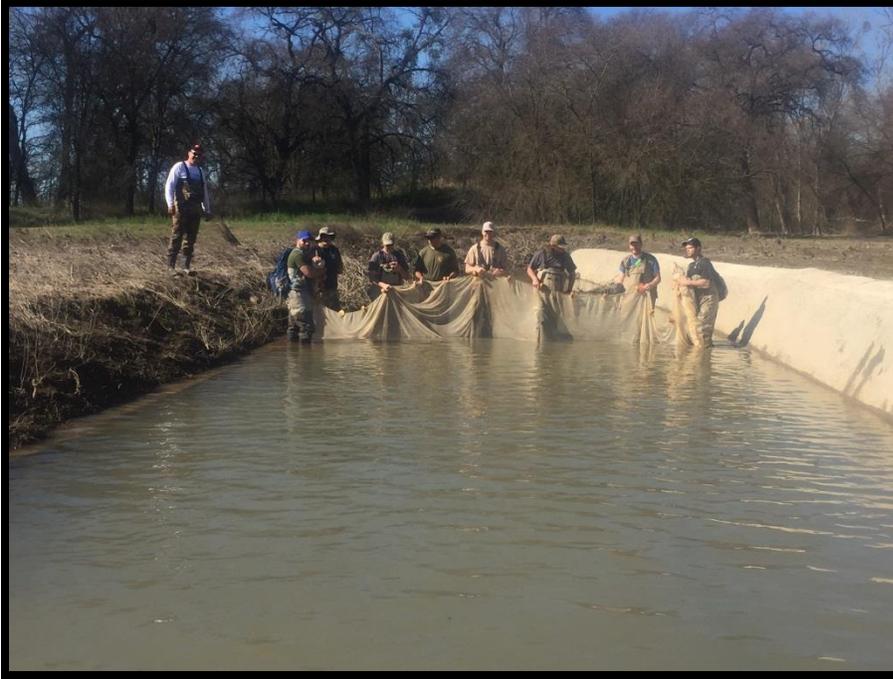
CDFW staff Initiating fish rescue effort at east section of Fremont Weir. The seine is slowly walked toward the temporary fish barrier shown on the previous page to crowd fish prior to capture and rescue. Photograph taken 14 March 2017.

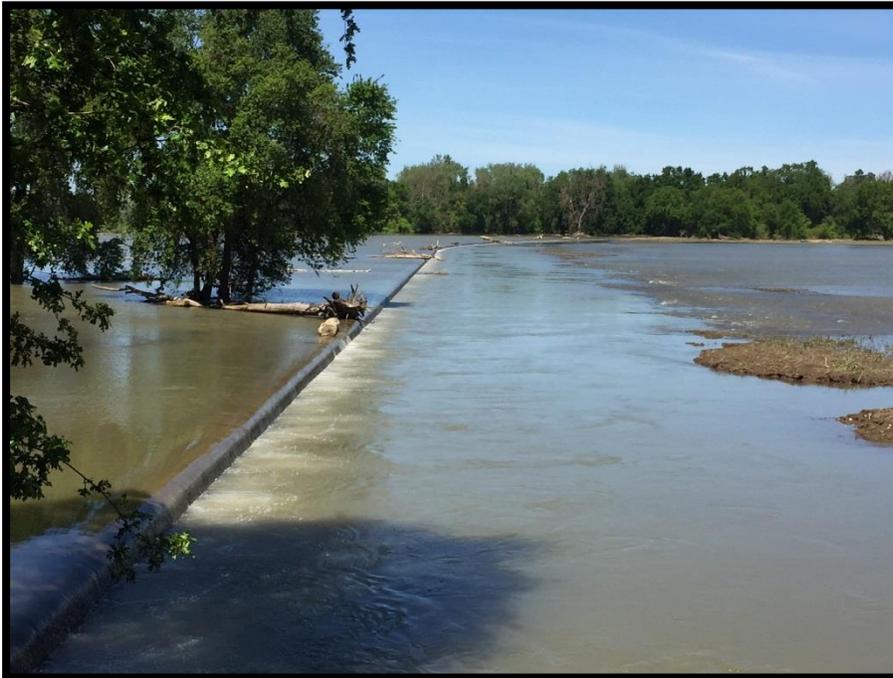
West section of Fremont Weir one day prior to 4 May 2017 fish rescue. Photograph taken 3 May 2017.

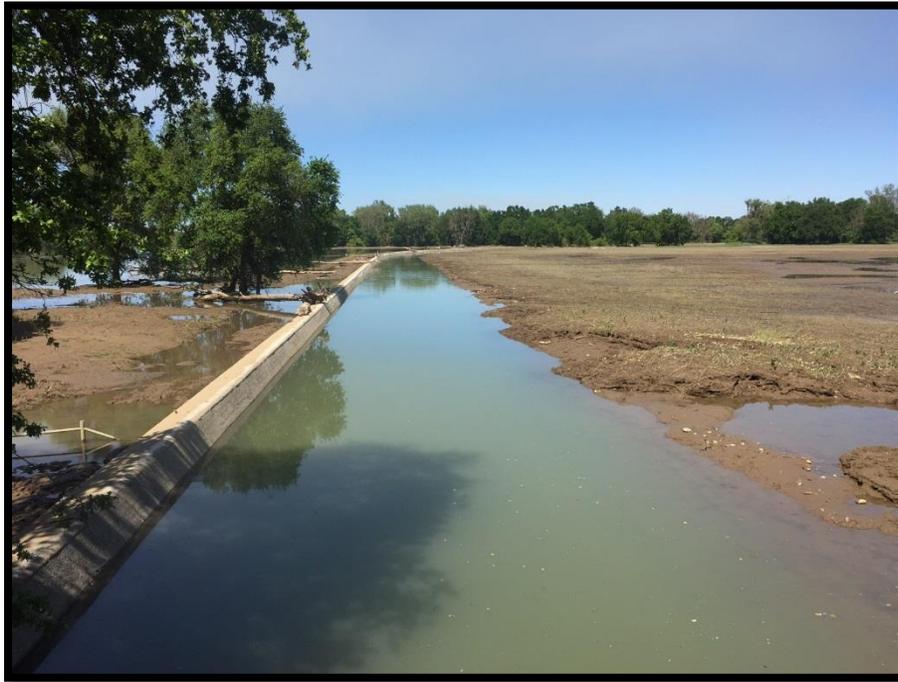
West section of Fremont Weir prior to 4 May 2017 fish rescue.
Photograph taken 4 May 2017.

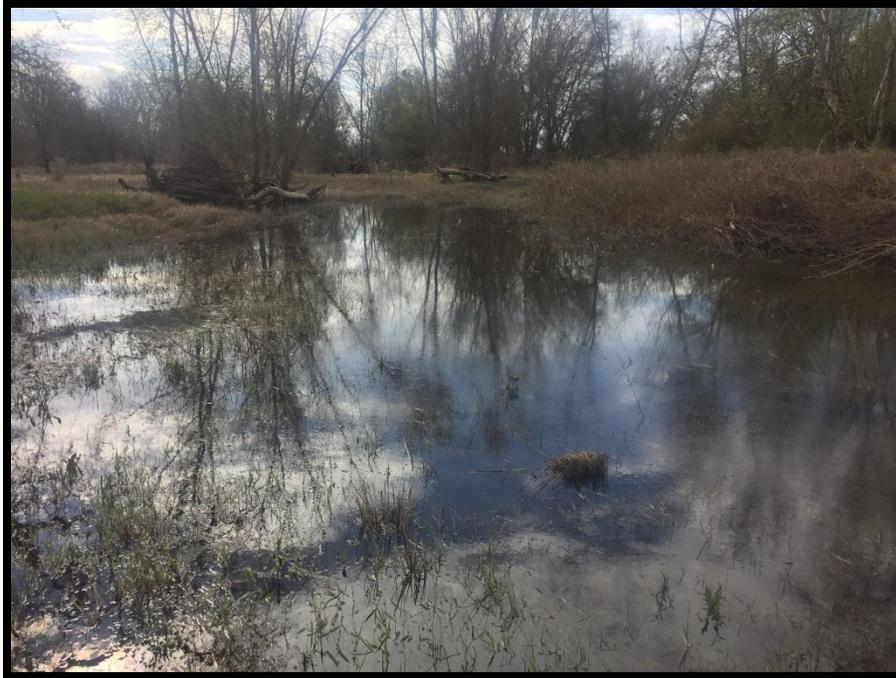
View of scour pool approximately 30 m southeast of the Fremont Weir Denil fish ladder. Hatchery origin Central Valley steelhead and fall run Chinook salmon were rescued from this pool on 15 March and 5 April 2017. Photograph taken 15 March 2017.

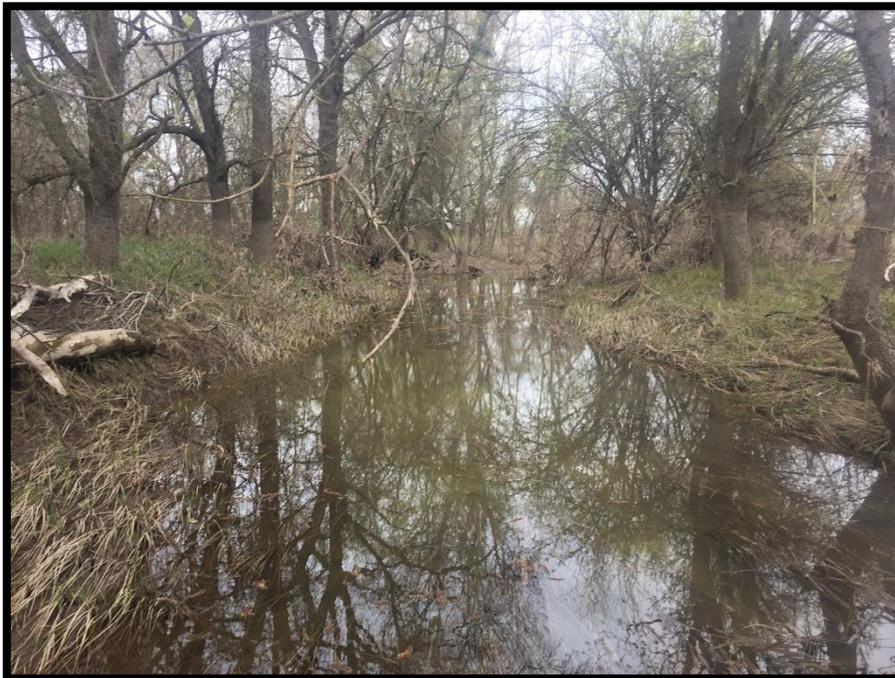
View of scour pool in the northern portion of the Fremont Weir State Wildlife Area. Central Valley steelhead were observed in this pool, however; excessive depth prevented capture and rescue. Photograph taken 15 March 2017.

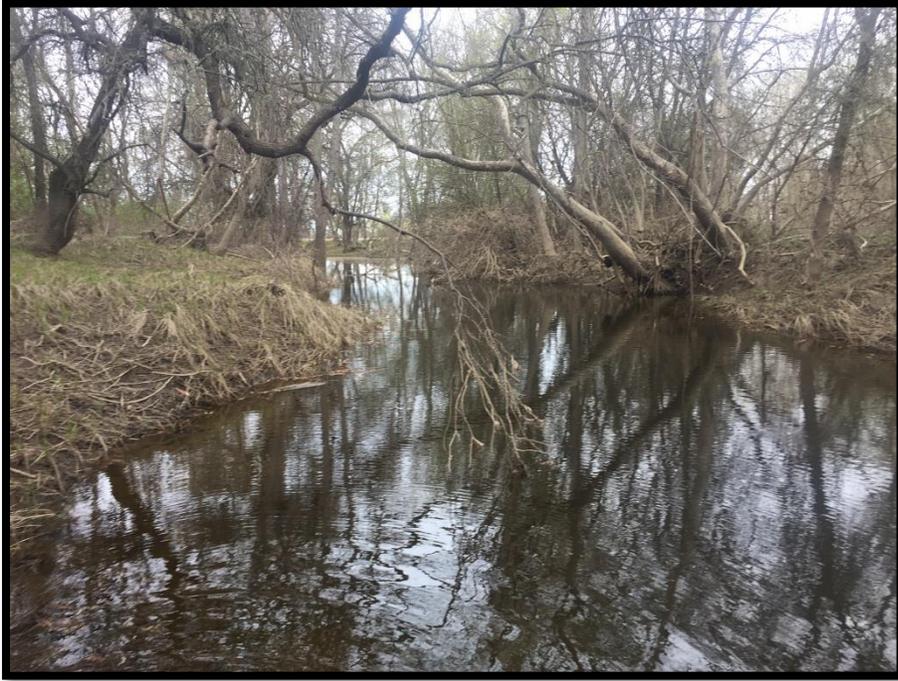
View of scour pool in the northern portion of the Fremont Weir State Wildlife Area. Central Valley steelhead were observed in this pool, however; excessive depth prevented capture and rescue. Photograph taken 15 March 2017.

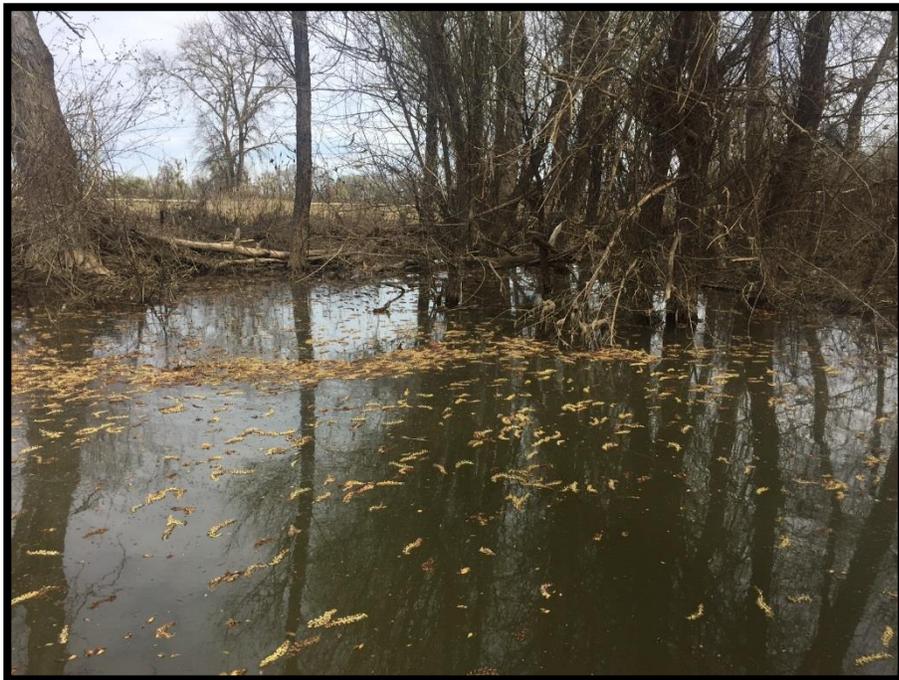
View of scour pool in the northern portion of the Fremont Weir State Wildlife Area. Central Valley steelhead were observed in this pool on 15 March 2017. Excessive depth prevented capture and rescue. Photograph taken 15 March 2017.

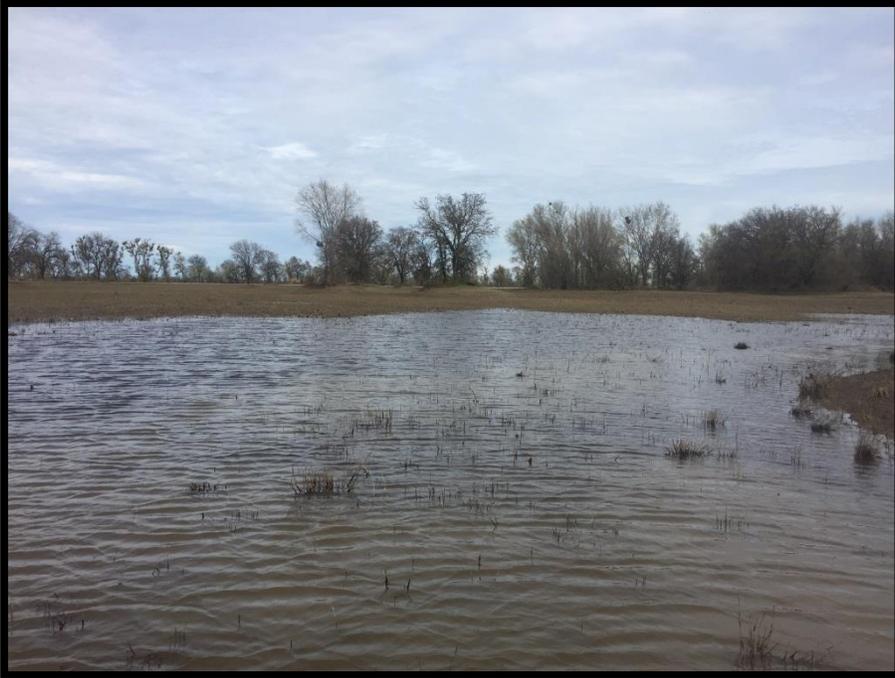
View of shallow pool 20 downstream of Fremont Weir. No fish were observed in this feature and in several others with similar characteristics. Abundant wading bird tracks were often observed in these features which may be an indication of avian predation. Photograph taken 15 March 2017.

Interestingly, hatchery origin Central Valley steelhead were the most numerous fish species encountered during stranding surveys of scour pools within the northern portion of the Fremont Wildlife area. A possible explanation is that the steelhead were rearing and foraging in the various scour channels which are similar in function to perennial stream habitat. The steelhead likely retreated to the deeper pools of these features after flows receded. Almost all of the salmonids encountered during the survey of downstream of weir features were captured or observed in relatively deep pools with complex habitat. Although salmonids or other fish were not observed in the majority of the scour pools and large ponds, conditions such as excessive depth, presence of woody debris, and turbidity limited the ability of staff to adequately sample these features, and it is likely that fish were present within them. Relatively few live juvenile salmonids or other fish species were encountered in the isolated shallow, grassy swales. Oftentimes considerable numbers of wading bird (e.g. blue heron, great egret) tracks were observed in these features, indicating avian predation may have occurred prior to our surveys.
