Drought assessments of imperiled Paiute cutthroat trout populations in California

2015

Alpine and Mono counties

Department of Fish and Wildlife

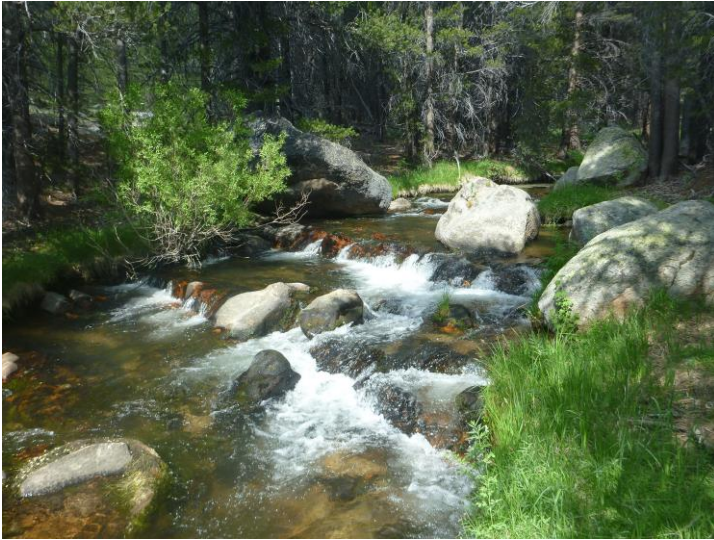
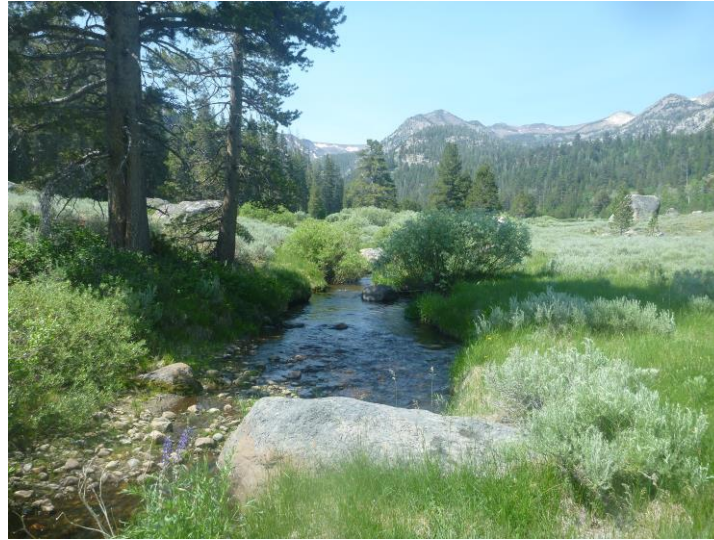
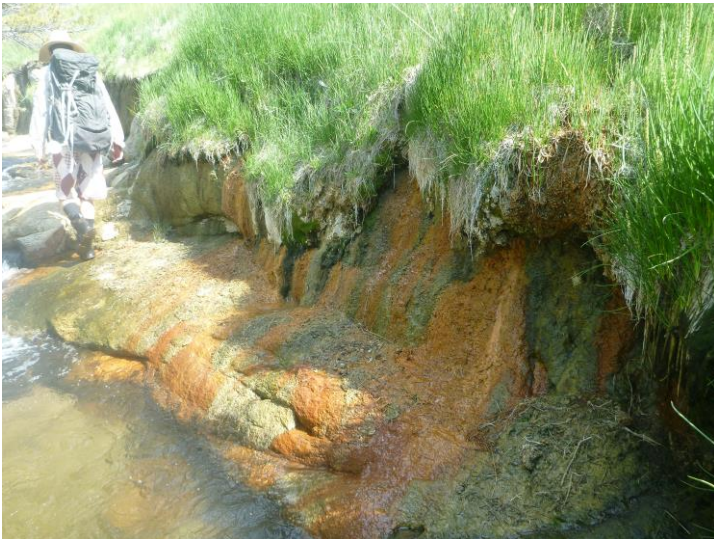
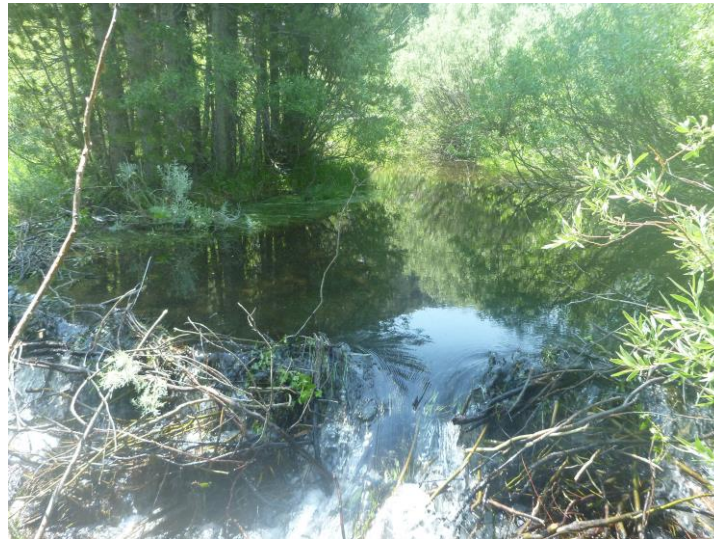
One small-sized trout was observed in 2.5 miles of habitat (assumed to be Paiute Cutthroat Trout). Visual assessment was difficult due to high water velocity, thick instream vegetation, and glare created by the substrate color and composition (Figure 2). Four wetted tributaries entered Silver King Creek in the surveyed reach: Bull Canyon, Four-mile Canyon, and Fly Valley creeks and one unnamed tributary. Two off-channel areas with active springs were observed (Figure 2).

An extensive complex of beaver dams was observed approximately .25 miles downstream of the Fly Valley Creek confluence (Figure 2). Deep and wide ponds spanned approximately a third of a mile. HWTP personnel were unable to navigate the entire expanse of the beaver complex due to water depth and time restraints. The water depth was measured at 4 ft in one location in the ponds. Signs of active beaver work were observed on willow branches.

Figure 2. Representative photos of drought assessment efforts on Silver King Creek (clockwise from top left): instream shot in higher gradient portion, instream shot of meadow habitat, active springs, and beaver complex.

Flow was contiguous throughout the surveyed area, the average streamflow was 7.65 cfs, and pools were frequent. With only one fish observed during the survey, Silver King Creek was characterized as at-risk and given a threat level of 2, assuming a low population exists. The HWTP recommends a more thorough evaluation of the population via electrofishing to determine whether this assumption is correct and whether a fish rescue/translocation is warranted. Potential negative effects from bottlenecks and low genetic diversity should also be evaluated.

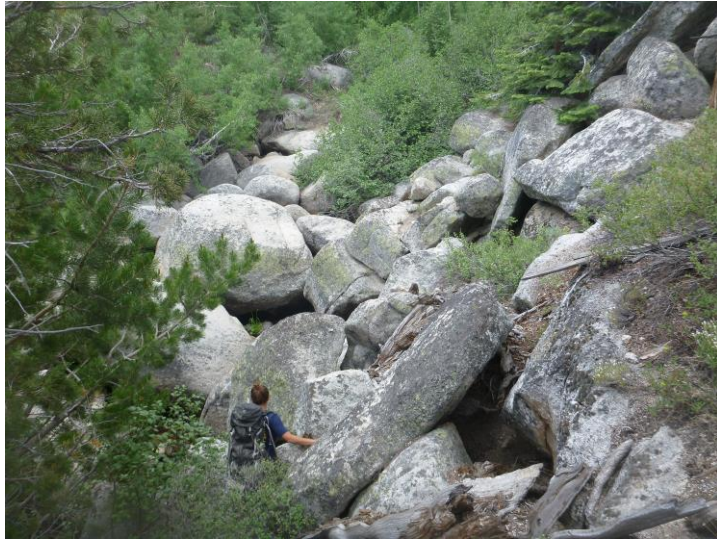
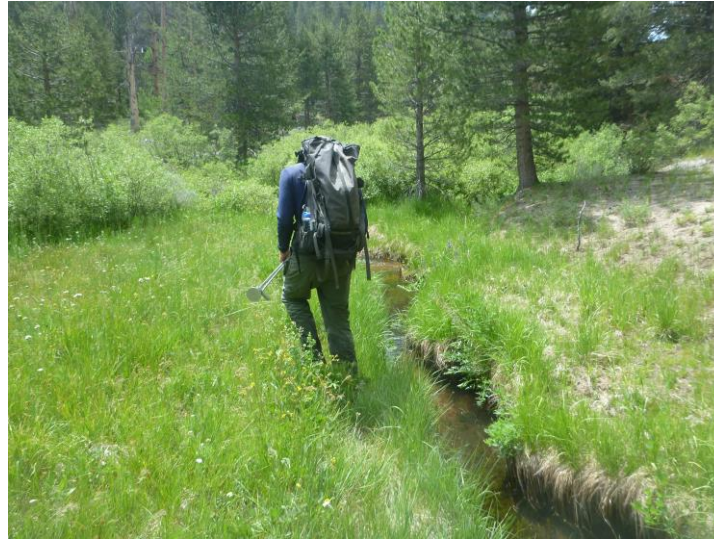
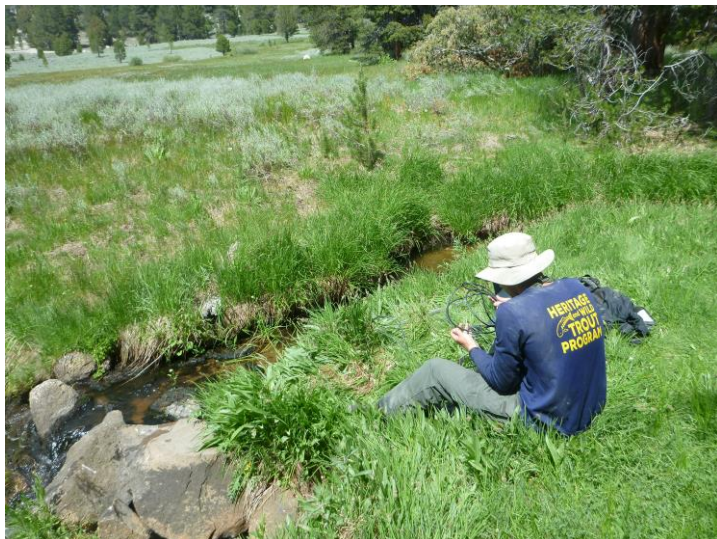
A total of 120 trout were observed in Coyote Valley Creek (all assumed to be Paiute Cutthroat Trout). Three small-sized trout were observed between two barriers in approximately 0.5 miles of stream. These fish were isolated from the remaining 117 trout observed upstream of the barrier in approximately 1.25 miles of meadow habitat (Figure 3). The majority of fish were observed in the meadow, upstream of the trail crossing. The size-class distribution for trout observed above the barrier was 98.3% small-sized fish and 1.7% YOY. There was approximately 0.4 miles of stream between the barrier and the meadow habitat where zero trout were observed.

One Yosemite Toad (*Anaxyrus canorus*) was observed (instream) near the end of the surveyed reach on Coyote Valley Creek (Figure 3). Multiple unidentified toads were also observed throughout the creek. Some areas of the creek had dense vegetation that made access to, and visibility of, the water difficult for fish detection. The survey ended

Figure 3. Representative photos from drought assessment efforts on Coyote Valley Creek (clockwise from top left): barrier separating observed trout, meadow habitat, yosemite toad, and second stream flow locaton.

The Paiute Cutthroat Trout population in Coyote Valley Creek was characterized as at-risk and assigned a threat level of 2. Instream water quality was sufficient to maintain biological function and fish health, flow was contiguous for 2.6 miles, and pool habitat existed and exceeded 300mm in depth. However, streamflow was an average of 0.46 cfs and the population was below 200 adults. The HWTP recommends that a more comprehensive survey, potentially utilizing electrofishers, should be performed to validate population numbers and size class distribution. Potential negative effects from bottlenecks and low genetic diversity should also be evaluated.

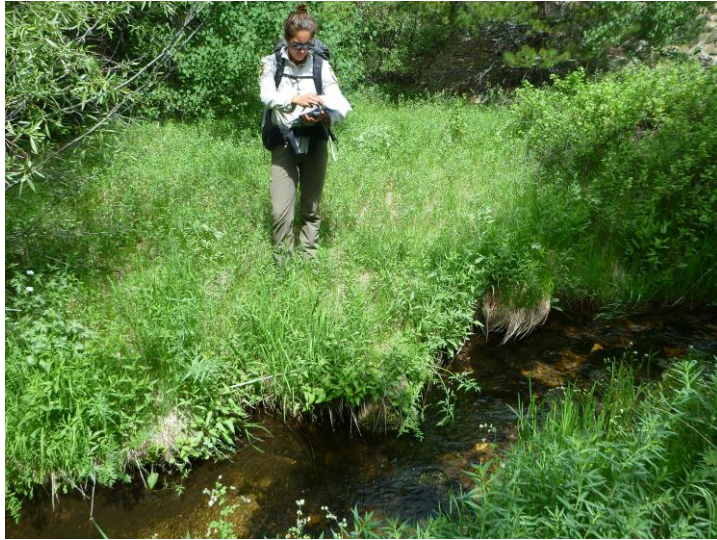
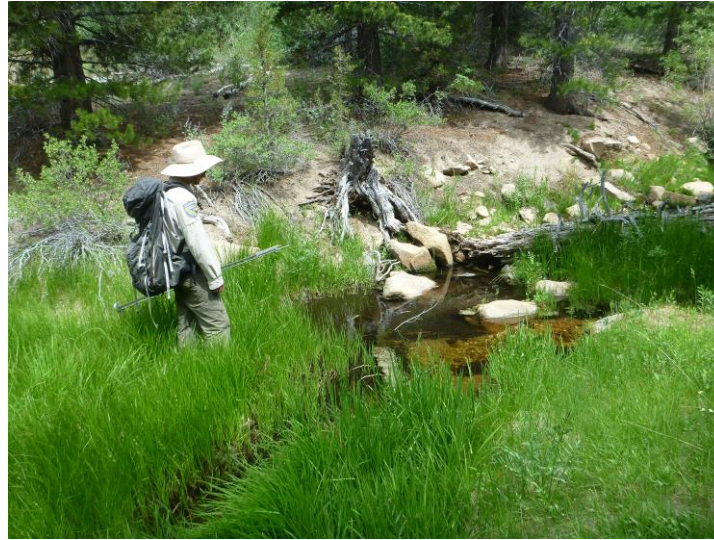
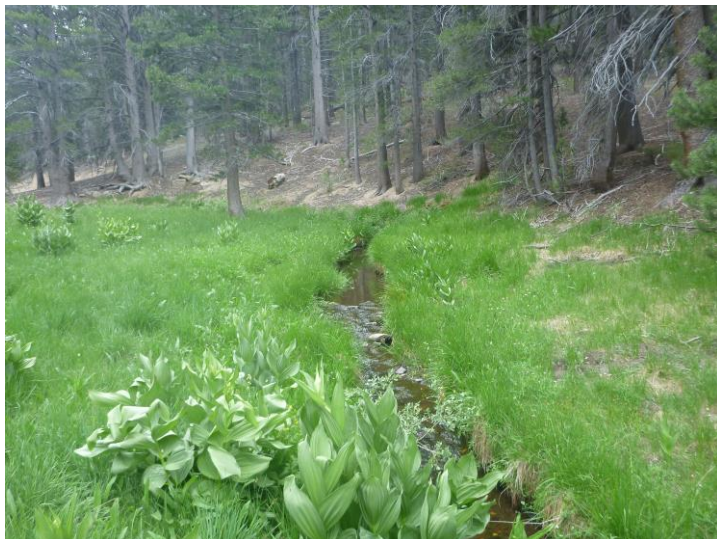
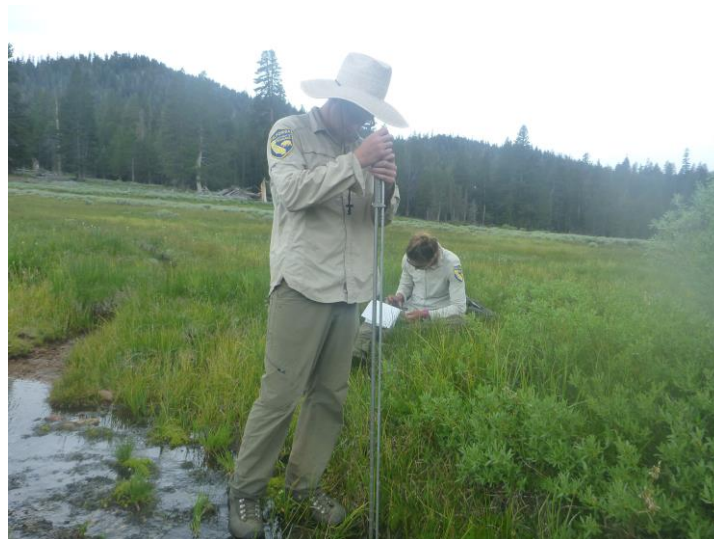
Eighty-five trout were observed with a size class distribution of 89.4% small- and 10.6% medium-sized fish (all assumed to be Paiute Cutthroat Trout). The first trout was observed less than 100 feet upstream of the survey start point. This small-sized trout was the only trout observed in the first 1.3 miles of stream surveyed. The remaining 84 trout were observed in 0.8 miles of meadow habitat. The survey ended after zero trout were observed in a quarter mile and instream vegetation became too thick to visually detect trout. Three unnamed, wetted tributaries entered Corral Valley Creek in the surveyed reach.

Figure 4. Representative photos from drought assessment efforts on Corral Valley Creek (clockwise from top left): location of single trout observed, instream photo, streamflow location, and meadow habitat with trout.

Flow was contiguous throughout the surveyed area and pools were deep and frequent, but streamflow was 0.03 cfs and only 85 Paiute Cutthroat Trout were observed in Corral Valley Creek. This population is considered to be at-risk and assigned a threat level of 2. The HWTP recommends a more thorough evaluation of the population via electrofishing to determine whether a fish rescue/translocation is warranted. Potential negative effects from bottlenecks and low genetic diversity should also be evaluated.

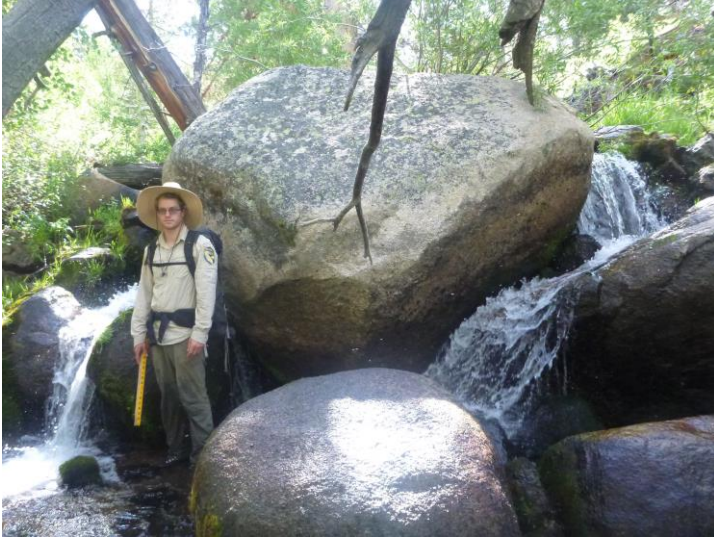
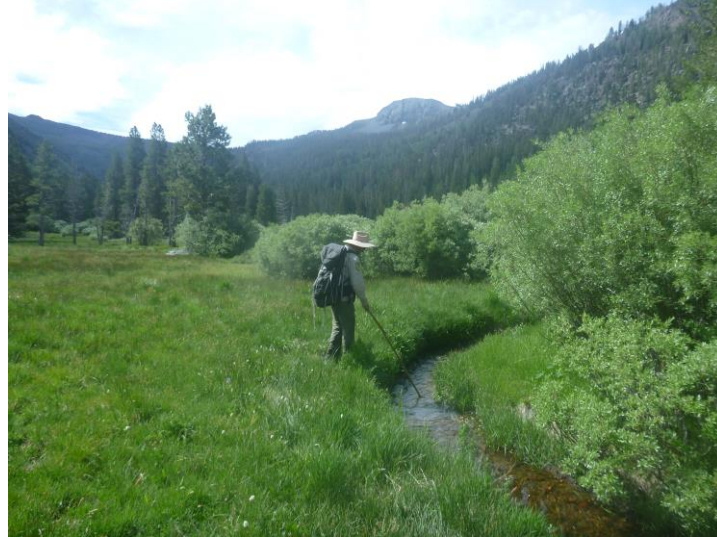
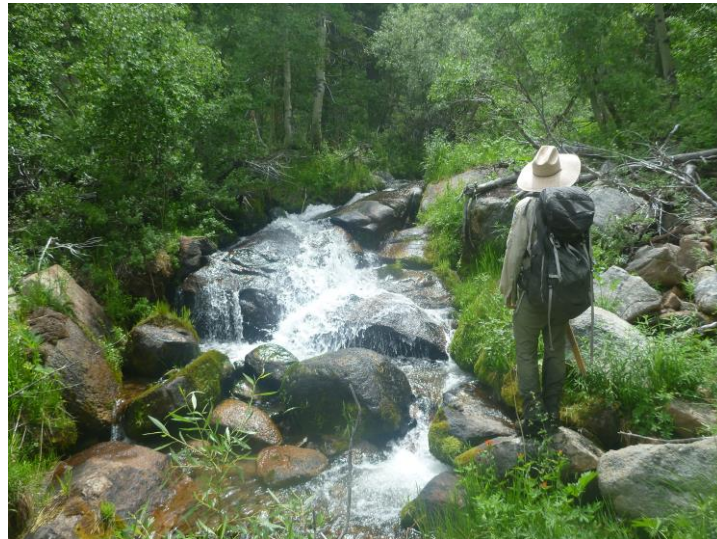
Two trout were observed with a size class distribution of 50% small- and 50% medium-sized fish (all assumed to be Paiute Cutthroat Trout). High water velocity and willows made visibility difficult in some areas of the creek. A barrier to fish migration was documented approximately .15 miles upstream of the Silver King Creek confluence. The barrier was a 15 ft waterfall composed of large boulders (Figure 5). One tributary with a small amount of water entered Four-Mile Canyon in the surveyed reach and, approximately .15 miles downstream from the end point of survey, the creek branched into two flowing streams.

Figure 5. Representative photos from drought assessment efforts on Four-Mile Canyon Creek (clockwise from top left): 15ft fish barrier and three instream photos moving upstream.

Pool habitat and sufficient flow were present in Four Mile Canyon Creek, however only two trout were observed. This population is considered to be at-risk and assigned a threat level of 2. The HWTP recommends a more thorough evaluation of the population via electrofishing to determine whether a fish rescue/translocation is warranted. Potential negative effects from bottlenecking and low genetic diversity should also be evaluated.

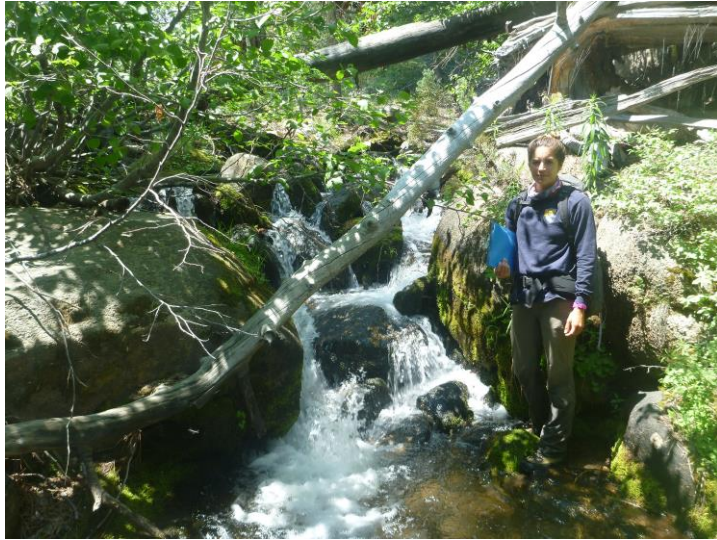
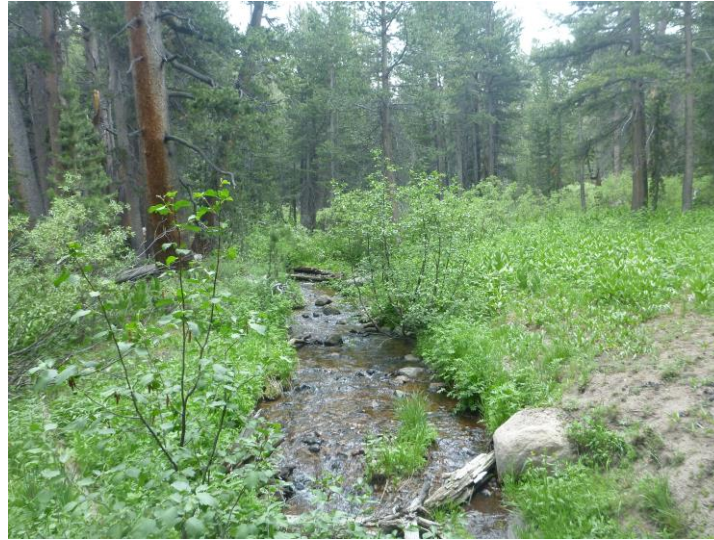
Two medium-sized trout were observed below a barrier approximately .3 miles upstream from the confluence with Silver King Creek (Figure 6). These trout appeared to be paired for spawning. Thirty-seven trout were observed above the barrier with a size class distribution of 73% small- and 27% medium-sized fish (all assumed to be Paiute Cutthroat Trout). An additional four YOY were observed above the barrier. No fish were observed 500 ft upstream of a branch in the creek.

Figure 6. Representative photos from drought assessment efforts on Fly Valley Creek (clockwise from top left): fish barrier and three instream photos moving upstream.

Habitat availability and quality appears sufficient in Fly Valley Creek, but there were only 37 adult trout observed in approximately 0.65 miles of connected habitat. The HWTP has assigned Fly Valley Creek a threat level 2 and considers this populations at-risk. The HWTP recommends that a more thorough assessment of this population is conducted, as well as evaluation of the potential negative effects of bottlenecking and low genetic diversity.
