2014–2015 Detailed Fish Passage Assessment Evaluations

Districts 1 and 2 – Mendocino, Trinity, and Humboldt Counties

May 2015
Revised May 2016

2015 Fish Passage Survey Results

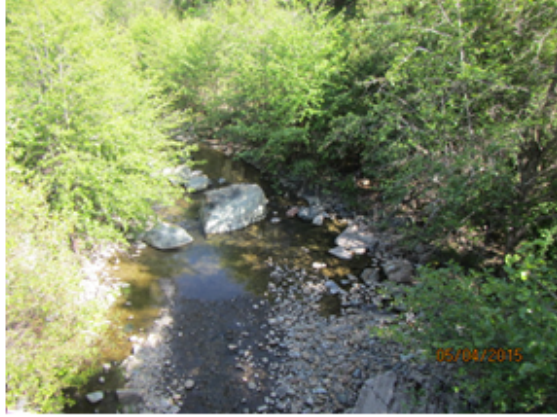
Upstream Looking Upstream	Upstream Looking Downstream

A photograph showing a small stream flowing through a dense forest of green trees and bushes. The water is clear and reflects the surrounding greenery. A date stamp '05/04/2015' is visible in the bottom right corner.

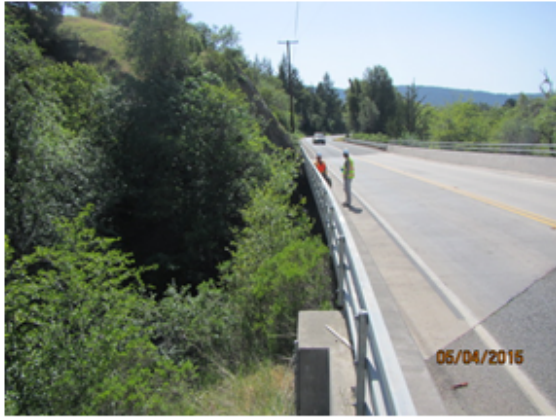
A photograph showing a paved road with a metal guardrail on the left side. The road curves to the right, and a person in a yellow safety vest is visible on the shoulder. The background shows a hillside with green trees and a clear blue sky. A date stamp '05/04/2015' is visible in the bottom right corner.
Downstream Looking Upstream	Downstream Looking Downstream

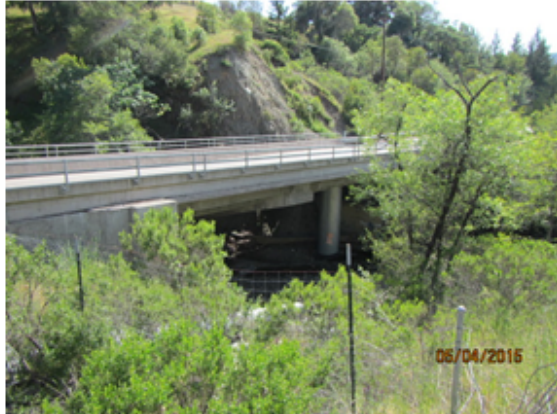
A photograph showing a concrete bridge spanning a stream. The bridge has a metal guardrail on top. The surrounding area is lush with green trees and bushes. A date stamp '05/04/2015' is visible in the bottom right corner.

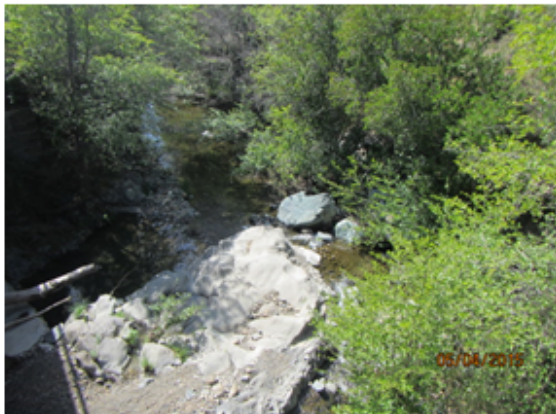
A photograph showing a stream flowing through a rocky and wooded area. The water is clear and flows over rocks. The surrounding area is dense with green trees and bushes. A date stamp '05/04/2015' is visible in the bottom right corner.

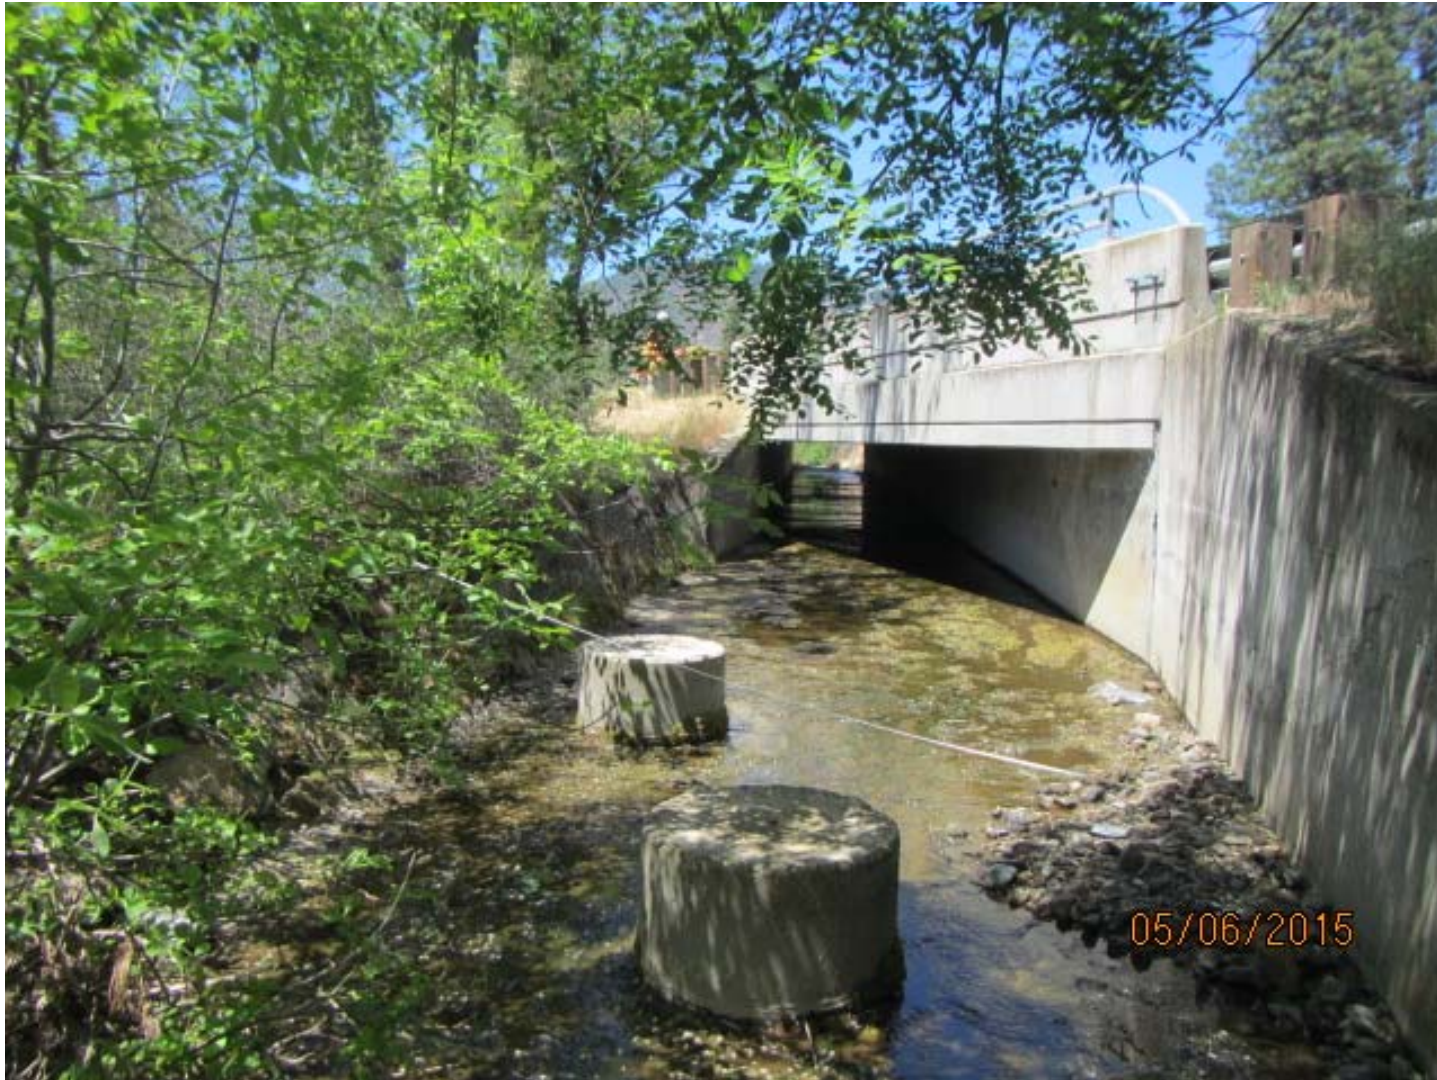
Figure 5. TRI 299 51.2 (Downstream looking upstream at TWC)

Based on simply applying the filter, the TRI 299 51.2 site was identified as “gray”, and the TRI 299 51.41 site was identified as “red”. The TRI 299 51.2 site was identified as “gray” due to insufficient residual inlet and outlet depths. The TRI 299 51.41 site was identified as “red” due to insufficient residual and outlet depths, and due to a culvert slope of greater than 3%. Because the TRI 299 51.41 site was identified as “red”, and because the site has previously been identified as undersized for fish passage (Taylor et al. 2002), this site was not further evaluated for fish passage. Both the Garden Gulch crossing (TRI 299 51.41) and the Sidney Gulch crossing (TRI 299 51.2) have been identified by Caltrans (2014) as priority fish passage barriers.

Despite FishXing identifying this site as a total barrier to adult salmonids due to insufficient water depth in the culvert, adult salmonids likely are able to pass upstream during some flow conditions because coho salmon and steelhead spawning has been documented upstream of the State Route 299 crossing (USFS 2004; Taylor et al. 2002). However, modification of the crossing at State Route 299 may not necessarily substantively improve fish passage conditions without other modifications to the channel downstream of the crossing. USFS (2004) reported that the section of concrete channel passing through the Weaverville Ranger District compound (just downstream of the State Route 299 crossing) prevents fish migration in all but "optimal" flows.
