# Interstate 280 Wildlife Connectivity Research Study: Findings and Recommendations

UC Davis Road Ecology Center  
Caltrans, District 4  
California Department of Fish & Wildlife

Prepared by Fraser Shilling

**December 13, 2013**

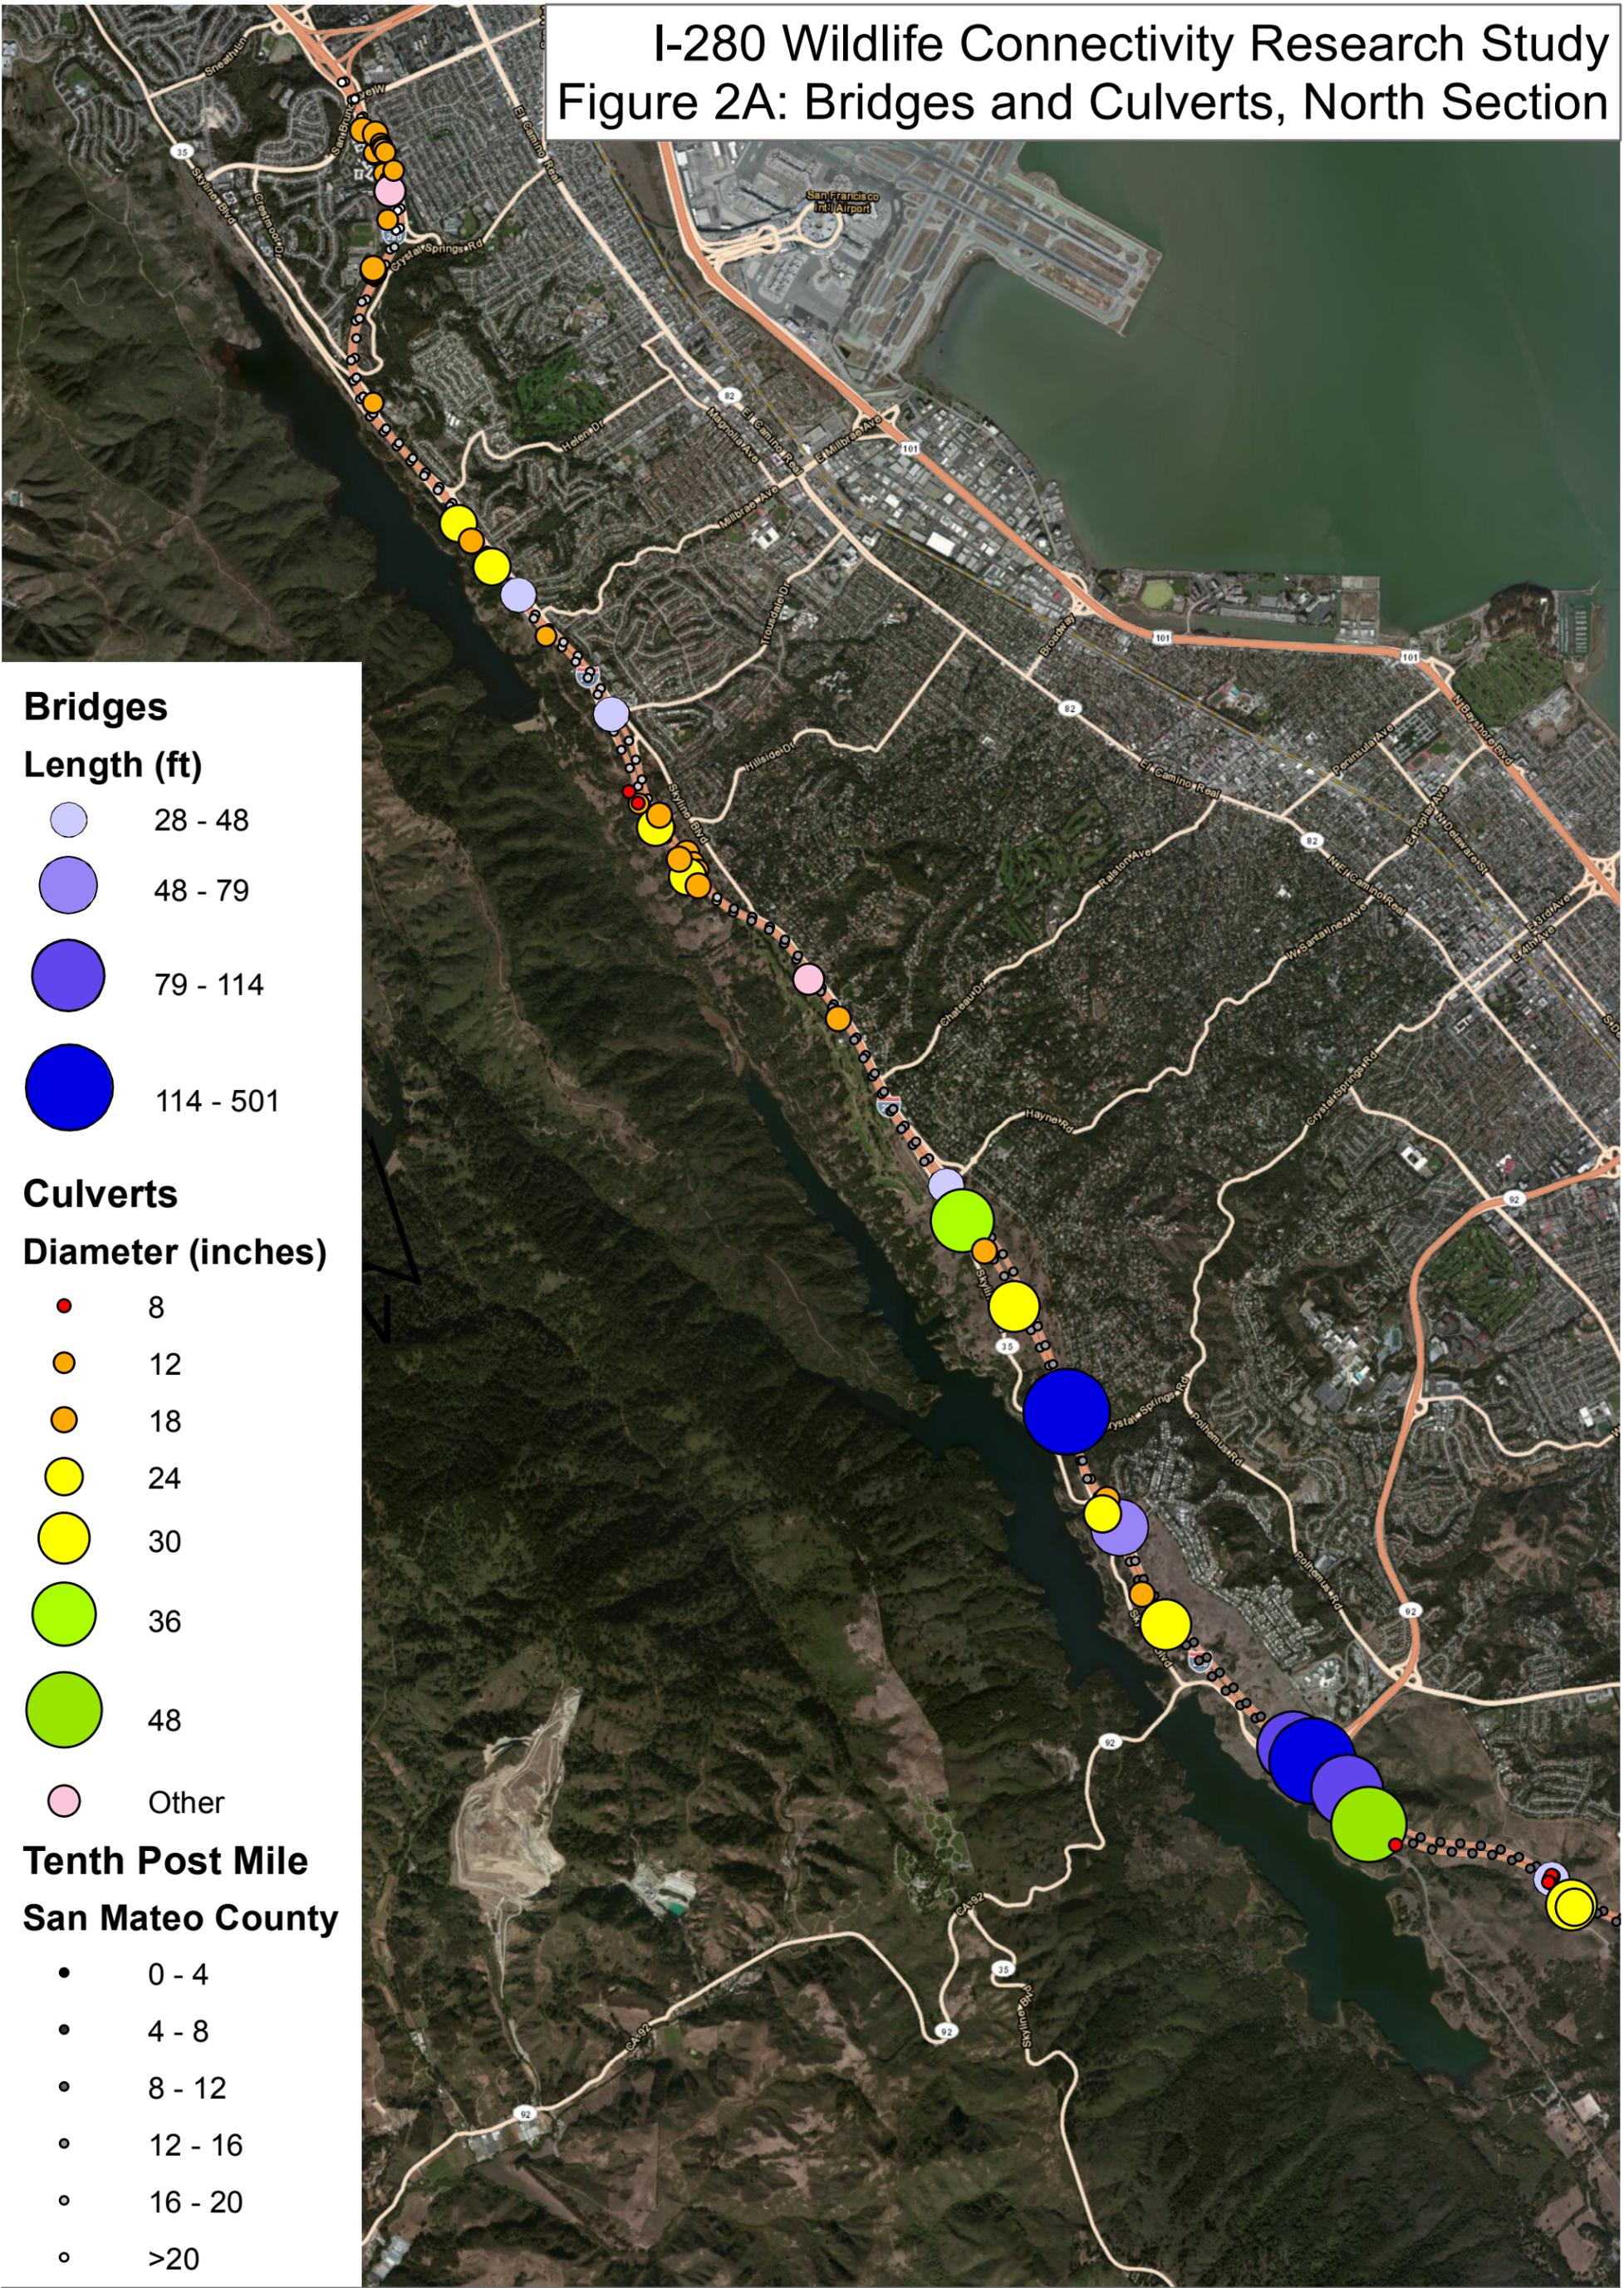
I-280 Wildlife Connectivity Research Study  
 Figure 2A: Bridges and Culverts, North Section

Using Caltrans data, we found 20 bridge spans in the study section, which included structures like the highway 92 interchange, which had 3 spans. We also found 68 culverts, which were primarily small

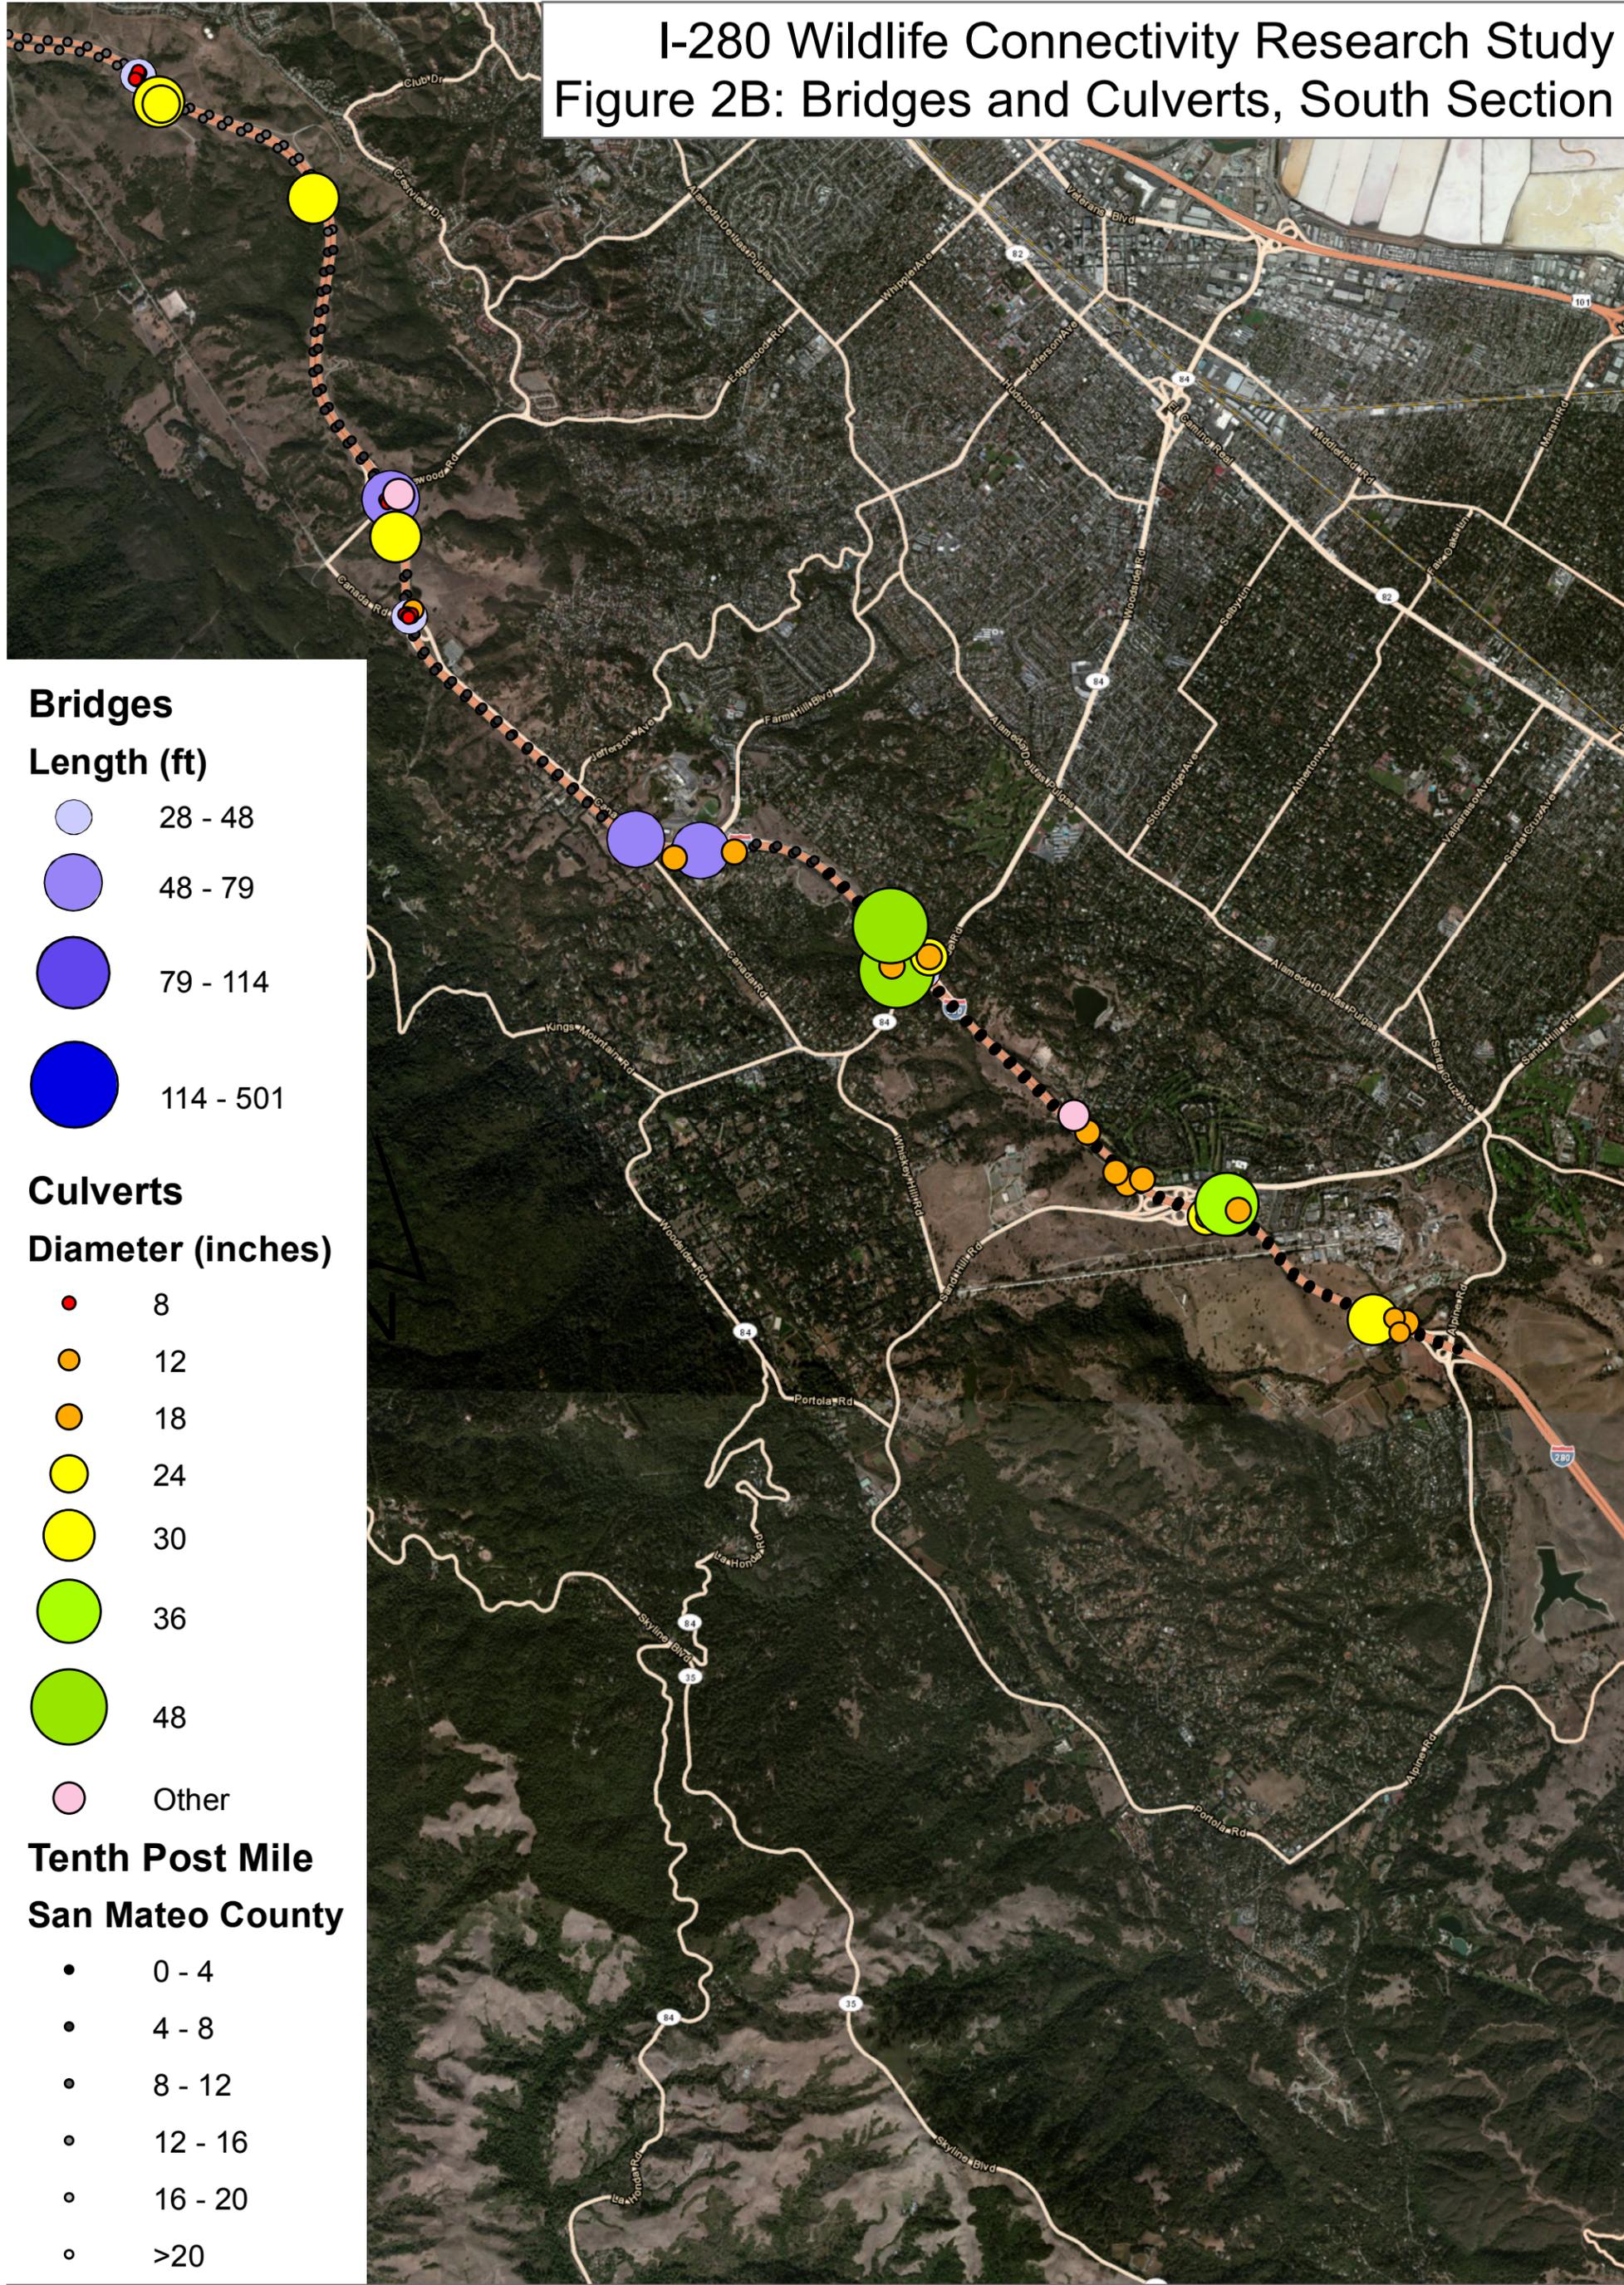
I-280 Wildlife Connectivity Research Study  
 Figure 2B: Bridges and Culverts, South Section

**Figure 2B. Infrastructure elements (culverts, bridges, and post-miles) along I-280, south section. (figure on next pages)**

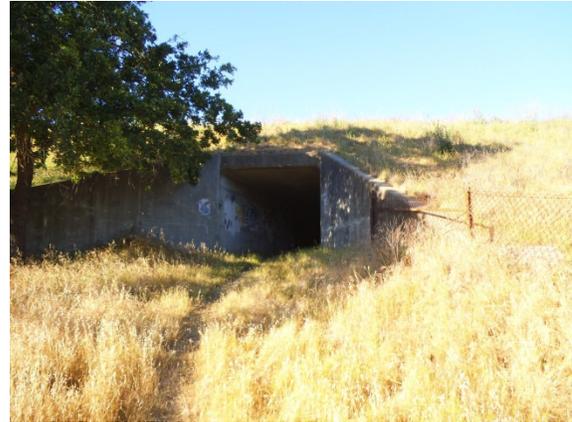
**Figure 5A. Box culvert at Sandhill Road**

Cameras and were placed at potential opportunistic crossing locations under and over I-280 in order to understand actual wildlife movement in response to the highway. Remote, motion-triggered wildlife cameras (Bushnell Trophy Cam II) were used to measure the wildlife and human use of crossing structures and the seasonal and daily use of structures. We deployed >40 cameras and experienced >50% camera loss during the study period, despite using security devices. The data from the cameras were used to estimate the rates of human and wildlife use of structure-location. Cameras were deployed at 24 positions at 18 locations along the interstate for 18 months (11/2011 to 4/2013) with a range of sampling per location of 25 to 366 days. A location refers to a single structure (e.g., Figure 5A), where a position refers to where a camera was attached and pointed at part of the structure (e.g., opening of a culvert, Figure 5B). Cameras were checked weekly to monthly. Approximately one camera was stolen per month, resulting in missing stretches of data. Street crossings with many cars and pedestrians were sampled for 1-7 days to provide approximate rates of use, while limiting the chance of camera theft.

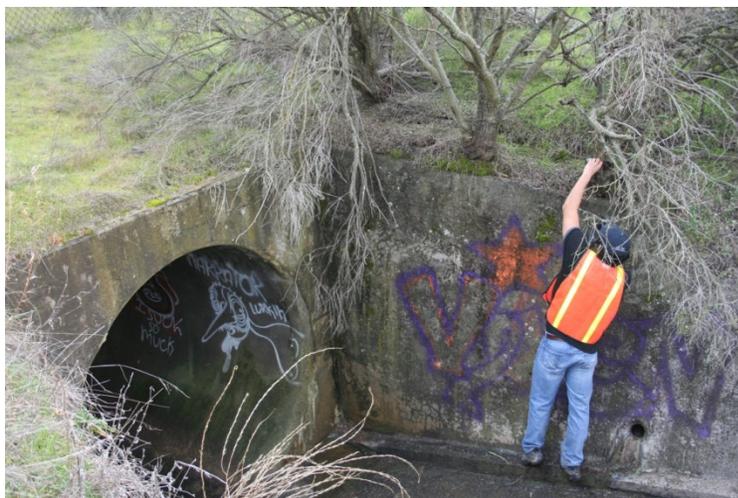
**Figure 5B. Road Ecology Center staff at round culvert at Sandhill Road**

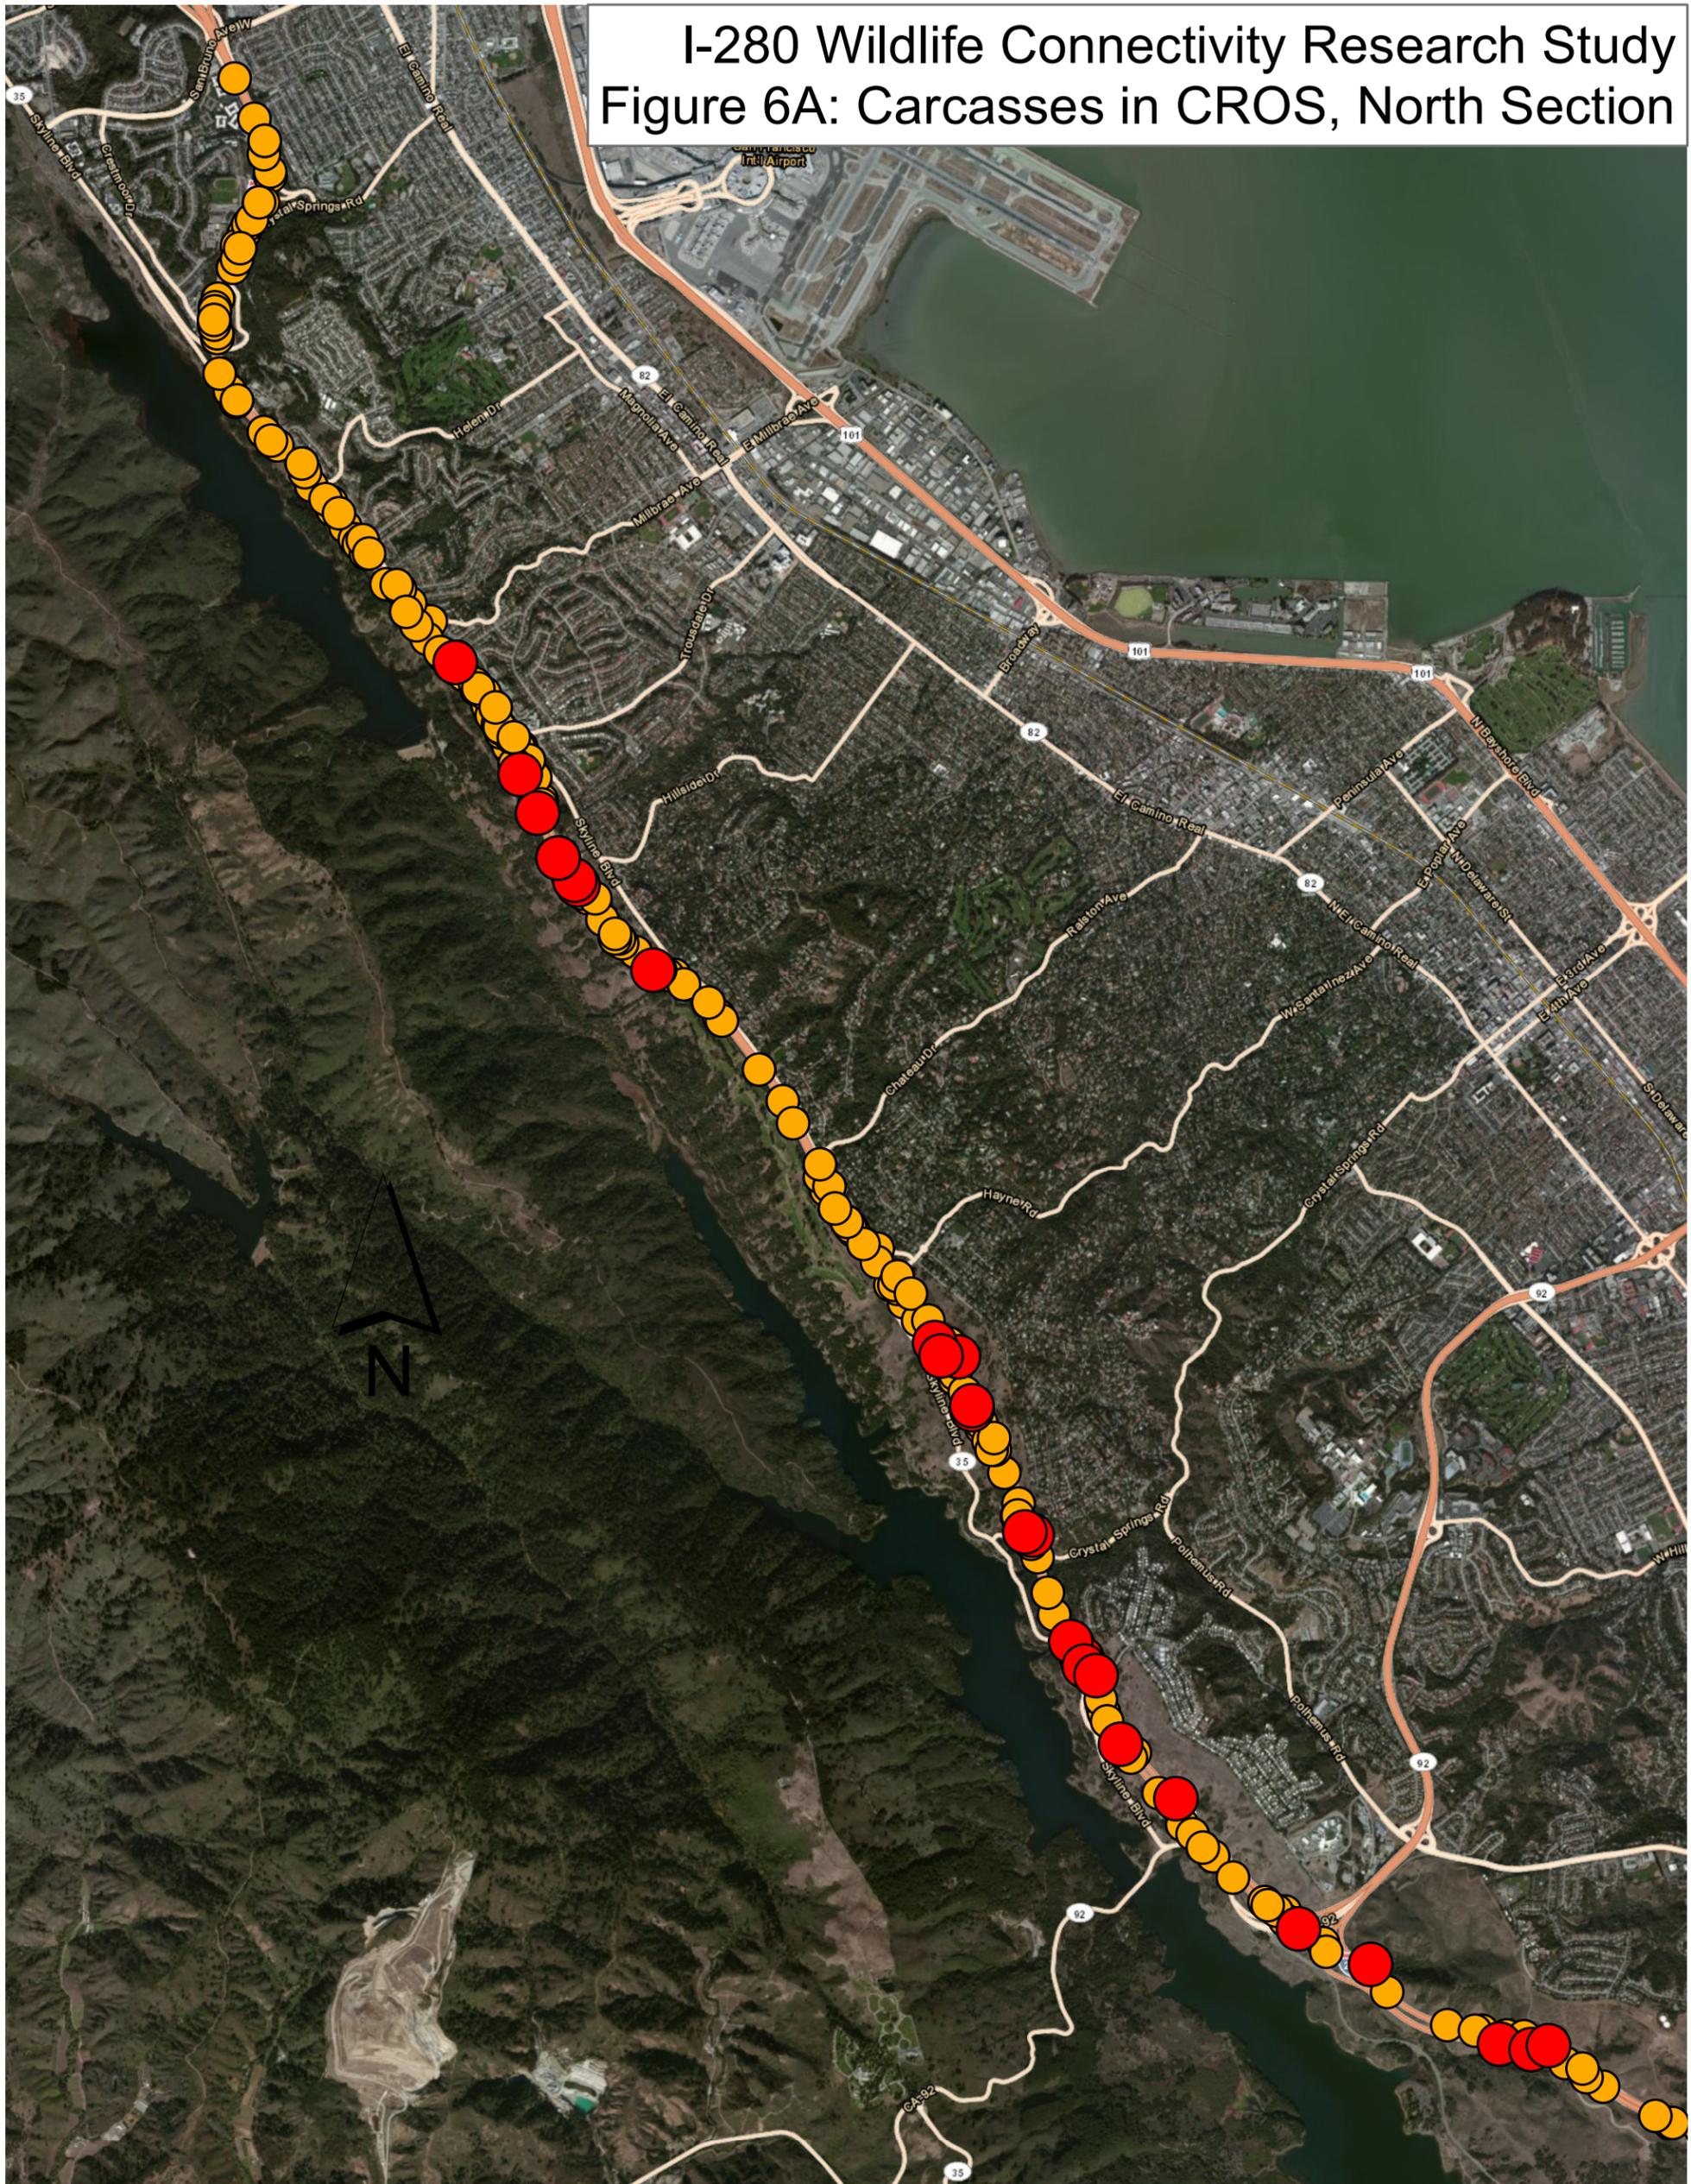
I-280 Wildlife Connectivity Research Study  
Figure 6A: Carcasses in CROS, North Section

**Figure 6. Locations of animal carcasses reported in the California Roadkill Observation System 2009 – 2013, (A) north section and (B) south section. (figures on next pages)**

Roadkill carcasses were observed at many locations along I-280 south and north bound between Millbrae Rd. and Woodside Rd. (Figure 6). These observations were for 19 species and 381 individual animals (CROS data). Many of the observations were for mule deer (46 of 381 carcasses). Caltrans Maintenance data for carcass retrieval included 478 carcasses, including 363 deer. This species is of particular concern from a collision point of view because property damage, injury, and even death can result when automobiles collide with them. These observations of deer occur at many areas along I-280 (Figure 6).

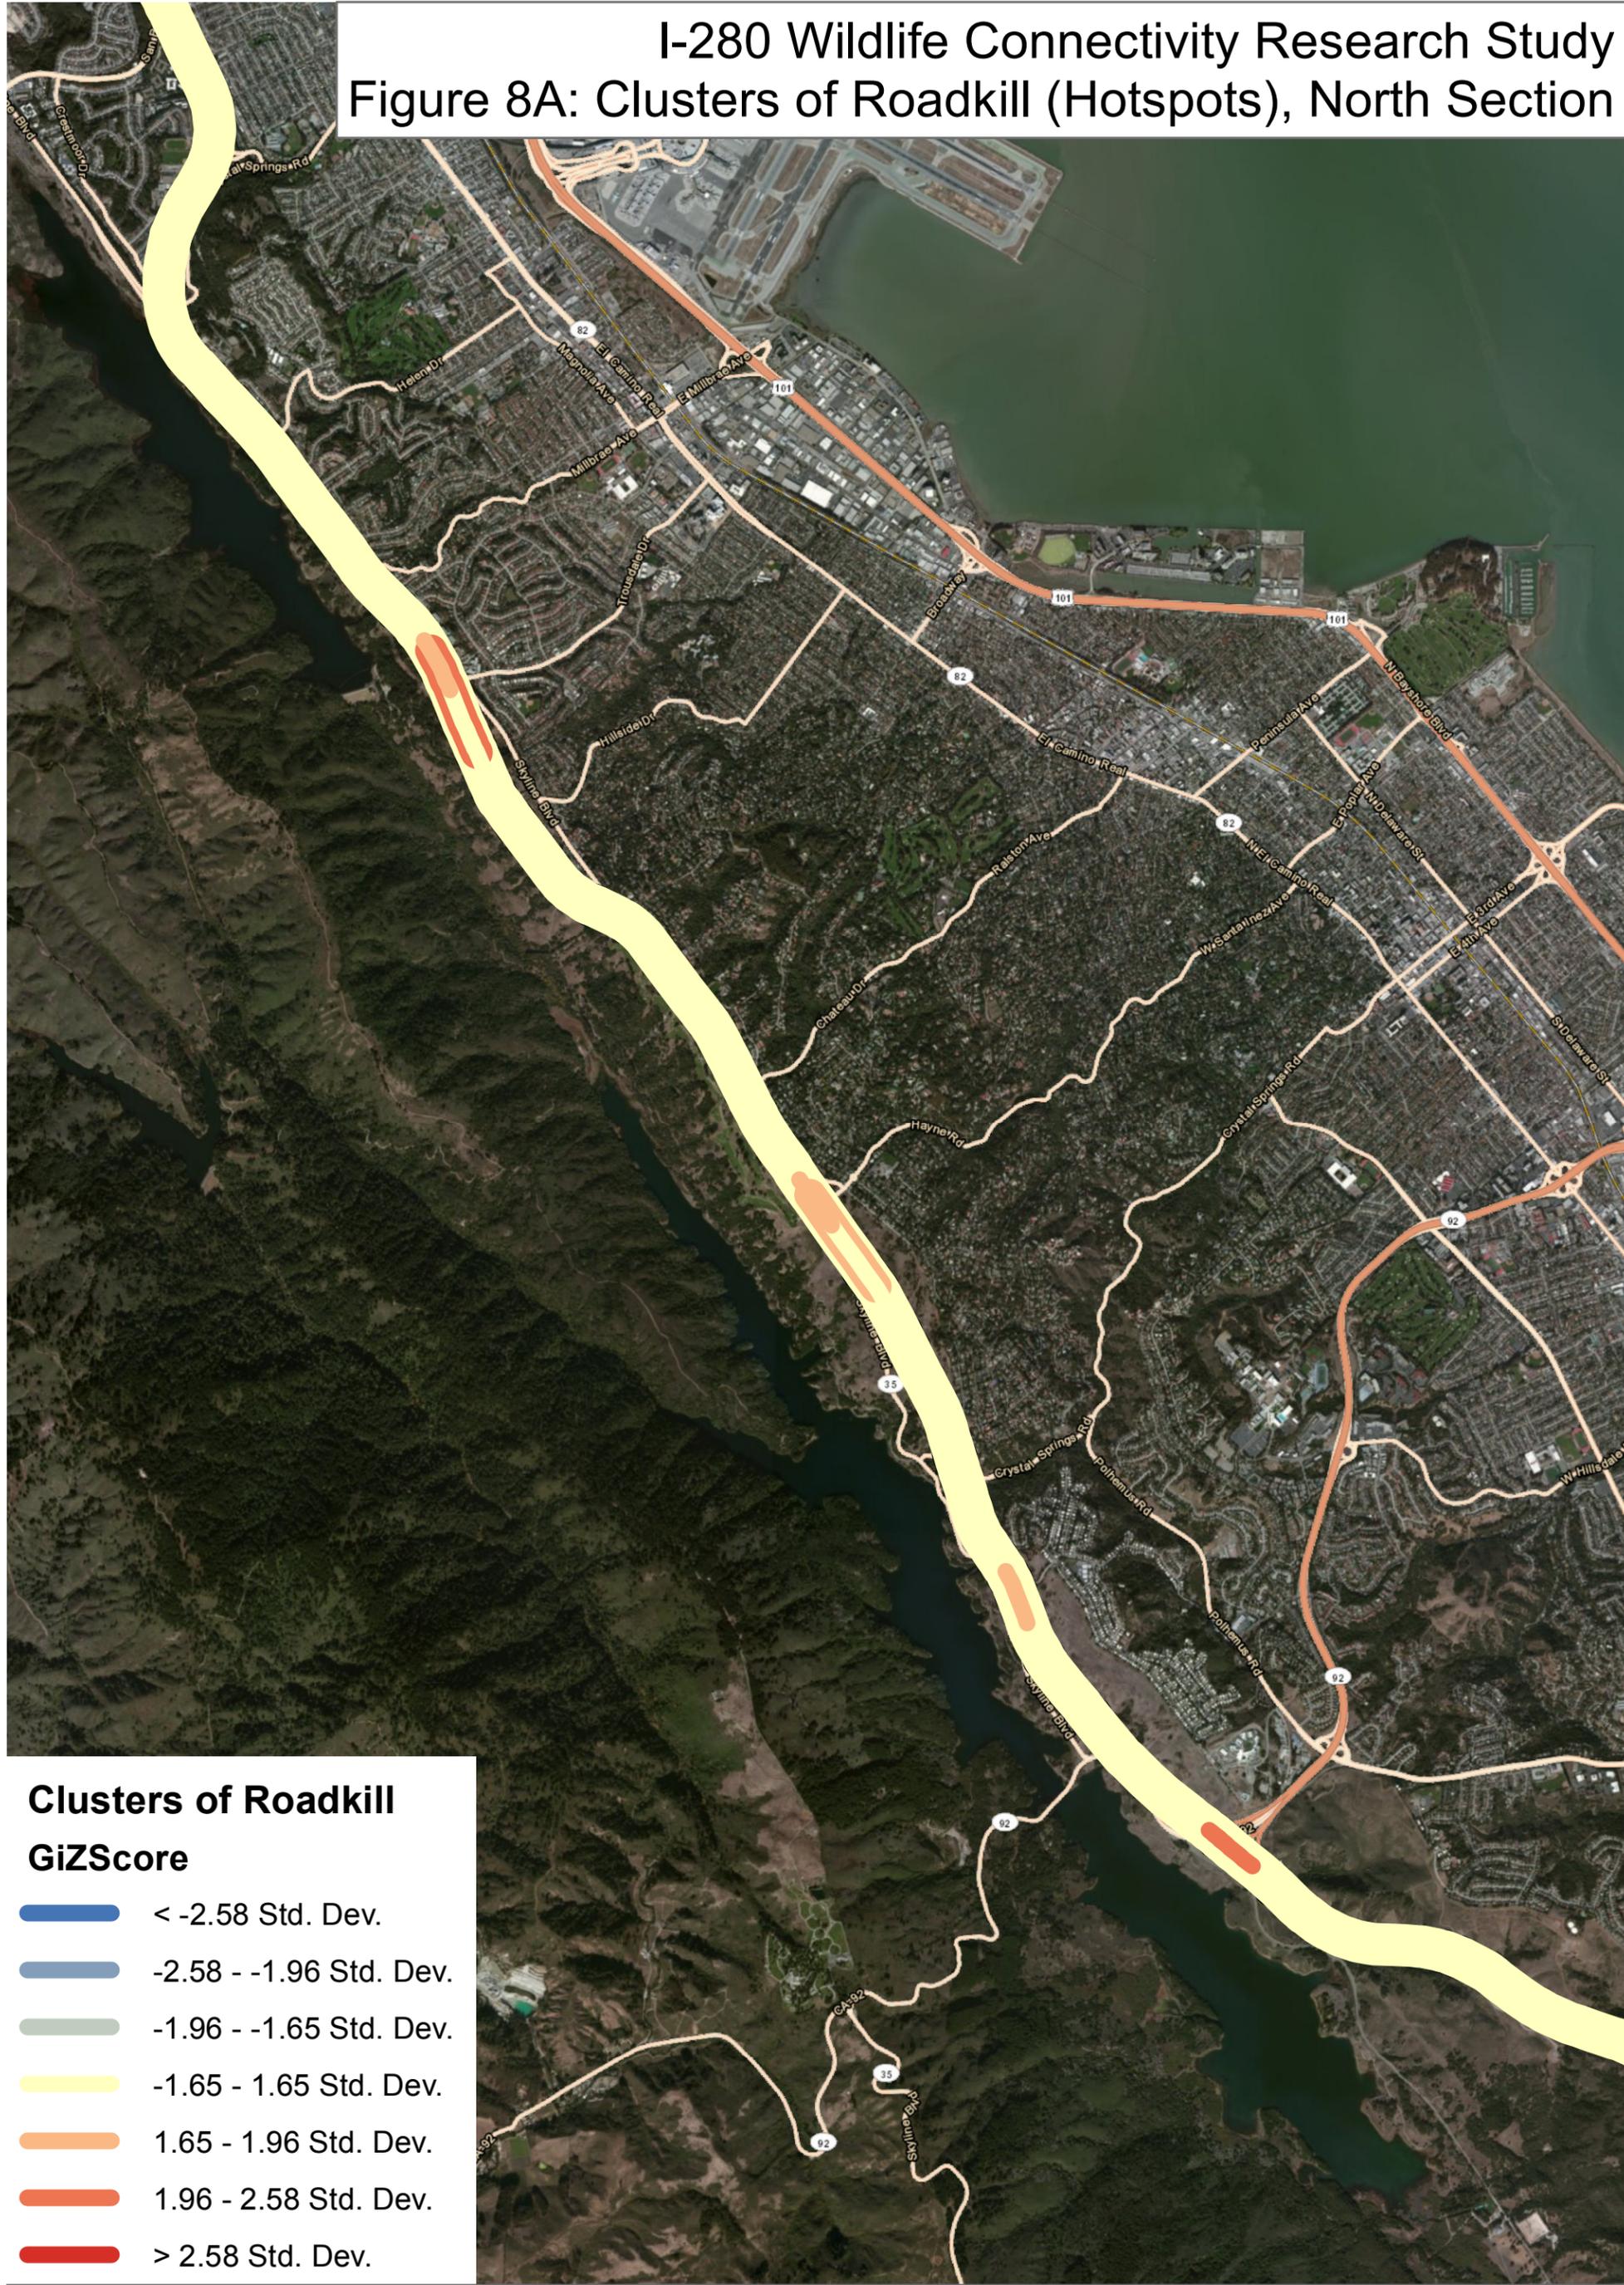
I-280 Wildlife Connectivity Research Study  
 Figure 8A: Clusters of Roadkill (Hotspots), North Section

Hotspots of some event of interest are often measured by estimating the spatial autocorrelation of the events. We used a measure of spatial autocorrelation called Getis-Ord, which results in a measure of statistical significance of the correlation, the “GiZ” score. The method compares the density of an event (i.e., number of carcasses per highway segment) for each set of neighboring analysis units. If there are big differences between a highway segment and its neighbors, a significant result will be found. If similarly low or high densities of an event are found among segments, then there will be a finding of no significance (and thus no hotspot). The GiZ score can be calculated for different lengths of highway segment, which can affect where hotspots are identified (figure 3). Shorter segment lengths (e.g., 1/20<sup>th</sup> of a mile) may result in more hotspots than longer segments (e.g., 1 mile) because there is greater likelihood at shorter distances that there will be a difference between # carcasses averaged over segments than at greater distances.

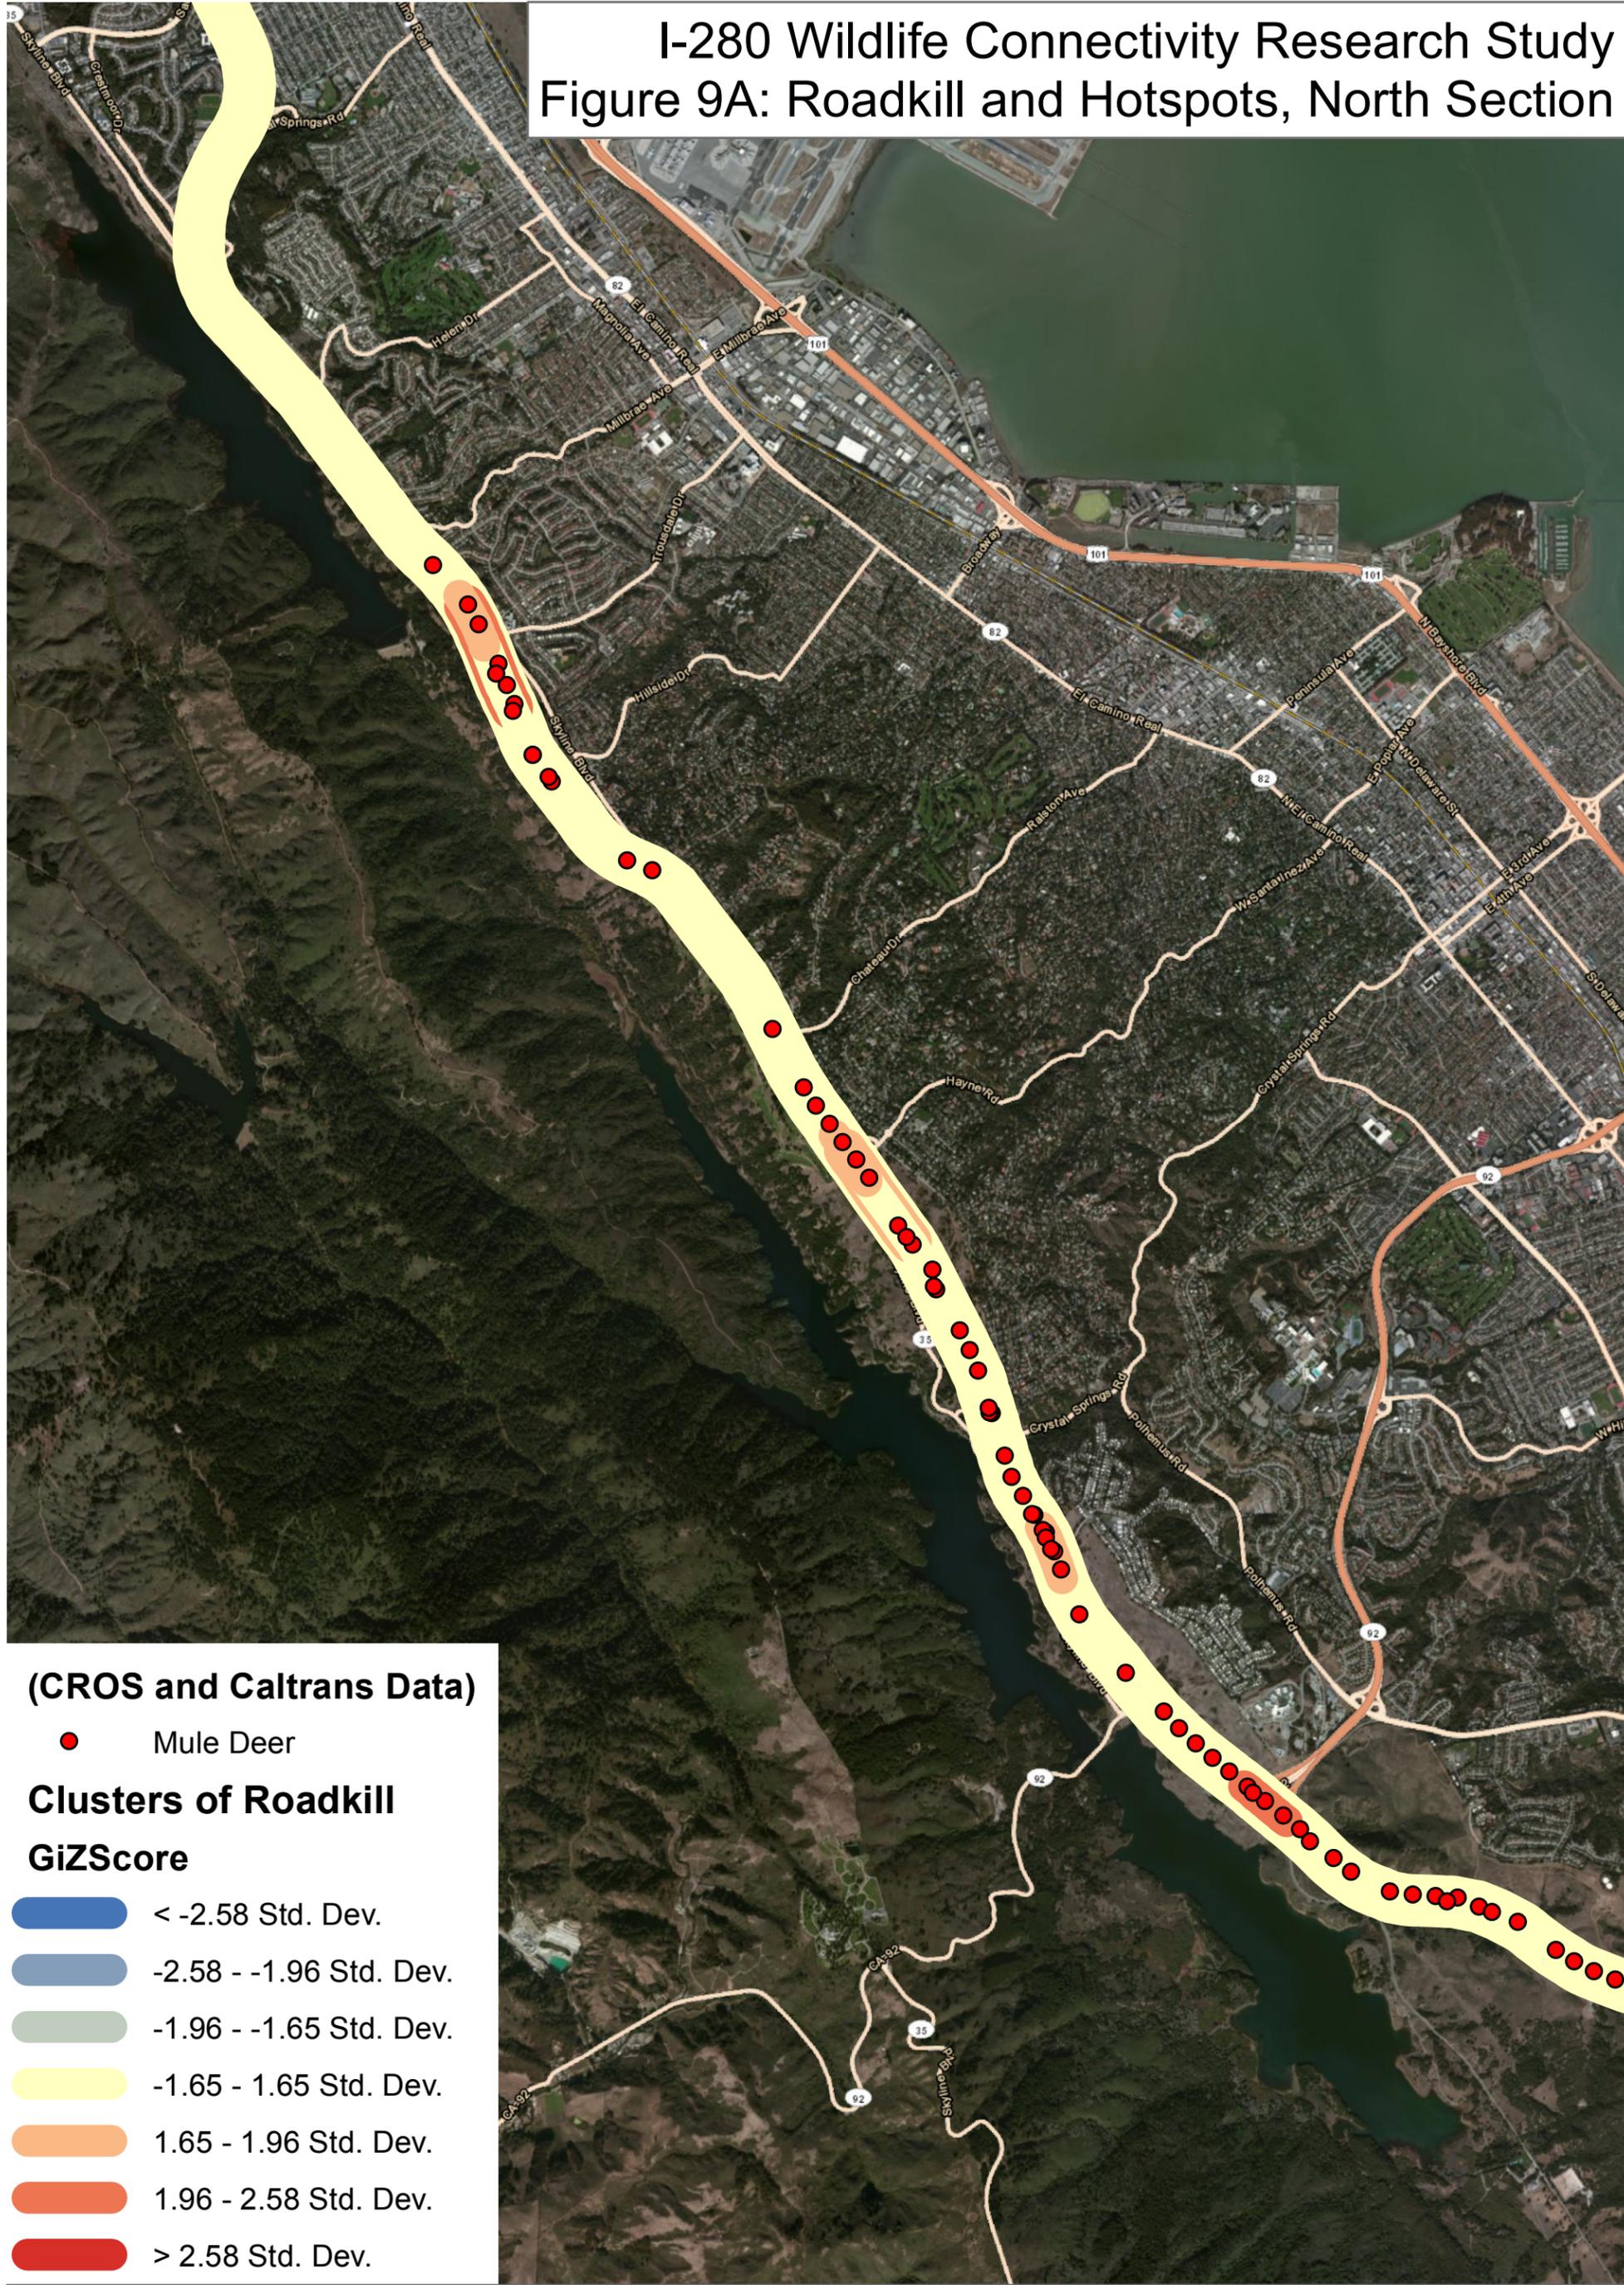
I-280 Wildlife Connectivity Research Study  
 Figure 9A: Roadkill and Hotspots, North Section

**Figure 9. Locations of WVC hotspots (0.25, 0.5, and 1 mile segments) based on all carcass counts and locations by post-mile (Caltrans data) and actual location (CROS data). The WVC carcass data were for 4 years (2009-2013) from the California Roadkill Observation System. The deer carcass data were for 7 years (2005-2012) from Caltrans. In some cases, the red symbol may represent more than one deer carcass. The GiZ score refers to the Getis-Ord statistic of significance, where values  $> 1.96$  indicate significant spatial clustering, (A) north section and (B) south section. (figure on next pages)**
