# Interstate 280 Wildlife Connectivity Research Study: Findings and Recommendations

UC Davis Road Ecology Center  
Caltrans, District 4  
California Department of Fish & Wildlife

Prepared by Fraser Shilling

**December 13, 2013**

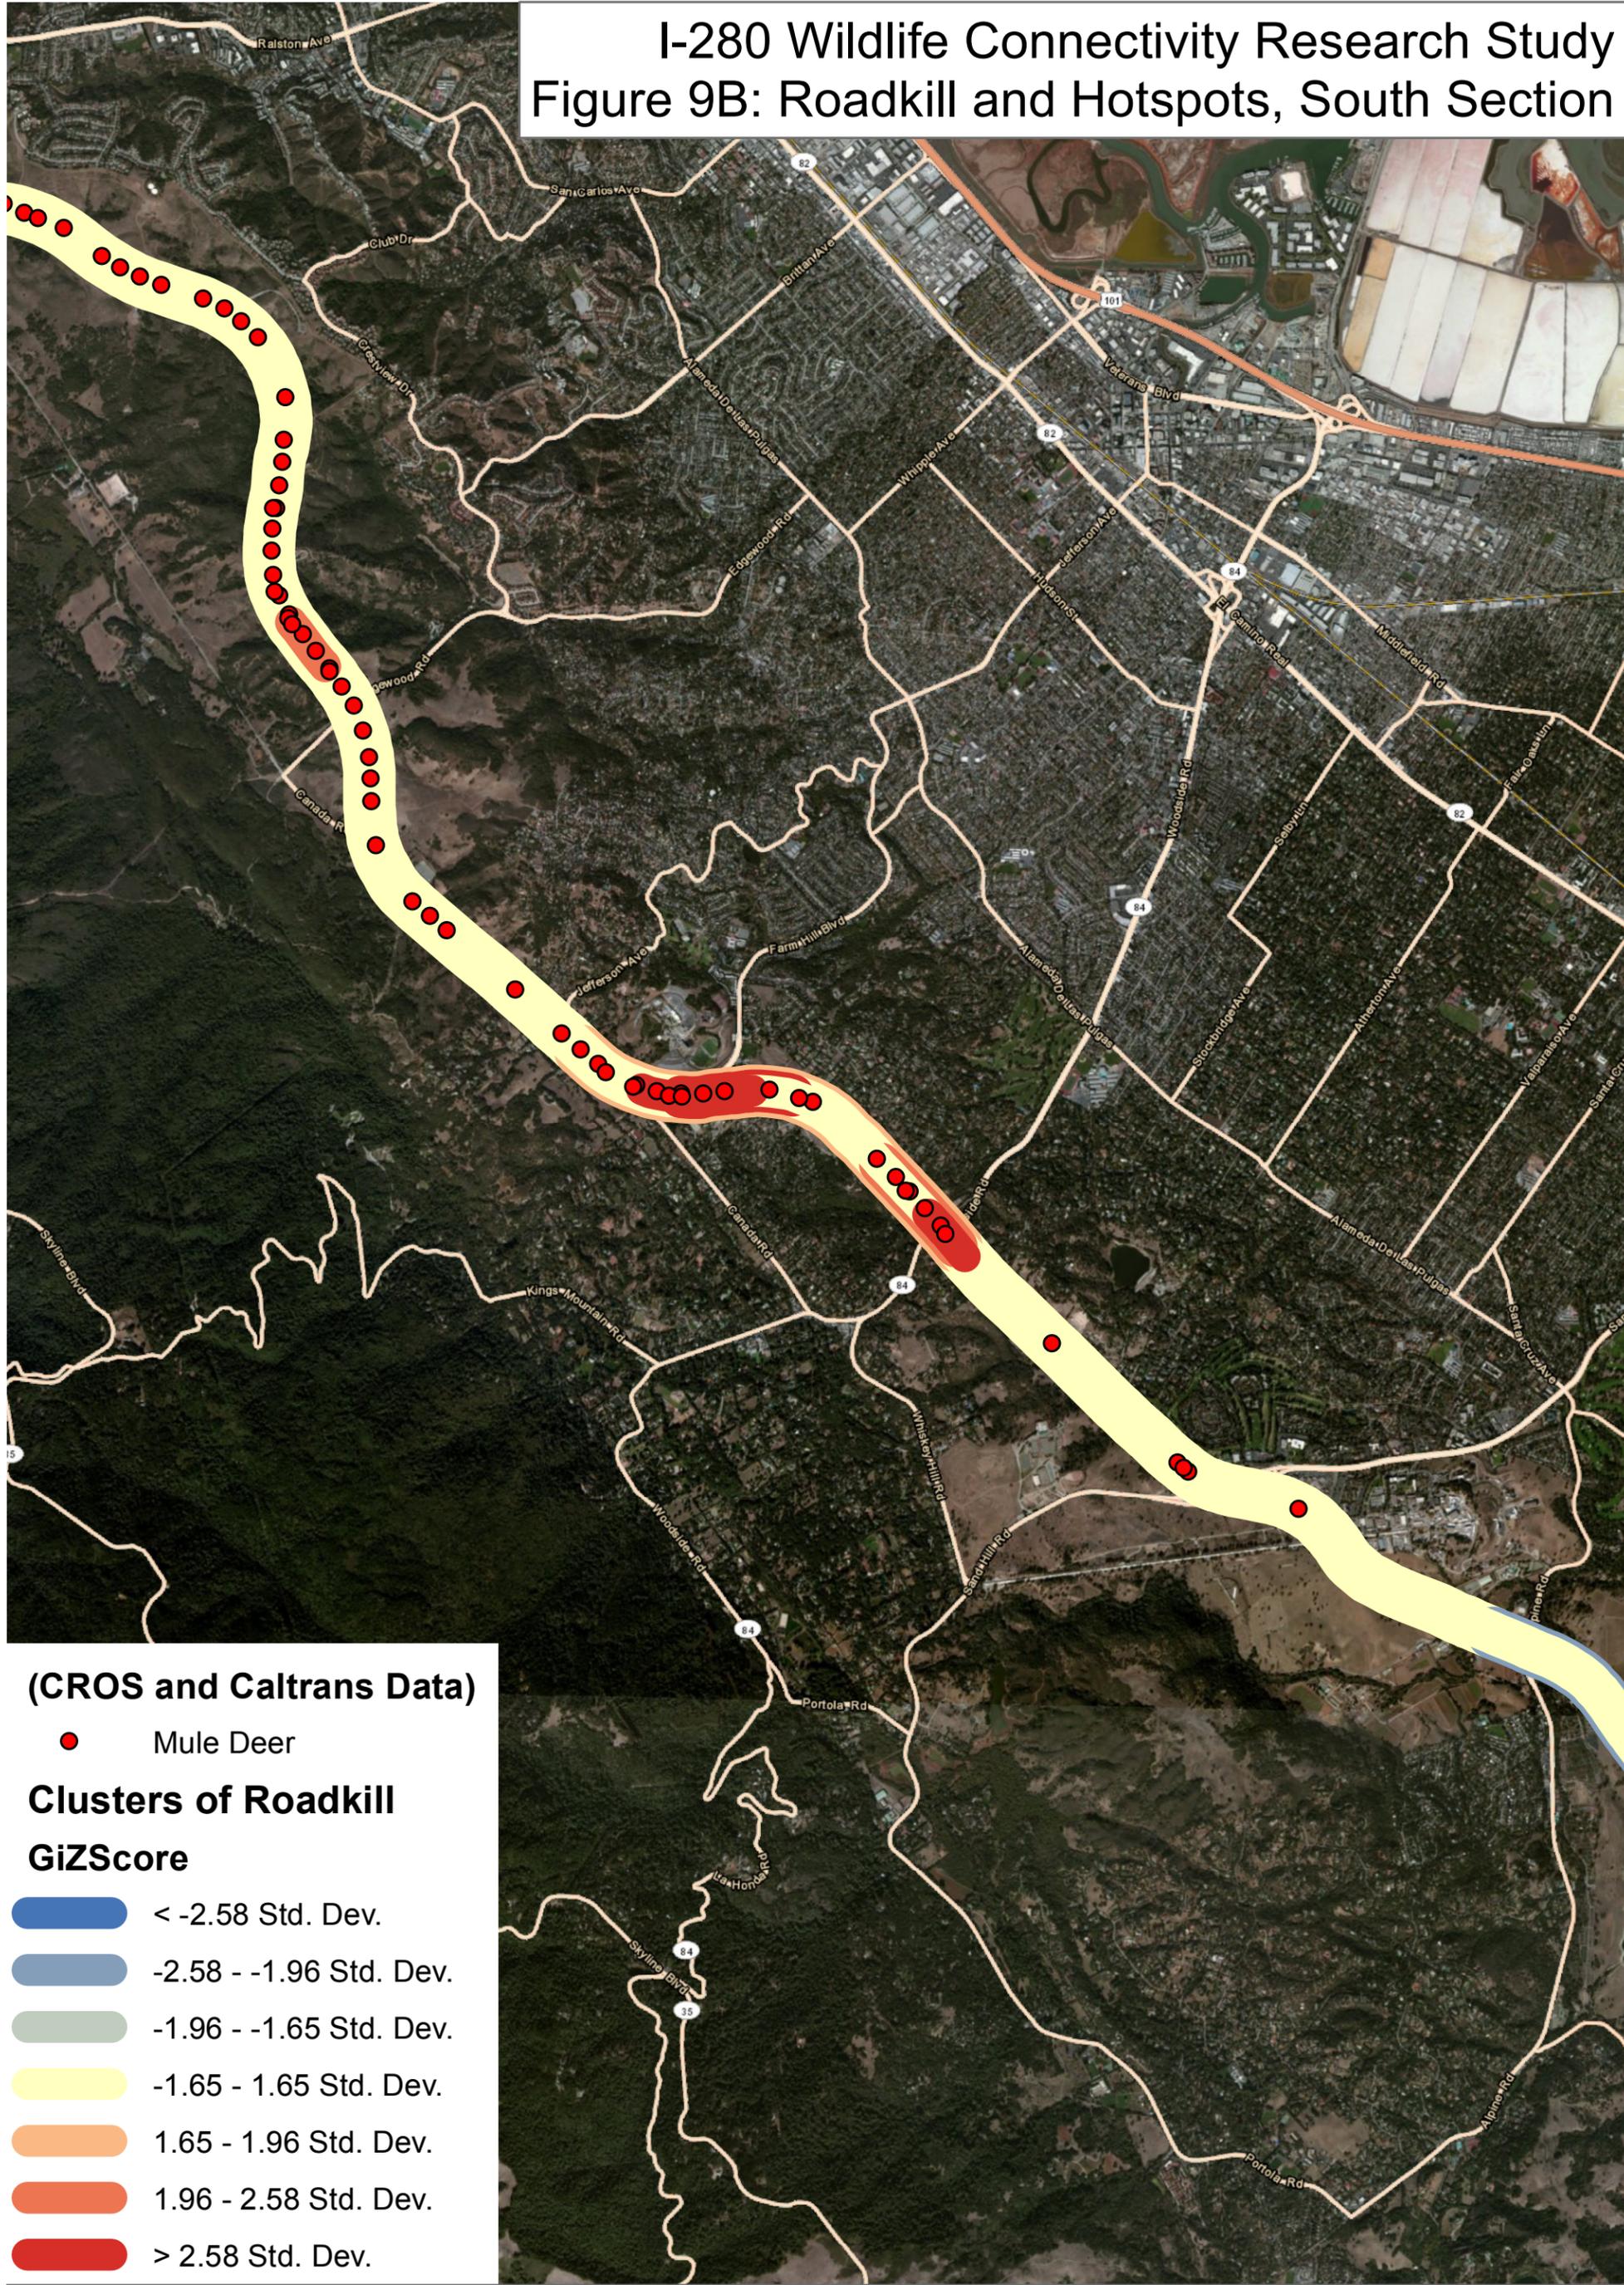
I-280 Wildlife Connectivity Research Study  
 Figure 9B: Roadkill and Hotspots, South Section

**Figure 9. Locations of WVC hotspots (0.25, 0.5, and 1 mile segments) based on all carcass counts and locations by post-mile (Caltrans data) and actual location (CROS data). The WVC carcass data were for 4 years (2009-2013) from the California Roadkill Observation System. The deer carcass data were for 7 years (2005-2012) from Caltrans. In some cases, the red symbol may represent more than one deer carcass. The GiZ score refers to the Getis-Ord statistic of significance, where values  $> 1.96$  indicate significant spatial clustering, (A) north section and (B) south section. (figure on next pages)**

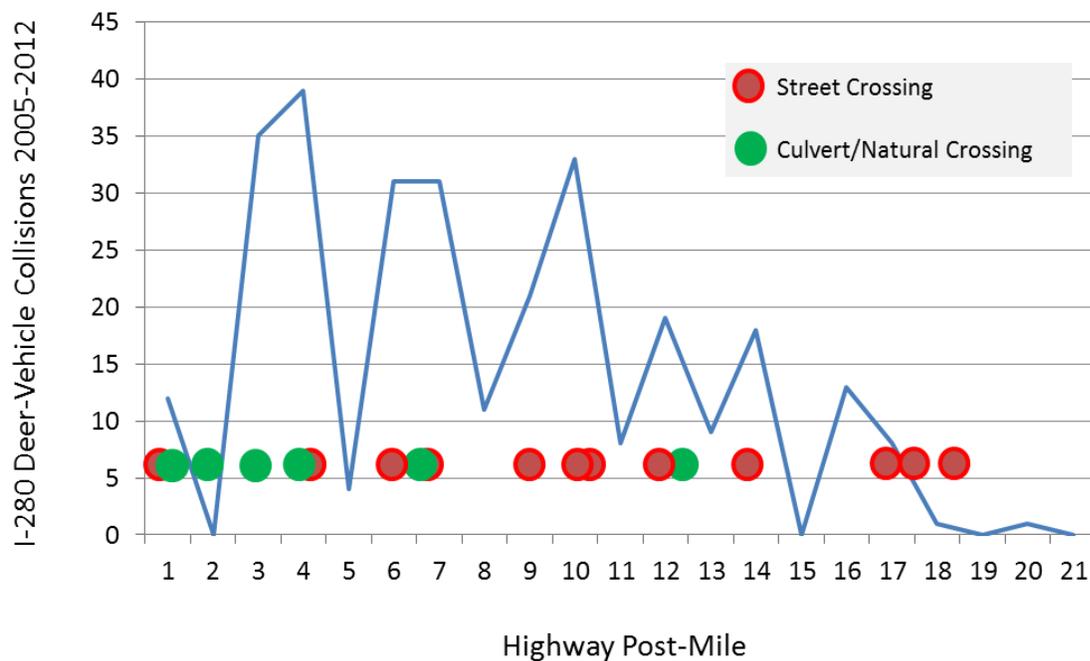
**Figure 11.** Comparison of number of deer-vehicle collisions (DVC) on I-280 per post-mile and the approximate location of street, culvert, and natural-bottomed crossing structures.

The presence of WVC were visually compared to the presence of crossing structures for safe movement across the right-of-way (Figure 10). There was no apparent negative relationship between the presence of WVC and available crossing structures (Figure 10A,B). Deer-vehicle collisions (DVC) are a special subset of WVC because of the risk posed to drivers and vehicles from the collision. DVC (data from Caltrans) by post-mile were compared to the availability of crossing structures under or over I-280. There was no apparent relationship between a structure being available and rate of DVC (Figure 10C and 11).

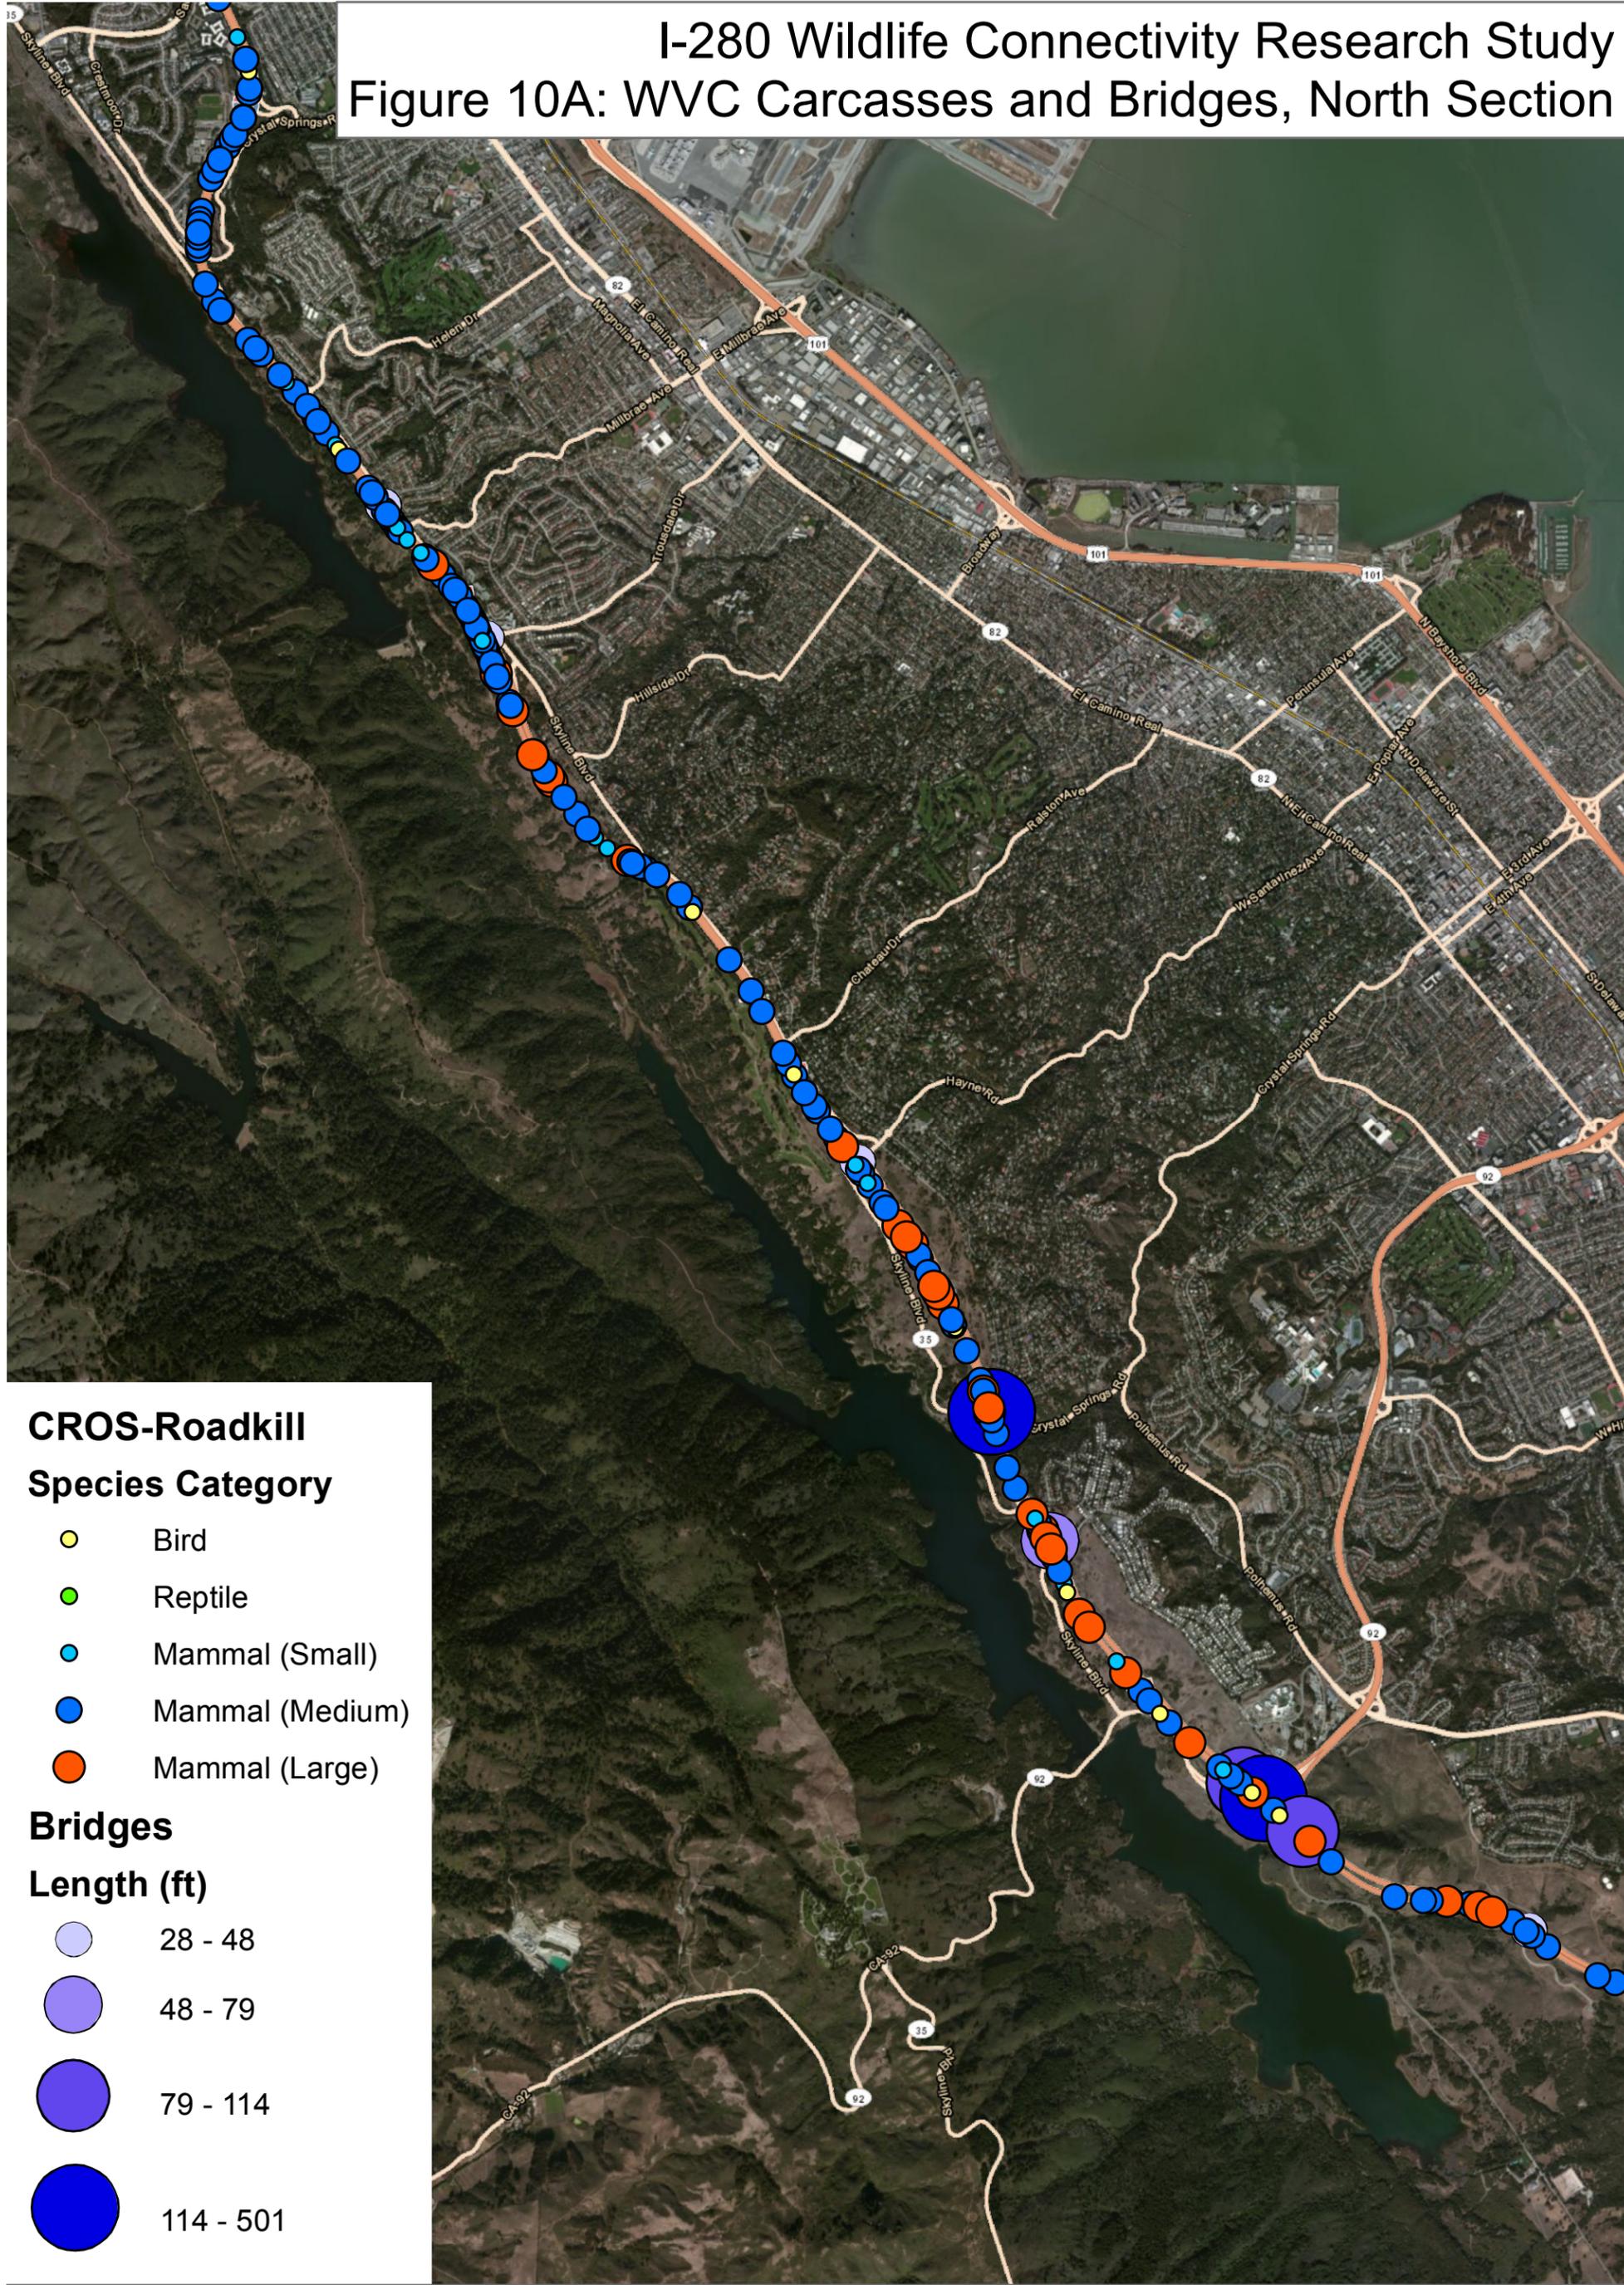
I-280 Wildlife Connectivity Research Study  
 Figure 10A: WVC Carcasses and Bridges, North Section

**Figure 10.** Deer carcass data from Caltrans Maintenance (2005-12) and availability of bridges of different span length, (A) north section and (B) south section. C) DVC carcasses by post-mile (PM) and availability of bridge structures of different span lengths. (figure on next page)

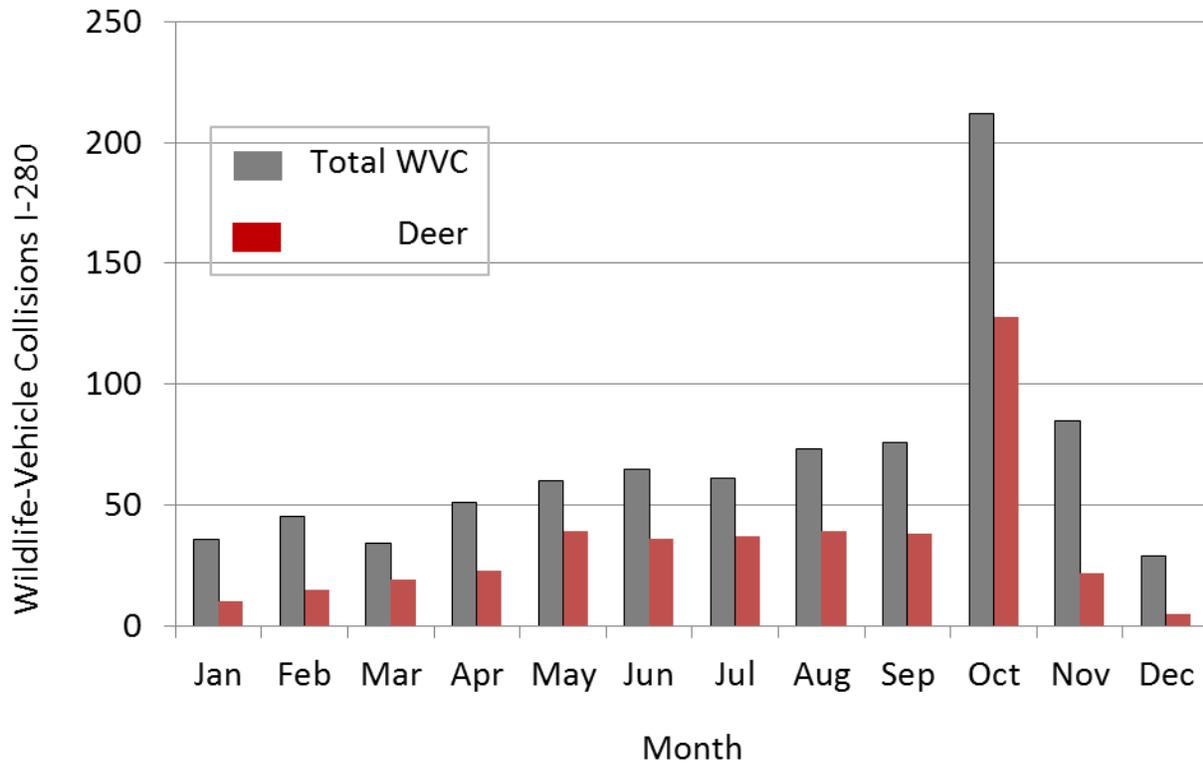
Wildlife-vehicle collisions were compared to months of the year to determine if there was a time of year when collisions were more likely (Figure 12). For both total wildlife-vehicle collisions and deer-vehicle collisions, October had the most collisions and all other months were similar.

**Figure 12. Rate of total wildlife-vehicle-collisions and deer-vehicle collisions per month, between January 2005 and May, 2013.**

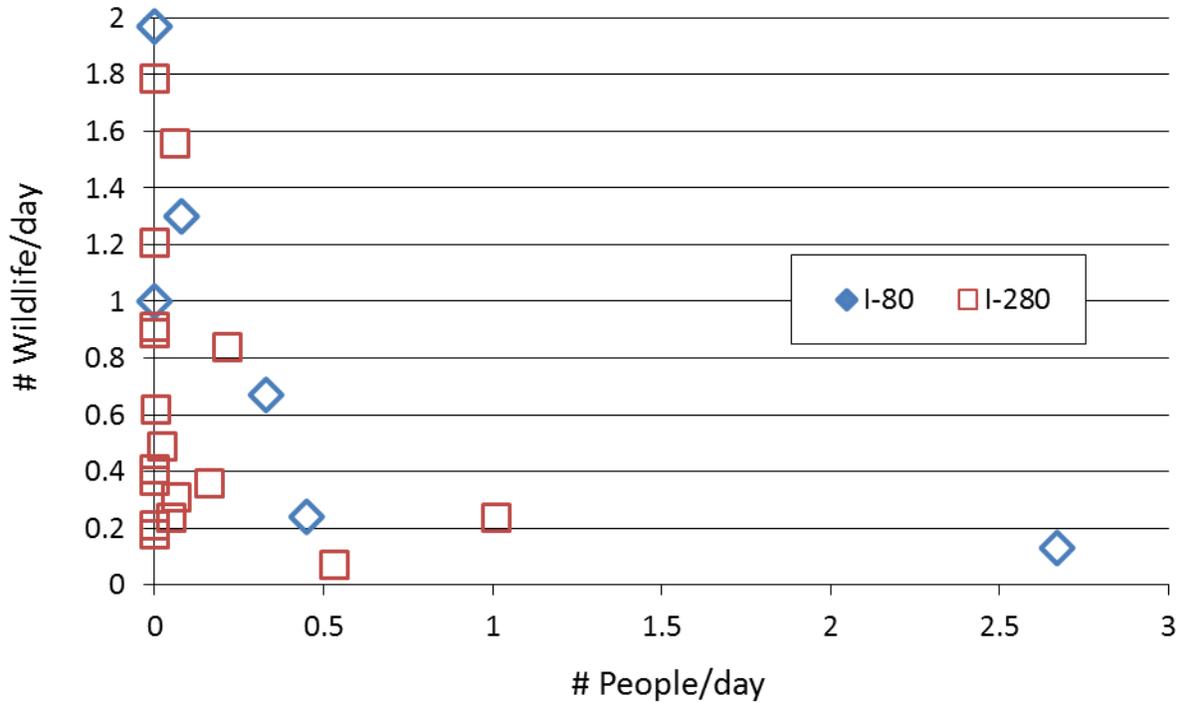
**Figure 14.** Comparison of wildlife rate of structure use with human use of the same structures. Each symbol represents a different structure. Data from a similar study on I-80 were included in order to increase the power of the analysis and understand the generality of the findings.

Deer and other wildlife can and will use certain under-crossing structures, but not others. This relative use seems to be related to the use of the structures by people. We found that if more than one person every few days crosses through a structure, animal (including deer) use will decline. This is consistent with findings for wildlife use of recreation areas (Reed and Merenlender, 2008) and has important implications for management of the existing crossing structures. If the current structures are to be re-managed to encourage wildlife use, then it may be necessary to curtail human use. In many cases, the pedestrian, equestrian and bicycle use of these crossing structures may be considered vital by users. Resolving these multiple uses so that wildlife can pass may be challenging. The alternative to re-managing these existing structures would be to build new wildlife passages.

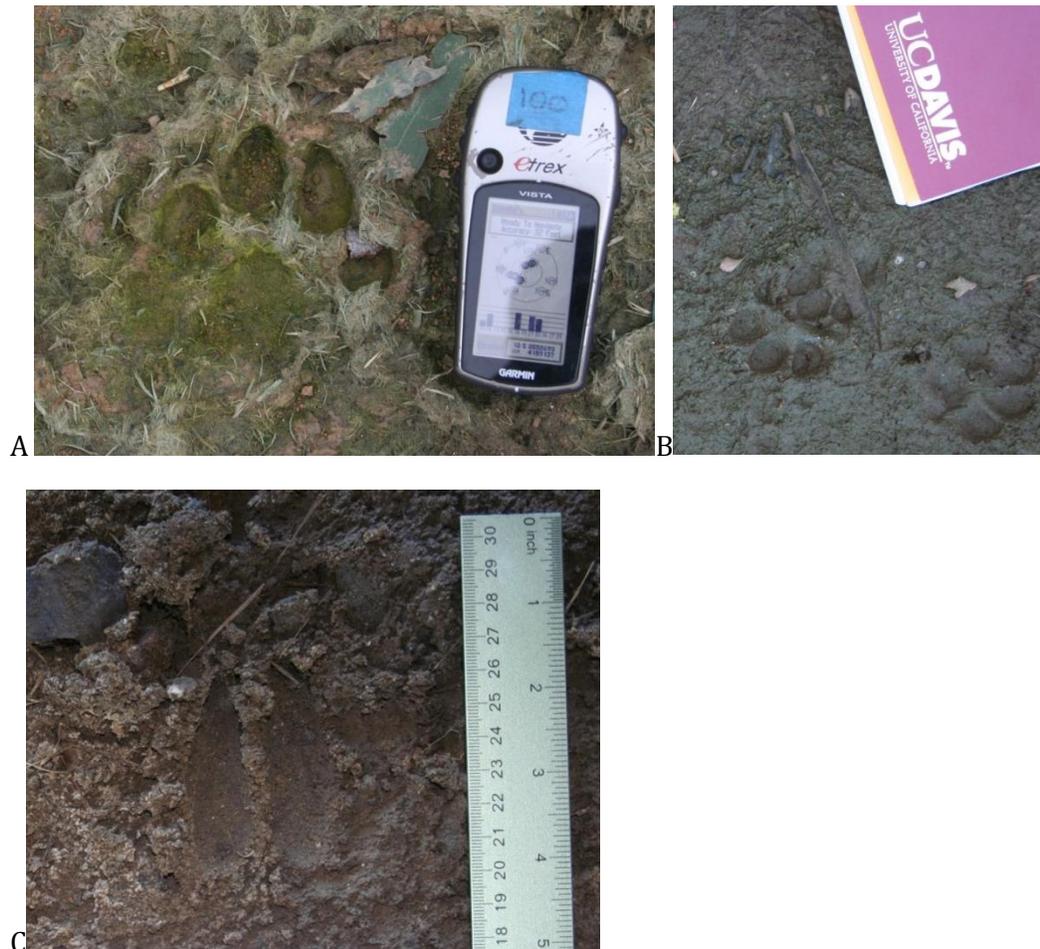
**Figure 16. A) Mountain lion track south of Trousdale, B) Bobcat track at Farm Hill Road Underpass and C) Deer track at Canada Road Underpass**

At certain locations, it was not feasible to place cameras, or cameras that were placed were stolen before data could be retrieved. At these locations, animals tracks were recorded, when observed. Because it was usually not possible to tell how many individuals had passed through a structure over a given time period, only the presence or absence of a certain species was recorded (Figure 16 & 17; Table 3).

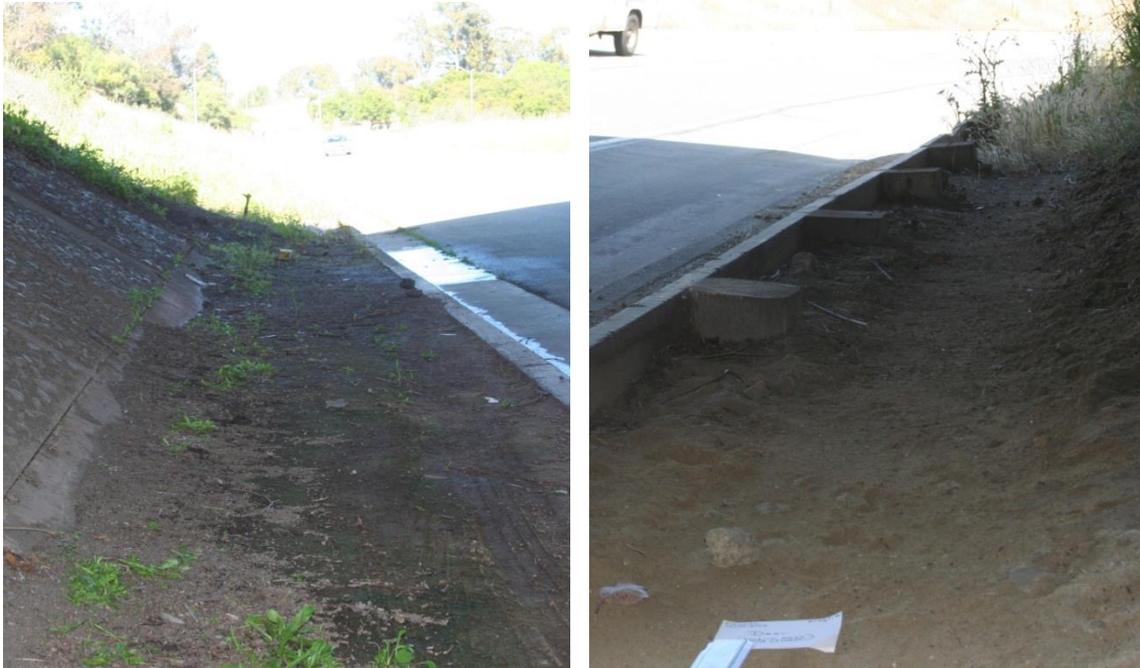
**Figure 17. Undeveloped strips adjacent to streets passing under I-280 often had tracks. A) Dirt “sidewalk” at Farm Hill Road Underpass and B) dirt sidewalk at Canada Road Underpass.**

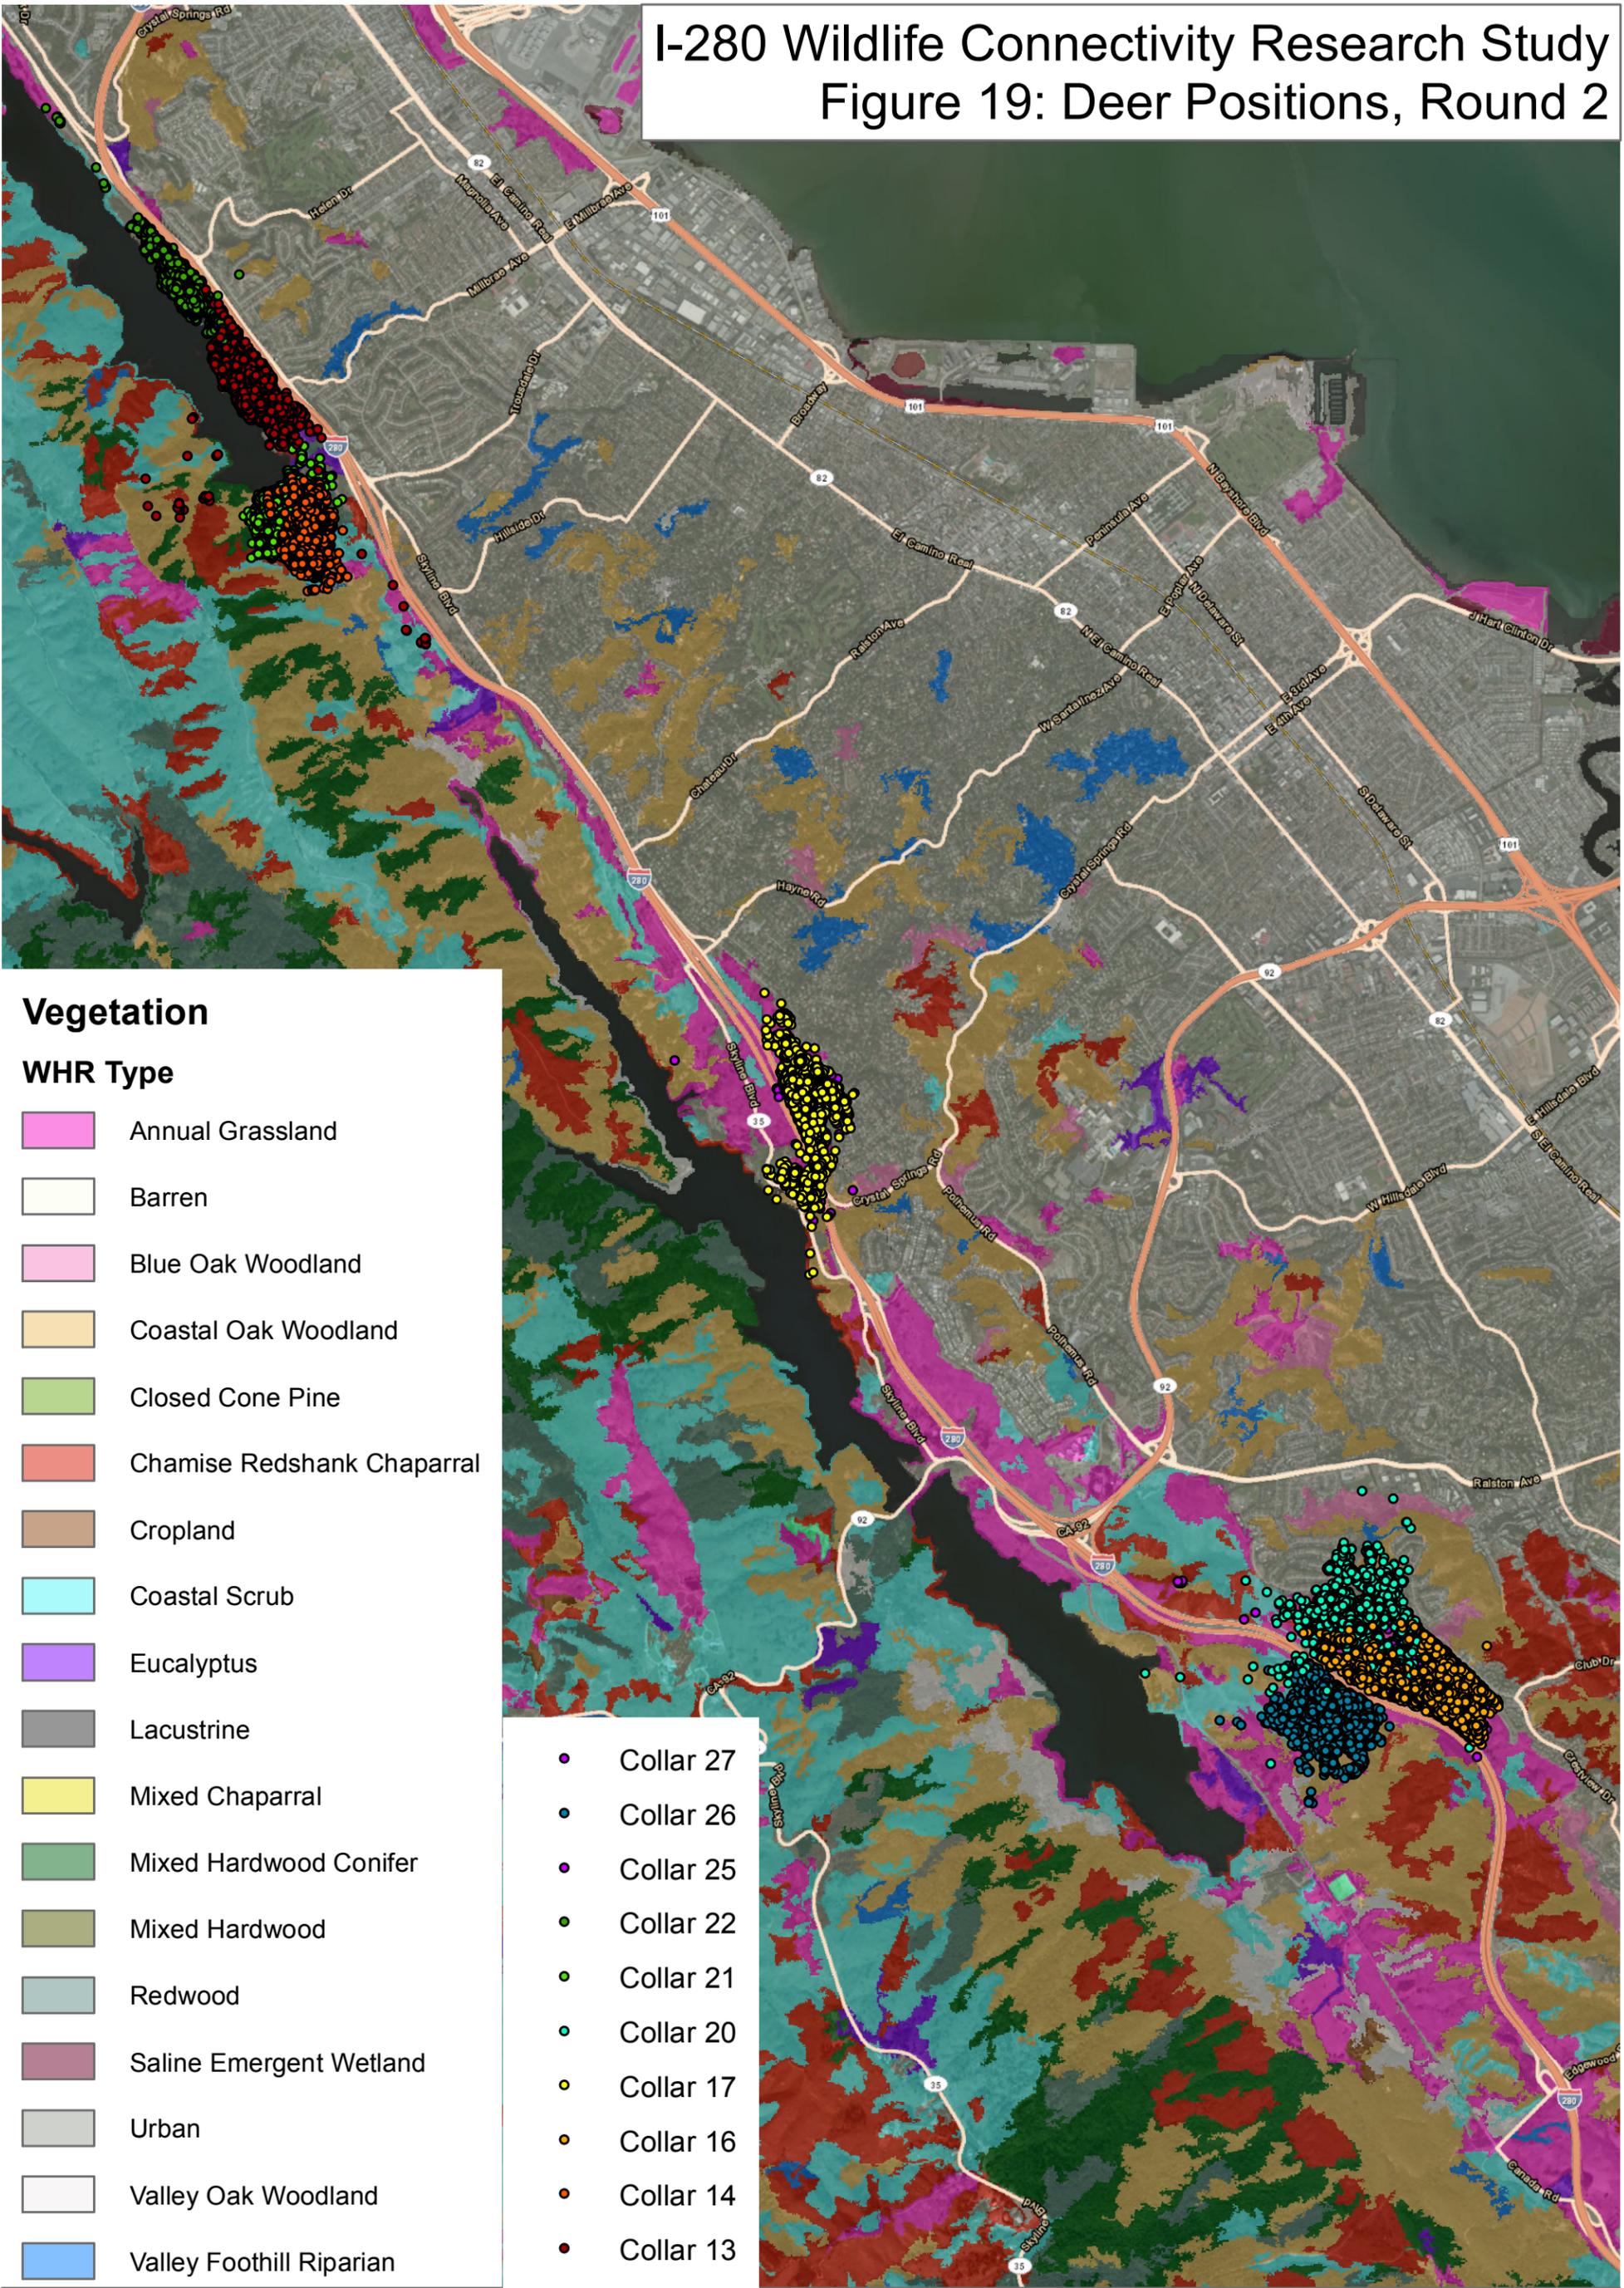
I-280 Wildlife Connectivity Research Study  
 Figure 19: Deer Positions, Round 2

Most of the collared deer stayed within a very circumscribed home range of ~1/2 square mile, with only very occasional movements away from and back toward the home range area (e.g., Collar 17, Round 1 and Collar 13, Round 2).

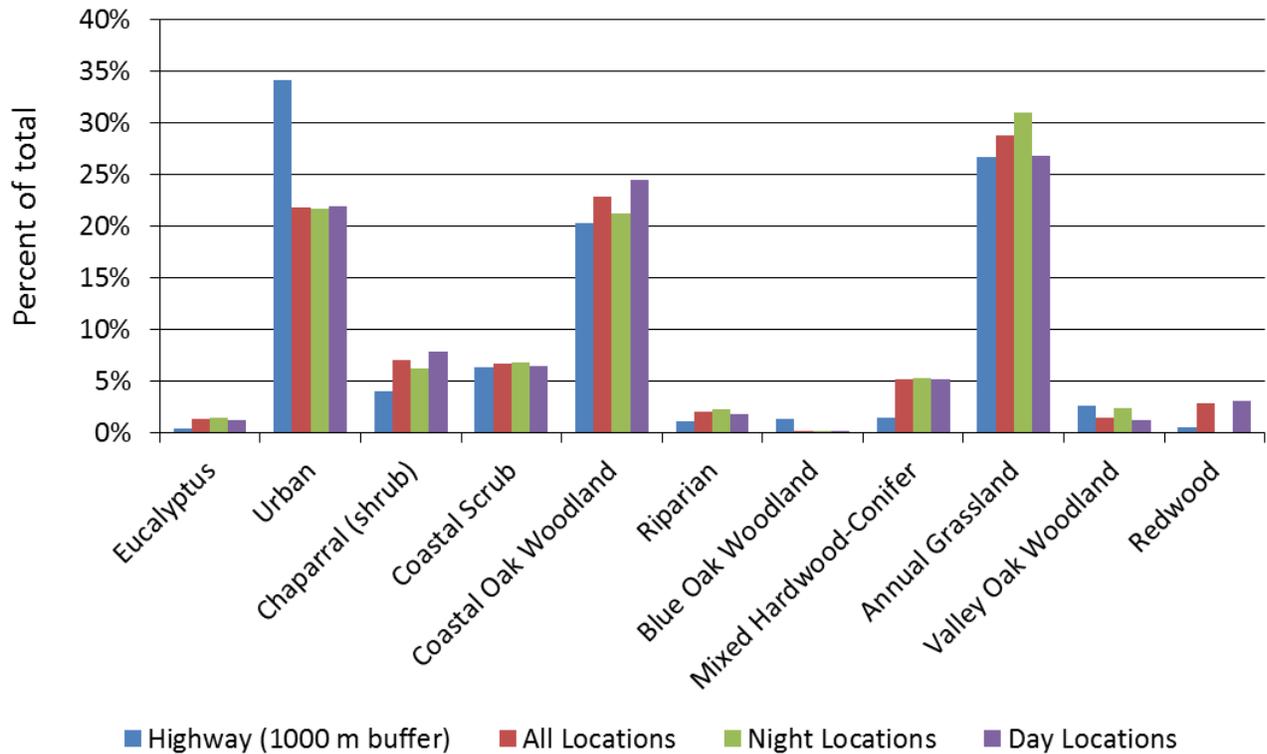
**Figure 20** Distribution of habitat types within 1000 m of I-280 within the study area and distribution of “All Locations”, “Night Locations” and “Day Locations” of deer within different habitat types in the study area, expressed in both cases as a percent of the total distribution.

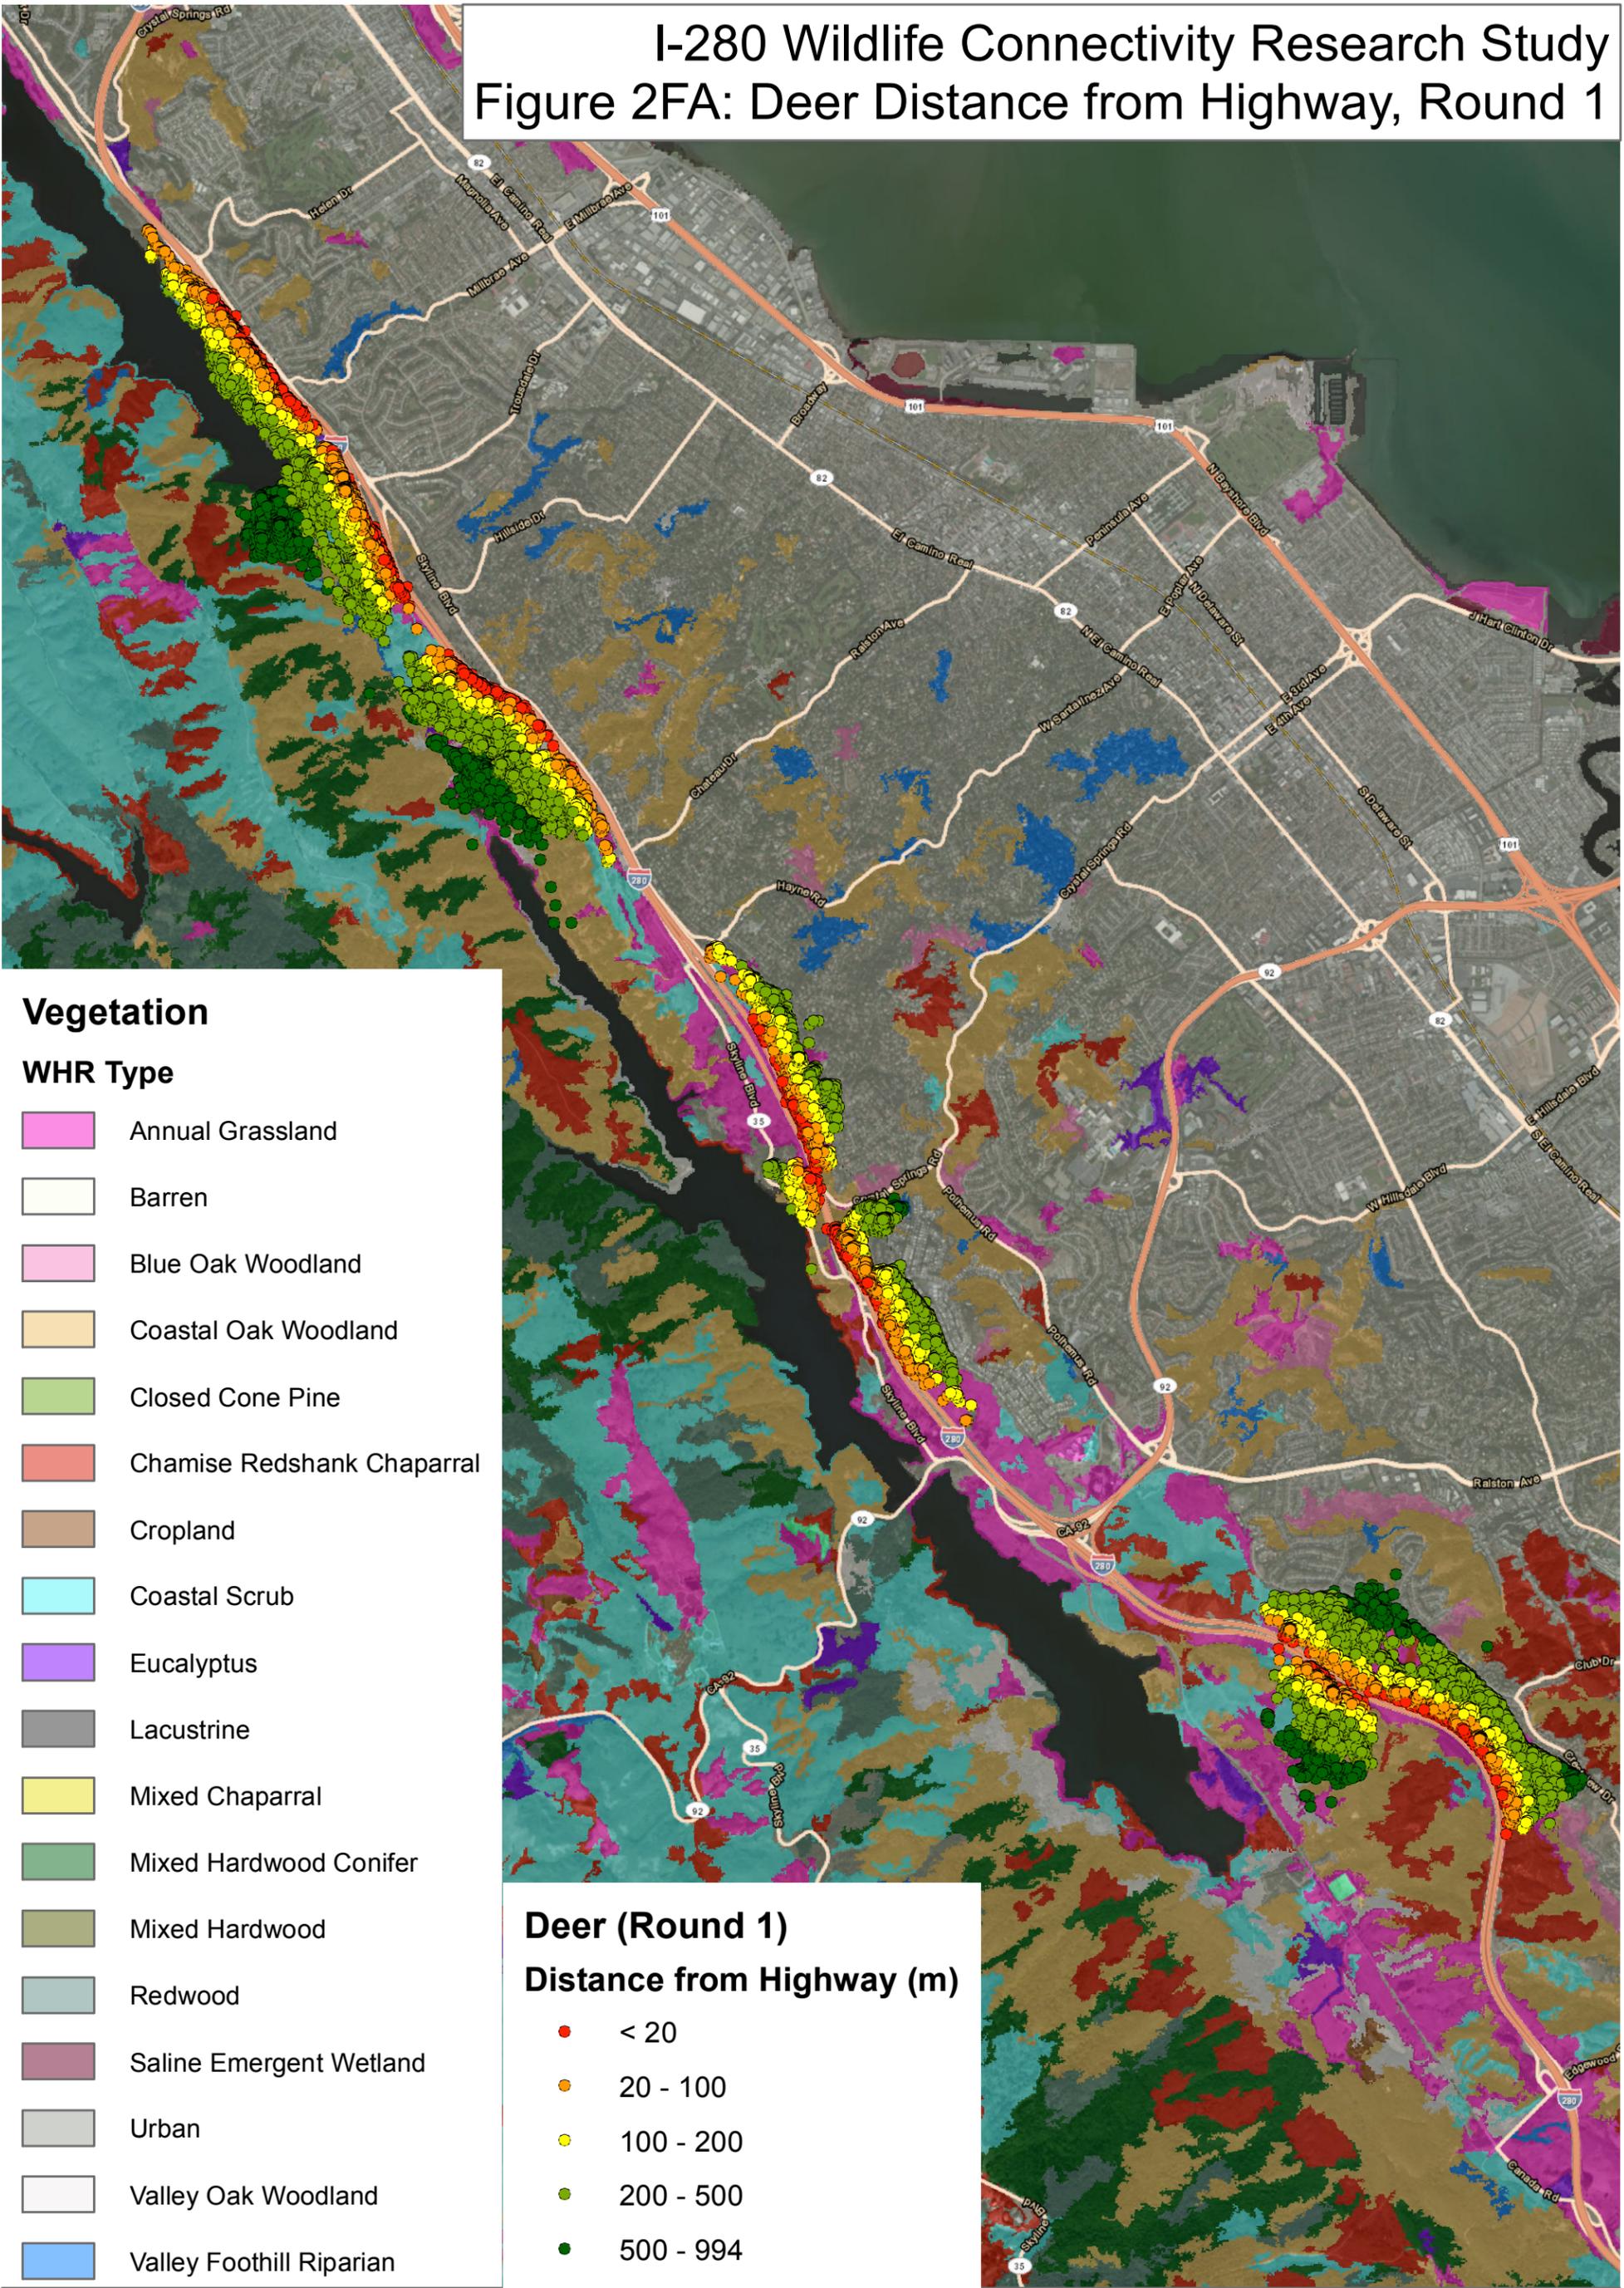
## Figure 2FA: Deer Distance from Highway, Round 1

Collared deer appeared to tolerate being within very short distances from the interstate (Figure 21). They also appeared to have very slight, but variable responses to the highway, in response to time of day. Across all deer, there was little variation in distance from the highway edge across the 24-hour day (Figure 22). For individual animals, this ranged from no response to the highway (Collar 13) to a significant diurnal response (Collar 15), where the animal was closest in the morning and furthest in the late afternoon. Both animals represented in the figure were within 1 km of each other and collared at the same time (12/2011 to 6/2012).
