# Interstate 280 Wildlife Connectivity Research Study: Findings and Recommendations

UC Davis Road Ecology Center  
Caltrans, District 4  
California Department of Fish & Wildlife

Prepared by Fraser Shilling

**December 13, 2013**

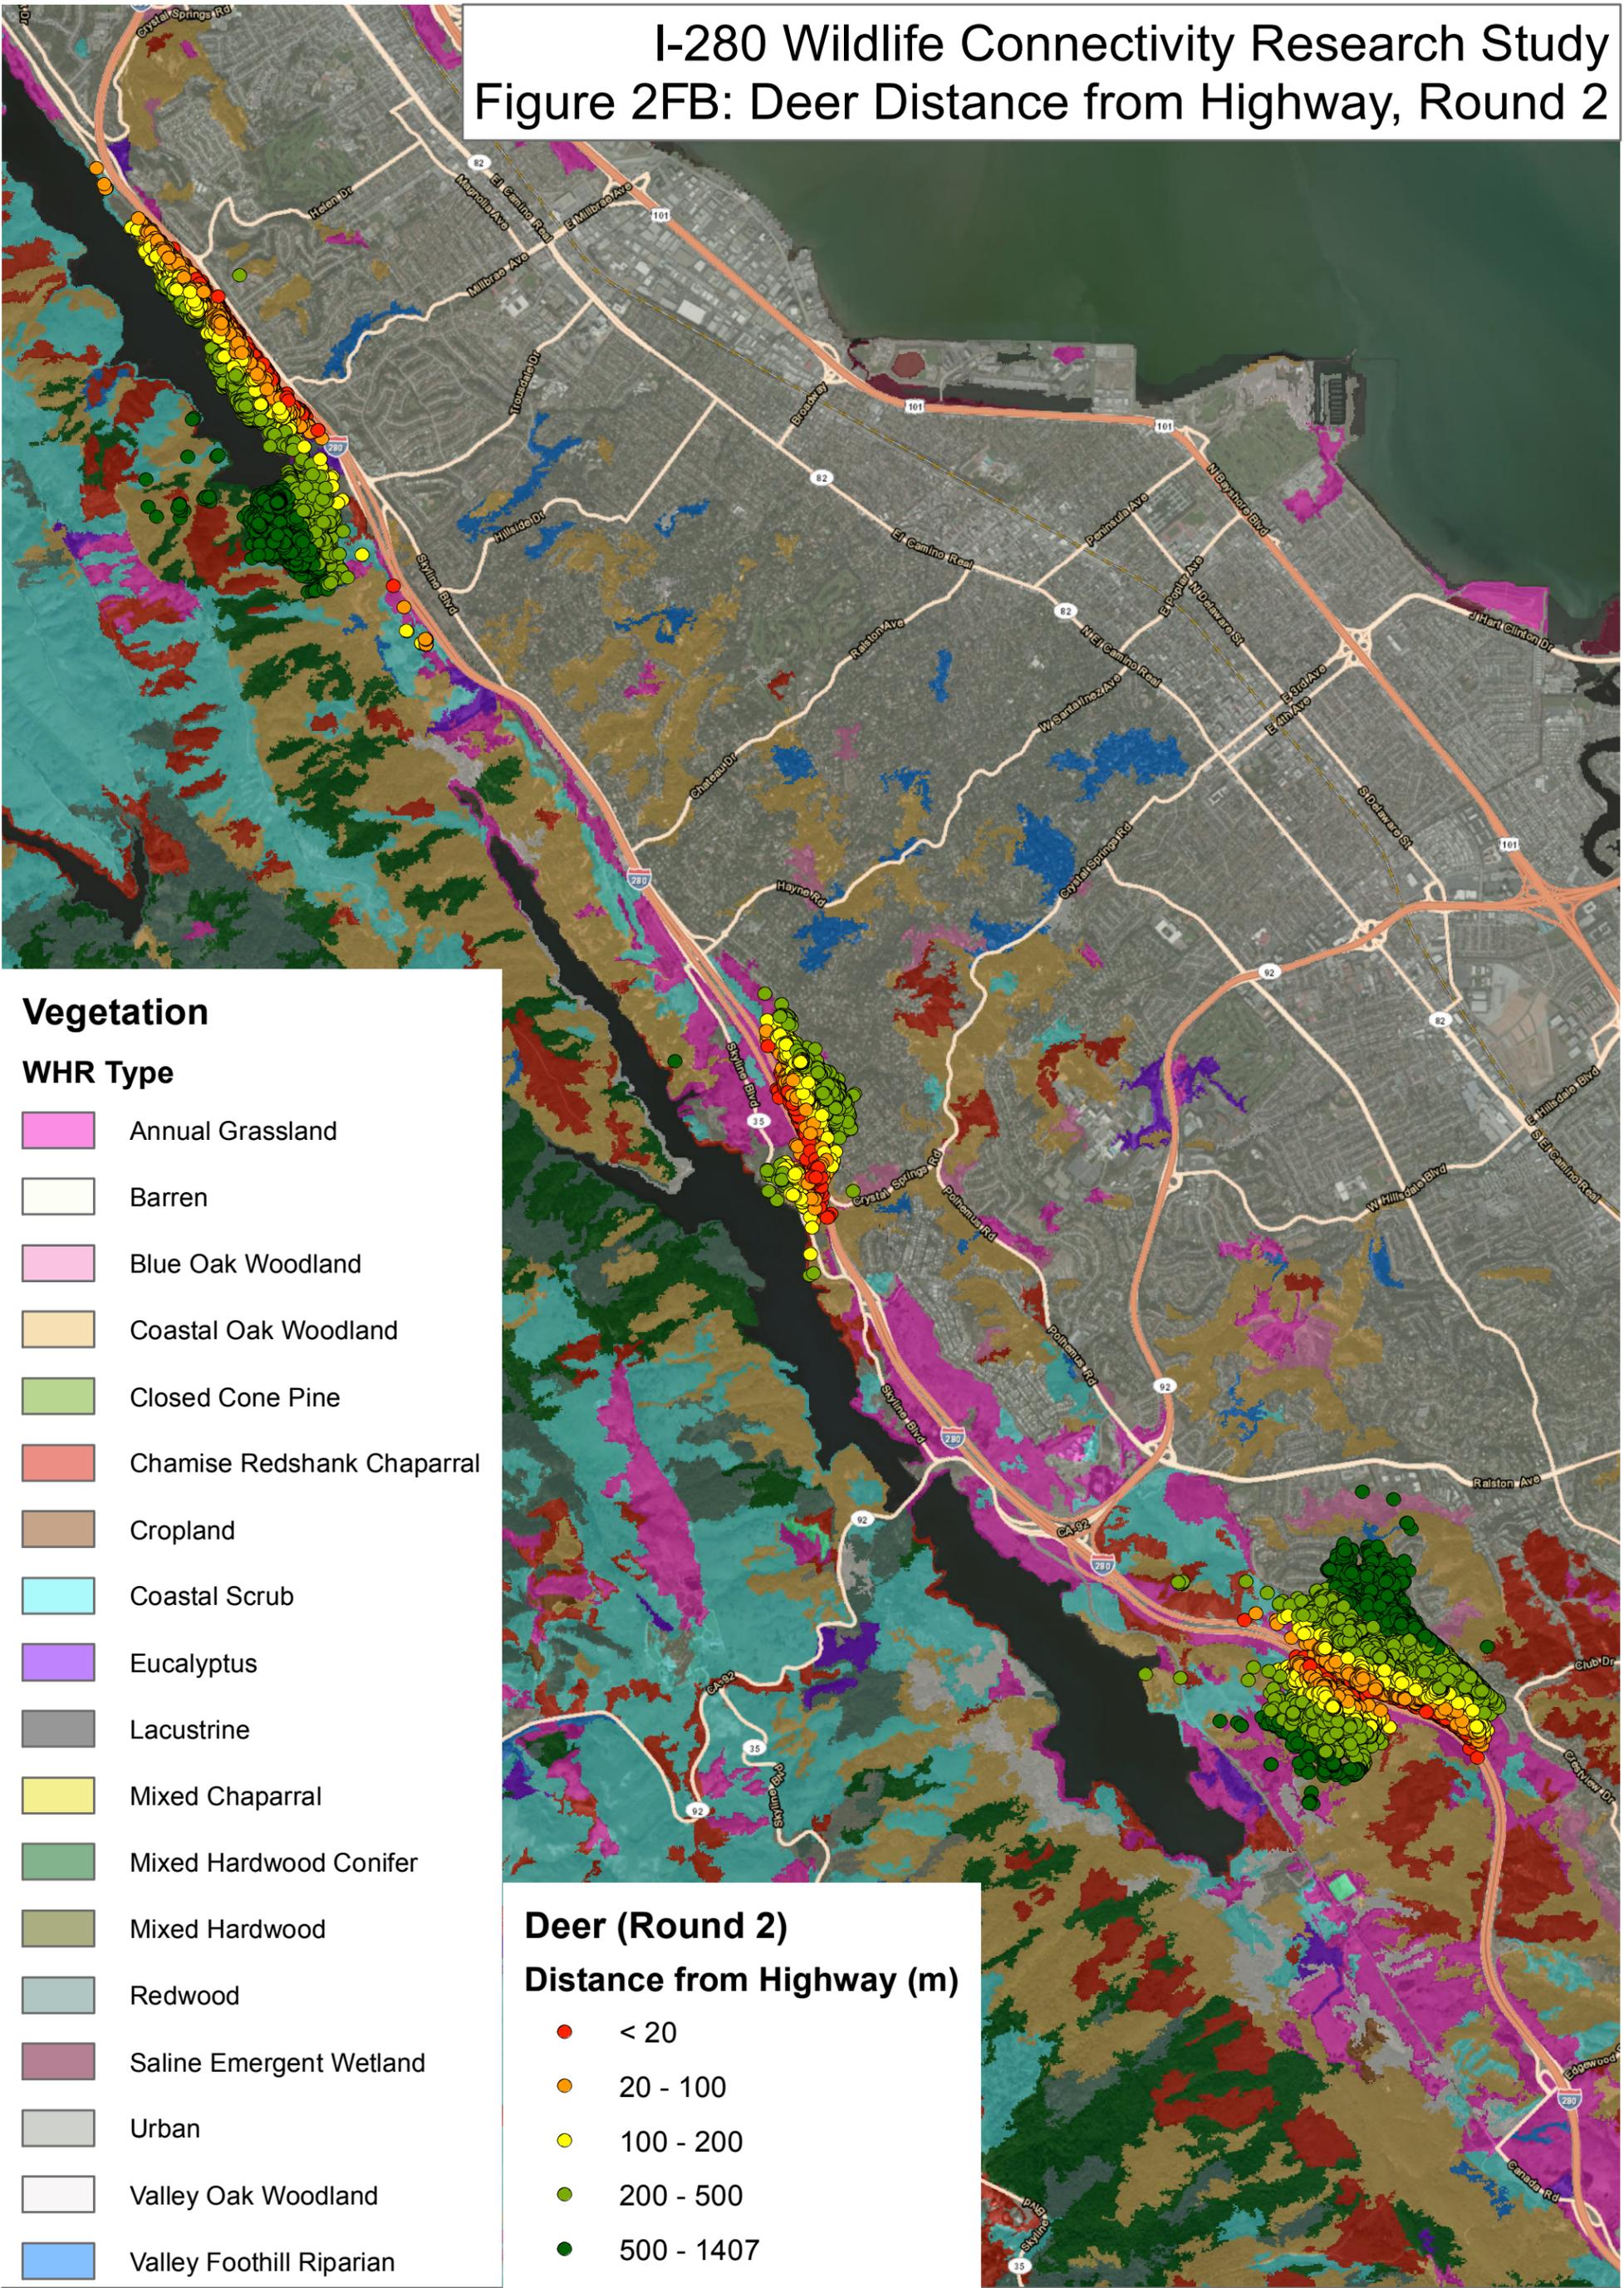
## Figure 2FB: Deer Distance from Highway, Round 2

Collared deer appeared to tolerate being within very short distances from the interstate (Figure 21). They also appeared to have very slight, but variable responses to the highway, in response to time of day. Across all deer, there was little variation in distance from the highway edge across the 24-hour day (Figure 22). For individual animals, this ranged from no response to the highway (Collar 13) to a significant diurnal response (Collar 15), where the animal was closest in the morning and furthest in the late afternoon. Both animals represented in the figure were within 1 km of each other and collared at the same time (12/2011 to 6/2012).

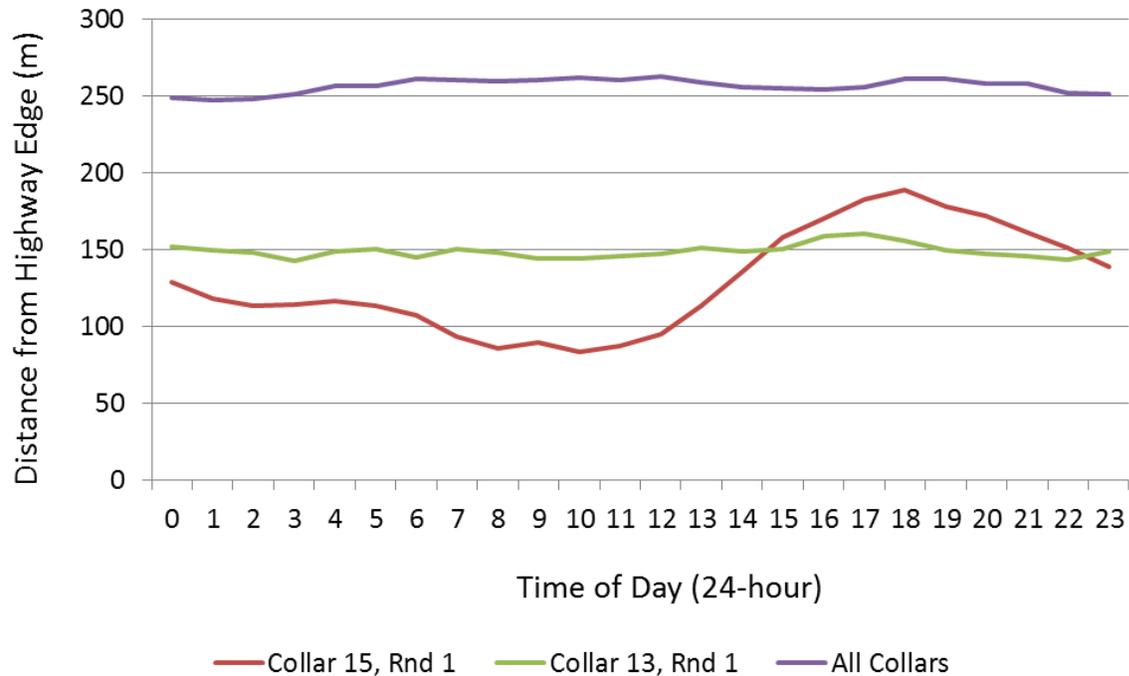
**Figure 22.** Average distance from the highway right-of-way of collared deer at different times of day. The purple line is the result for all collared deer. The red and green lines are the results for two deer (Collar 15 and 13) collared in the first round of collaring (“Rnd 1”).

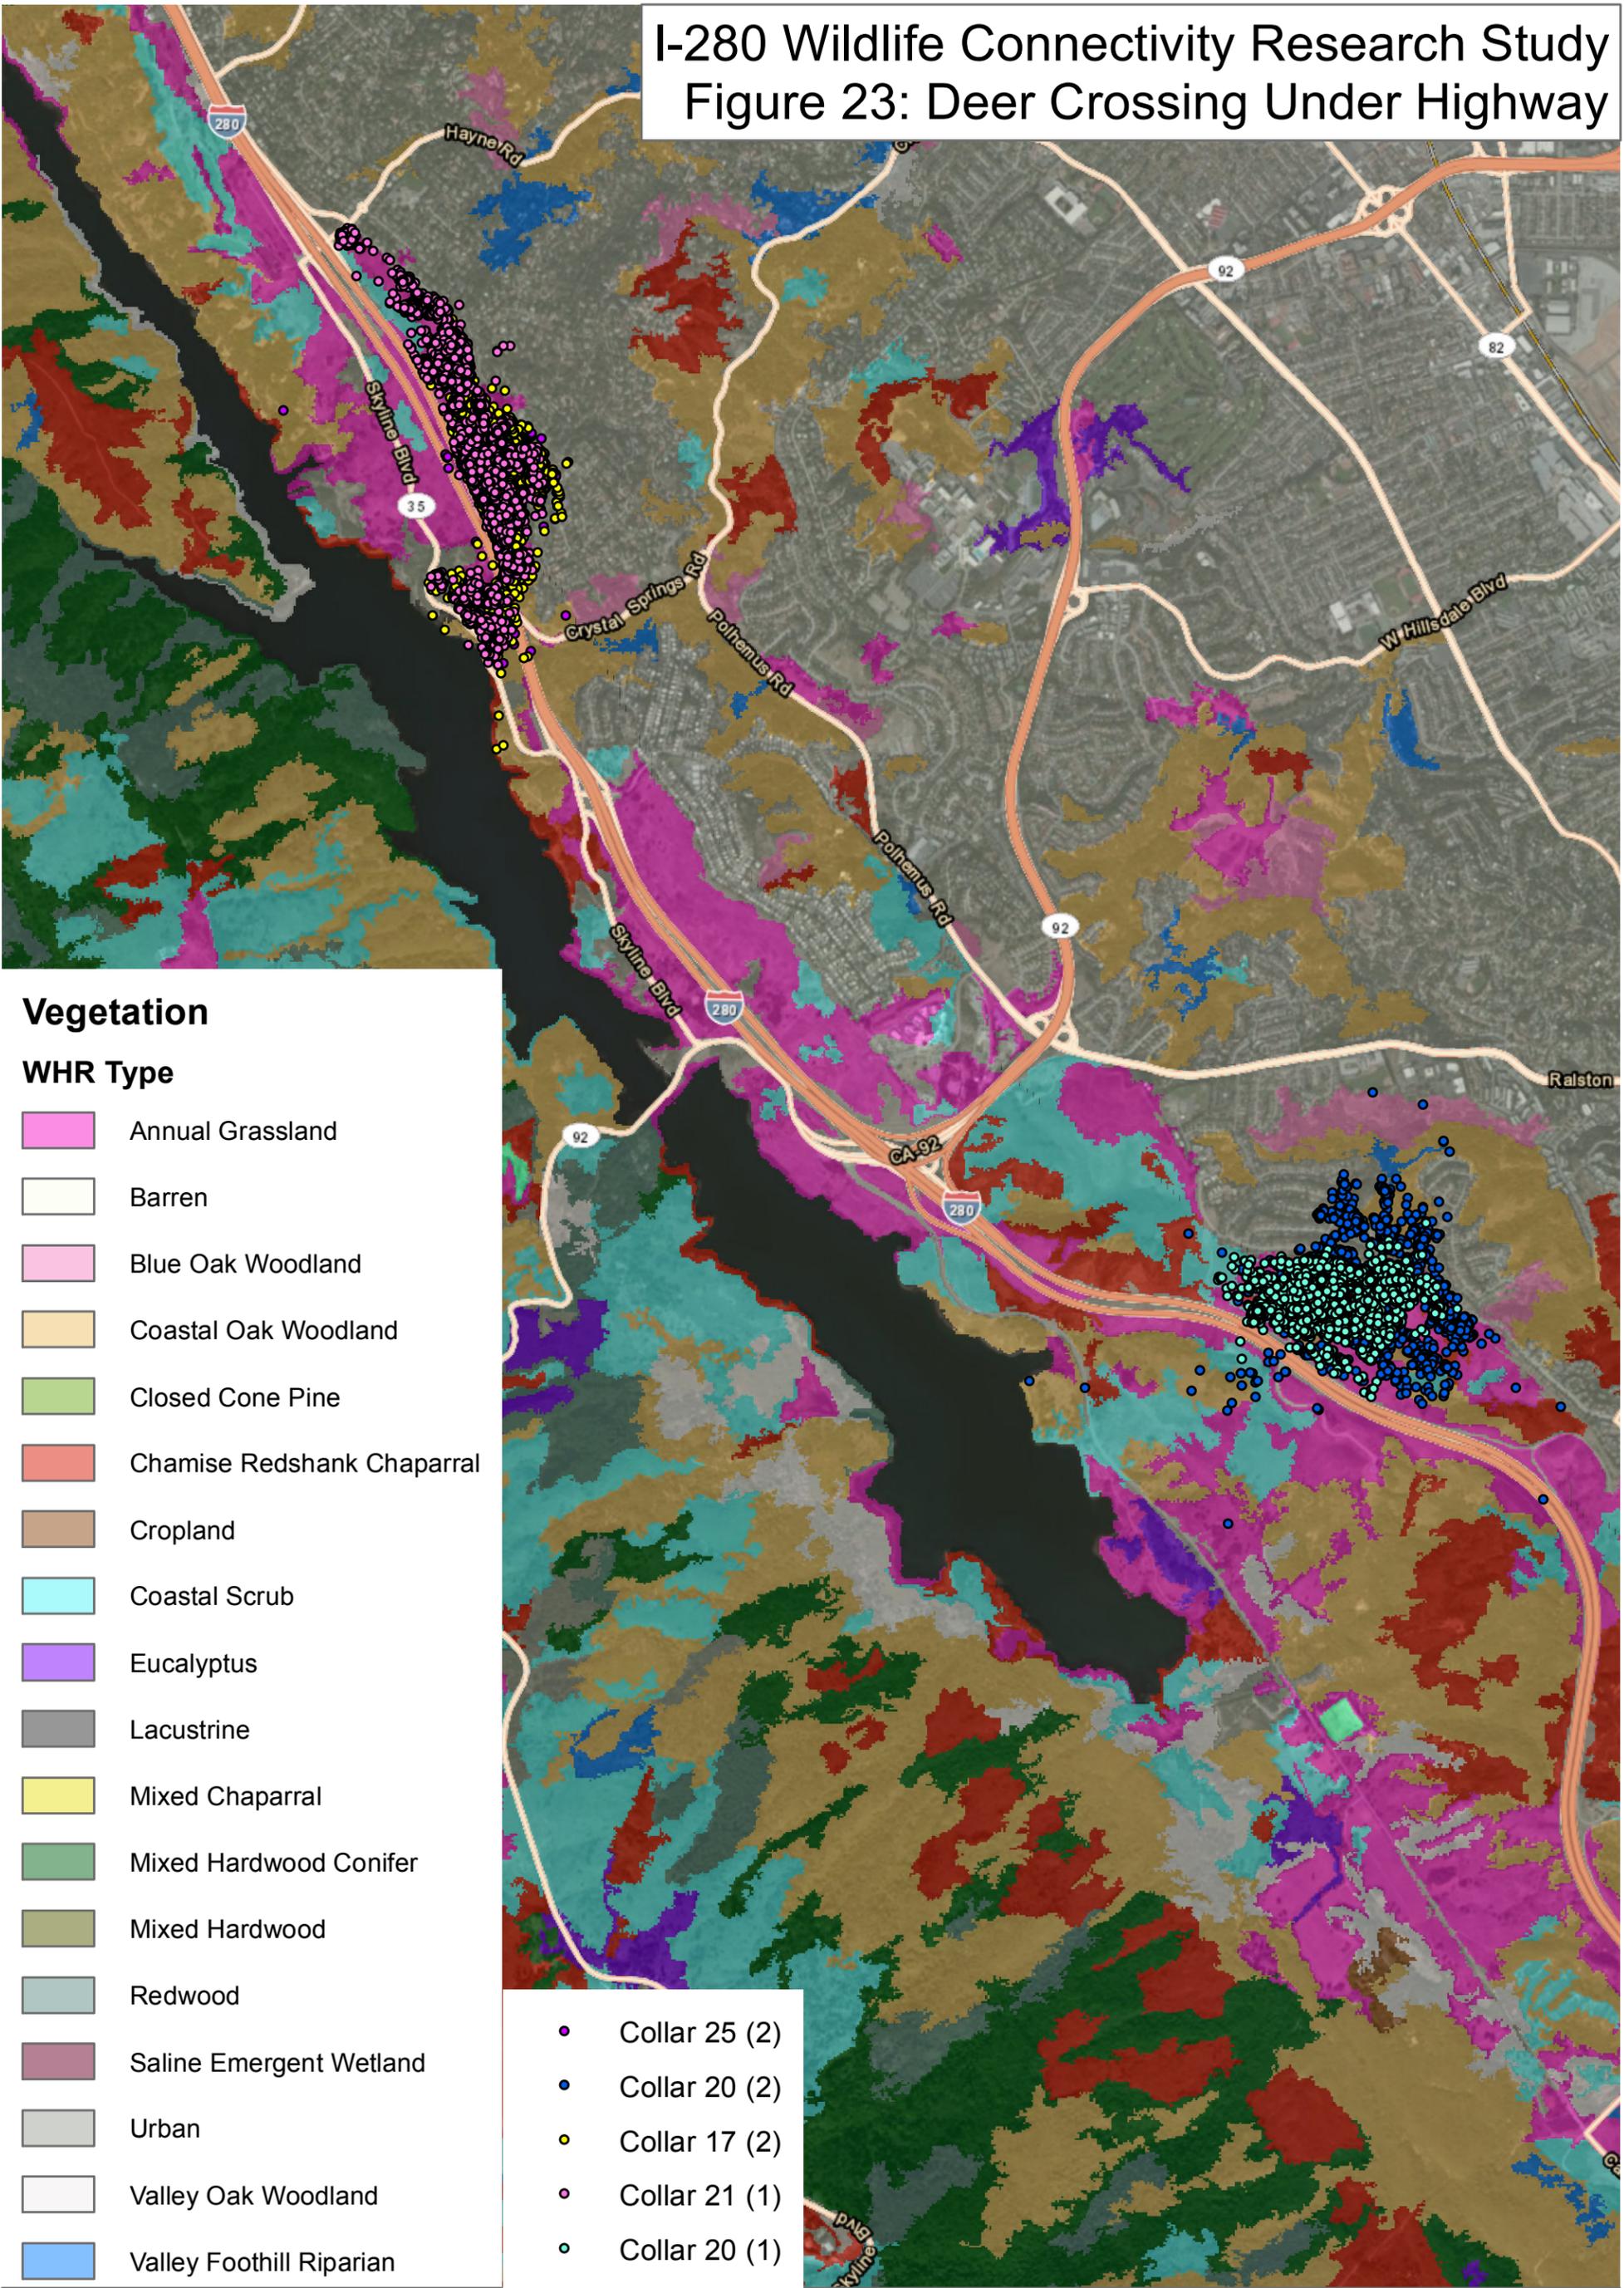
I-280 Wildlife Connectivity Research Study  
 Figure 23: Deer Crossing Under Highway

We also found that 5 collared deer would cross the interstate using 2 of 5 available bridge under-crossings (Crystal Springs Rd/San Mateo Creek and Vista Point Road UC), not including the highway 92 interchange bridges (Figure 23). These crossings were within the home range of the collared deer. The habitat on either side of the crossings structures consisted of chaparral, oak woodland, and annual grasslands. One of the collared deer was eventually hit on the road at the San Mateo Creek bridge, so the availability and occasional use of these crossings by themselves does not ensure their use for safe passage under the interstate.

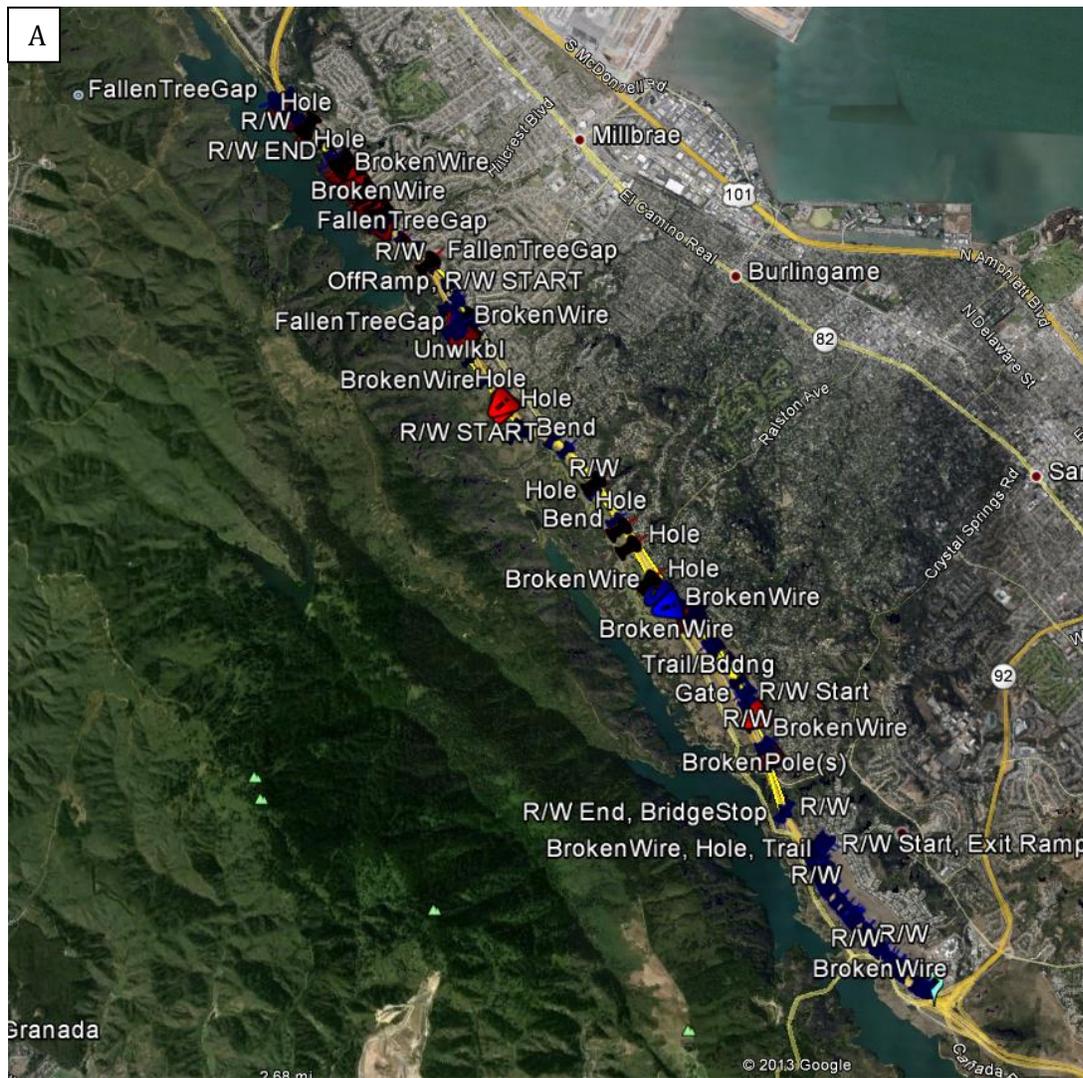
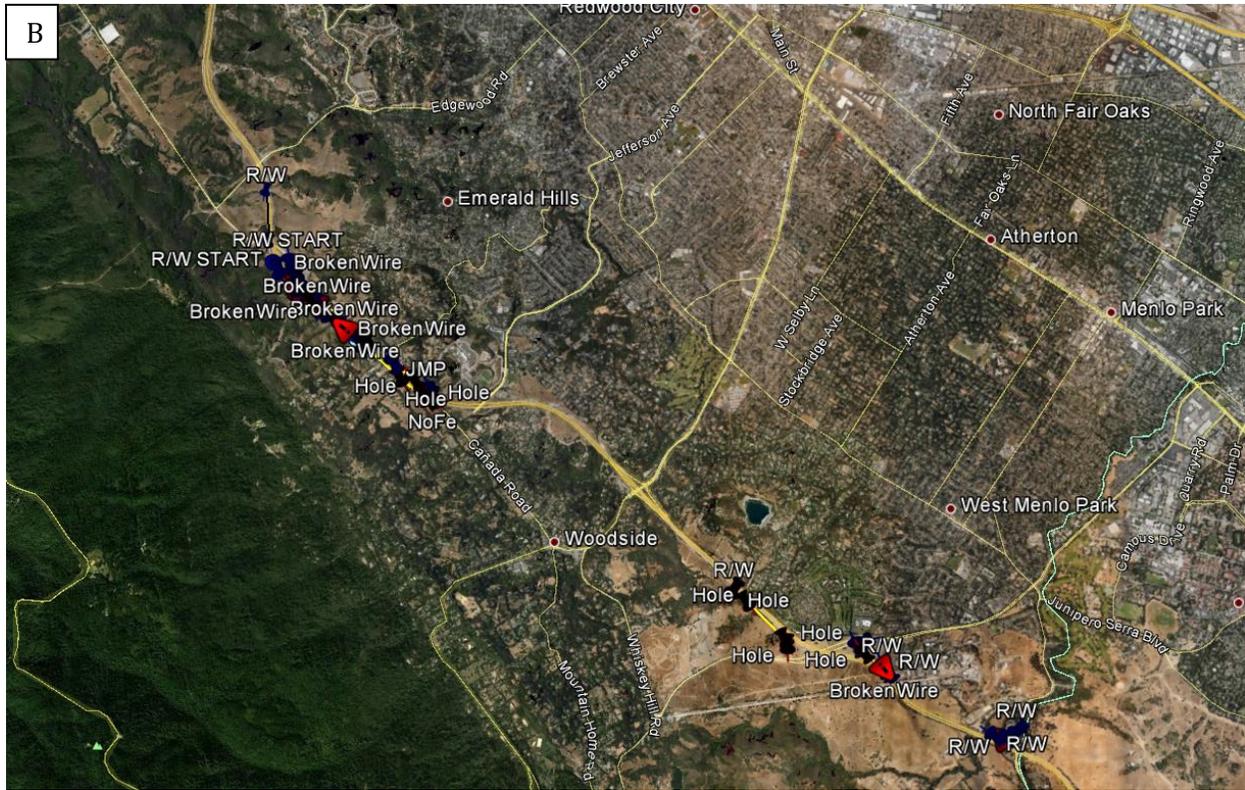
There were segments of fence that were 5-6 feet tall and in good condition. This was especially true at the north end of the study section. There were also segments that were missing, had fallen down, or were severely damaged. These are shown generally in figures 24 A and B and can be more closely examined in the corresponding Excel spreadsheet or Google Earth KML file. Certain sections were not surveyed for various access and safety reasons described in the Methods section.

**Figure 24. Fence segment end-points and condition assessment for (A) north section and (B) south section.**

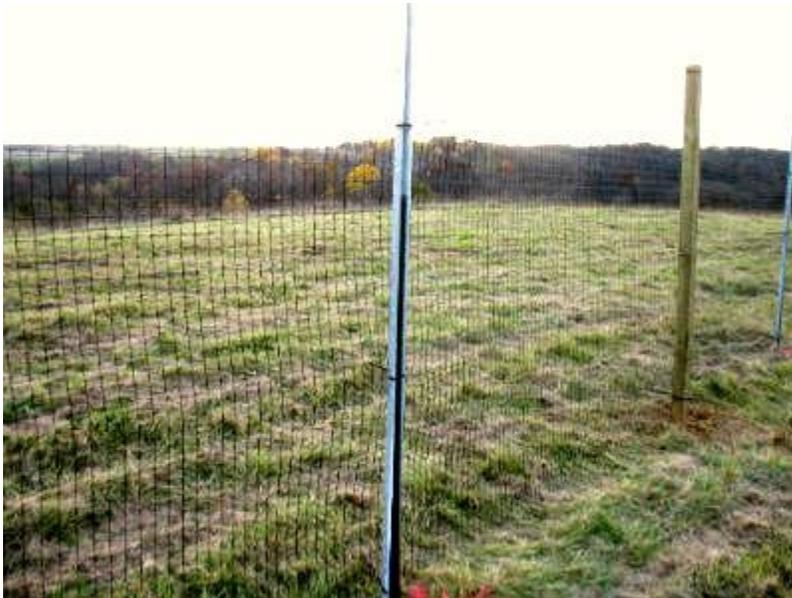
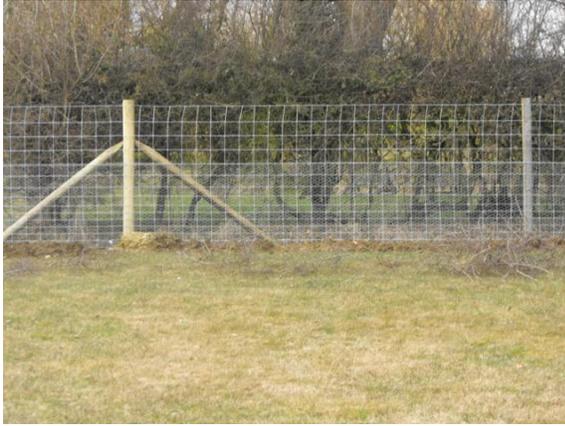
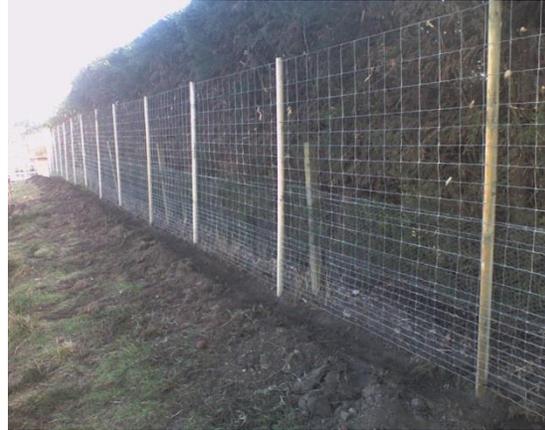
Effective deer fencing is at least 8 feet tall, with a maximum fabric mesh size of 8” (Figure 25). Fence posts can be wood or metal and of sufficient strength and frequency to reduce maintenance needs due to downed fencing. In order to reduce the chance of other animals besides deer from pushing through the fence, a finer mesh is often used along the lower 3-4 feet and the foot of the fence is buried (to reduce the chance of animals pushing under) or pushed out underground at least 3 feet (for burrowing animals).

**Figure 25.** Different styles of fence used to exclude deer (source: <http://lowadnr.gov>).

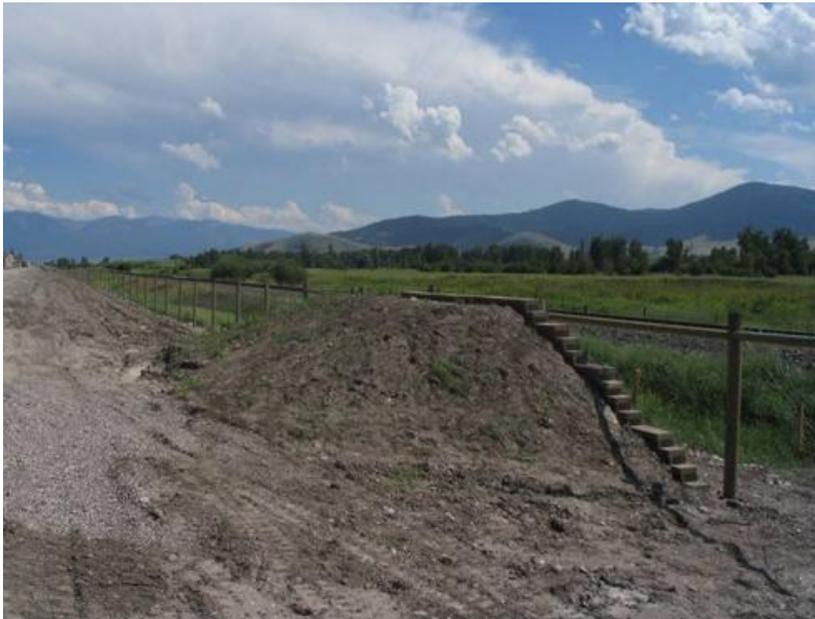
Fencing is effective in promoting safe passage of animals across a right-of-way when it has associated structures like over or under-passes, jump-outs and cattle-guards. Jump-outs are designed so that animals can jump from the road side of a dirt embankment to ground outside the fence-line (figure 26).

**Figure 26.** Dirt jump-outs on I-93, Arizona (Photo: <http://www.fhwa.gov>)

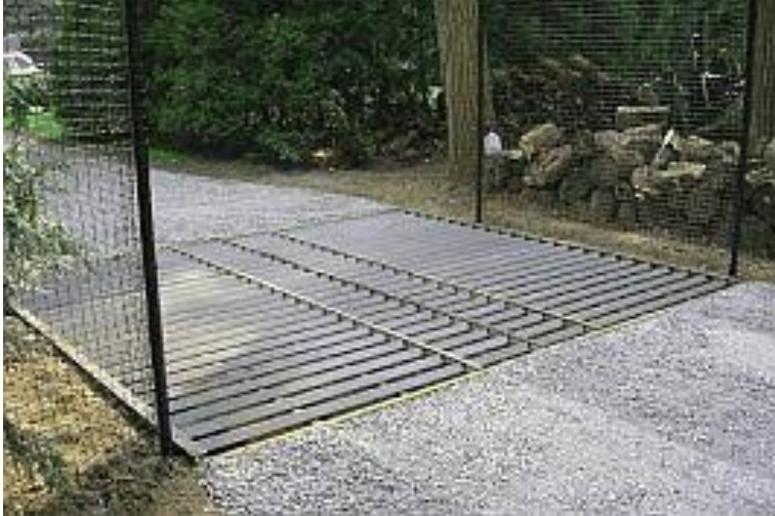
Like most highways, I-280 has entry and exit ramps that allow surface street connectivity. If the right-of-way was fenced, then these ramps would permeate the fence, allowing animals to enter the highway surface via the ramps. Cattle-guards are an effective way to reduce or eliminate this entry (Figure 27), making the fence-line effectively impermeable even at the ramps.

**Figure 27.** Cattle-guard linked to 8-foot fence to prevent deer from entering a road-way around the ends of a fence.

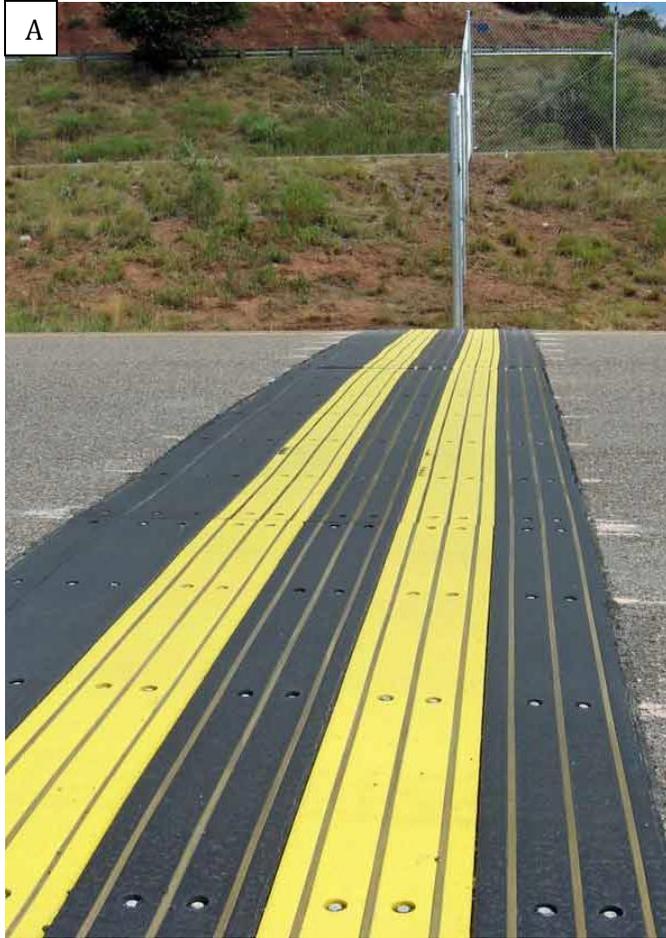
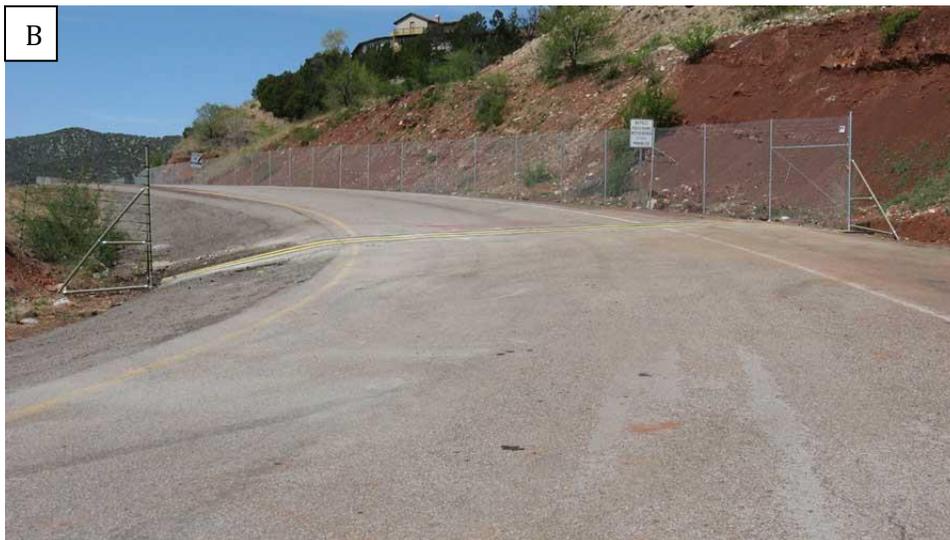
Another method for excluding deer from the ROW via on and off-ramps is by using electrified mats, which can be very effective when correctly deployed (>95%; Seamans and Helon, 2008). These are generally specialized commercial products that use a surface charge to repel deer (Figure 28A). To be effective, these devices must be tied into fence-lines with no space between the fence and the electrified mat (Figure 28B).

**Figure 28. (A) Electrified mat deployed across an asphalt road. (B) Electrified mat associated with adjacent fences.**

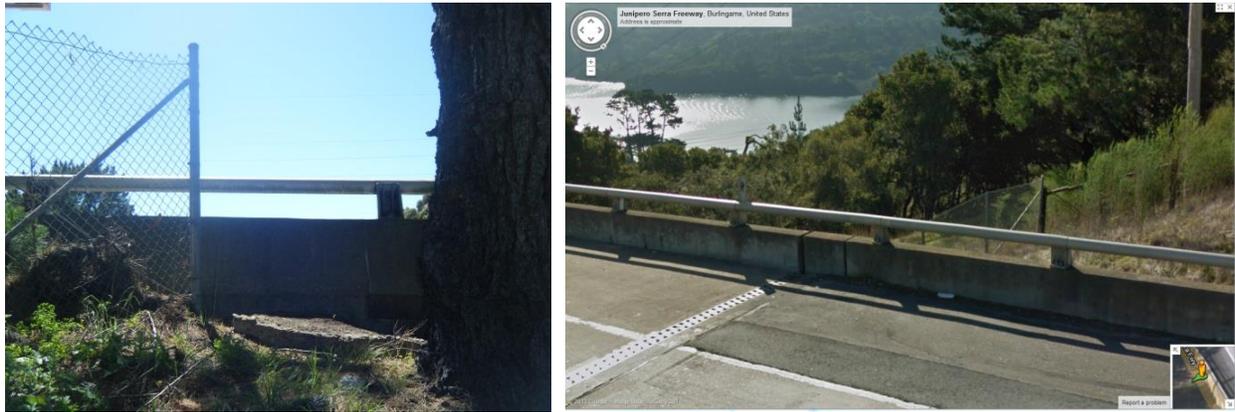
Examples of two potential tie-in points on I-280 are shown in the pictures in Figure 29. Both are places where a 6-foot chain link fence runs into a bridge structure, allowing minor modifications to be added to ensure animals can't work their way around or over the end of the fence. The advantage of places like this is that fencing can be added in stages, rather than all at once.

**Figure 29. Fence-lines joining bridge abutments creating tie-in points for deer-proof fencing.**
