COSUMNES **FLOODPLAIN** MITIGATION BANK  
HABITAT DEVELOPMENT PLAN

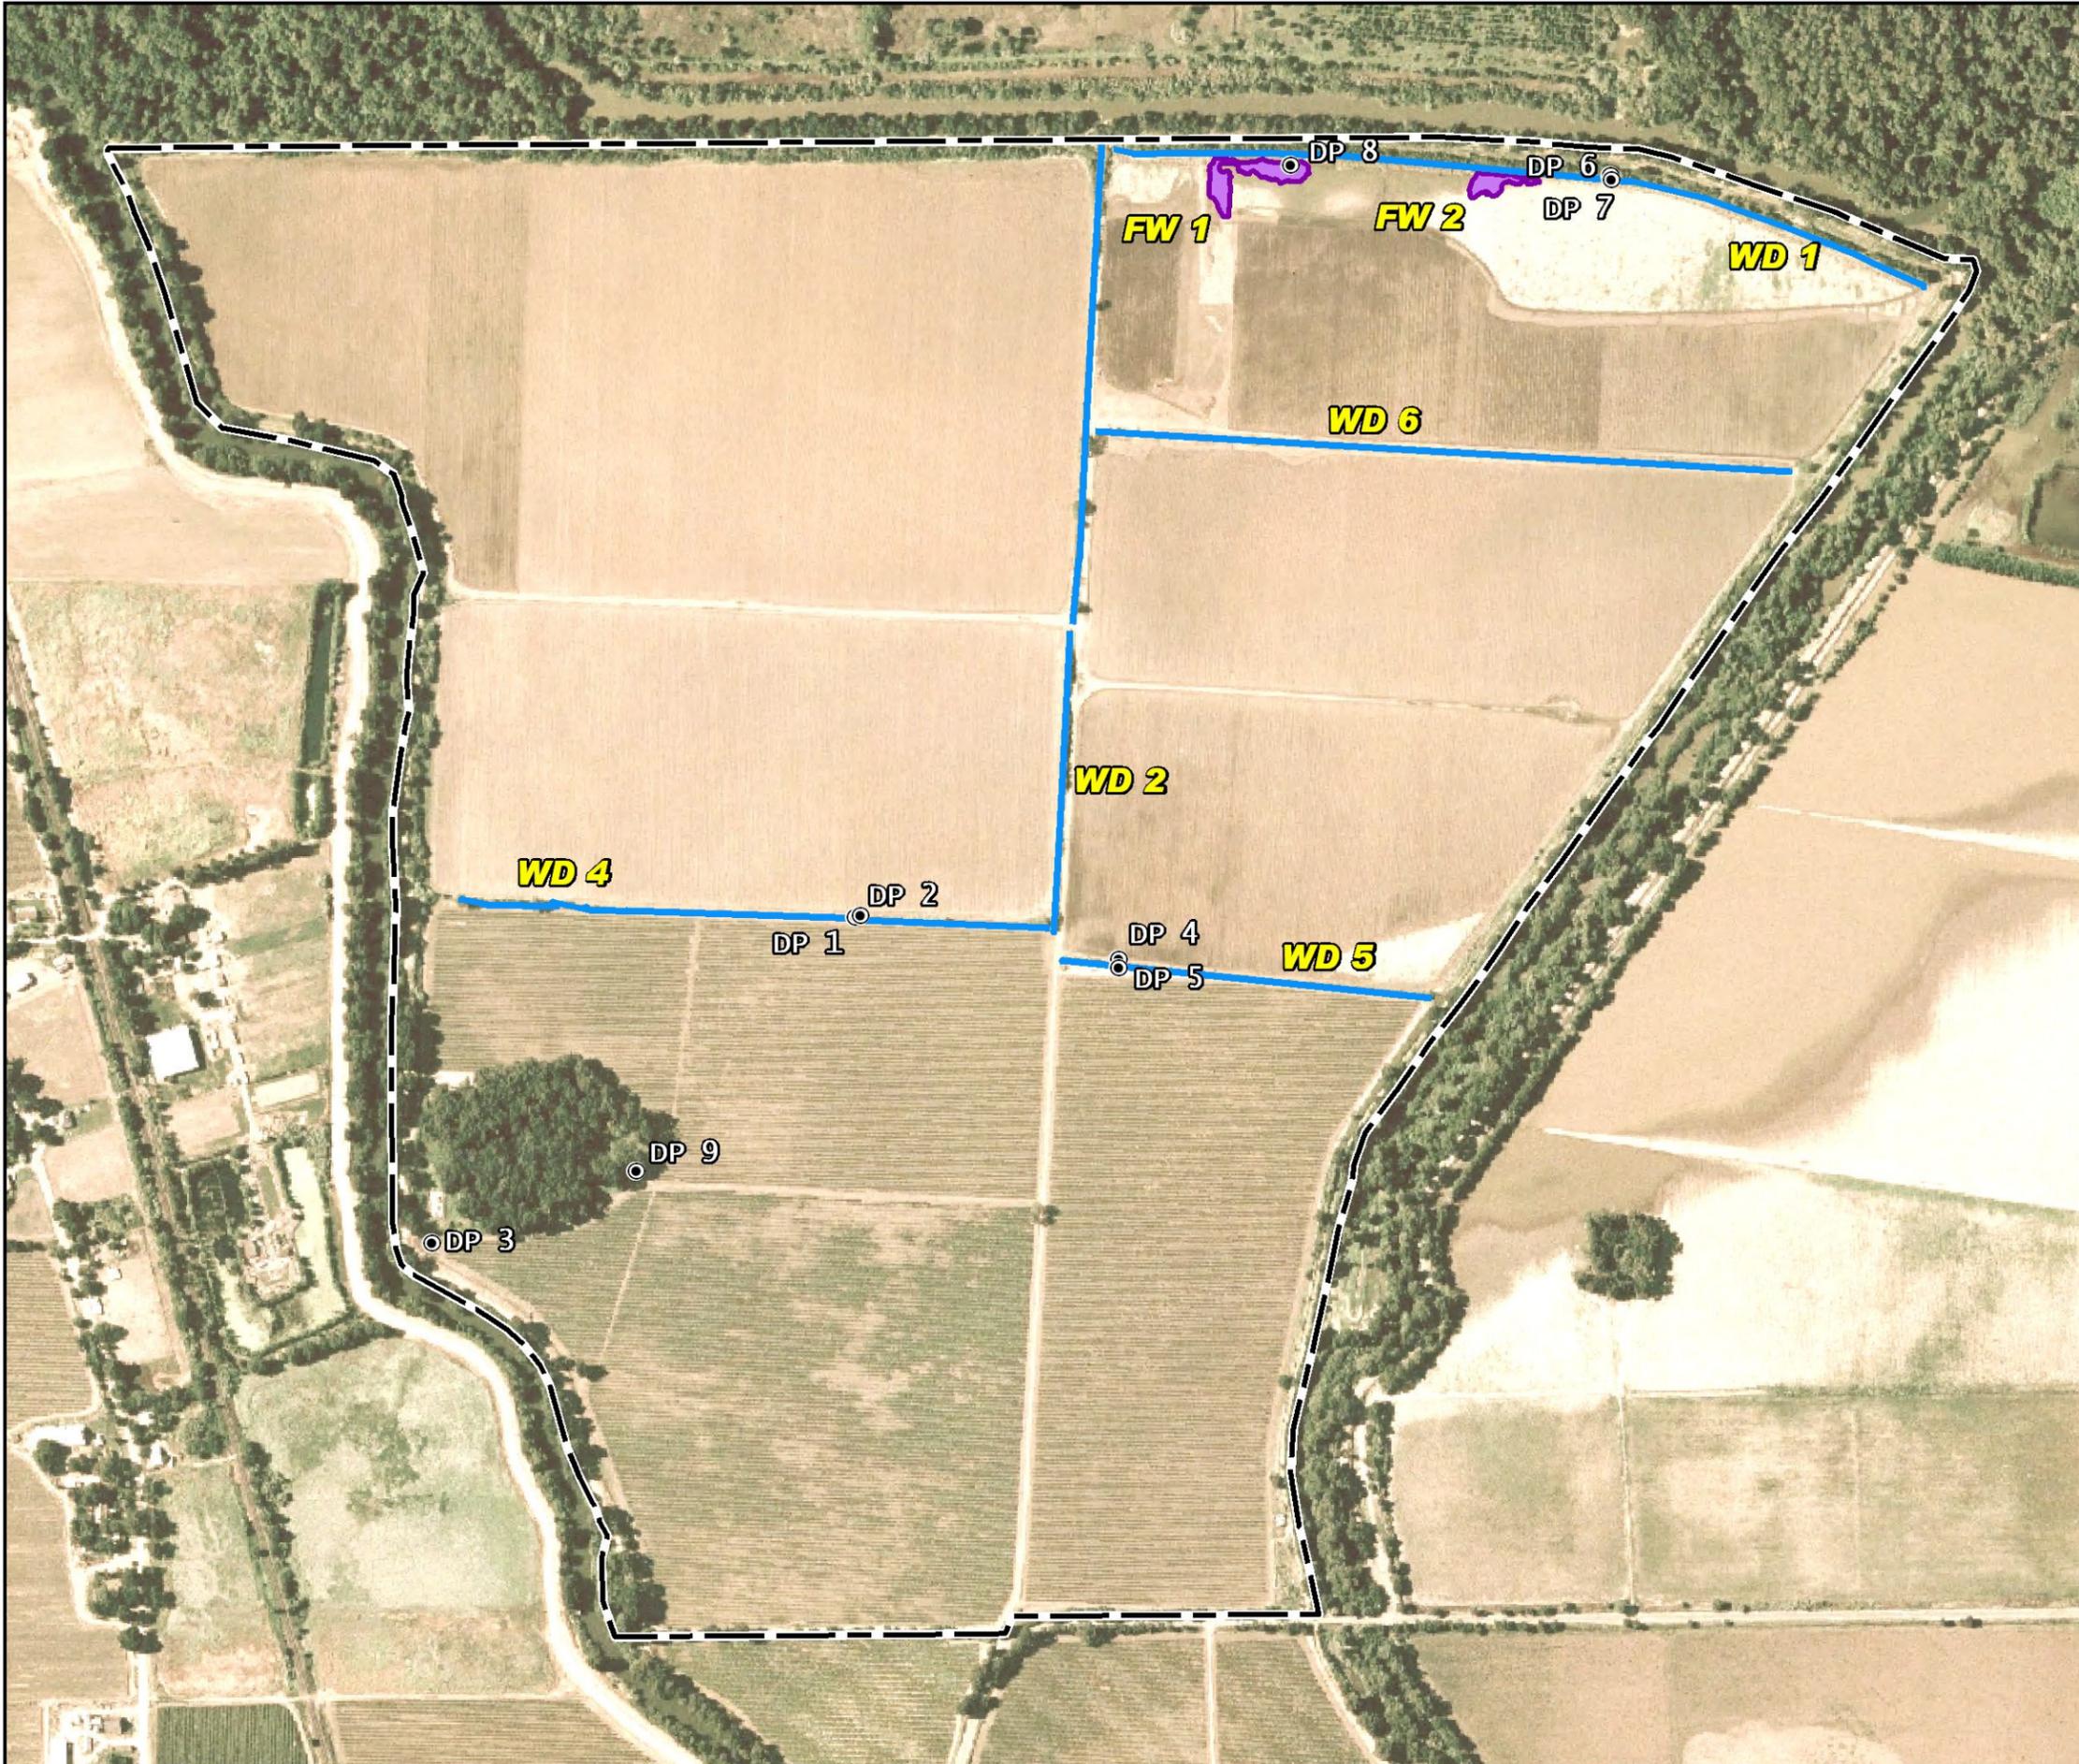
**Figure 8**  
**Delineation of Wetlands**  
**and Other Waters of the U.S.**  
**for**  
**The Cosumnes Floodplain**  
**Mitigation Bank**  
**Sacramento County, CA**

FW 1	0.568
FW 2	0.243
WD 1	0.124
WD 2	0.093
WD 3	0.030
WD 4	0.060
WD 5	0.073
WD 6	0.051
<b>Total Wetlands</b>	<b>1.242 Acres</b>

Wetland delineation conducted by:  
 Valley Environmental Consulting, LLC  
 September 17 and 18, 2007
