Field Note:

Date of Survey: February 15, 2018

Stream Name: Dinner Creek

Watershed: South Fork Eel River

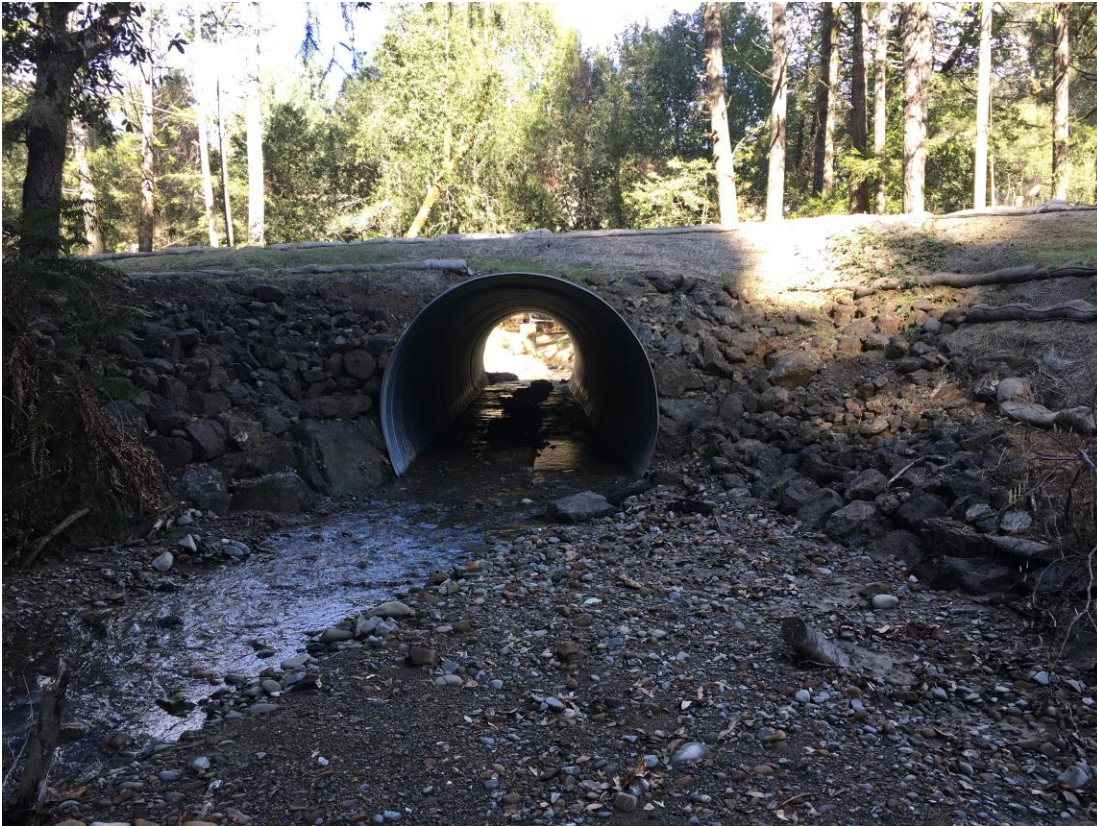
Picture 1. Looking upstream at Briceland Thorn Road crossing replaced during winter 2016/2017. PAD ID 713215.

Purpose: The purpose of this survey was to document winter steelhead upstream of the Briceland-Thorn Road crossing on Dinner Creek, PAD ID 713215 (Picture 1). The crossing was replaced in winter 2016 due to a blowout during a storm. The landowner upstream of the crossing had seen two or three adult steelhead in a pool upstream of the crossing during the week of 2/12/2018. Steelhead-trout had not been previously documented above the Briceland Thorn Road crossing.

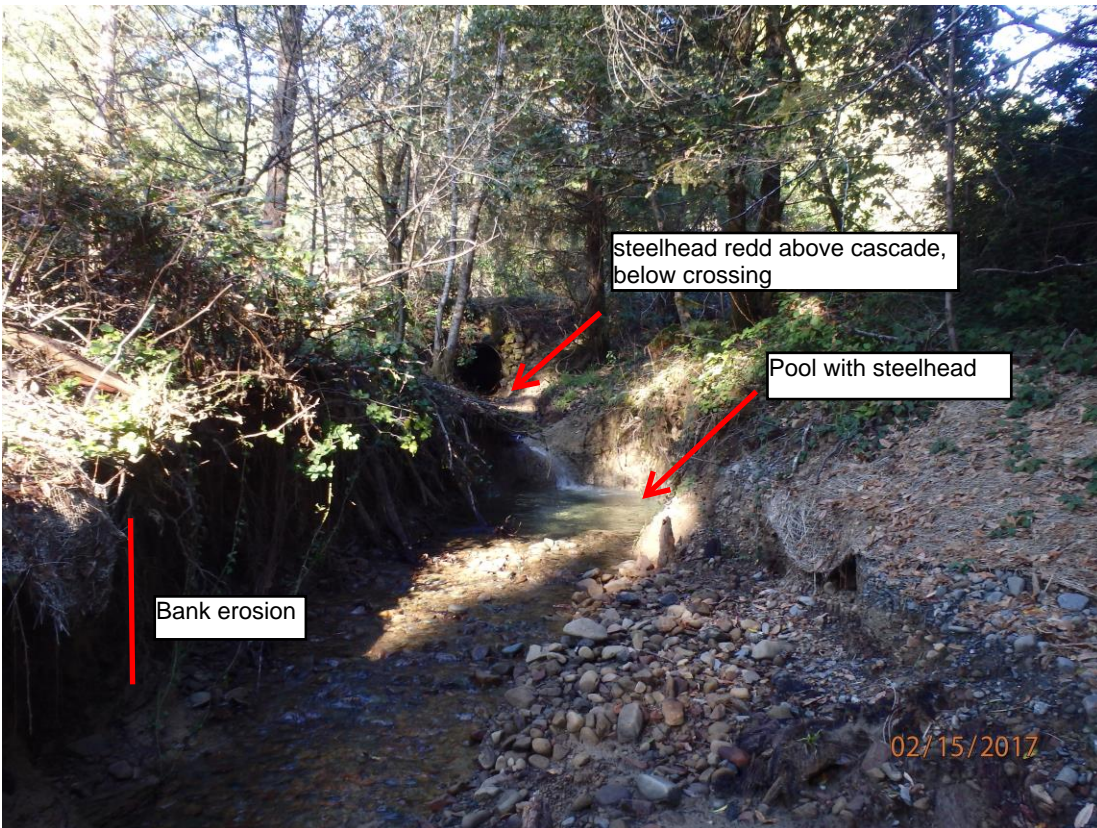
Observations: I met with the landowner on 2/15/2018 to locate the pool with steelhead. The pool is located approximately 75' upstream of the Briceland Thorn Road crossing and approximately 25' below a private crossing (Picture 2). Two adult steelhead were observed from streambanks. With the aid of an underwater camera, three adult steelhead were detected hiding at the upper end of the pool, under a bubble curtain and undercut bank (Picture 3). The fish are partially observed in an attached picture. Underwater visibility was ~2ft. The weather was sunny and cold. Air and water temperatures were not taken. The previous significant rainfall happened January 24 through January 25, 2018 in the amount of 0.41 inches.

Notes: Approximately two feet of streambed material had been evacuated between Briceland Road and the private crossing following the upgrade of the Briceland Rd culvert in winter 2016/17. Landowners at the site said the pool where the steelhead are located was not there prior to the culvert upgrade.

Picture 2. Looking upstream at pool with adult steelhead, bank erosion, and upstream private crossing. Steelhead redd is located between pool and crossing, near alders on right bank. The redd was observed on 2/1/18.

Recommendations: It is recommended that these adult steelhead be observed through February and into March due to the low forecasted rainfall amounts. Large wood should be installed to slow the headcut upstream of Briceland Rd crossing. Bank armoring may be necessary to reduce bank scour between the private crossing and Briceland Rd crossing.

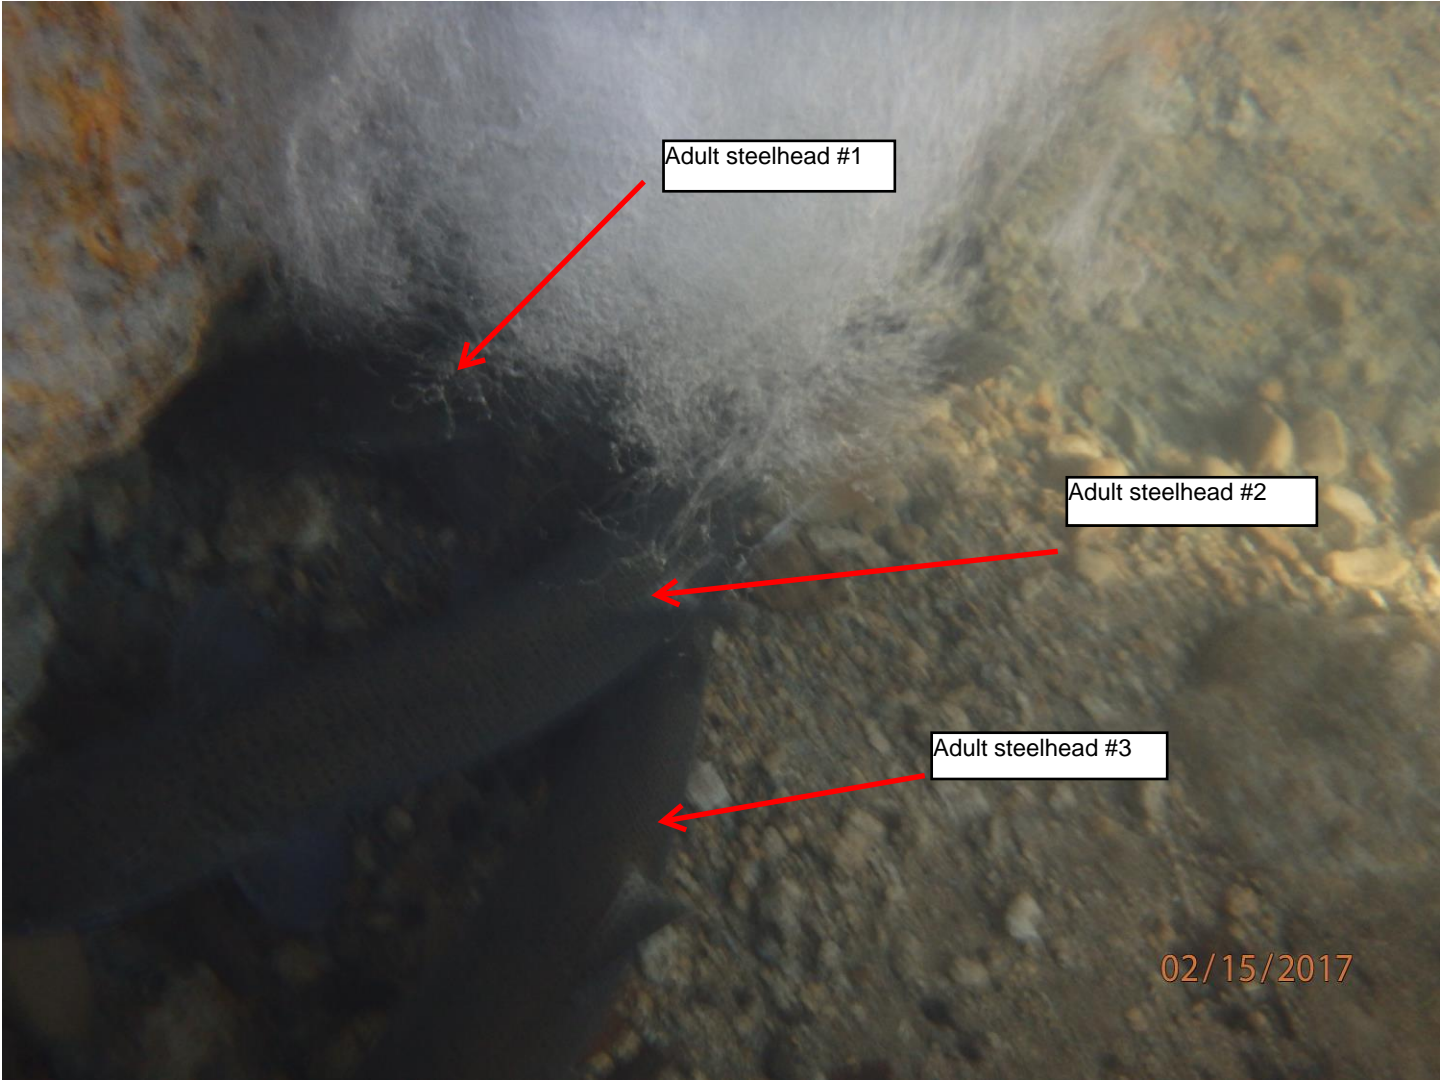
Picture 3. Three adult steelhead with heads pointing upstream. The head, eyes and pectoral fins of a smaller steelhead can be seen to left of bubble curtain.
