SHASTA RIVER RIPARIAN VEGETATION ASSESSMENT

Shasta River Riparian Vegetation Assessment

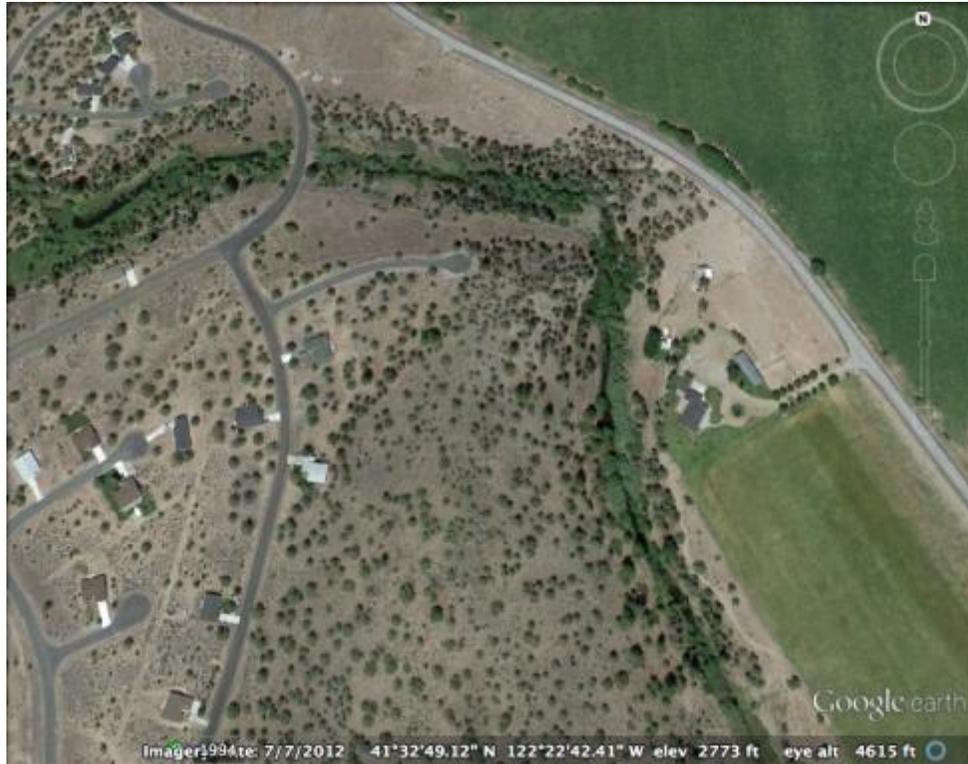
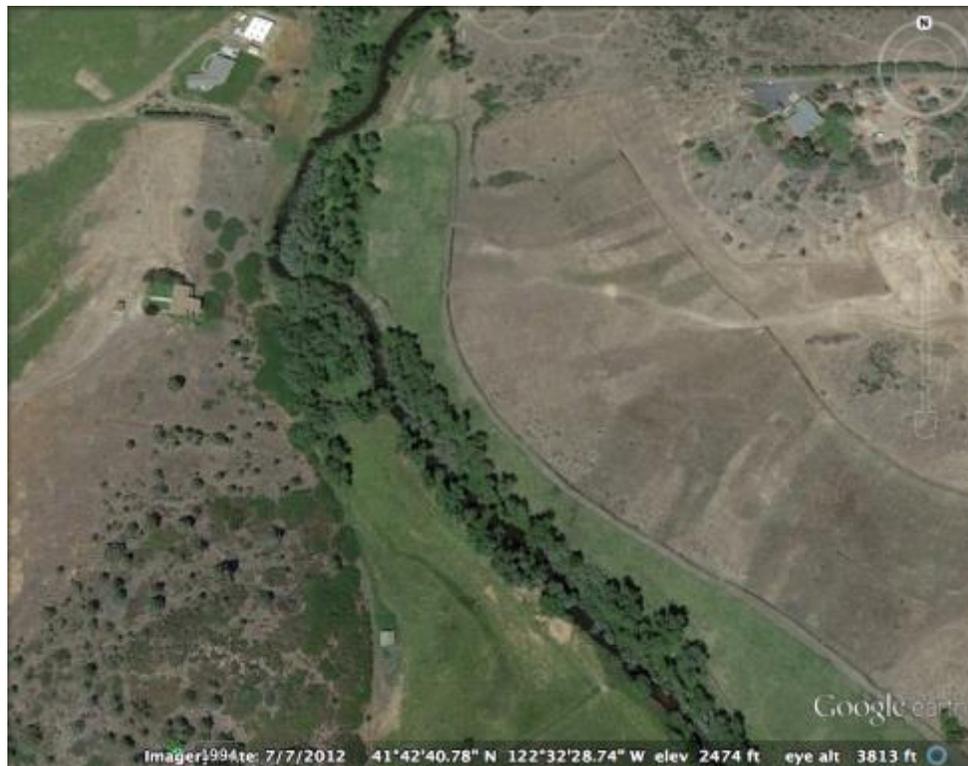
Shasta River sites illustrating common conditions of continuous and discontinuous narrow riparian corridor.

Appendix A presents images displaying typical riparian conditions along the Shasta River.

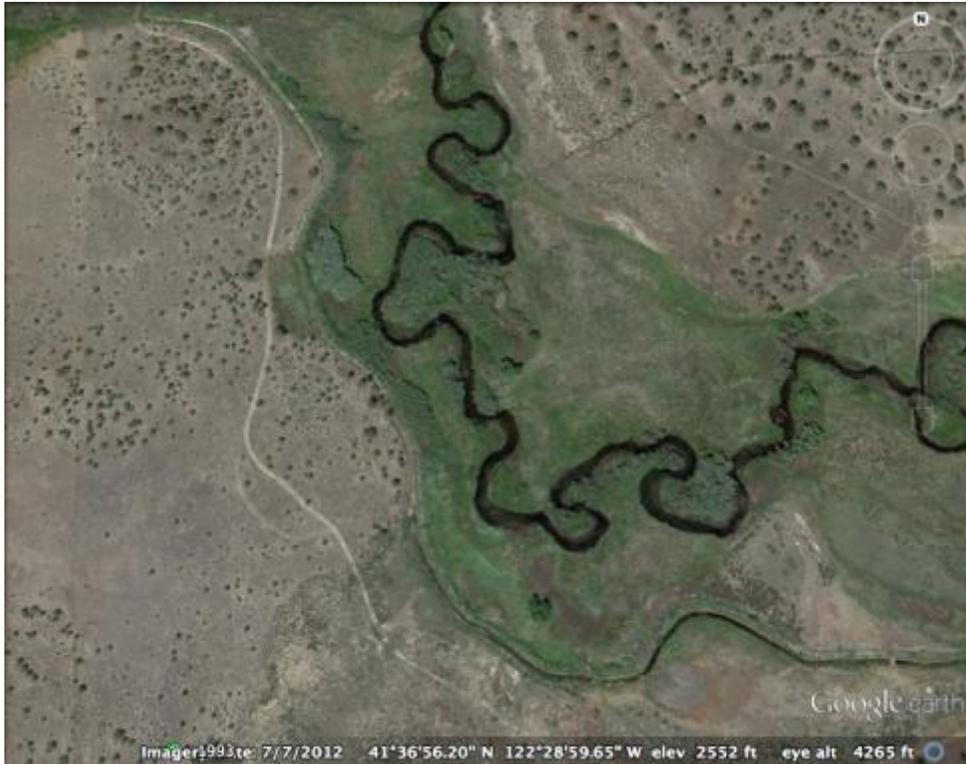
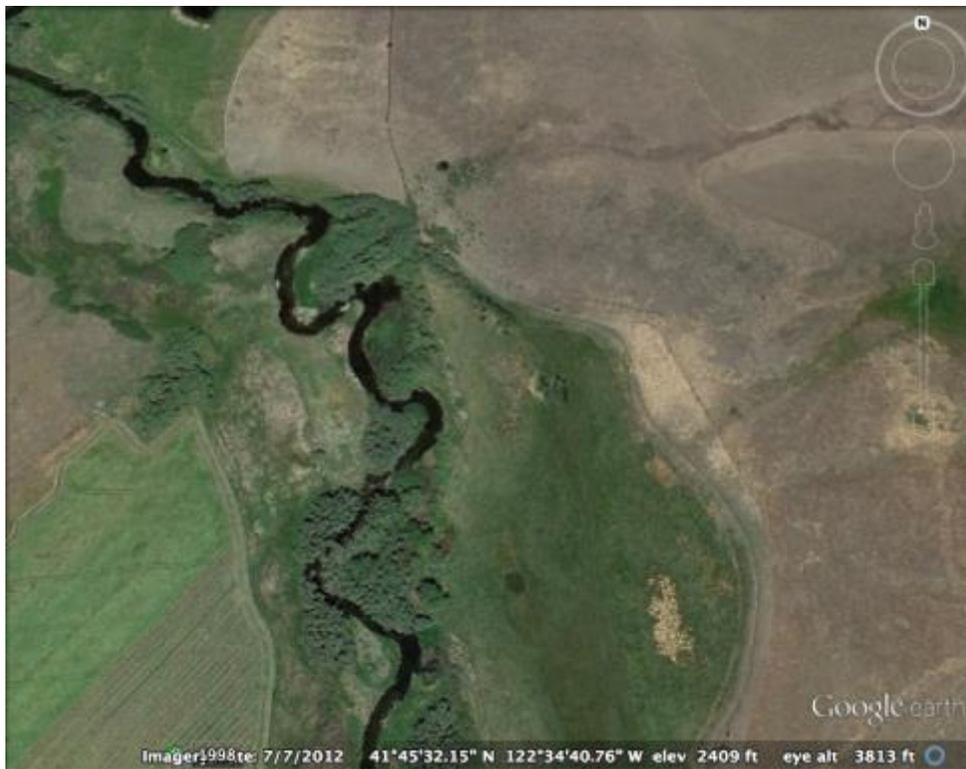
Locations where agricultural impacts have been minor still support some relatively large patches of riparian cover.

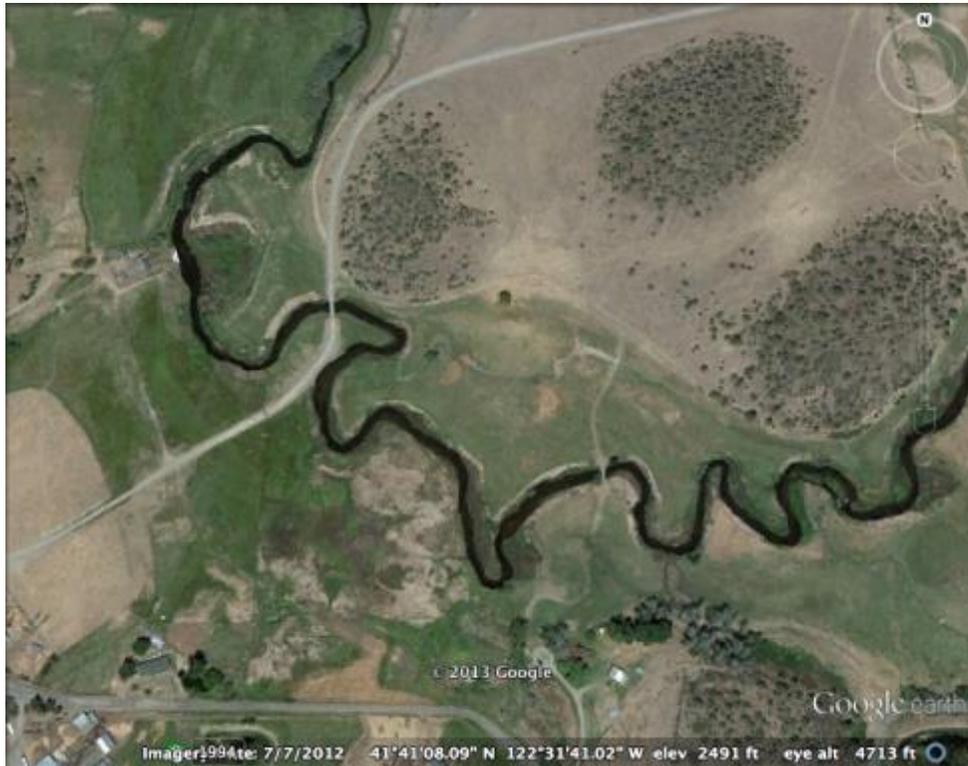
Where agricultural or other uses are directly adjacent to the stream, riparian cover may be absent or consist of relict trees.

- Land use, particularly presence of grazing animals or cultivated fields. Exclusionary fencing in the Shasta River watershed is limited. Any efforts at restoration or enhancement must either control the potentially negative impacts of agriculture or be focused on locations where agriculture is not occurring.
