California Department of Fish and Game
Petaluma River Watershed
Stream Habitat Assessment Reports
Adobe Creek
Surveyed 2007

STREAM INVENTORY REPORT

Adobe Creek

Survey conducted summer 2007

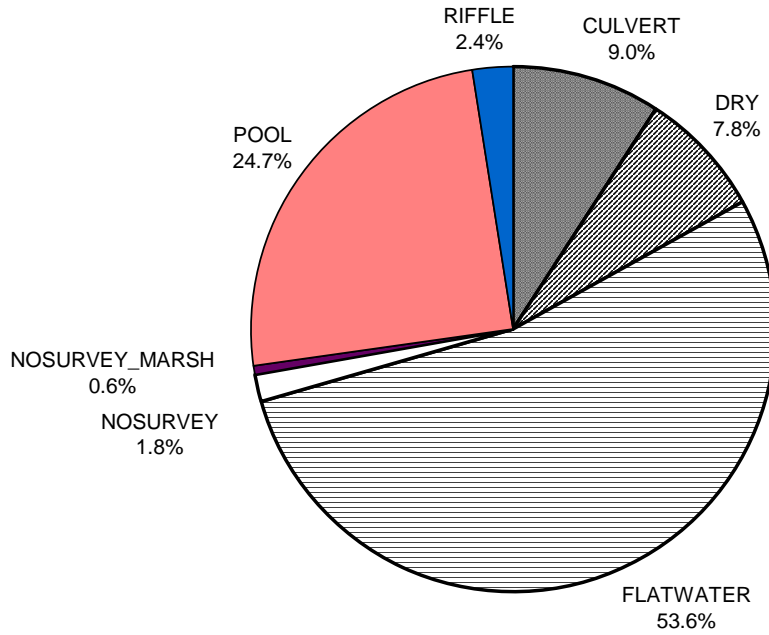
GRAPH 1

**ADOBE CREEK 2007
HABITAT TYPES BY PERCENT OCCURRENCE**

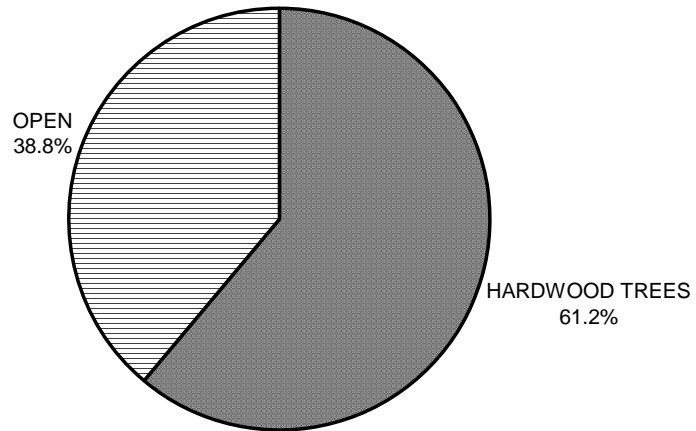
GRAPH 9

The mean percent canopy density for the surveyed length of Adobe Creek was 61%. The mean percentages of hardwood and coniferous trees were 100% and 0%, respectively. Thirty-nine percent of the canopy was open. Graph 9 describes the mean percent canopy in Adobe Creek.

**ADOBE CREEK 2007
MEAN PERCENT CANOPY**

The mean percent canopy density for the stream was 61%. Reach 1 was not measured for canopy density, Reach 2 had a canopy density of 64%, Reach 3 had a canopy density of 63%, Reach 4 had a canopy density of 33% and Reach 6 had a canopy density of 60%. In general, revegetation projects are considered when canopy density is less than 80%.

- 5) Increase the canopy on Adobe Creek by planting appropriate native vegetation like willow, alder, redwood, and Douglas fir along the stream where shade canopy is not at acceptable levels. The reaches above this survey section should be inventoried and treated as well, since the water flowing here is affected from upstream. In many cases, planting will need to be coordinated to follow bank stabilization or upslope erosion control projects.

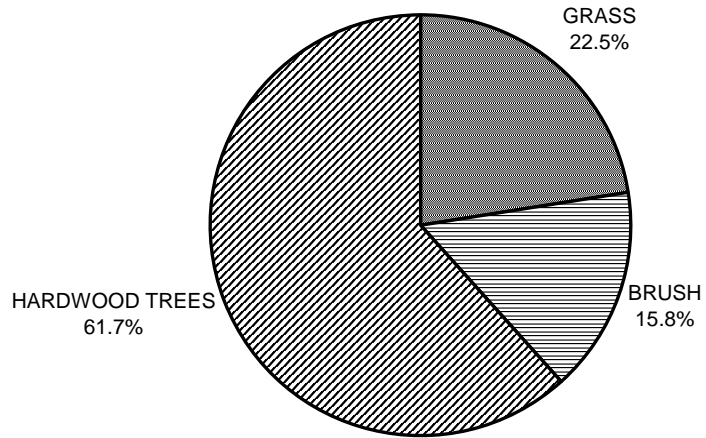
GRAPH 11

For the stream reach surveyed, the mean percent right bank vegetated was 70%. The mean percent left bank vegetated was 69%. The dominant elements composing the structure of the stream banks consisted of 1% bedrock, 10% boulder, 11% cobble/gravel and 78% sand/silt/clay (Graph 10). Deciduous trees were the dominant vegetation type observed in 62% of the units surveyed. Additionally, 22% of the units surveyed had grass as the dominant vegetation type, and 16% had brush as the dominant vegetation (Graph 11).

**ADOBE CREEK 2007
DOMINANT BANK VEGETATION IN SURVEY REACH**

The percentage of right and left bank covered with vegetation was HIGH at 70% and 69%, respectively. In areas of stream bank erosion or where bank vegetation is sparse, planting endemic species of coniferous and hardwood trees, in conjunction with bank stabilization, is recommended.
