State of California
Department of Fish and Wildlife

M e m o r a n d u m

Subject: Barrier Evaluation to Delineate Hybridization Zones within the Upper Truckee River Lahontan Cutthroat Trout Restoration Project Expansion Area, El Dorado County, California

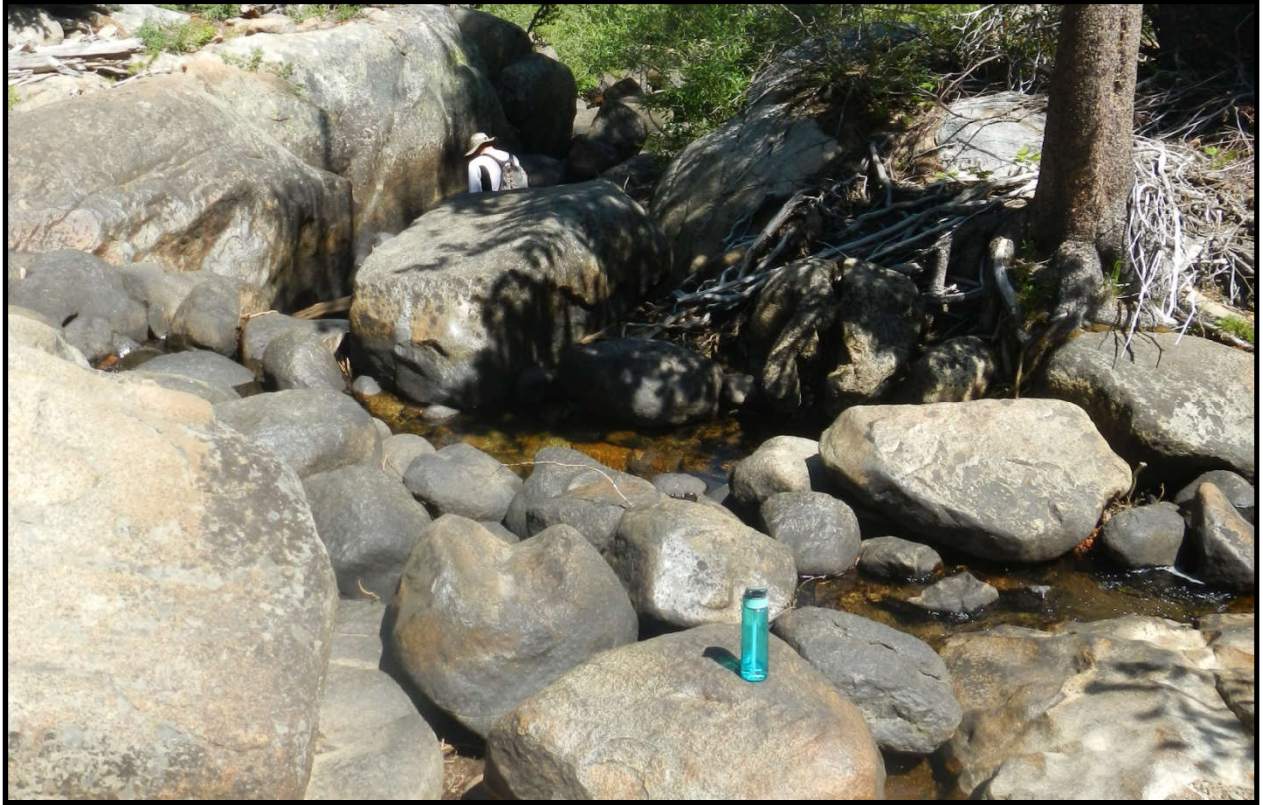
Mitch Lockhart concludes that B36C is a small impediment and does not serve as a barrier during low flow conditions (Figures 2 and 3). The ample bedrock surrounding the feature may serve as a suitable foundation to construct an artificial barrier.

Figure 3: The Upper Truckee River immediately upstream of impediment B36C looking roughly north. This photo illustrates the low stream gradient and the absence of impeding features immediately upstream of B36C that may have been out of frame of the previous photo. Photo taken July 19th, 2015 (CDFW).

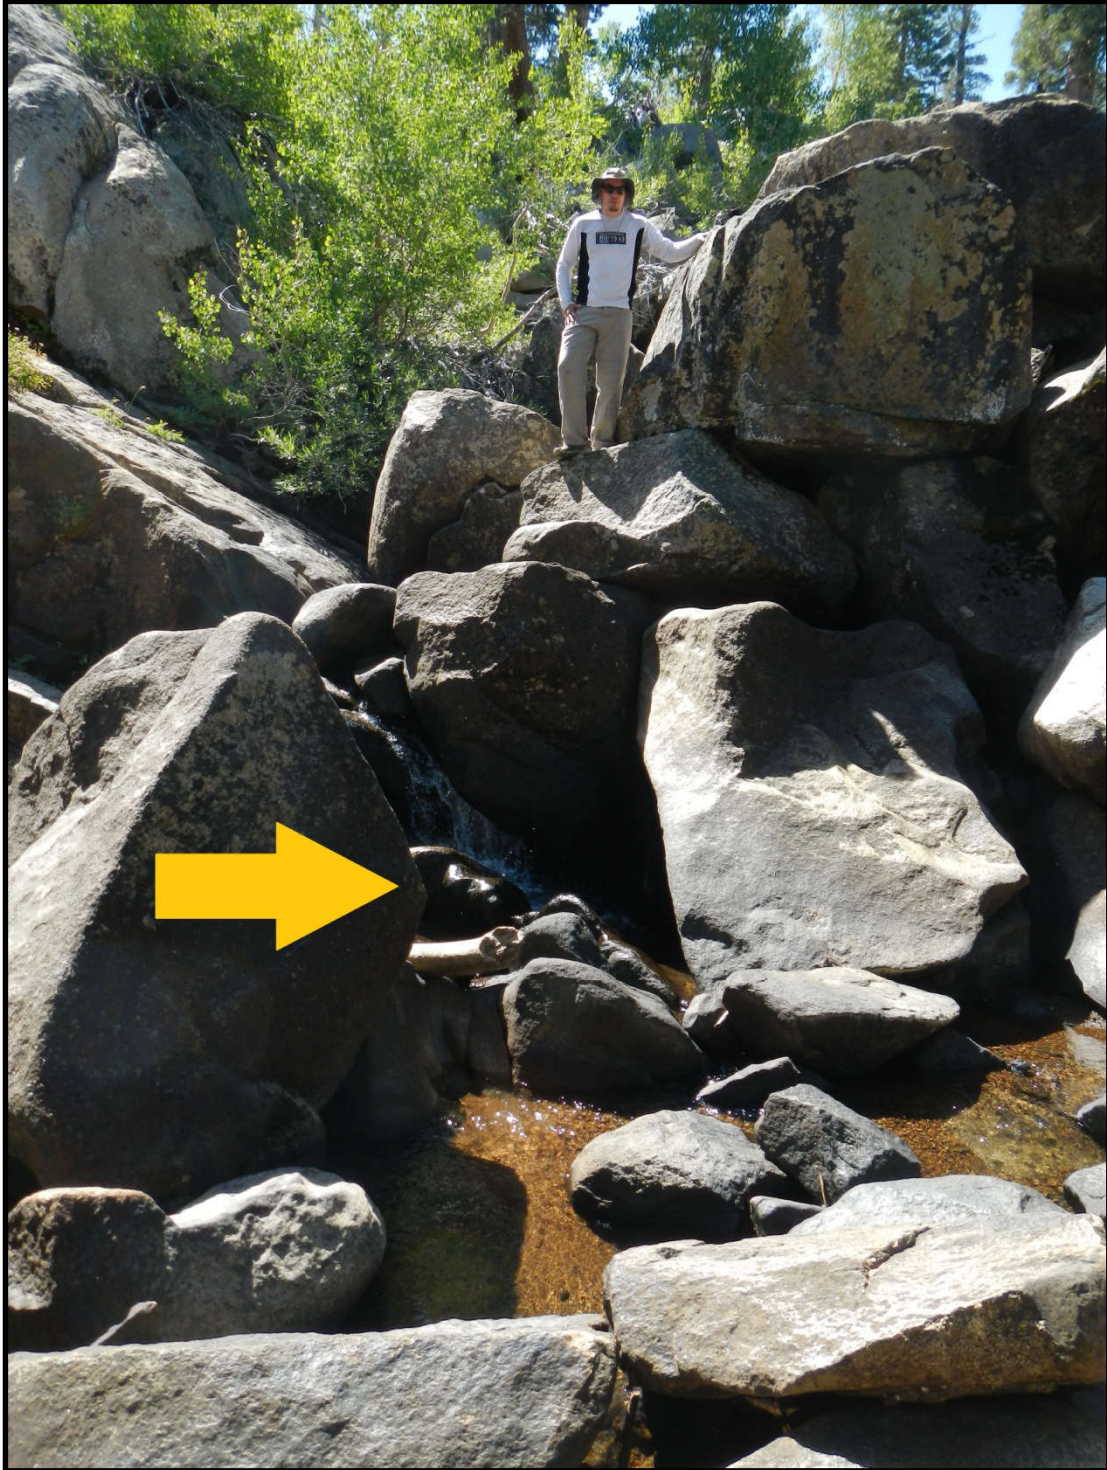
Feature B36B is a low flow barrier and may be a barrier in a variety of flow conditions but additional field visits during high flow conditions would be necessary to validate (Figures 4 and 5). This feature also marks a point at which the gradient of the Upper Truckee River changes dramatically. Upstream of feature B36B, the Upper Truckee River is characterized by steep boulder cascades and bedrock slides. Downstream, the

Figure 4: The Upper Truckee River at impediment B36B looking upstream or roughly south. At low flow the impediment is a 3 to 4 foot elevation plunge onto boulders with no jump pool. The yellow arrow points at the boulders below the plunge. There are alternate high flow paths with similar features. While this feature is likely a barrier during low flow conditions, it is unclear if it impedes upstream movement during high flow. However, this feature is the downstream endpoint of a 150-200 foot reach characterized by steep gradient and large boulders. Photo taken July 19th, 2015 (CDFW).

In conclusion, B36B should be considered the upper limit of the Upper Truckee River where hybridization between Lahontan cutthroat trout and rainbow trout may occur. All Lahontan cutthroat trout captured below feature B36B should be considered hybridized and lethally removed from the project area pursuant to the Amendment of the Biological Opinion for the Upper Truckee Lahontan Cutthroat Trout Restoration Project (BO; File #: 2008-F-0434-BO-R001). However, assessing the barrier during high flow would be valuable to help validate and lend confidence to these conclusions.

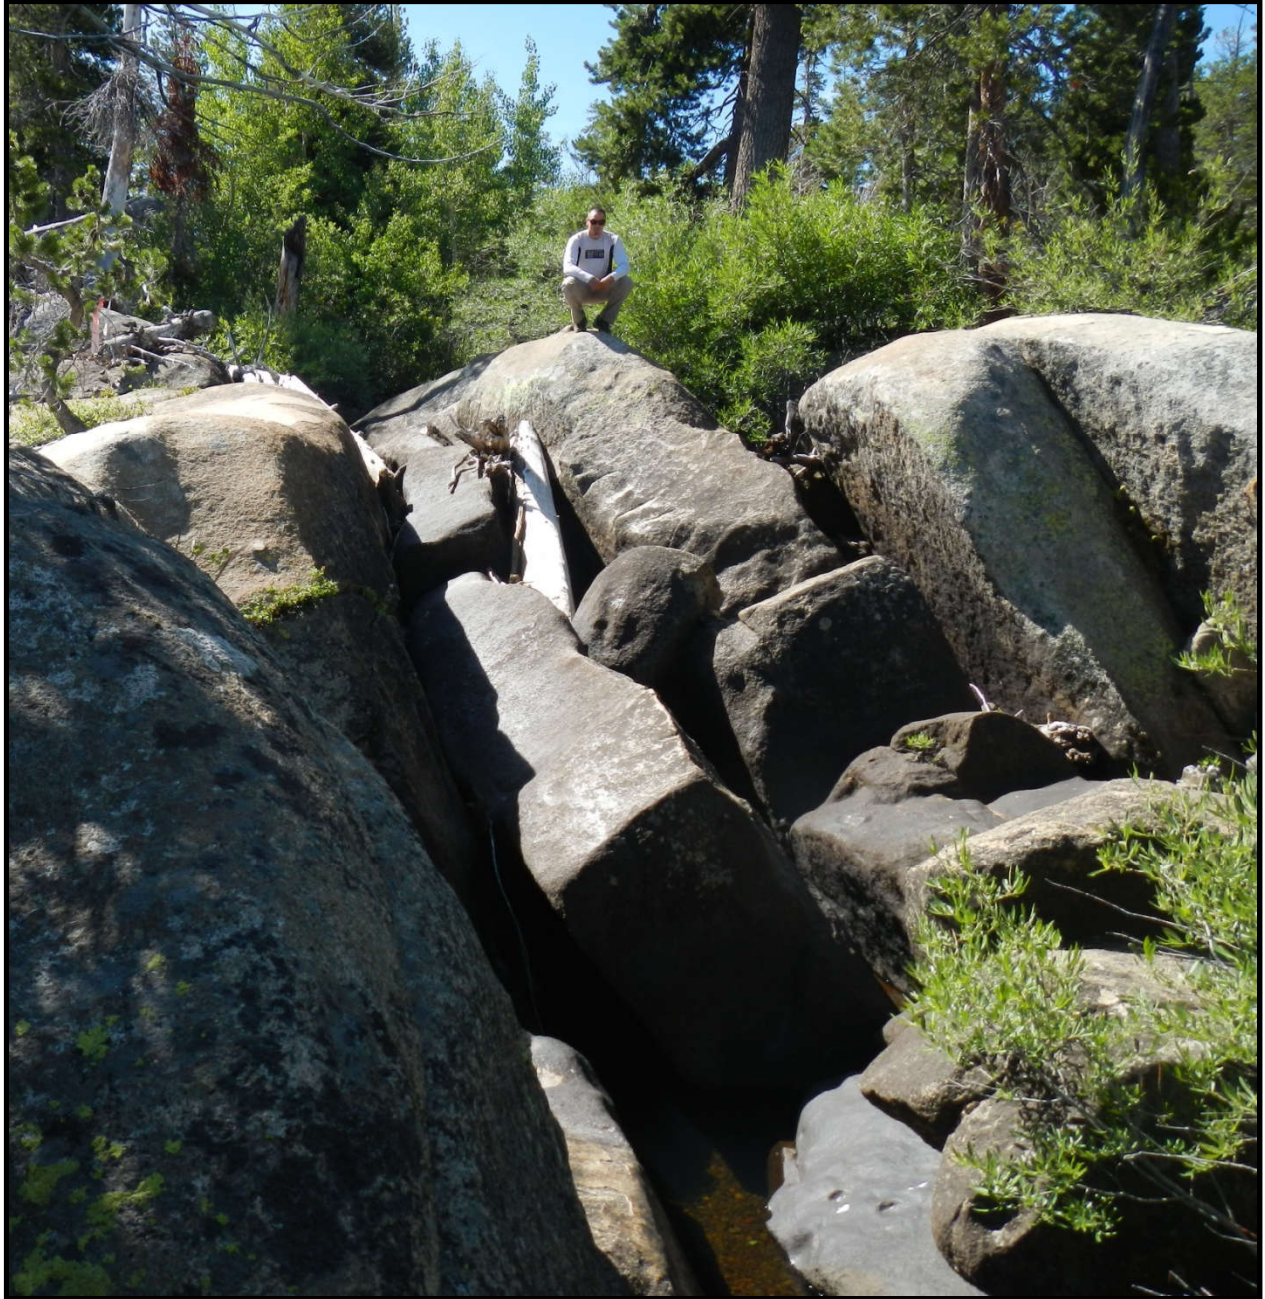
Feature B36A is a high quality low flow barrier and was the most significant single barrier feature observed during the assessment (Figures 7 and 8). However, an alternate high flow channel bypasses B36A and has no impeding features that would preclude trout from migrating above B36A.

Figure 7: The Upper Truckee River at impediment B36A looking upstream or roughly south. The feature is a 15 foot long, high-angle slide that ends in a 4 foot overhanging plunge with a jump pool. This feature is a barrier during low flow conditions; however, alternate high flow channels bypass this feature on the east side of the river. In addition, this feature marks the upstream endpoint of the 150-200 foot steep, boulder strewn reach that the author concludes is a functional barrier to upstream trout movements. Photo taken July 19th, 2015 (CDFW).

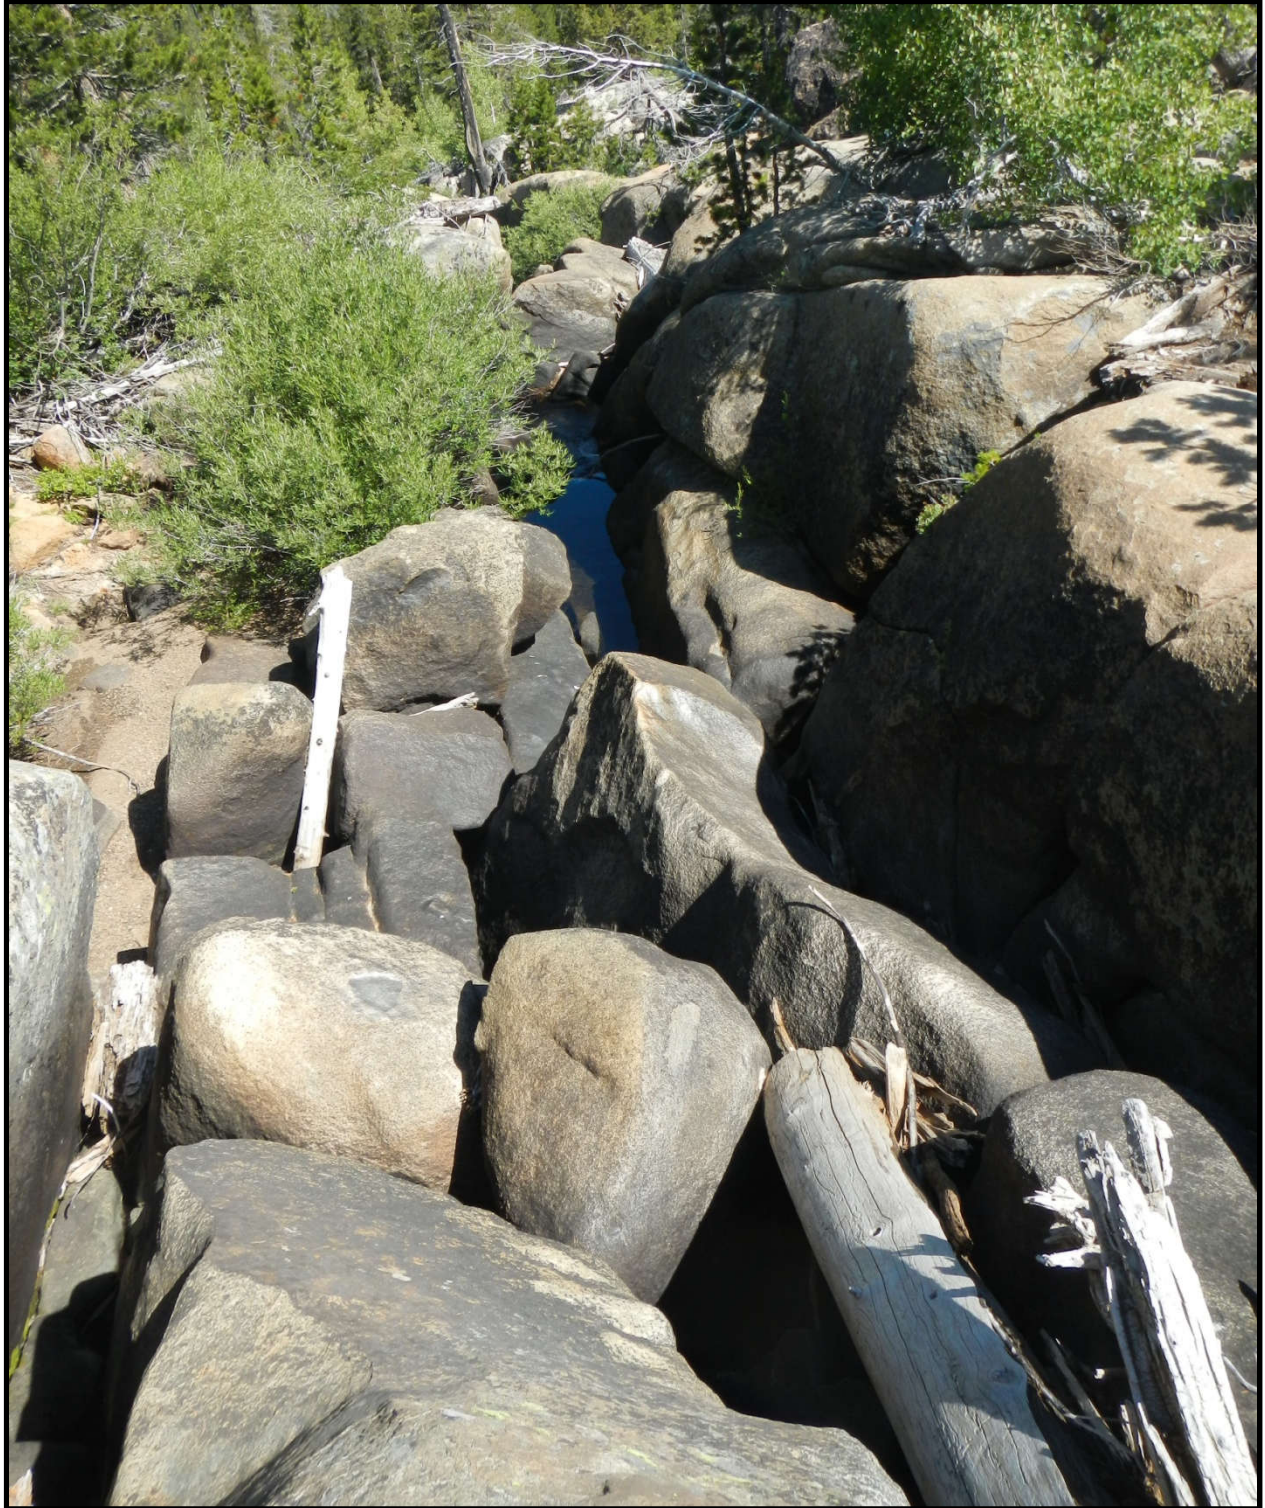
Figure 8: The Upper Truckee River at impediment B36A looking downstream or roughly north. The feature is a 15 foot long, high-angle slide that ends in a 4 foot overhanging plunge with a jump pool. The steep, boulder strewn reach can be seen, in part, in the distance. Photo taken July 19th, 2015 (CDFW).
