NPS Cosco Busan Recreational Use Program

Bay Trail – Replace Decking on Crissy Field Promenade Bridge

Final Programmatic Report

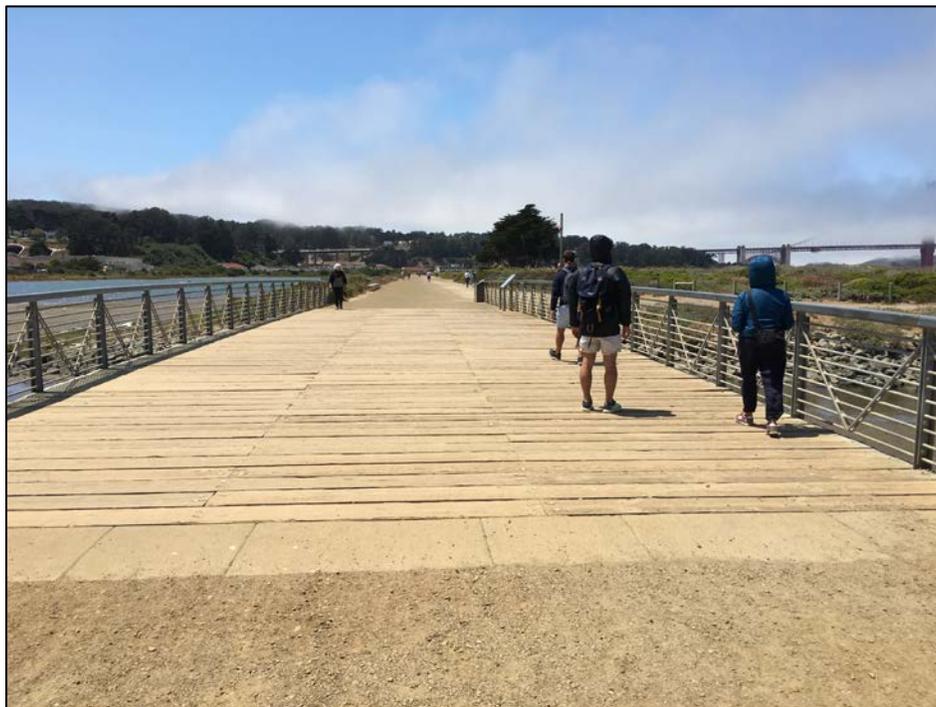
Figure 2. Crissy Field Promenade pedestrian and bicycling bridge in 2017, after the decking boards were rolled over in 2015 as part of this project, and before complete replacement of the decking in 2017.

removed and disposed of the original tar caps and lag screws, and inspected the underlying stringer boards. The existing deck boards were then rolled over, with a limited number requiring complete replacement. The boards were then bolted down with new ½"x7" stainless steel lag bolts into a countersunk hole. Once installed and fastened, each of the holes was tarred to create an even finished surface. The project necessitated closing the bridge for 2 weeks and rerouting pedestrians and cyclists to the multi-use trail along Mason Street.
