## **NPS Cosco Busan Recreational Use Program**

### **South Rodeo Beach Access Improvement Project: Final Programmatic Report**

September, 2018

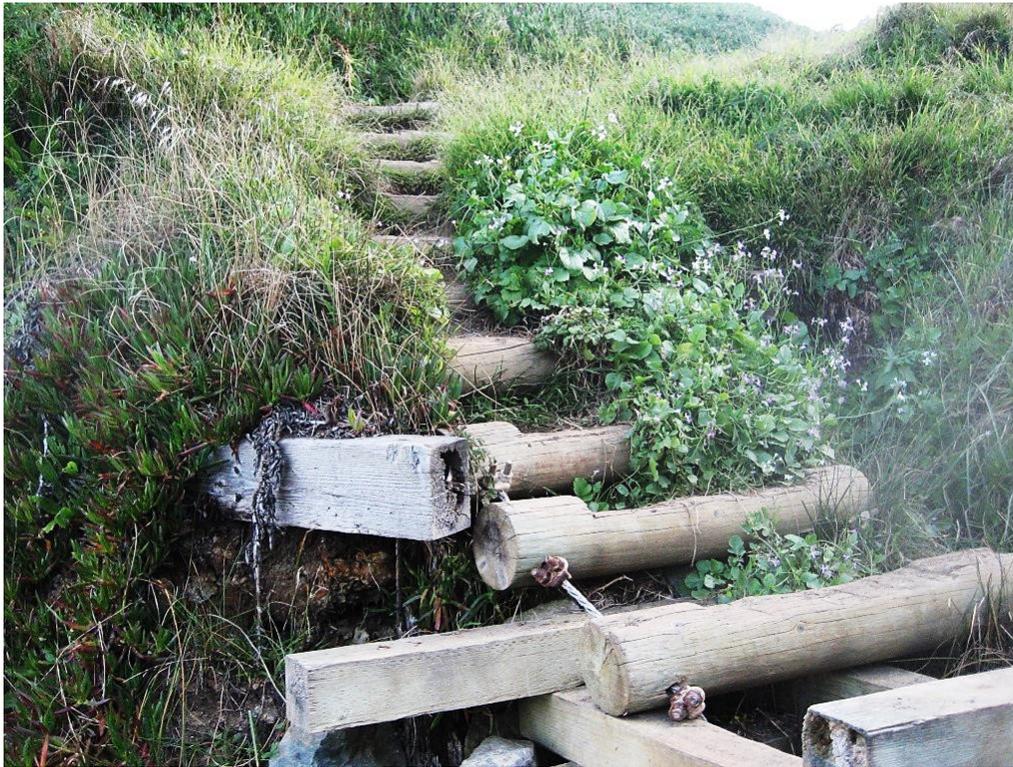
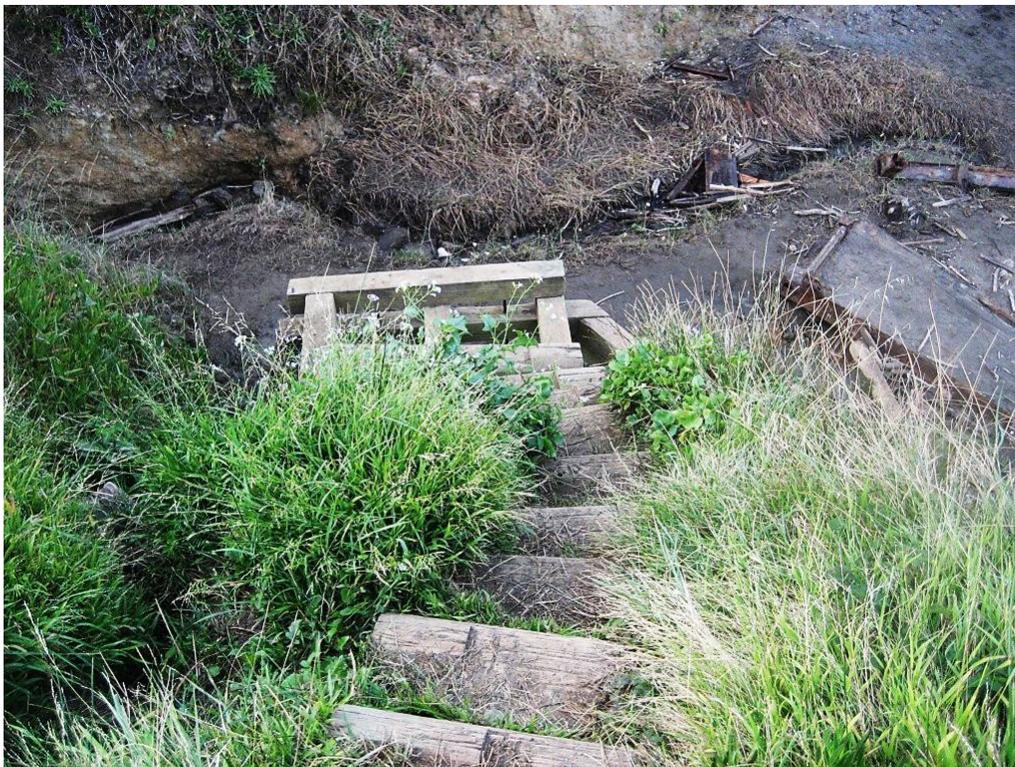
South Rodeo Beach Access – Before Cosco Busan Project, 2012

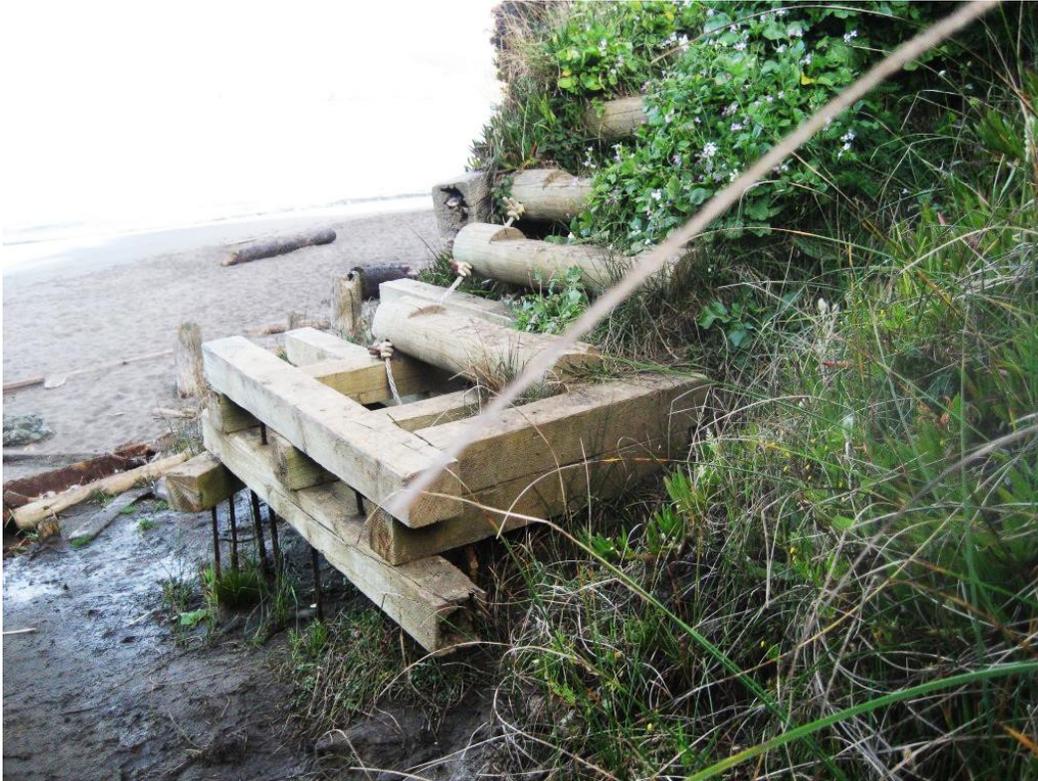
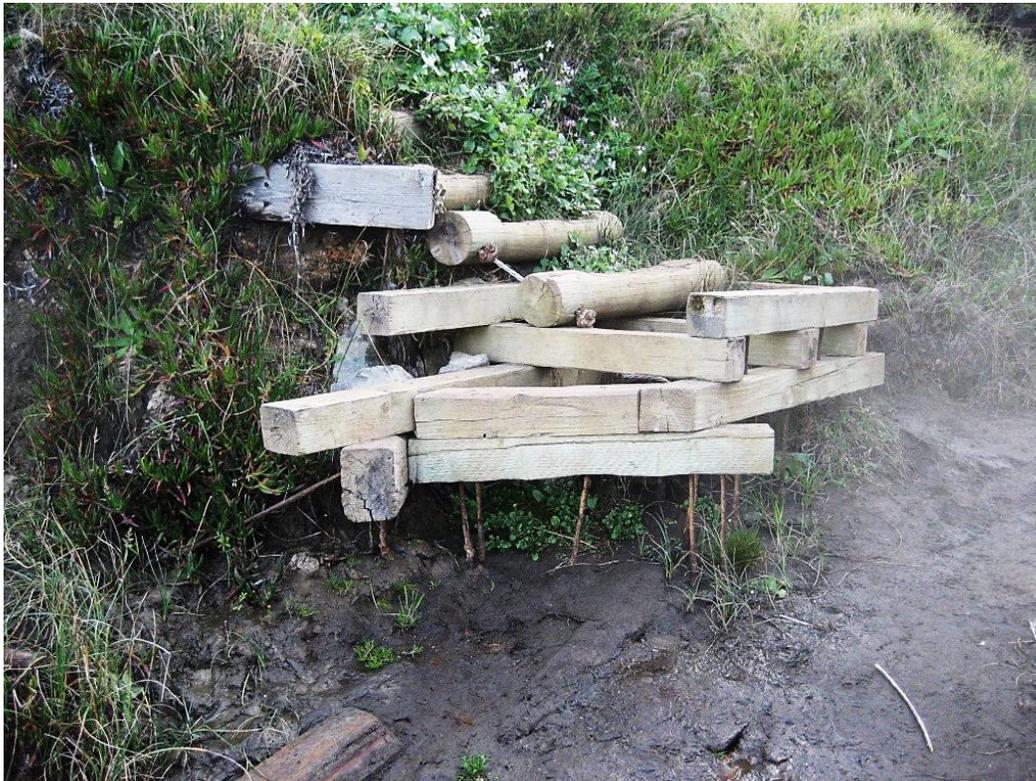
South Rodeo Beach Access – Before Cosco Busan Project, 2012

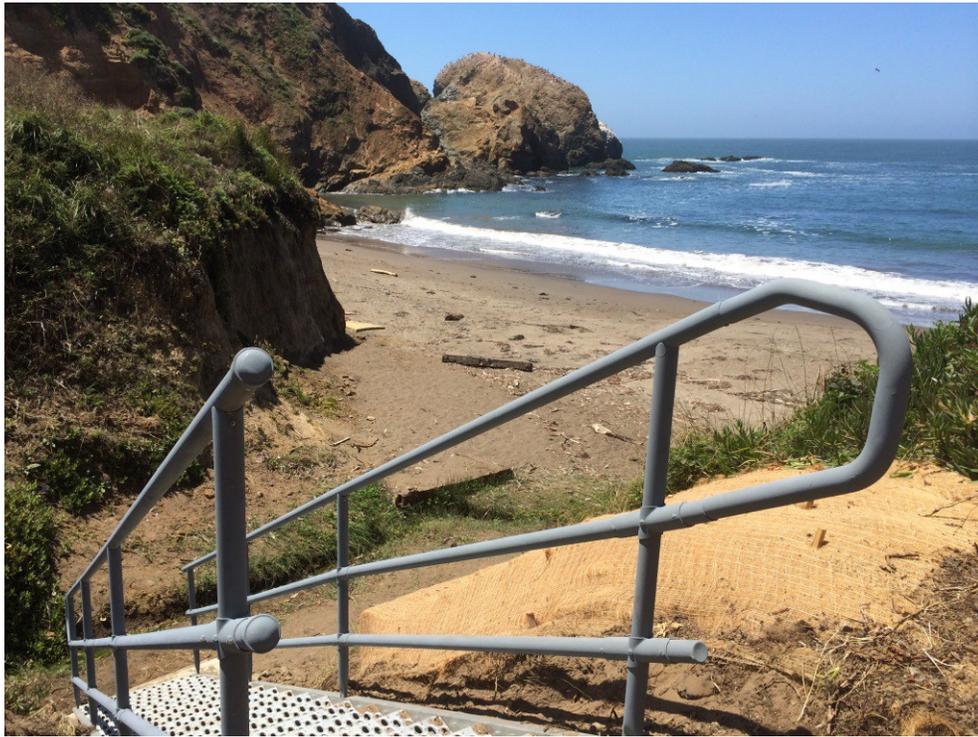
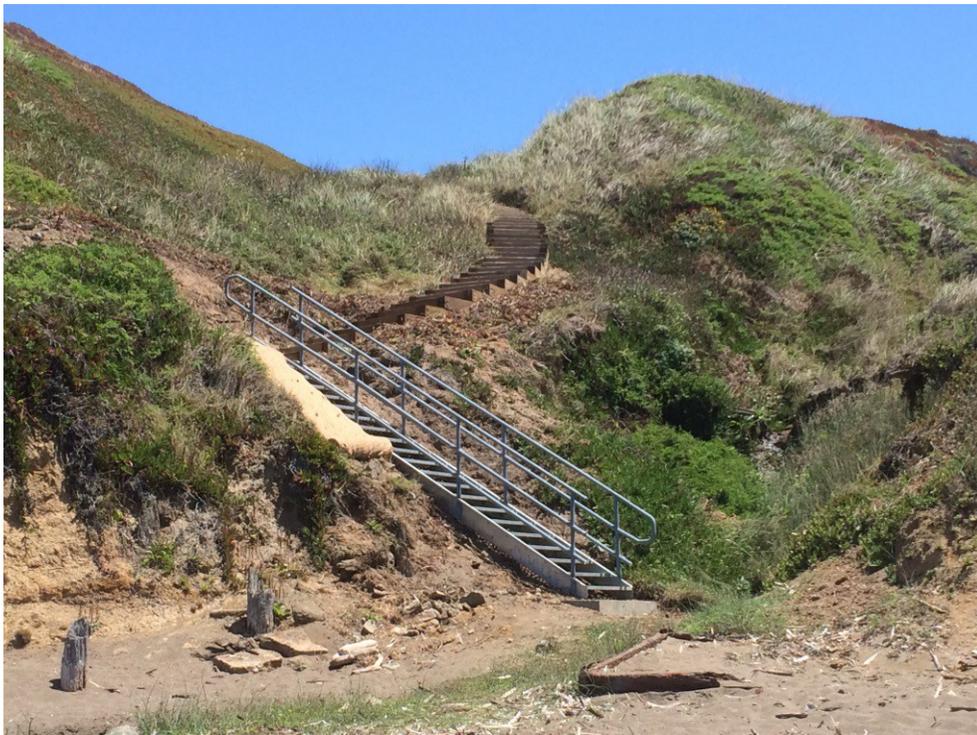
South Rodeo Beach Access – New Cosco Busan-funded access stairs, 2014

The Trail Crew demolished the old stairway, re-graded the slope to accommodate the new stairs, poured a concrete footing for the new stairway, purchased materials for the new staircase and pre-fabricated the staircase, which was then transported to the site, and anchored into place. Some ground disturbance and vegetation removal was necessary in the project vicinity. Erosion control best management practices, including installation of fiber erosion matting, were employed to stabilize and restore the site. The trail was closed during construction, with signage posted at the trailhead, and notification given to park offices, programs, partners and stakeholders of the closure dates and times. The project was completed with approximately a \$250 budget overrun, which was covered using other funds.

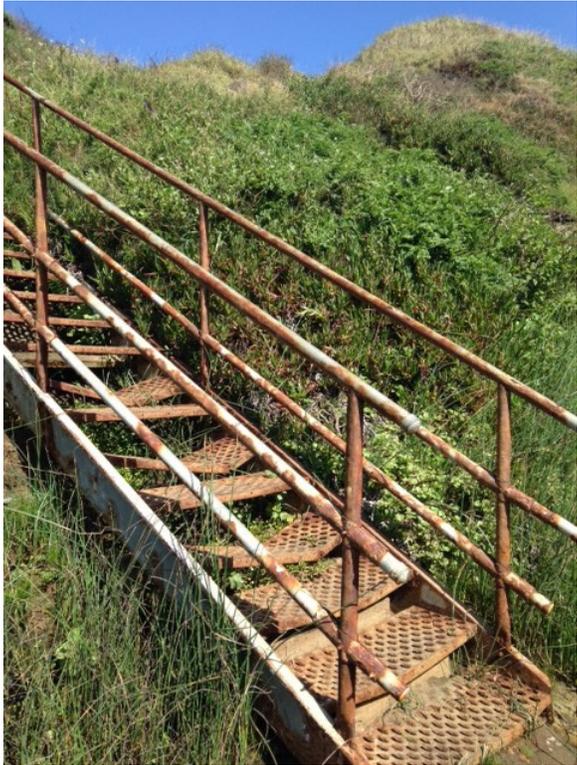
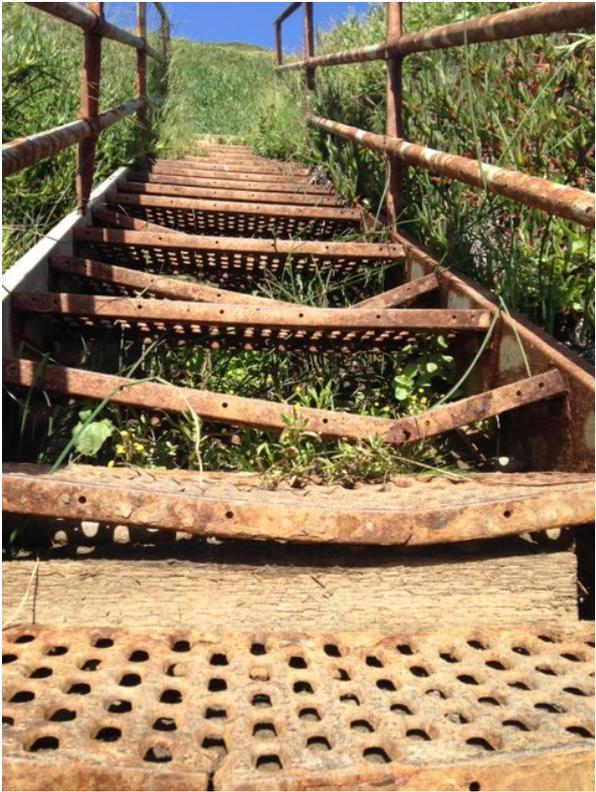
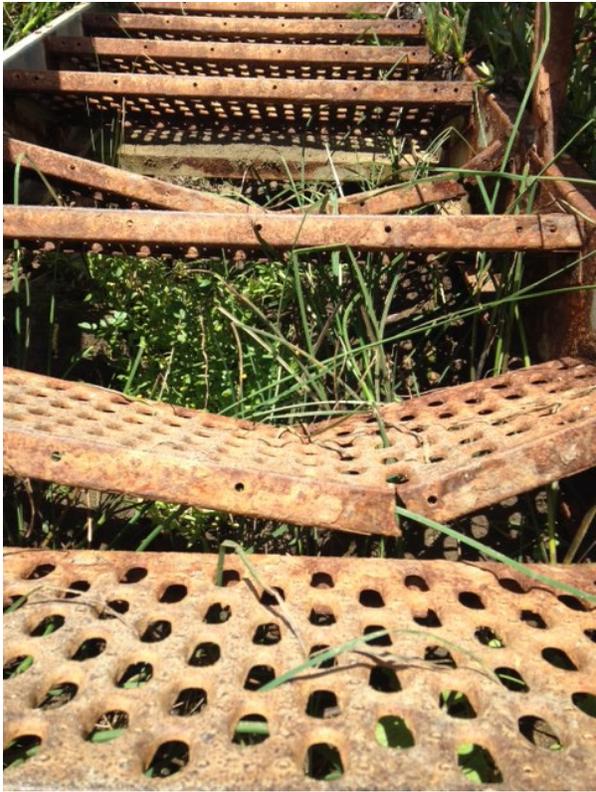
The most critical lesson learned is that galvanized metal cannot withstand the marine environment on the outer coast for an extended period of time. While the new stairway did provide safe access to the beach for 2-3 years, it became its own safety hazard in a little over 3 years' time, due to corrosion and metal failure. The concrete footing for the metal staircase is still in excellent condition and continues to serve as the footing for the new wooden stairway. The original stairway (pre-Cosco Busan), in generally the same location as the current stairway, was poorly constructed and undermined by coastal

South Rodeo Beach Access Project – Metal Staircase Failure, September 2017

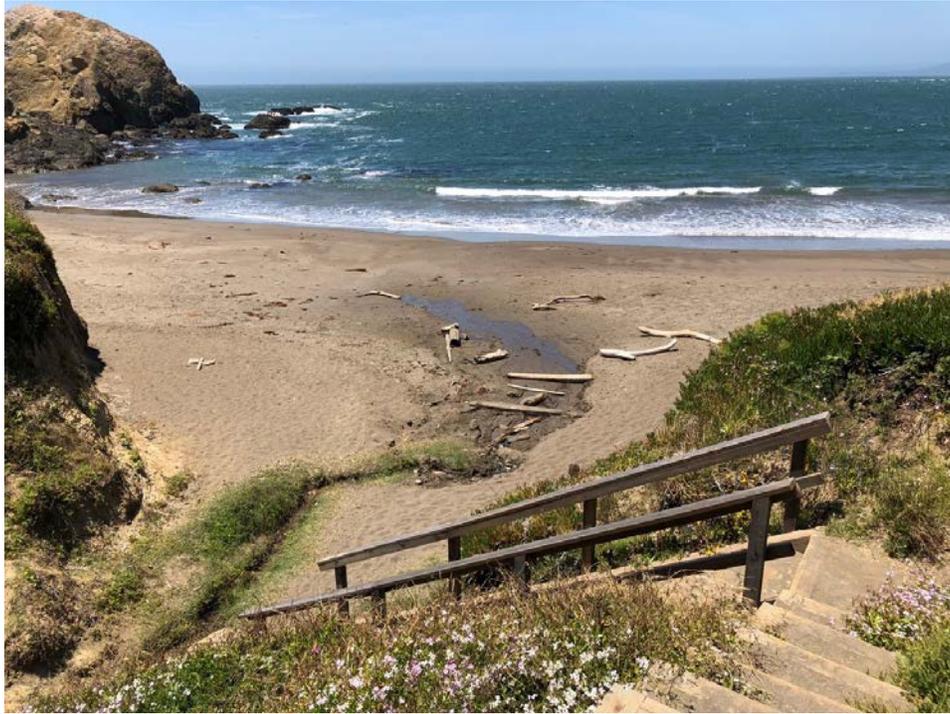
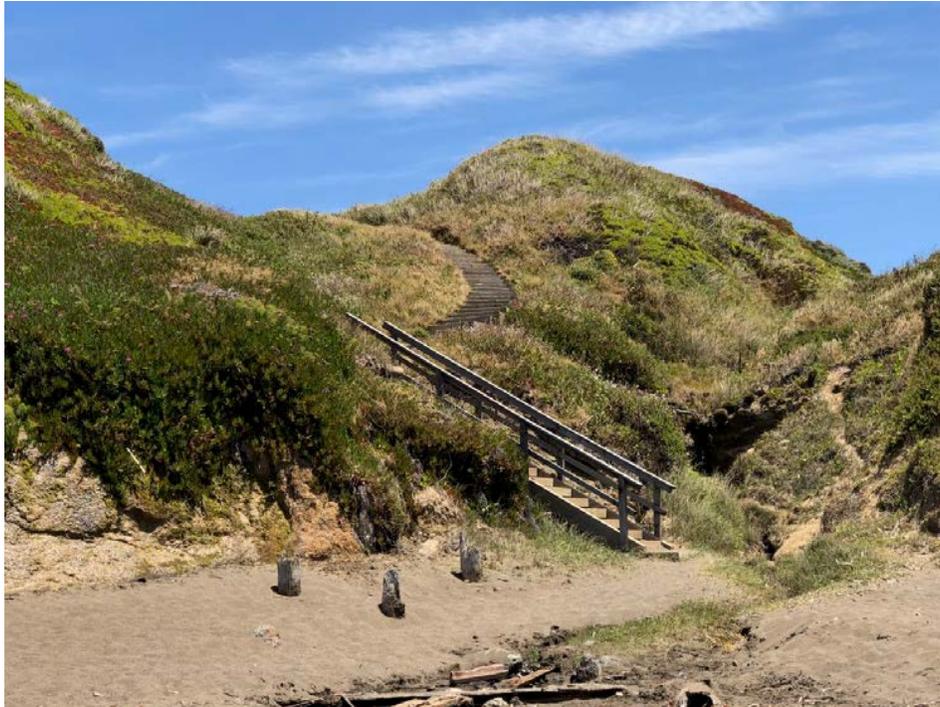
South Rodeo Beach Access – Reconstruction of access stairway with NPS funds  
September 2017

erosion; it will be interesting to watch how the more solidly constructed wooden staircase survives the coastal environment.

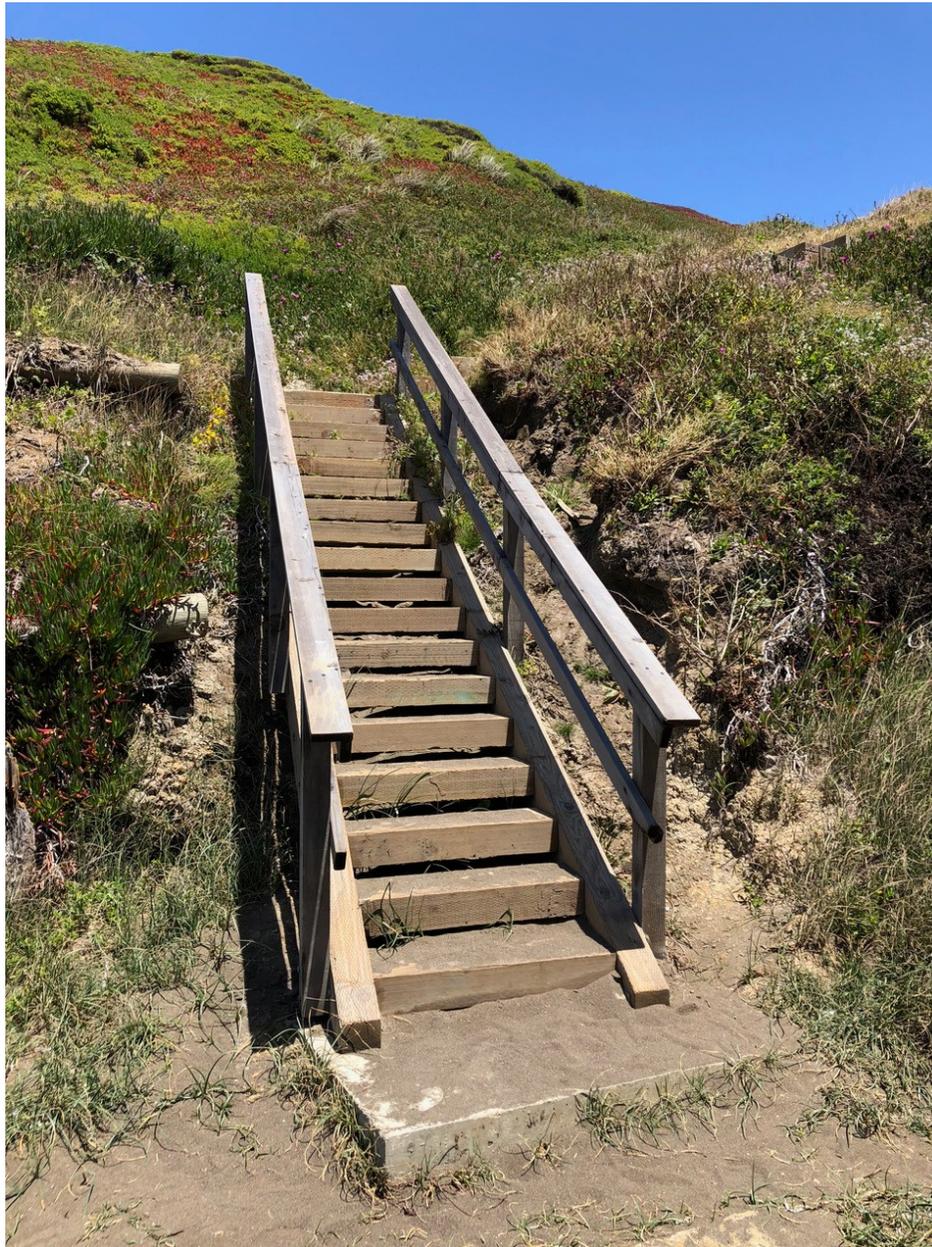
South Rodeo Beach Access – Reconstruction of access stairway with NPS funds  
September 2017
