FINAL REPORT  
**RESTORATION ACTIONS**  
WITHIN THE  
**SAN LUIS OBISPO CREEK WATERSHED**  
PREPARED FOR THE AVILA BEACH TRUSTEE COUNCIL  
with Funds from the Avila 1992 Unocal Oil Spill Settlement  
San Luis Obispo County, California  
MARCH 2008

This report summarizes the work completed and highlights three revegetation and bank repair projects, two fish passage projects and two community outreach projects.

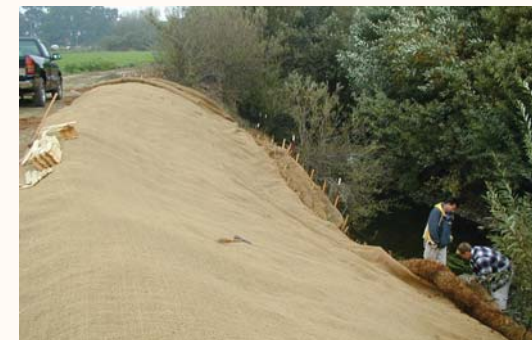
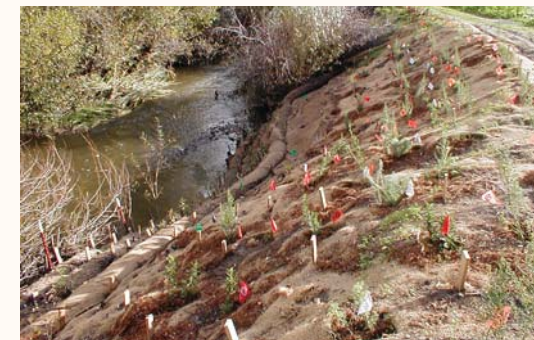
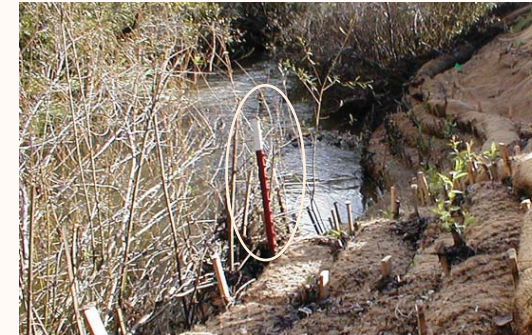
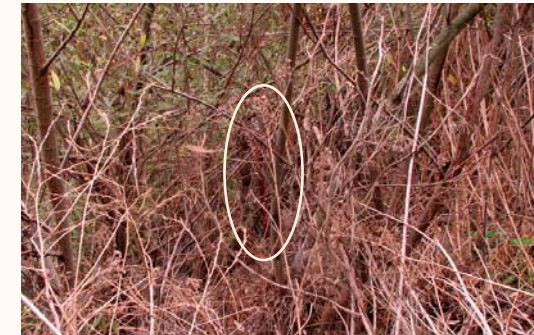
## REPLANTING A STREAM BANK

1. San Luis Obispo Creek, near South Higuera Street and the Octagon Barn.
2. Mats woven from an organic coconut fiber called *coir* protect the bank from erosion caused by rushing water. The mats take a few years to decompose completely, allowing young plants time to grow and take over the job of holding soil in place.
3. Holes are made in the mat and native vegetation is planted.
4. Biologs are flexible rolls of coir mat covered with coir netting. The biologs are placed at the base of the slope to stabilize the bank.
5. Compare this photo with number 4 to the left. The red stake that was placed to stabilize the biologs is still there, but mostly hidden by 4 - 6" diameter willows.

To repair the eroded stream bank, the bank was first re-sloped with a backhoe to an angle gentle enough for vegetation to be established. Precautions were taken during the grading to make sure none of the soil entered the stream.

Once the bank was properly shaped, the toe of the slope required protection so the stream would not undercut the new sloped bank. For this step, a natural slope protection method was used.

Rather than using large boulders, fiber rolls made from shredded coconut husks (biologs) were used in tandem with live willow planting.

These materials help build the strength of the bank naturally while providing habitat cover for fish and birds. The upper portions of the sloped bank were planted with other native plants and covered with an erosion control net. Several seasons later, the restored bank is naturally restored... and even hard to find.

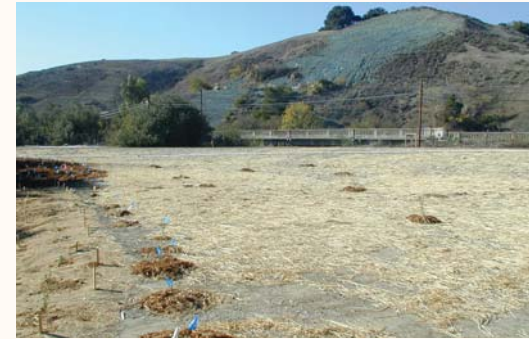
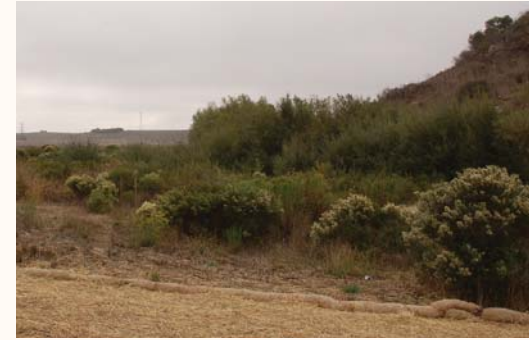
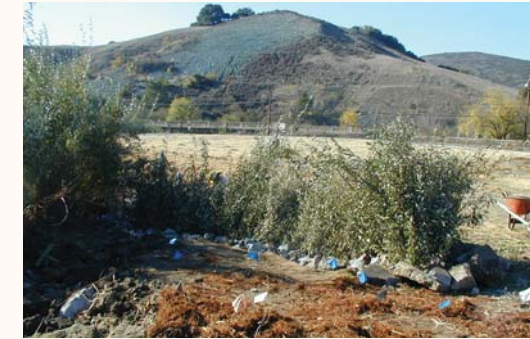
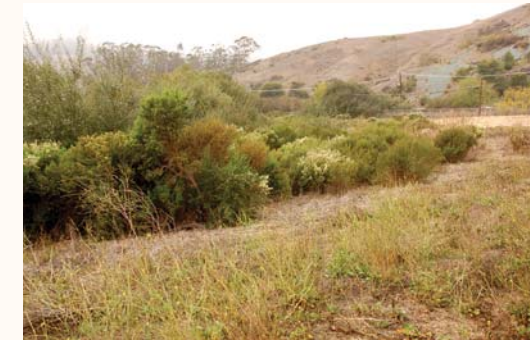
## REVEGETATING A FLOODPLAIN

The South Higuera Street bridge can be seen in the background of the photos above. (1, 2) Before the project, the streambank was eroded and vegetation was sparse. Parts of the bank were re-sloped to hold vegetation, using netting and biologs. The plantings are now thriving on this site. (3, 4)

Before the project, the stream banks were eroded and were supporting little vegetation. Parts of the bank were re-sloped to hold vegetation, using netting and biologs. Grading undertaken through this grant included reduction of the floodplain elevation along a 500-foot section of the East Fork of San Luis Obispo

Following the grading, the banks and floodplain were replanted with a mixed palette of native plants. Approximately 400 feet of streambank was replanted. Some minor repairs were necessary following a winter flood, as was the installation of a live willow siltation baffle. The plantings thrived on this site and the area is already recruiting other native plants.

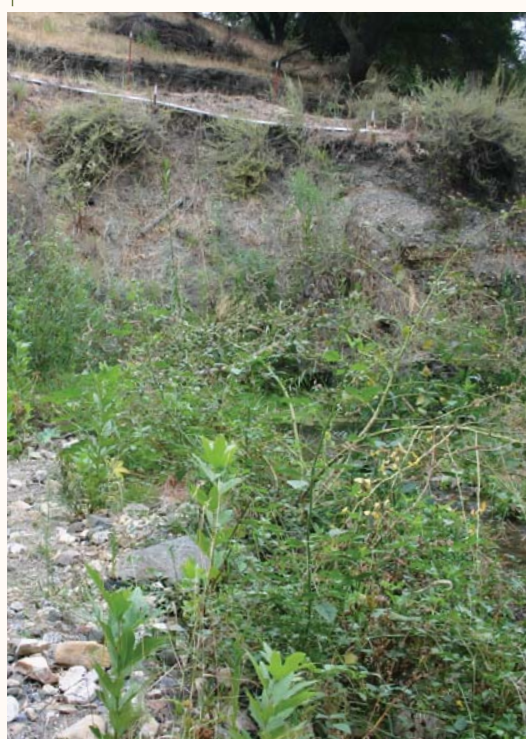
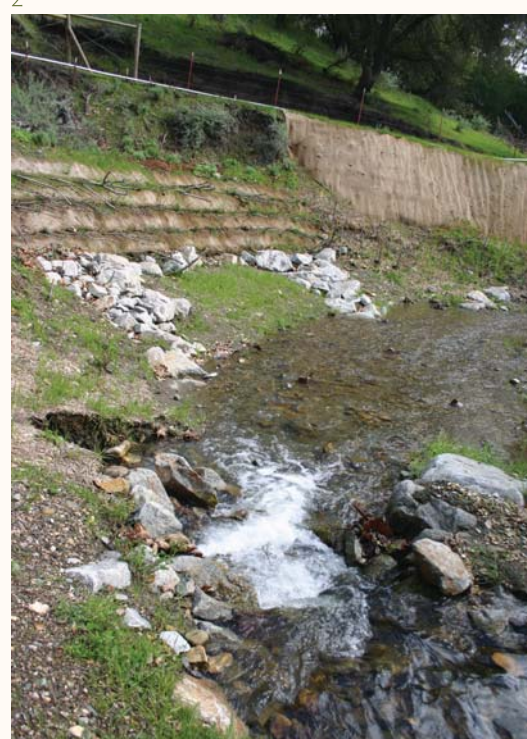
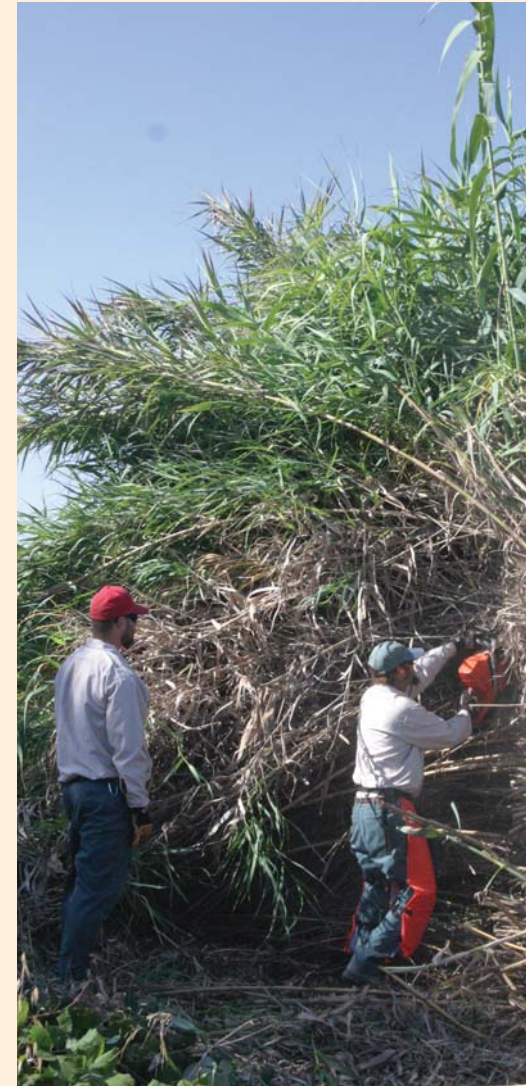
### UPPER SAN LUIS OBISPO CREEK BANK STABILIZATION

1. The crumbling bank before the project began.

2. After, with rock vanes in place to help re-direct the flow away from the banks.

3. A bench was created to support the coir mats and live willow stakes.

4. The bank is replanted with native species.

5. The eroding bank was 18 feet tall and falling fast.

6. The creek was dammed and boulders were placed at the foot of the bank.

First, the stream was diverted through pipes to protect it from construction because the project required that heavy equipment enter the streambed. To protect the banks, low-profile rock structures were constructed along the toe of the vertical banks and live willow stakes were planted. Innovative structures named rock vanes were installed to re-direct the flow away from the banks and guide the creek through the site.

At the base of the 18-foot bank a bench was created that allowed us to build “soil wraps” of biodegradable erosion control blankets and live willow branches. This provides extra strength to the slope to allow for the willows to develop strong roots and subsequently grow larger and support the slope for the long term while providing shade for the creek. On top, the planted native shrubs and trees will one day grow up to provide even more shade on the creek. In total, 40 pounds of native seed were applied, over 750 willow stakes were placed, and 130 tons of rock was set to rebuild the banks.

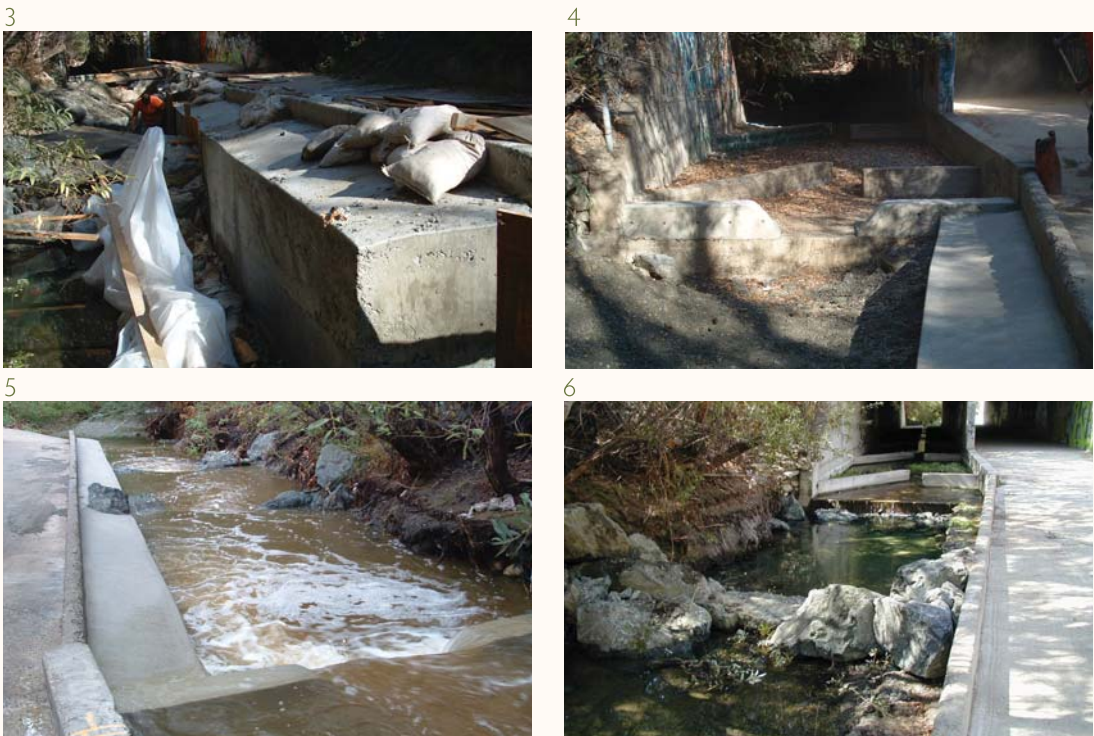
### FIXING THE FISH PASSAGE

1. Before, the road was undercut and a steep drop created a barrier for fish.
2. The finished project allows juvenile steelhead to negotiate the creek.
3. The undercut road was filled in and shored up with boulders.
4. The barrier is reduced...
5. ...so water can flow and fish can pass.
6. Pools were created with boulders cemented in place.

This former fish migration barrier on Stenner Creek is located on the Cal Poly campus. The problem at this site was the vertical drop that fish had to negotiate. Juvenile fish in particular lack the jumping ability of adult fish.

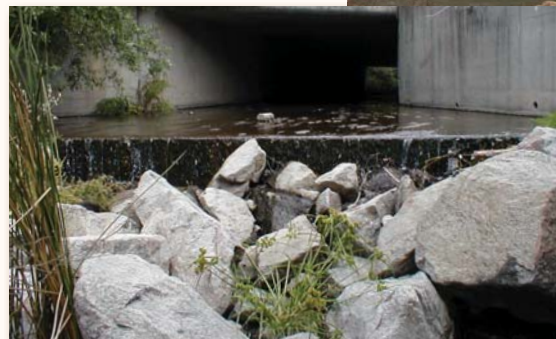
2. New pools, after  
construction of baffles  
to slow the water and create  
depth sufficient for fish to  
swim through.

These problems were addressed first by rearranging the rocks below the outfall to make pools, then grouting the rocks so the pools would hold water. This made for four small jumps instead of one high jump. The grouting also made for permanent pools that would create a path for migrating fish. The actual culvert was modified by adding a baffle system that slows down the water flow and creates sufficient depth for fish migration. The project subsequently provided successful fish passage.

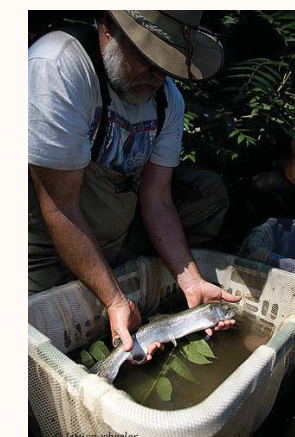
One of the longest  
trout found in lower  
San Luis Obispo Creek in  
August, 2007 measured  
over 12 inches.
