Summary of Fish Rescues Conducted within the Yolo Bypass, 2018 Water Year
Prepared for the United States Bureau of Reclamation

Prepared by:
California Department of Fish and Wildlife
Region 2 Anadromous Fisheries
October 8, 2019

**SUMMARY OF FISH RESCUES CONDUCTED WITHIN THE YOLO BYPASS, 2018
WATER-YEAR**

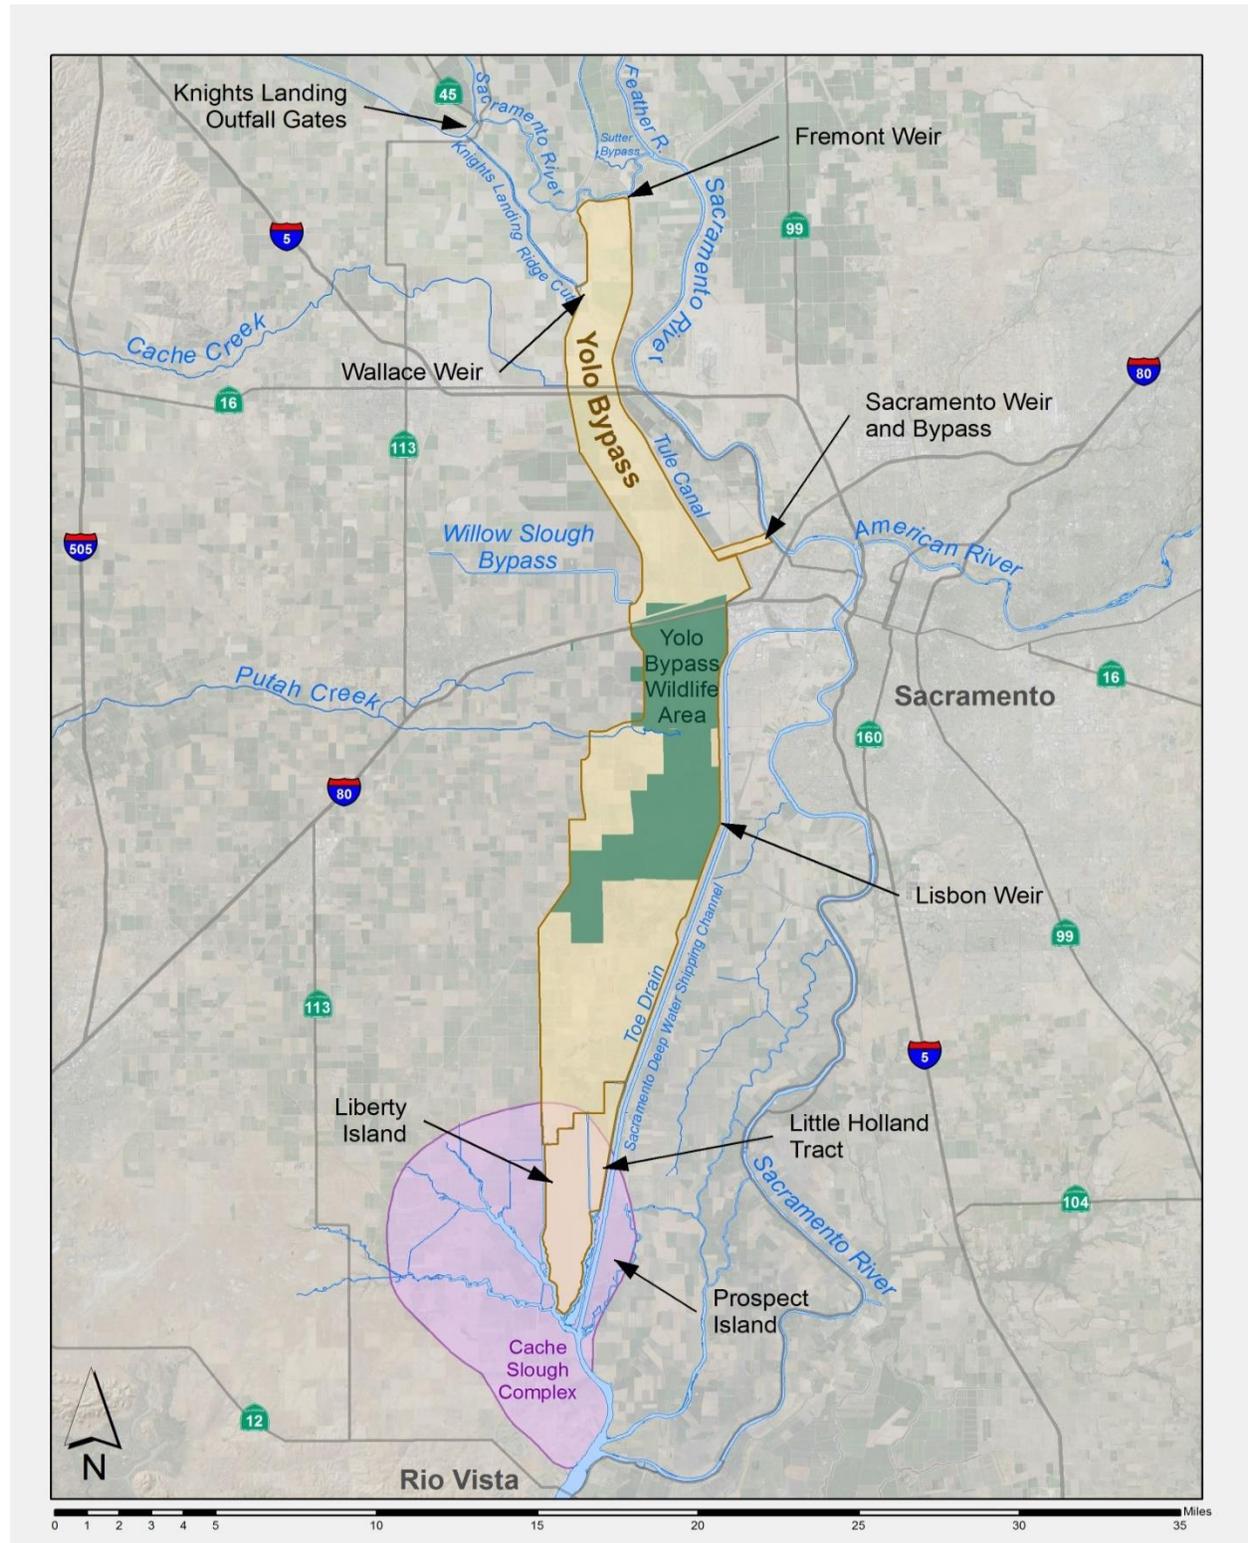
Figure 1. Fremont Weir, Yolo Bypass, Westside Tributaries and Cache Slough Complex

The approximately 59,000-acre Yolo Bypass is essentially designed to convey floodwaters from the Sacramento River and west side streams and drains around the populated regions of the Sacramento Valley (**Figure 1**). Inundation of the Yolo Bypass primarily occurs when Sacramento River flows overtop the Fremont Weir, located at Sacramento River kilometer (RK) 226 (River Mile 140.4). The Fremont Weir spills on average once every two to three years (USBR and DWR 2012). Inundation of the Yolo Bypass occurs when Sacramento River flows at the Fremont Weir exceeds a stage height of 32.3 feet above mean sea level North American Vertical Datum of 1988 (NAVD 1988) which occurs at a flow of approximately 1,622 cubic meters per second (57,290 cfs) (DWR 2016). Inundation of the Yolo Bypass is augmented by flows from west side tributaries including Cache Creek, Willow Slough, Willow Slough Bypass, Putah Creek, and South Fork Putah Creek (**Figure 2**). Up to 80 percent of the Sacramento River's floodwaters are conveyed for a distance of approximately 50 km (31 miles) through the Yolo Bypass and returned to the Sacramento River via the Cache Slough Complex approximately two miles upstream of

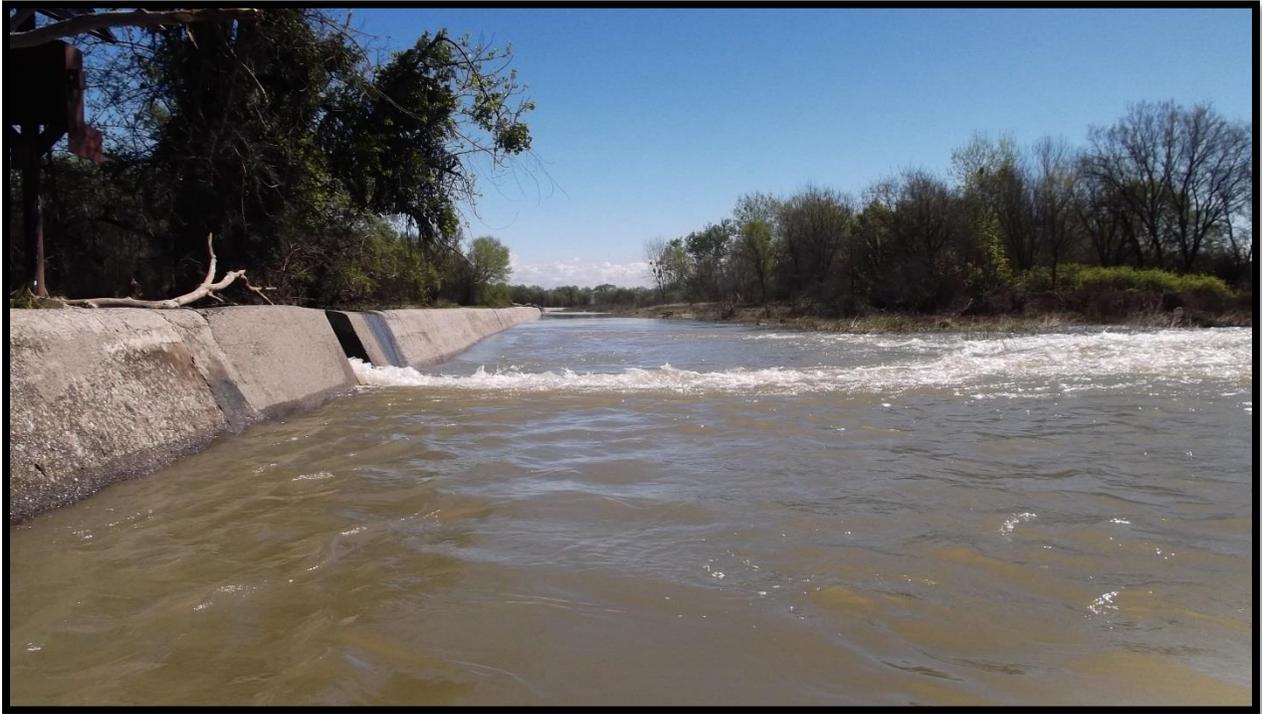
Figure 2. View of Fremont Weir during after cessation of overtopping event in March 2017. Flashboards have been removed to facilitate volitional fish passage to the Sacramento River prior to rescue operations

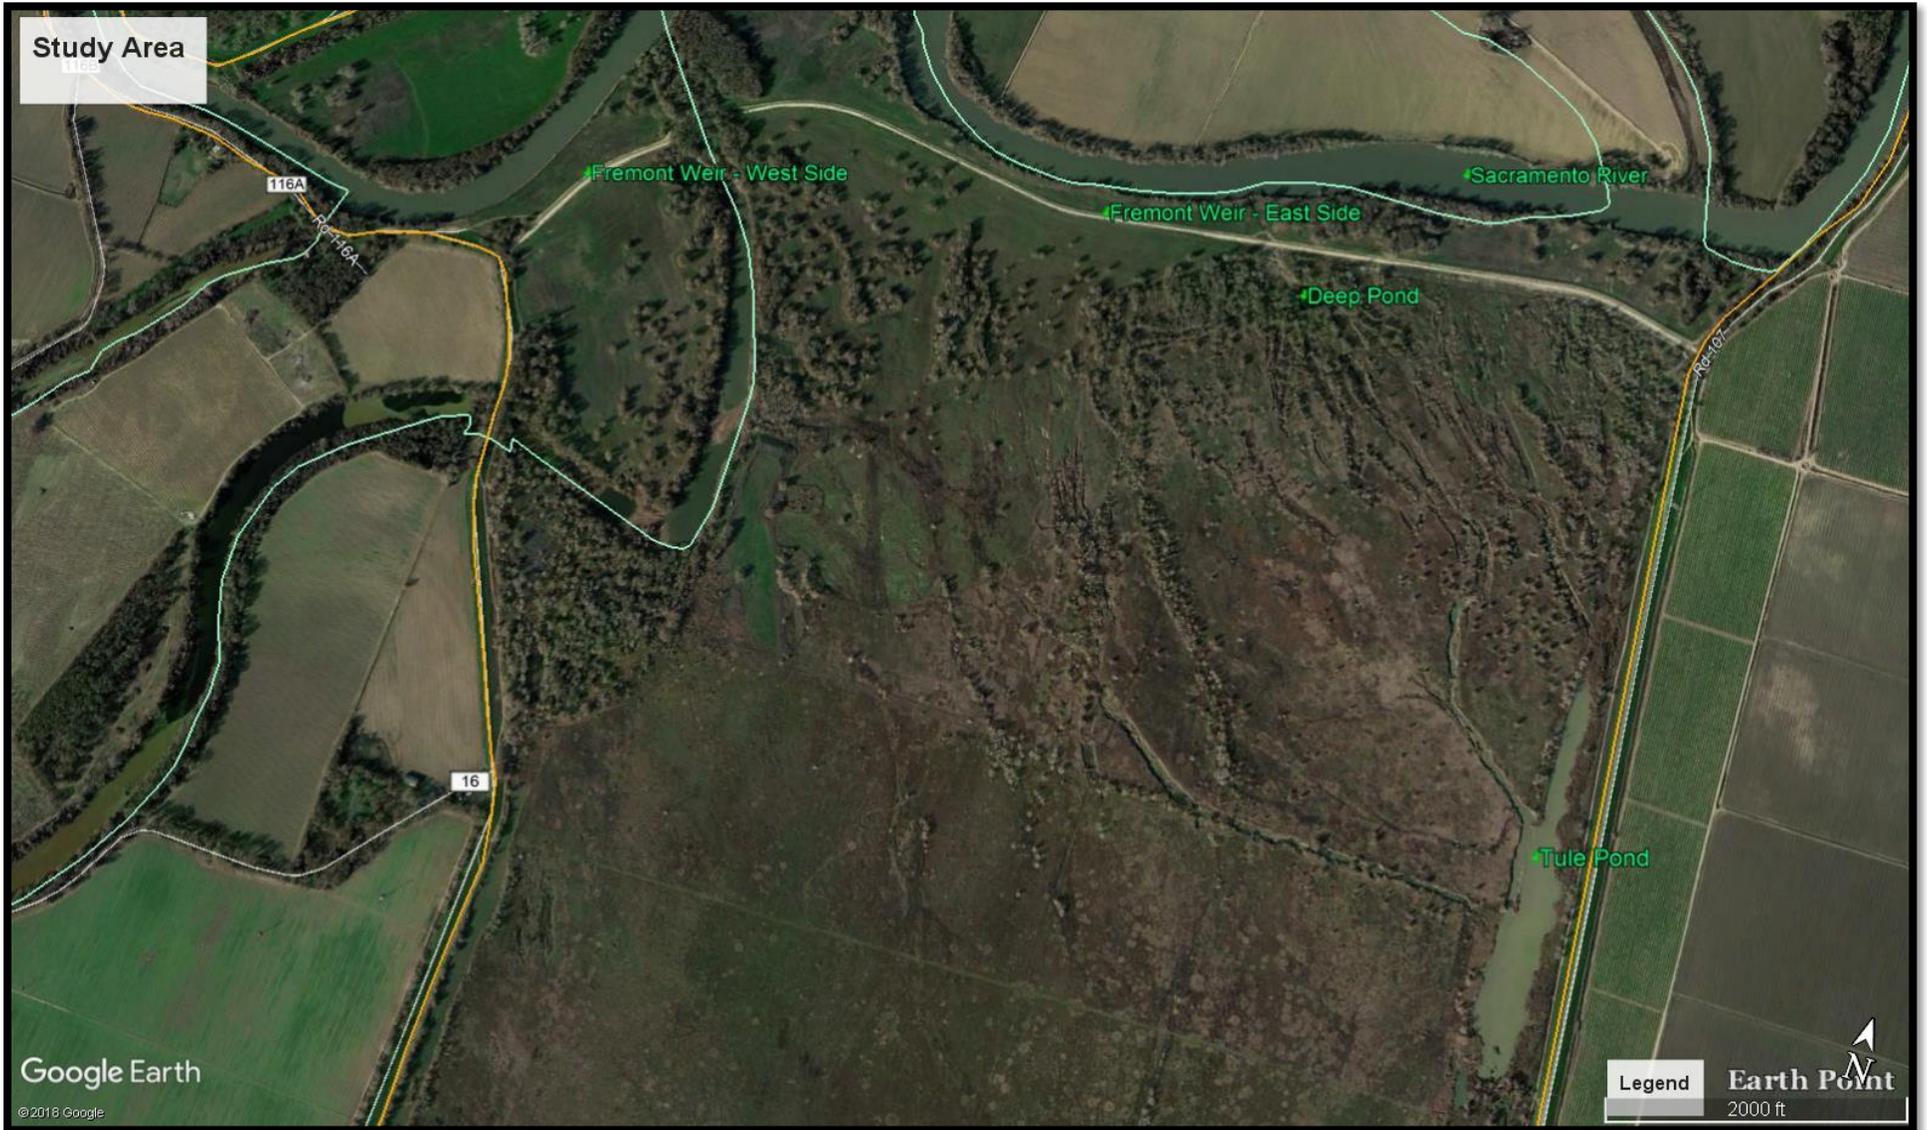
Figure 3. Fremont Weir and Northern Yolo Bypass (Fremont Weir Wildlife Area)

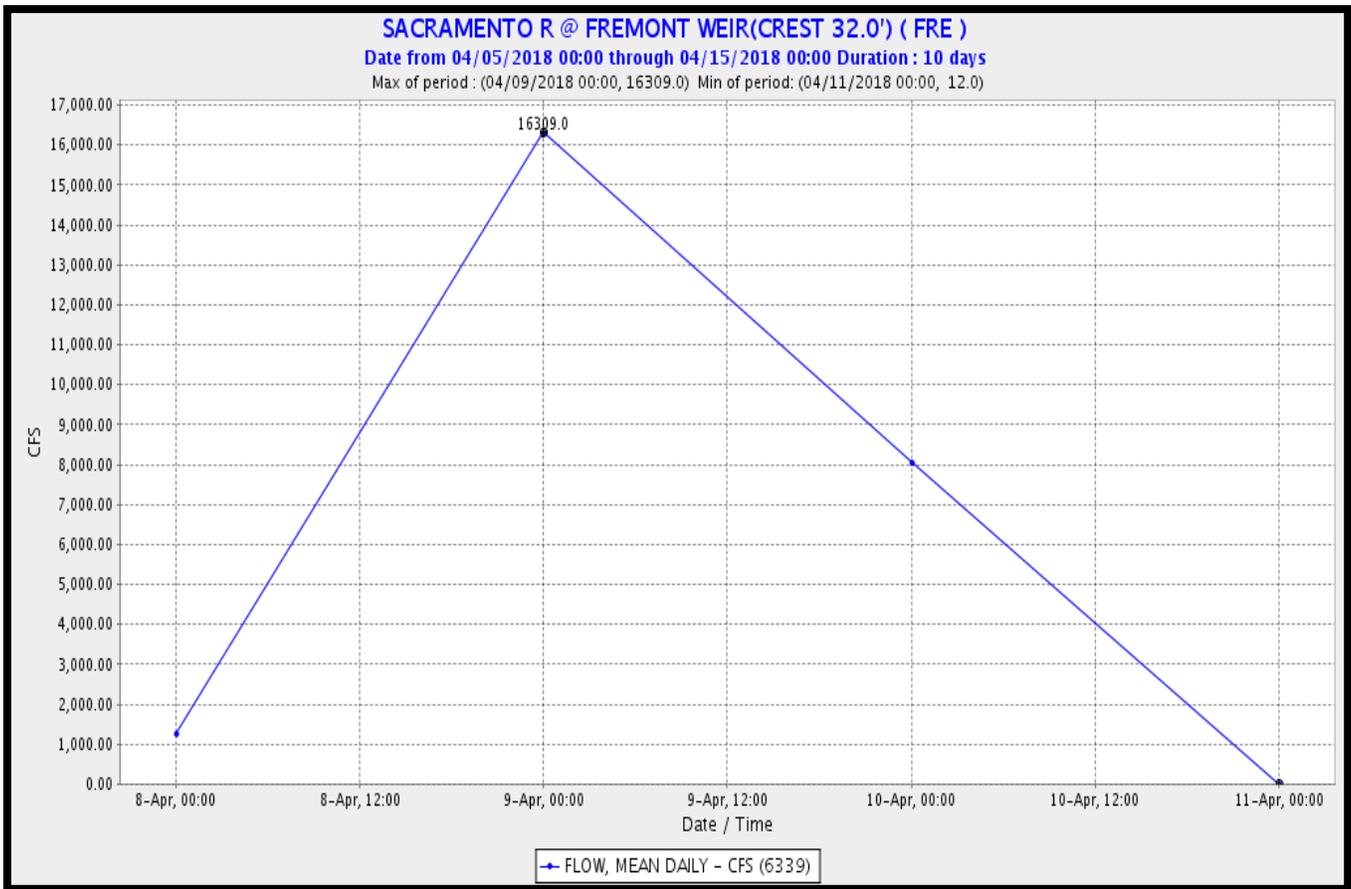
Figure 4. Hydrograph of Fremont Weir 4-day overtopping event, 8 April through 12 April 2018. Mean daily flow during the period was 6,339 (cfs) with a maximum flow of 16,309 (cfs)

During the 2017-2018 water year, the Fremont Weir experienced one overtopping event beginning 8 April and ending 12 April 2018 at which time the flashboards were pulled by CDFW staff. The maximum flow during the overtopping event was 16,309 cfs on 9 April at 00:00 hours (**Figure 4**) (DWR 2018). Water levels in the weir splash basin decreased rapidly between the time the fishway flashboards were removed on 12 April and the initiation of rescue operations on 13 April. The average depth in the weir basin on the morning of 13 April was less than 0.3 m, and long stretches of the east section of the splash basin had already dried. Because of limited area to survey, fish rescue was completed at both the east and west sections of the Fremont Weir splash basin on 13 April. The water temperature in the east section ranged from 13°C to 20°C during the course of rescue operations (10:15 to 13:00), and 22°C in the west section at the start of rescue operations at 13:40. A total of 546 fish consisting of five native species and eight non-native species were captured, identified, and released in the Sacramento River. Listed fish species rescued included 20 juvenile Central Valley spring-run Chinook salmon as determined by length-at-date (**Table 1**). In instances when large numbers (> 20) of Chinook salmon were captured in seine hauls, subsets of 20 individuals were measured to avoid excessive handling stress. Therefore, it is possible that an additional 19 adipose intact juvenile Chinook salmon rescued from the west splash basin may have been Central Valley spring-run ESU based on extrapolation of the ratio of spring-run to fall-run juvenile Chinook salmon as determined by length-at-date measurements. No other special status fish species were encountered, although one juvenile hatchery-origin Central Valley steelhead was rescued from the west section weir splash basin.
