South Sailing Cove Parking Lot Renovation Project: Final Programmatic Report (AMENDED)

Recipient Organization/Agency: City of Berkeley
Date Submitted: May 31, 2019 (Final Submission)
Award Amount: \$214,630.00
Matching Contributions: \$1,444,218.00
Total Disbursements: \$214,630.00
Project Number: 8006.17.033635

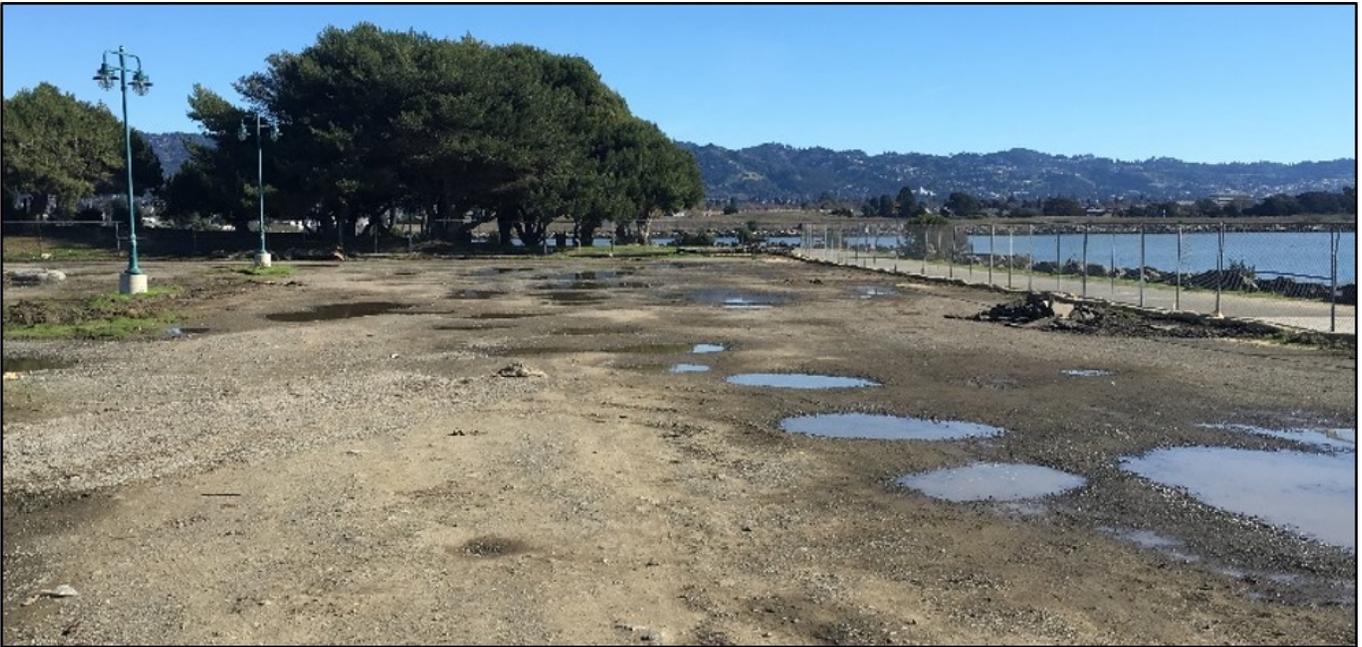
Image 1: South Cove East Parking Lot – Prior to construction. A badly deteriorated gravel parking lot with poor conditions (drainage, striping, pedestrian safety, etc.). (Photo by R. Miller)

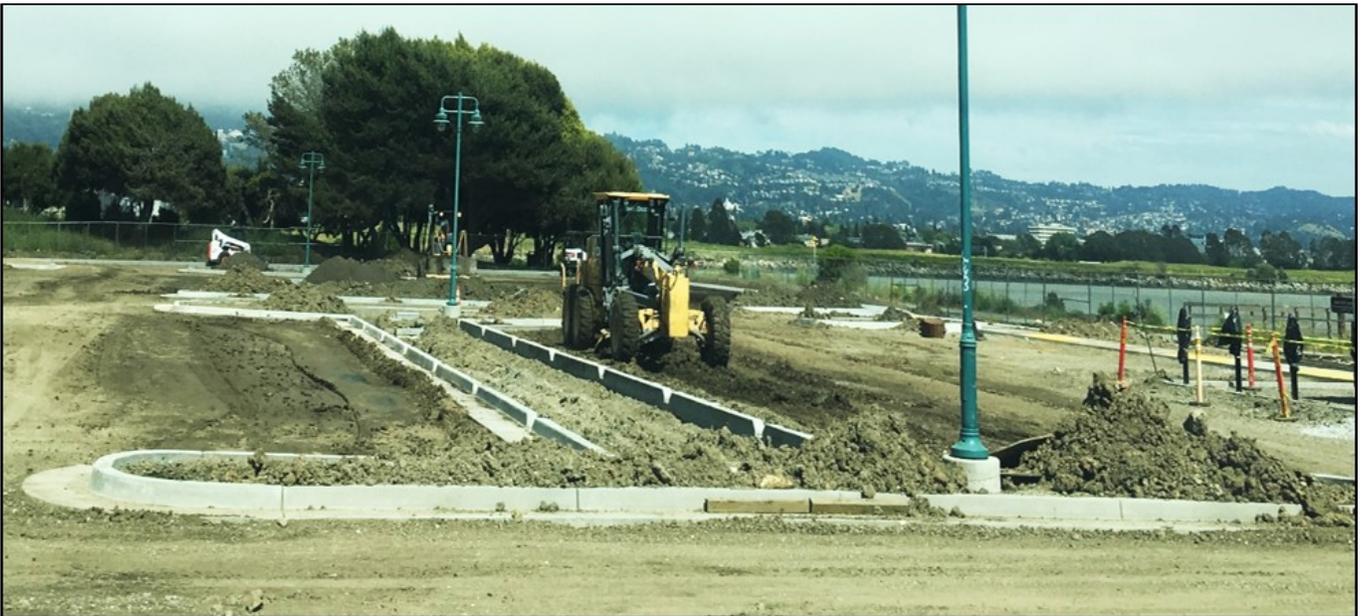
Image 2: South Cove East Parking Lot – Mid-way through construction. Subsoil is being graded and compacted to provide a strong structural base layer for the new asphalt. (Photo by D. Sheils)

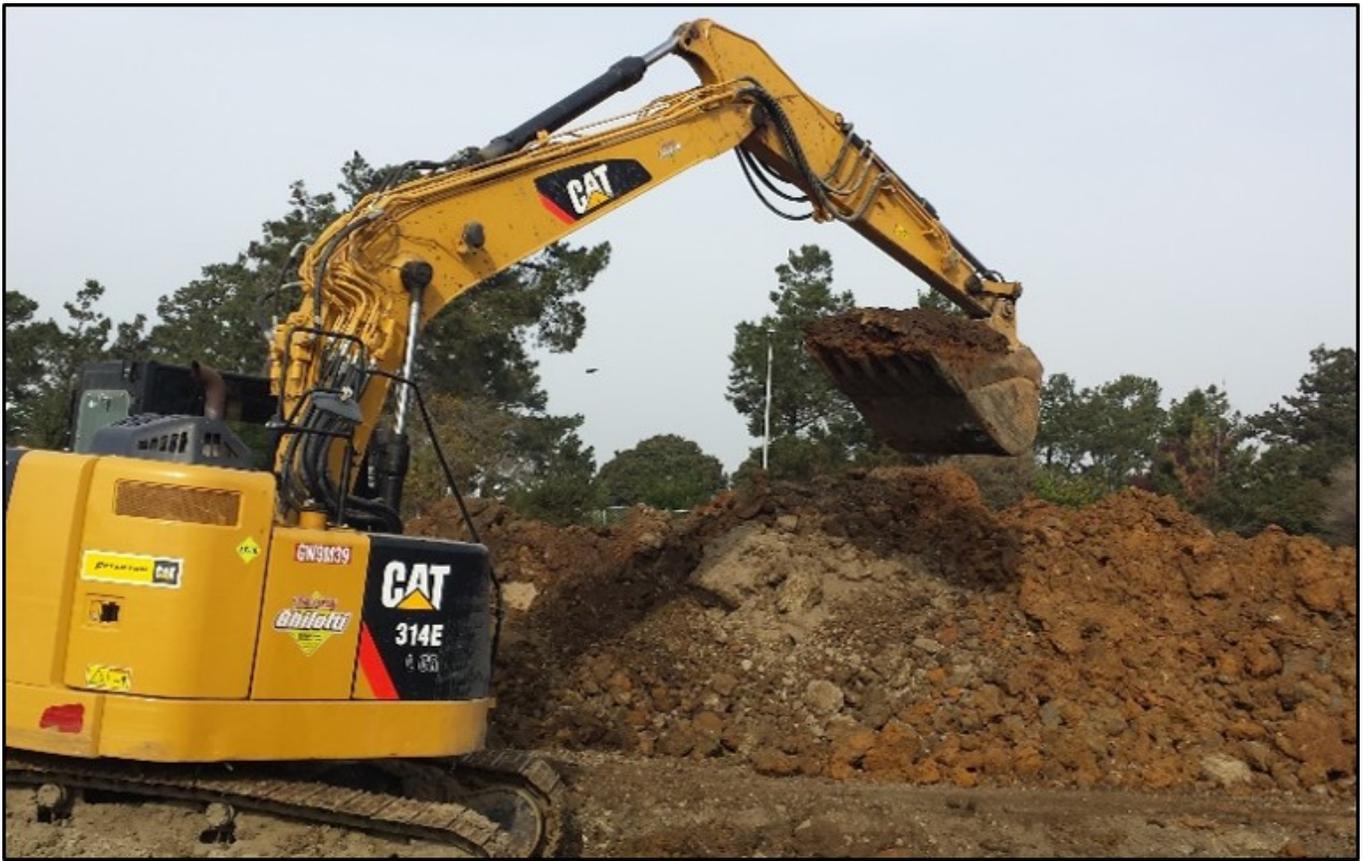
Image 3: South Cove East Parking Lot – Excavating large trenches to install new storm drain pipes and pre-cast storm drain structures to drain new bioswales that remove pollutants from stormwater before it enters the San Francisco Bay. (Photo by D. Sheils)

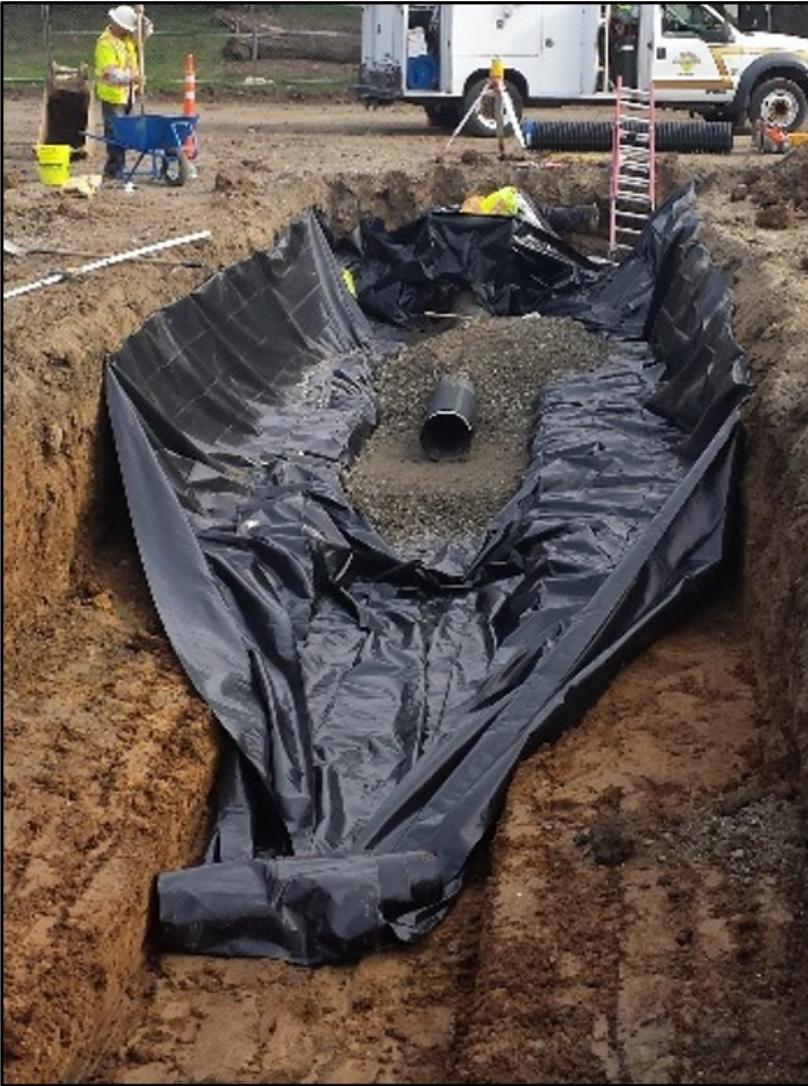
Image 4: Example installation of new storm drain pipes. (Photo by D. Sheils)

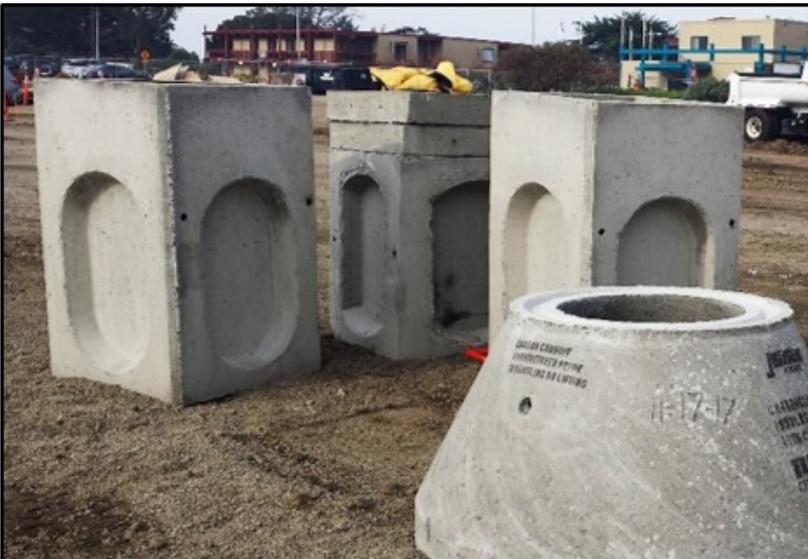
Image 5: Example pre-cast storm drain structures. (Photo by D. Sheils)

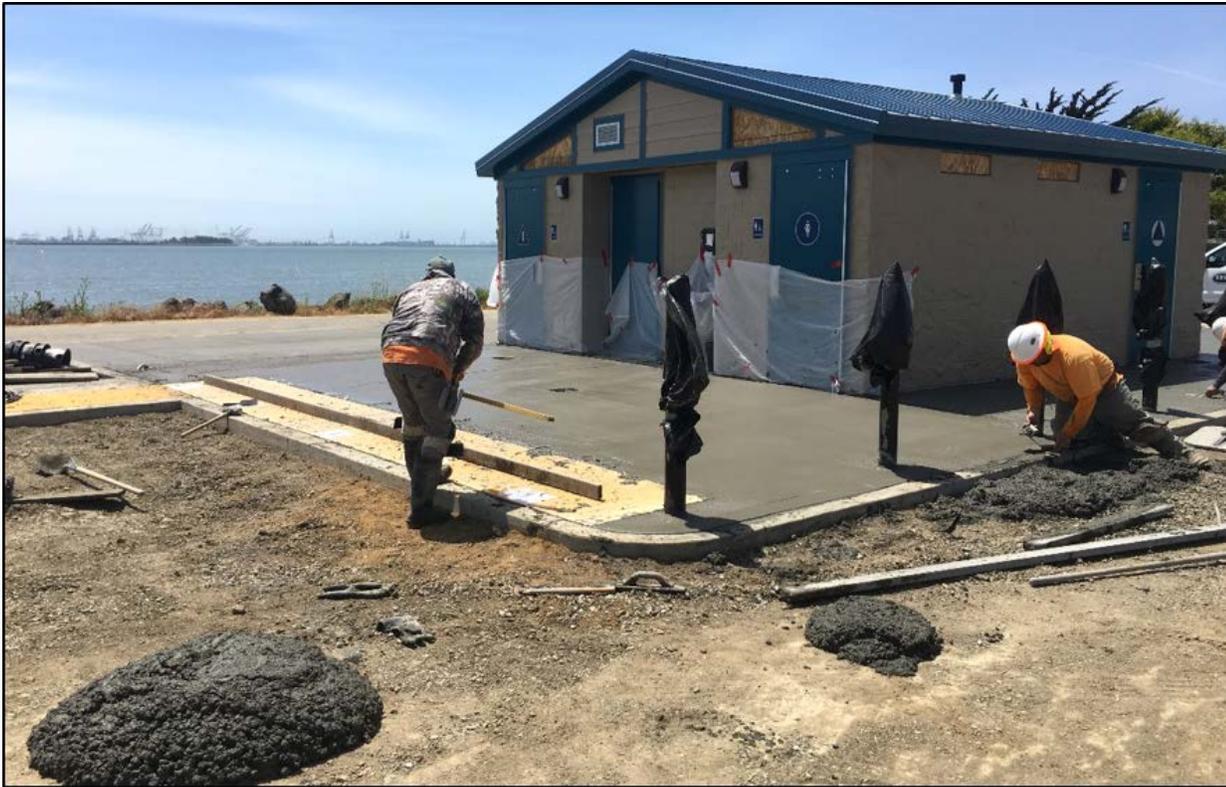
Image 6: South Cove East Parking Lot – Installing the new concrete restroom plaza adjacent to ADA accessible parking slots to provide accessible paths of travel. (Photo by D. Sheils)

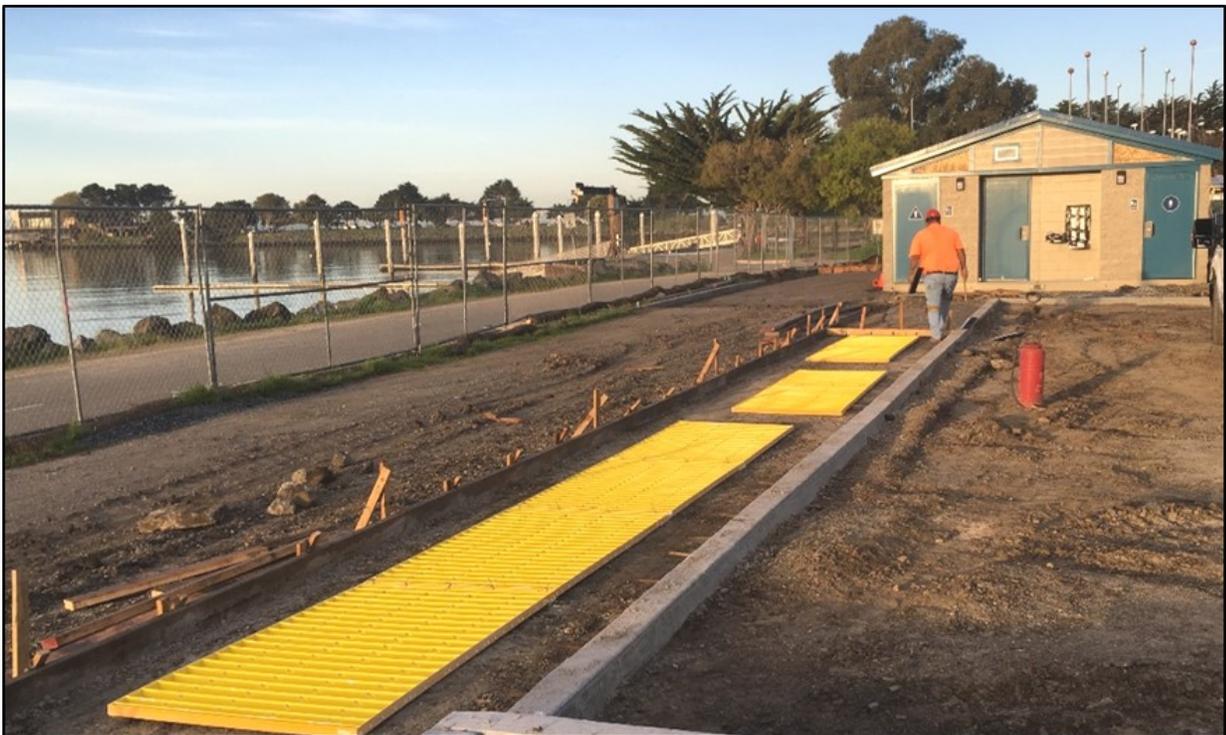
Image 7: South Cove East Parking Lot – Installing truncated dome detectable surfaces for the new accessible concrete sidewalk path of travel from the renovated parking lot to the new public restroom. (Photo by D. Sheils)

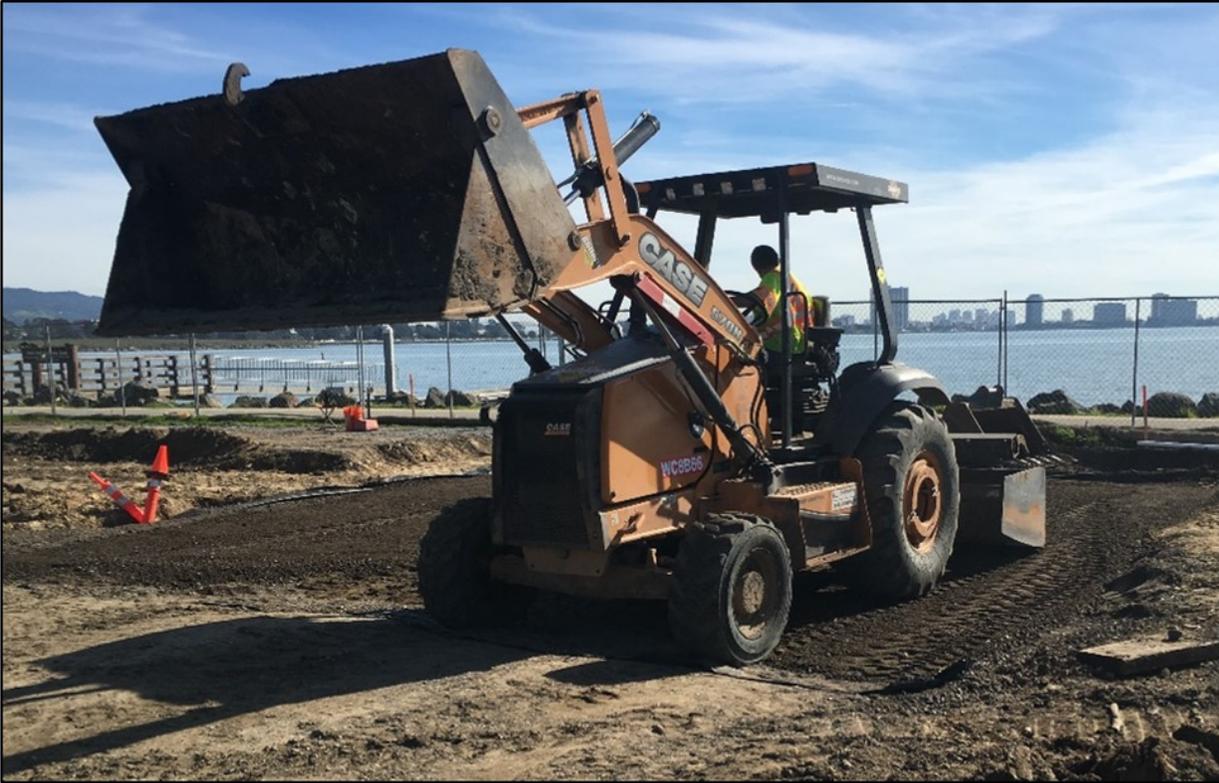
Image 8: South Cove East Parking Lot - Grading and compaction of the existing unconsolidated subsoils atop Bay muds to prepare the base layer for asphalt paving. (Photo by D. Sheils)

- **Discrepancy:** Despite a thorough geotechnical investigation of the site during the design phase, the grading and compaction operation encountered locations where the underlying water-saturated Bay mud soils were close to the surface. This situation required some unexpected off-haul of Bay mud soils to install the deep bioswale and its storm drain lines, as well as additional compaction by heavy equipment in selected areas (these change orders were covered by City contingency funds).

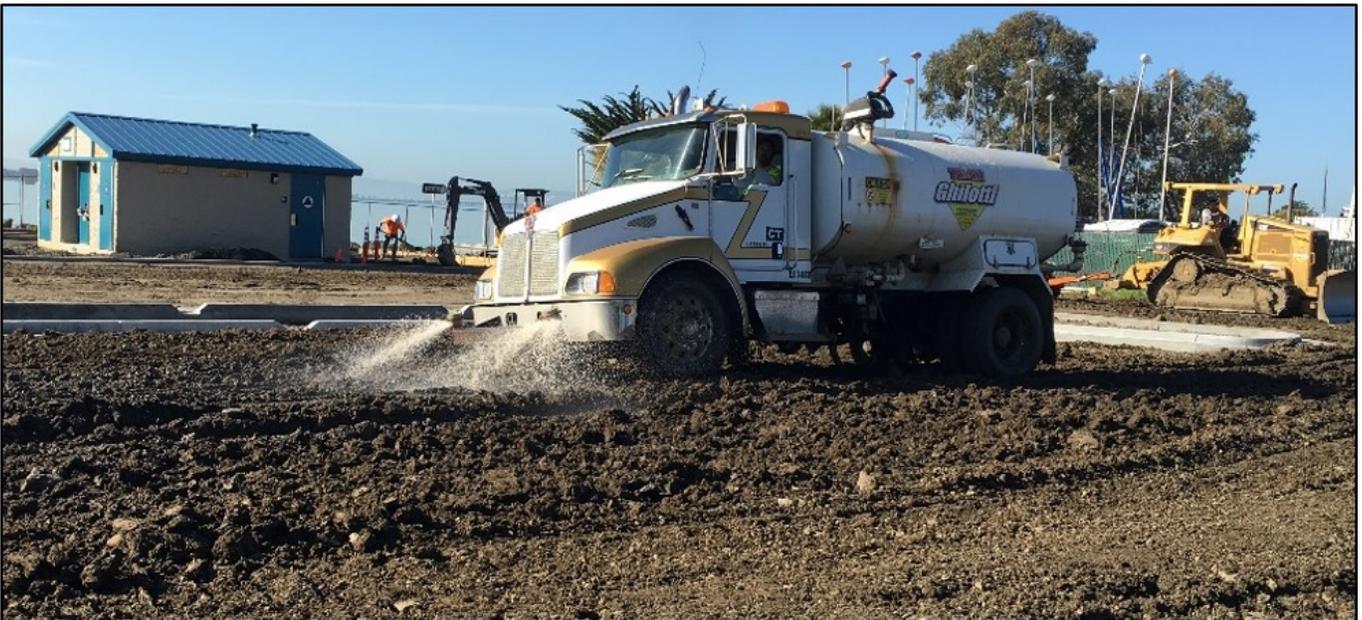
Image 9: South Cove East Parking Lot - Hardening the existing site soils with a soil stabilizer via water truck to create an eighteen inch structural base layer for the top asphalt layer. Re-using the existing soils greatly reduced the need to off-haul soils to the landfill. (Photo by D. Sheils)

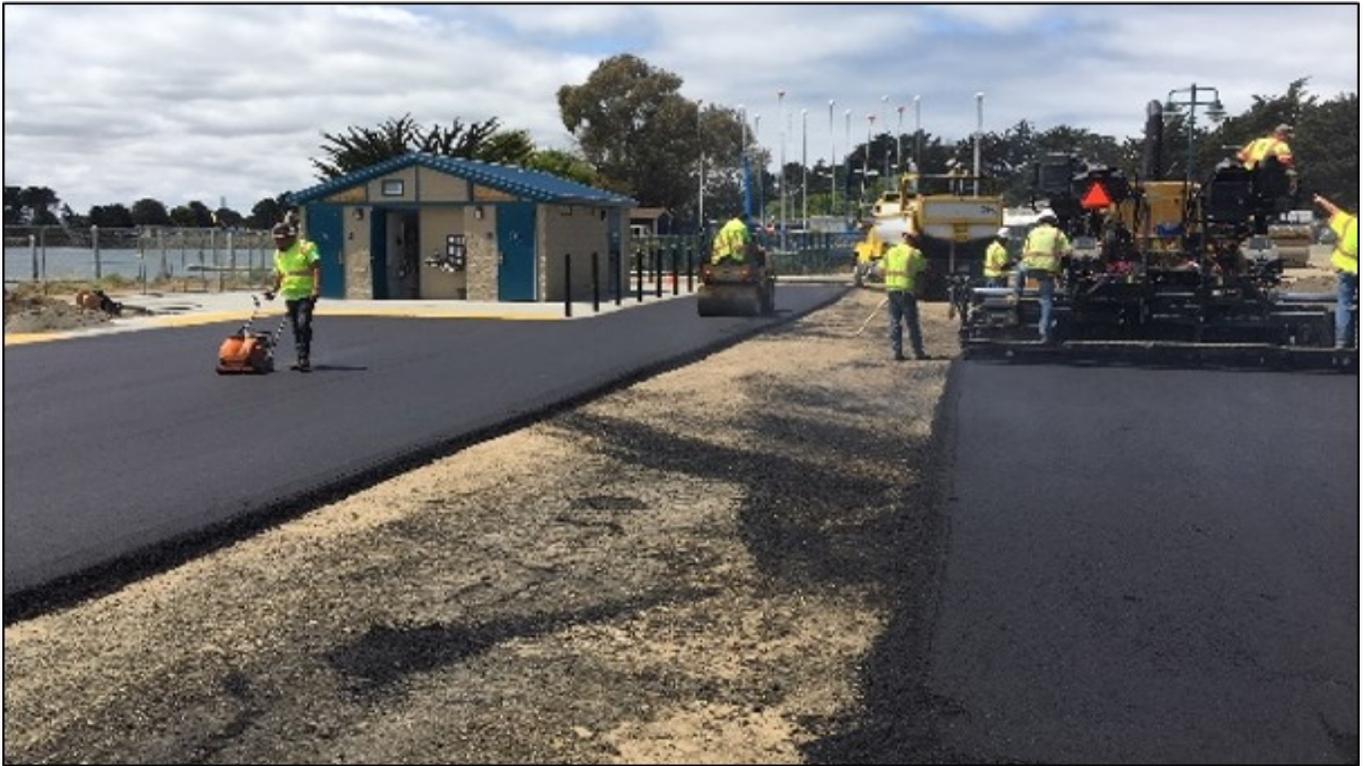
Image 10: South Cove East Parking Lot - New asphalt paving atop the stabilized base layer. (Photo by D. Sheils)

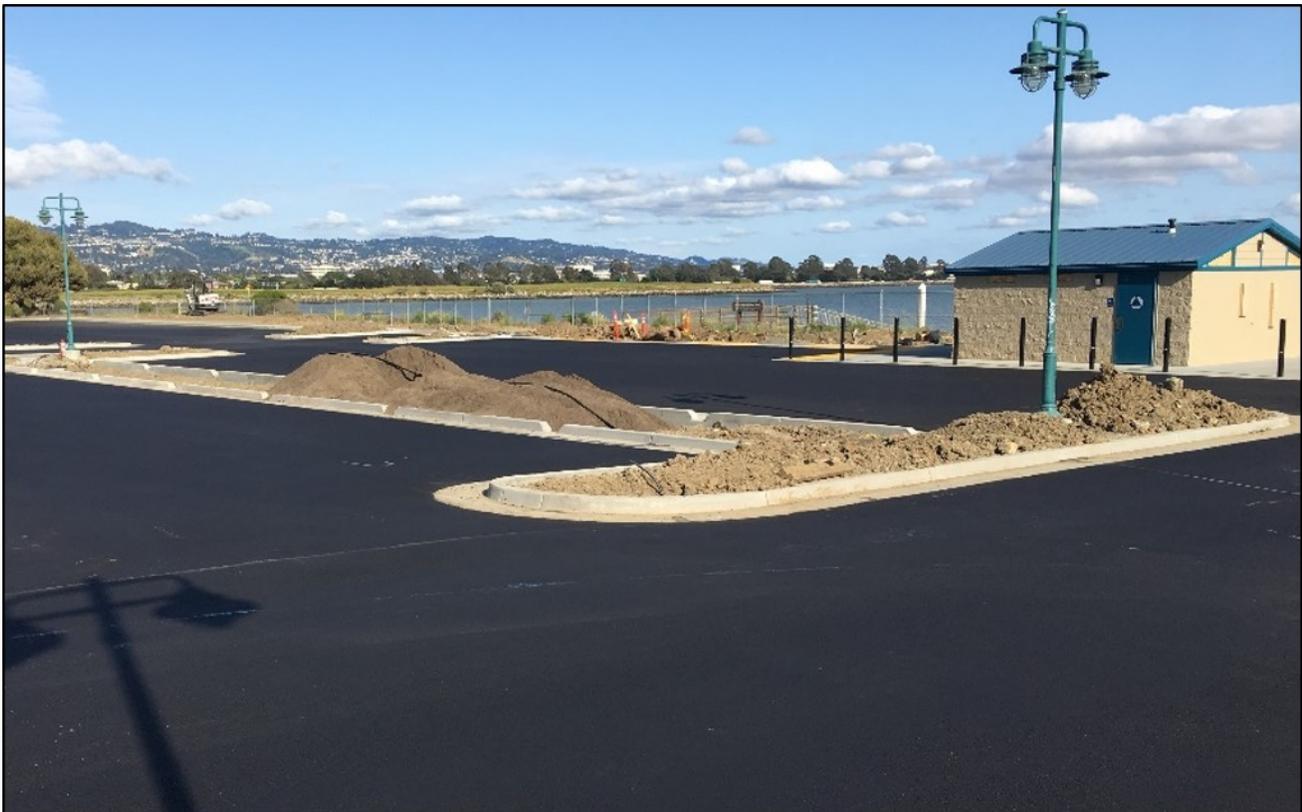
Image 11: South Cove East Parking Lot - The full parking lot was paved in one day. Traffic and ADA striping came later after the asphalt cured. (Photo by D. Sheils)

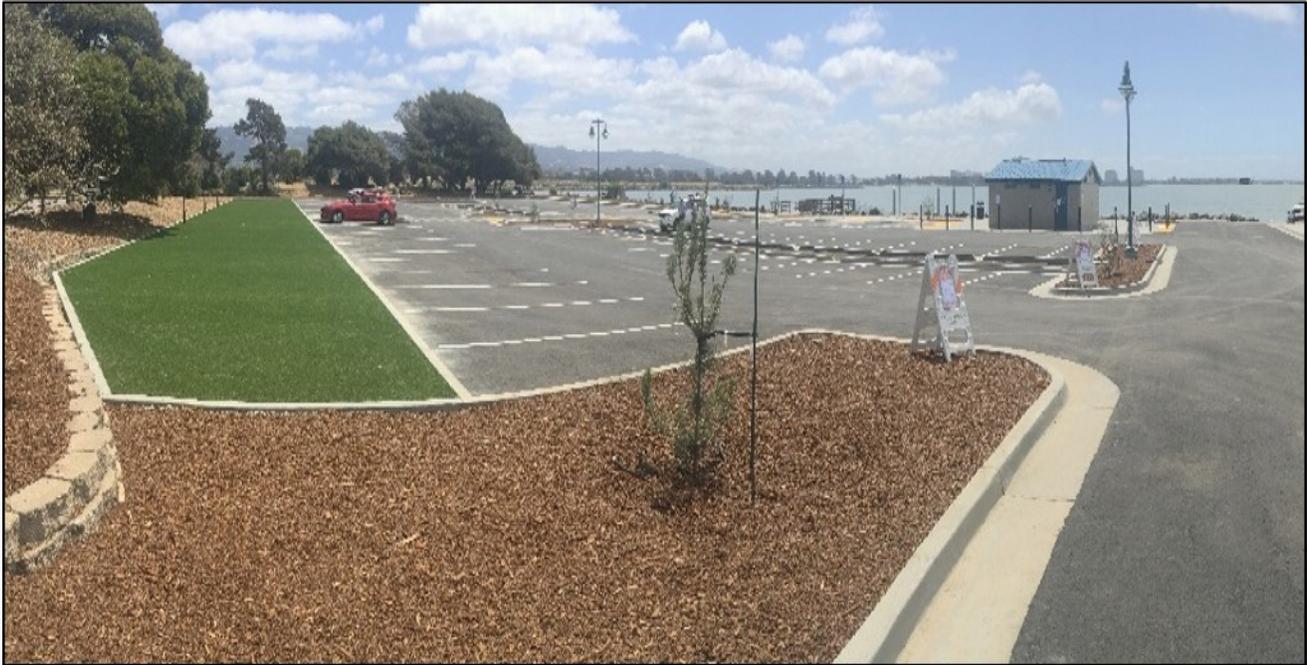
Image 12: South Cove East Parking Lot and New Public Restroom - Renovation completed! Wide-angle site view looking southeast. (Photo by D. Sheils)

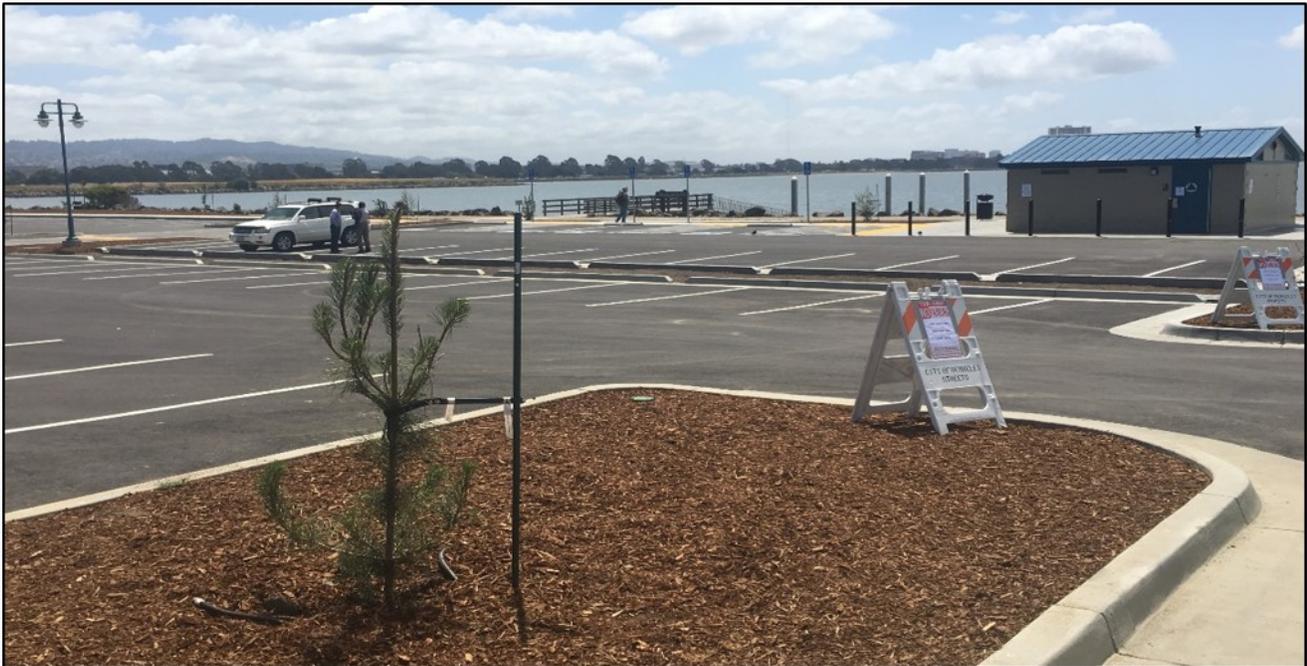
Image 13: South Cove East Parking Lot and New Public Restroom - Renovation completed! Closer photo facing southeast. (Photo by D. Sheils)

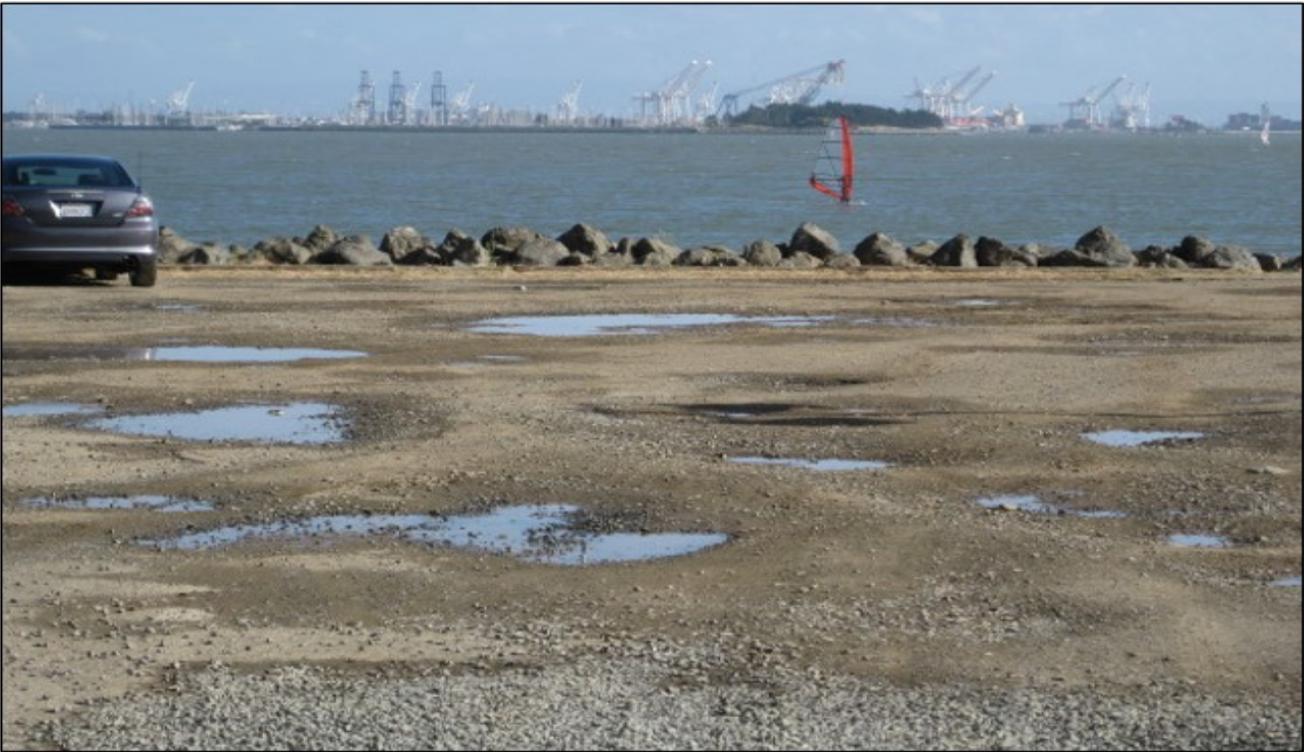
Image 14: South Cove East Parking Lot - Before renovation (looking south), the surface was deteriorated and over 40 years old. (Photo by D. Sheils)

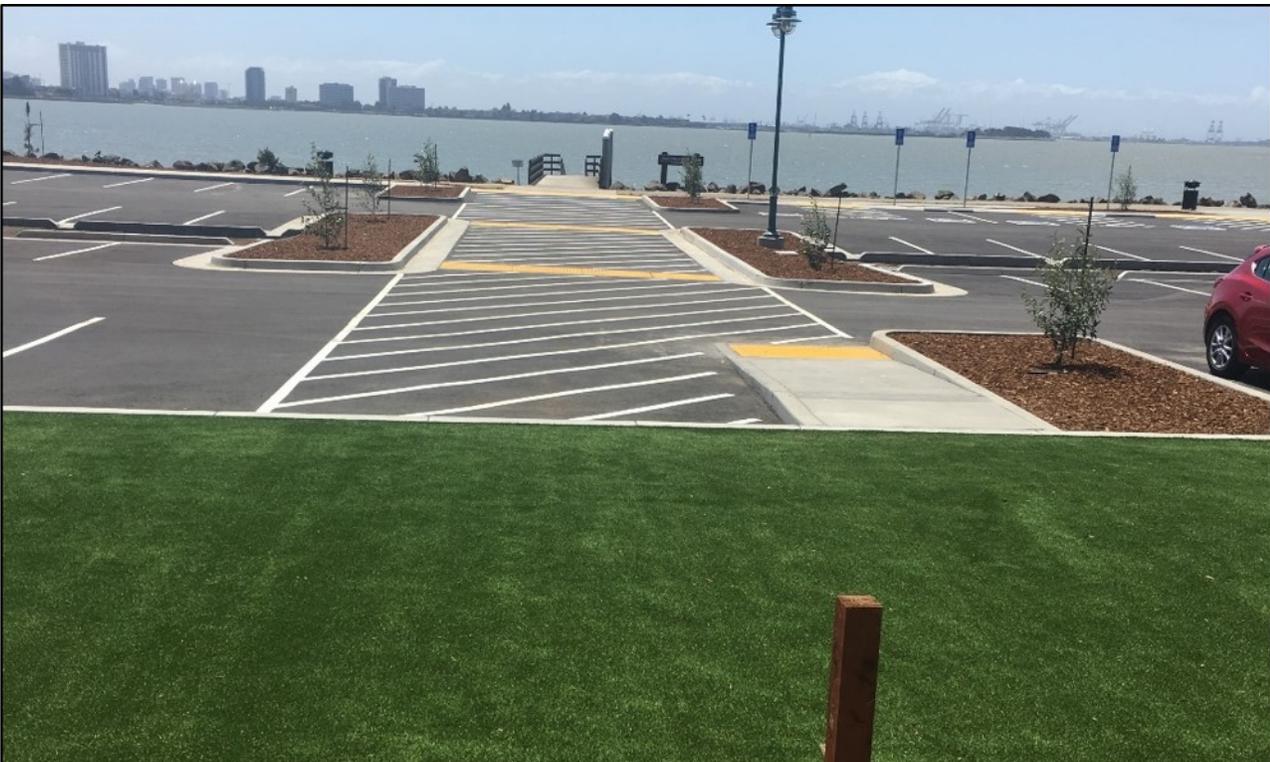
Image 15: South Cove East Parking Lot - After renovation, there is a dedicated safety pathway from the windsurf staging area (foreground) to the docks at the waters edge (background). (Photo by D. Sheils)

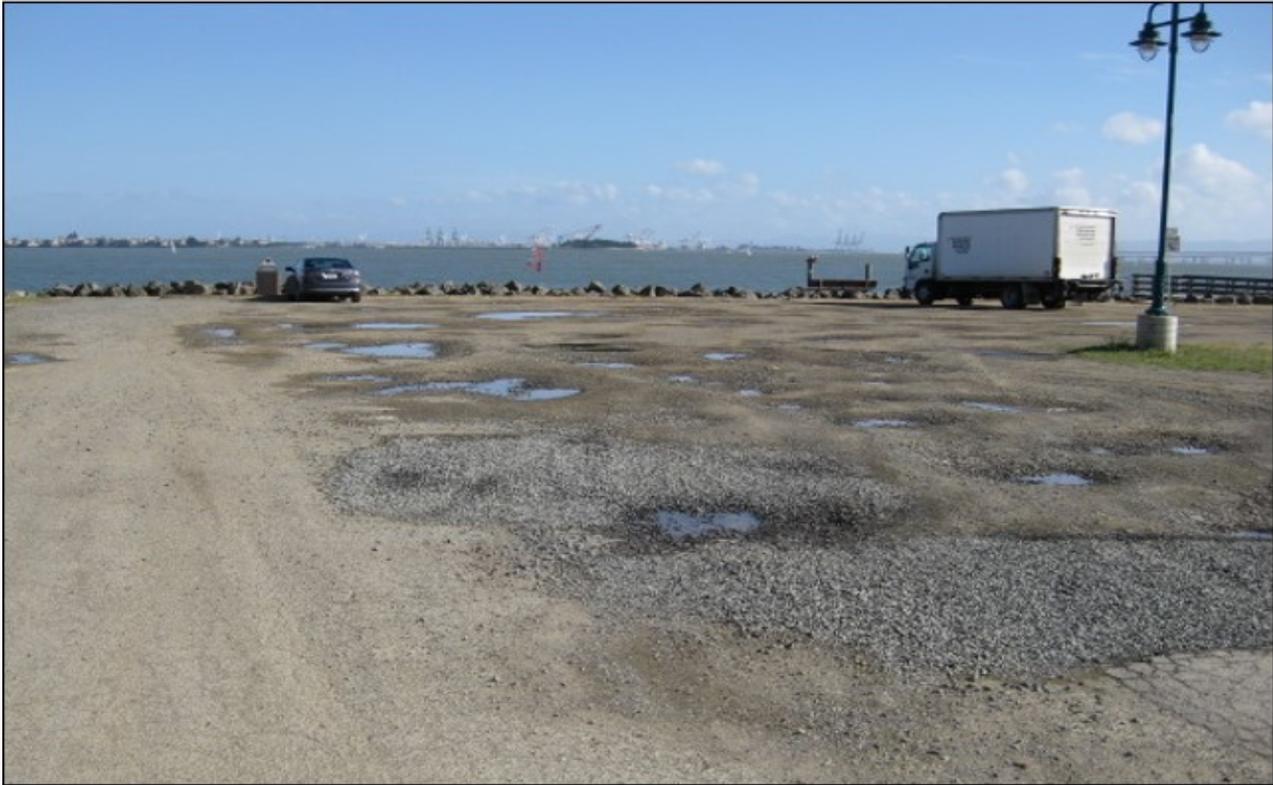
Image 16: South Cove East Parking Lot - Before renovation (looking southwest), the surface could be soggy, dusty, bumpy, and chaotic. (Photo by R. Miller)

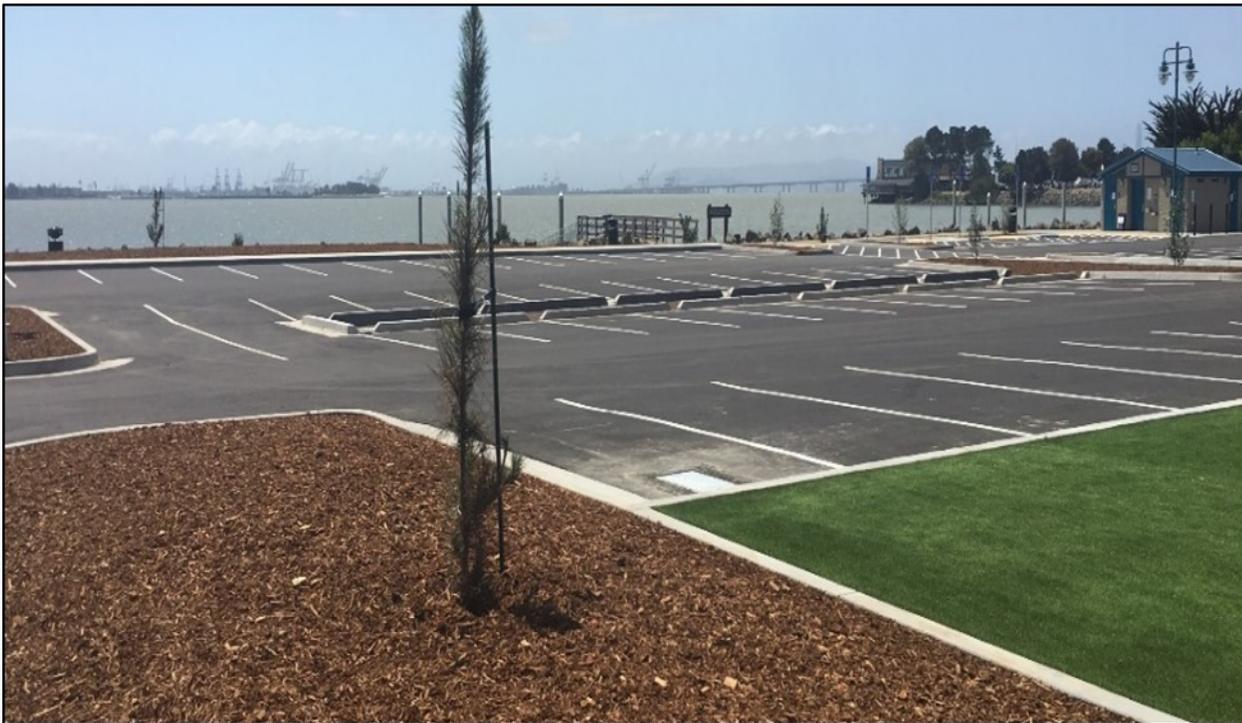
Image 17: South Cove East Parking Lot - After renovation (looking southwest), there is improved asphalt surface, drainage, striping, circulation, safety, windsurf area, and new public restroom. (Photo by D. Sheils)

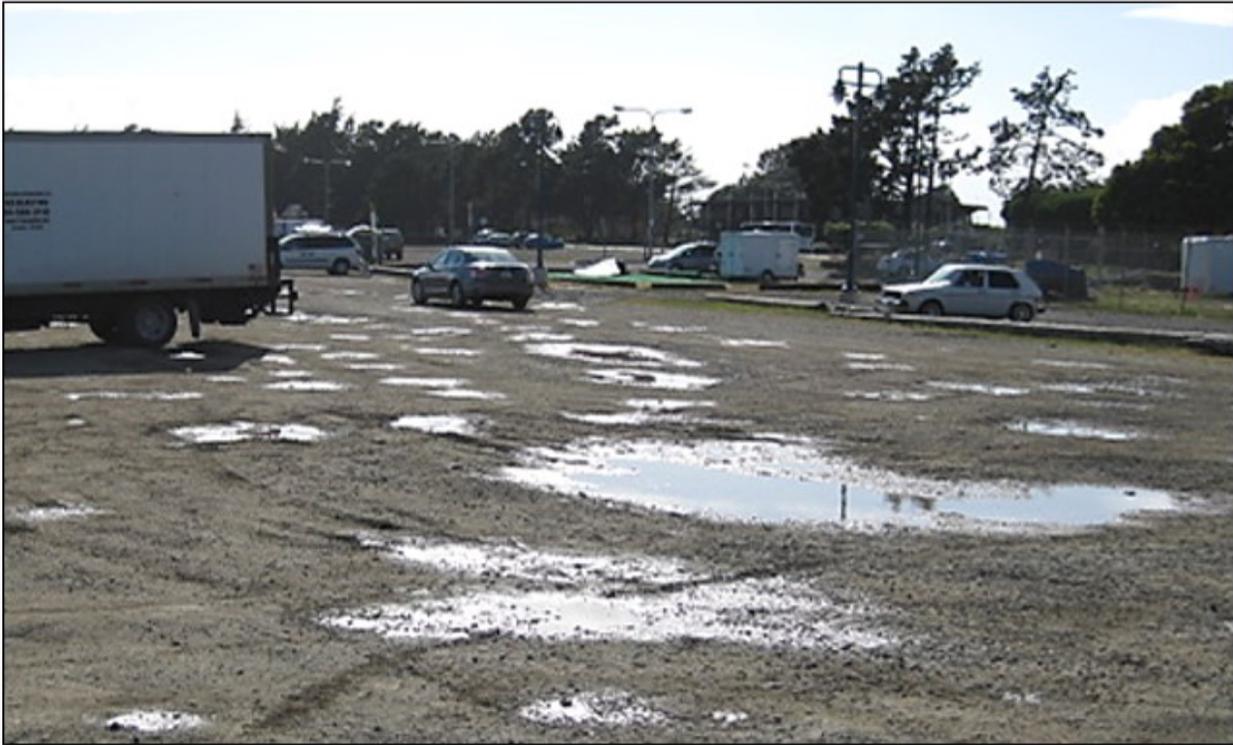
Image 18: South Cove East Parking Lot - Before renovation (looking north), there was poor drainage. (Photo by R. Miller)

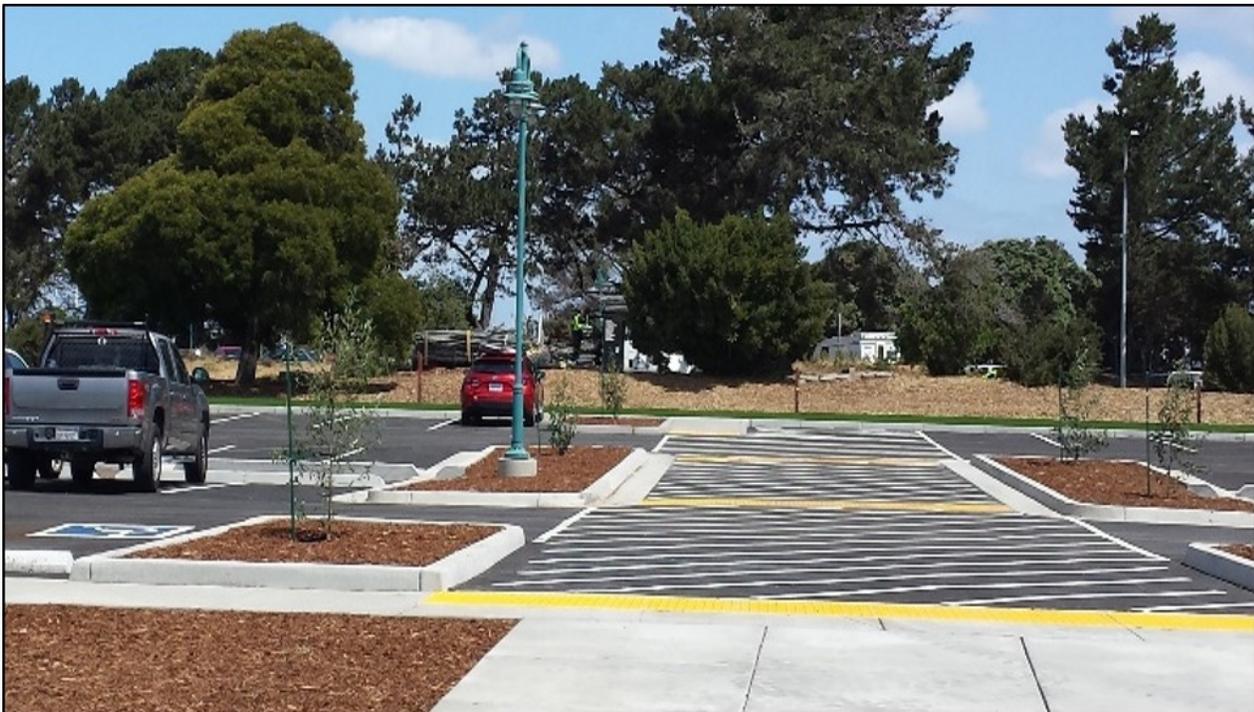
Image 19: South Cove East Parking Lot - After renovation (looking north), there are new stormwater bioswales, a dedicated path of travel to the windsurf staging area, ADA accessible parking spaces, and new striping for improved circulation and safety. (Photo by R. Miller)

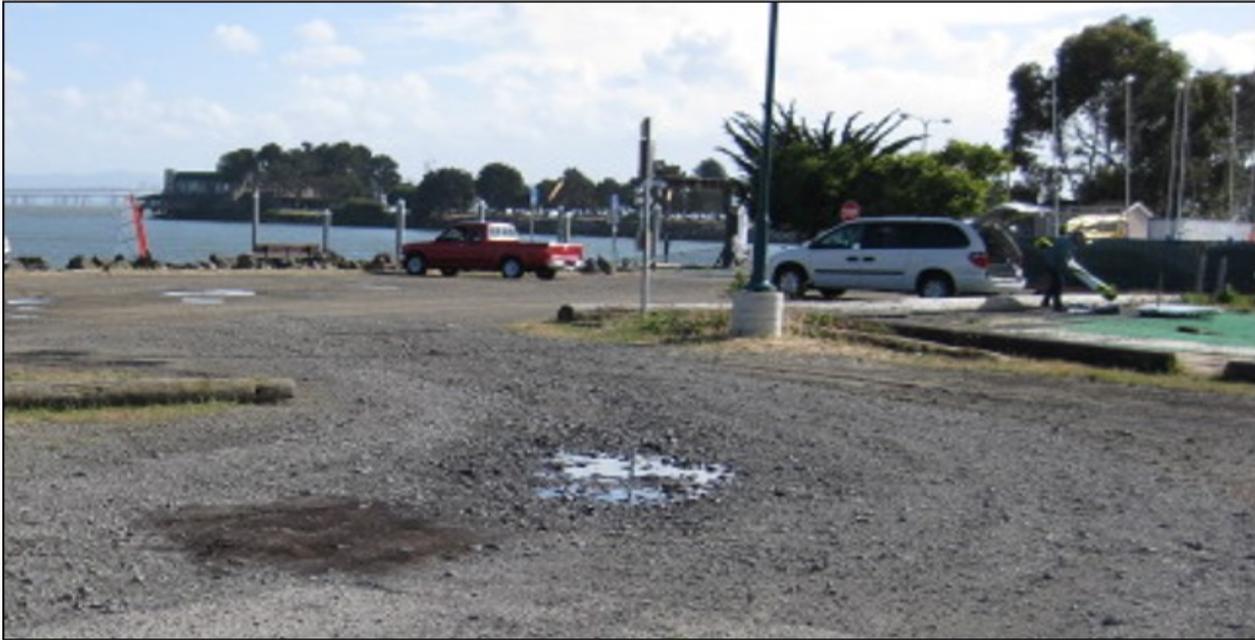
Image 20: South Cove East Parking Lot - Before renovation (looking southwest), there was poor drainage, a dilapidated windsurfing staging area, and no public restroom. (Photo by D. Sheils)

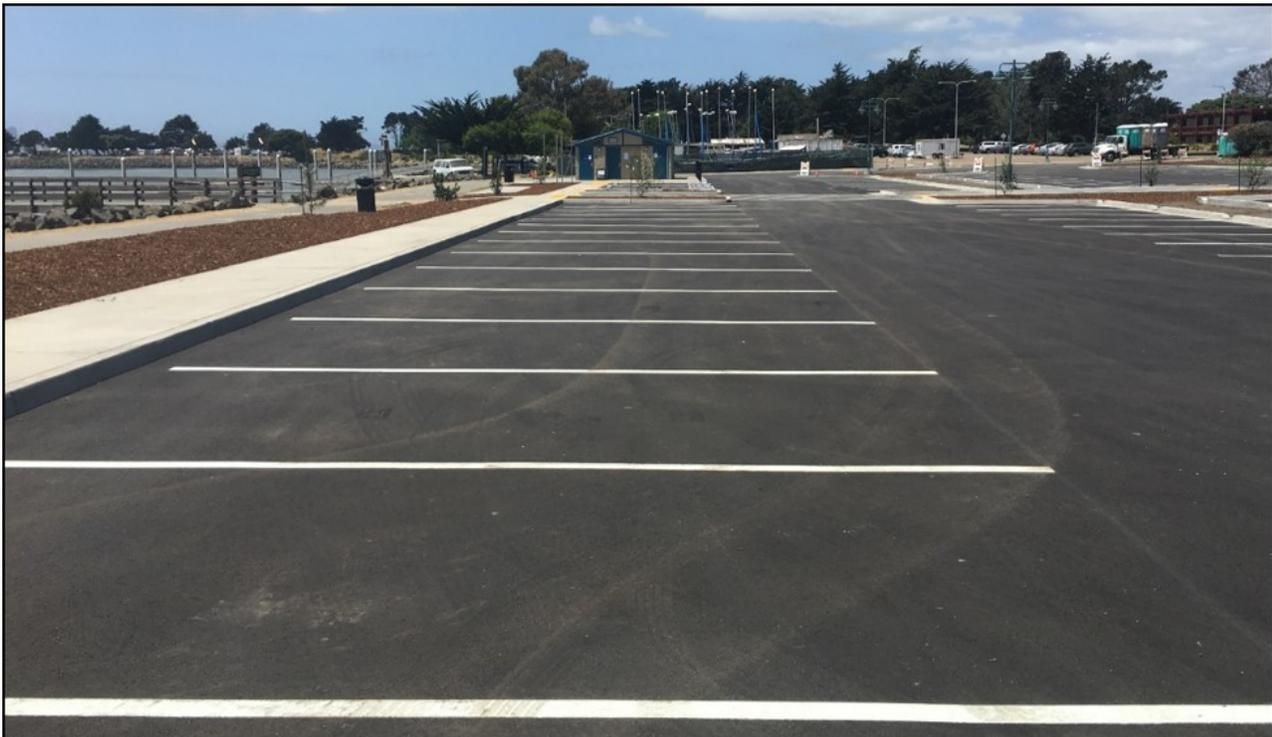
Image 21: South Cove East Parking Lot - After renovation (looking west), there is a newly paved parking lot with new striping, accessible parking and paths of travel, new stormwater bioswales, and a new public restroom. (Photo by D. Sheils)

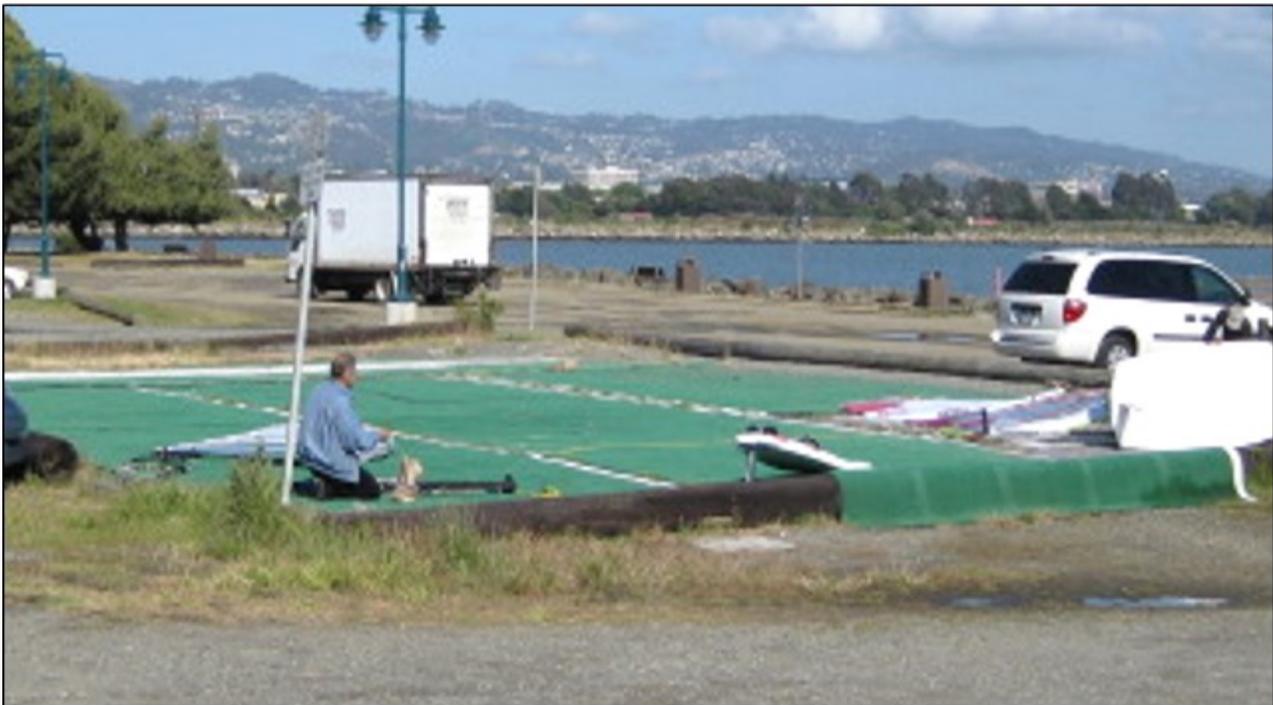
Image 22: South Cove East Parking Lot - Before Renovation the old windsurfing staging area was dilapidated carpet, had poor drainage, had leaking washdown hoses, and was an unsafe path to the docks. (Photo by R. Miller)

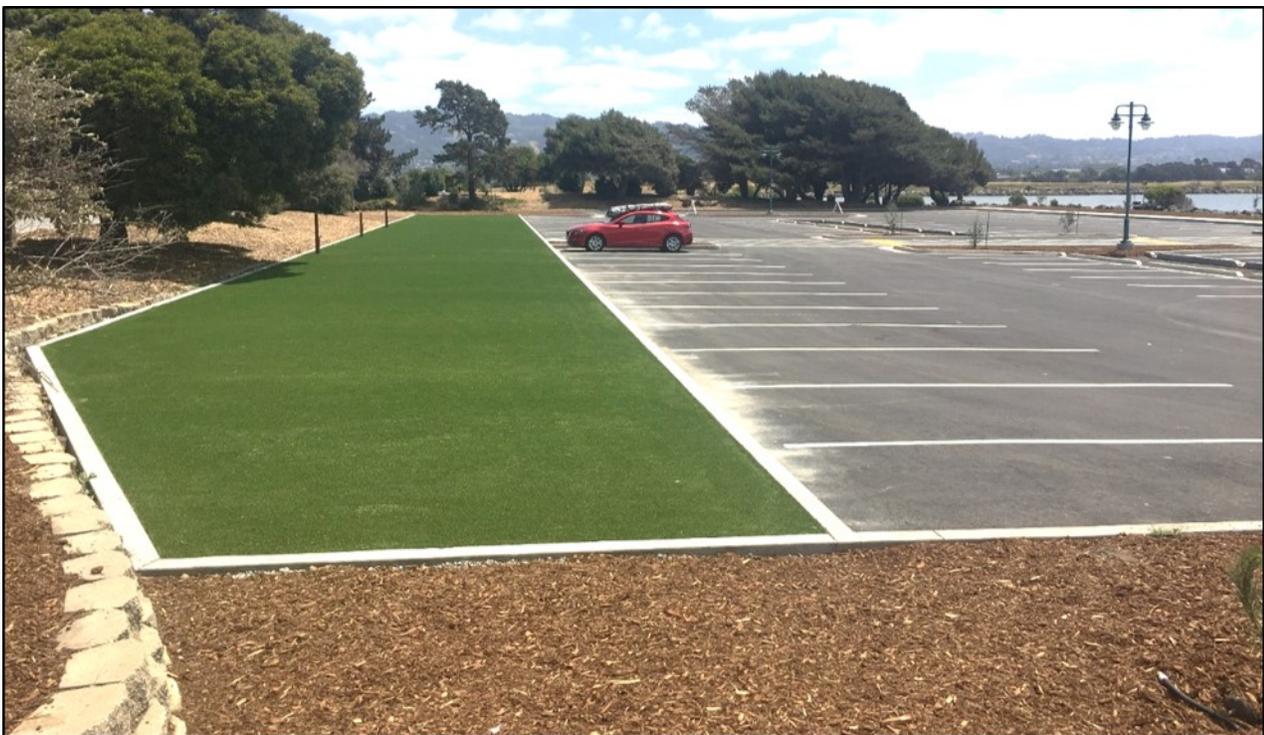
Image 23: South Cover East Parking Lot - After renovation, the new windsurfing staging area had improved drainage and washdown hoses, along with a dedicated path to the docks. (Photo by D. Sheils)
