Dry Creek Meadow and Stream Restoration

(amended)

Recipient: Truckee River Watershed Council

Summary of Accomplishments

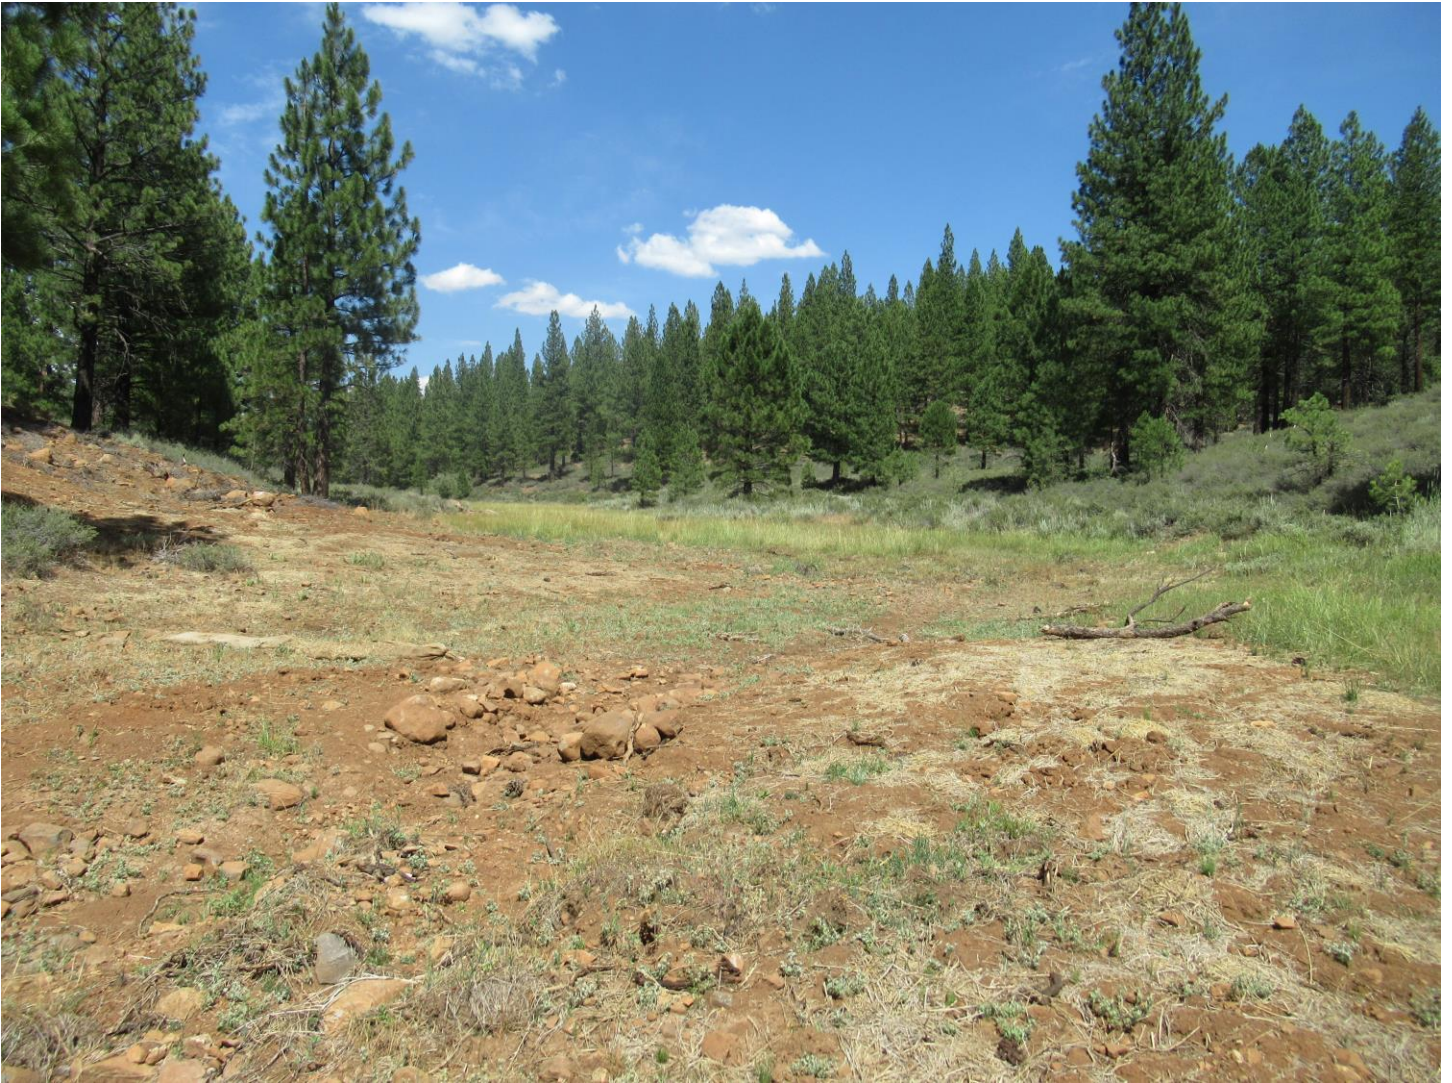
Image 1: Photograph at Site 5 of headcut repair. Prior to project implementation, the headcut was migrating upstream into high quality meadow habitat. The project arrested this erosion.

Site 5. Work included repair of a headcut that was eroding into highly functioning meadow habitat. Since the project was identified in a 2013 watershed assessment (USDA, 2013), the headcut had moved at least 20 feet upstream into the meadow and had not stabilized. We used heavy equipment

to grade out the headcut to provide a sustainable transition between the meadow above and below the incision point. Fill material was generated from adjacent hillslopes.

Initial revegetation included placement of salvaged sod and topsoil by heavy equipment contractors, and seeding and mulching completed by the Sacramento Regional Conservation Corps (SRCC).

- Arrest erosion. The primary headcut at Site 5 has been stabilized. We will continue to monitor the site for additional evidence of erosion and make adjustments like those described for our “Adaptive Management” activity.
- Restore natural channel. The natural drainage pattern has been restored.
- Restore hydrology. Wetland vegetation growing at Site 5 indicates that hydrology has been restored.
- Protect meadow. Grading and stabilizing the headcut appears to have limited any upstream erosion into the intact meadow habitat. We will monitor the site into the future.

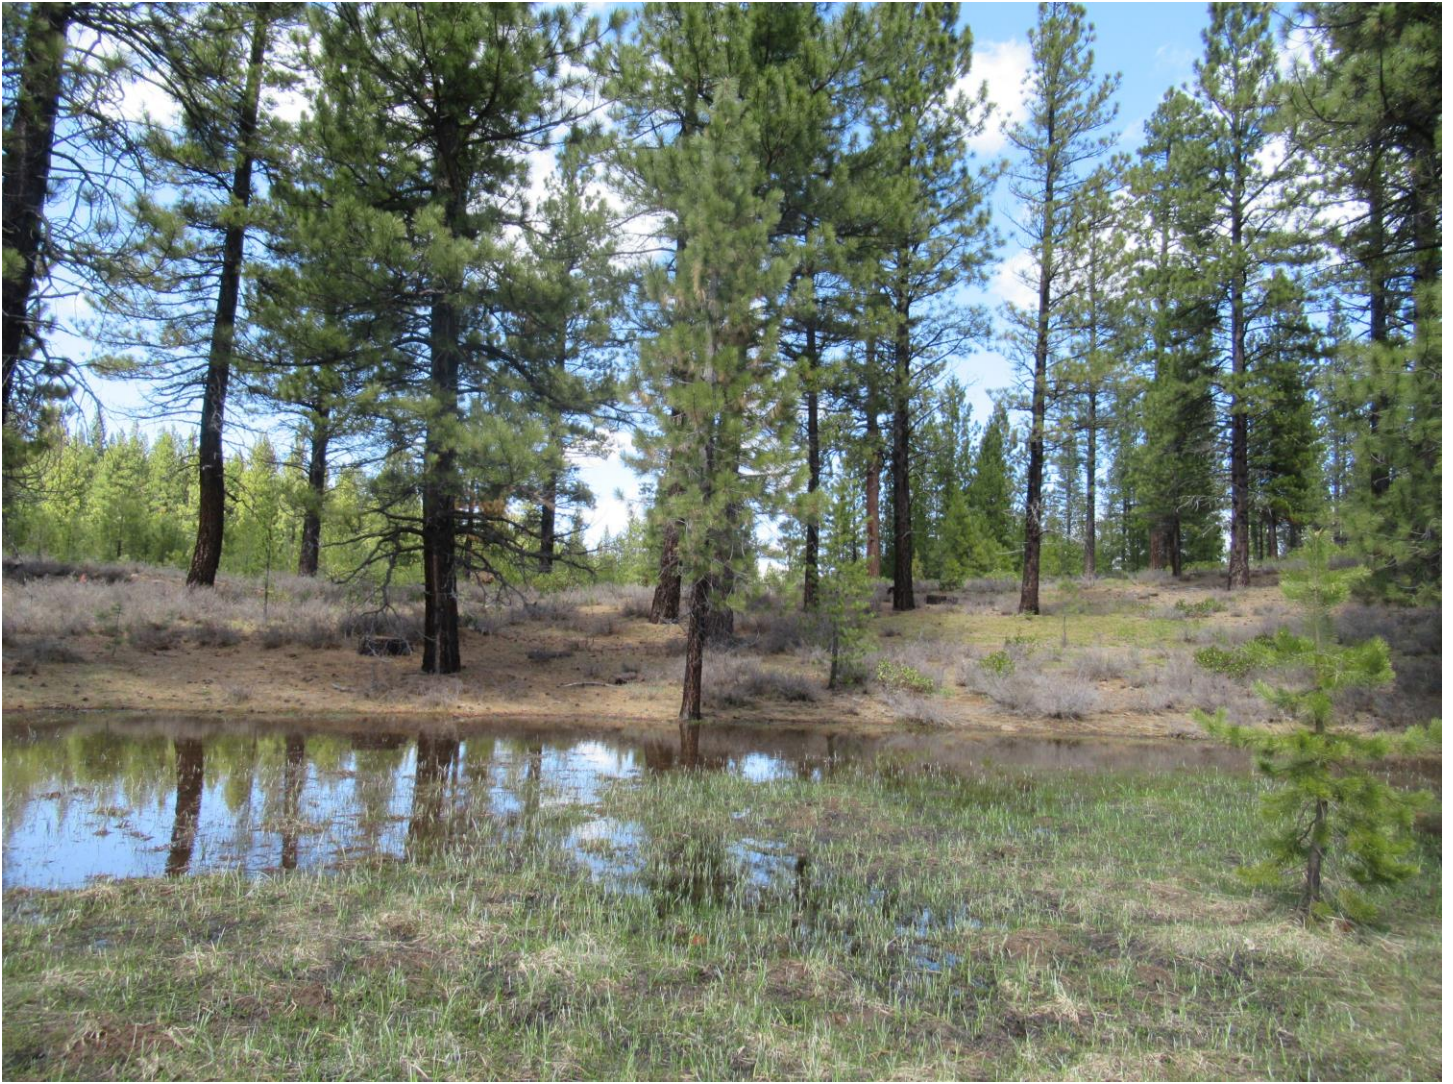
Image 2: Photo at Site 7 of restored flow path in the meadow. Flow had been blocked to this portion of the meadow through railroad grade construction. We removed the grade and reconnected the stream to rewater the meadow.

Site 7. Work included removing a redundant road spur to restore meadow habitat and natural drainage patterns. A second redundant road spur was decommissioned. Prior to restoration, the drainage through the meadow had been channelized into a culvert through the redundant road segment and was eroding into the meadow upstream and downstream of the road. Removing the road fill entirely restored the full meadow and stream floodplain and allowed for reconnection of the historic drainage path. The fill was off hauled and used for restoration of Site 8.

Initial revegetation included placement of salvaged sod, topsoil, and slash by heavy equipment. Additional revegetation was completed by the SRCC and included spreading native seeds and mulch.

- Restoring drainage. We restored at least 85 feet of drainage. We were able to reconnect the stream channel upstream and downstream of the removed road segment for greater function.
- Improving hydrology/meadow condition. The meadow appears to be functioning well with wetland vegetation growing in the filled gully area.
- Reducing erosion. Site 7 is very stable, however we will continue to monitor the site for erosion into the future.

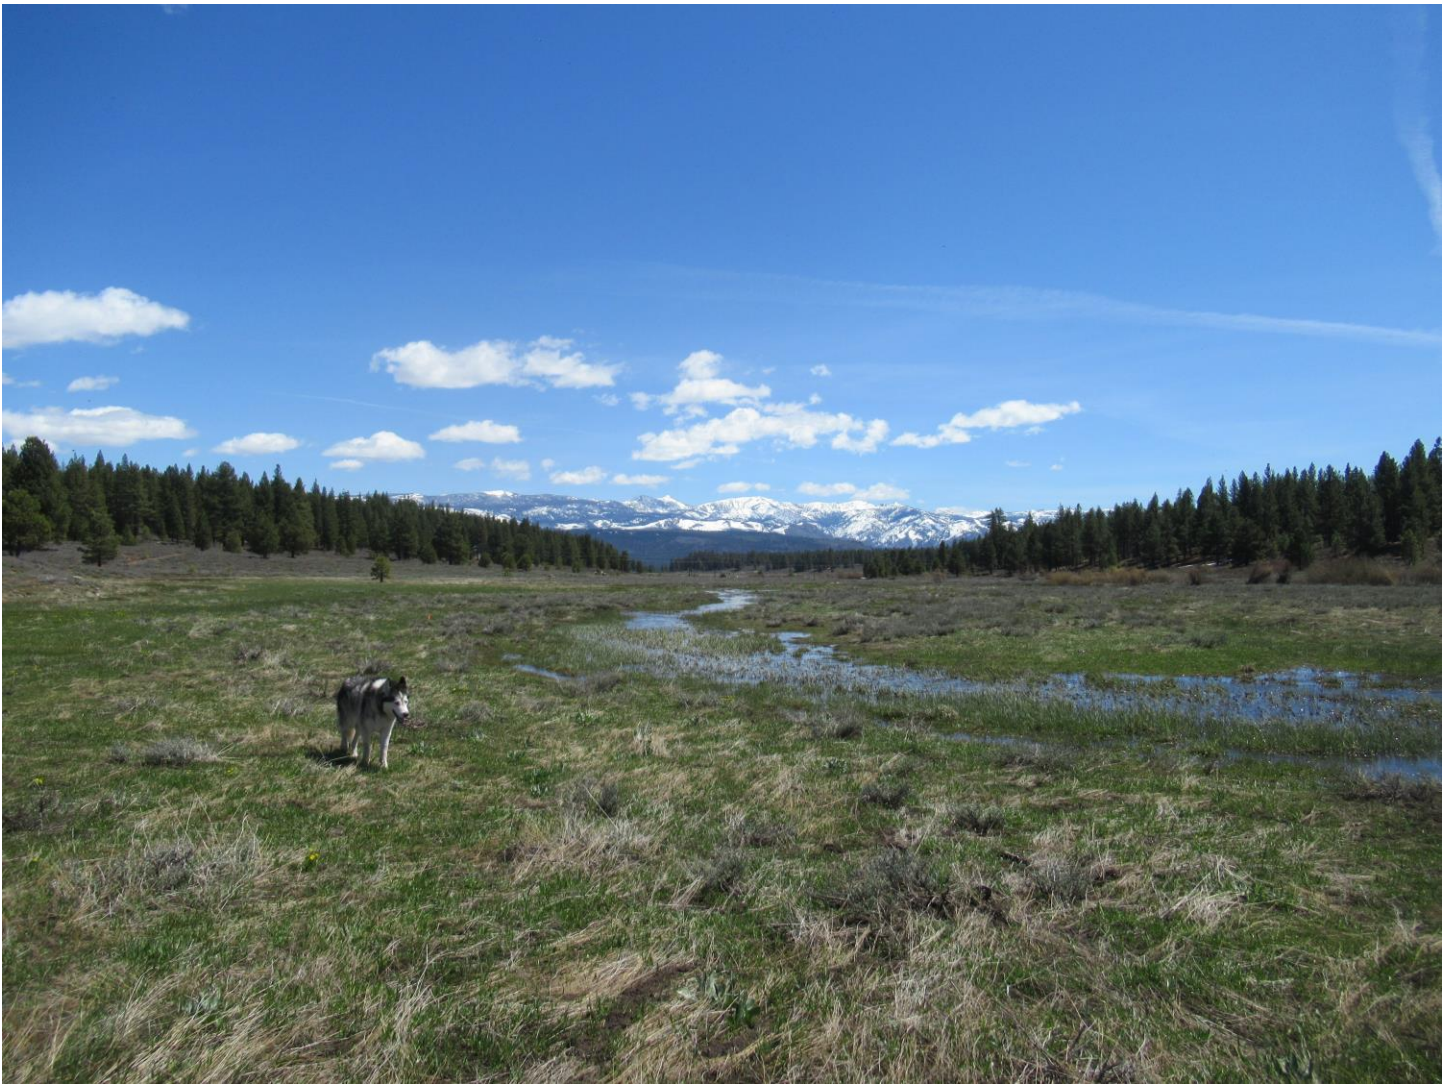
Image 3: Photograph at Site 8 showing an example of one of the restored meadow streams. Prior to project implementation, the stream was confined to a deeply incised channel and had limited floodplain access.

Site 8. Site 8 is the largest and most complex restoration site. Past human actions diverted the existing channel of Dry Creek into a straight channel – causing the stream to downcut and disconnect from the historic meadow surface. Restoration included restoring flow to historic remnant channels thereby increasing stream length and floodplain connectivity. Work included diverting the flow of Dry Creek around the work area, salvaging and stockpiling the existing wetland sod, filling the existing channel, replanting the salvaged sod with heavy equipment, and planting willows by hand. Fill for the project came from removing an on-site railroad grade, Site 7, and from material salvaged from a previous restoration project. A minor amount of fill was generated by excavating two ponds within the former stream channel.

- Flow was restored the natural stream channel. The restored stream channel measures 3,900 feet as per the project design.
- Re-engage valley floor floodplain. Aquatic habitat surveys showed that we increased valley floor floodplain by 442%. Observations during spring runoff, even in a very dry water year, confirmed that the floodplain was re-engaged.
- Re-water/restore wetlands. Vegetation conversion will take a few growing seasons. We began collecting post-project vegetation to document this shift. However, groundwater elevations rose to a level that will support wetlands.
- Restore natural hydrology to 20 acres of degraded wetland. Wetland hydrology was restored.
