## Hope Valley Restoration and Aquatic Habitat Enhancement Project – Phases II & III

Organization: Alpine Watershed Group (AWG)

Location: West Fork Carson River, Alpine County

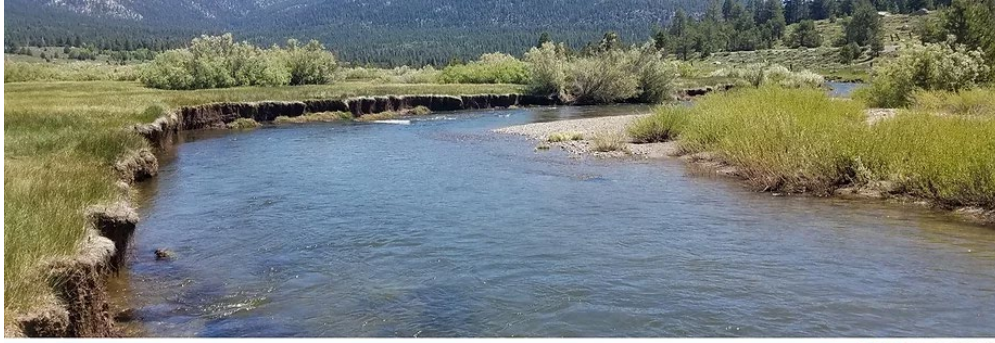
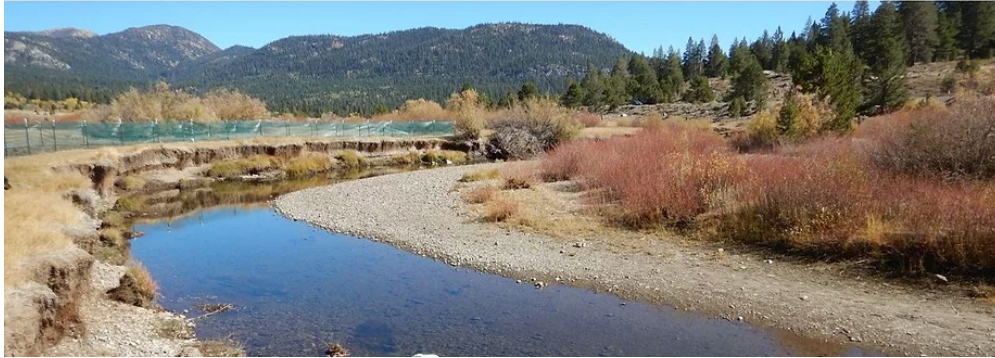
**Project Site 1 before (above) and after construction (below) - restoration technique mimics an abandoned oxbow feature. A bench was created behind the failing bank and filled with live sod blocks, willow stakes, and live willow shrubs.**

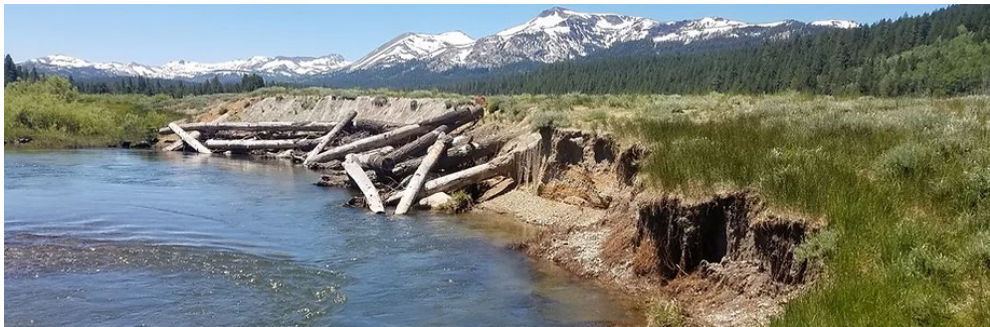
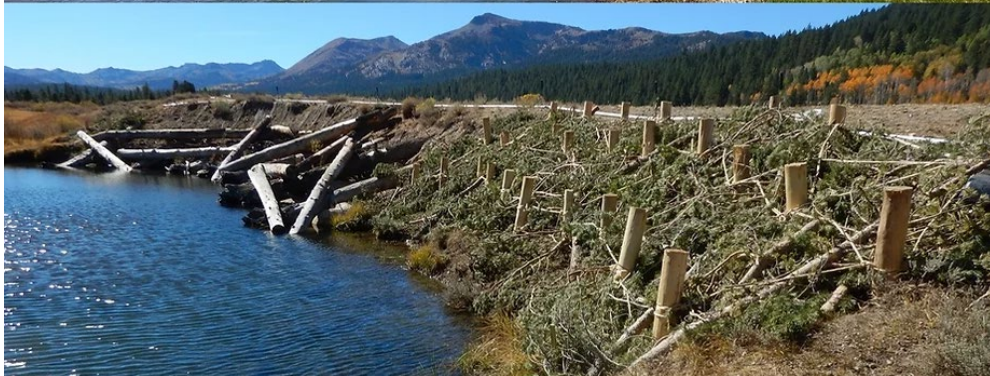
**Project Site 2 before (above) and after construction (below) - updates were needed to divert stream energy from scouring behind the 2015 log crib structure so slash was installed at the ends of reach to add stability.**
