Hope Valley Restoration and Aquatic Habitat Enhancement Project – Phases II & III

Organization: Alpine Watershed Group (AWG)

Location: West Fork Carson River, Alpine County

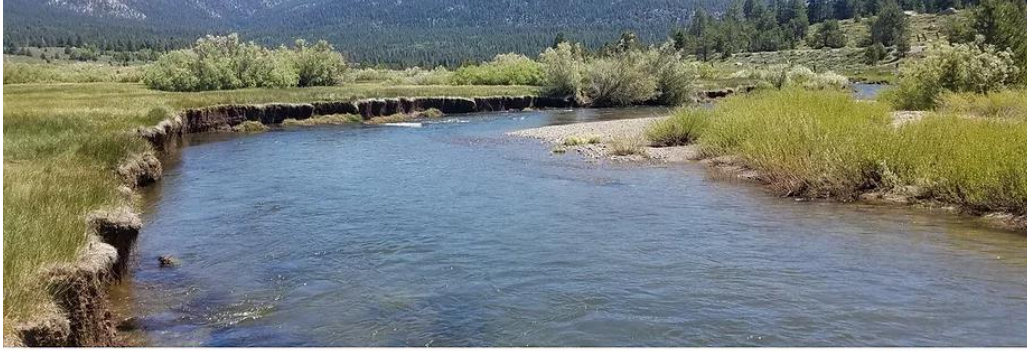
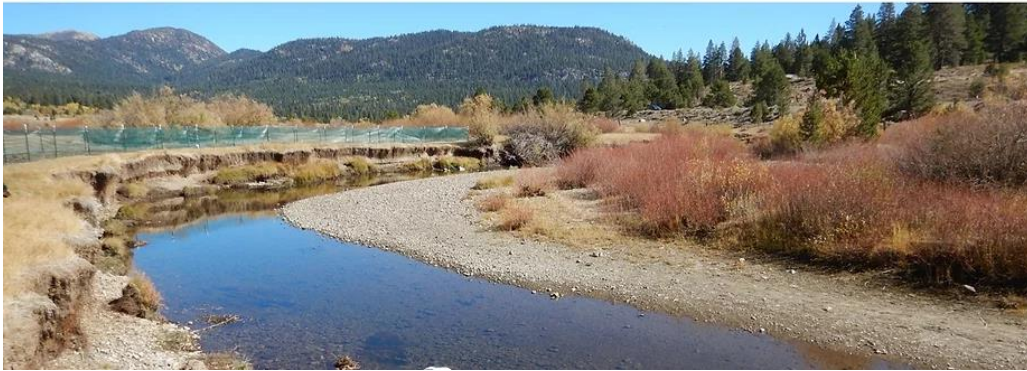
Project Site 1 before (above) and after construction (below) - restoration technique mimics an abandoned oxbow feature. A bench was created behind the failing bank and filled with live sod blocks, willow stakes, and live willow shrubs.

Project Description: This project will stabilize approximately 450 feet of eroding banks along the West Fork Carson River in lower Hope Valley and will help improve aquatic habitat within two specific reaches. Partners for this project are landowner California Department of Fish and Wildlife, American Rivers, Carson Water Subconservancy District, Friends of Hope Valley, Lahontan Regional Water Quality Control Board, US Forest Service, and the Washoe Tribe of Nevada and California. At Project Site 1, a trench will be constructed behind the failing bank and filled with live sod blocks, willow stakes, and live shrub transplants, mimicking an abandoned oxbow feature. The river will continue eroding the failing bank, and in the meantime the willows and sod in the trench will have time to establish and serve as good habitat for birds and amphibians, eventually becoming vital fish habitat when the erosion pushes back that far. At Project Site 2, 6-8” conifer and willow cutting slash will be woven in between 10’-long slash anchor logs. These updates to the 2015 project will provide additional stability to divert stream energy from scouring behind the current log crib structure. At both project sites, erosion and sedimentation will be reduced, and stream shading will be increased.

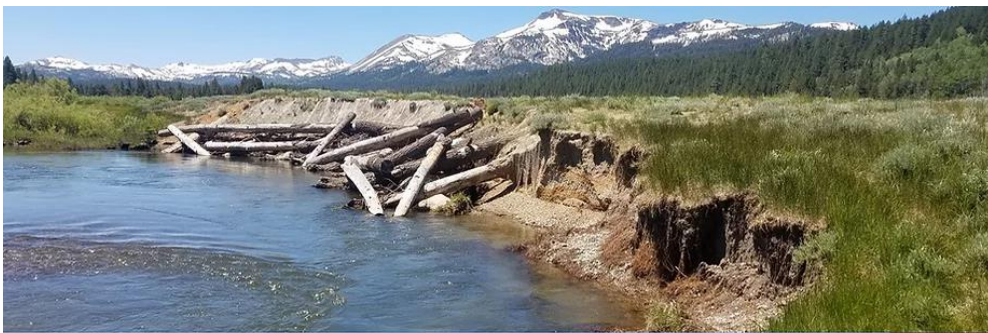
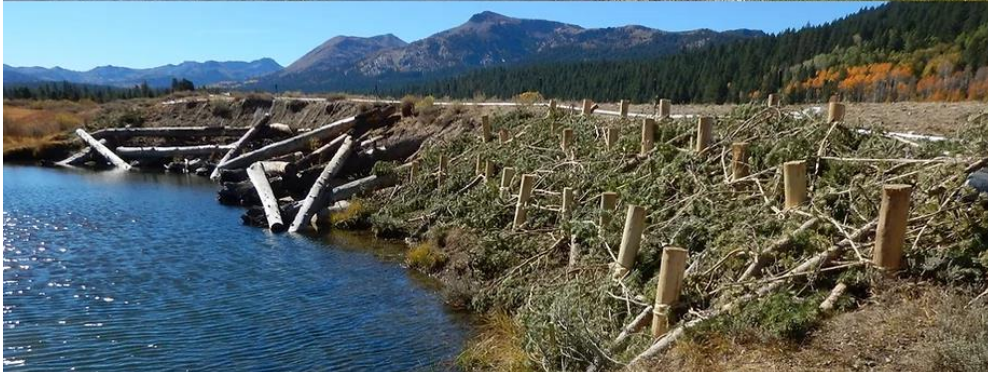
Project Site 2 before (above) and after construction (below) – updates were needed to divert stream energy from scouring behind

the 2015 log crib structure so slash was installed at the ends of reach to add stability.
