Van Duzen River Basin Assessment

**FINAL
DRAFT
2013**

Van Duzen River Watershed Assessment

January 2013

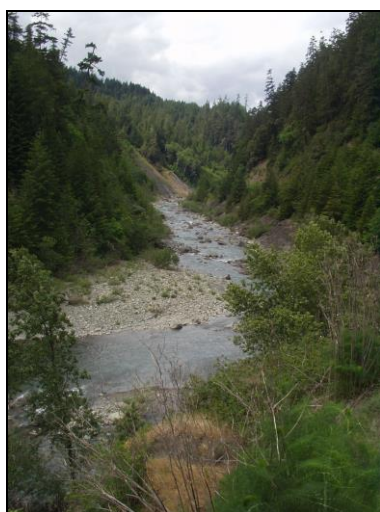
Chalk Mountain landslide (left bank) on the Van Duzen River just west of Grizzly Creek. Continuous secondary slides eroding the toe fill the inner gorge area for at least 1 mile downstream. This slide complex is located within Yager Terrane.

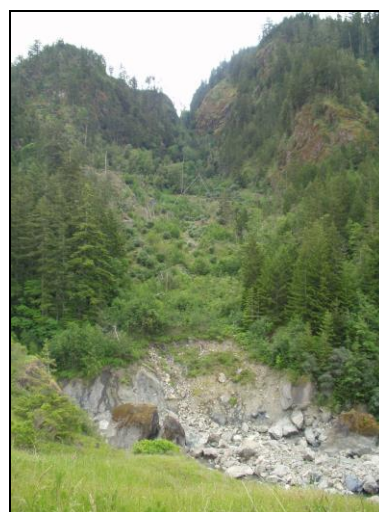
Debris flow at Goat Rock on the Van Duzen River with erosion of the toe located on the Coastal Belt Thrust.

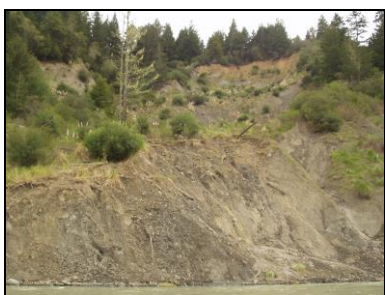
Debris slide/Rotational slide complex in Wildcat undifferentiated into the mainstem of the Van Duzen R (river mile 9).

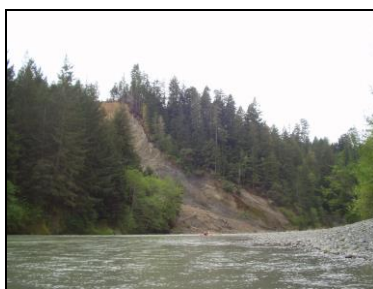
Debris slide in Wildcat undifferentiated near "Blue Slide Creek" into the mainstem of the Van Duzen.

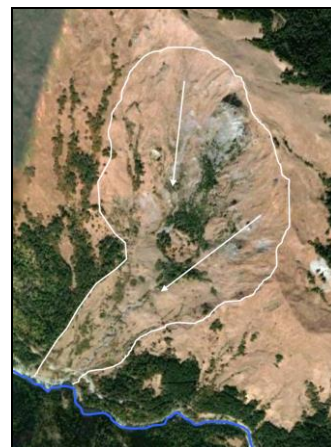
Donaker Creek earthflow in Central belt mélangé. This is the largest earthflow within the Van Duzen River basin. Located just west of Bridgeville.

Figure 8. Examples of sedimentary material entering the Van Duzen River from landslides, debris flow and earthflows.

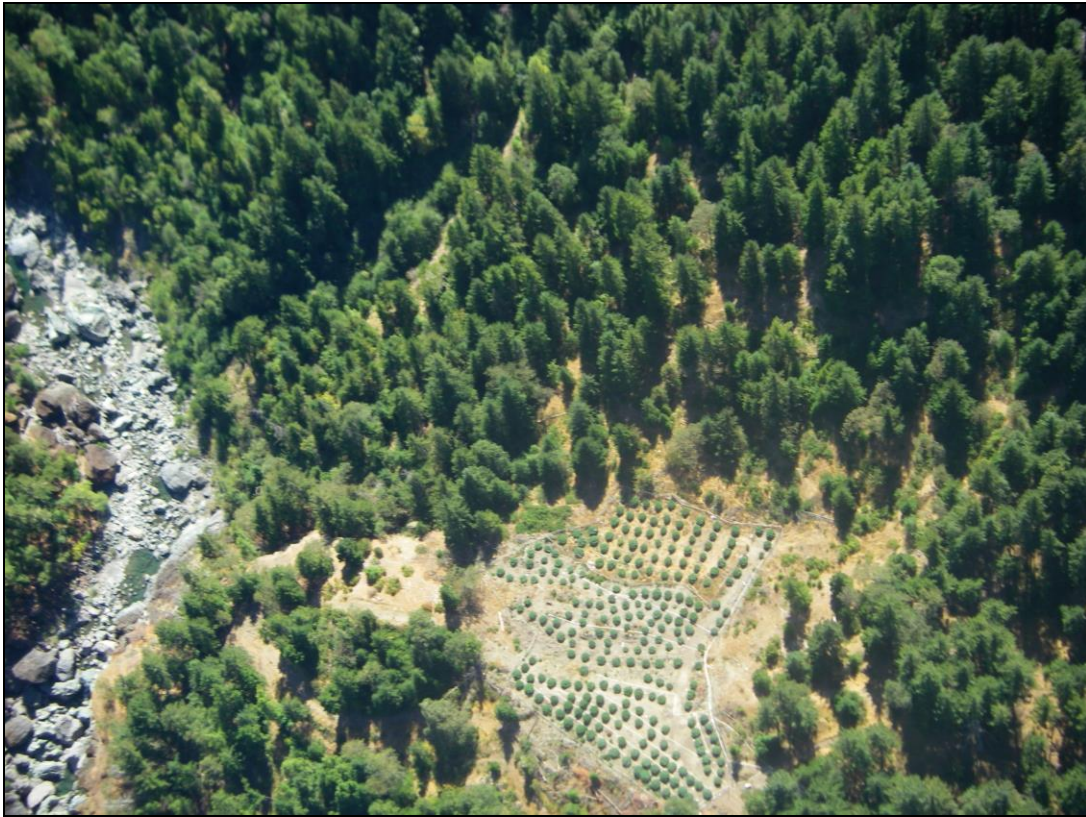
Figure 22. View of marijuana cultivation along the Van Duzen River. Note, the entire summer steelhead population (federally listed species) is located just upstream. With 250 plants using approximately 6 gallons of water a day, this operation would use 1, 500 gallons a day (approximately), equaling 225,000 gallons for the 5 month growing season.

Figure 22. View of marijuana cultivation along the Van Duzen River. Note, the entire summer steelhead population (federally listed species) is located just upstream. With 250 plants using approximately 6 gallons of water a day, this operation would use 1, 500 gallons a day (approximately), equaling 225,000 gallons for the 5 month growing season.	49
Figure 23. Current range of winter steelhead trout in the Van Duzen River Basin based on California Department of Fish and Game estimates.	56
Figure 24. Current distribution of coho salmon in the Van Duzen River Basin based on California Department of Fish and Game estimates.	57
Figure 25. Combined results from CDFG Chinook spawner surveys in Van Duzen Basin streams 1984 - 2006. Streams surveyed include Lawrence, Shaw, Grizzly, and Root creeks.	61
Figure 26. Current range of Chinook salmon in the Van Duzen River Basin based on California Department of Fish and Game estimates.	64

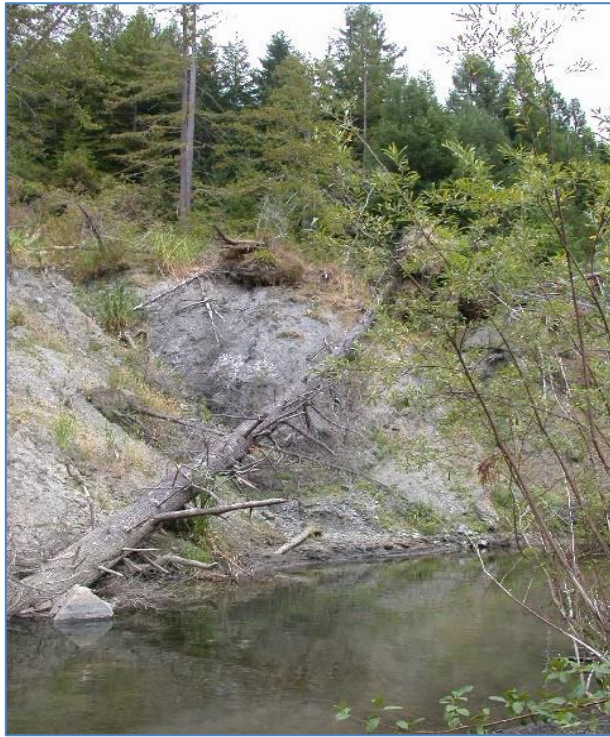
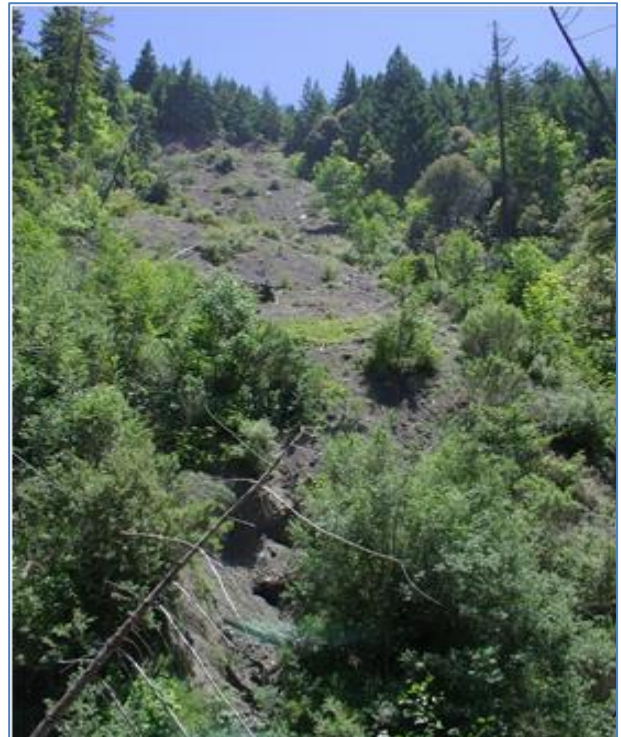
Figure 4. Streamside landslide photos. Left: Re-activated landslide originating along a shear zone related to the Yager fault within the Yager terrane. Right: Bank erosion and sediment source input to lower Lawrence Creek.

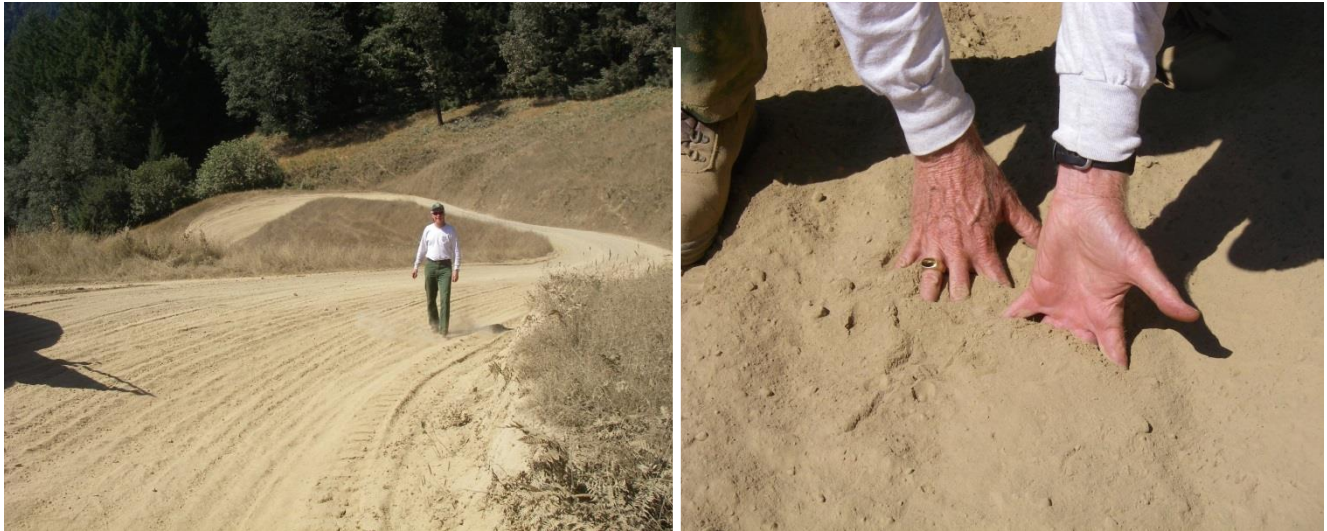
Figure 15. Fine sediment from surface erosion on Humboldt County maintained Showers Pass Road near head waters of N.F. Yager Creek. This road is hydrologically connected to Class I, II, and III watercourses and the loose road surface material (up to four inches) will be delivered.

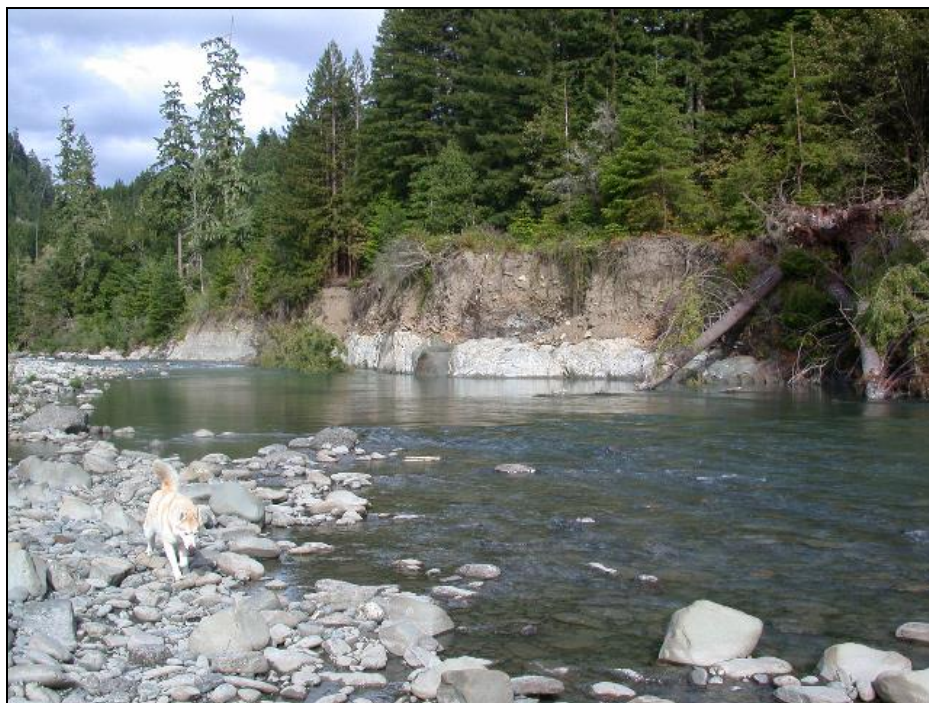
Figure 4. River Terrace deposit overlays wildcat group along bank of the Van Duzen River near Root Creek. Note Large Woody Debris which provides pool and habitat complexity for fish.

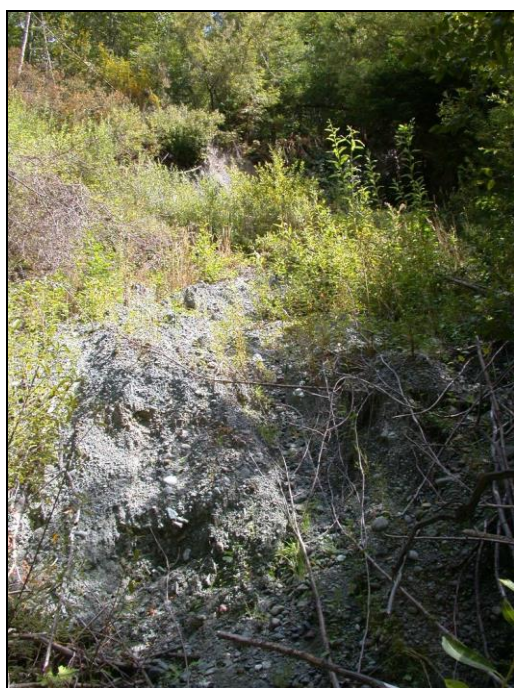
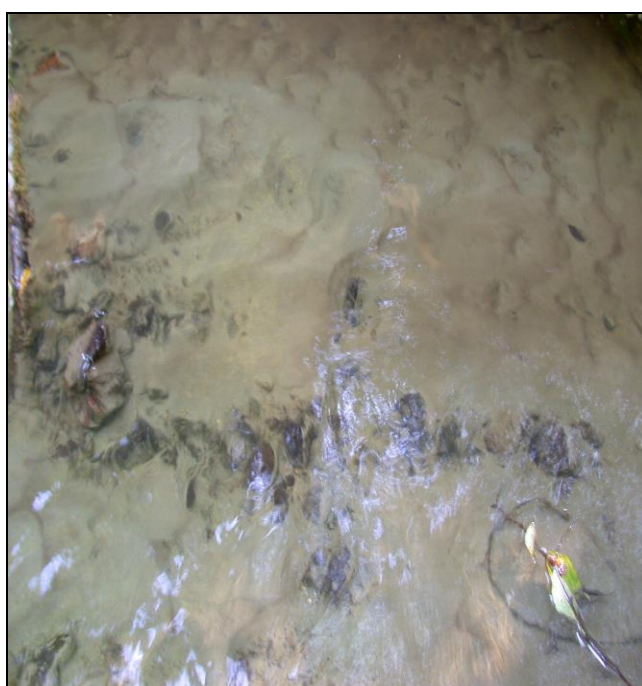
Figure 5. a) Fine sediments of the Wildcat formation erode from hill slope to Hely Creek, b) fine sediment from the Wildcat formation accumulate in Hely Creek.

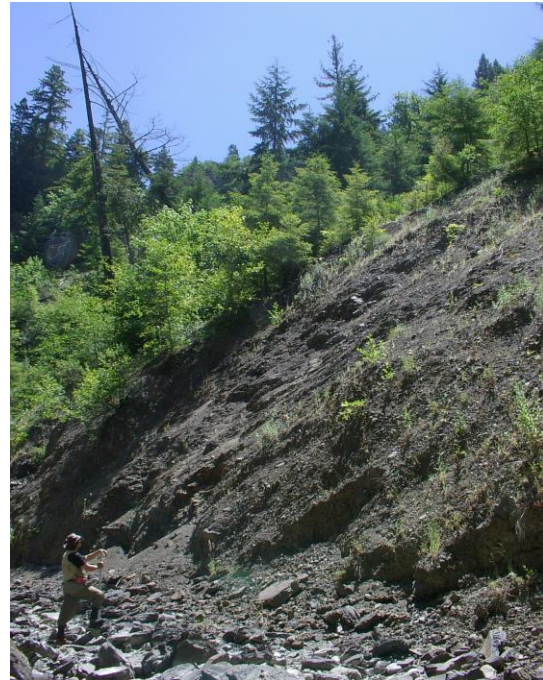
Figure 6. Toe of streamside landslide on steep slope actively eroded and undercut by Grizzly Creek destabilizing the deposit as well as persistently contributing fine sediments to the creek.

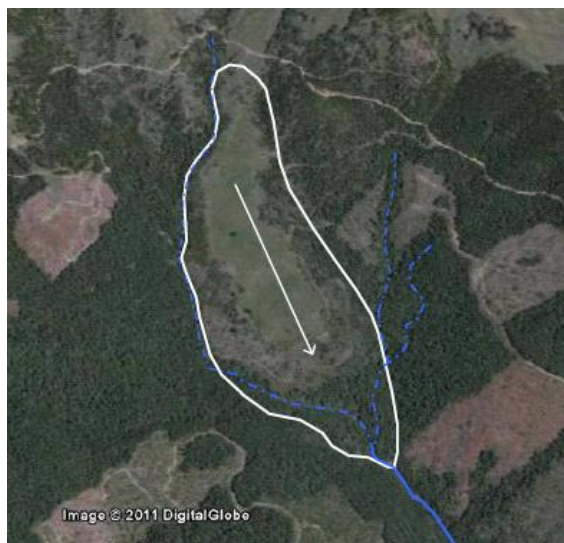
Figure 8. Pseudo-aerial view looking northeast of an Earthflow in the headwaters of Steven's Creek.

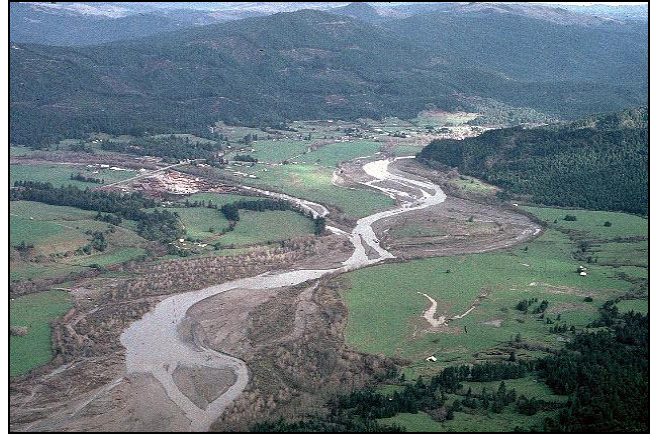
Figure 10. Confluence of Yager Creek with Van Duzen River. Note channel widening and bank erosion in the Van Duzen River linked to sediment inputs and high flows from Yager Creek. Photo courtesy of Kris Coho.

The mainstem Van Duzen River flows approximately 23 miles (RM 23-0) through the Lower Subbasin from Grizzly Creek to the Eel River. Within this river segment there are three distinct reaches: 1) from the confluence of Grizzly Creek to Root Creek where the river flows at an average 4% gradient for approximately three miles through a narrow boulder laden gorge; 2) the 12 miles between Root Creek to near Cummings Creek (~RM8) where the channel gradient is approximately 1% and the river flows through entrenched meanders confined by bedrock banks; and 3) from RM 8 near Cummings Creek to the Eel River where the channel widens to a largely unconfined, alluvial plain bed channel. Low gradient alluvial channels are characterized as having lower sediment transport capacity to supply ratios and thus tend to accumulate sediments delivered from upstream sources (Montgomery and Buffington 1997). Sediment deposition and storage occurs in the wide and unconfined sections of the lower river. The amount of stored sediments is noticeably larger downstream of the confluence with Yager Creek (Figure 10).

Many of the wide sections along the lower Van Duzen River, such as the area below the Yager Creek confluence, have experienced stream bank erosion in response to flood flows and channel aggradation. The process of channel widening and associated sediment accumulation contribute to detrimental impacts to both land owners and to aquatic habitats. Landowners lose potentially valuable land and may have to invest in bank protection methods to reduce or minimize channel erosion along their property. While in addition to a loss of valuable riparian land from erosion, channel widening and excessive lower sediment accumulations have reduced the quality of fisheries habitat by filling in valuable pool habitats and increasing width to depth ratios resulting in a wide, shallow channel. Wide shallow reaches without a shade canopy allows sunlight to heat the water to stressful or levels lethal to salmonids during warm summer months. These wide, shallow channel reaches and such conditions are common along the Van Duzen River in the Lower Subbasin. An increase in sediment deposition also occurs in the lowest river segment where the current velocity slows as it pushes into the larger Eel River, also known as a “delta effect” (Figure 11). The slowing current reduces the river’s ability to transport sediments along the lowermost reach of the Van Duzen.

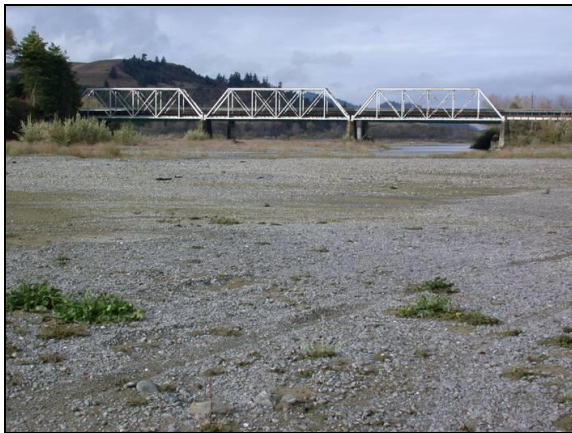
Figure 11. Van Duzen River plane bed channel caused fish stranding at low flows. Photo taken near dry channel confluence with Eel River.

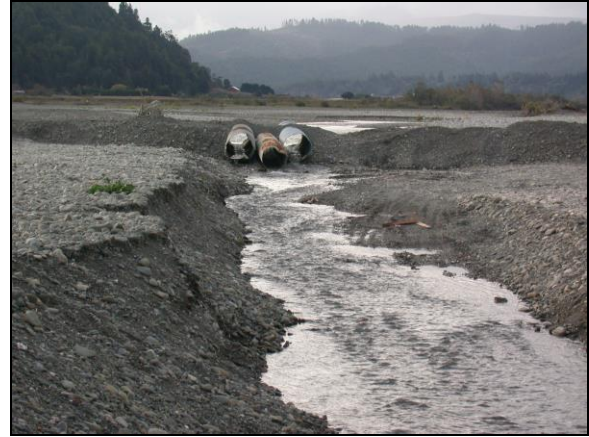
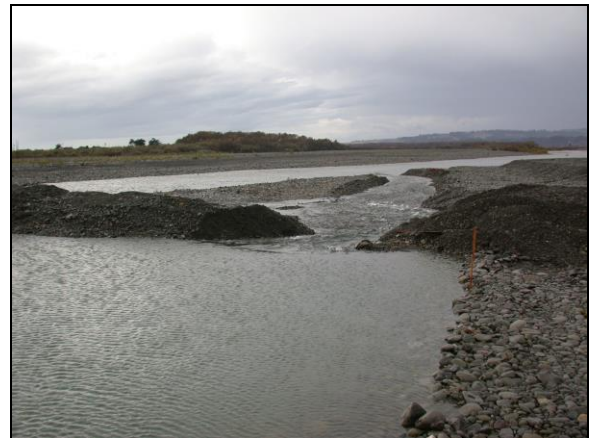
Figure 12. Excavated channel with exclusion culverts (top) looking upstream and looking downstream with culverts removed (bottom) to allow fish passage into Van Duzen River at flows of ~160 cfs.

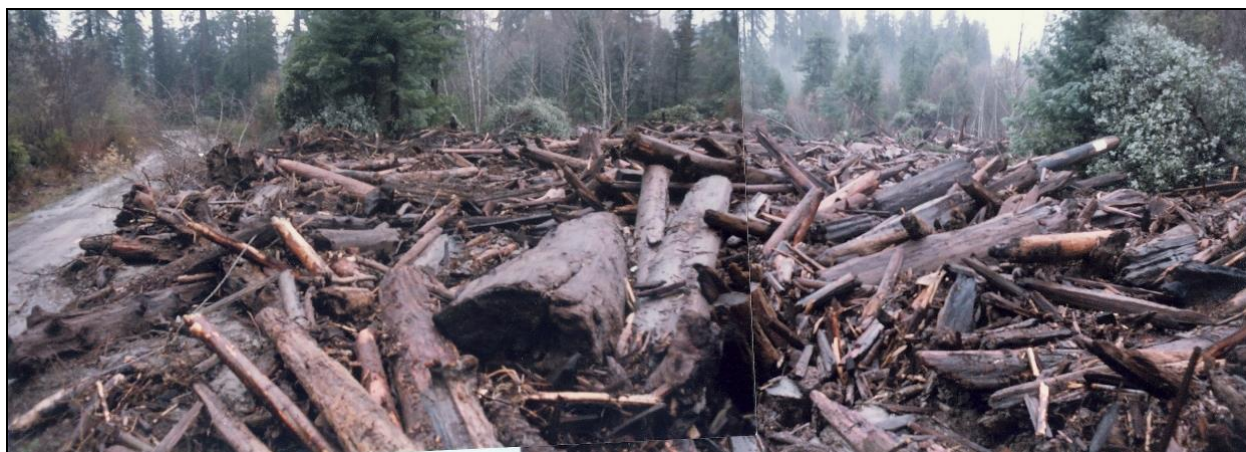
Figure 18. Debris torrent buries Hely Creek with logging debris near Redwood House Road in 1983.

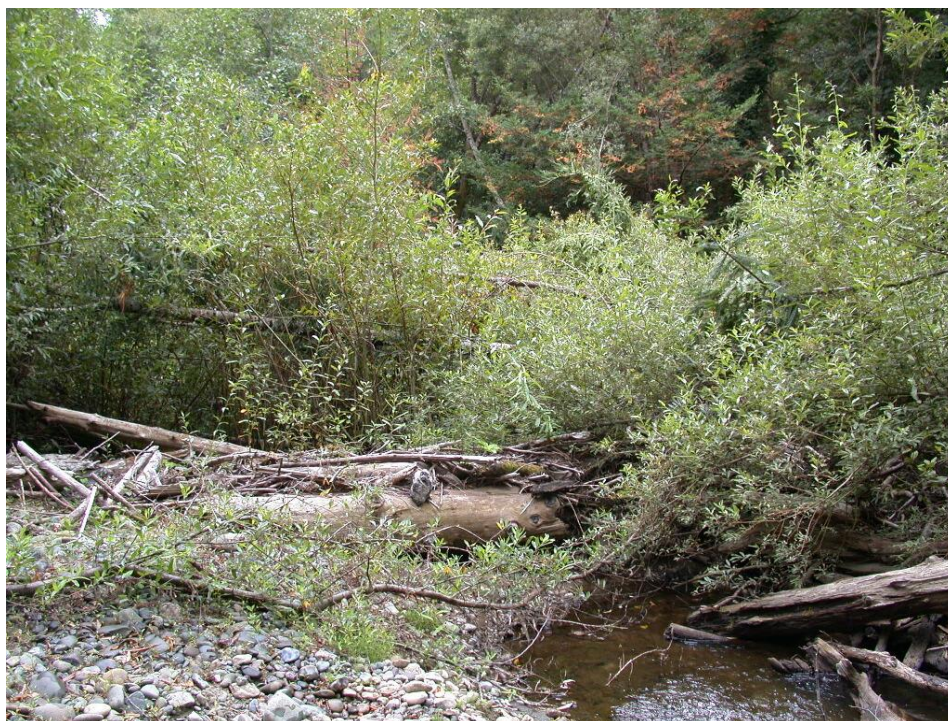
Figure 20. Hely Creek 2006. While large wood occupies the bank and channel providing cover and habitat for salmonids and potential spawning cobble has replaced some fine sediment, the recovery of Hely Creek remains ongoing. A dense growth of young willow resides in the active, braided channel.

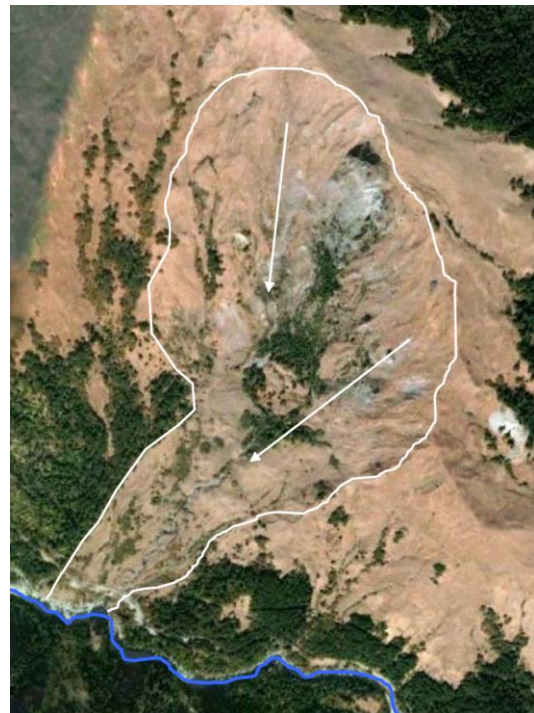
Figure 4. Aerial photo of Fish Creek debris slide in the Middle Subbasin of the Van Duzen River.

The Fish Creek debris slide (RM 25) was associated with a logging road constructed in the 1950s within the active channel of Fish Creek and initiated by the 1964 flood event (Fig. 4). Debris sliding along the banks of Fish Creek was continuous for over a mile upstream of its confluence with the Van Duzen River. It is estimated that the Fish Creek debris slide flushed 4.9 million cubic feet of alluvium into the Van Duzen River (Kelsey 1975) and was the largest slide associated with the 1964 flood.

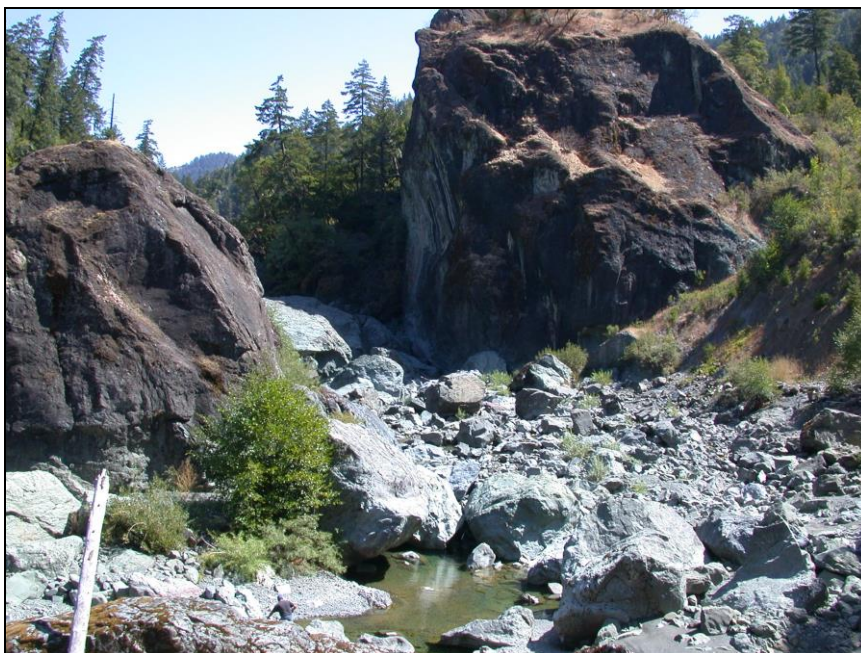
Figure 14. Salmon Falls: boulder roughs typically impede Chinook and coho salmon spawning migration, although steelhead are able to pass above the site.

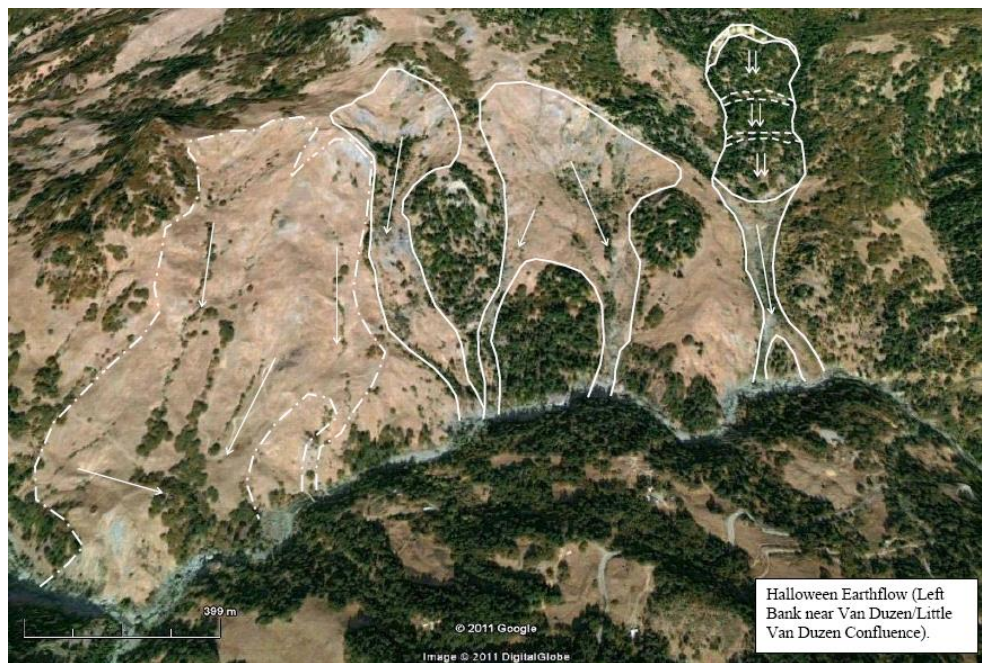
Figure 4. Halloween Earthflow complex on the right-bank of the Van Duzen River near the confluence of the Little Van Duzen River.

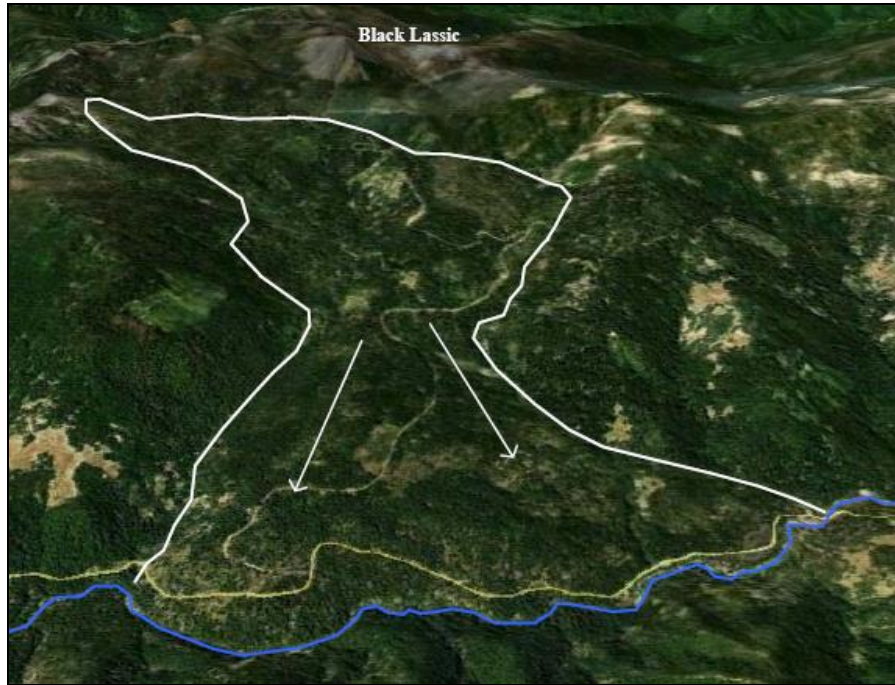
Figure 5. Pseudo-aerial view looking west of the Black Lassic landslide into the Van Duzen River.

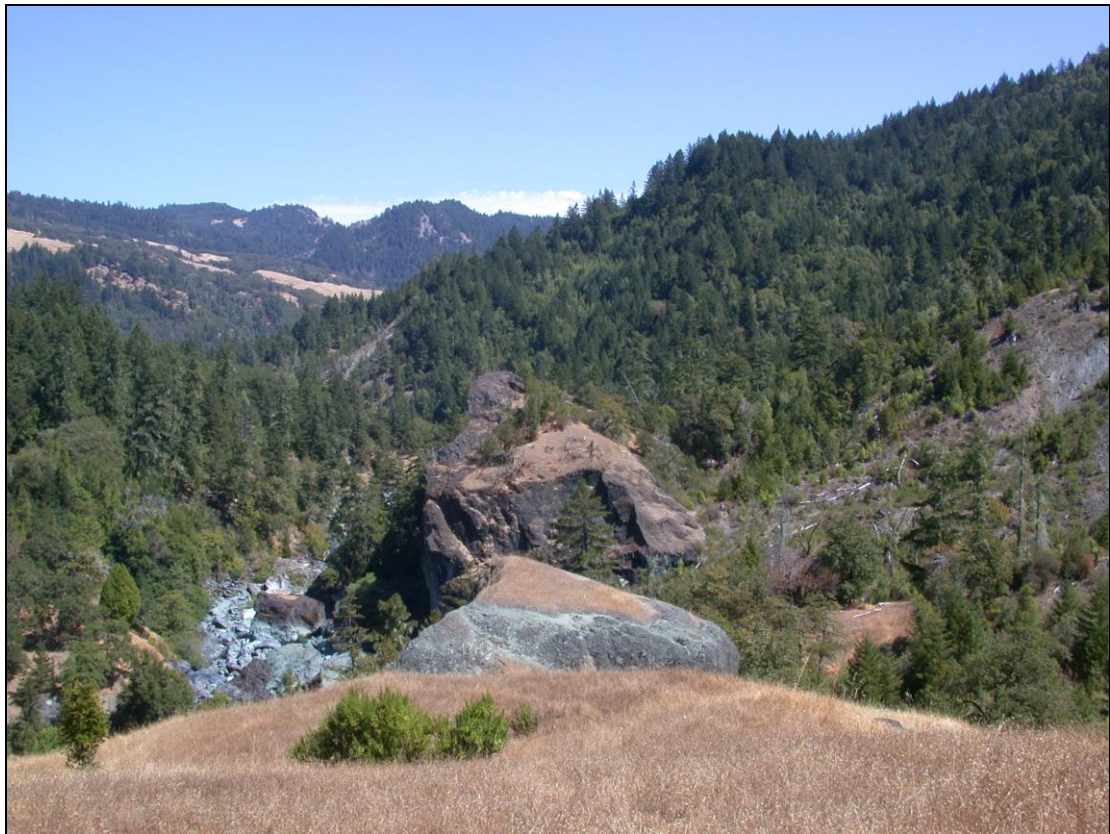
Figure 6. View of older landslide (on right side of photo) in the Upper Van Duzen River near Eaton Falls (RM 46).

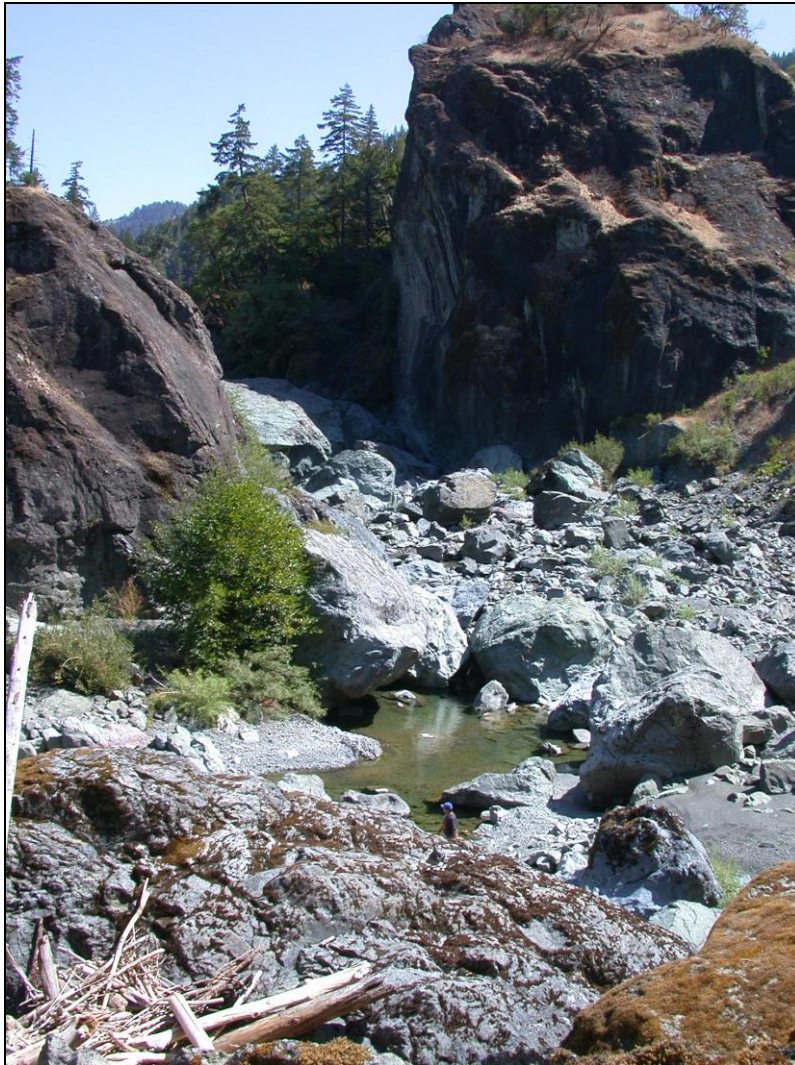
Figure 8. Upper Van Duzen River at Eaton Falls (RM 46).

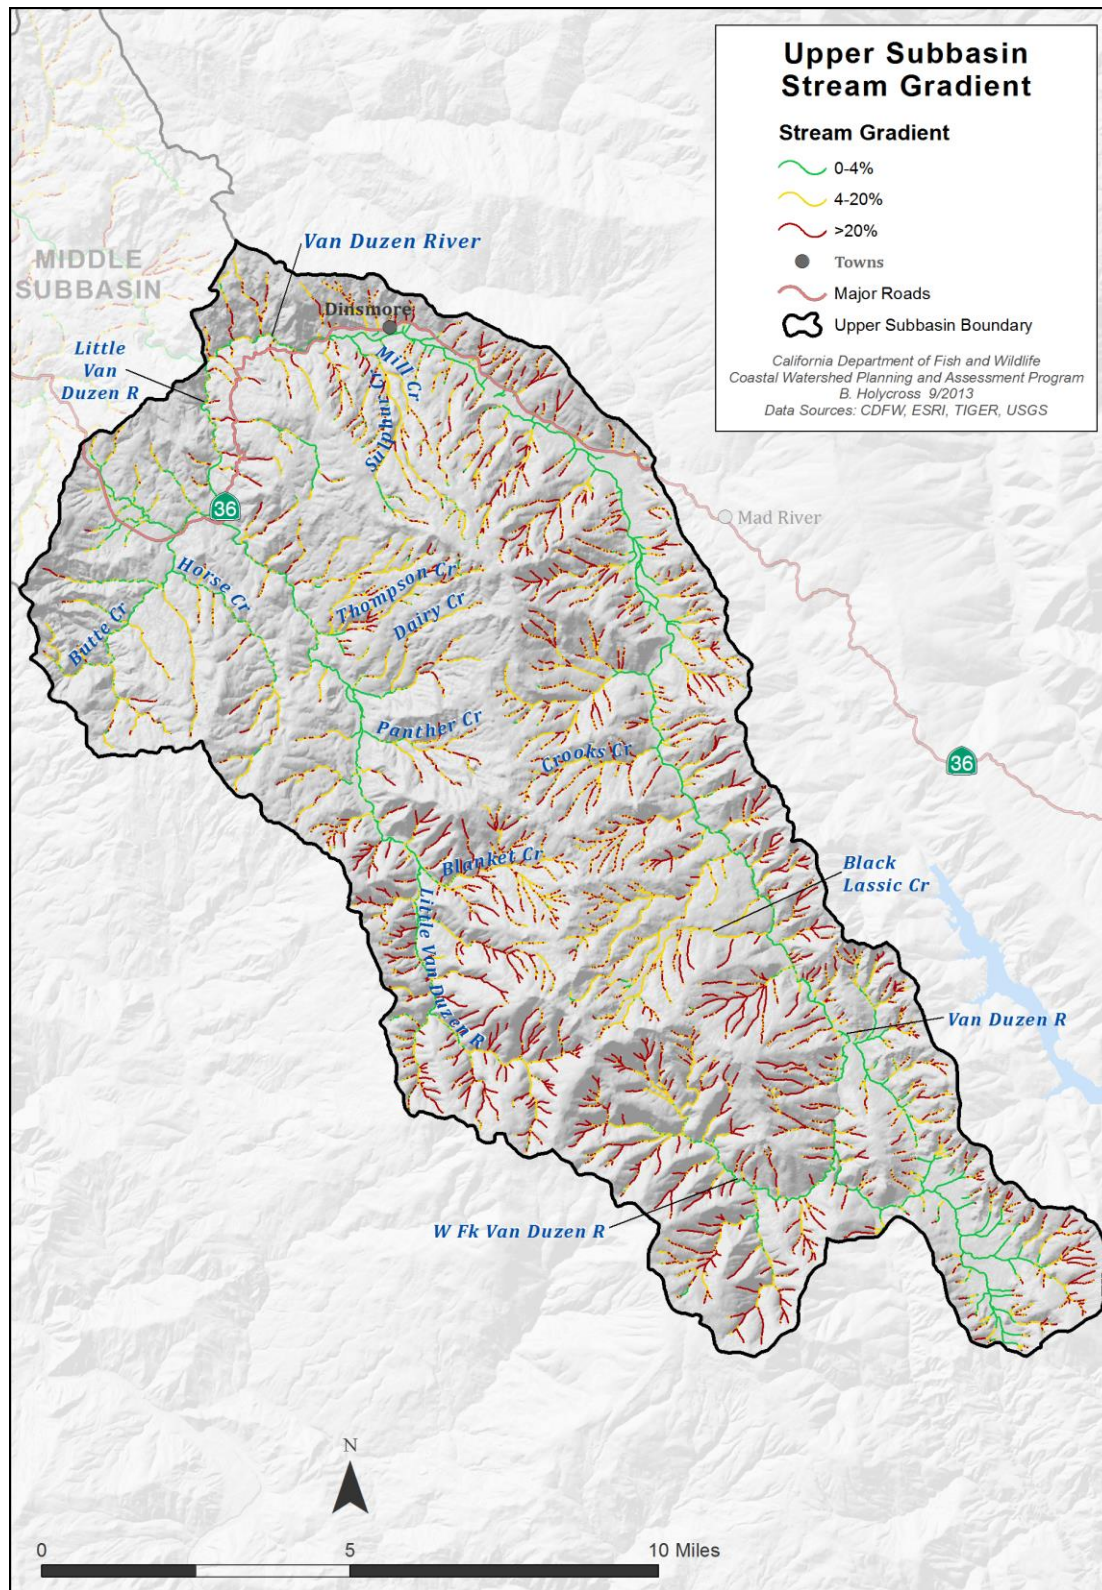
Figure 10. Stream gradient classification for sediment response, transport, and source for Middle Subbasin of the Van Duzen River.

Many of the intermittent stream channels are steep and are considered as sources areas for sediment (Montgomery and Buffington, 1997) delivered to the Van Duzen River (Figure 10). While the Van Duzen River and the Little Van Duzen River are low gradient streams until their headwaters. The average mainstem channel gradient is approximately 1.5 %. The average Little Van Duzen channel gradient is approximately 4.5%.

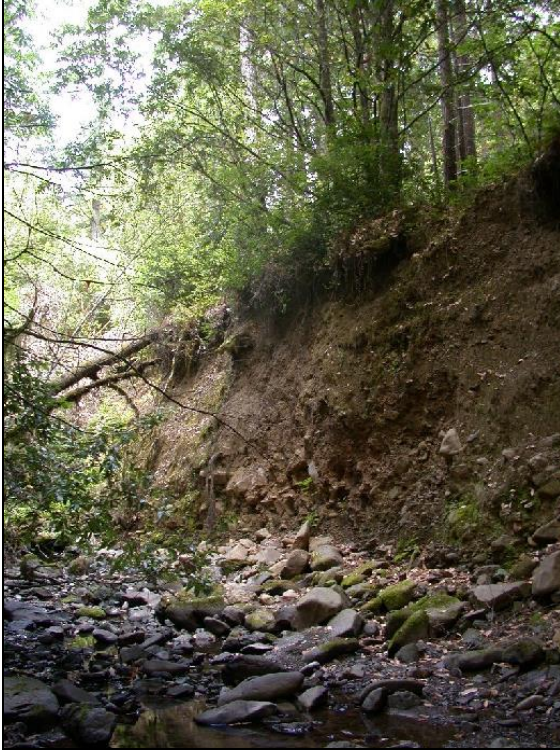
Figure 1. Blanton Creek armored plane bed channel, bank erosion into pre-historic landslide deposits, intermittent flow and lack of large trees needed for shade and LWD loading.

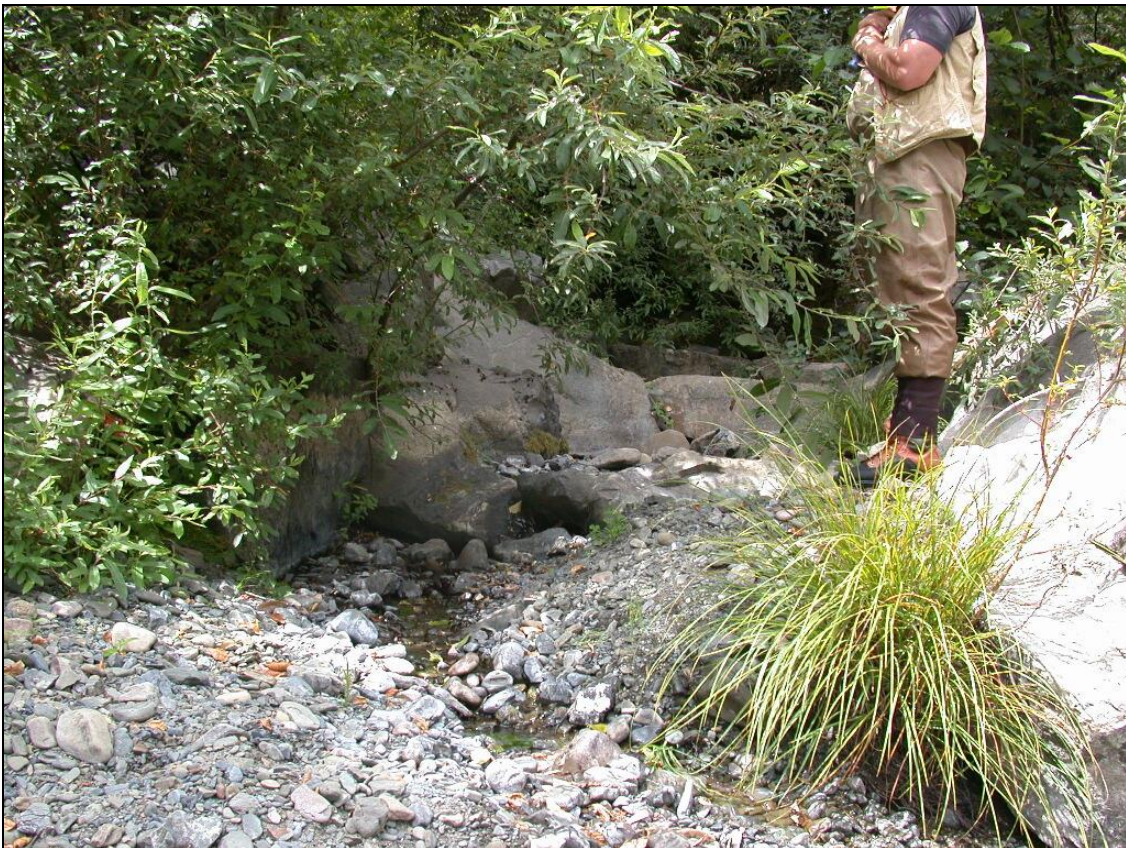
Figure 2. Mouth of Blanton Creek, August 16, 2006.

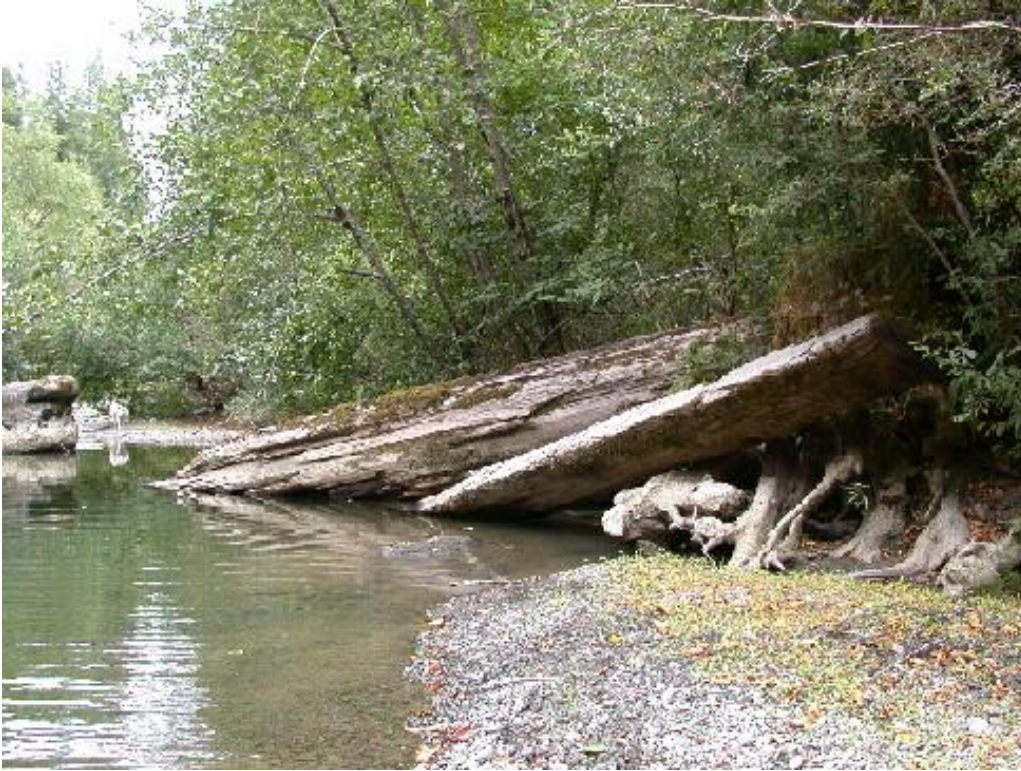
Figure 1. Instream habitat structures made of LWD form pool in Lawrence Creek

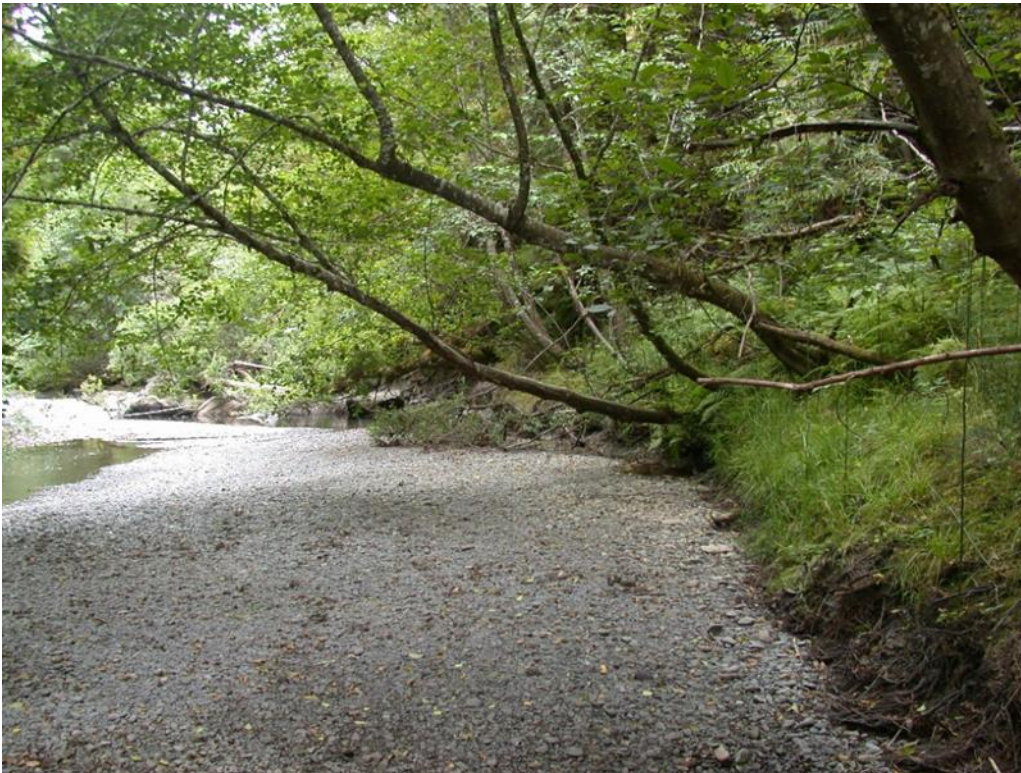
Figure 4. Lawrence Creek plane bed channel August 15, 2006. The lack of LWD means no pools here.

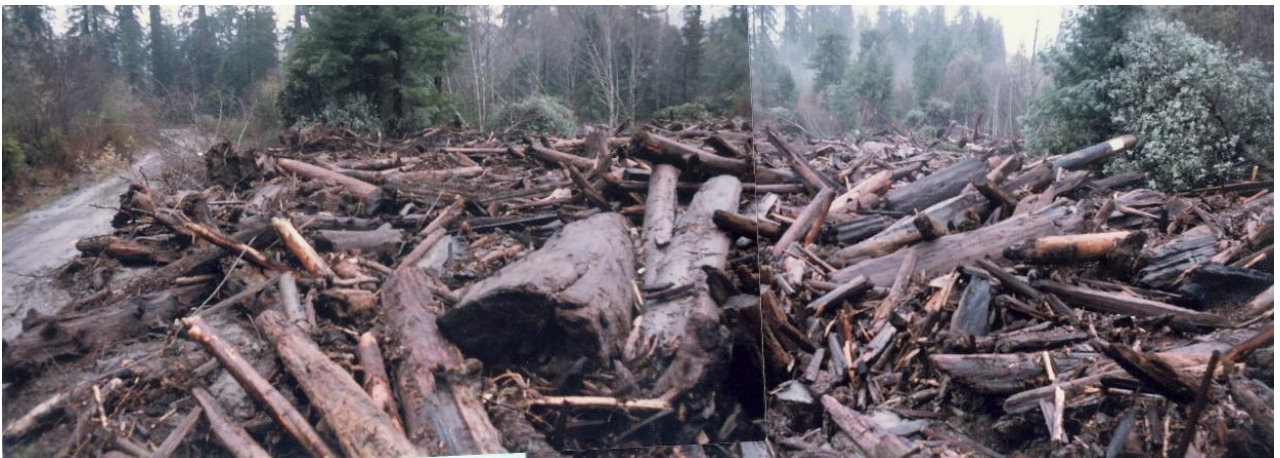
Figure 2. Debris torrent buries lower Heley Creek in 1983. The site is located approximately 1100 feet up Redwood House Road from HWY 36.

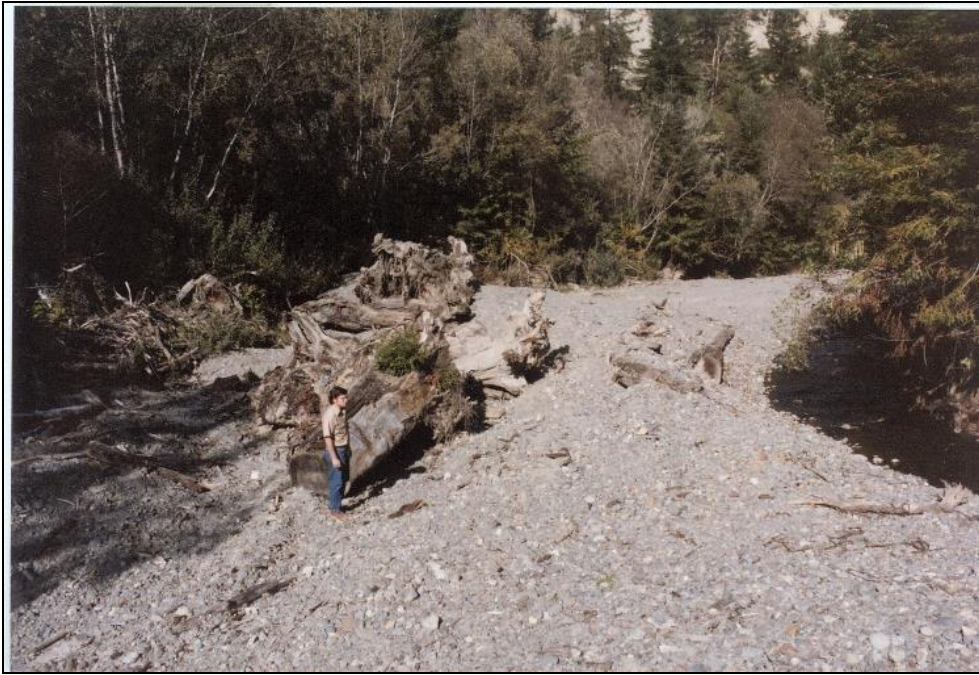
Figure 3. After clean up of debris torrent in Hely Creek. Photo taken in 1983.

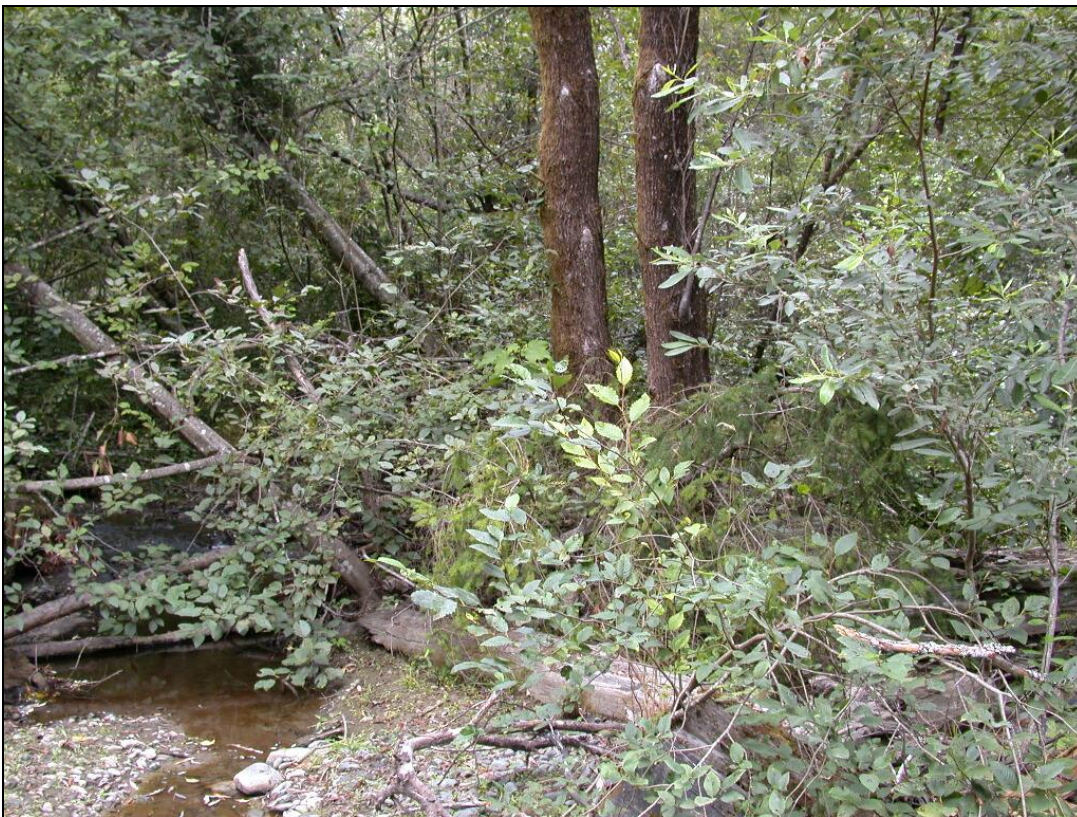
Figure 4. Riparian vegetation encroaches in Hely Creek channel. The stream forms a braided shallow channel around small islands of sediment and vegetation. Photo taken in 2006.

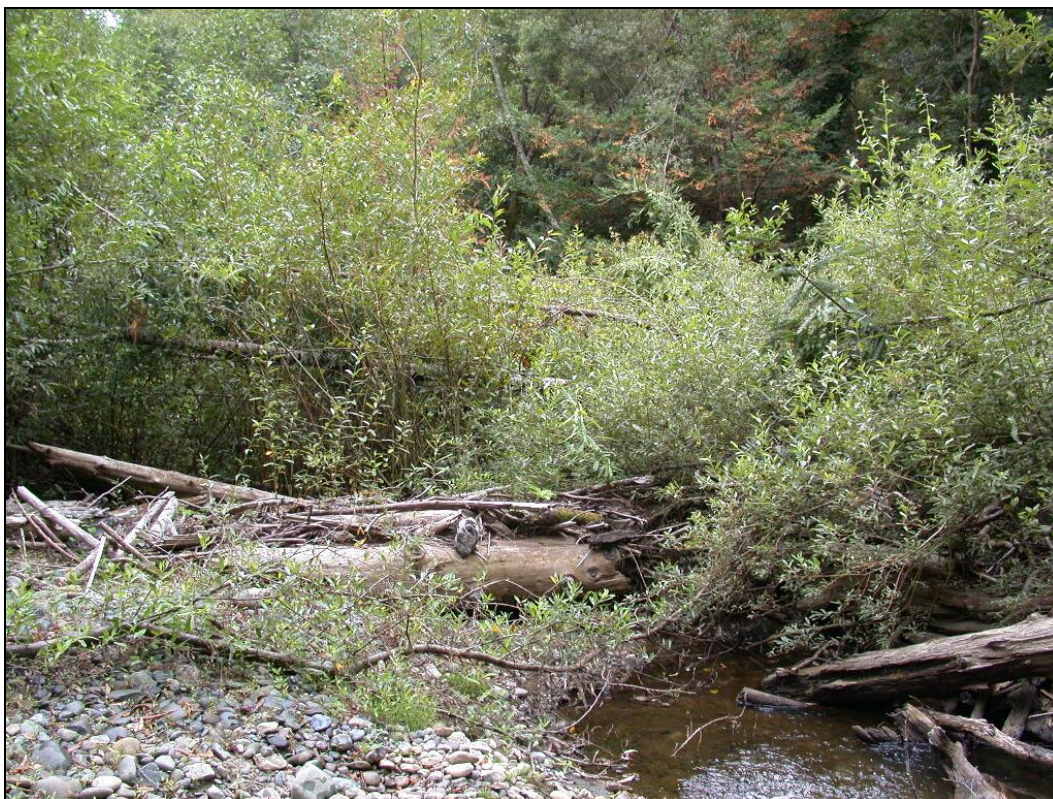
Figure 5. Hely Creek, photo of vegetation, gravel island and debris blocking channel.

At extremely high fine sediment loading (Figures 5 & 6), the entire channel may become buried by a blanket of fine sediment. Hence the spatial distribution of fine sediment can indicate the relative magnitude of the fine sediment load, but the calibration of this indicator will vary with channel type and other factors such as the local geology (Schnackenberg and MacDonald 1998).

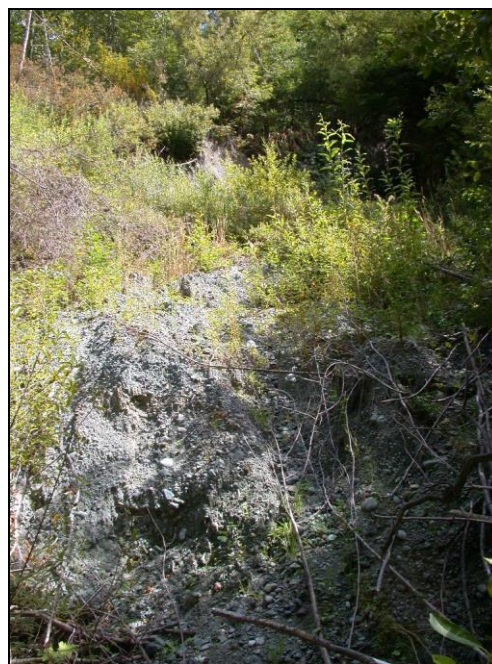
Figure 6. Hely Creek (~1600 feet above Highway 36) showing signs of high delivery of fine sediments in 2006.
