Van Duzen River Basin Assessment

**FINAL
DRAFT
2013**

Van Duzen River Watershed Assessment

January 2013

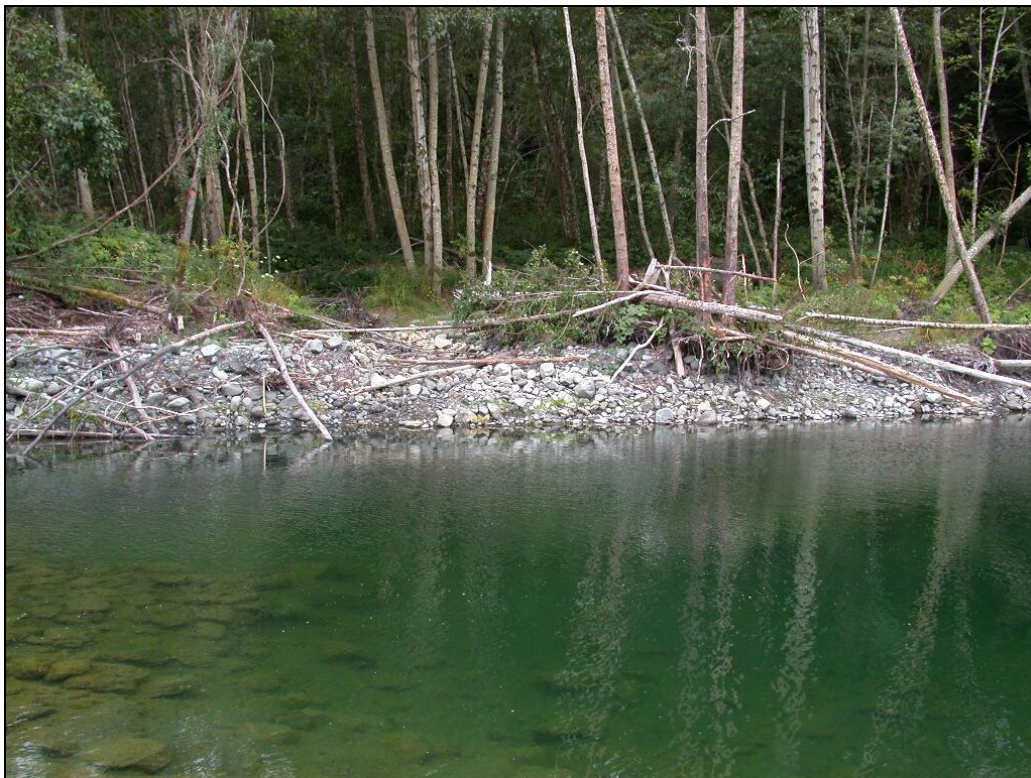
Figure 7. Confluence of Root Creek and Van Duzen. Fish access into Root Creek may be limited during low flows by sediment accumulations at creek mouth.

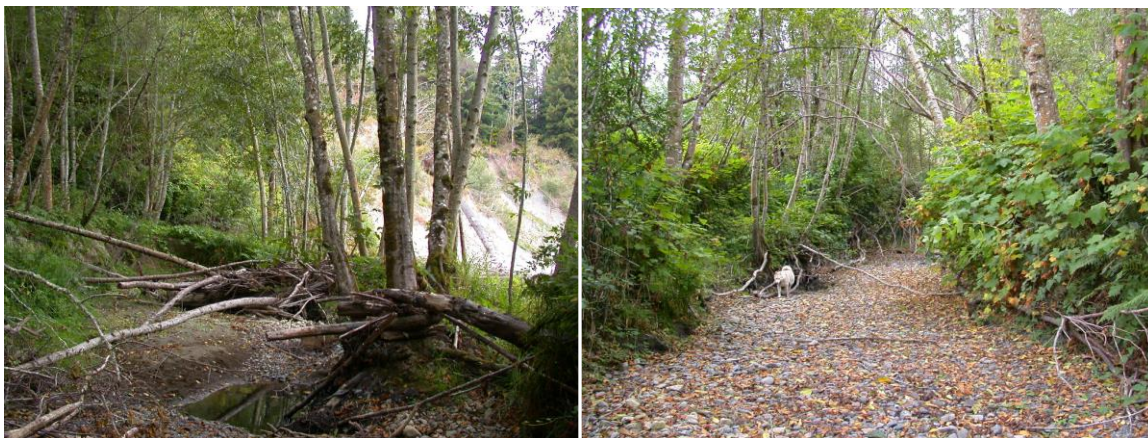
Figures 8 and 9. Lower Root Creek. Just upstream of mouth (left) and dry cobble substrate channel about 50 feet further upstream (right). Photos taken August 29, 2006

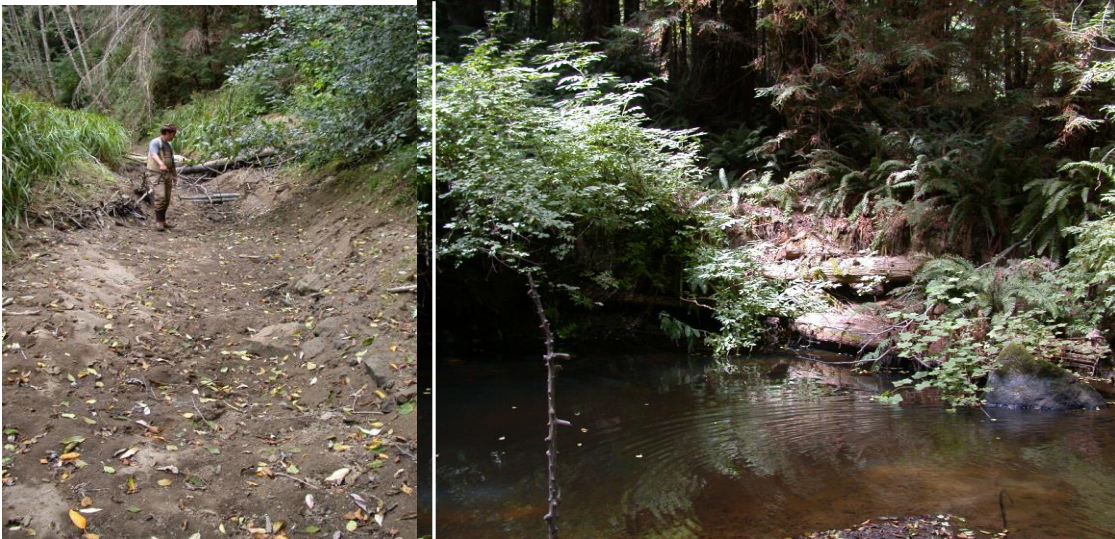
Figures 10 and 11. Lower Root Creek transition reach. Channel changes from dry cobble bottom to silt laden reach (left). Further upstream (RM 0.5) flows form pool habitat (right). Photo taken August 29, 2006.
