*Coastal Watershed  
Planning & Assessment  
Program*

# Lower Eel River Basin Assessment

# Lower Eel River Watershed Assessment

July 2010

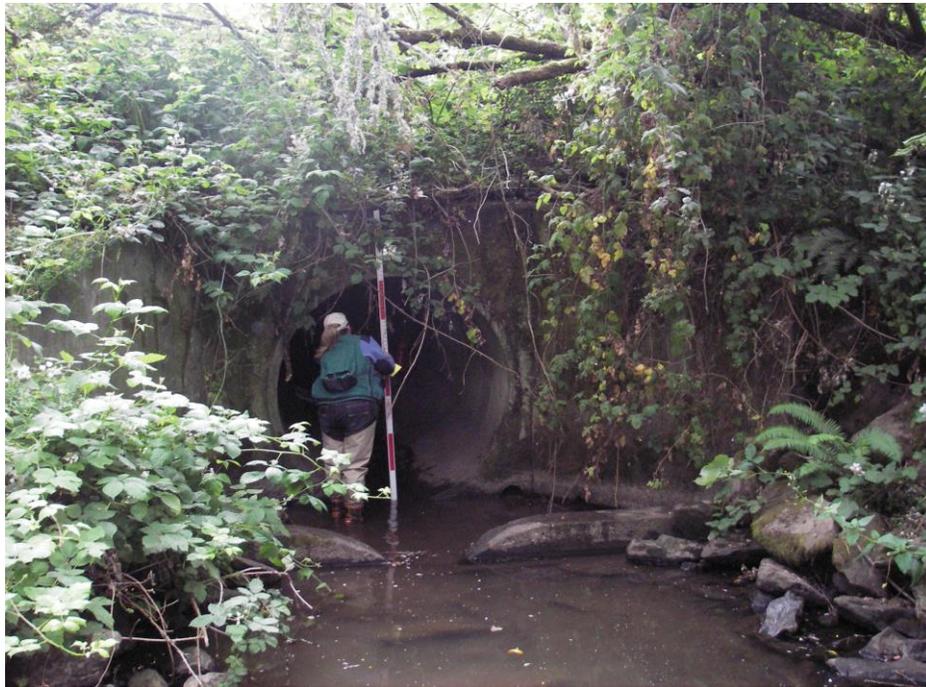
*Figure 24. Outlet of culvert where Rohnerville Road crosses Mill Creek, tributary to Strongs Creek, June 18, 2008.*
