Salt River Watershed Assessment

**May
2005**

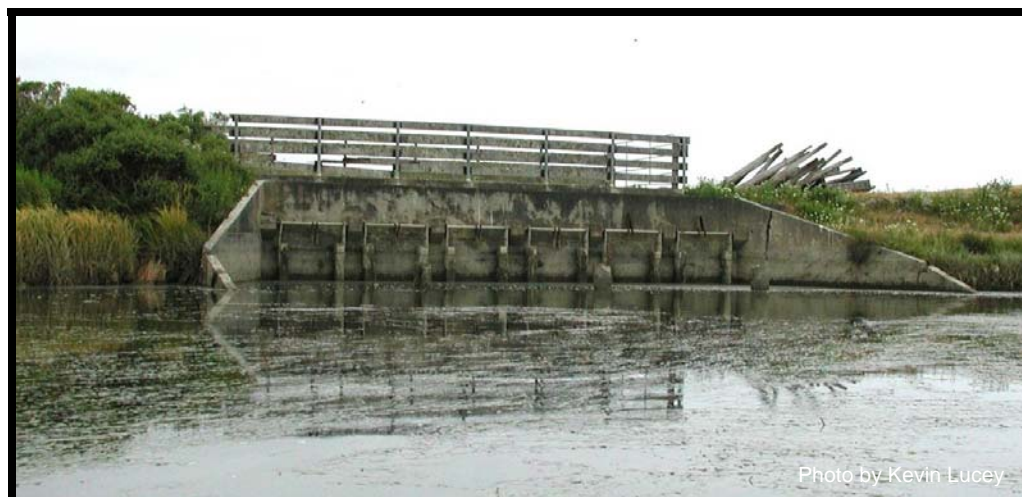
Figure 8. Cutoff Slough tide gate

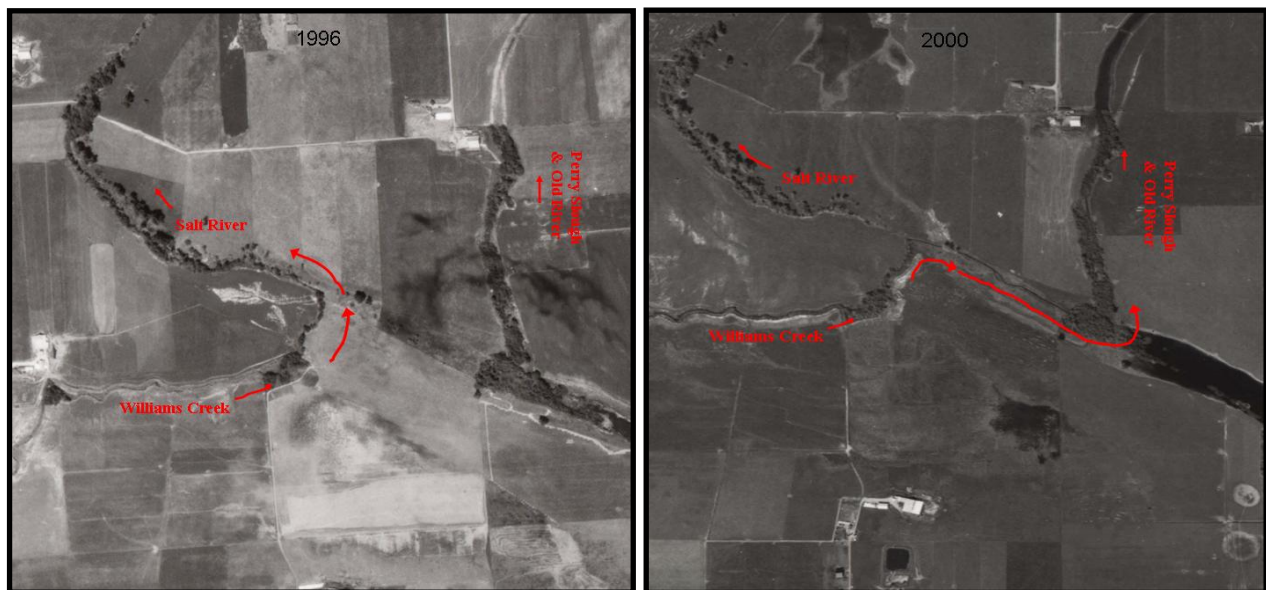
Figure 10. Aerial Photographs of the confluence of Williams Creek and the Salt River 1996 (left), 2000 (right). Note the change in the Williams Creek drainage in the center of the photos from a westward course in the Salt River (left) to an eastward course into the Old River (right). This action has caused a 42% reduction in Salt River Watershed size.

In the past 25 years, the four eastern-most drainages to the Salt River have been diverted from the mainstem Salt River into the Old River via Perry Slough creating a new watershed. In 1978, a sediment plug completely blocked the Salt River channel (R.M 7.7); diverting the flow of Coffee Creek into the Old River channel. In 1998 Williams Creek (R.M. 7.5) was also diverted into the Old River. The Old River/ Perry Slough system is an ephemeral watercourse, meaning that is dry in the summer. Old River flows north under the Old River bridge that crosses Highway 211 and meets the Eel River 0.7 miles downstream of Fernbridge (Eel River Mile 5.8).

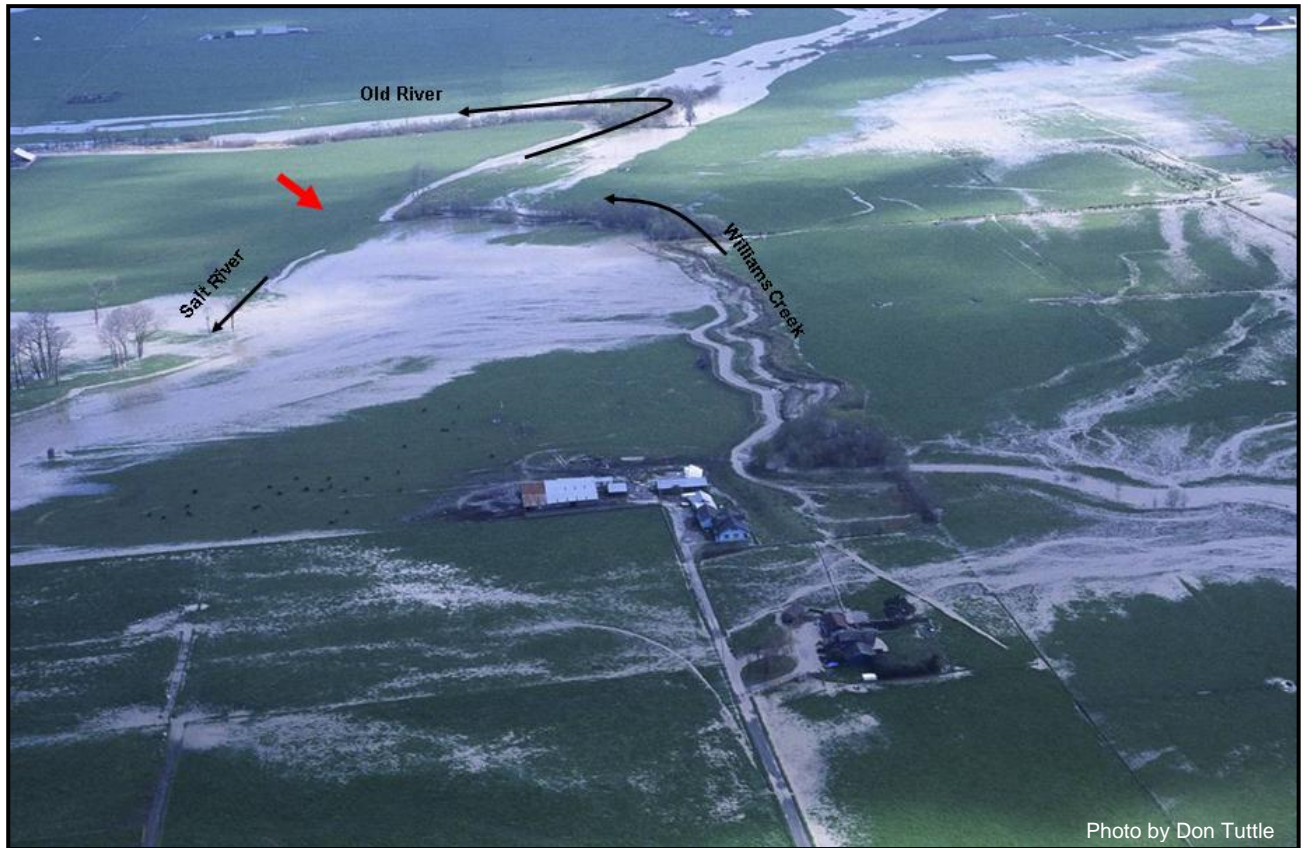
Figure 11. Williams Creek, Salt River and the Old River in February 2004. Red arrow indicates the sediment plug in the Salt River at river mile 7.5.

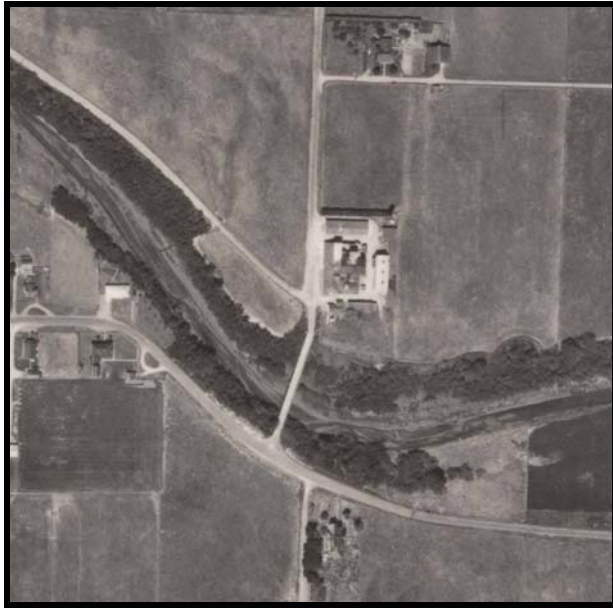
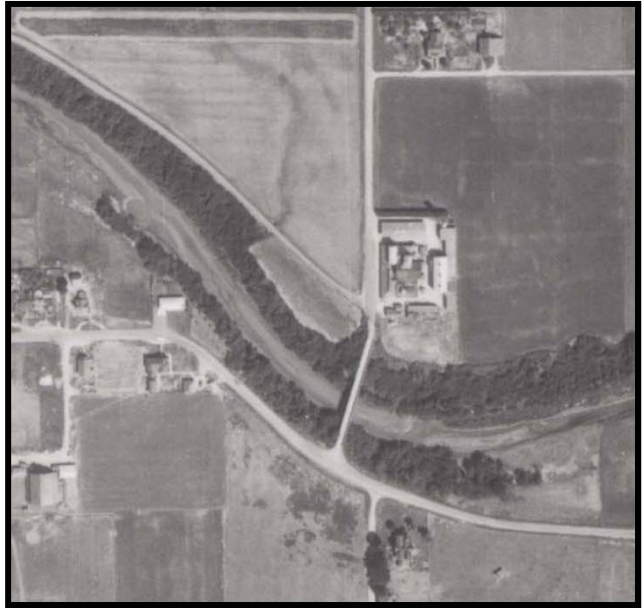
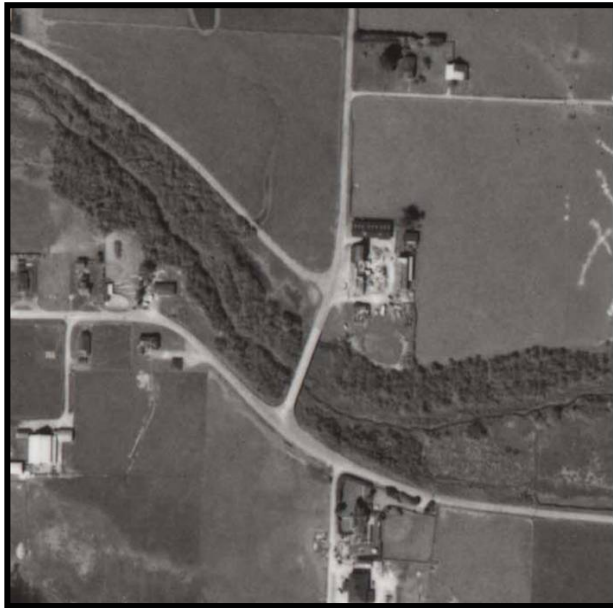
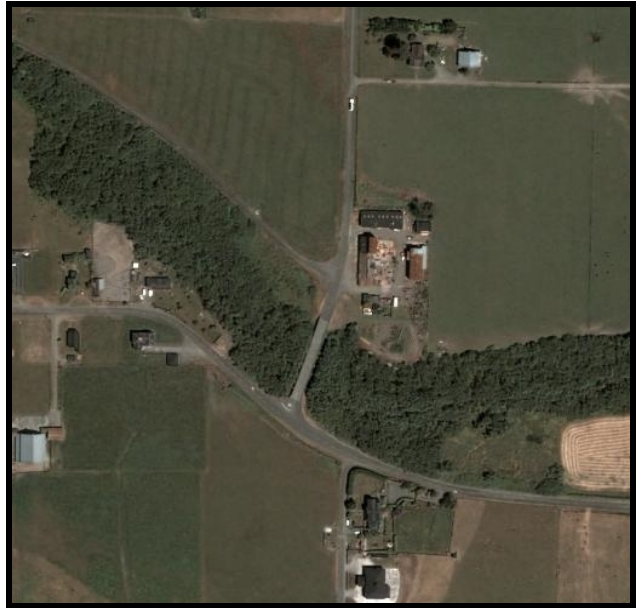
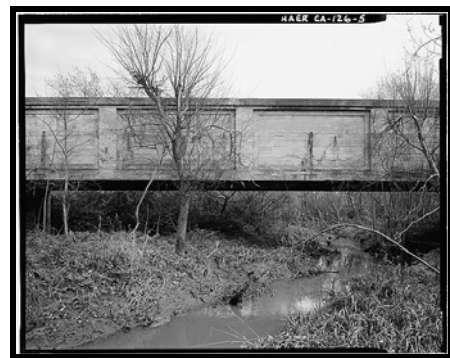
Figure 13. Aerial view of Salt River at Dillon Road Bridge in 1963, 1965, 2000, 2004. Cross-section view of Valley Flower Bridge (Dillon Road Bridge) from 1920 (left) and early 1990's (right)

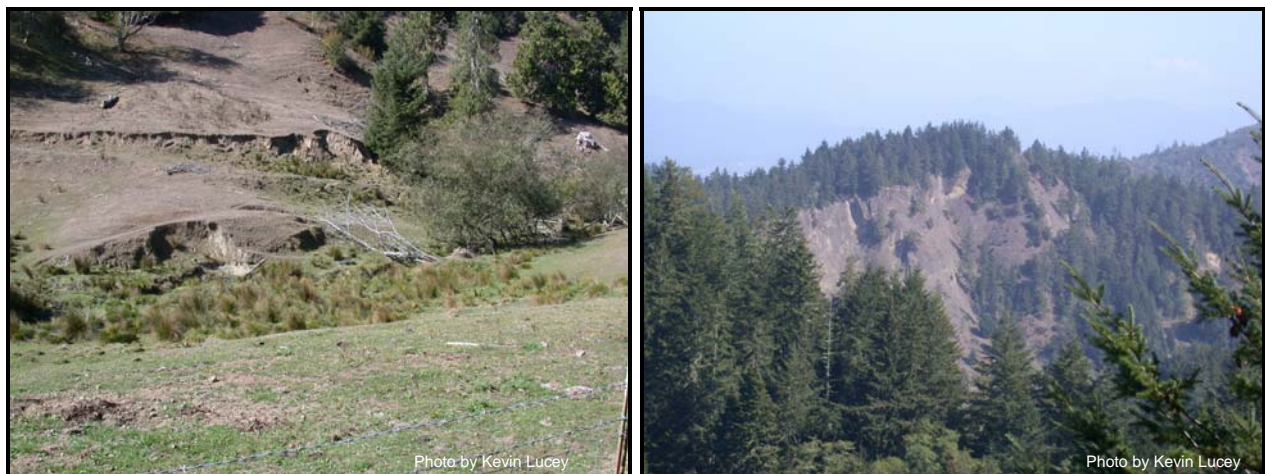
Figure 15. Preventable (left) and non-preventable erosion (right).

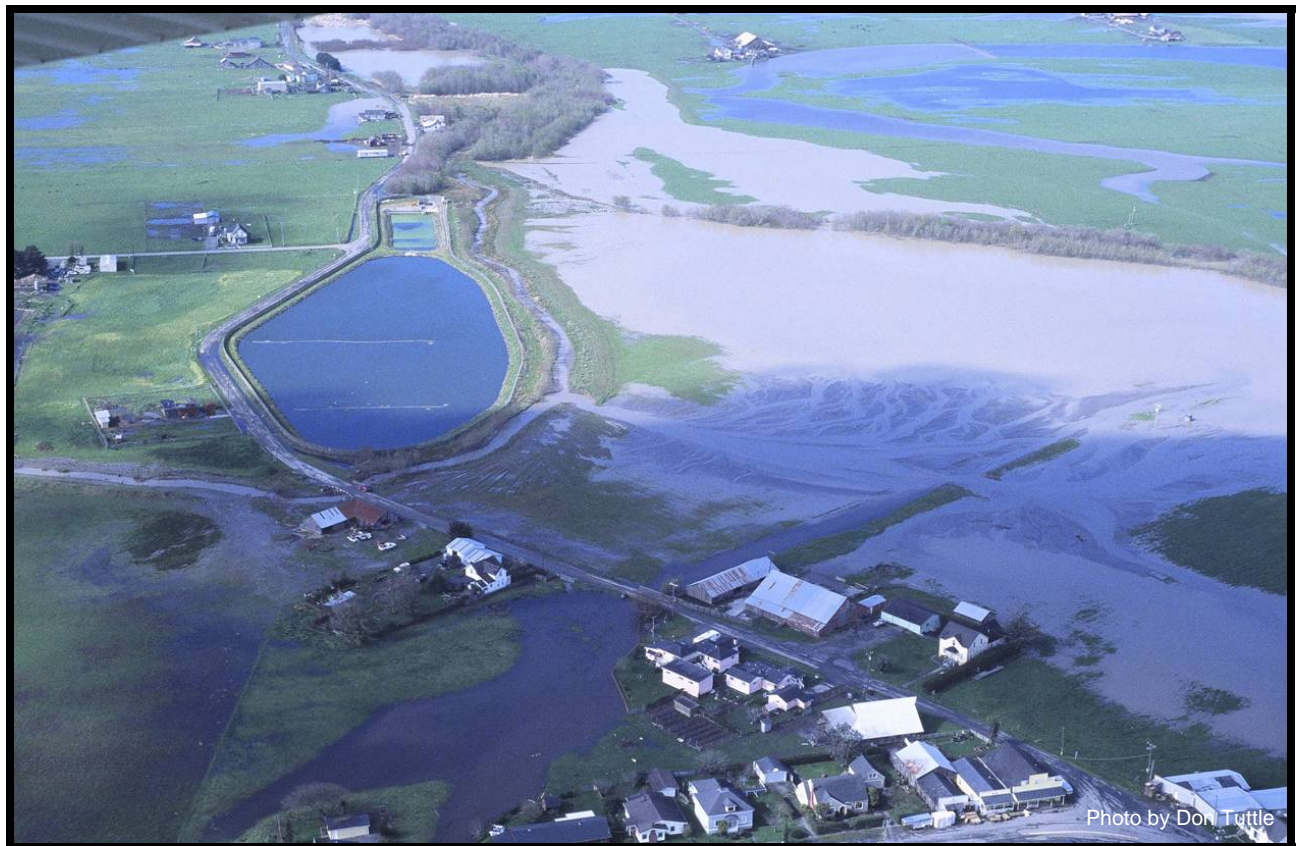
Figure 21. Westward aerial view of the Ferndale waste water treatment plant during February 2004. The ponded area on the right is known as Lake Vevoda. Francis Creek flows around the settling pond, Arlynda Corners is in the foreground.

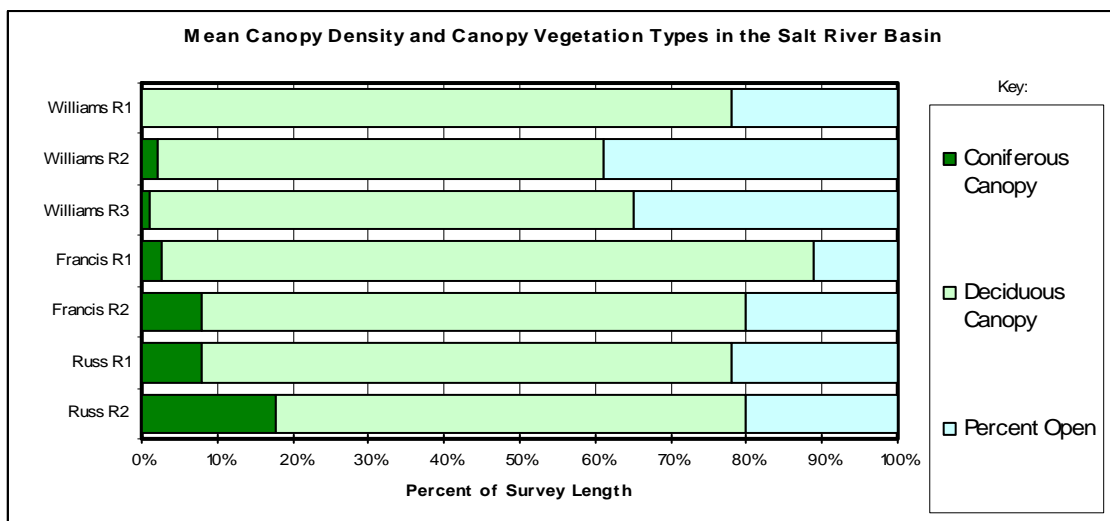
Figure 22. Canopy density and the relative percentage of coniferous, deciduous and open canopy above surveyed streams in the Salt River Basin analyzed by reach. Target value is greater than 80%.

When analyzed by individual reaches it was determined that reach one of Francis Creek was the only reach that exceeded target values (Figure 22). Reach two and three of Williams Creek had low canopy density measurements and are candidates for riparian improvement. The remaining reaches scored close to or slightly below the target value of 80% canopy density.

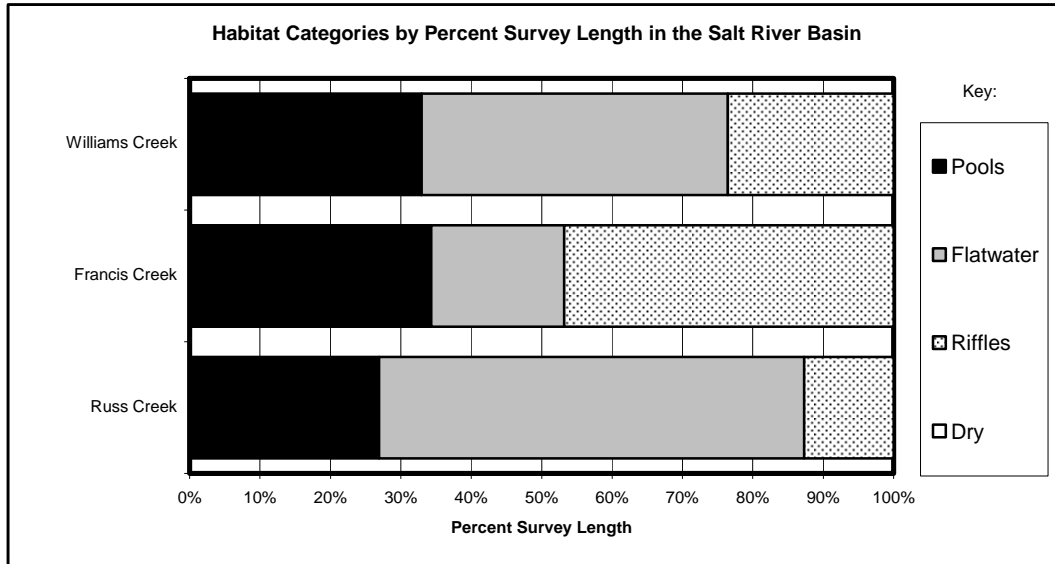
Figure 23. Percent of pool habitat, flatwater habitat, riffle habitat by survey length in the Salt River Basin

Pool, flatwater, and riffle habitat units were measured, described, and recorded during CDFG stream surveys. During their life history, salmonids require access to all of these types of aquatic habitat. It is recommended that a stream be comprised of 40% primary pools by length (>2 feet). The Salt River tributaries on average have 31% pools by length (Figure 23).

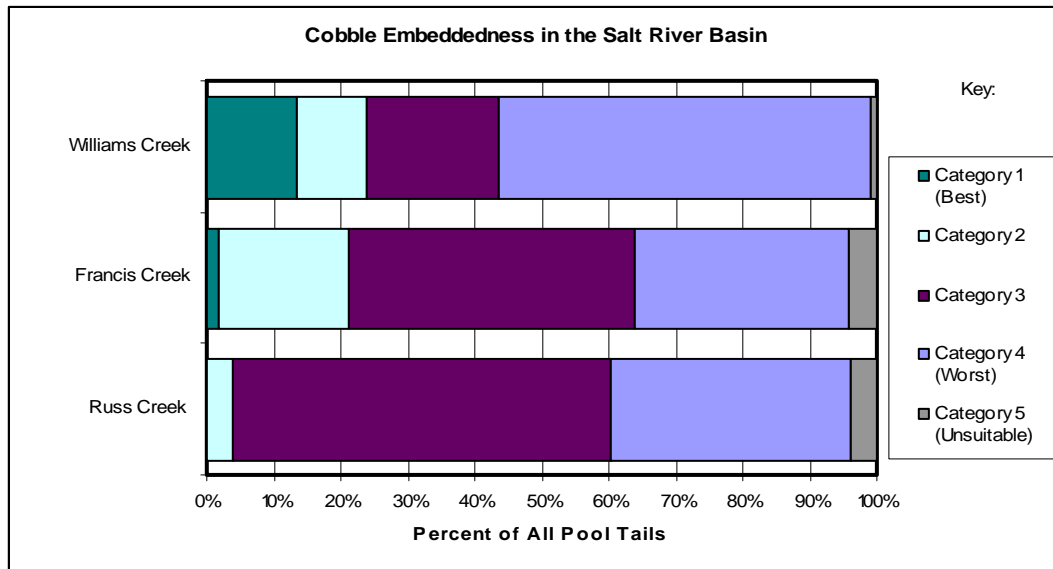
Figure 24. Cobble embeddedness categories as measured at pool tailouts in surveyed streams in the Salt River Basin.

The Wildcat tributaries do not meet the optimal target value for cobble embeddedness. Based on CDFG cobble embeddedness target values only 23.8% of Williams Creek; 21.3% of Francis Creek; and 3.8% Russ Creek are supportive of salmonids (Category 1 and 2) (Figure 24).

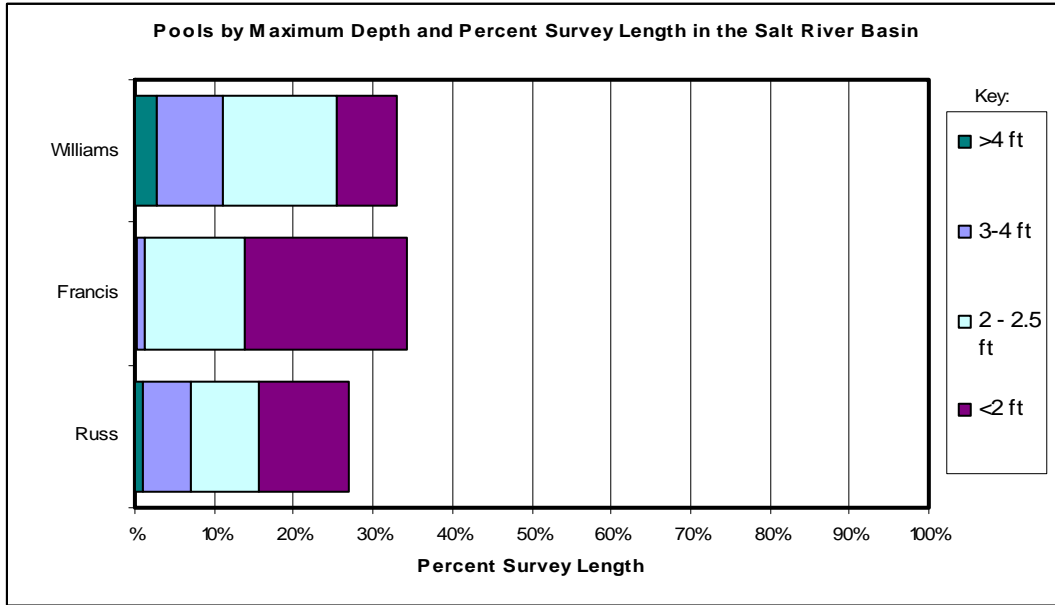
Figure 25. Percent length of survey composed of pools in the Salt River Basin

All survey reaches were below the CDFG target values for primary pool depths. Williams Creek ranked the best with 26% of stream length comprised of primary pools (> 2 feet) while Francis Creek had 9% and Russ Creek had 16%. Mean maximum residual depth was highest in Williams Creek and lowest in Francis Creek, meaning that Williams Creek has the deepest pools throughout followed by Russ and Francis creeks.

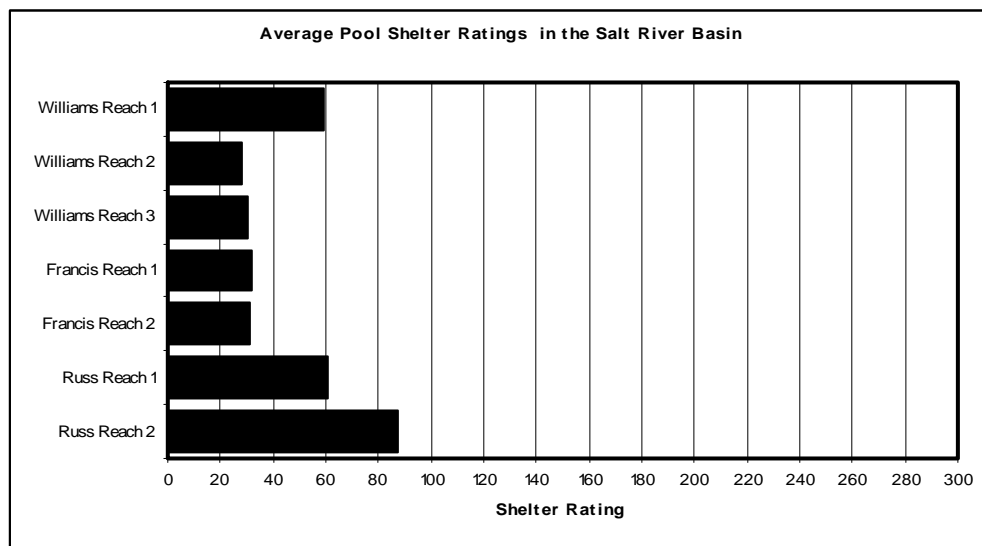
Figure 26. Average pool shelter ratings from stream surveys in the Salt River Basin

Both reaches within Russ Creek were considered suitable for salmonids and provided the best shelter of all surveyed reaches within the Salt River Basin with an average shelter value of 79. Both Francis and Williams creeks were considered barely suitable for salmonids with shelter values of 32 and 34, respectively (Figure 26). It should be noted that the reach 2 of Williams Creek was considered fully unsuitable with a shelter value of 28. Reach 3 of Williams Creek was 30, which is on the border of unsuitable habitat.

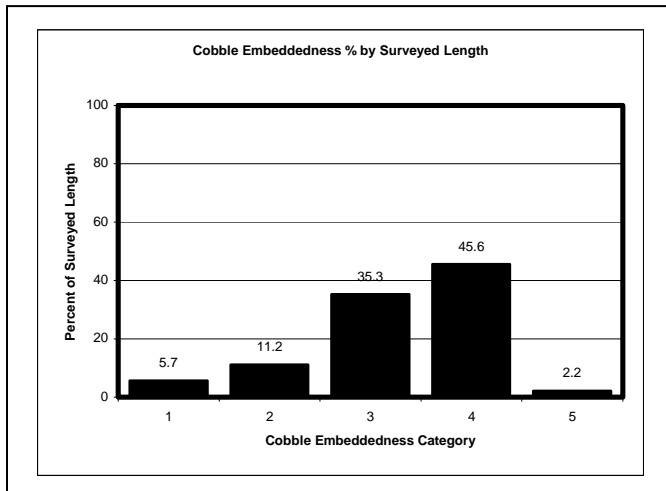
Figure 28. Cobble embeddedness in the Salt River Basin.

Comments: 83% of pool tail outs measured fall into categories 3 and 4, which does not meet spawning gravel target values for salmonids.

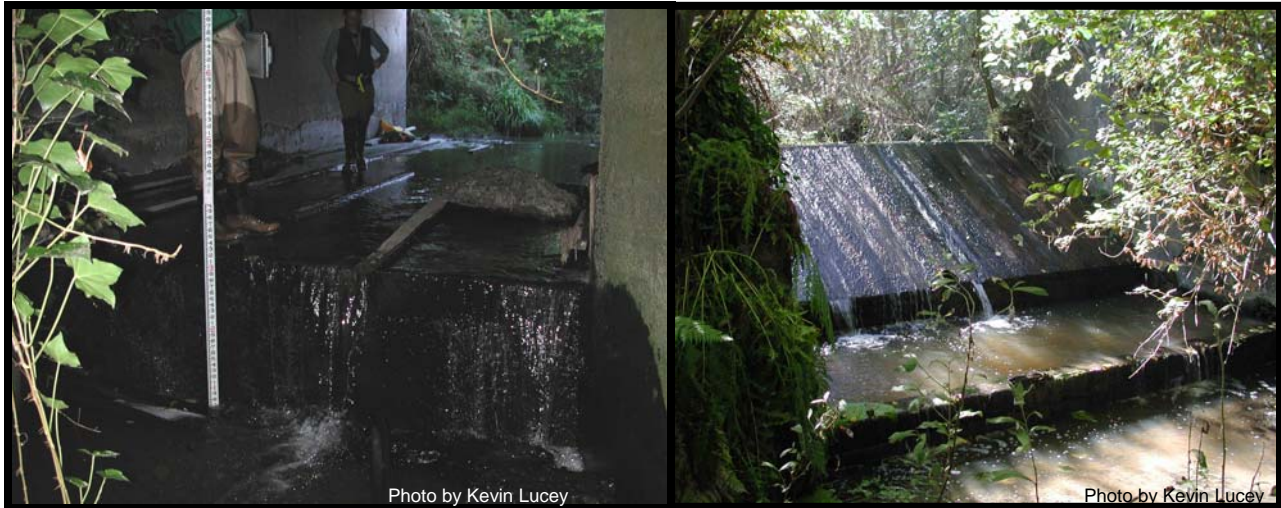
Figure 31. Centerville Road culvert on Russ Creek (left) and fish barrier on Russ Creek 500 ft. above Centerville Road (right).

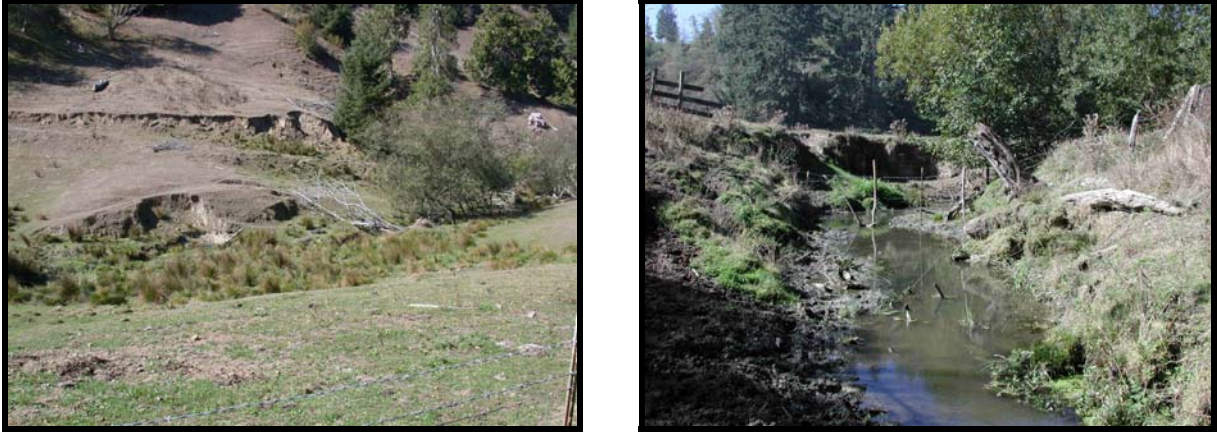
Figure 33. Examples of erosion in the upland Salt River Tributaries.

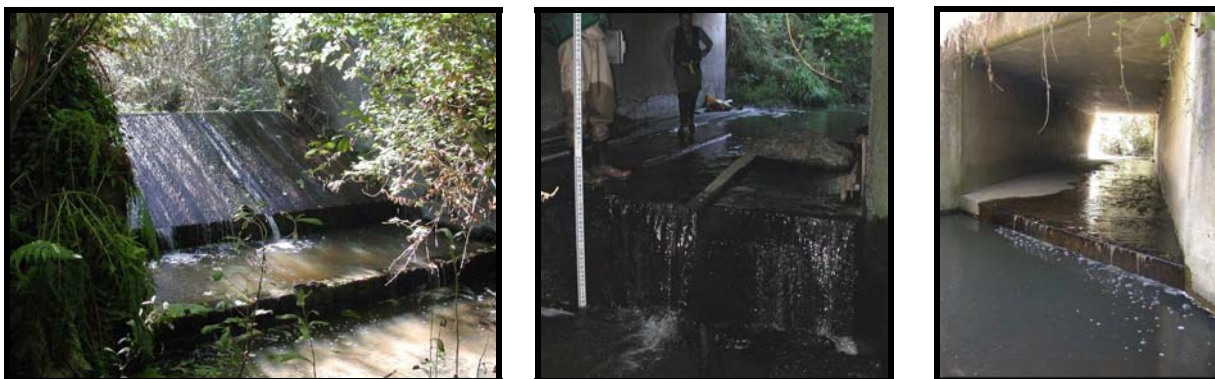
Figure 34. Examples of fish passage barriers in the upland Salt River tributaries.
