Appendix D. Shoreline Exposure and Injury Evaluation Studies

The Shoreline Technical Work Group (TWG) consisted of two subgroups during the early stages of the Refugio Beach Oil Spill Natural Resource Damage Assessment (NRDA): one focused on sandy beach habitat and the other on rocky intertidal habitat. Subsequently, these subgroups merged to become the Shoreline TWG. The TWG identified several goals early on, including documenting the presence of the oil on shorelines, then documenting oil exposure and injury to shoreline organisms on those stretches of oiled shoreline. The injury evaluations proceeded by bifurcating the assessment of injuries attributable to oil exposure and injuries attributable to cleanup operations. Table 1 shows the planning strategy for the Sandy Beach TWG in October 2015. A similar strategy, documenting exposure and effects, was employed to assess rocky intertidal habitat injuries. Data and other information used to prepare this report are found in the Administrative Record for the case at <https://www.diver.orr.noaa.gov/web/guest/diver-admin-record/6104>.

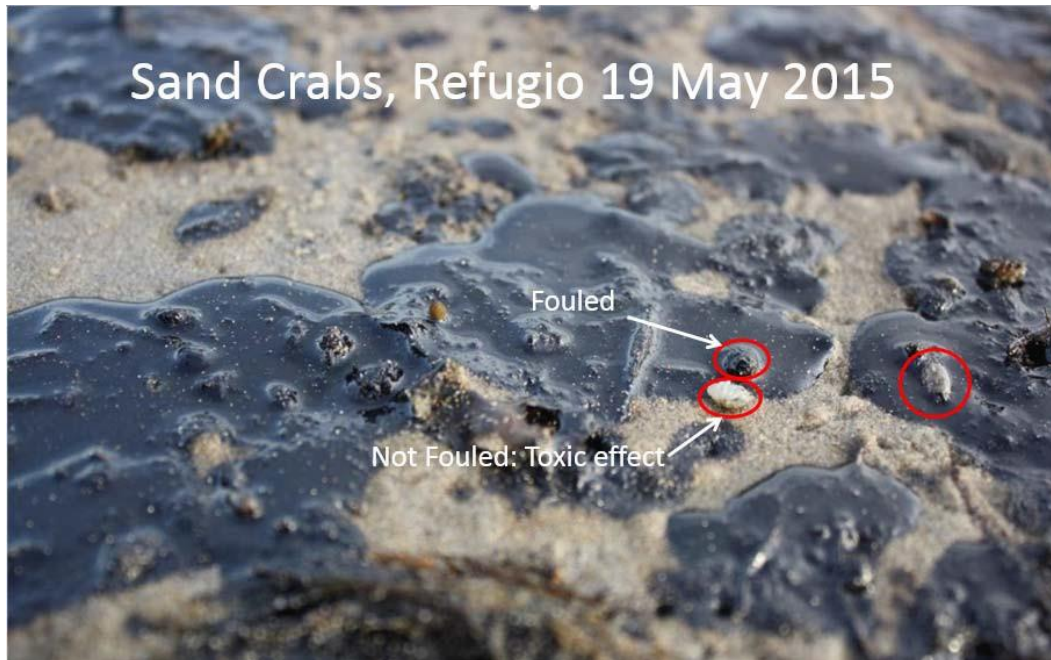
Figure 2. Sand crabs fouled and affected by the Line 901 oil on 19 May 2015, at Refugio State Beach.

Exposure to Line 901 oil was documented in several ways, ranging from observations that were recorded in field notes to photographs of oil on or in association with organisms (Figures 1 and 2), as well as a variety of chemical measurements of oil constituents in field samples. Chemical analysis results, including concentrations of polycyclic aromatic hydrocarbons (PAHs), were obtained from both surf water and porewater samples. Porewater is the water that exists in the pore spaces between sand grains. PAHs are known to be a toxic fraction of crude oil that is taken up by organisms. Surf water and porewater come into contact with a wide range of organisms, including three species sampled on sandy beaches: sand crabs (*Emerita analoga*), polychaete worms commonly referred to as Euzonus (*Thoracaphelia spp.*), and talitrids, more commonly known as beach hoppers (*Megalorchestia spp.*).

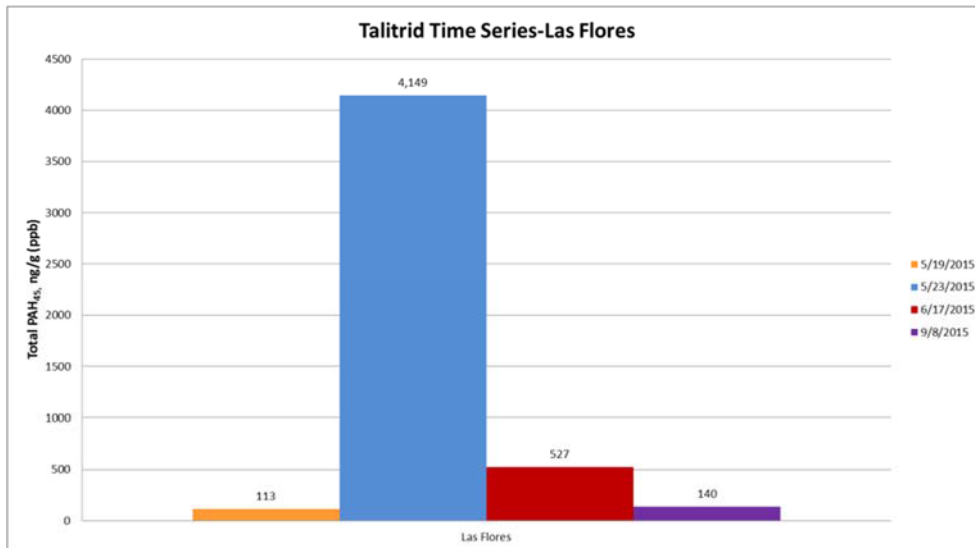
Figure 3. Talitrid tissue chemistry results for one sandy beach location, Las Flores, from a time series in 2015.

Multiple tissues types were collected at multiple locations at multiple points in time following the spill and analyzed for PAHs to document the extent of exposure to these toxic components of crude oil (Figure 3). This allowed for both a spatial and a time series data evaluation, providing a better understanding of where PAH uptake was occurring, its magnitude, and how long it persisted. Details on the forensic chemical results for tissues can be accessed in Appendix B of the Damage Assessment and Restoration Plan.

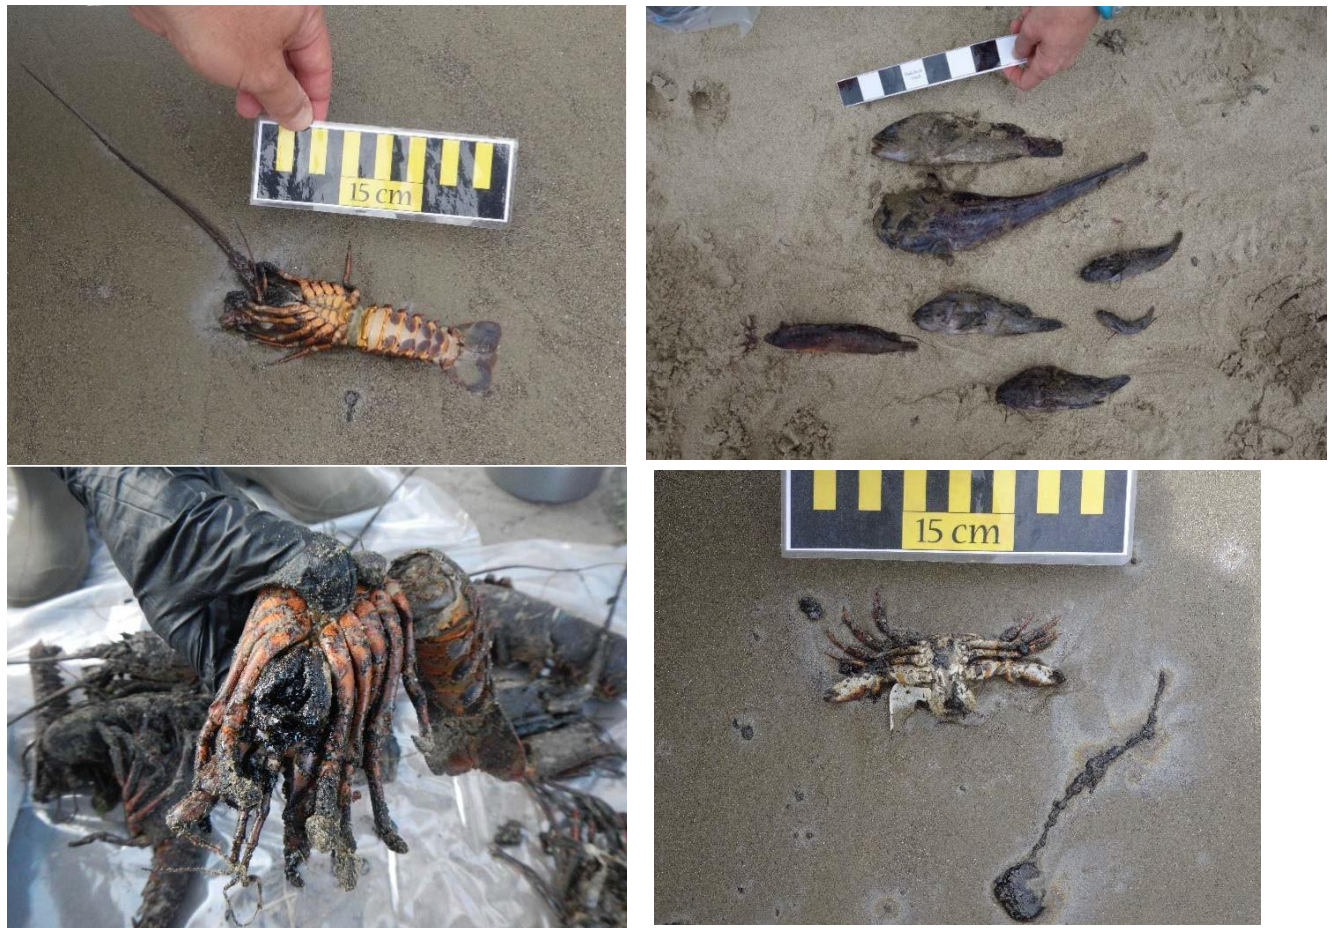
Figure 4. A subset of the dead organisms found on 21 May 2015, Refugio State Beach.

There was early and obvious evidence of the toxicity of the spilled material to aquatic and terrestrial organisms in the days following the Line 901 rupture and oil spill (Figure 4). Dozens of dead subtidal organisms (multiple species of various life stages) washed up on nearby shorelines in the days following the spill and were observed by NRDA teams and cleanup crews. The organisms were so numerous that response personnel overseeing early-phase cleanup activities and debris removal from Refugio State Beach contacted NRDA staff to discuss how best to capture and document the carcasses being found on the shoreline before they were disposed of along with all the other oily debris being removed by cleanup workers. A system for collecting these carcasses in boxes was quickly arranged. By day two or three of the spill cleanup, cleanup workers began separating the carcasses from other oily materials being removed from the beach and placing them into boxes to be photographed and enumerated by an NRDA team each day. This data set became known as the “dead box” data by the NRDA Trustees. This data provides evidence of injury to the subtidal- and shoreline-associated organisms that had washed up dead or in a moribund condition on nearby shorelines immediately following the spill. A summary of the types and numbers of organisms

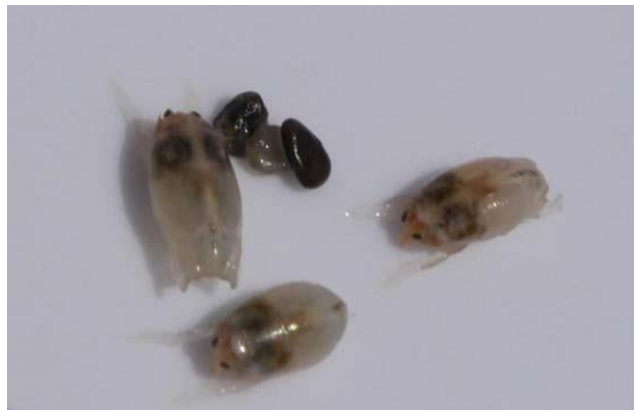
Figure 6. Early life stage sand crabs (megalope stage, the first non-pelagic life stage) collected for use in the bioassay, or toxicity tests, seen next to three grains of sand

To evaluate the toxic effects of the 901 oil, bioassays, also known as toxicity tests, were conducted with the oil collected near the site of the Line 901 pipe rupture. Two common shoreline organisms were tested: the sand crab (*Emerita analoga*), and the mussel (*Mytilus spp*). Early life stage organisms were utilized in these tests, as this spill occurred in the spring season when young organisms were present on the shoreline (Figure 6 is a photograph of the sand crabs). Results of the sand crab bioassays were compared to the chemistry results of both surf water and porewater samples collected following the spill, to estimate the toxic effects of the spilled material on this species (Figure 7). The results indicate that concentrations of oil constituents in surf-water samples exceeded levels found to affect growth and levels found to cause mortality (lethal concentration exceeded at Los Flores; lethal concentration exceeded at multiple locations when phototoxicity is taken into account). More details on the bioassay methods and results can be found in Appendix E of the Damage Assessment and Restoration Plan.

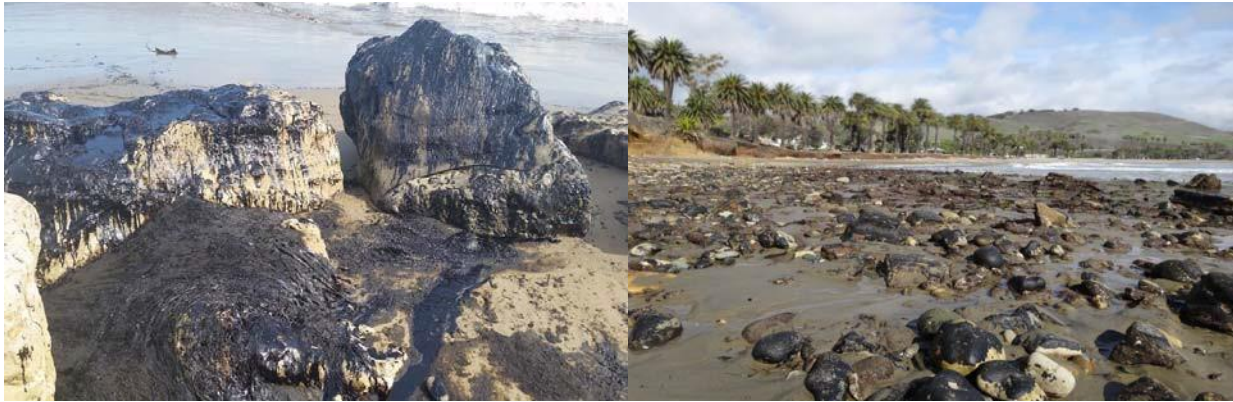
Figure 8. Oiled intertidal cobble/boulders near Refugio Beach soon after spill (left). Lower intertidal cobble at Refugio Beach, January 2016, showing lingering tar in heavily oiled locations (right).

The Trustees conducted rocky intertidal surveys to determine whether the oiling of rocky intertidal substrates (Figure 8) affected rocky intertidal communities, i.e., species composition. The surveys monitored for changes in abundances of sessile organisms, substrate, and “condition” (oil/tar presence, bleaching), within fixed plots over time (post spill and both six and twelve months post-spill). Teams surveyed permanent, “Long Term Monitoring” plots that already occurred within or adjacent to the approximate spill area footprint, allowing for comparison to historical data. In addition, several “Rapid Assessment” sites (sites selected specifically to incorporate the footprint of the oiling) were surveyed to collect data shortly after the spill, using the same protocols. Transects of each site was established, running the length of the intertidal zone, and representative photographs were taken within quadrats (Figure 9) placed throughout the transects. Each photograph was quantified for overall proportion of substrate type and species presence, as well as general condition (oiled/bleached) of each. A more detailed discussion of methods and results can be found in Raimondi et al. (2019).

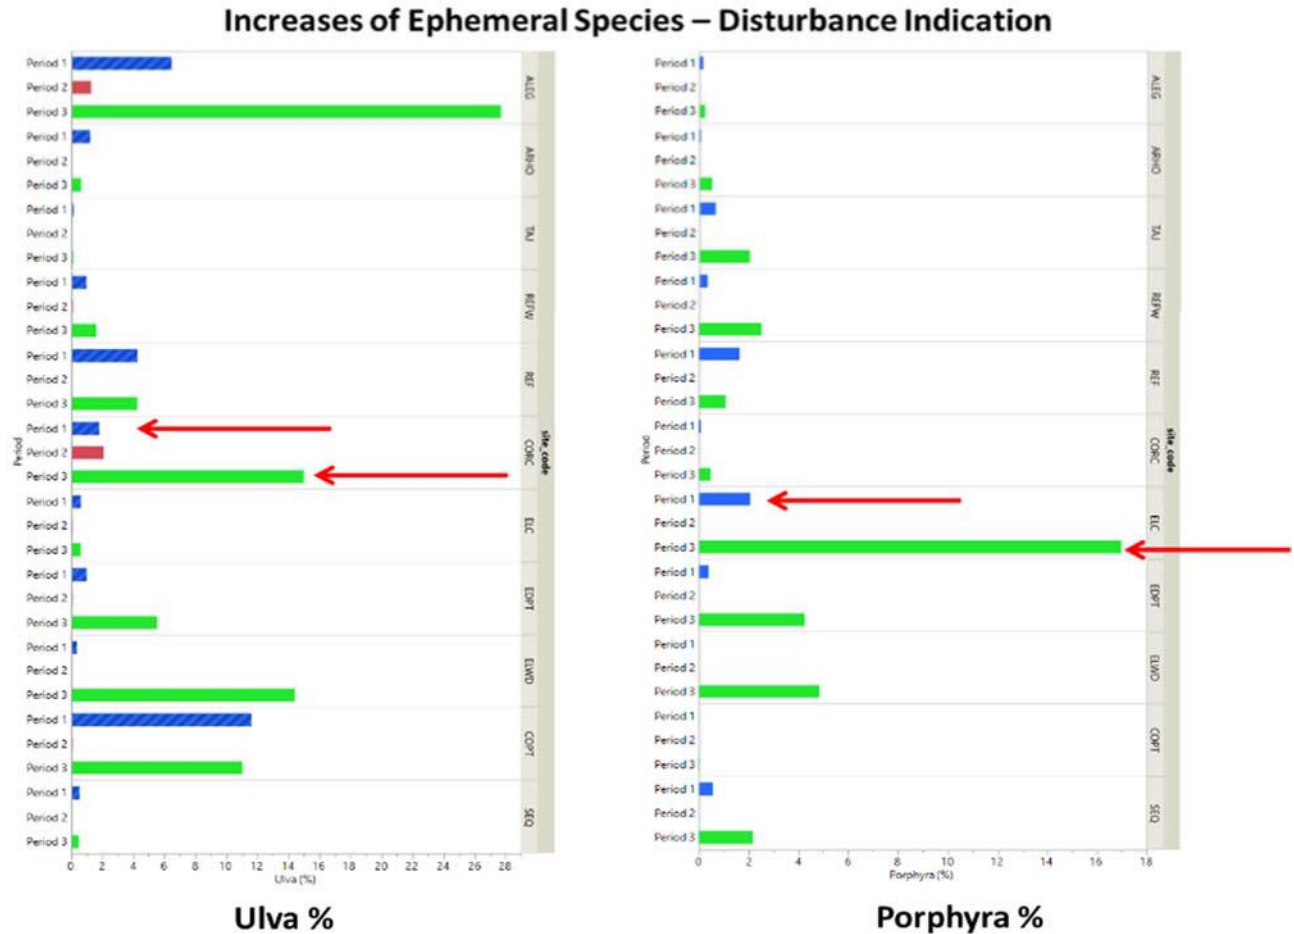
Figure 10. Proportion of *Ulva sp.* (green algae) and *Porphyra sp.* (red algae) presence across sites and time (Period 1 – post spill; Period 2 – 6mo post spill; Period 3 – 12mo post spill).

heaviest spill zone exhibited oiled biota, with some oil/tar persisting in anniversary sampling. In addition, minor community changes, including increases of algae species potentially indicative of oil-related impacts, were noted in the heaviest oiled locations when compared to less impacted sites (Figure 10).

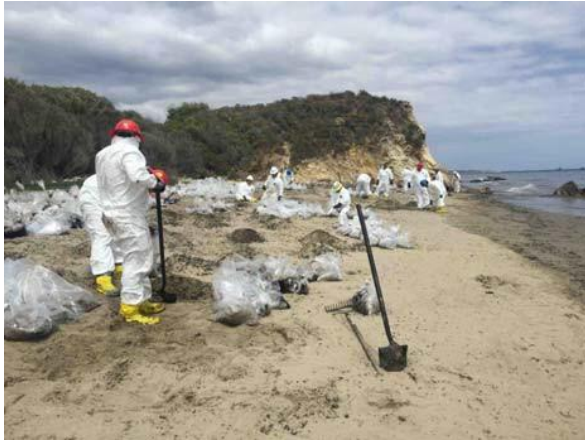
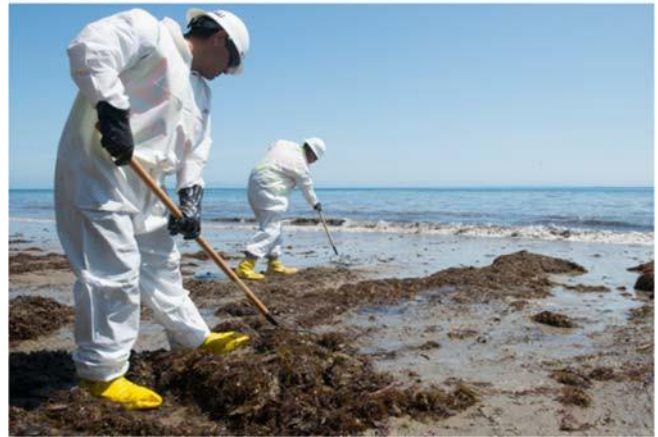
Figure 11. Manual removal of oil and oily material from sandy shorelines. Stranded kelp, also known as wrack, was one material that was removed from shorelines.

portions of the shoreline. These efforts removed oil and oily materials to a visual endpoint (Figure 11).

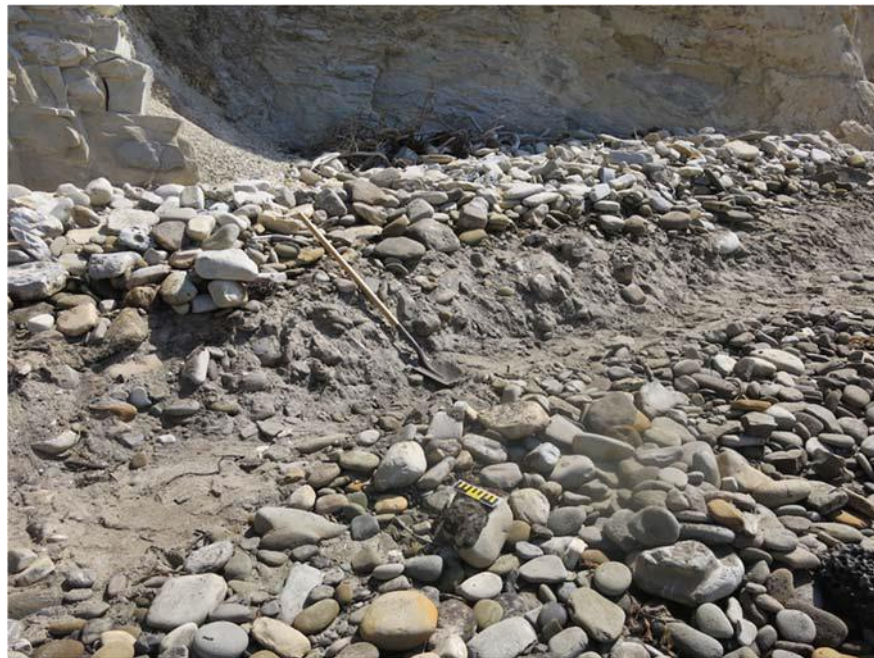
Figure 12. A highly disturbed shoreline in the process of being cleaned by the response operations workers.

Other cleanup efforts involved the scraping of rock and hard substrates on the shorelines, though crews were instructed not to remove visible biota in the process. Some cobble beaches were disassembled in the cleaning process, and cobble was placed in the surf zone for the final phase of the cleaning (Figure 12).

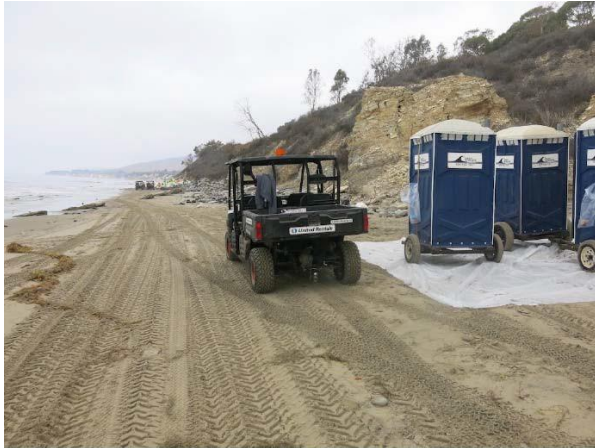
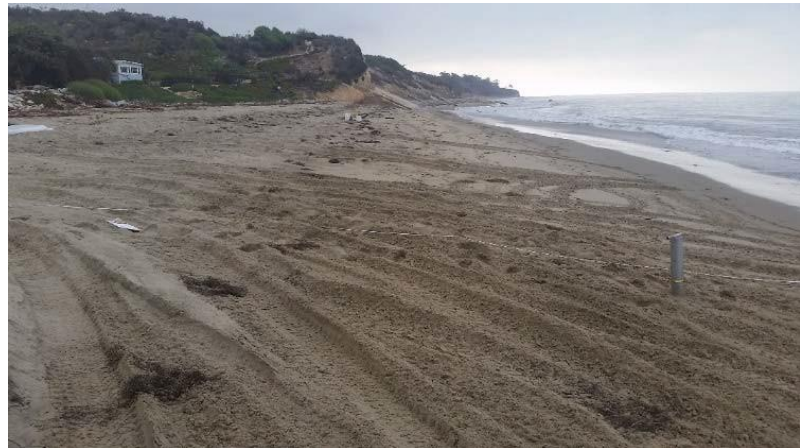
Figure 13. Vehicle use and tracks near Arroyo Quemado.

dwelling organisms such as talitrids, and left visible signs of tire tracks on the shoreline in some locations (Figure 13). Records were reviewed and summarized (Hubbard and Dugan, 2016) to estimate the amount of cleanup activity, quantified in days, on the shoreline habitats following the spill (Figure 14).

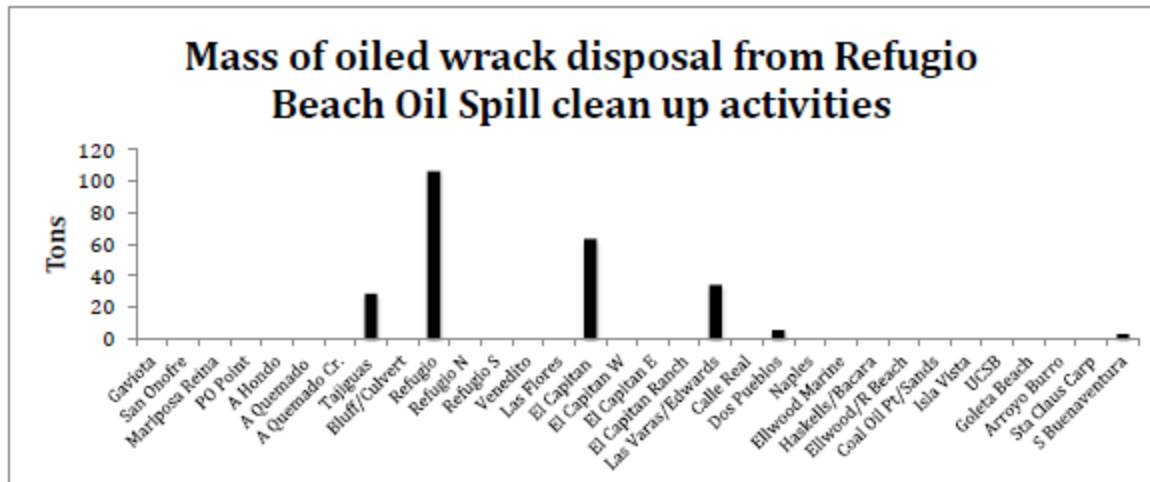
Figure 15. Mass of wrack (kelp, surf grass, and other biological materials) removed at six locations during the cleanup period. Locations are organized from West to East, or up-coast to down-coast.

The operations unit of the response effort quantified (Figure 15), the mass of oily waste removed from beaches (e.g., wrack, sand and cobble). This response operations activity directly removed wrack community organisms, as well as a food source for birds, fish, and other vertebrates that feed on the organisms in that community. These data were used in evaluating the effects of clean up activity on shoreline ecosystems.
