Coastal Watershed Planning Assessment Program

Big River Basin Assessment

November 2006

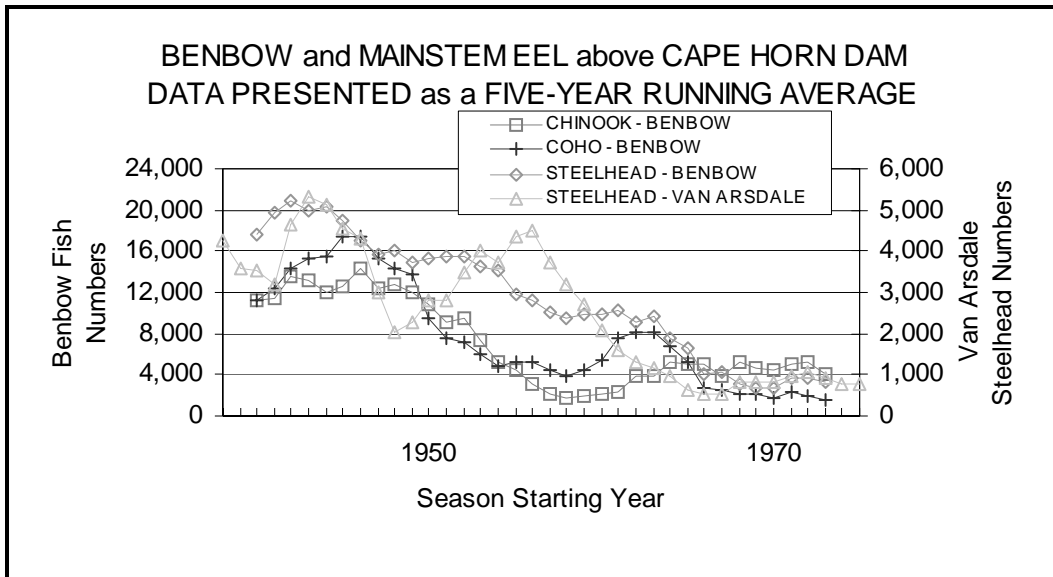
Figure 2. Five-year running average of salmonids at Benbow Dam, South Fork Eel River, and mainstem Eel River above Cape Horn Dam.

Although no long-term fish counts exist for the Big River Basin, Department of Fish and Game fish ladder counts at Benbow Dam and Cape Horn Dam, in the Eel River system, reflect an over 80% decline in coho salmon, Chinook salmon, and steelhead trout populations over the span of the last century (Figure 2, Figure 3). The Eel River, especially the South Fork Eel River, which is the location of Benbow Dam, although much larger, has similar watershed conditions and land use history to the Big River Basin. Anecdotal evidence from anglers and longtime local residents supports the likelihood of a similar decline in Big River fisheries (see Big River Basin Profile).

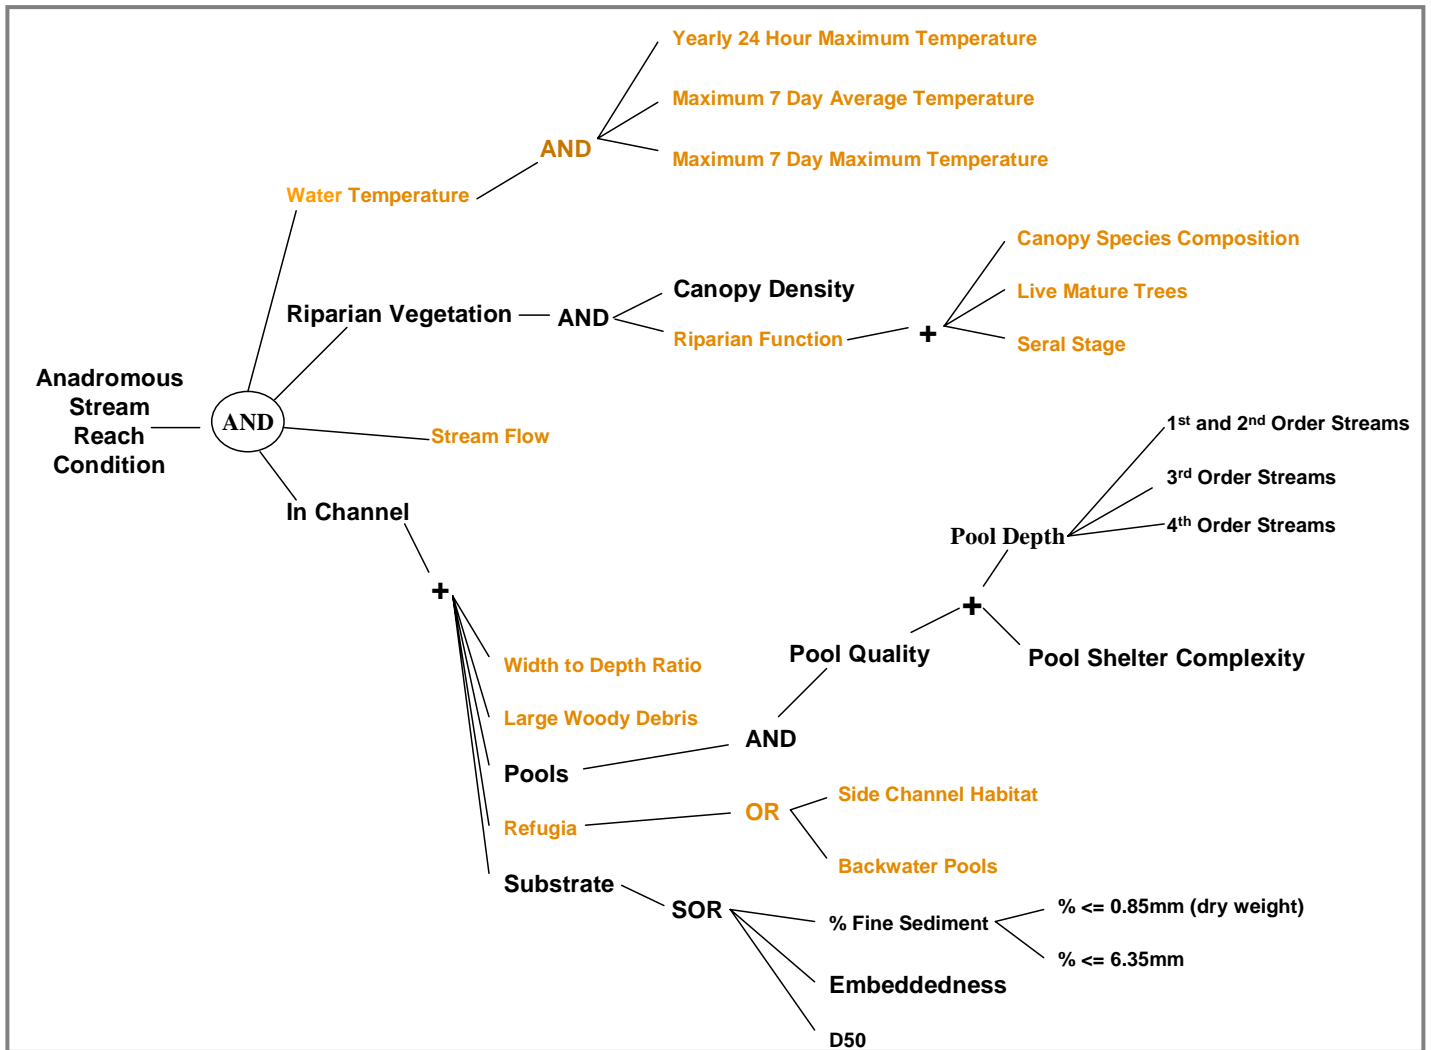
Figure 8. Graphic representation of the Stream Reach Condition model.

Although model construction is typically done top-down, models are run in EMDS from the bottom up. That is, stream reach data are usually entered at the lowest and most detailed level of the several branches of the network tree (the leaves). The data from the leaves are combined progressively with other related attribute information as the analysis proceeds up the network. Decision nodes are intersections in the model networks where two or more factors are combined before passing the resultant information on up the network (Figure 8).

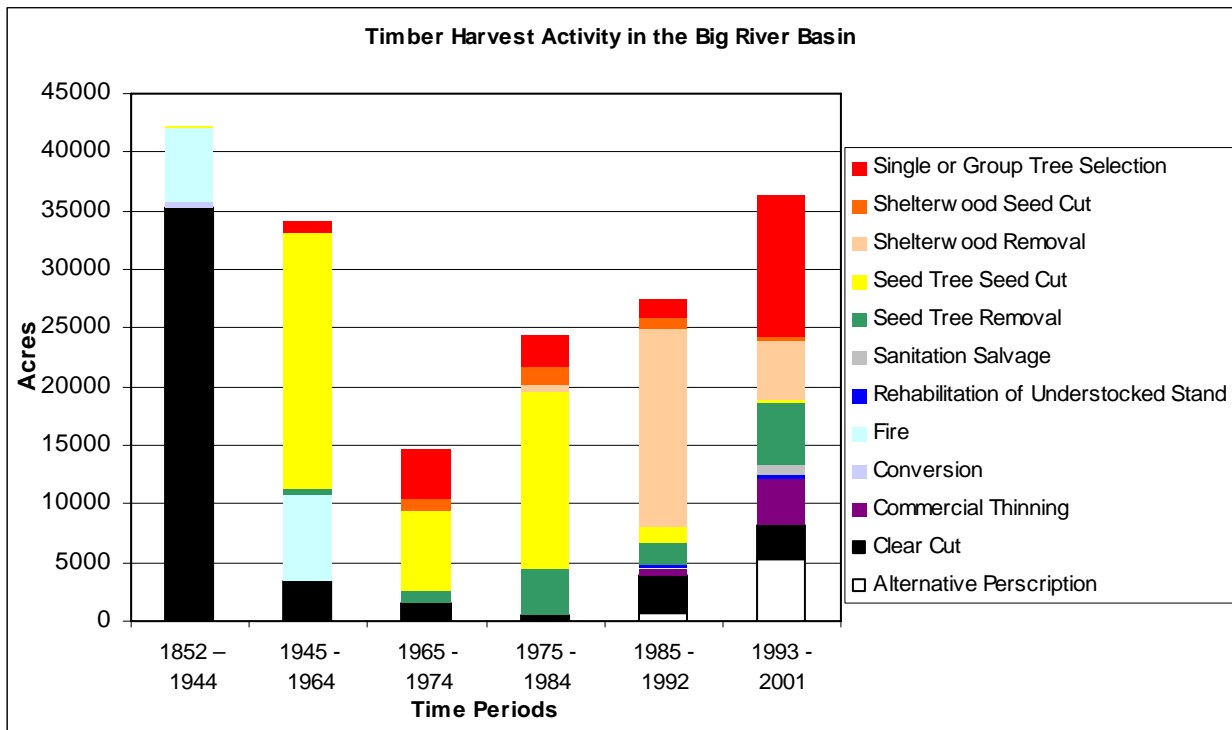
Figure 32. Acres of timber harvest activities in the Big River Basin.

Today a myriad of silvicultural practices are used to manage the young growth stands, resulting in more partial cutting with greater vegetation retention over the landscape and less disturbance in any one area (Figure 32). Clearcuts have been reduced in size from continuous, extensive areas to discrete units typically less than 30 acres in size. Buffers between even-aged management units were also required during this time period as part of the new rules.

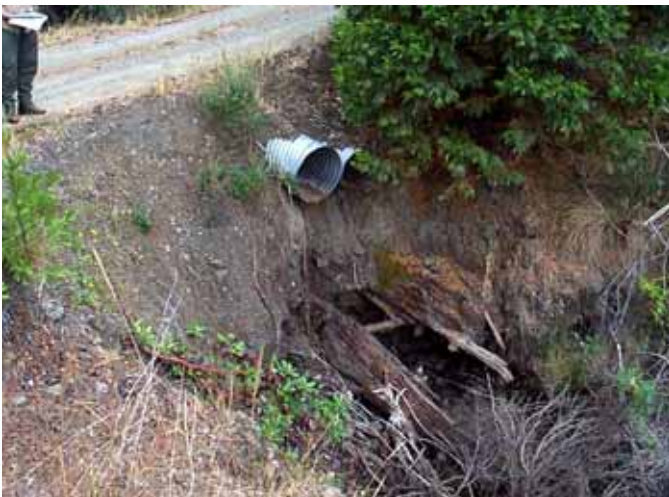
Figure 36. Watercourse crossing at high risk of failing.

Some of the techniques being used currently for abandonment of roads include the removal of watercourse crossings and re-contouring of the road prism (Figure 36, Figure 37 and Figure 39). Additionally, the number of roadside turnouts and large landings used for large old growth logging are being reclaimed (Figure 38).

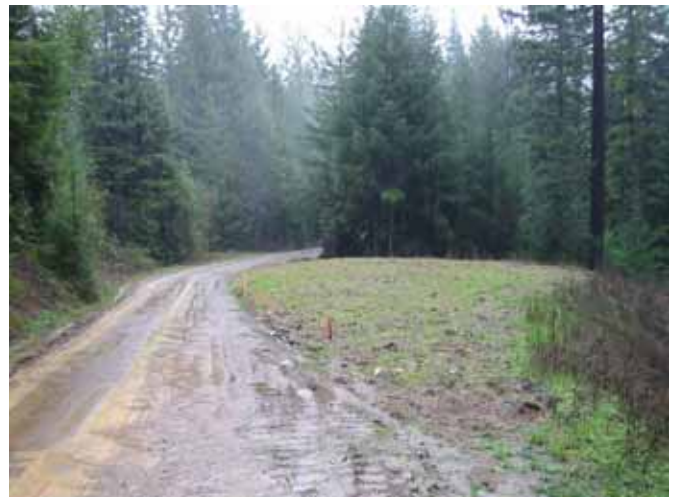
Figure 38. Reclaimed landing on mainline road.

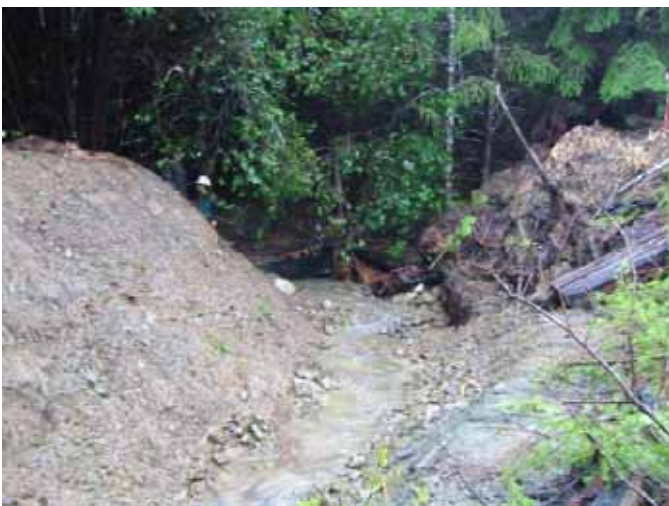
Figure 37. Legacy watercourse crossing removal.

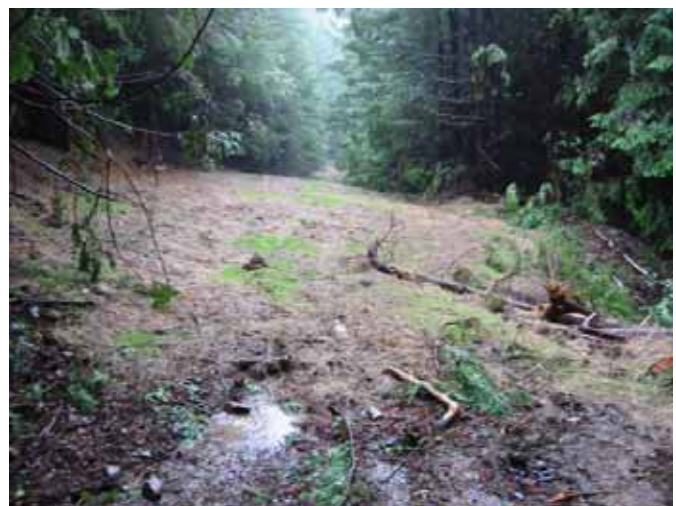
Figure 39. Abandoned road re-contoured to natural slope.

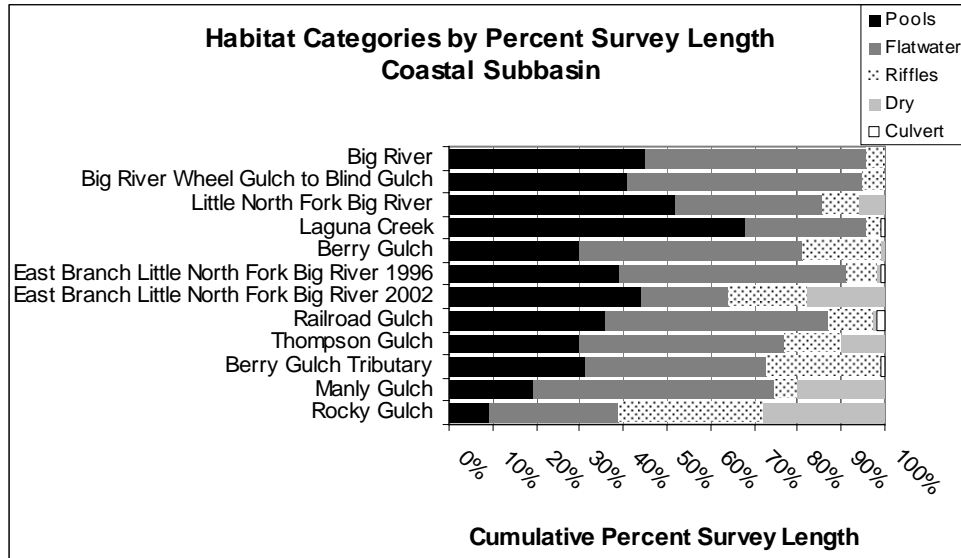
Figure 71. The percentage of pool habitat, flatwater habitat, riffle habitat, dewatered channel, and culverts by survey length in the Coastal Subbasin.

20% pool habitat by length (Figure 71). Dry units were measured and indicate a lack of habitat for fish. Culverts were also measured on four streams.
