Vegetation mapping and monitoring at wetland restoration sites in the Delta and Suisun Marsh

Aicha Ougzin, Fish Restoration Program, California Department of Fish and Wildlife

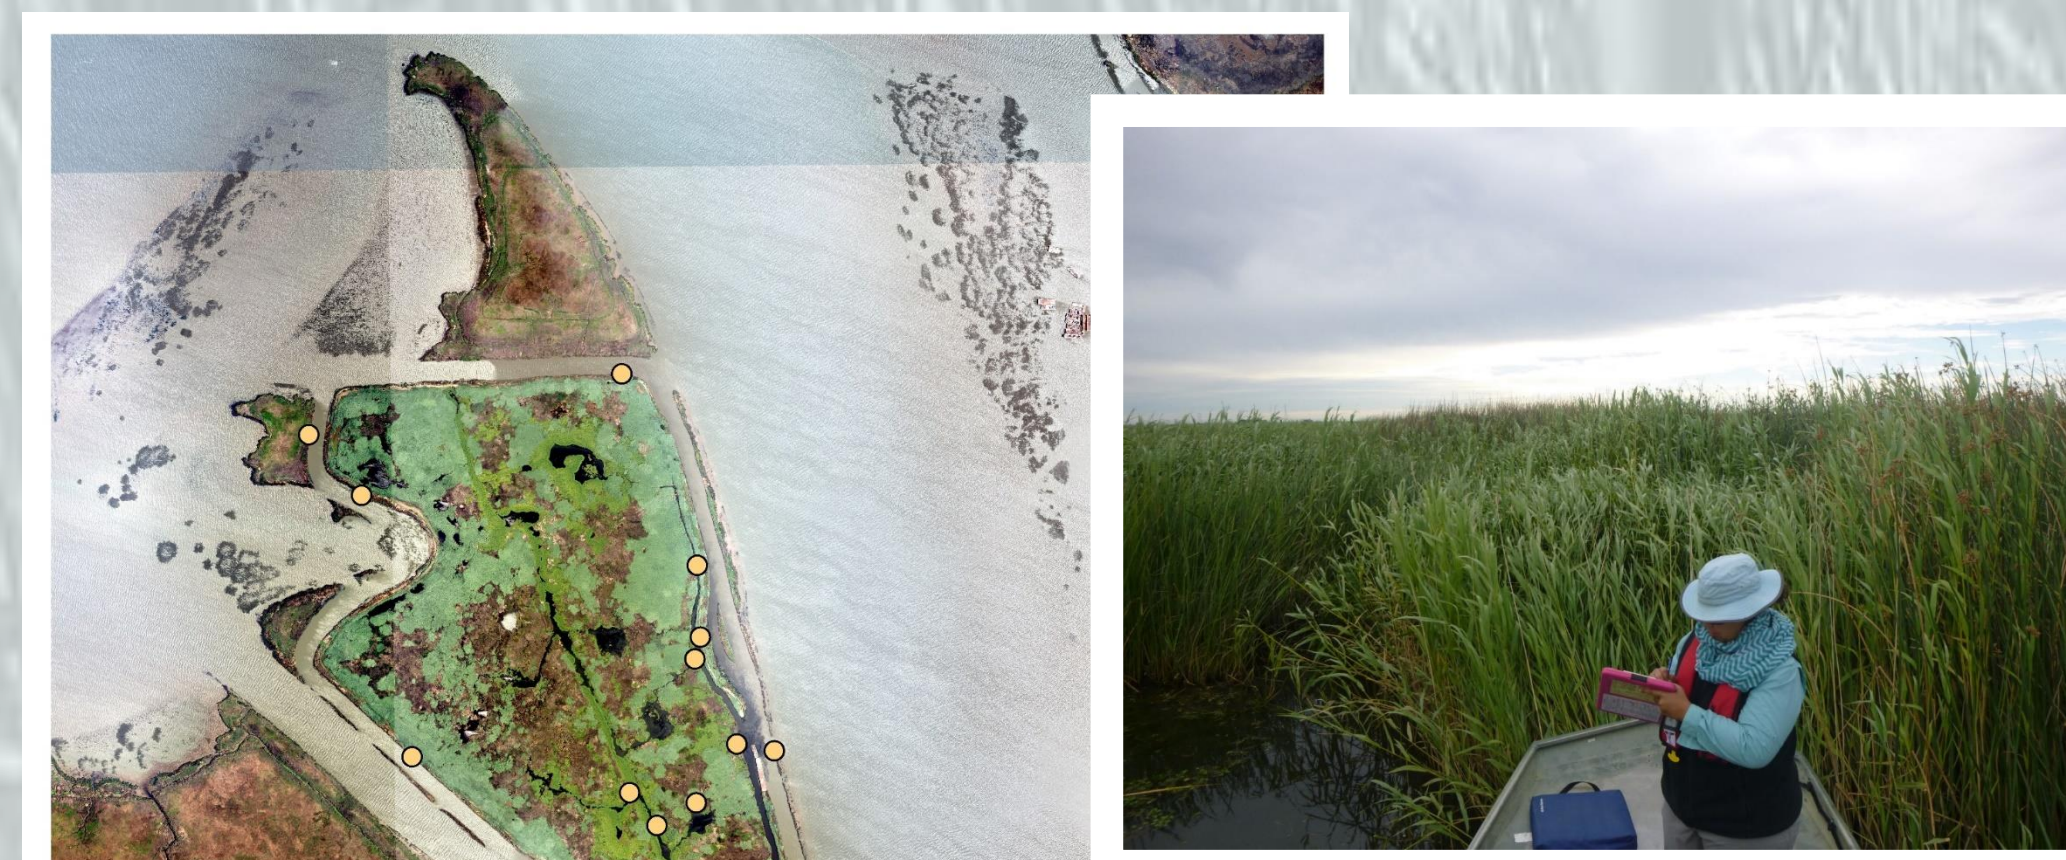
Survey Form Field	Value
Waypoint ID	PEN1808130910
Surveyors	AO, JM
Date	8/13/2018
Location Name	Winter Island
Coordinates	600377E, 4211519N
Photos	FRP: 581-584-N-W
Stand Size	1-2 acres
Field Alliance/Association	Phragmites australis
Comments	Dense Phragmites australis with mix of Schoenoplectus acutus and Schoenoplectus californicus.
Tree Cover	0%
Tree Height	N/A
Tree dbh	N/A
Shrub Cover	0%
Shrub Height	N/A
Herb Cover	70%
Herb Height	2-5m
Non-native Plant Cover	High >66%
Species Cover	Phragmites australis 70%, Schoenoplectus acutus 10%, Schoenoplectus californicus 15%

Figure 3. Field surveys were conducted at both restoration and reference sites in the Spring/Summer of 2018 and 2019. Yellow points represent locations where vegetation surveys were conducted. At each survey point vegetation cover, plant species composition and photographs were collected to aid in vegetation mapping.

Pre-construction field surveys were conducted in the spring and summers of 2018 and 2019.

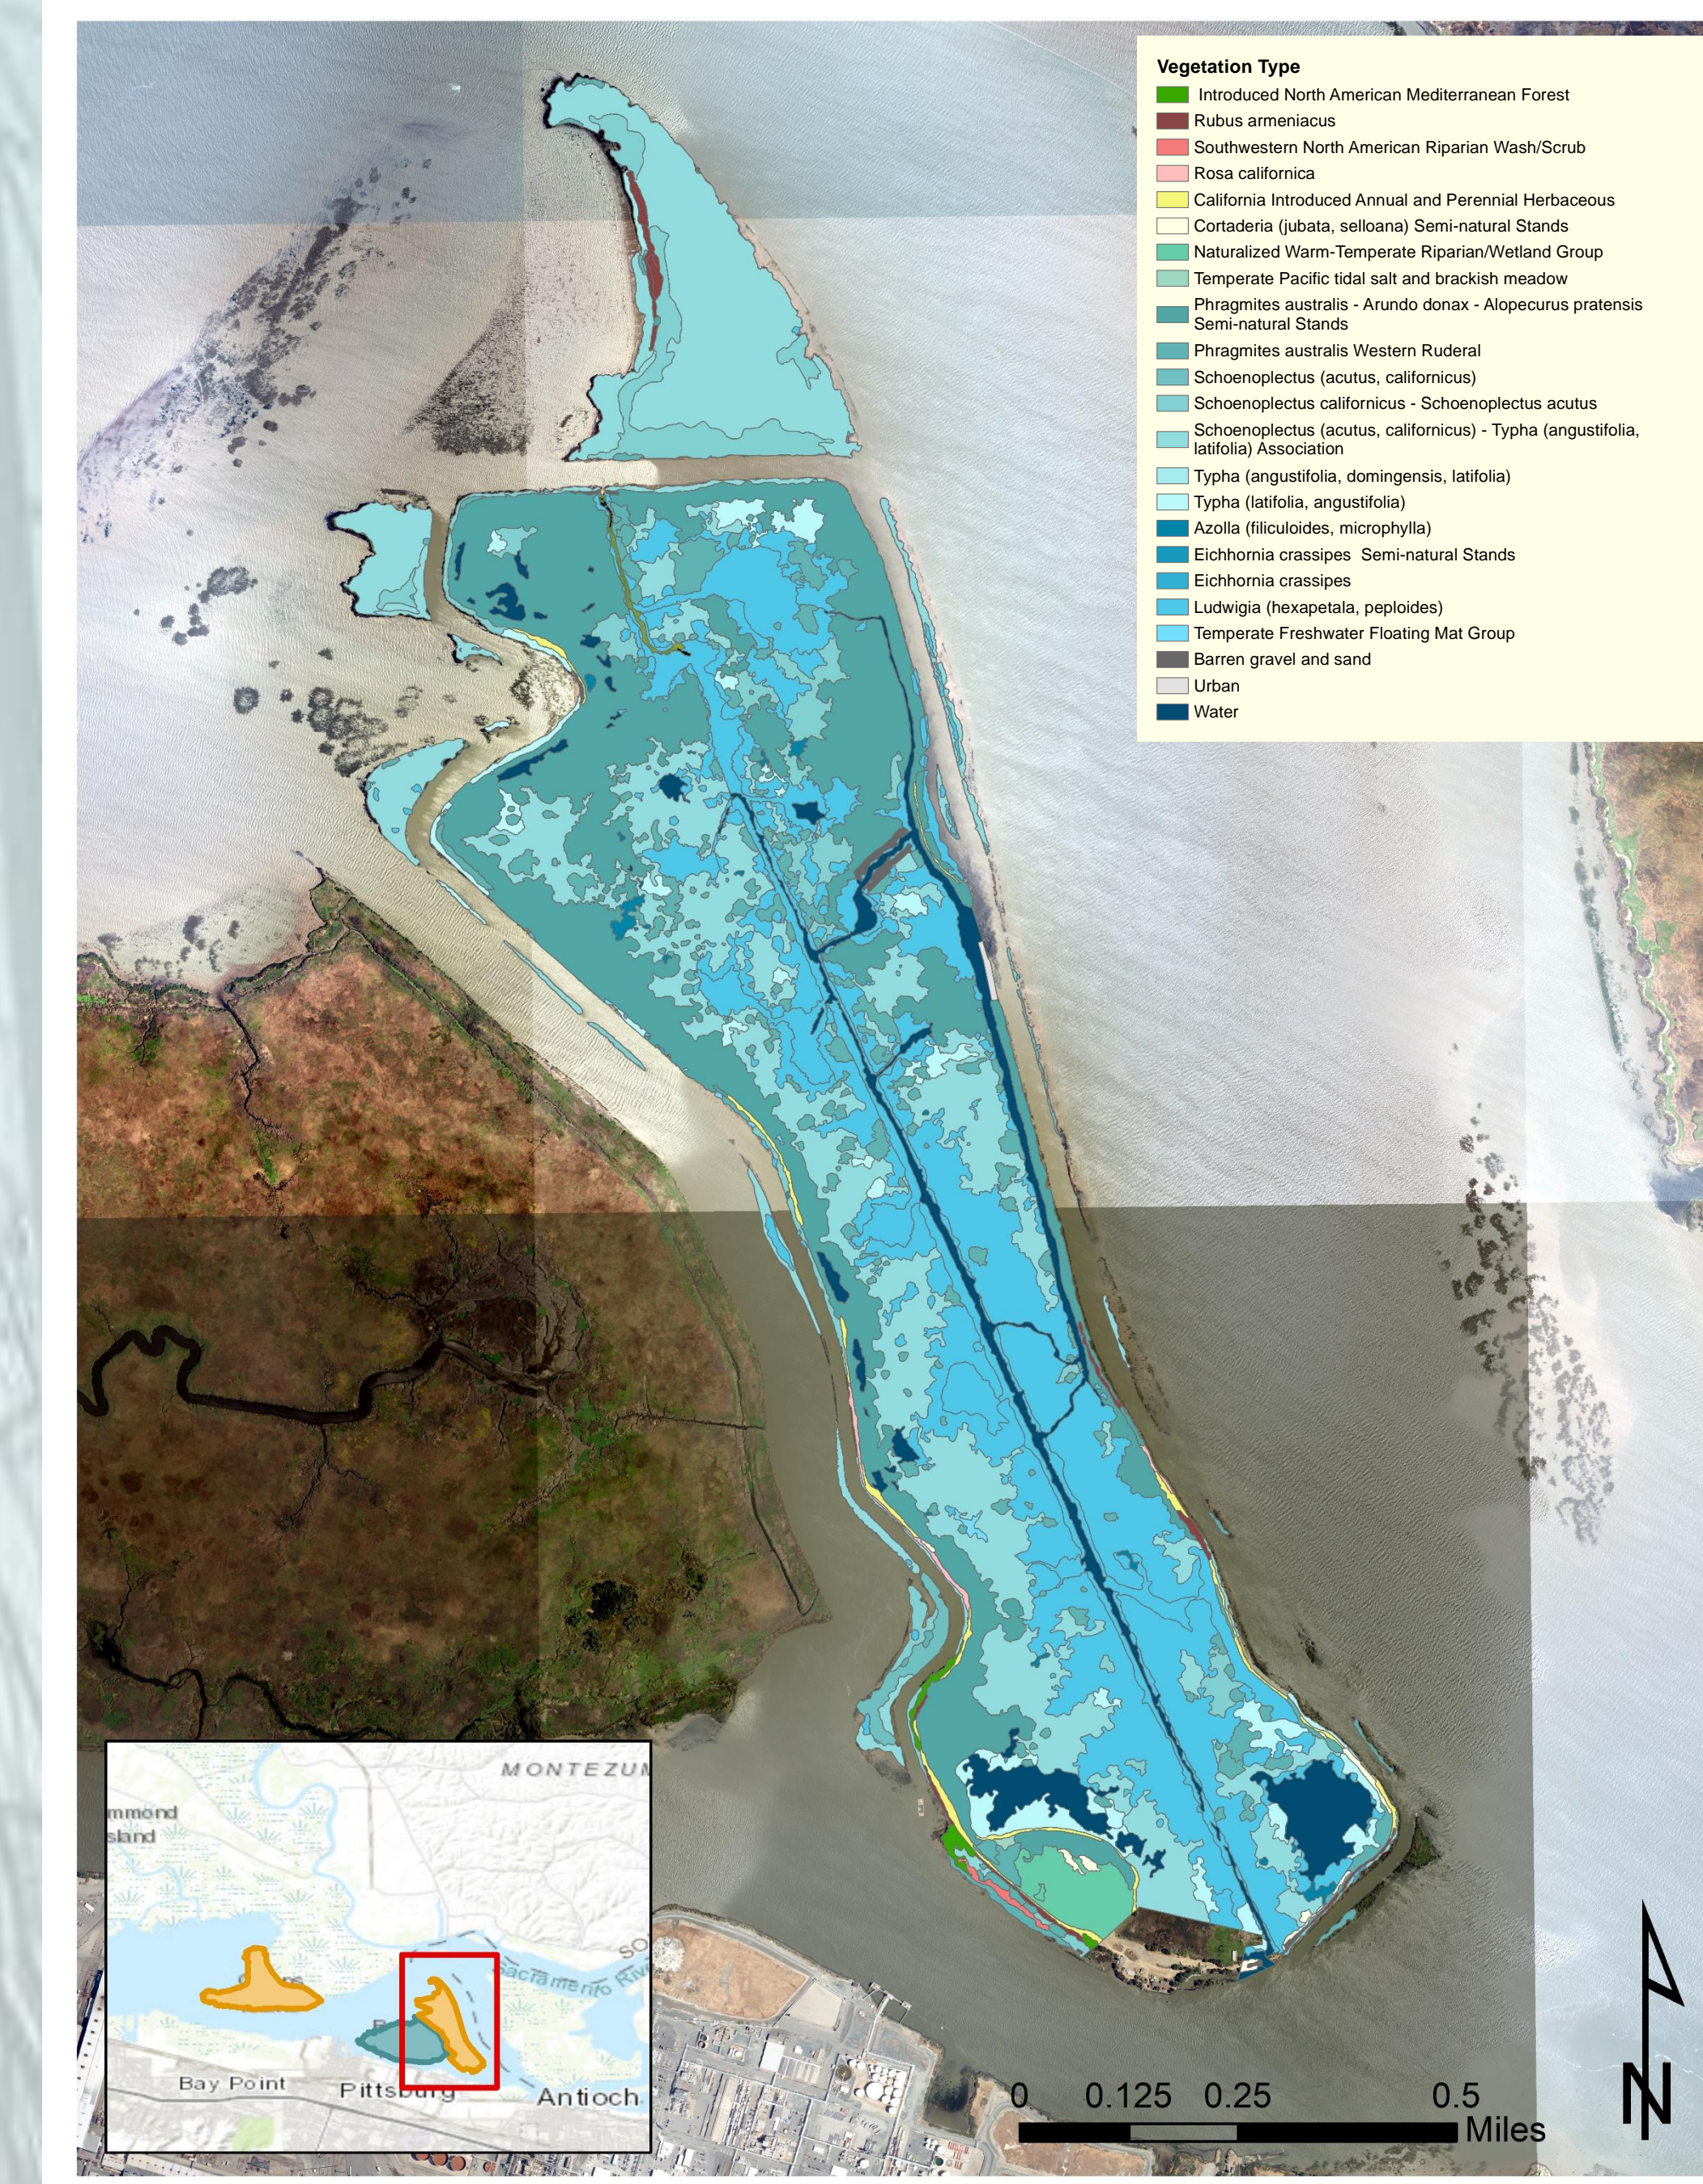
Figure 4. Post-restoration vegetation map of Winter Island. Each colored polygon represents a mapped vegetation type. This vegetation map was created using 0.75-in resolution imagery collected by CDFW with a drone. Each mapped polygon is assigned attribute values, including percentage vegetation cover, vegetation height and percentage of invasive species cover. Polygons were mapped and attribute values assigned using a combination of information obtained during field surveys and photointerpretation of the aerial imagery.

Pre-construction vegetation maps were completed for all restoration sites and reference sites. Restoration projects were completed at 4 sites in 2018 and 2019 and post-construction (as-built) vegetation maps were completed for each of these sites.

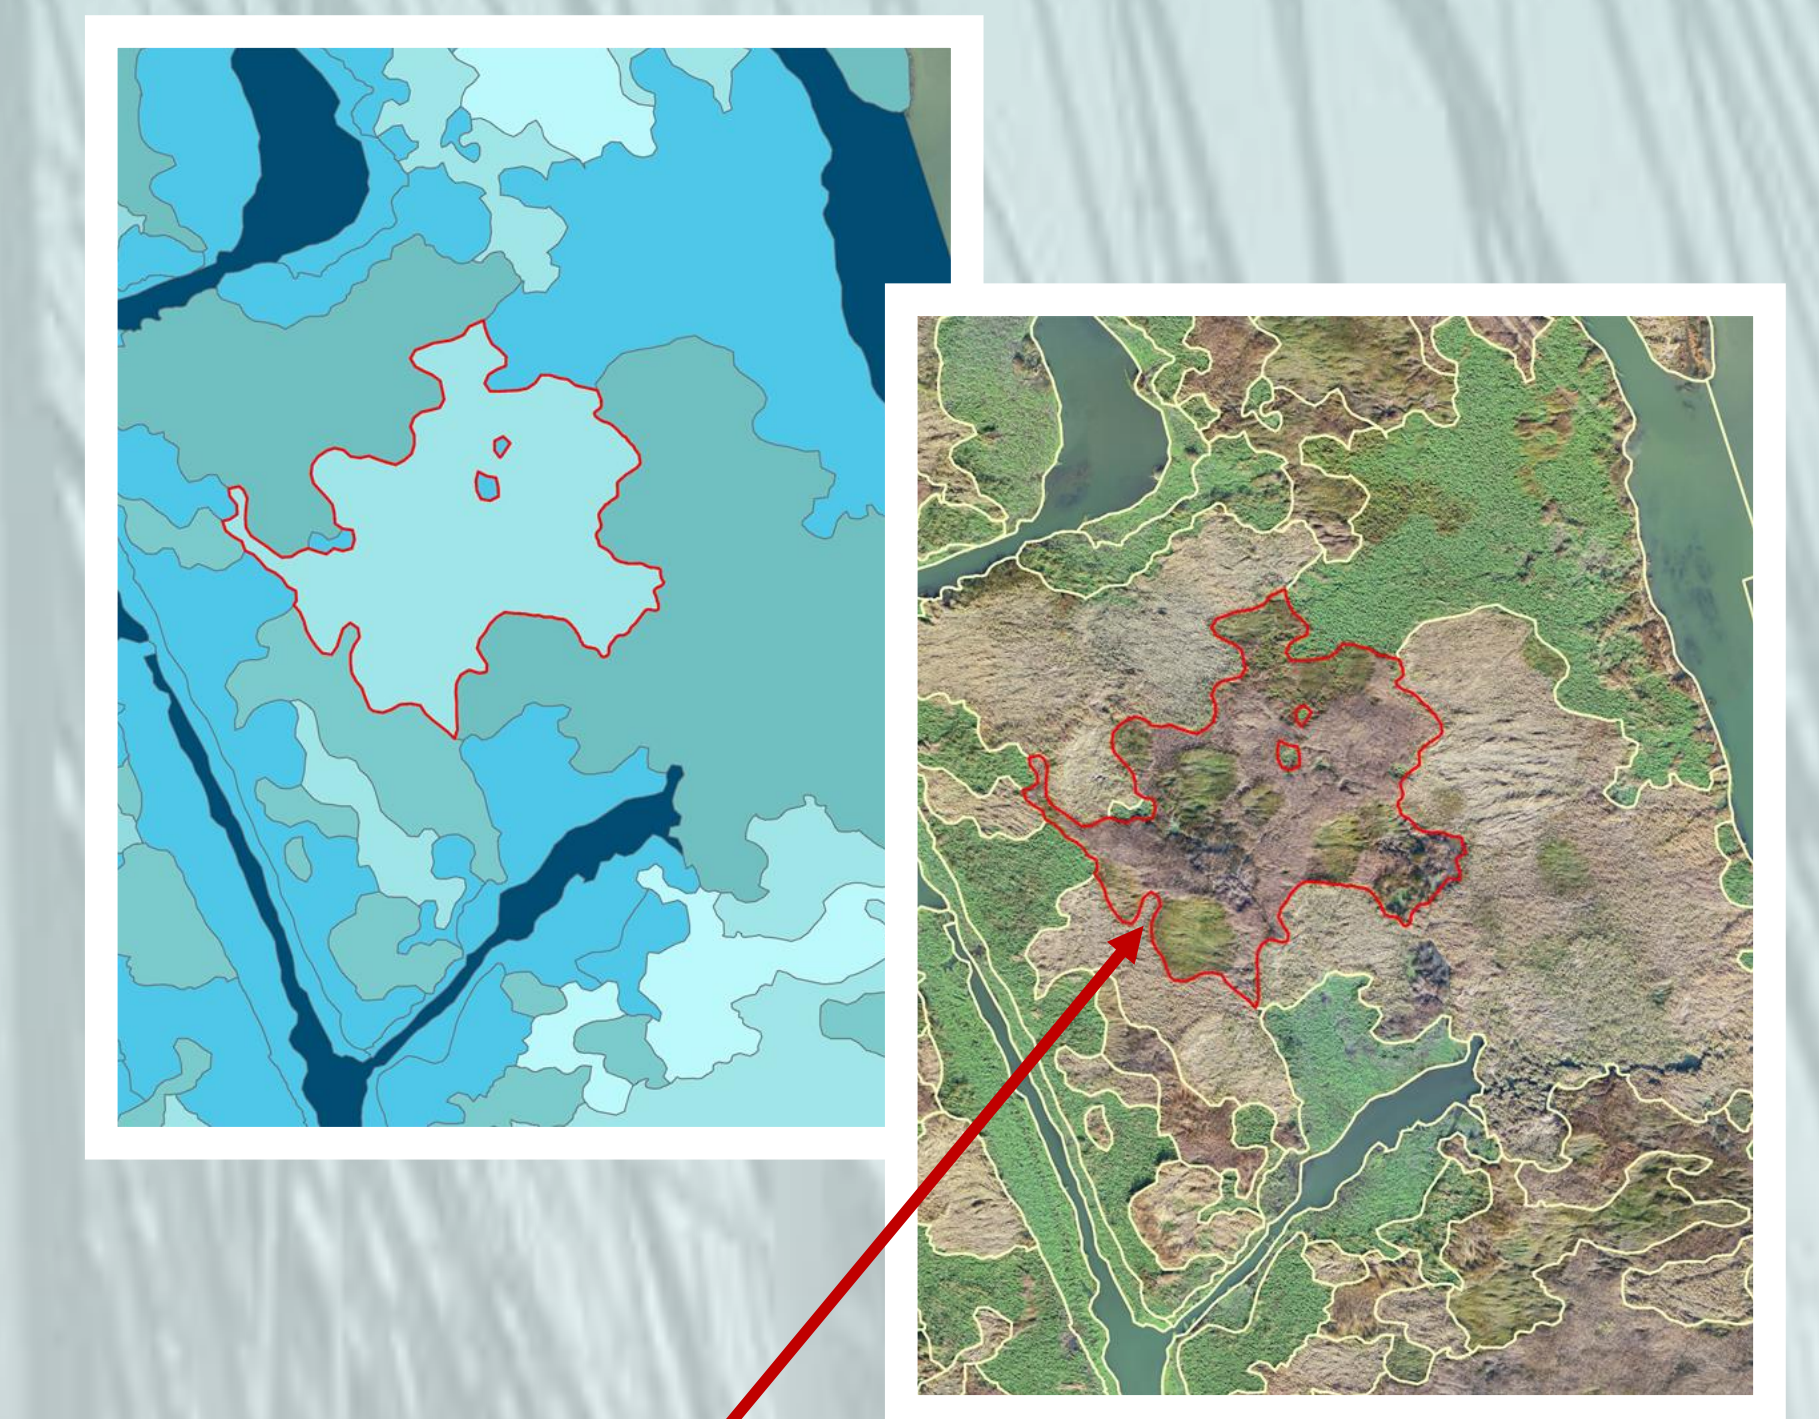
Map Attribute	Value
Map Unit	Schoenoplectus (acutus, californicus) - Typha (angustifolia, latifolia) Association
Height Class	2-5m
Size Class	NA
Hardwood Cover	0
Conifer Cover	0
Total Tree Cover	0
Shrub Cover	0
Herb Cover Class	>59%
Total Veg Cover	65%
Invasive Plant Cover	No Invasive =<5%
Isolated Tree	No
Restoration	No
Clearing Disturbance	No Disturbance =<5%
Lepidium	No
Ludwigia	Yes
Comments	Sub mmu patches of Typha sp within stand, patches of Ludwigia sp in stand that are too small to map
Method ID	Photo Interpretation
Acres	2,146738
