THE STATUS OF BANK SWALLOW POPULATIONS
ON THE SACRAMENTO RIVER, 1986.

Joan M. Humphrey and Barrett A. Garrison

^{1/} Wildlife Management Division Contract Final Report. Supported by California Endangered Species Tax Check-off Program, Nongame Bird and Mammal Section, California Department of Fish and Game. Additional study funding provided by U.S. Army Corps of Engineers, Sacramento Division, and the Department of Water Resources.

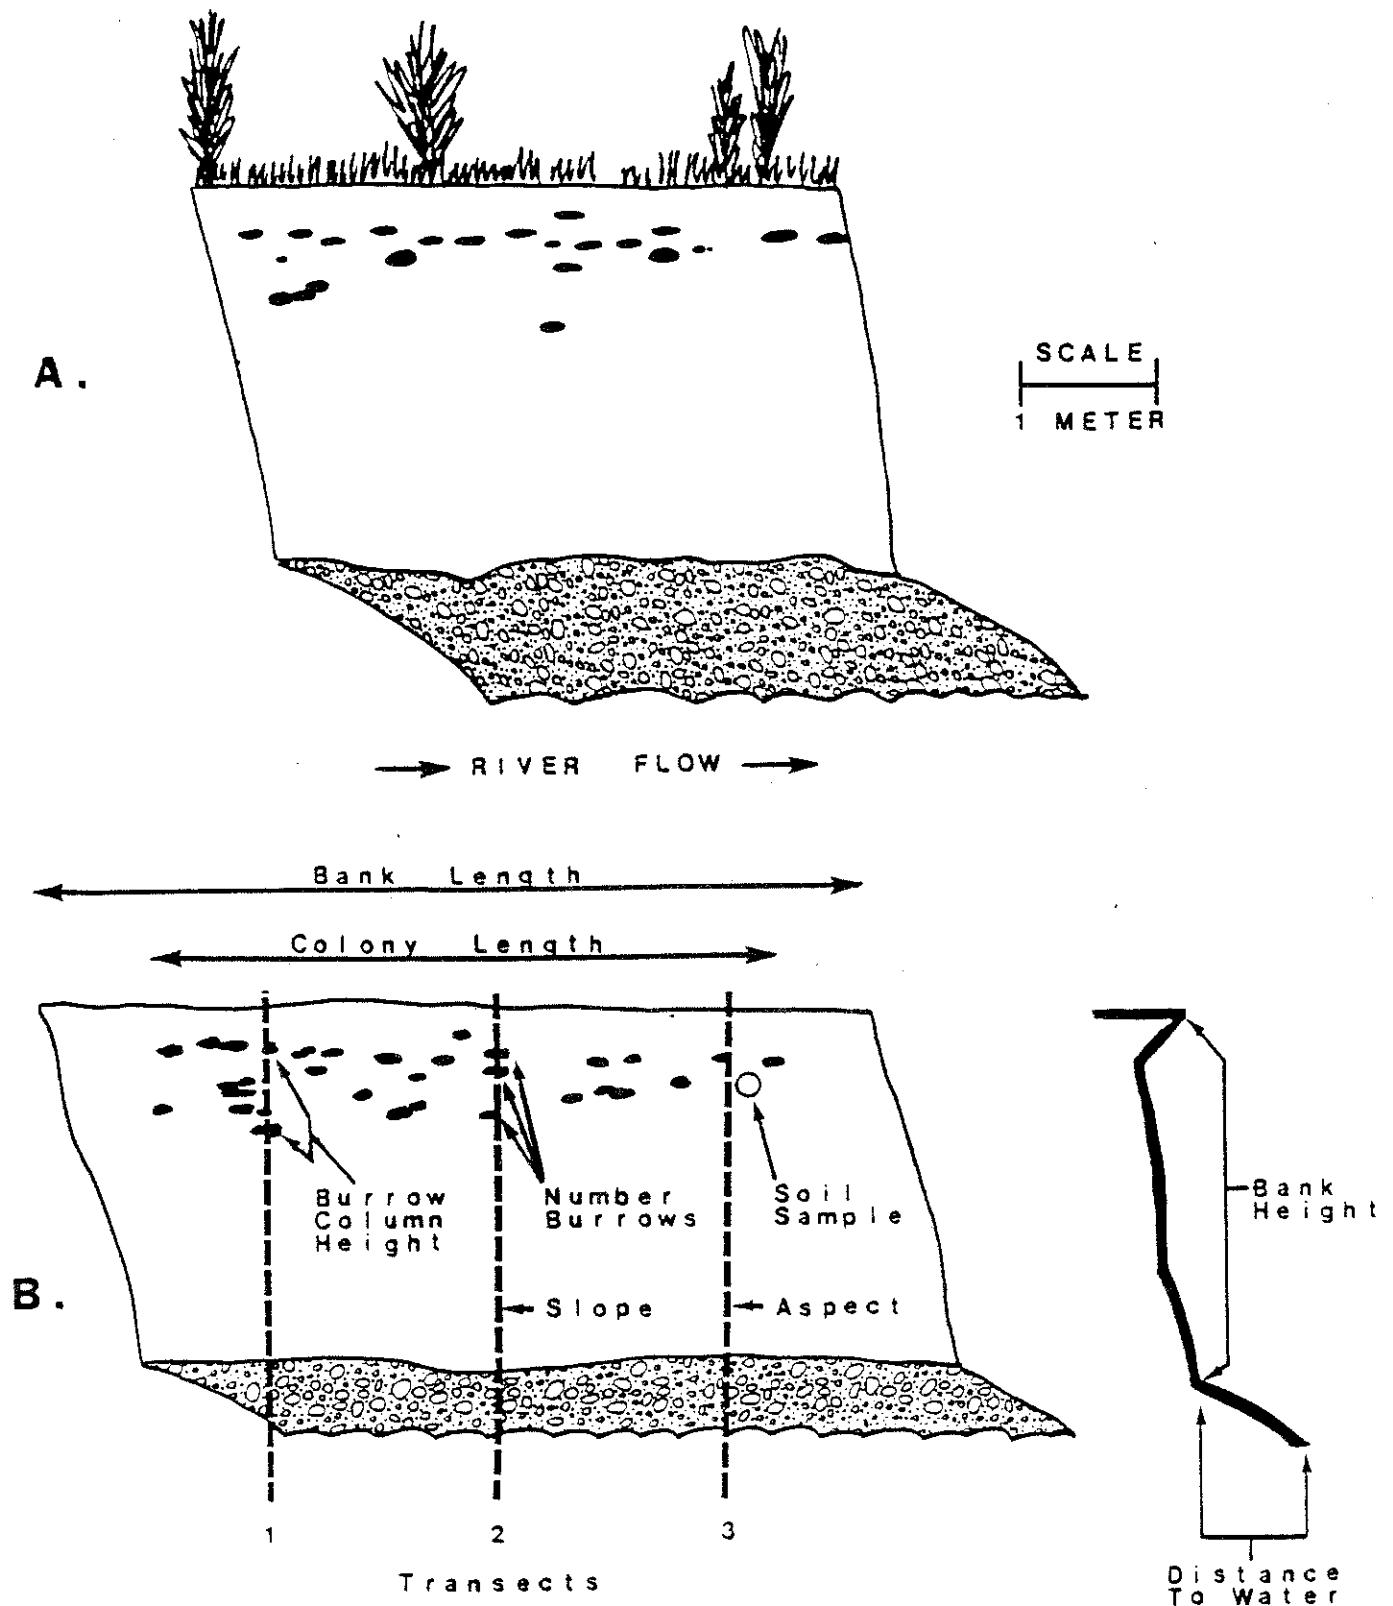
Figure 2. A) Front view diagram of bank section of a typical Bank Swallow colony on the Sacramento River, 1986, illustrating a Swiss cheese appearance. B) Front and side view diagrams of Bank Swallow colony illustrating habitat sampling design.

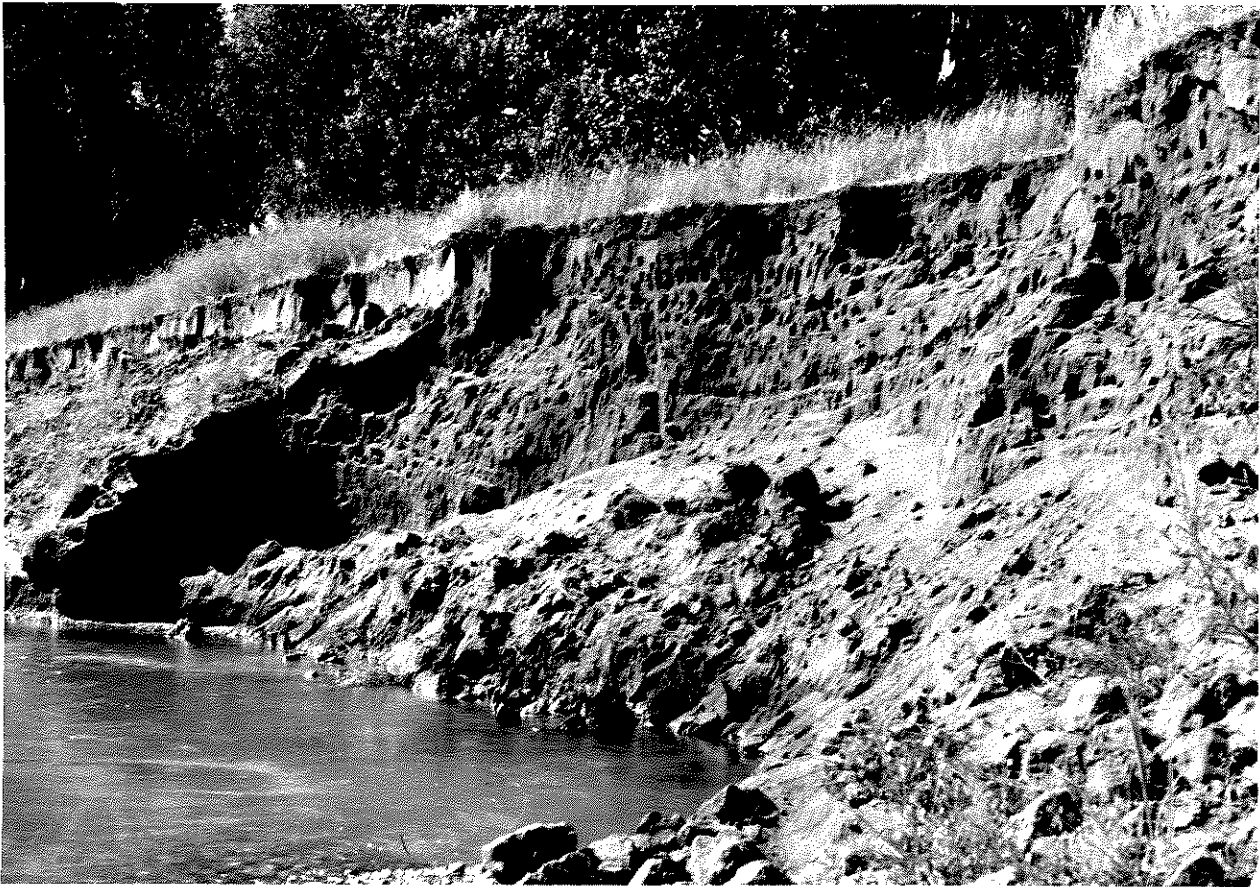
Figure 7. Example of a typical medium sized (131-375 burrows) Bank Swallow colony on an outer bend of the Sacramento River with a forested area immediately above and behind the site.

Except for a sandstone bluff at RM 280, all Sacramento River Bank Swallow colonies were found in recently eroded vertical riverbanks. Bank Swallows showed a preference for the outer curves of the river bank where erosion is heaviest (Hamblin 1975). We found 44 (73.3%) of the 60 colonies on outer bends, 9 (15.0%) were on straight reaches of the river, and 7 (11.6%) were on inner bends. Of the breeding pairs, 14,266 (88.3%) were found on outer bends, 1220 pairs (7.6%) were on inner bends, and 663 pair (4.1%) were on straight reaches of the river. This tendency toward outer bank selection was most obvious within the meandering area between RM 243-143, where 35 (81.8%) of the 44 colonies and 12,695 (92.4%) of the 13,737 breeding pairs nested on outer bends (Figure 7).

Bank Swallow colonies we located on the Sacramento River were relatively similar in appearance (Table 4, Figures 7 & 9). The 3-4 m (10-13 ft) tall, vertically eroded riverbanks were usually devoid of green vegetation and at water's edge. We estimated roots present in 33.7% of the colonies. The typical colony had burrows occupying only 15% of the bank's vertical face, with 20% of the bank above and 65% of the bank below the colony. The average

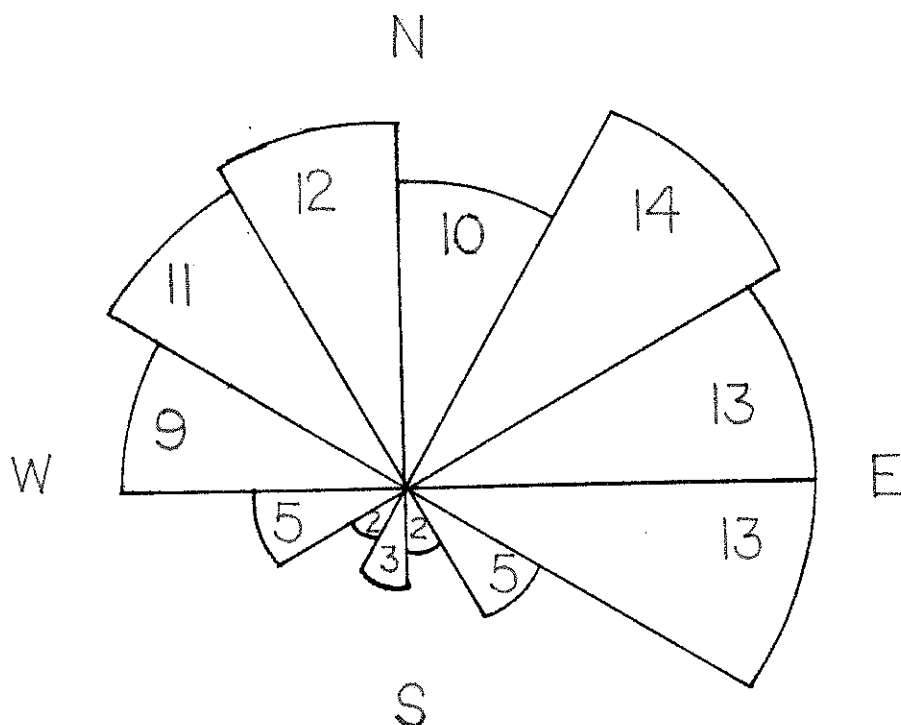
Figure 8. Orientation (compass direction faced) of burrow entrances from 99 transects taken at 32 Bank Swallow colonies on the Sacramento River, 1986.

Most (82%) of the 99 transects sampled at Bank Swallows colonies faced directions other than South or Southwest (Figure 8). Further study is needed to determine the cause for this preference. Soil moisture and bank availability may play roles in colony orientation.

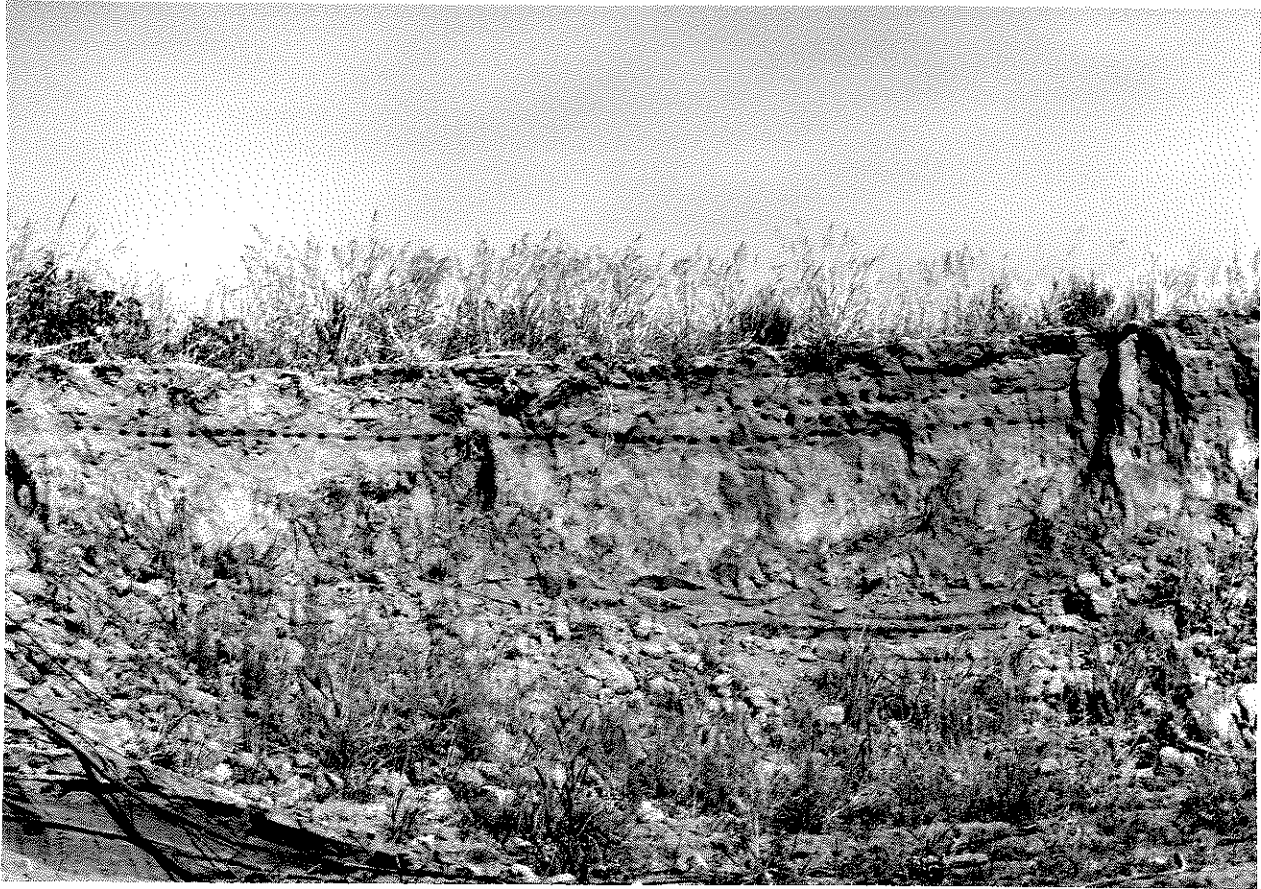
Figure 9. Example of a typical Bank Swallow colony showing marked stratification of burrow locations and open habitat immediately above and behind the site.

Most (73.8%) of the 88 Bank Swallow burrows analyzed were located in evenly textured silty loam to sandy loam soils (Table 6). The mean bulk density of soils samples ($N = 88$) was 1.23 ± 1.2 grams/cc, a loam soil (Hausenbuiller 1978). Bank Swallows were not found burrowing in coarser soils or soils mixed with small rocks or pebbles. The typical colony had burrows in narrow layers of softer silty or sandy soil sandwiched between layers of other soils (Figure 9).

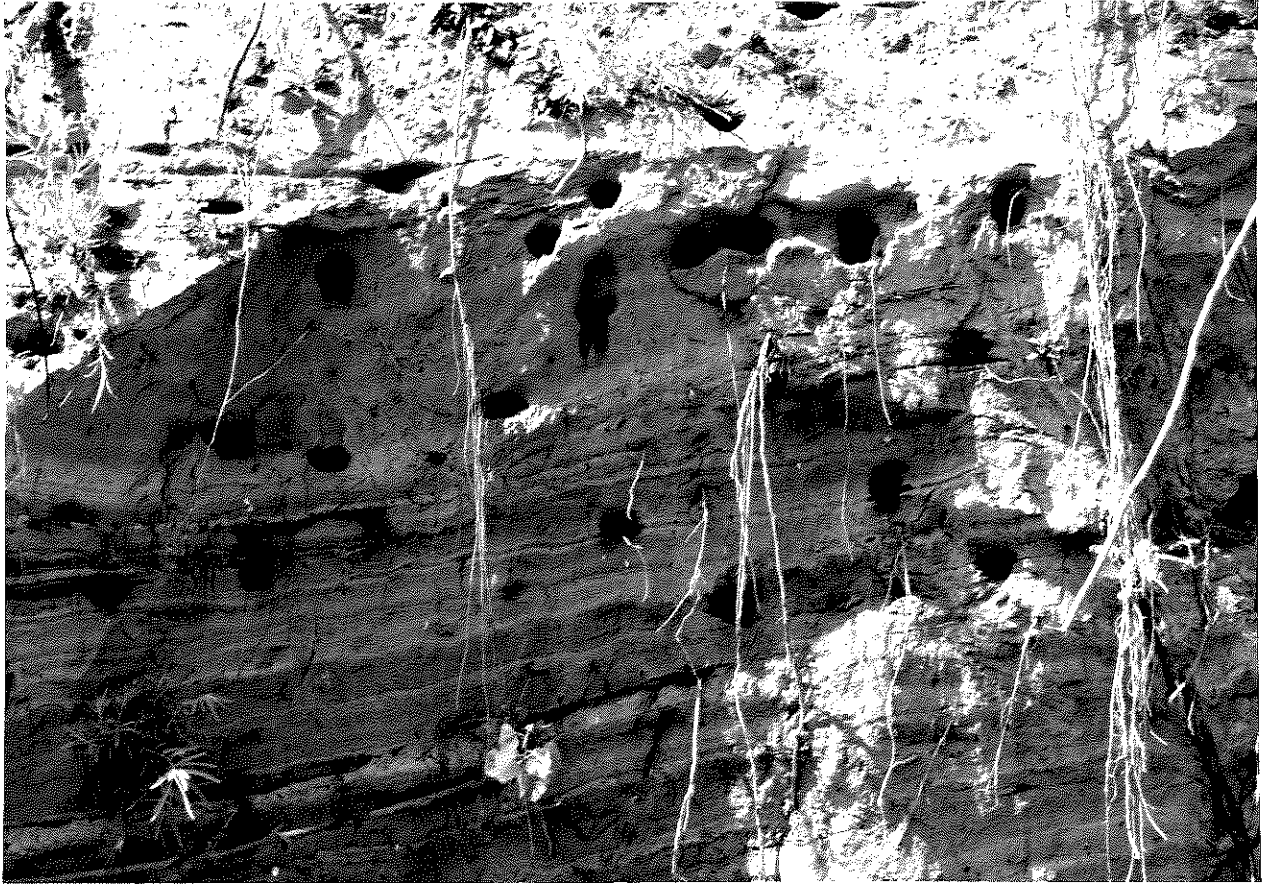
Figure 10. Typical view of a portion of a Bank Swallow nesting colony showing soil stratification and size and distance relationships of individual burrows.

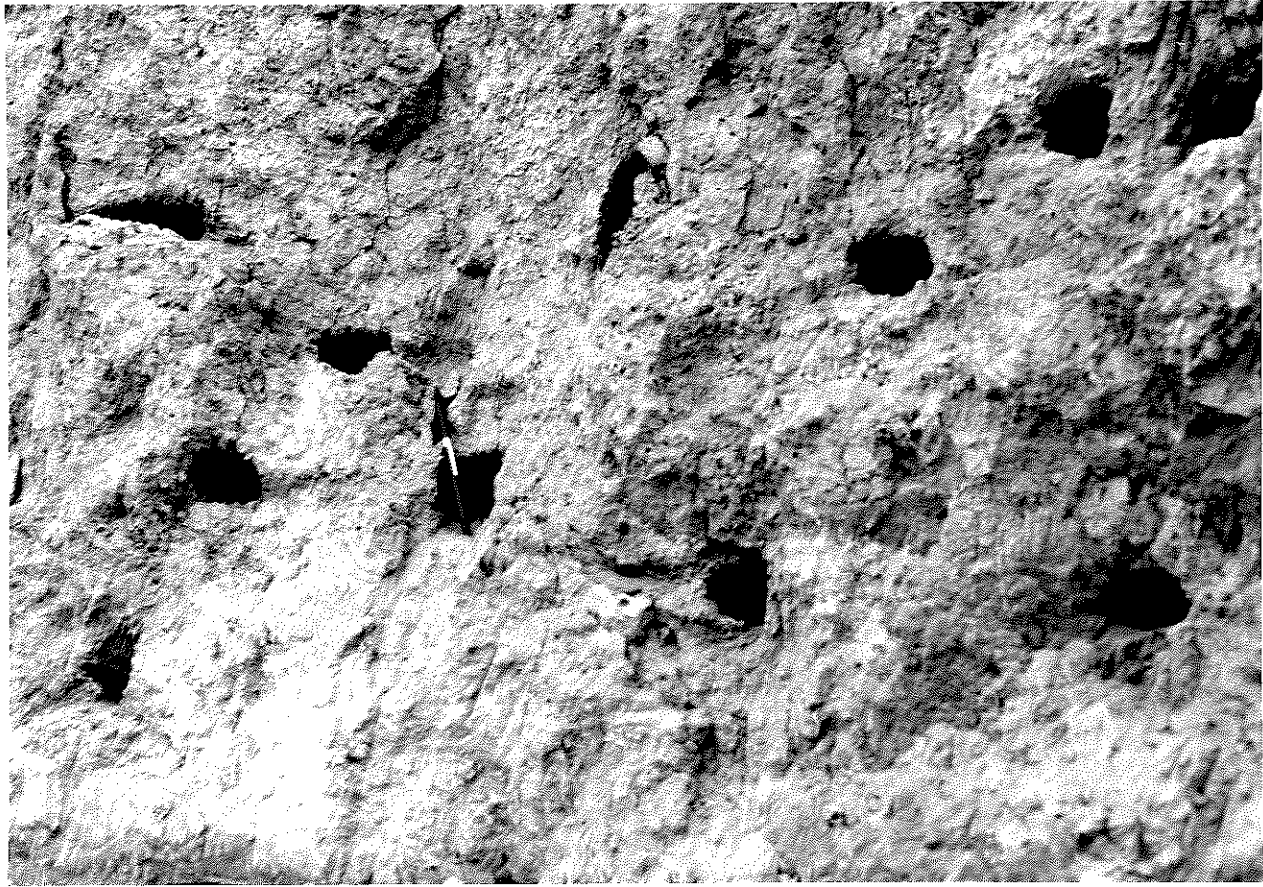
Figure 11. Example of relative size of Bank Swallow burrows (see pen) and spacing pattern and distance between burrows.

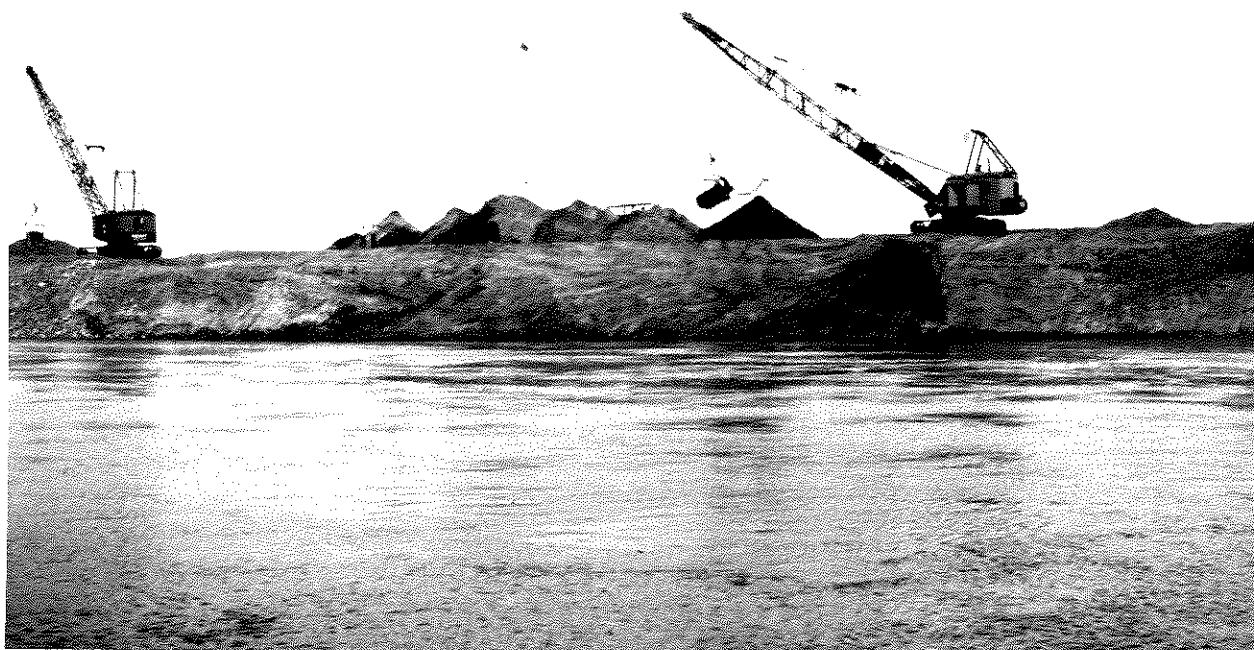
Figure 12. Bank stabilization activities of State and Federal agencies, such as those depicted here, have the potential to eliminate much of the remaining Bank Swallow habitat on the Sacramento River.

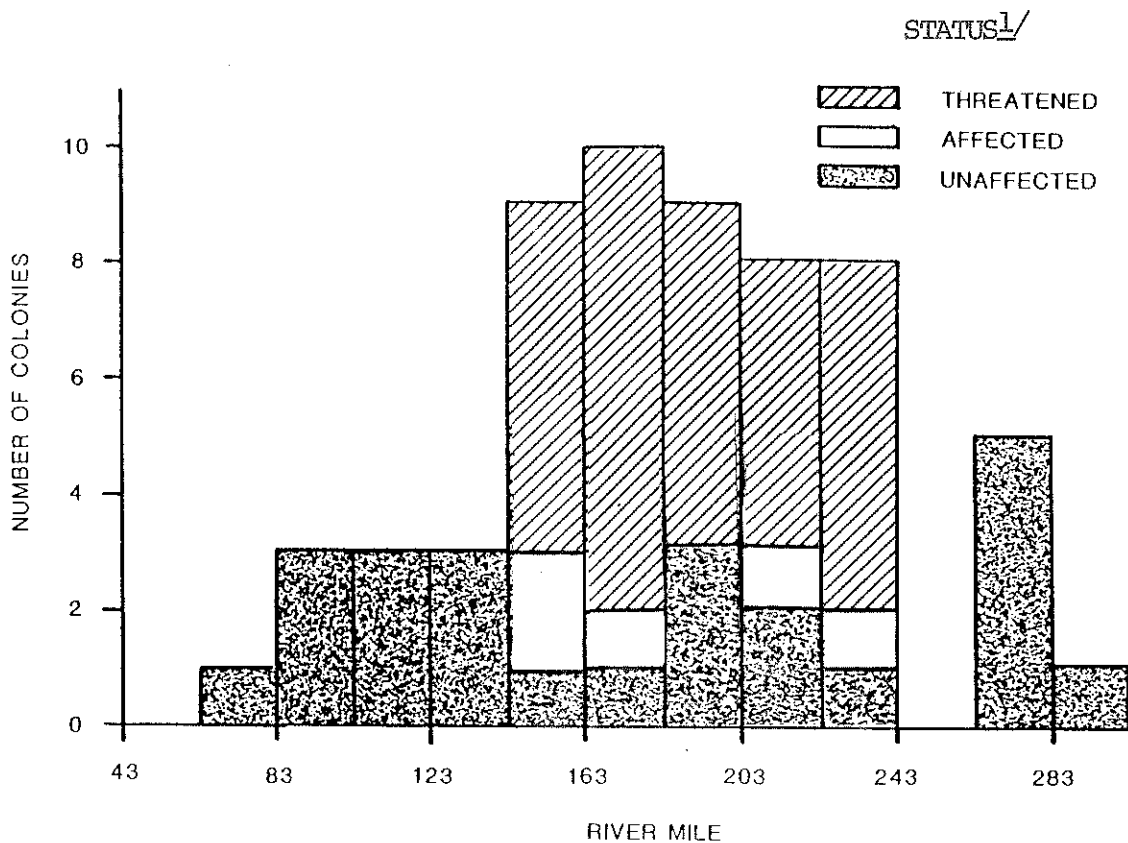
Figure 13. Geographic distribution of 60 Bank Swallow Colonies located on the Sacramento River, 1986, denoting colonies threatened, affected, or unaffected by proposed State and Federal bank stabilization projects from RM 143-243.

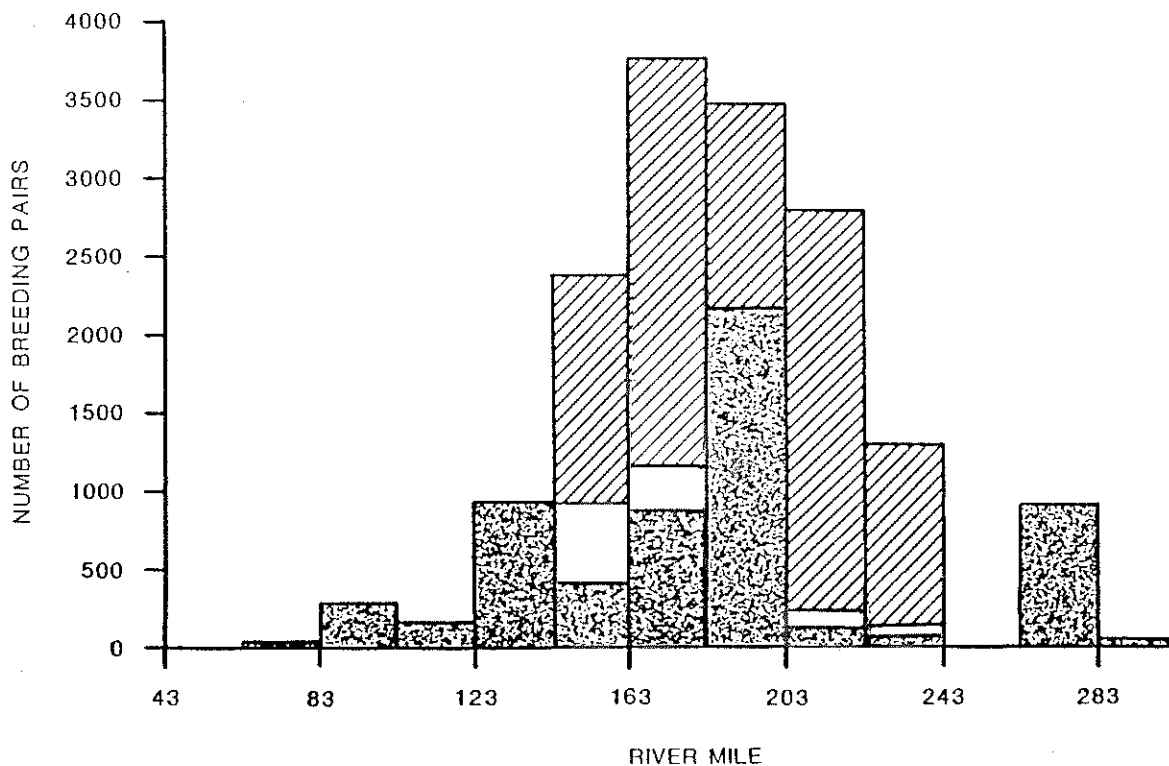
Figure 14. Geographic distribution of Bank Swallow population (estimated 16,150 pairs) on the Sacramento River, 1986, denoting breeding pairs threatened, affected or unaffected by proposed State and Federal bank stabilization projects from RM 143 to RM 243.

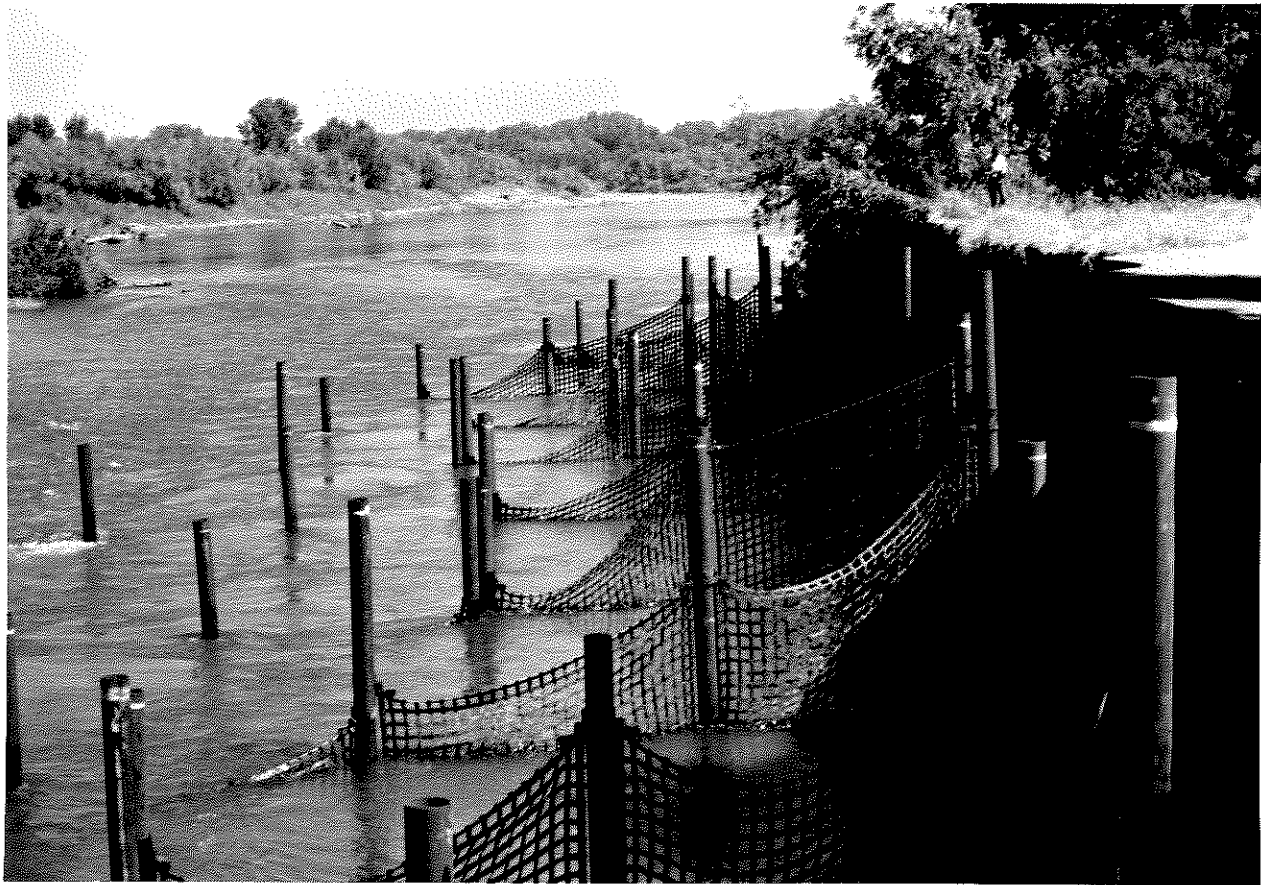
Figure 15. An alternative bank stabilization method called palisading was constructed at Woodson Bridge State Recreation Area in August, 1986 after the Bank Swallow breeding season. The impact of construction on this Bank Swallow nesting colony is currently unknown (note person on bank for scale).

Experimental techniques such as palisading may be effective in controlling erosion, may be more visually pleasing and may provide habitat for some later successional stage riparian species. However, these techniques do not take into account the needs of the flora and fauna, especially bank nesting species and those dependent on early stages of riparian habitat, for a free flowing river.
