# Memorandum

**Subject:** Tisdale Bypass Sturgeon Rescue

## Purpose

The report documents sturgeon rescue operations conducted within a Tisdale Bypass scour pool located approximately 2.9 km downstream of Tisdale Weir or 300 m west of Reclamation Road.

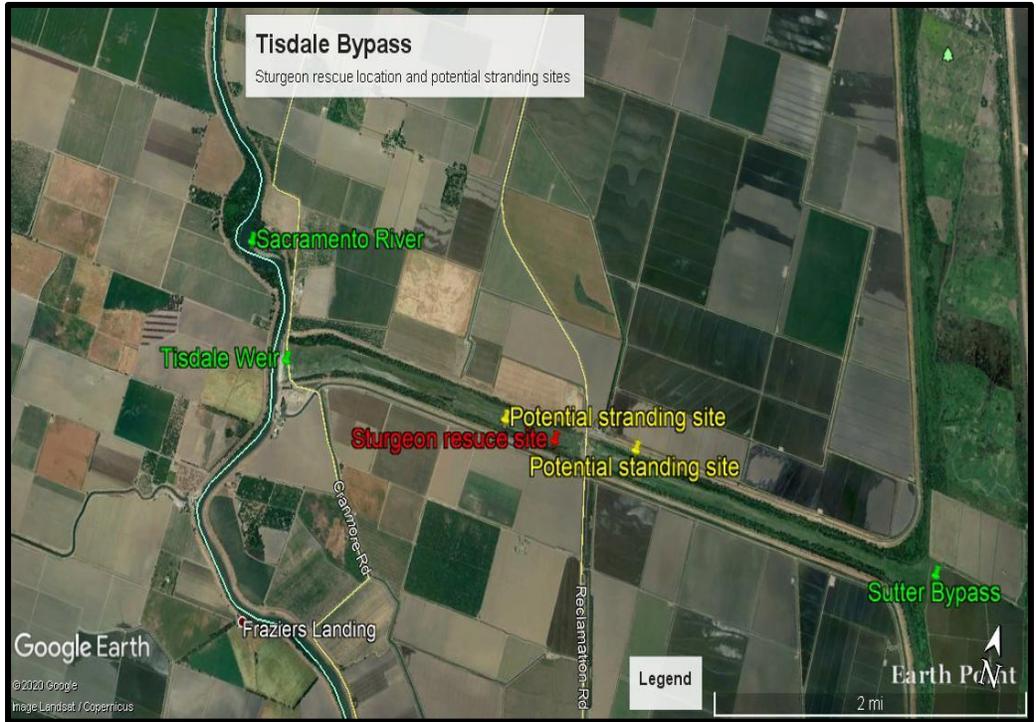
**Figure 1. Tisdale Bypass sturgeon rescue location and potential stranding sites.**

CDFW staff conducted a reconnaissance survey on 29 April 2020 but were unable to locate the scour pool due to the somewhat ambiguous directions provided by the hunter. CDFW staff returned on 1 May 2020 and located the scour pool situated along the south Tisdale Bypass levee. (**Figure 1**). The pool was approximately 600 m<sup>2</sup> with a maximum depth later determined to be in excess of three meters (**Figure 2**). Although turbidity in the feature reduced visibility to around 0.5 m, staff were able to conduct a visual survey and observed an unidentified sturgeon species in the scour pool. A 100-ft by 12-ft; 4-in square mesh heavy-duty beach seine was deployed to capture the sturgeon. There were several large partially and completely submerged logs which snagged the seine and facilitated the sturgeon escaping during the initial seining attempts. On the third seine haul, two sturgeon were observed in the net. The larger of the two sturgeon was able to escape but was eventually captured during the fifth or sixth seine haul.

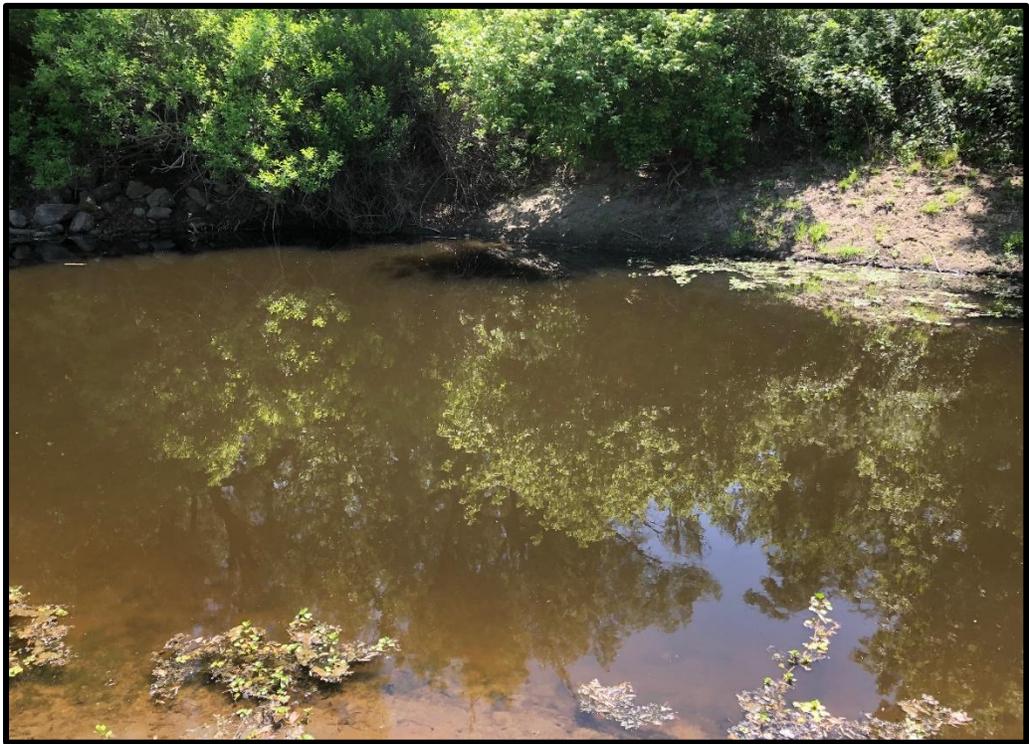
**Figure 2. Tisdale Bypass scour pool along south levee; 1 May 2020.**
