Memorandum

Subject: **Manning Creek Fish Ladder Project**

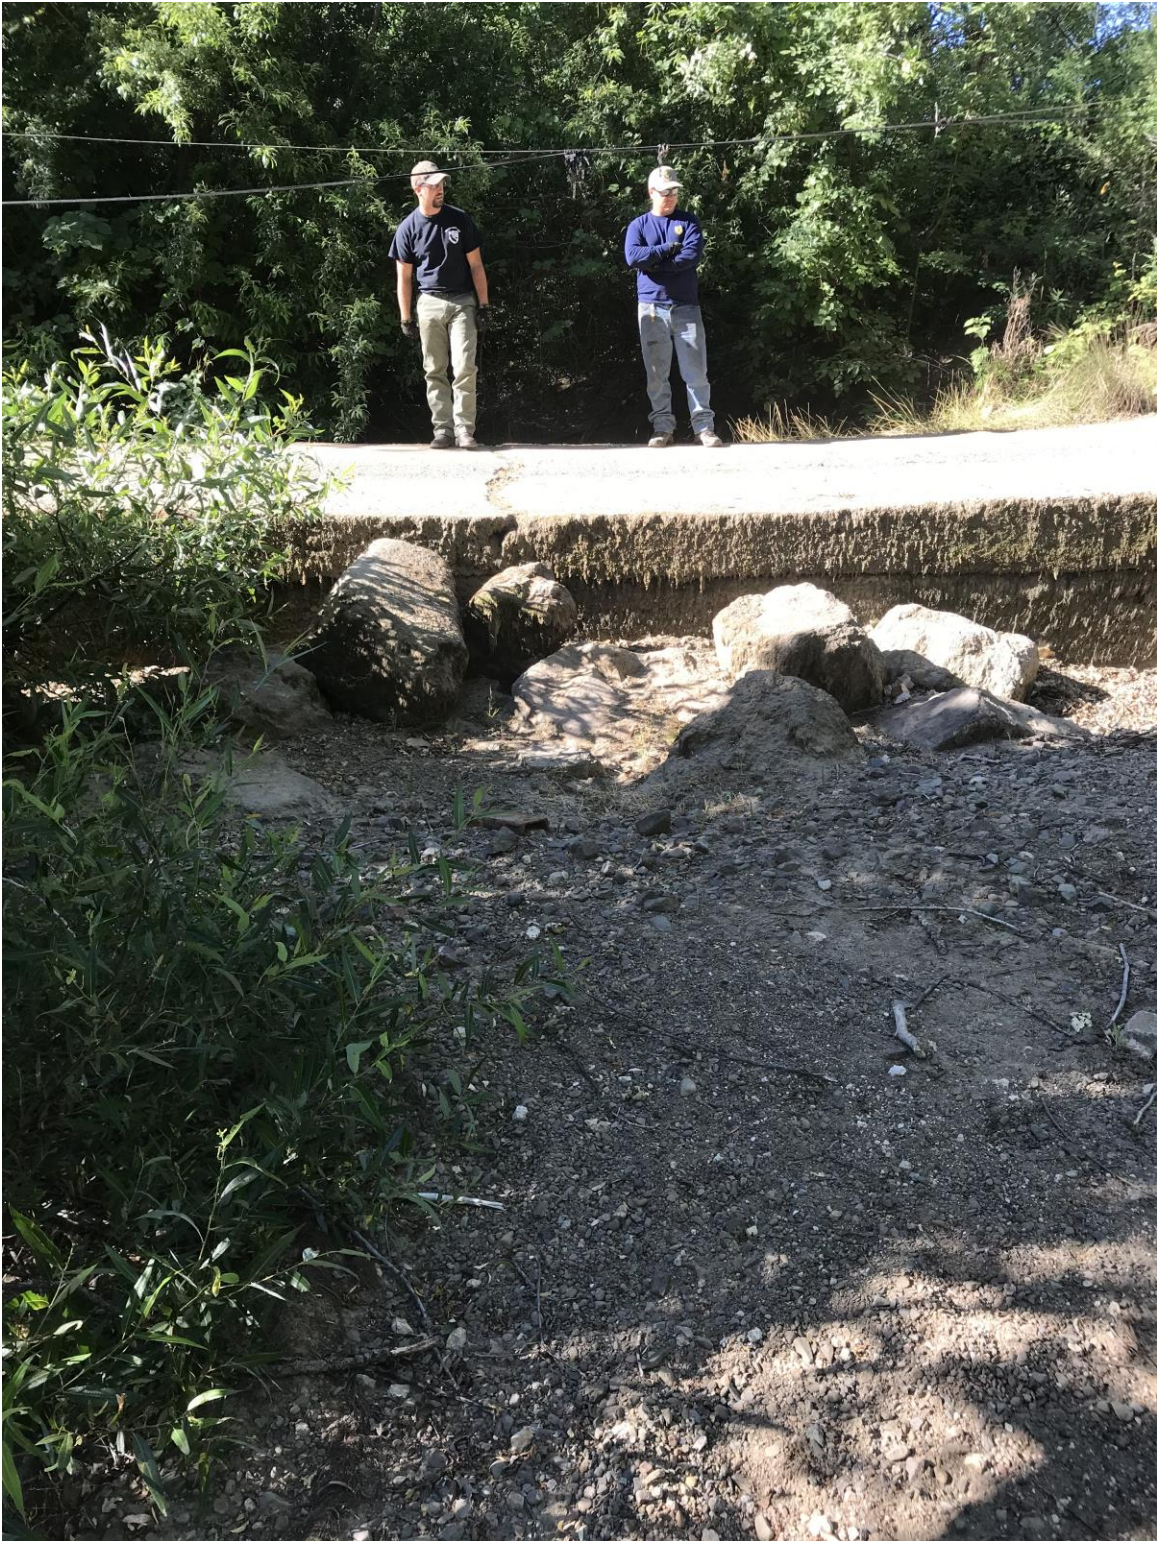
Figure 2. Manning Creek looking upstream towards road crossing/barrier on June 16, 2020. (Photo by P. Clark)

Figures 2 – 5 are pictures documenting the construction of the fish ladder. The fish ladder installation included removing some loose vegetation from the channel of Manning Creek. Department staff then moved a few of the large boulders next to the existing concrete creek crossing and cleaned the concrete for ladder installation. Department staff used ½" X 4 ½" wedge anchors and installed a fabricated plate to the side of the creek crossing and brought the ladder in and installed it with some ½" pipe so that, if needed, the ladder could be raised or lowered. Angle iron on either side of the ladder was used to help funnel any available water towards the ladder in lower flow conditions. The ladder is 4' 4" at the top and narrows to 2' at the bottom and is 12' long. Eleven gauge mild steel was used for the ladder and was reinforced from below with 1.5" X 1.5" mild steel angle. Removable baffles were installed in the ladder to help funnel water down the center and give hitch a resting spot on the way up if needed. In the spring of 2021 and future spring seasons, Department staff will monitor how well the ladder improvements have aided in the migration of hitch.

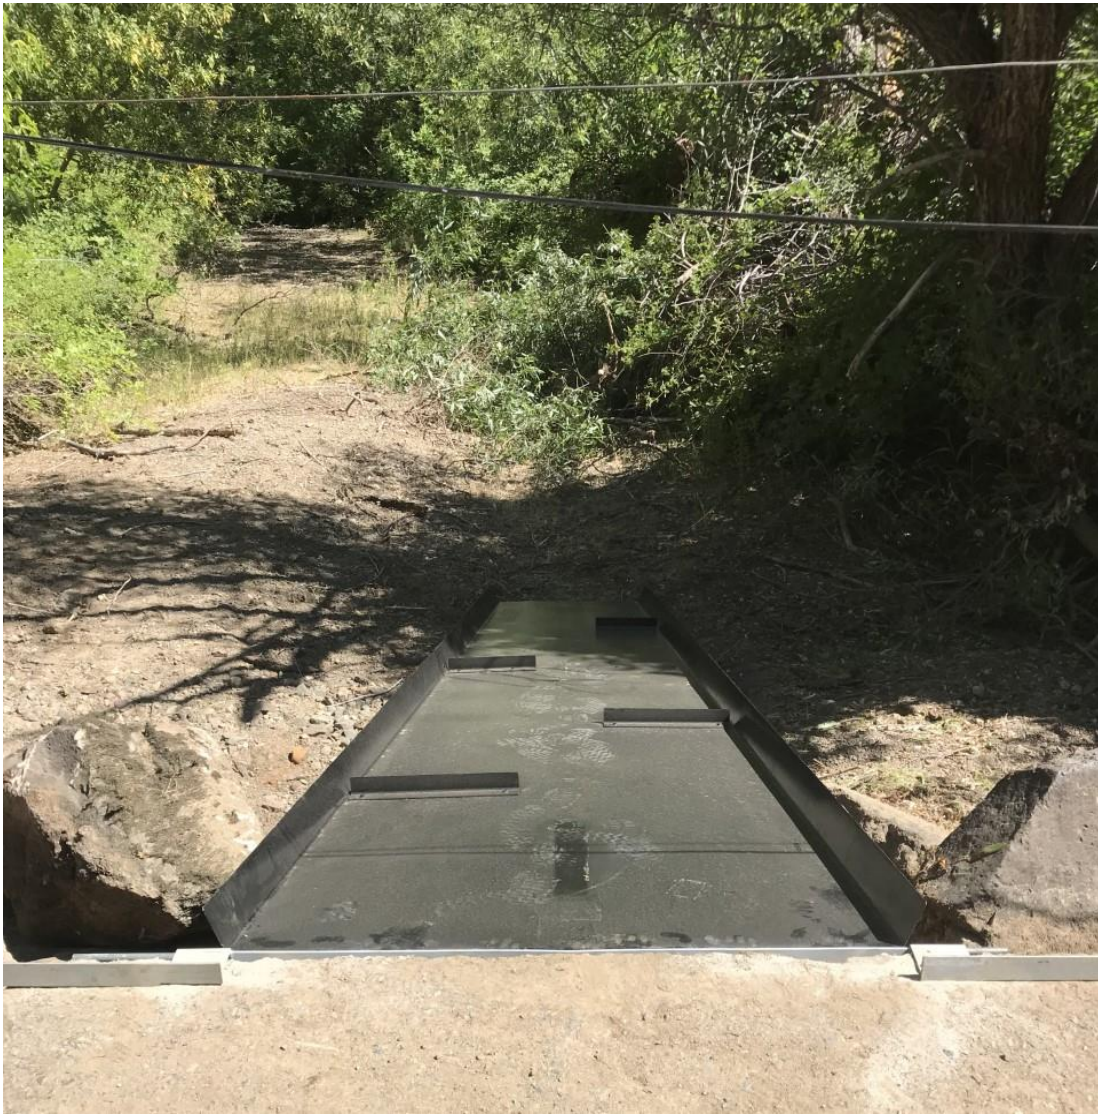
Figure 4. Manning Creek Fish Ladder looking downstream from road crossing/barrier on June 16, 2020 (Photo by P. Clark).

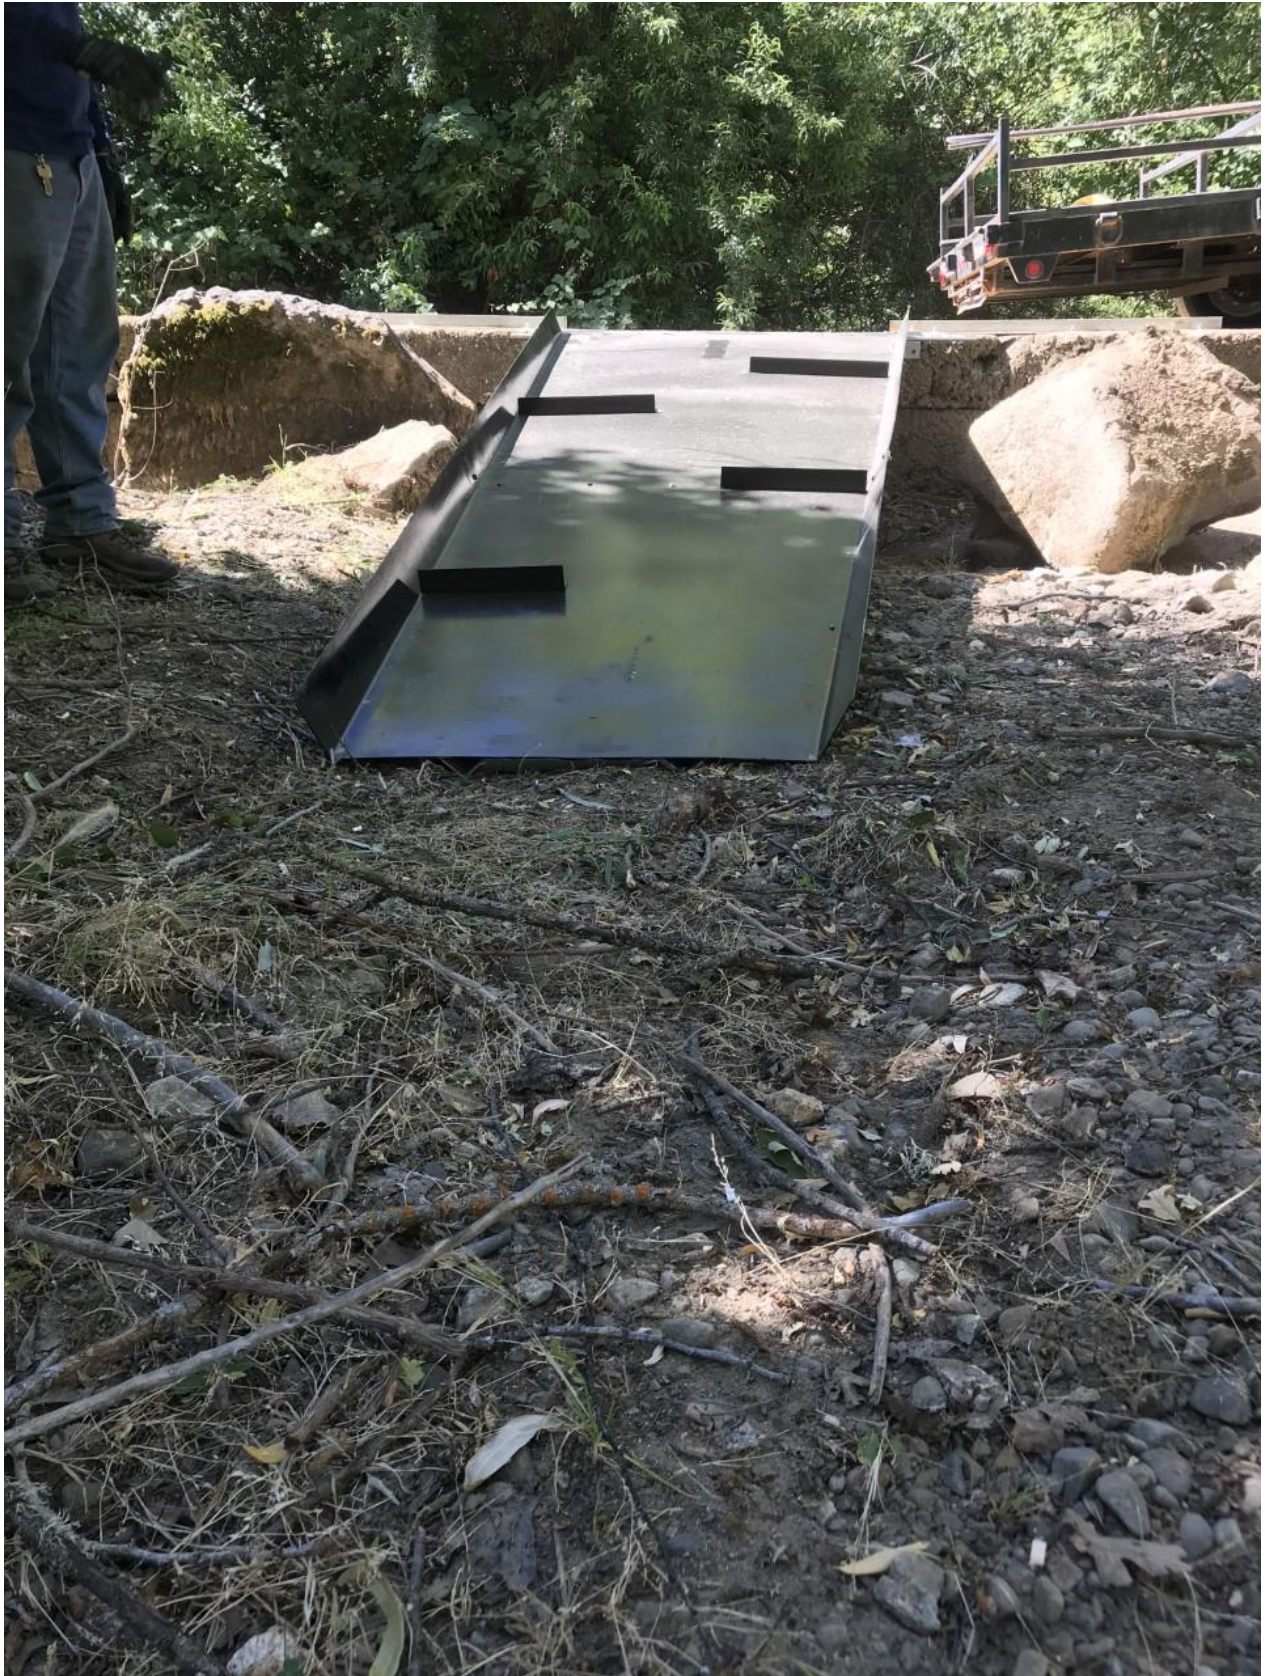
Figure 5. Manning Creek Fish Ladder looking downstream from road crossing/barrier on June 16, 2020 (Photo by P. Clark).
