Smith River Plain Dissolved Copper Monitoring Report 2017-2018

**National Marine Fisheries Service
Northern California Office
Arcata, CA**

**California Department of Fish and Wildlife
Arcata, CA**

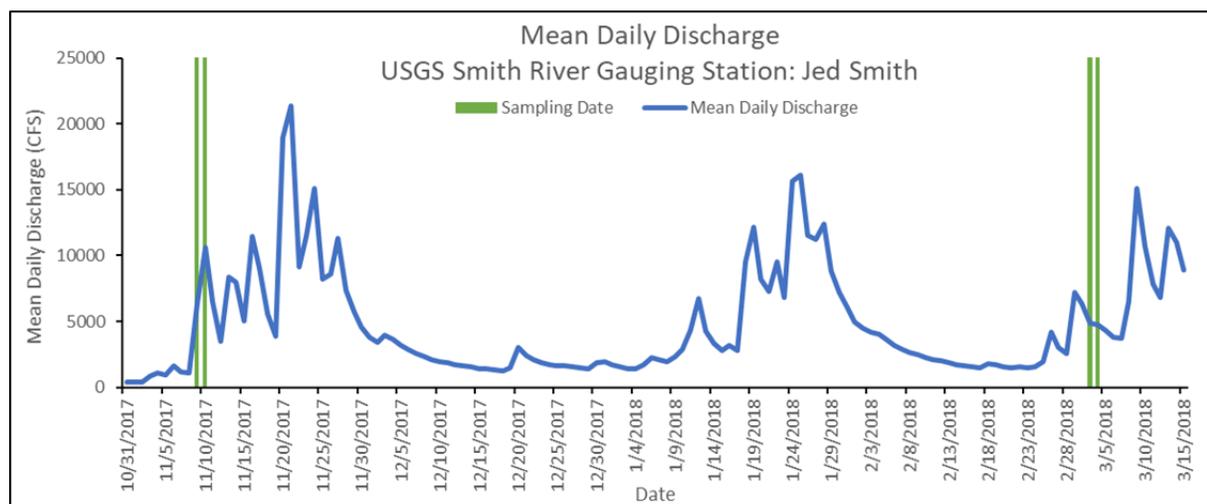
Figure 1. Mean daily discharge in cubic feet per second during the winter of 2017-2018 for the Smith River at the USGS Jed Smith gauging station, Del Norte County, CA.

Two sampling events were targeted; one in the fall 2017 (November 9 and 10, 2017) when streams first began flowing and the second after a significant rainfall event in the late-winter/Spring 2018 (March 3 and 4, 2018)(see Figure 1)

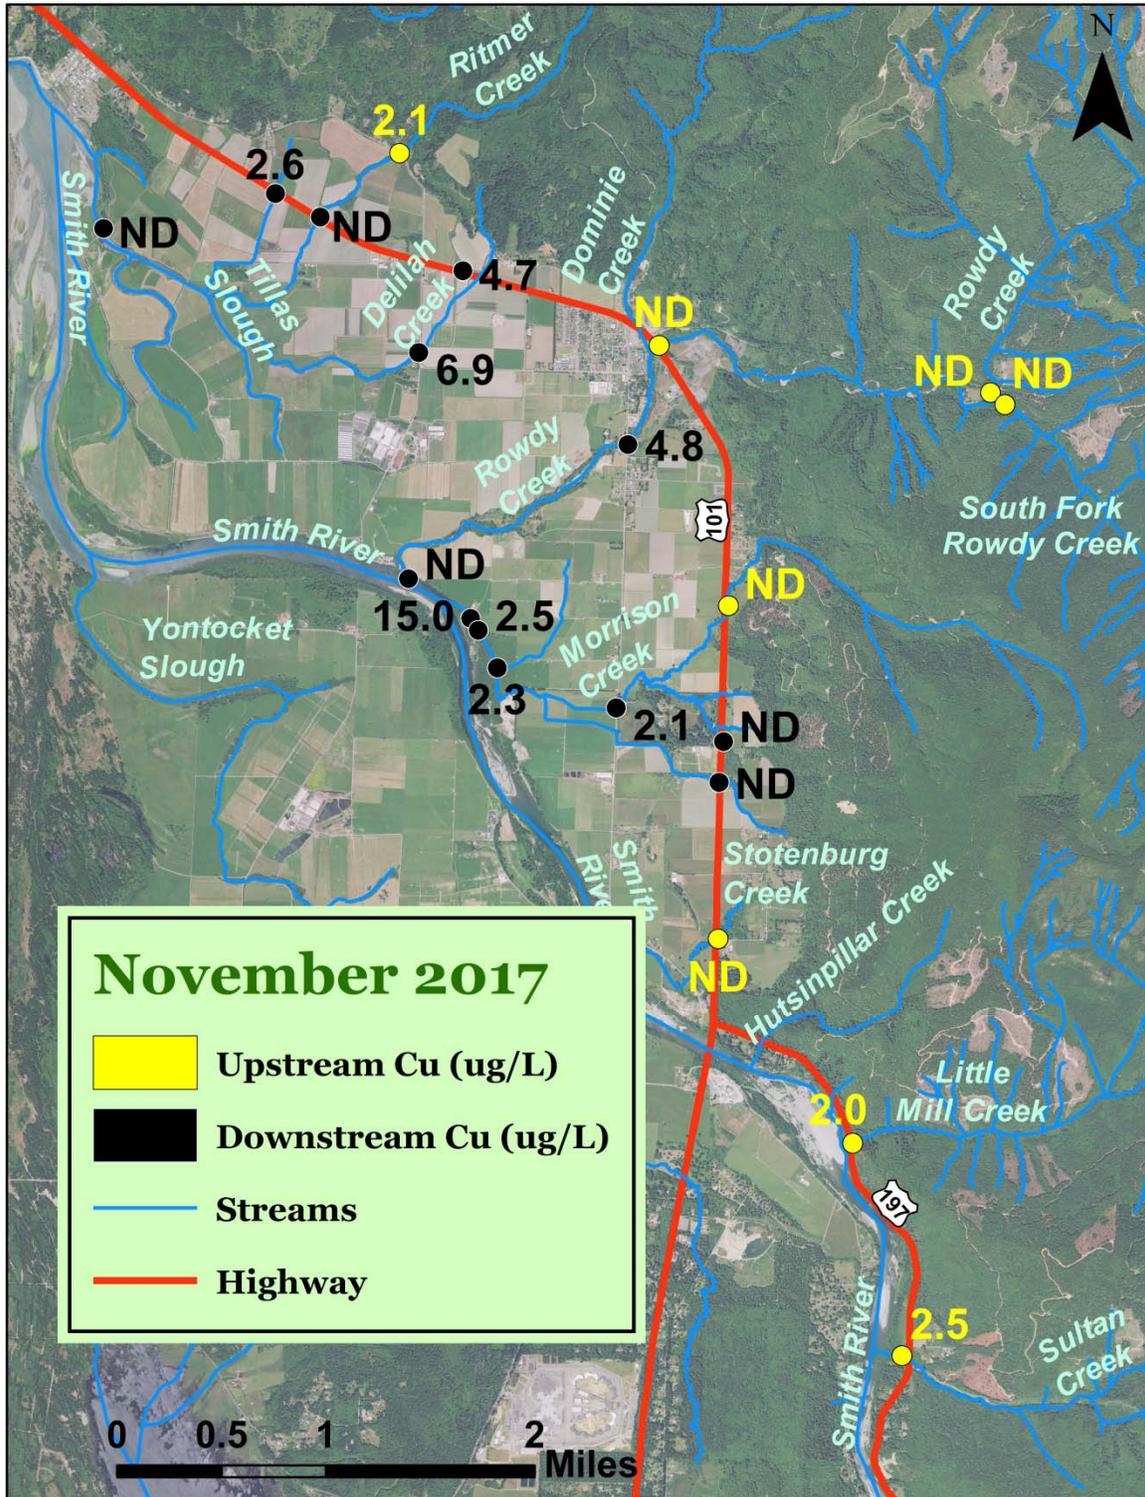
Figure 2. Sampling sites and dissolved copper concentrations both upstream and downstream of lily fields, November 10 and 11, 2017, Del Norte County, CA.

Results from the November 9 and 10, 2017, first flush sampling nearly always showed an increase in copper concentrations downstream from lily bulb fields when copper was detected (Figure 2, Table 1). Dissolved copper was detected at 8 of 13 downstream sites and 3 of 8 upstream sites. Note that the copper reporting limit used by the laboratory that processed fall samples is 2.0 µg/L, so the samples with “No Detections” may have contained dissolved copper at concentrations below 2.0 µg/L. For every site where dissolved copper was detected, concentrations were well above those that cause olfactory and lateral line damage. The highest concentration (15 µg/L) was at Lower Morrison Creek backwater tributary (Figure 2, Table 1). Some samples did not have copper detected and some sites had copper concentrations that were either from natural sources or other anthropogenic sources besides lily bulb field run-off (*e.g.*, Sultan Creek and Little Mill Creek) (Figure 2, Table 1). Hardness does not appear to be high enough to reduce dissolved copper toxicity, ranging from 21 to 45 mg/L (Table 1). DOC was not sampled during this event. Note that the reporting limit for copper analyzed by North Coast Laboratories (fall samples) is 2.0 µg/L so the “no detections” reported may in fact have had dissolved copper at concentrations below 2.0 µg/L

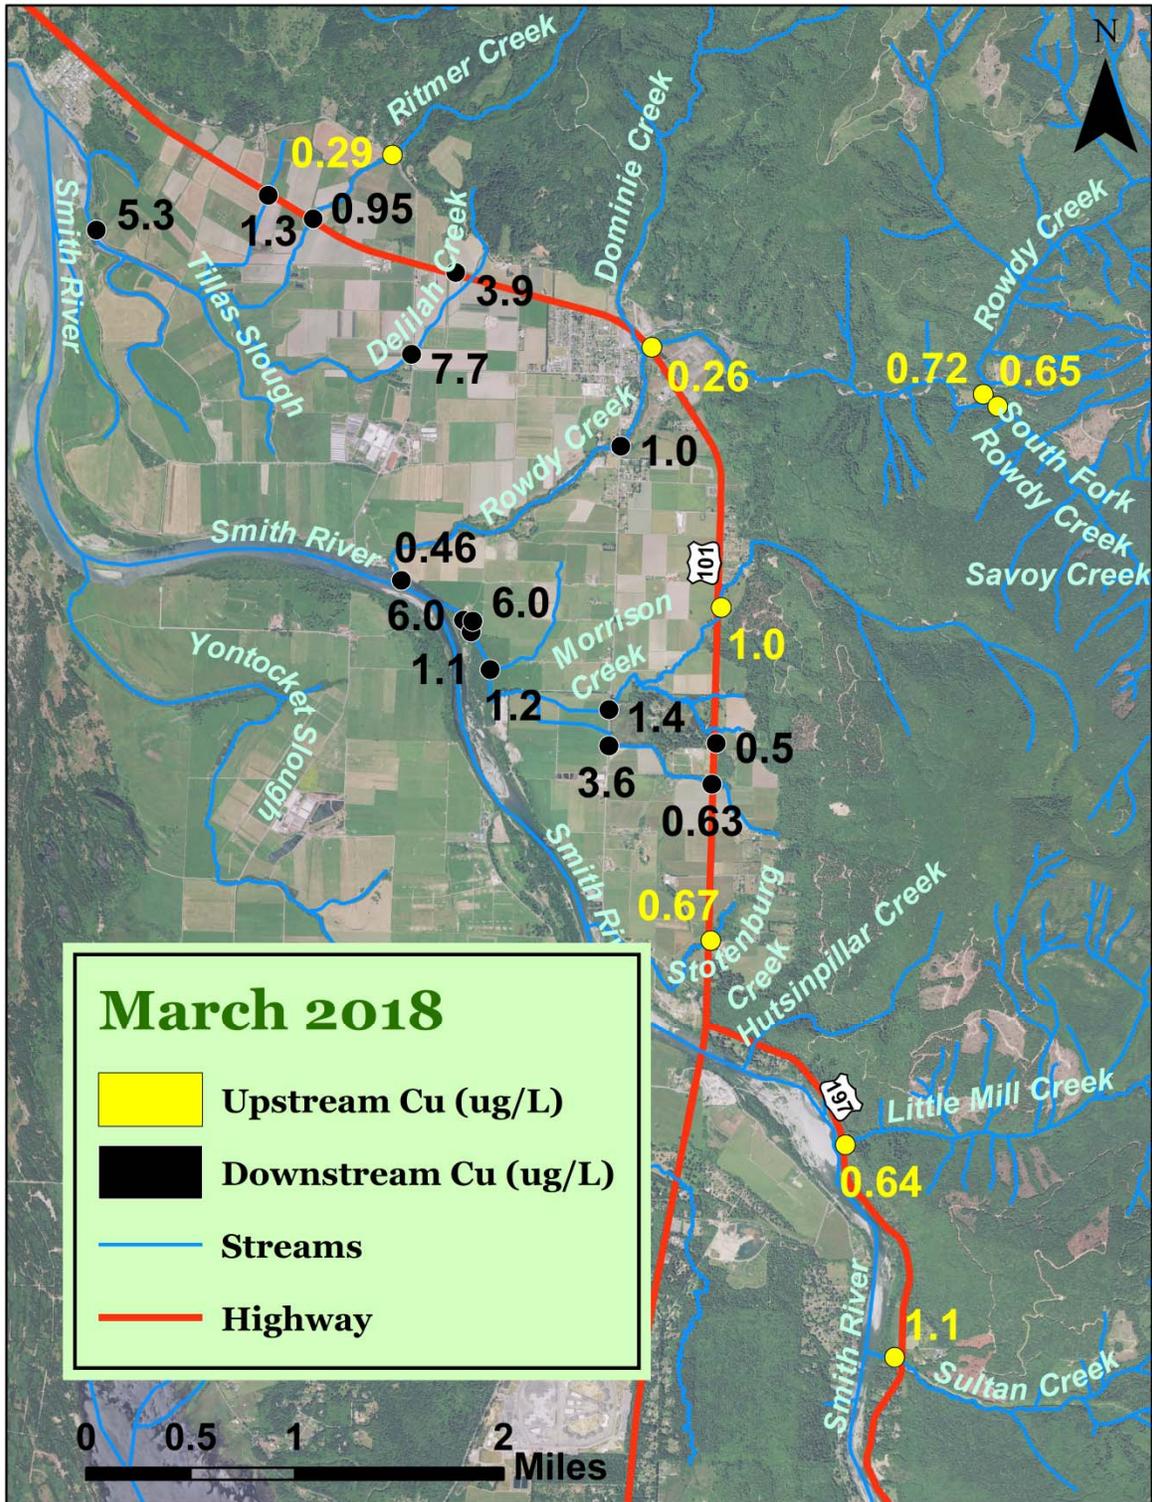
Figure 3. Sampling sites and dissolved copper concentrations both upstream and downstream of lily fields, March 4 and 5, 2018, Del Norte County, CA.

Dissolved copper was detected at all upstream and downstream sites¹ (Figure 3, Table 2). Results from the March 3 and 4, 2018, sampling event showed similar “hot spots” to the fall sampling period at Delilah Creek and several locations on the Morrison Creek backwater tributary. However, most locations were higher in the fall than the spring (Figure 4). The Tillas Slough location was a notable exception having a relatively high copper concentration in the spring (5.3 $\mu\text{g/L}$) relative to none detected in the fall. In the fall, we sampled Tillas Slough during an incoming high tide in contrast to the spring where we sampled an outgoing tide near the low point. For every downstream site, concentrations were above those that cause olfactory and lateral line damage. Again, hardness was not high enough to reduce copper acute toxicity, and DOC levels were not high enough (~6 mg/L) at most locations to significantly reduce sensory toxicity.

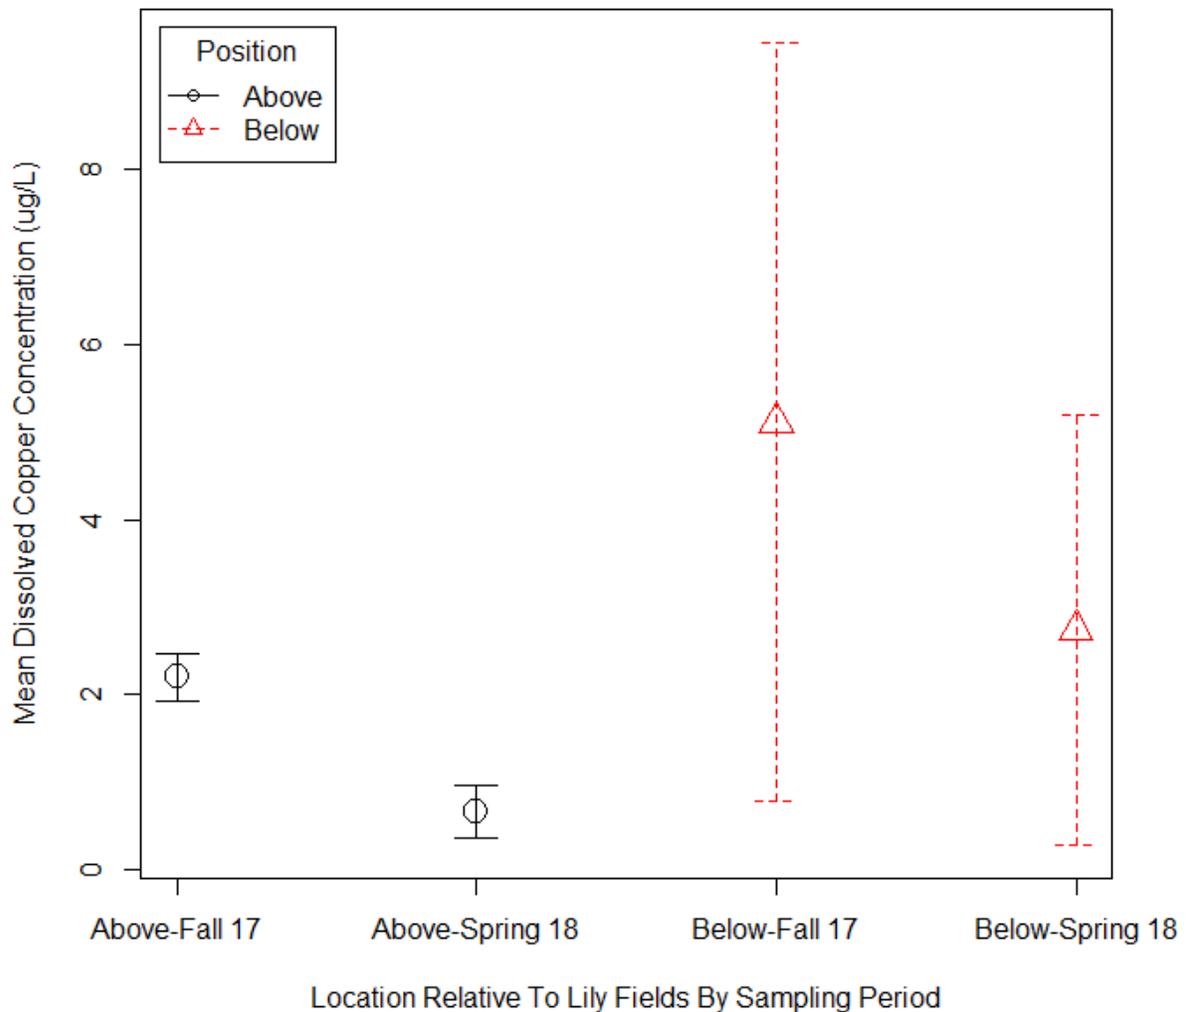
Figure 4. Mean dissolved copper concentrations for upstream and downstream sites for Fall 2017 and Spring 2018. Bars around the mean are standard deviation from the mean.

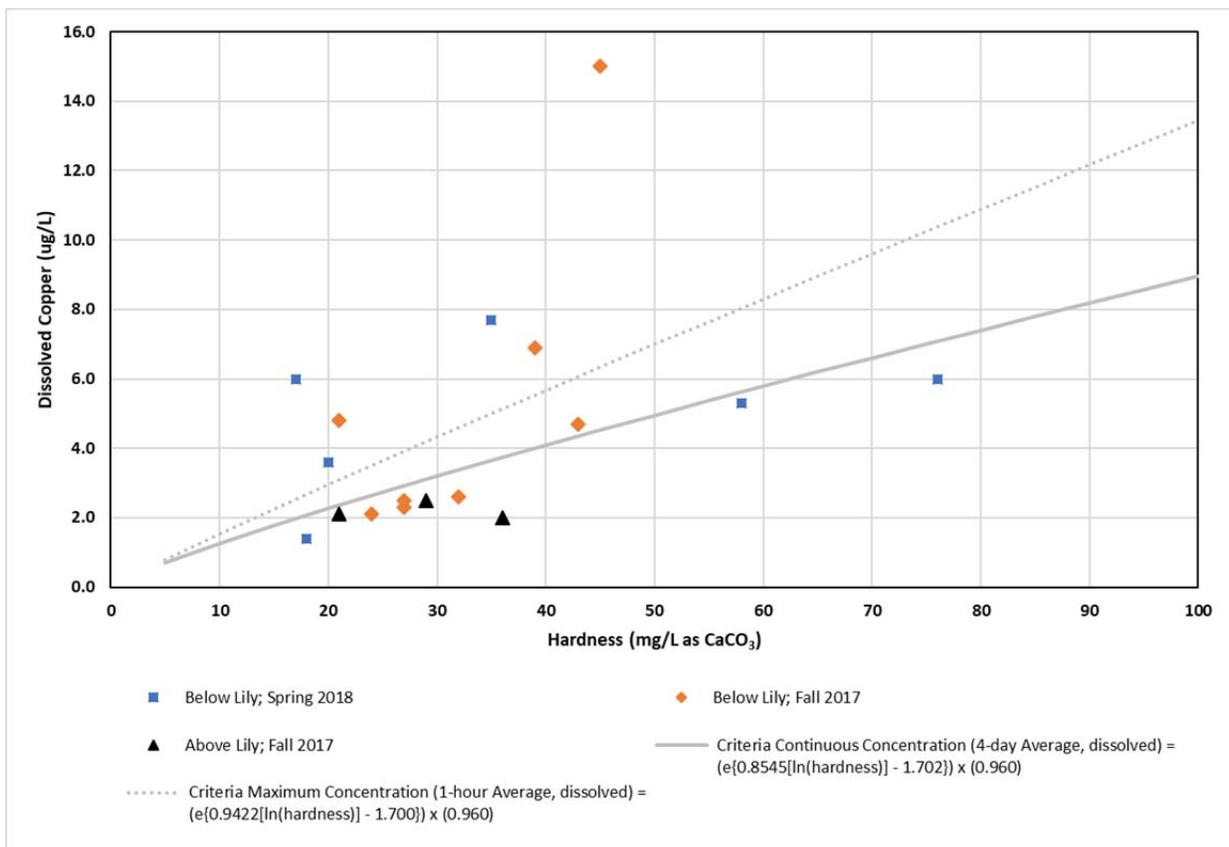
Figure 5. Dissolved copper concentrations and hardness in 17 of 44 surface water samples collected from November 2017 and March 2018, Smith River, California.

Of the 14 water samples collected in waters below lily fields, seven (50%) exceeded the aquatic life criterion to protect freshwater from chronic toxicity impacts. These seven (50%) sites exceeded criterion continuous concentration (CCC) for freshwater aquatic life for reproductive and/or other toxicity (Figure 5). CCC is the chronic standard defined as the highest concentration of a pollutant to which aquatic life can be exposed for an extended period of time (four days) without deleterious effects (NCRWQCB 2018). A total of six water samples (43%) exceeded criterion maximum concentration (CMC) for freshwater aquatic life criteria for reproductive and/or acute toxicity (Figure 5). CMC is the acute standard defined as the highest concentration of a pollutant to which aquatic life can be exposed for a short period of time (one hour) without deleterious effects (NCRWQCB 2018). None of the three control samples exceeded CCC or CMC (Figure 5).

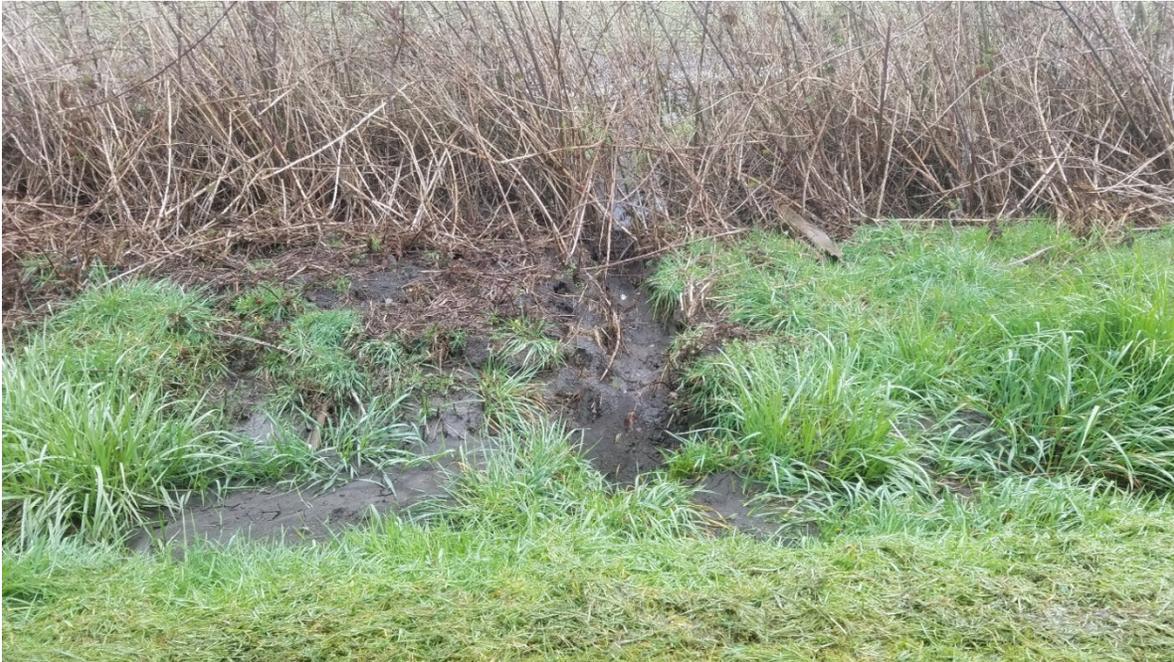
Figure 5. Evidence of concentrated flow and sediment (center of photo) from adjacent lily bulb field (background) entering roadside ditch (foreground) that is connected to Delilah Creek, a tributary to the Smith River on the Smith River Plain.

NMFS and CDFW have observed lily bulb field conditions and their proximity to waterways in the Smith River Plain, and believe that these conditions result in a high likelihood of delivering agricultural chemicals (*e.g.*, dissolved copper) to salmonid rearing habitats (Figure 5). Some of these chemicals, like copper, are very toxic to salmonids, especially coho salmon (NMFS 2007, Sandahl *et al.* 2007, McIntyre *et al.* 2012) and other aquatic life that is important for healthy ecosystem function. These lily bulb field conditions include minimal buffers with little or no vegetation, saturated fields during chemical applications, and concentrated flow off fields feeding directly into waterways and tributaries of the Smith River Plain. Lily bulb fields are rotated often into pasture and then back to lily bulb production after a varied number of seasons, but it is unknown whether residual copper, like some organochlorine pesticides, becomes concentrated in soils to the extent that run-off may continue to pollute streams despite no recent pesticide applications.
