# Gulch C Coho Salmon Fish Passage Improvement Project *(amended)*

Recipient: Trout Unlimited, Inc.

Project Period: 10/01/2020 – 10/29/2021

Project Number: #8006.20.070765

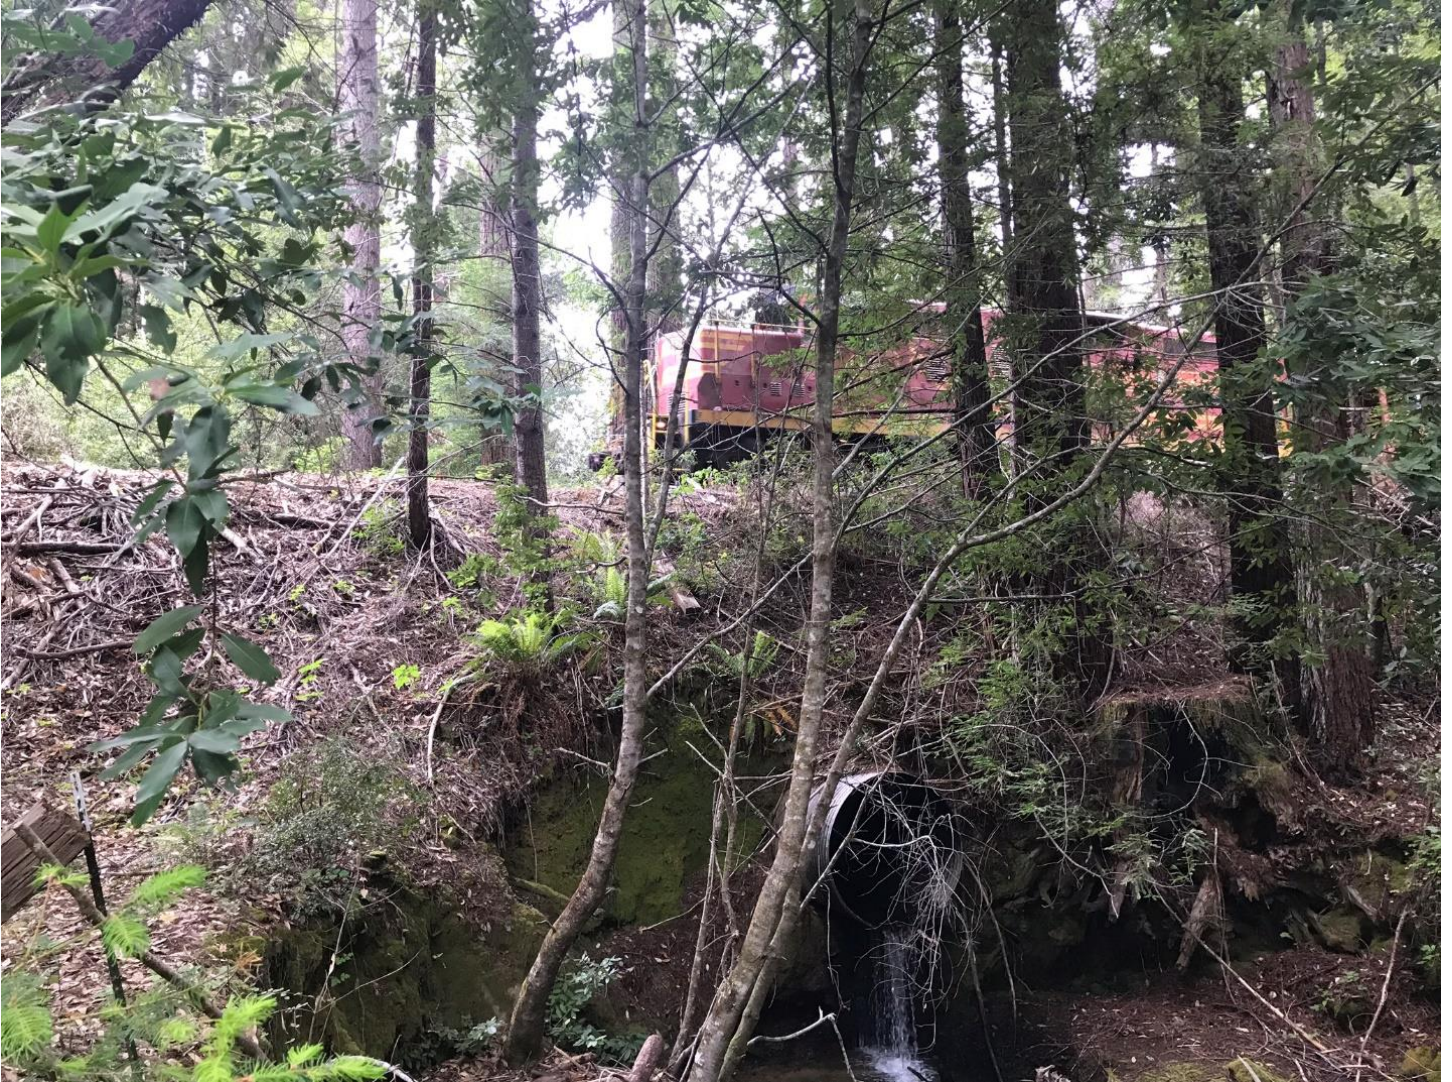
*Image 1: Rail Culvert before construction. View is from downstream looking upstream.*

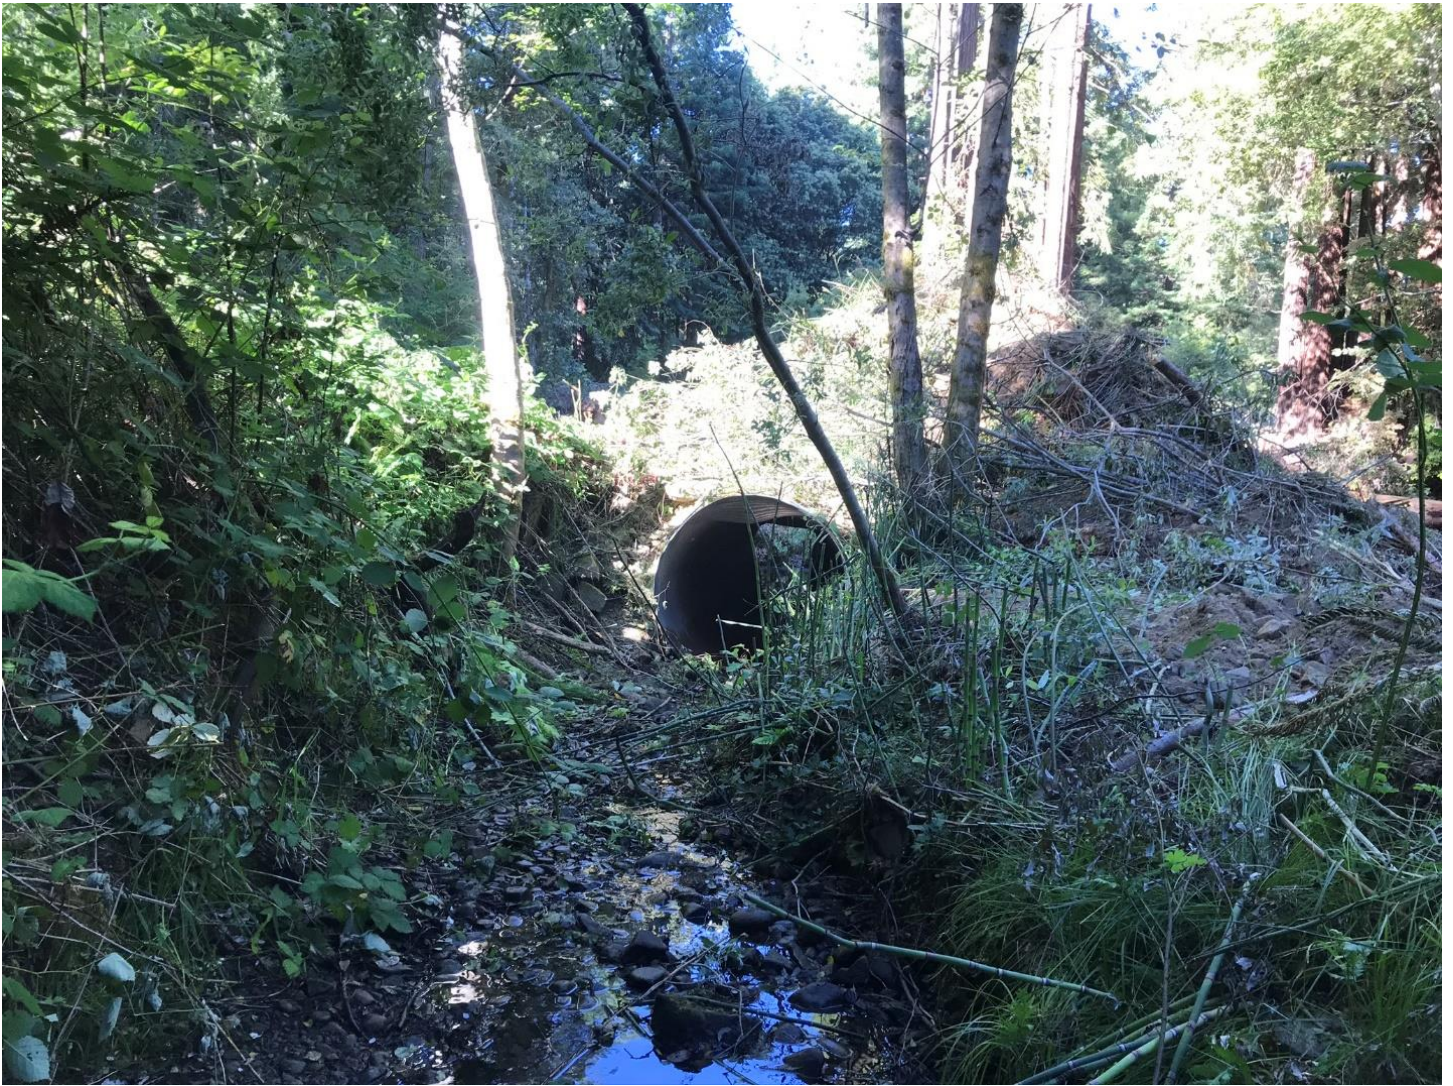
*Image 2: Timber Road culvert before construction. View is culvert inlet, looking downstream.*

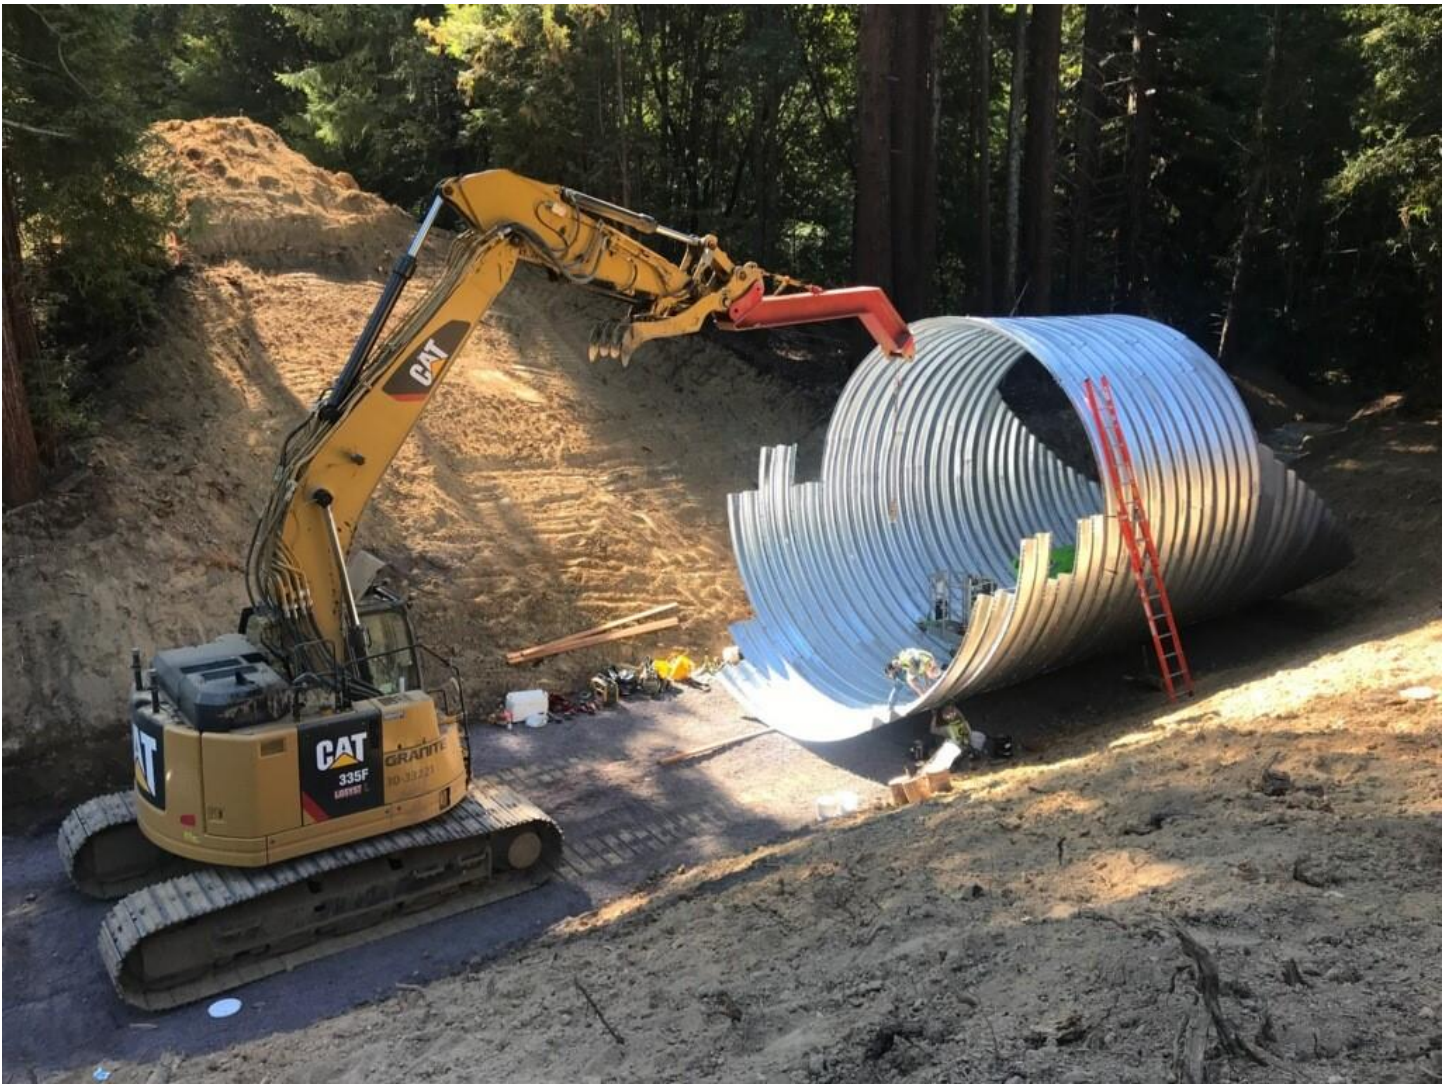
*Image 3: Rail culvert during construction.*

The project implementation included installing a 20-foot diameter structural steel plate (SSP) culvert placed (beneath the rail) at a 2.6% slope with the invert embedded 4 feet below the overall design profile and, a 50-foot span prefabricated bridge with steel girders and concrete decking (at timber road crossing). Additionally, the project restored channel conditions near the confluence with the Noyo River to the existing channel upstream, for a length of 385 feet. The restored channel bed was constructed with large wood that controls the channel profile by creating discrete steps (i.e. log steps in channel) and forcing riffle-pool bed morphology. A total of 13 steps were constructed to serve as forcing features; there were four rock steps nine log steps. The nine log weirs steps were constructed through the project reach, consisting of a top log and a footer log, combined training logs on each side that focus the water toward the center of the channel and reduce risk of flanking. Large, imported boulders were used as ballast and logs were anchored together. Root wads salvaged from large redwood trees removed during construction were used to protect the streambanks in two locations. The first is at the upstream end of the project where a plug was placed into the existing channel as part of the channel reroute. These root wads were placed on the outside of the bend with the bole sticking up and the stem buried into the bank. The second location for root wad placements was downstream of the rail culvert outlet.

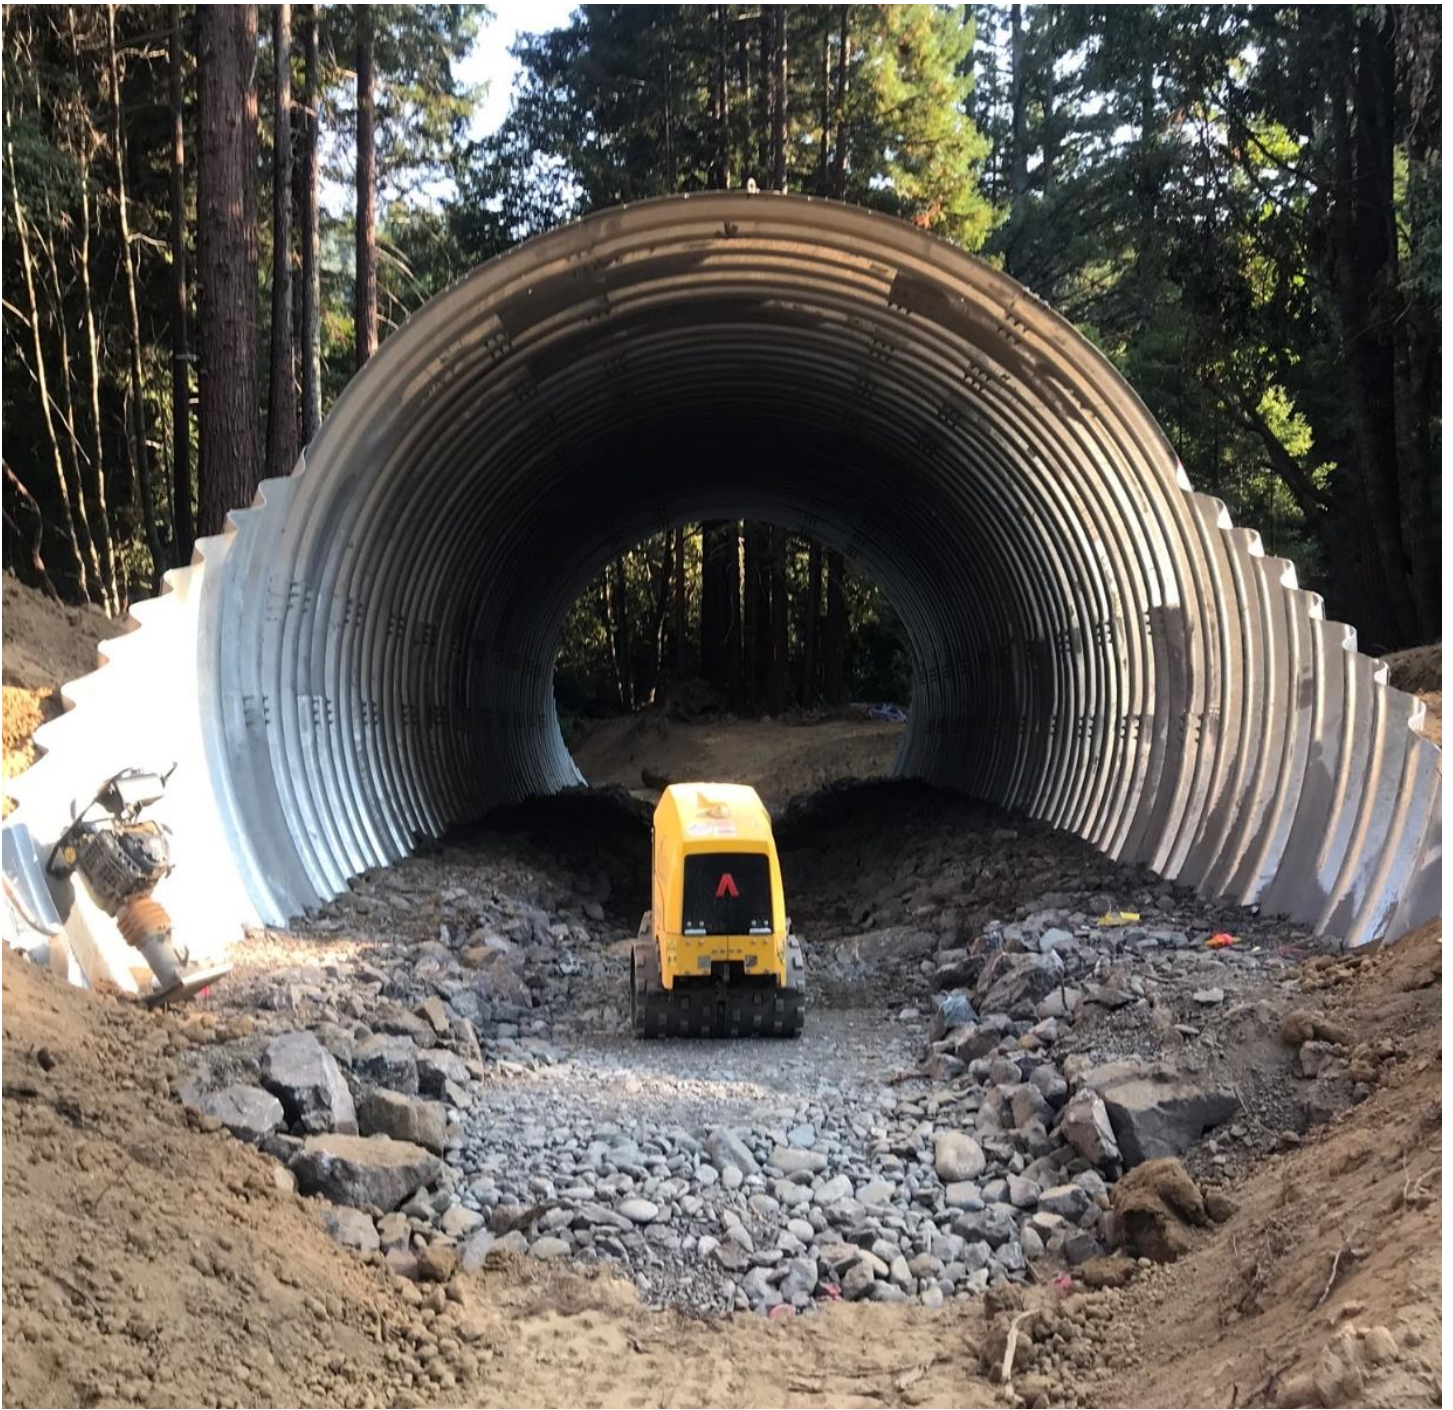
*Image 4: Rail culvert during construction.*

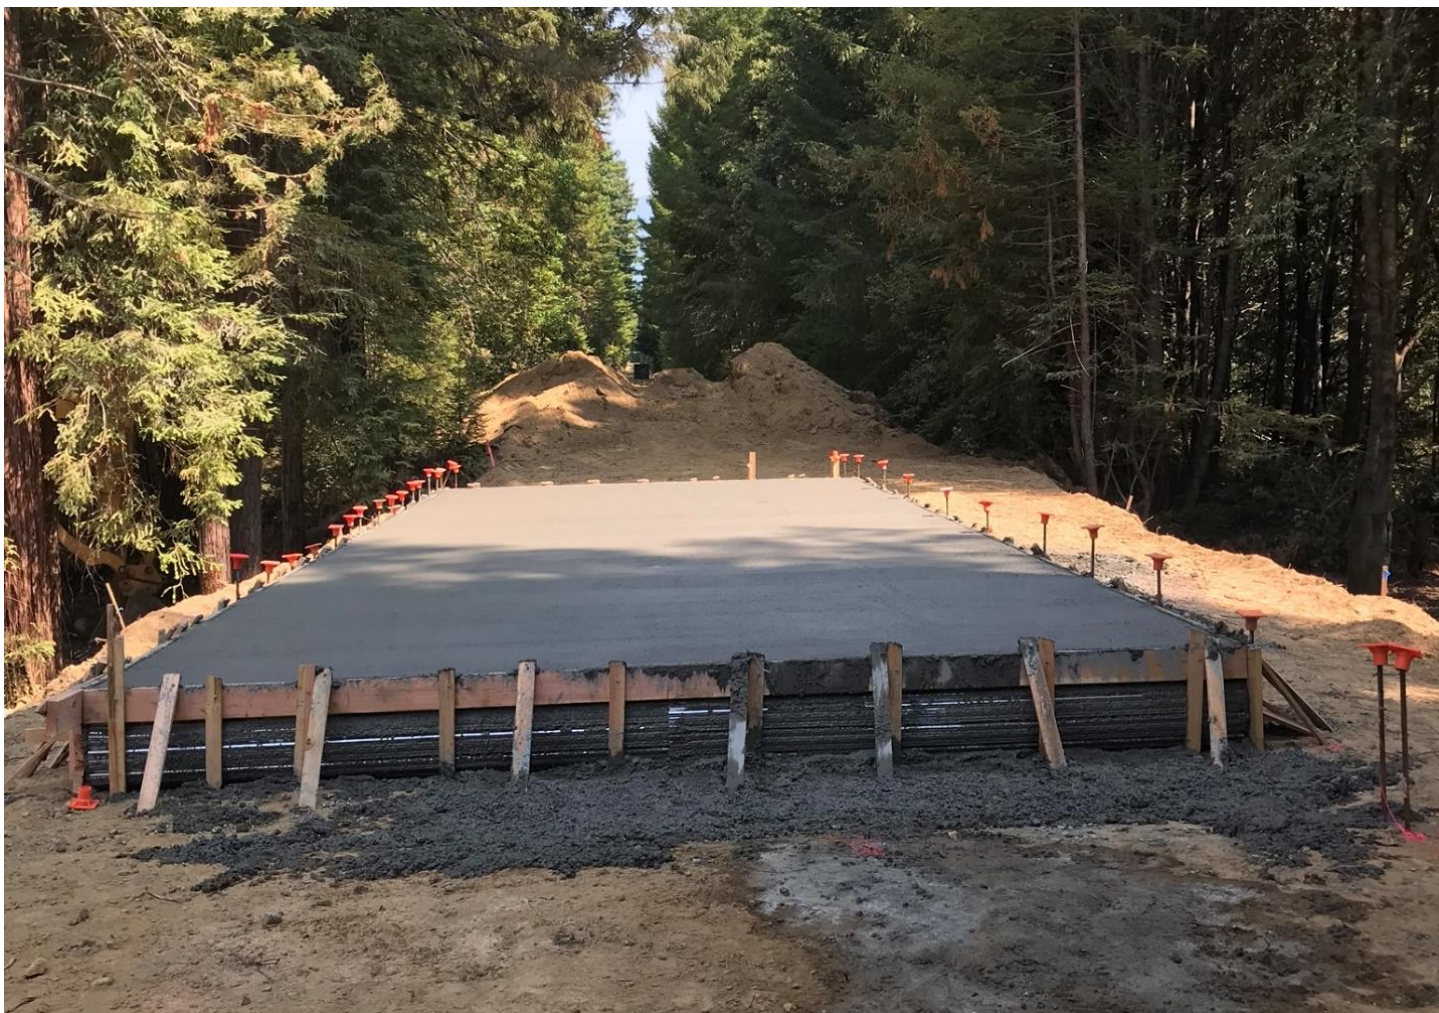
*Image 5: Concrete pad placed as structural support on rail bed.*

Specific activities associated with the NFWF-OSPR award occurred during the last month of construction October 1, 2020 to October 31, 2020. In early August 2020, TU was notified by Mendocino Railway subcontractors, AECOM, Inc. and Granite Inc., that additional materials (e.g., rock and concrete) were required to ensure that the rail and road crossing were structural sound and adequately protected. To maintain the construction schedule, TU needed to immediately address the gap in funds required to complete the project. TU identified funds within existing awards to address \$60,084 of the costs and secured an additional \$10,000 from The Nature Conservancy. This award of \$50,000 addressed the final amount required to cover the gap created by the additional expenses.

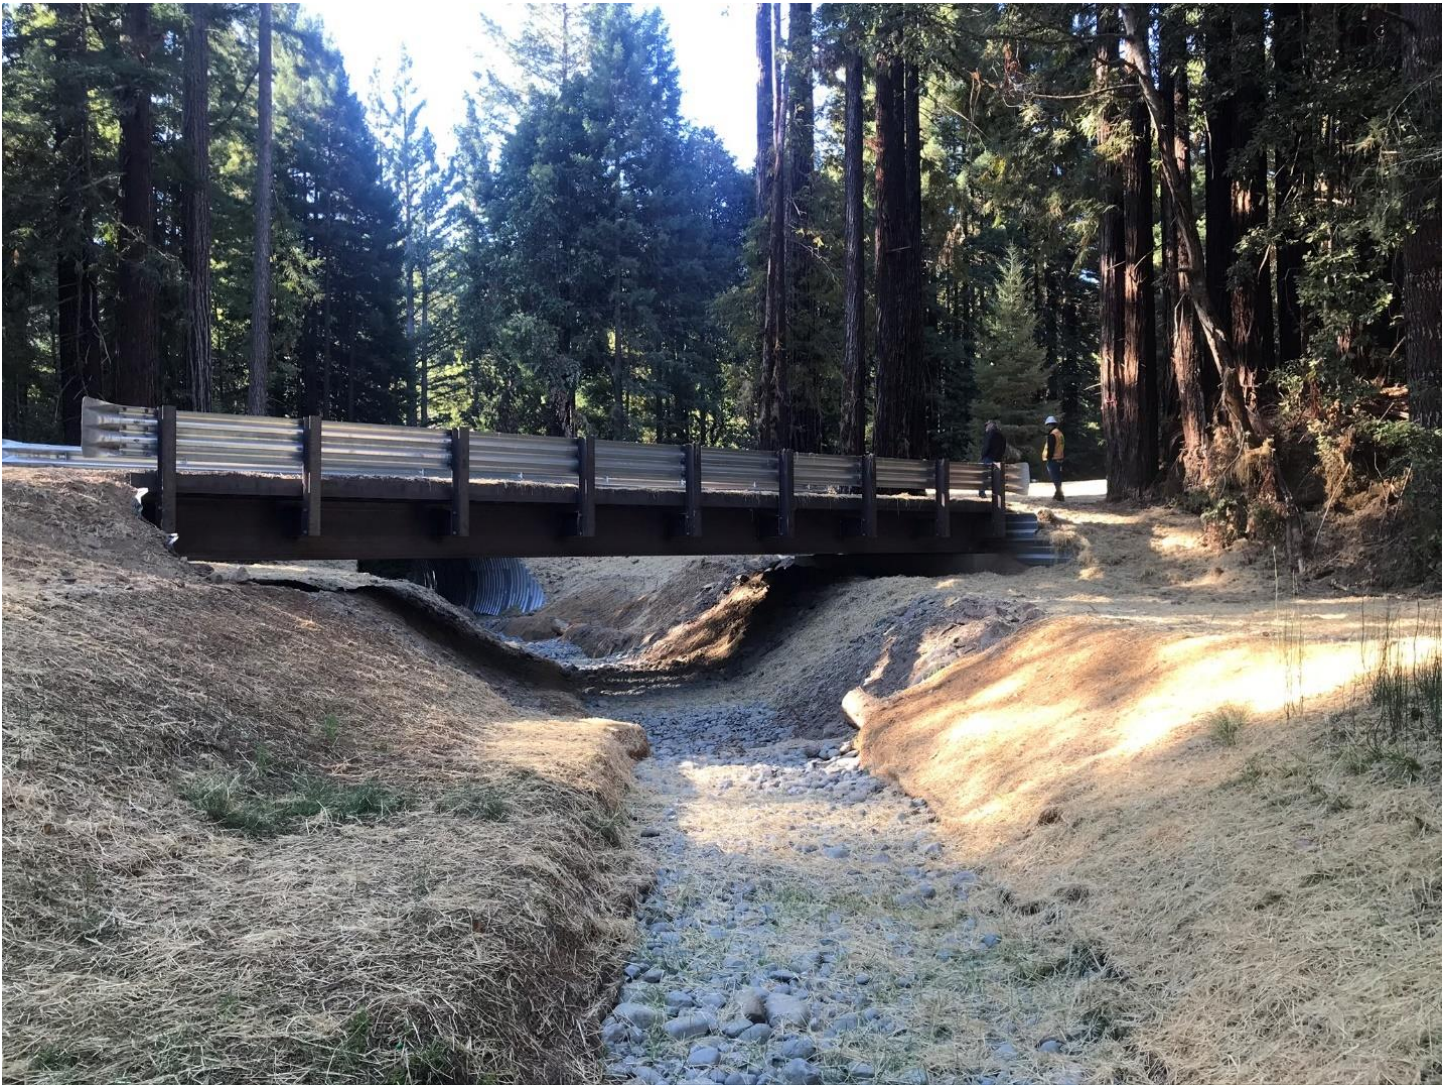
*Image 6: Timber Road after construction. View of bridge is from upstream project extant looking downstream.*

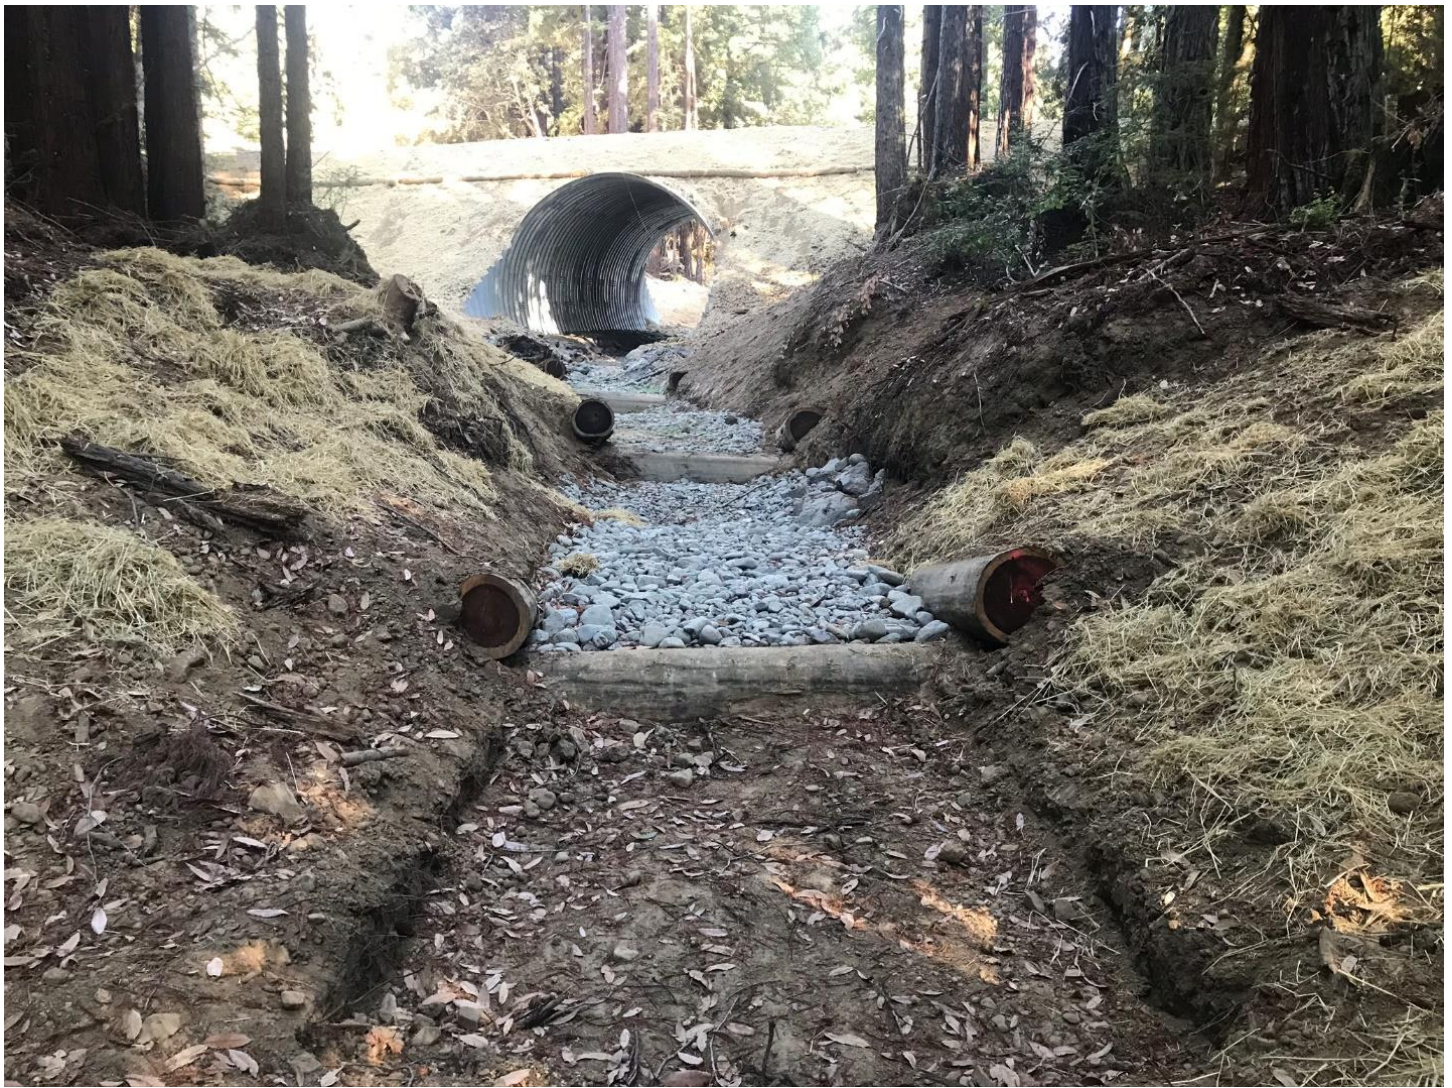
*Image 7: Log steps, photo taken at downstream project end, looking upstream.*

The overall construction activities included removing the old culverts (2), stream channel was excavated, streambed and bank materials were placed, large wood log step weirs (9) and root wads (4) were installed in the channel, the culvert was erected and the engineered backfill and structural pad were installed, the bridge abutments were constructed, and rock slope protection was added, and the bridge and railing were installed.

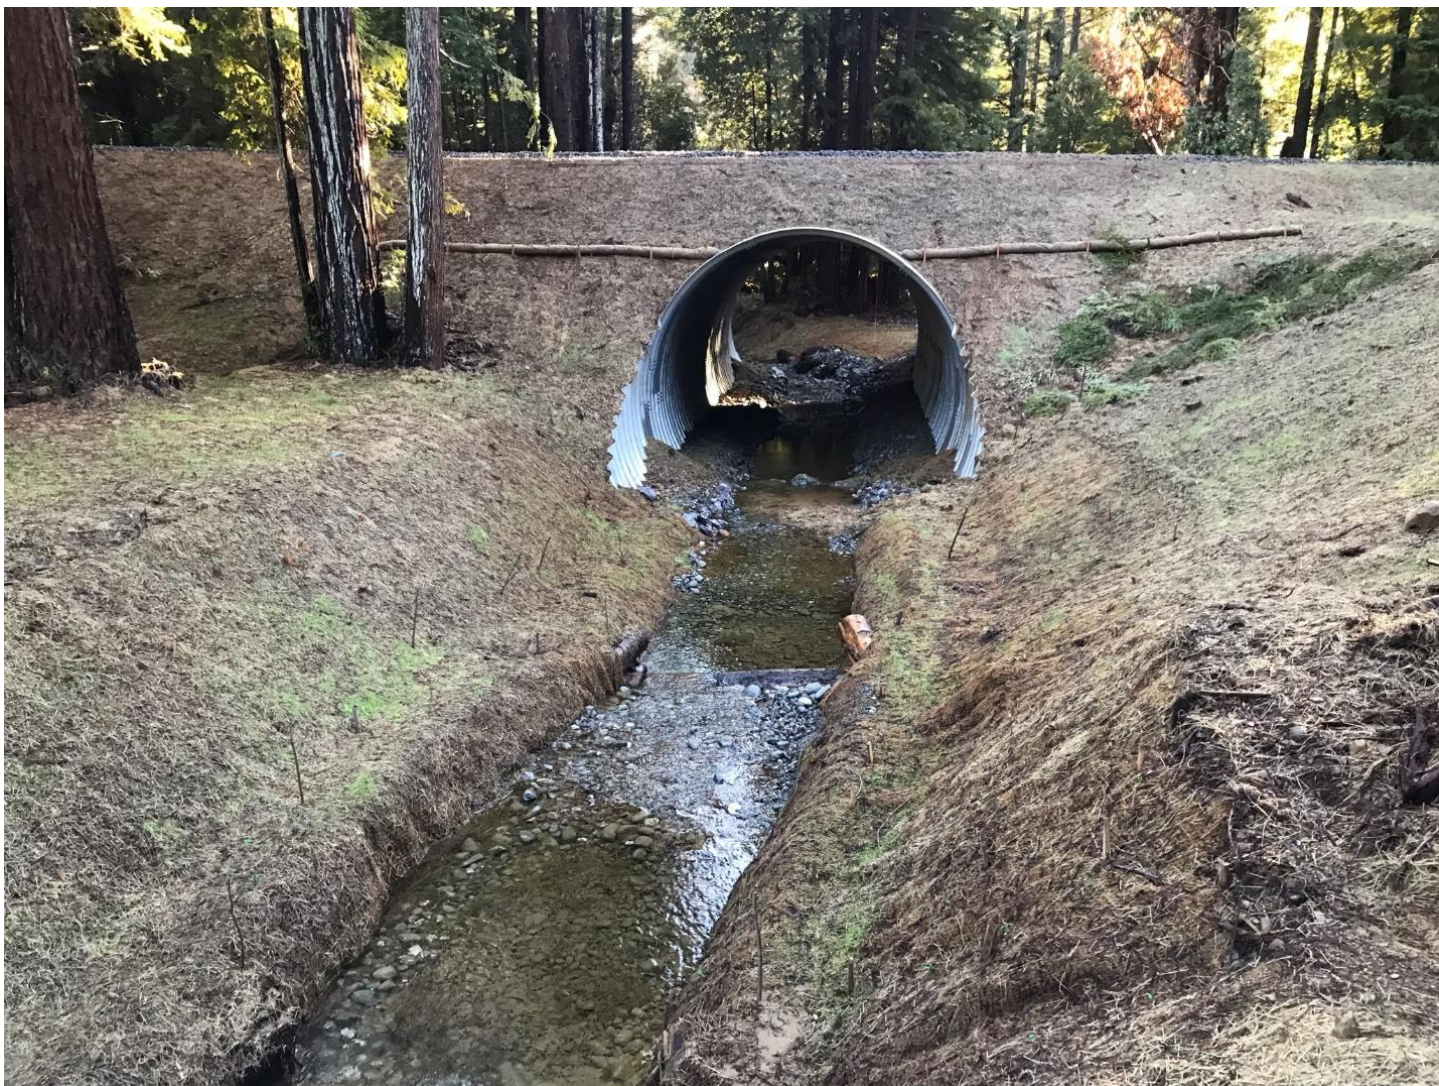
*Image 8: Rail culvert looking downstream, from bridge.*

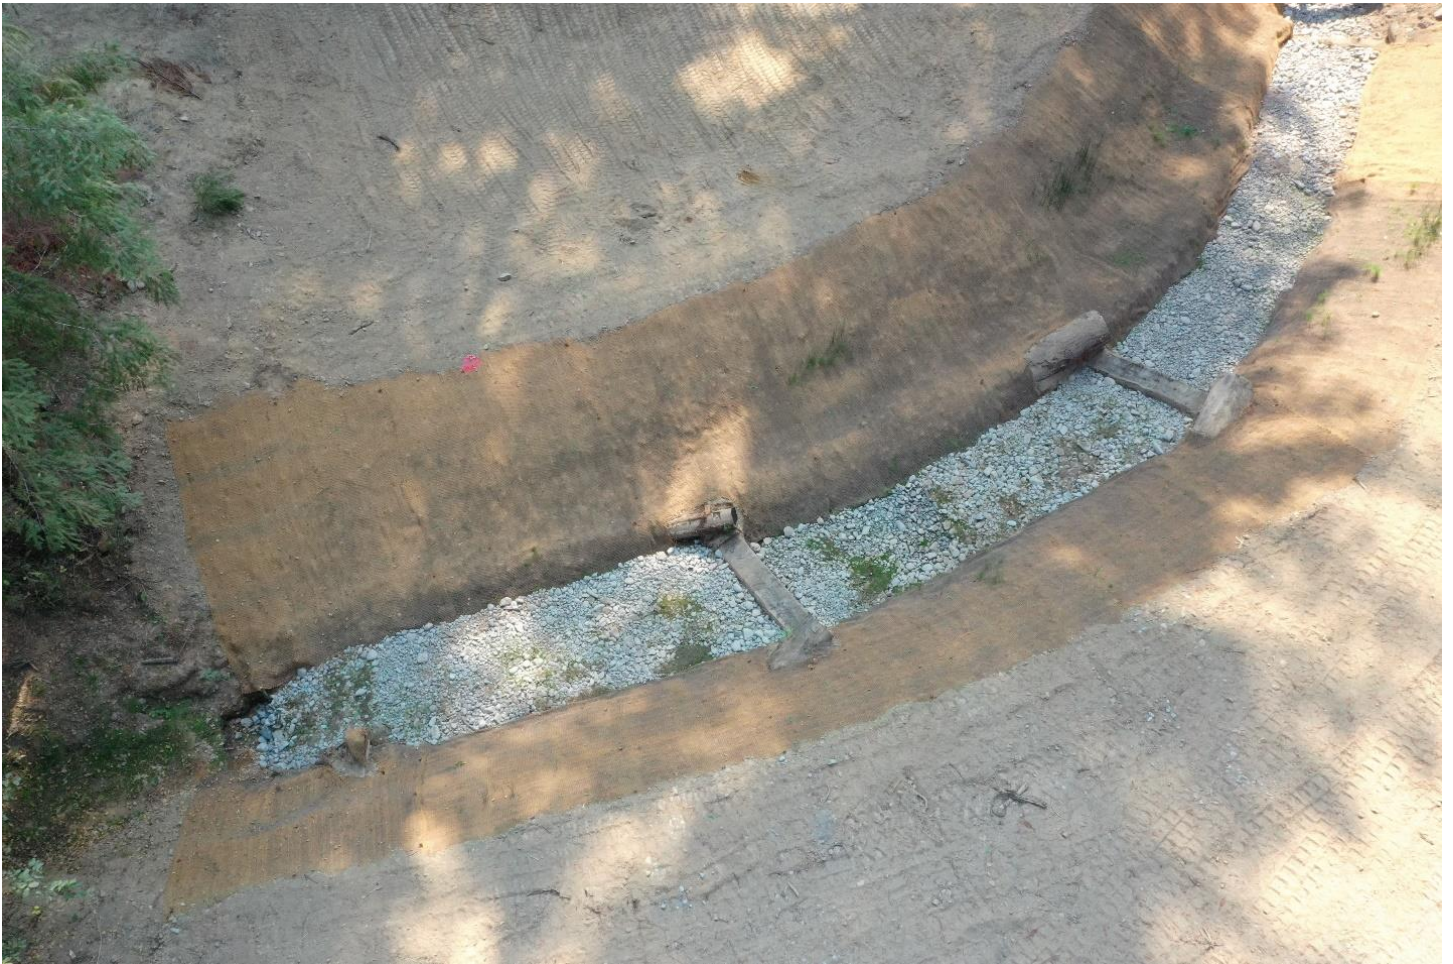
*Image 9: Aerial view of upstream channel, during construction.*

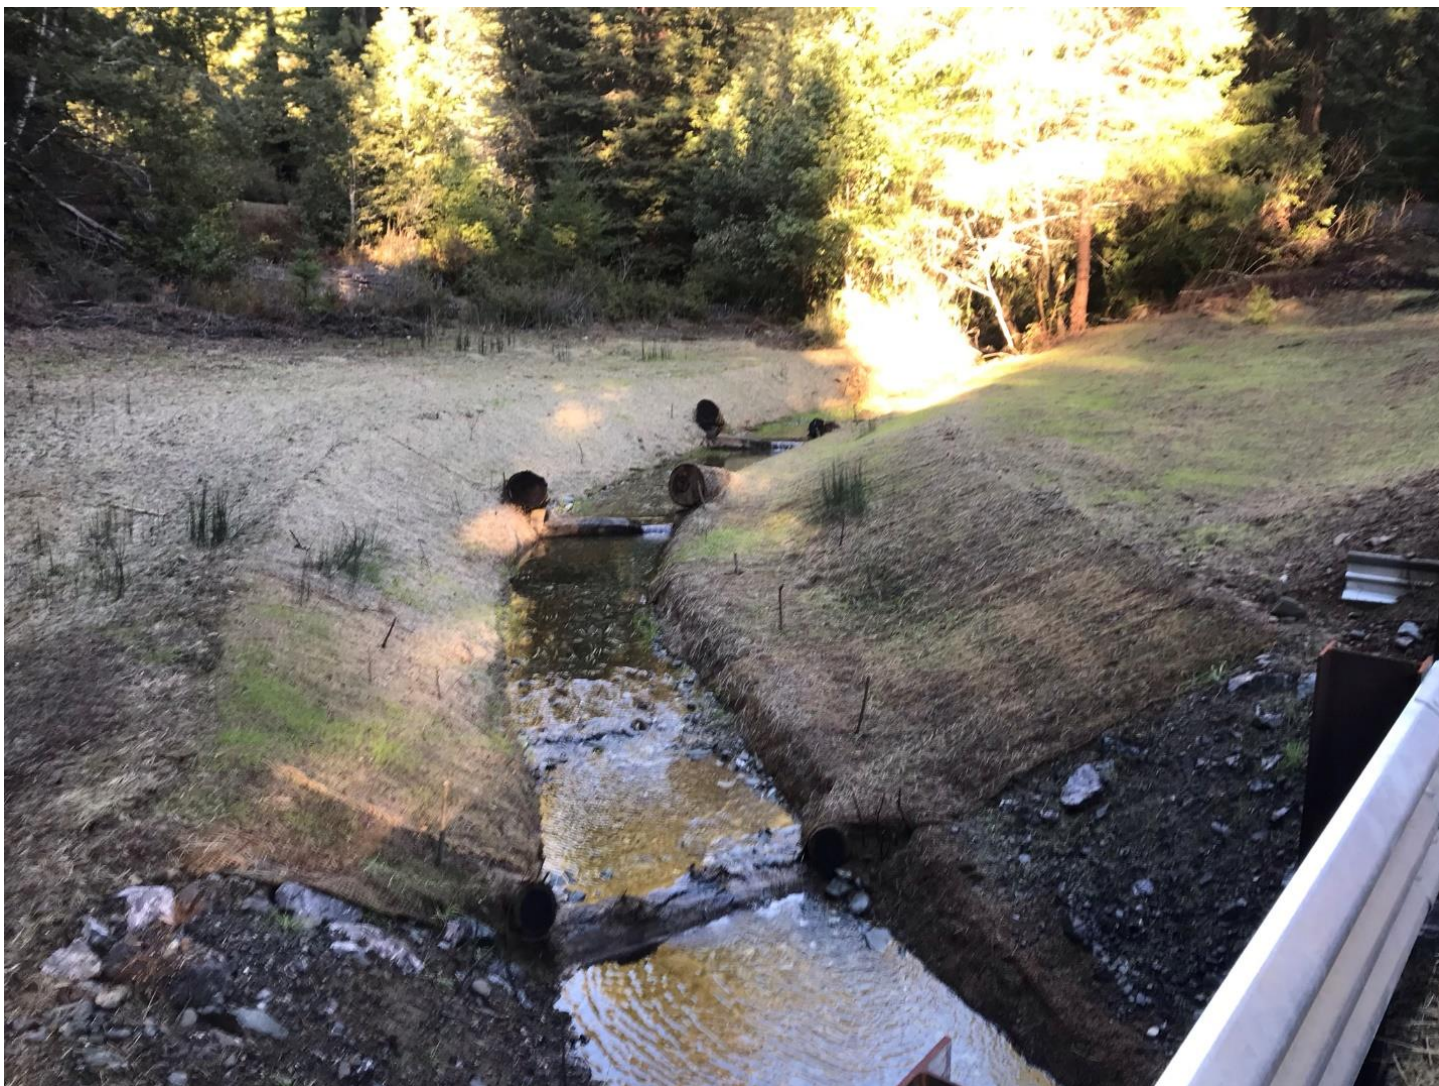
*Image 10: Restored channel with winter base flow. View taken from bridge, looking upstream.*
