Wildlife Permeability and Hazards across Highway 152 Pacheco Pass: Establishing a Baseline to Inform Infrastructure and Restoration.

February 2020

PREPARED BY PATHWAYS FOR WILDLIFE FOR THE SANTA CLARA VALLEY HABITAT AGENCY.

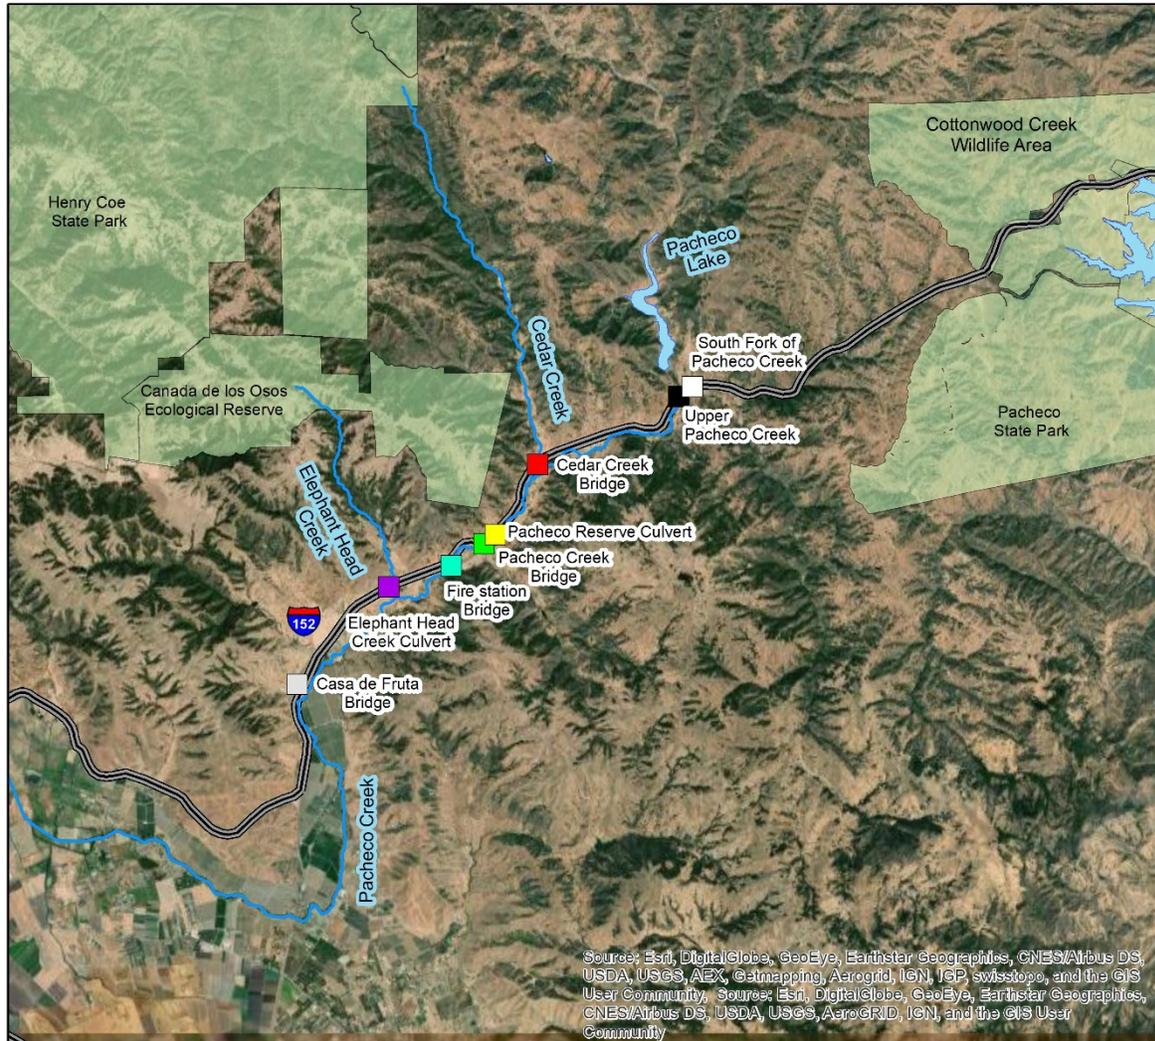
Figure 3. SR-152 Study area and monitoring sites.

Three bridges and two dual box culverts were selected for monitoring within the study area (Table 1 & Figure 3). The three bridges include a bridge by the fire station, the Pacheco Creek bridge at the Pacheco Creek Reserve, and the Cedar Creek Bridge (Table 1 & Figure 3). The two dual box culverts included the Elephant Head Creek culvert and the Pacheco Creek Reserve culvert (Table 1 & Figure 3). Three additional bridges in the study area were not monitored due to access issues. These bridges may be monitored in future project phases (Figure 3).

The two dual box culverts are both 5 feet height and 5 feet wide cement box culverts. Each of the three bridges are large open span bridges that have three sections with a creek running through the middle section. The bridge by the Fire stations spans 59 meters long and 25 meters wide, the Pacheco Creek bridge spans 67 meters long and 54 meters wide, and the Cedar Creek bridge spans 54 meters long and 50 meters width.

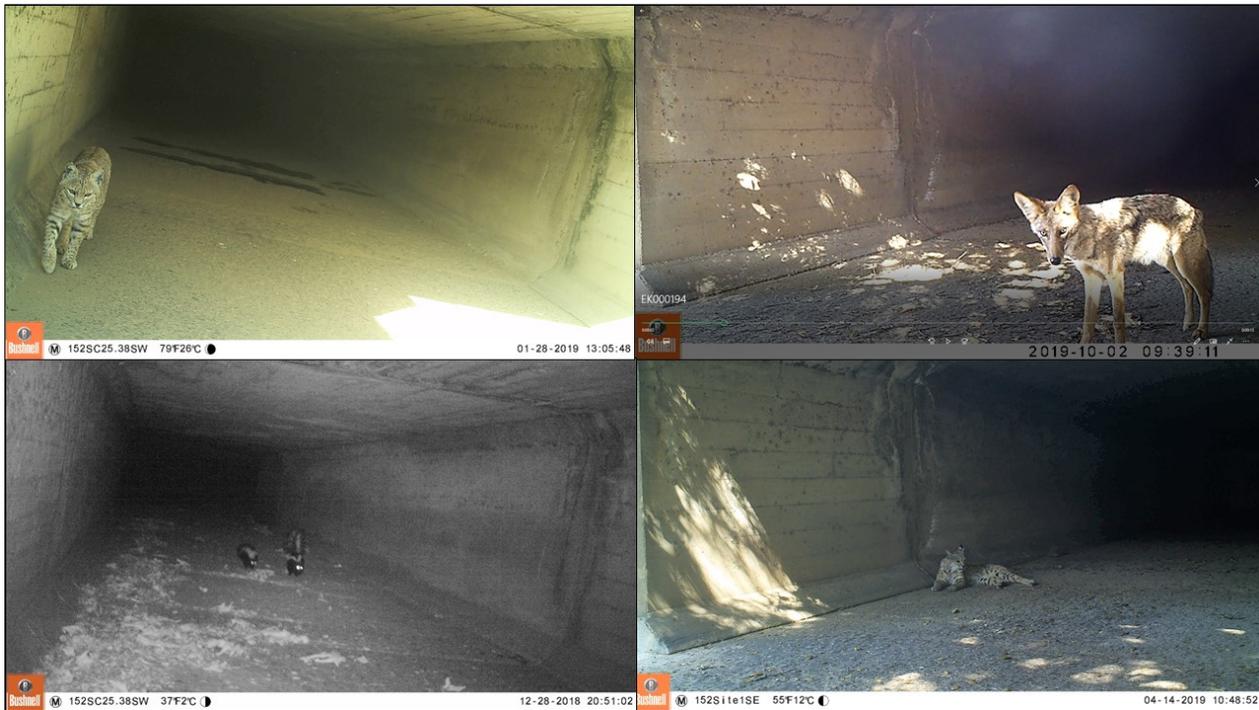
Figure 5. Multiple species use of the Elephant Head creek culvert.

There was a total of 375 passages of wildlife traveling through the Elephant Head Creek dual box culvert. The species with the highest detections include bobcat (150) and raccoon (111) (Table 4). The culvert facilitated small to medium sized mammal movement through it consistently throughout the year except for when it was flooded with water (Figure 5).

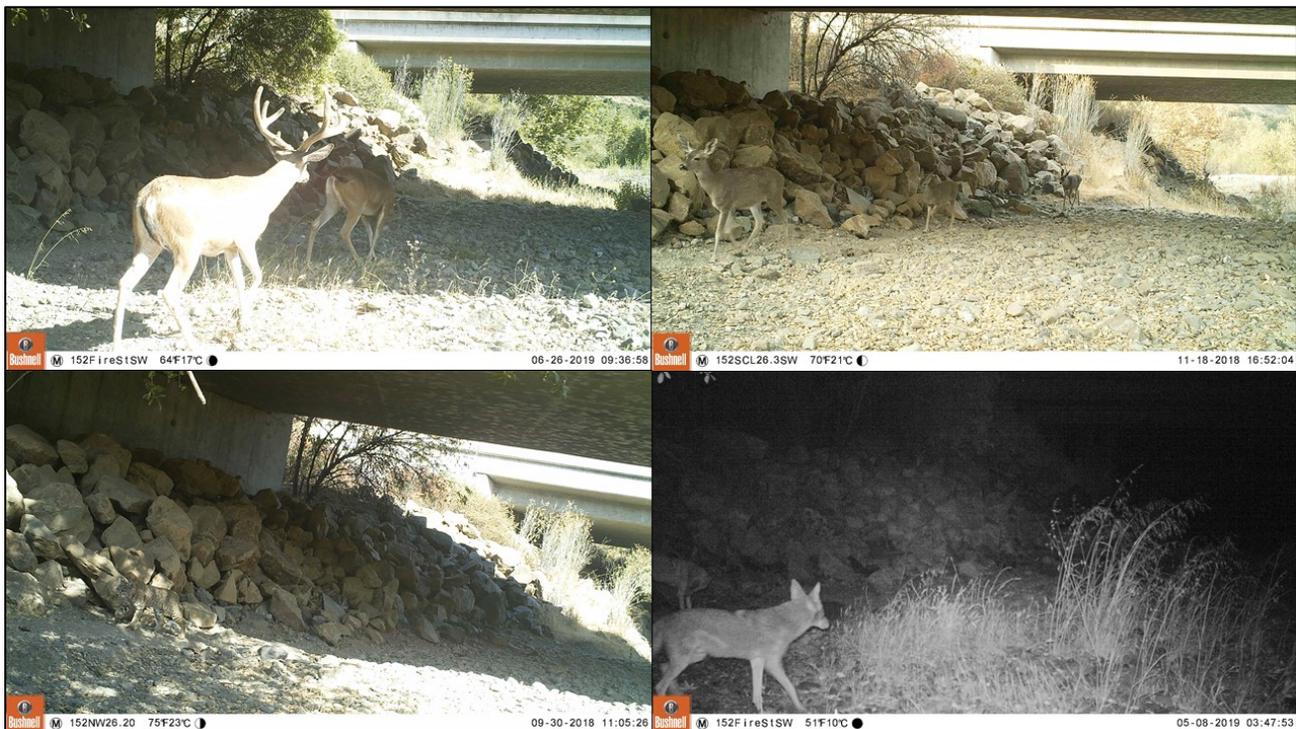
Figure 6. Multiple species use of the Fire Station bridge.

There was a total of 700 passages of wildlife traveling through the Fire Station bridge. The species with the highest detections include deer (395), coyote (161), and bobcat (80) (Table 5). The bridge facilitated small to large sized mammal movement consistently throughout the year (Figure 6). The bridge is playing an important role in facilitating multiple individuals of deer in traveling safely under the highway (Figure 6).

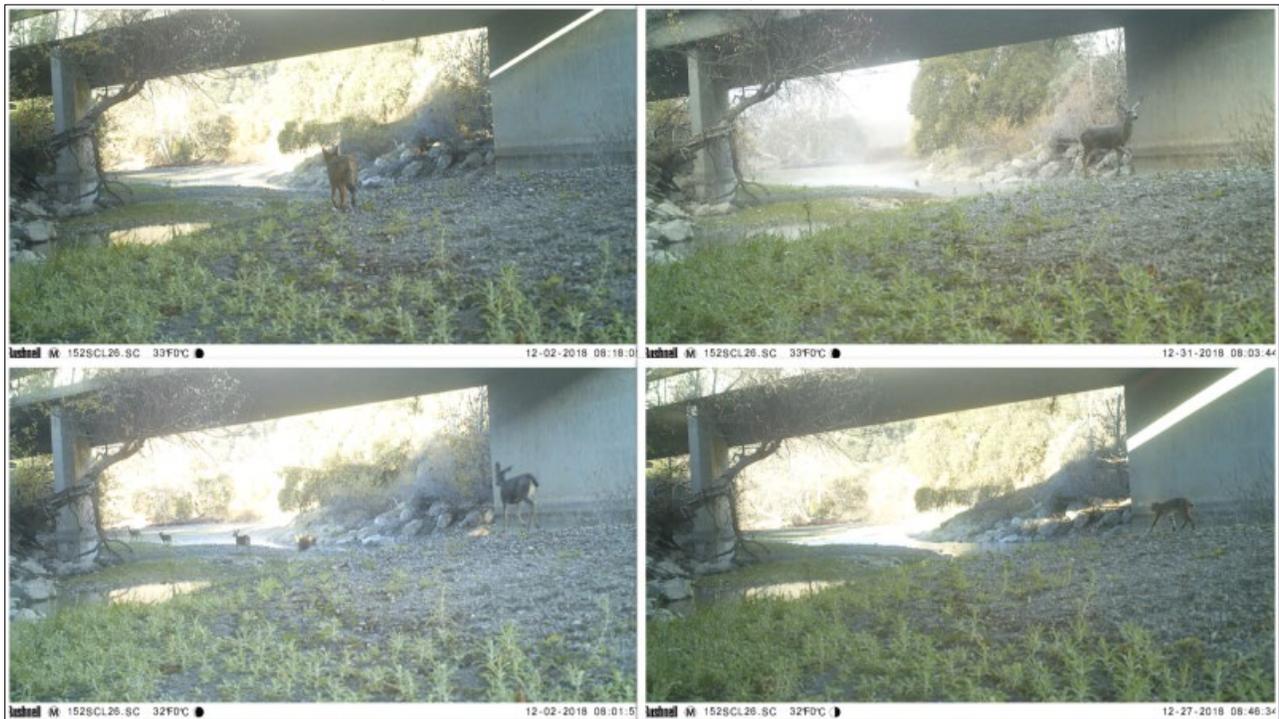
Figure 7. Multiple species use of the Pacheco Creek bridge middle east section.

There was a total of 909 passages of wildlife traveling through the Pacheco Creek bridge. The species with the highest detections include deer (351), gray fox (130), skunk (130), and bobcat (109) (Table 6). The bridge facilitated small to large sized mammal movement consistently throughout the year (Figures 7, 8 & 9). The bridge is playing an important role in facilitating multiple individuals of deer in traveling safely under the highway (Figure 7).

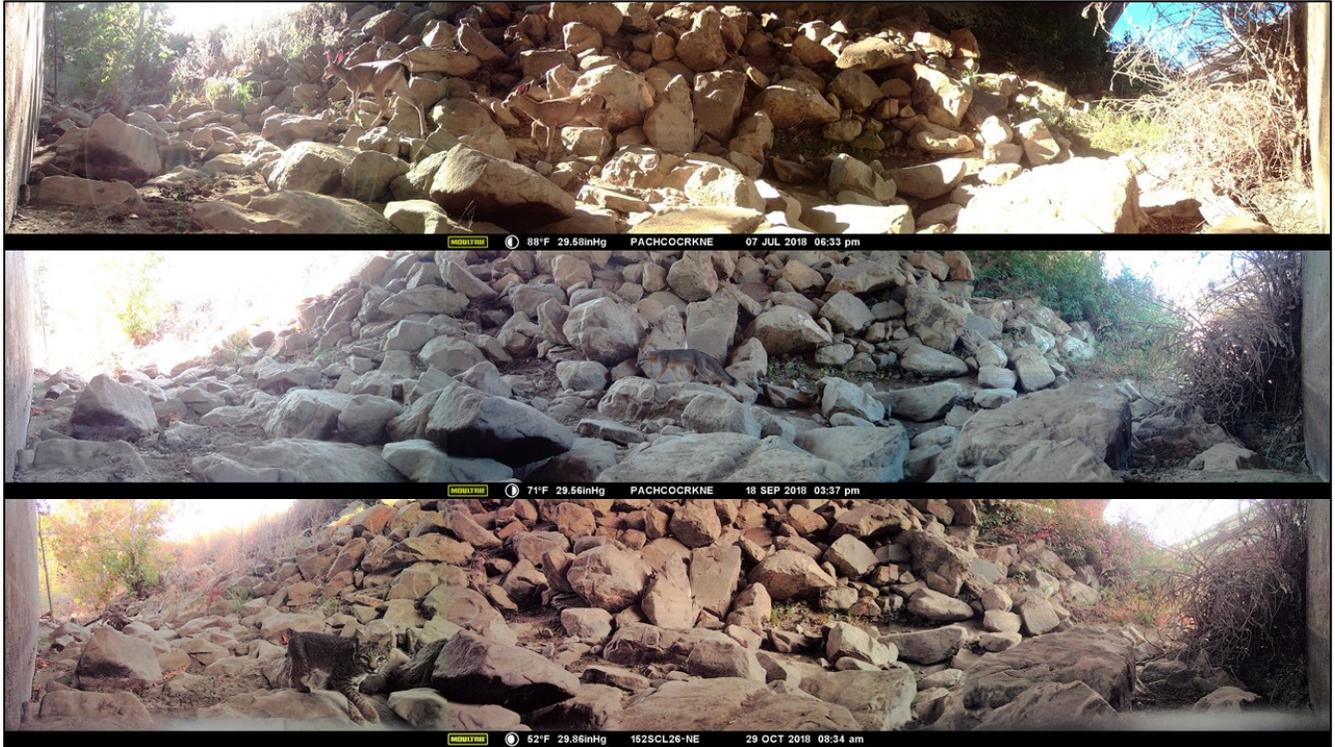
Figure 8. Multiple species use of the Pacheco Creek bridge north east section.

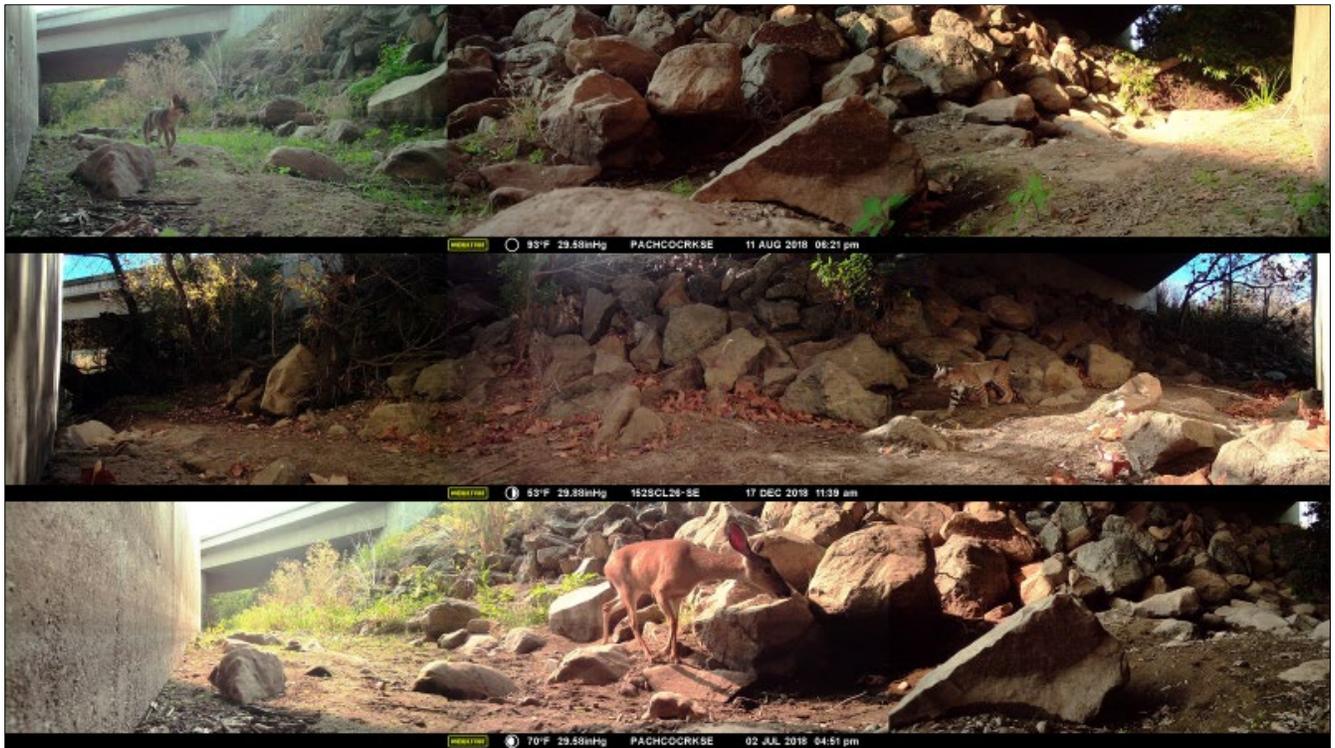
Figure 9. Multiple species use of the Pacheco Creek bridge south east section.

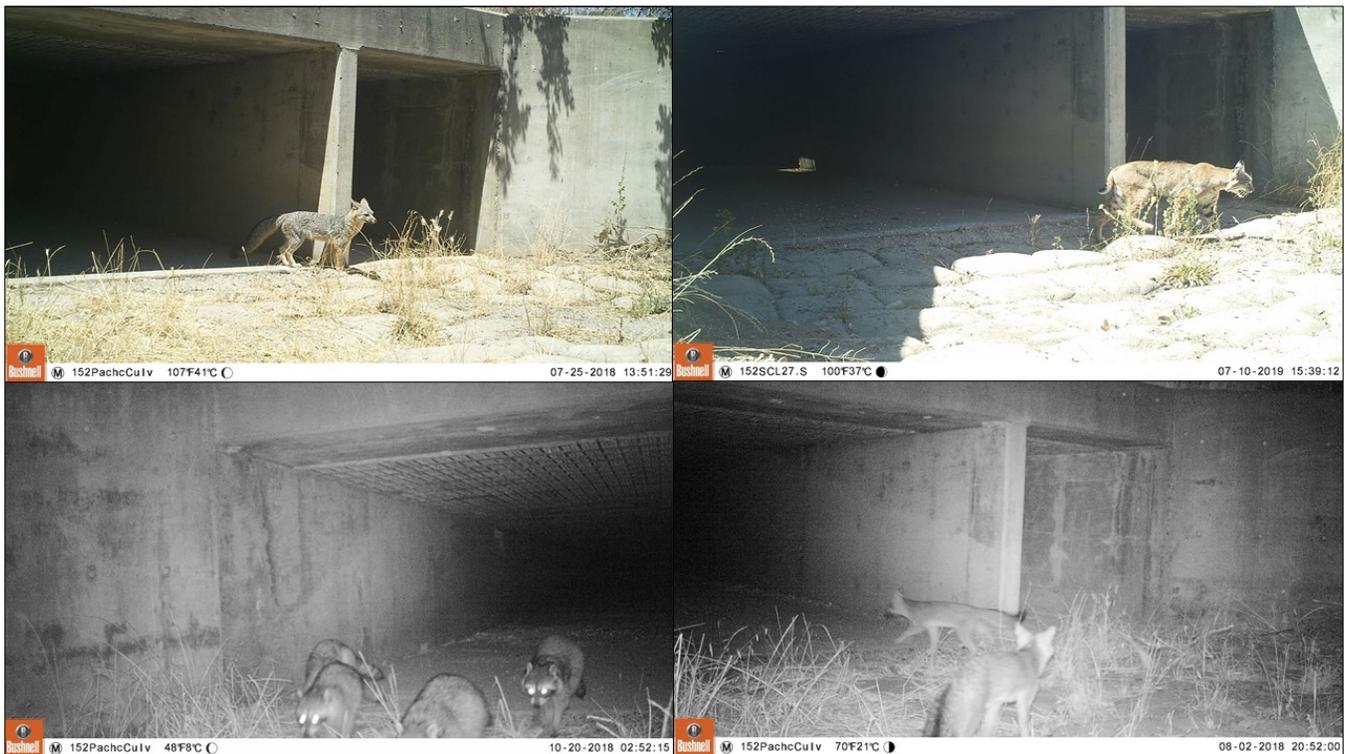
Figure 10. Multiple species use of the Pacheco Reserve dual box culvert.

There was a total of 720 passages of wildlife traveling through the Pacheco Creek dual box culvert. The species with the highest detections include gray fox (289) and skunk (229) (Table 7). The culvert facilitated small to medium size mammal movement through it consistently throughout the year except for when it was flooded with water (Figure 10). Of special note, this culvert facilitated the highest amount of gray fox passages within the study area (Table 3).

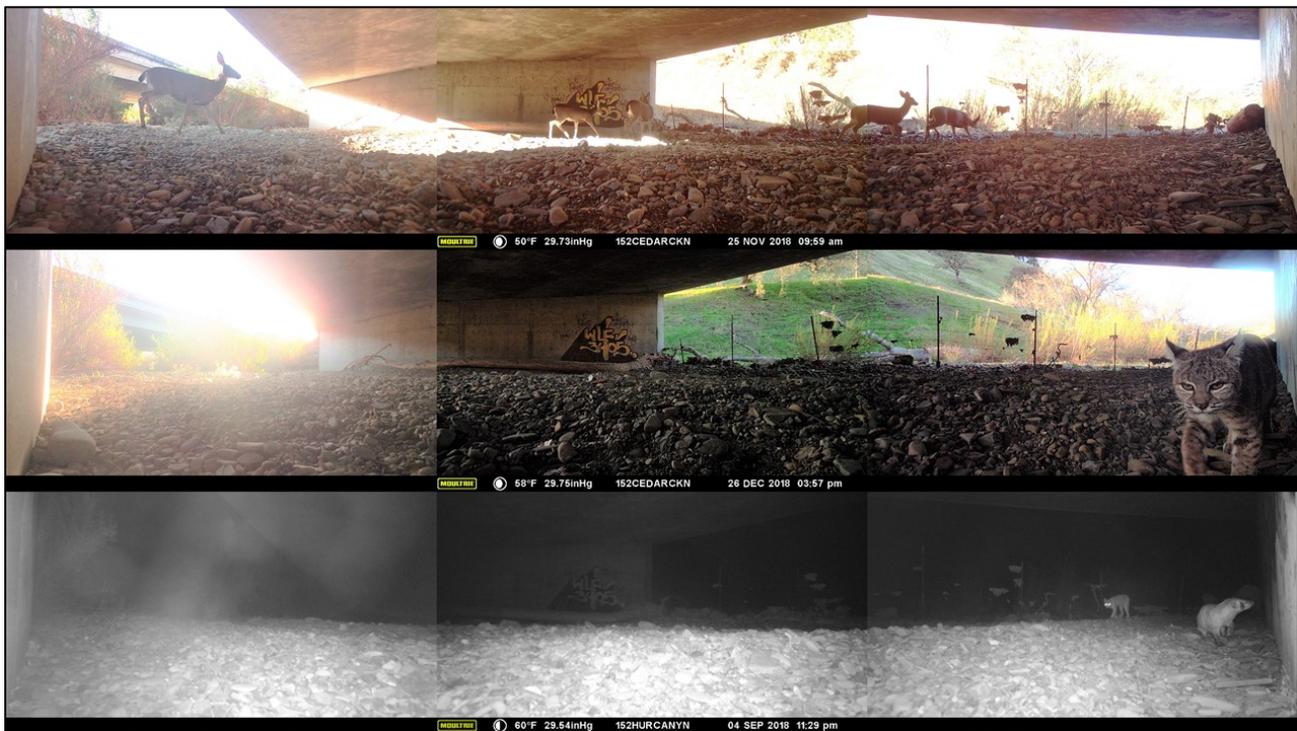
Figure 11. Multiple species use of the Cedar Creek bridge.

There was a total of 485 passages of wildlife traveling through the Cedar Creek bridge. The species with the highest detections include deer (184), coyote (132), and bobcat (105) (Table 5). The bridge facilitated large to small mammal movement consistently throughout the year (Figure 11). The bridge is playing an important role in facilitating multiple individuals of deer in traveling safely under the highway (Figure 11).

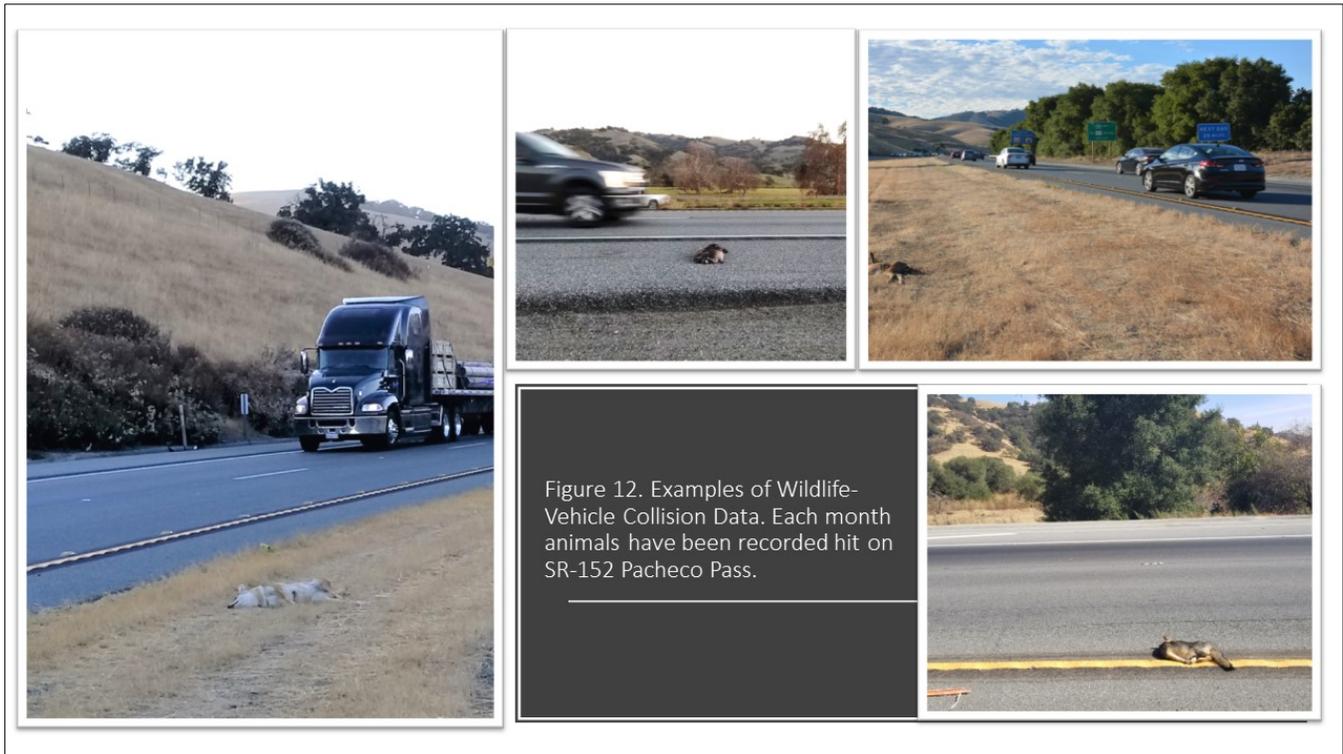
The recorded wildlife-vehicle collisions span across the entire stretch of the study area, including animals hit by the culverts and bridges. (Figure 13). The same species recorded using the bridges and culverts to travel under the highway were also being recorded as hit by cars.

Figure 13. Wildlife-vehicle collision data collected from August 2018-July 2019.

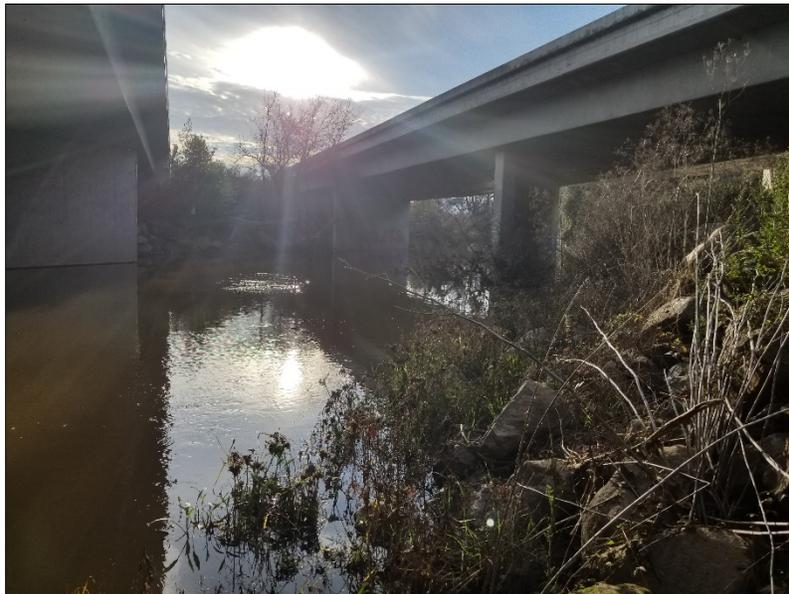
Figure 15. Pacheco Creek bridge flooded during February 2019.

During the winter season of the study, there were several storm events that caused the bridges and culverts to flood with water (Figures 15 & 16). Before the flooding events occurred, multiple species were recorded to consistently travel through the bridges and culverts during the months of August-December 2018 (Chart 3).

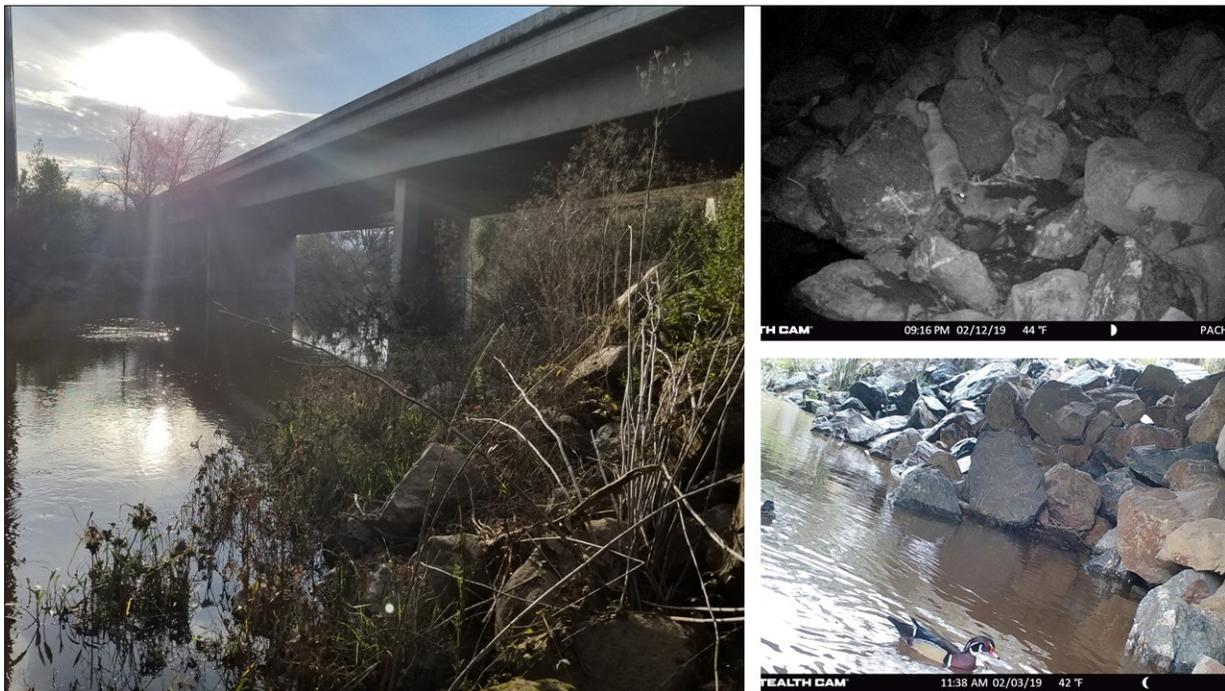
Figure 18. Pacheco Creek bridge in February 2019 and camera data.

At the Pacheco Creek bridge, where multiple species had been recorded consistently traveling under the bridge, we recorded wood ducks (*Aix sponsa*) swimming by the camera (Figure 18). The only species we recorded during January and February traveling under the bridge were raccoons (Figure 18).

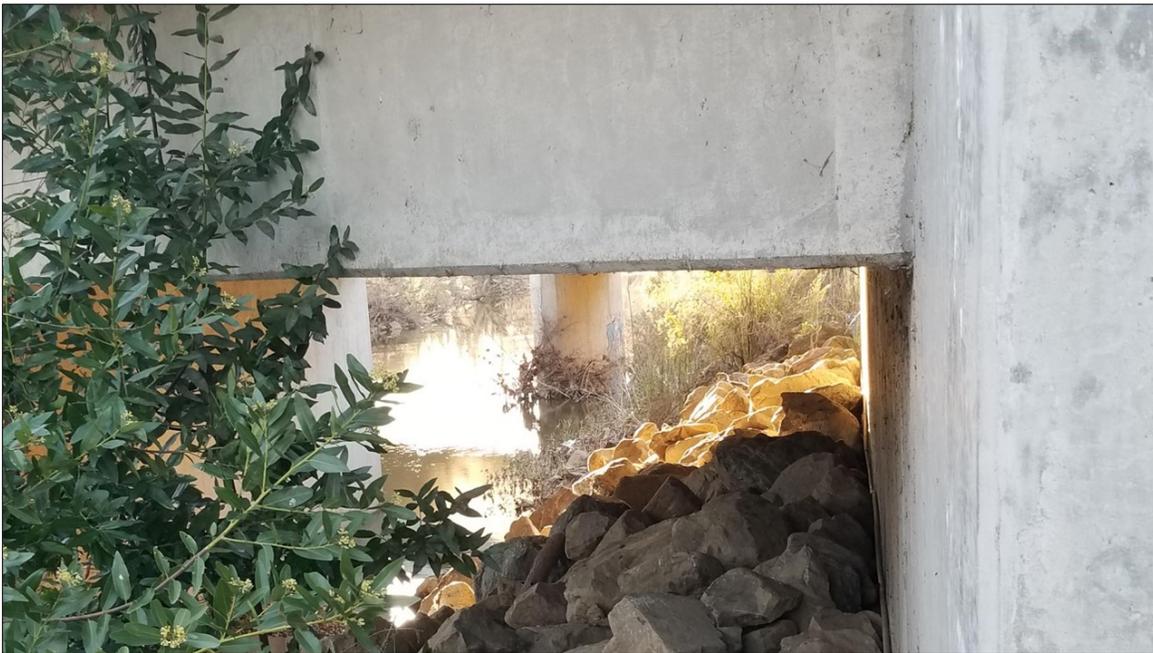
Figure 19. The east side of the Pacheco Creek bridge at the Pacheco Reserve.

The east and west sides of the Pacheco Creek bridge are lined with large rip rap rocks (Figure 19). The rip rap [or RSP] makes it difficult for some wildlife species to travel under the bridge when the creek is full and inundates the bank below the RSP. The only species recorded traveling along the rip rap were raccoons and bobcats; both species are agile climbers, which allow them to navigate the large rip rap at the bridge abutments.

On March 20, 2019, the Santa Clara Habitat Agency, Caltrans, CDFW, and Peninsula Open Space Trust (POST) toured the wildlife crossings. The site visit was conducted to review data collected up to date and discuss potential wildlife connectivity enhancements (Figure 20). Removal of the rip-rap rocks is not advised as it would interfere with the structural integrity of the bridge. However, both Caltrans and CDFW suggested it would be feasible to fill the spaces between the rip-rap with a type of cement substrate. This would create a hard surface for wildlife to walk on. A CDFW biologist would approve the design. This project would engage the San Jose Conservation Corps to fill in the rip-rap.

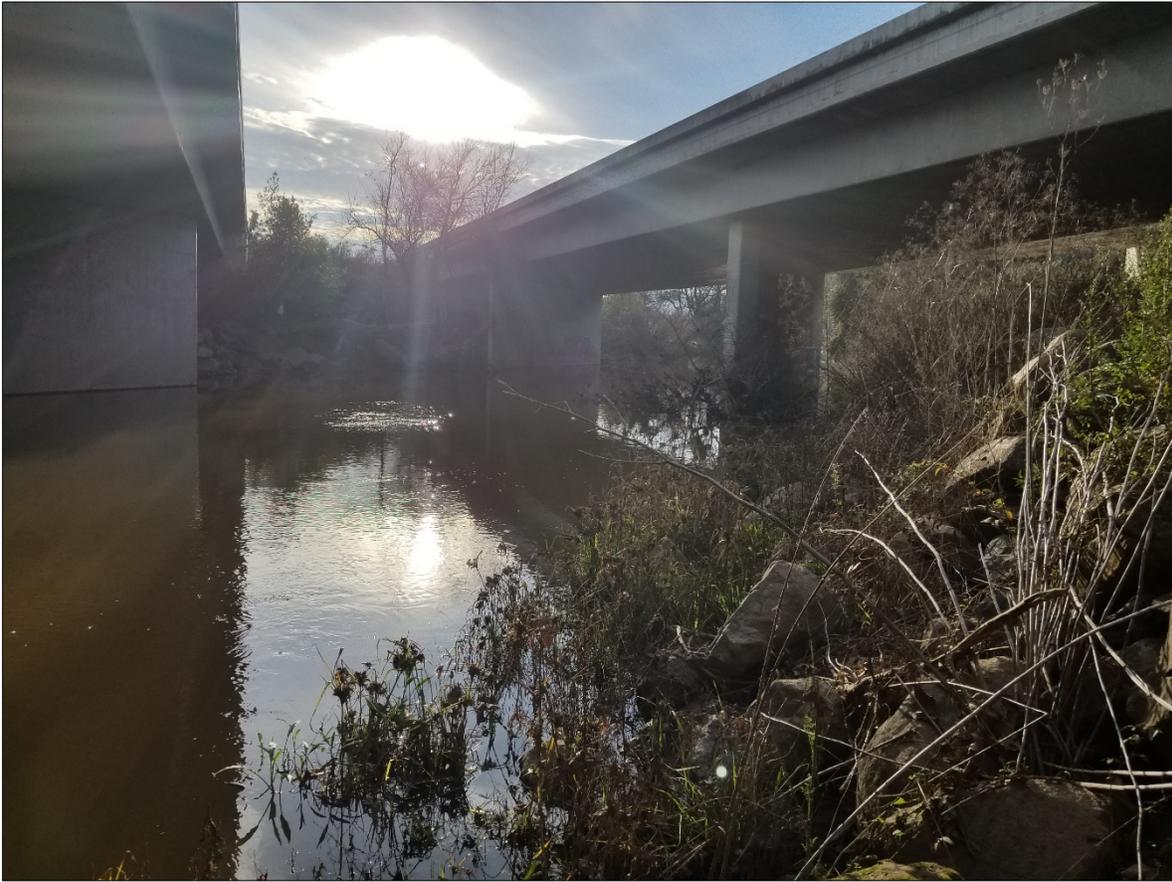
Figure 21. The east side of the Pacheco Creek bridge.

3. BANK IMPROVEMENTS AT THE PACHECO CREEK BRIDGE AT THE PACHECO CREEK RESERVE
 Wildlife passage during high flows could be improved by removing dead trees, dead shrubs, and dense invasive vegetation along the banks to increase bank width at higher slope areas and restoring with native vegetation. Both the east and west sides of the bridge have large amounts of dead tree and invasive vegetation build up that can restrict species movement through the bridge (Figure 21). By removing this debris, it would increase the amount of creek bank available for wildlife to traverse under the bridge. As with the RSP improvement, this project would engage the San Jose Conservation Corps to conduct the work.
