SANTA PAULA CREEK SEEP SSEP: Sources

Final Report, Volume 1

Prepared by Ira Leifer¹ and Ken Wilson²

December 3, 2014

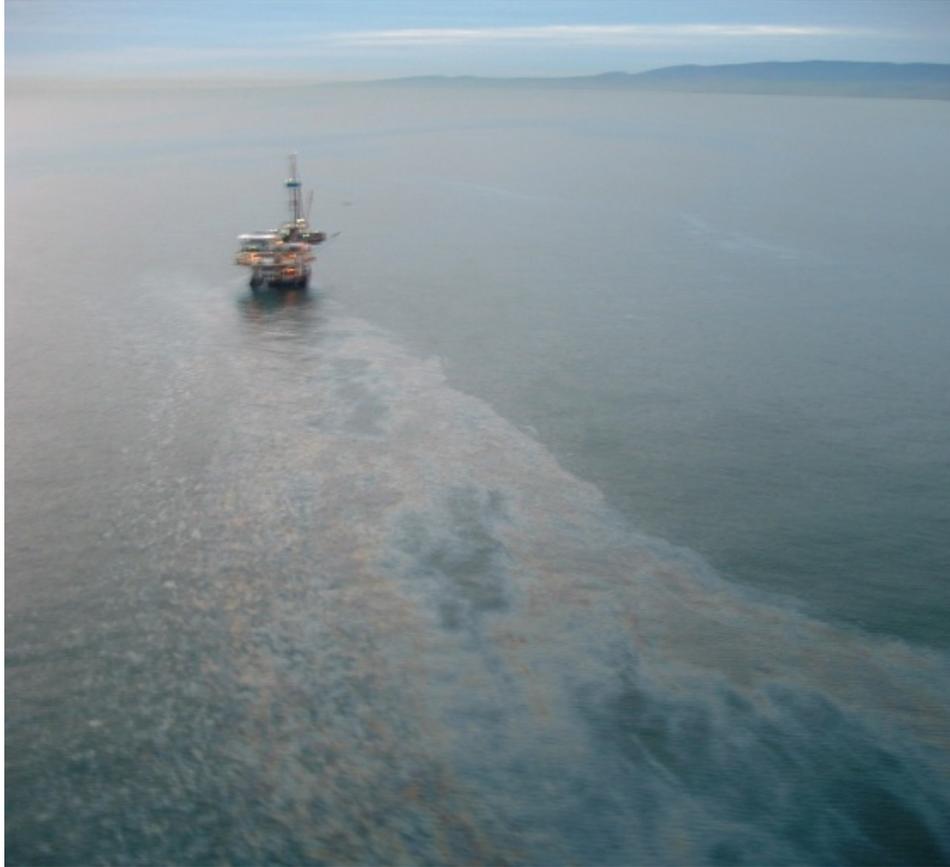
Fig. 2. Aerial photo showing oil slicks arising from near Platform Holly on 14 Jan. 2005. Photo courtesy of Laird Henkel, CA-CDFW.

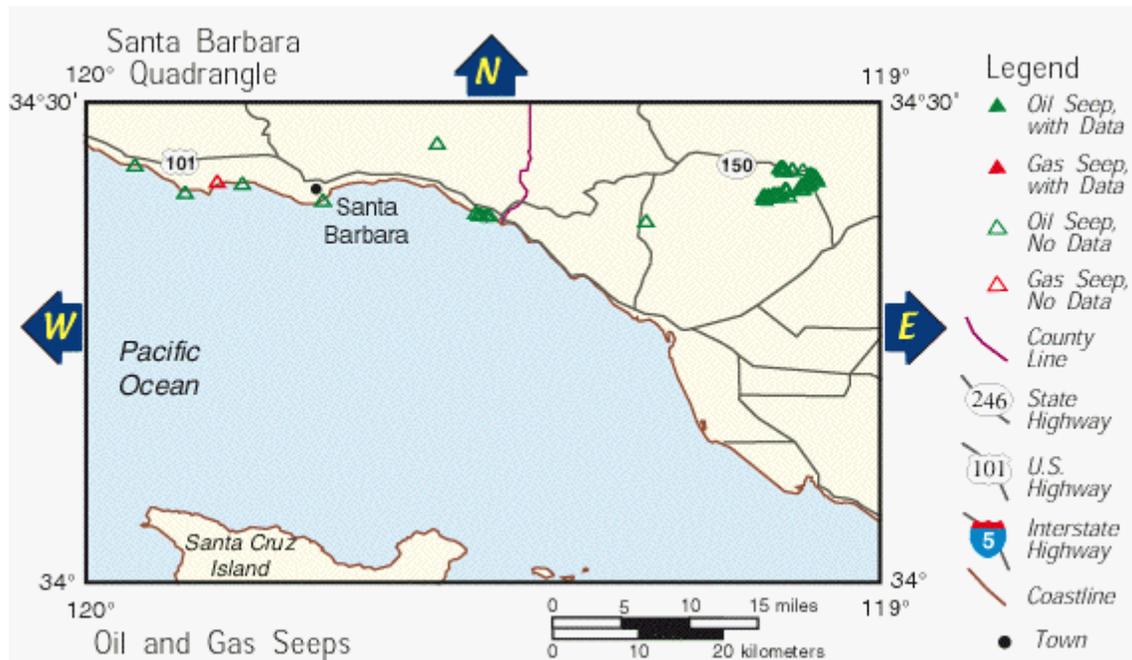
Fig. 6. Map depicting some of the natural oil seeps in the Santa Barbara-Ventura County Areas. The natural oil seeps studied in the Santa Paula Creek watershed are among those designated by green triangles in the upper right quadrant of the image (Hodgson, 1987).

Many active oil seeps are located within several of the larger and some of the smaller sub-watersheds of streams and rivers in Santa Barbara, Ventura, and northern Los Angeles Counties (DOGGR, 1992; Hodgson, 1987). Among the most notable onshore seeps, which are most likely to affect the riverine and coastal environments are those seeps occurring within the tributaries to the SCR. Seeps located in Carpinteria and Toro Canyon Creeks in southern Santa Barbara County are less likely to affect the riverine and coastal environments (**Fig. 6**).

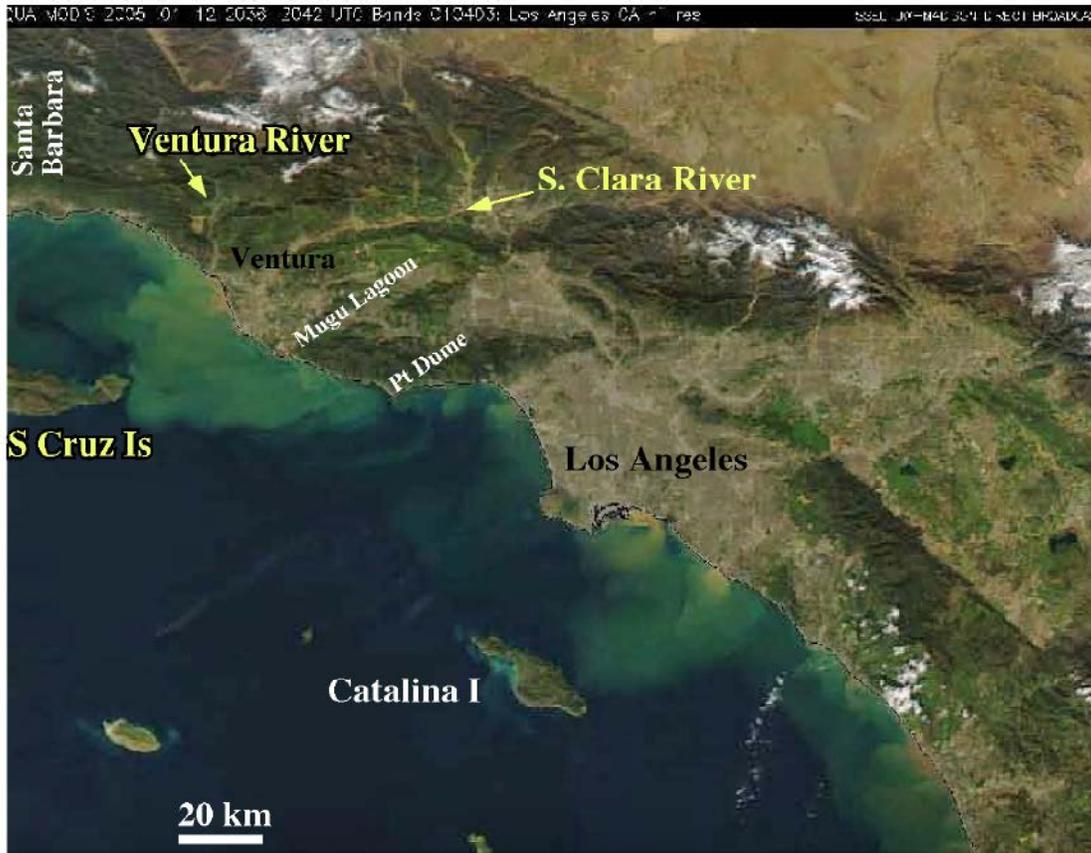
Fig. 8. Satellite image showing sediment plumes offshore the central and southern California coastline on Jan. 2005. The light green area in the upper left quadrant of the image is the sediment plume arising primarily from the Santa Clara and Ventura Rivers.

A satellite photo taken shortly after the Jan. 2005 storm (**Fig. 8**) showed sediment plumes that resulted from freshwater stormflows originating from the Santa Clara and Ventura Rivers as well as other smaller coastal streams. The plumes (upper left quadrant of photo) extended more than 22 miles offshore from the mainland, enveloping marine waters around Anacapa Island and on the east end of Santa Cruz Island, and along the coast for about 40 miles from about Pitas Point in Ventura County southward to Point Dume on the Malibu coast in Los Angeles County. At the time of the satellite photo, this sediment plume covered ~492 sq. mi.

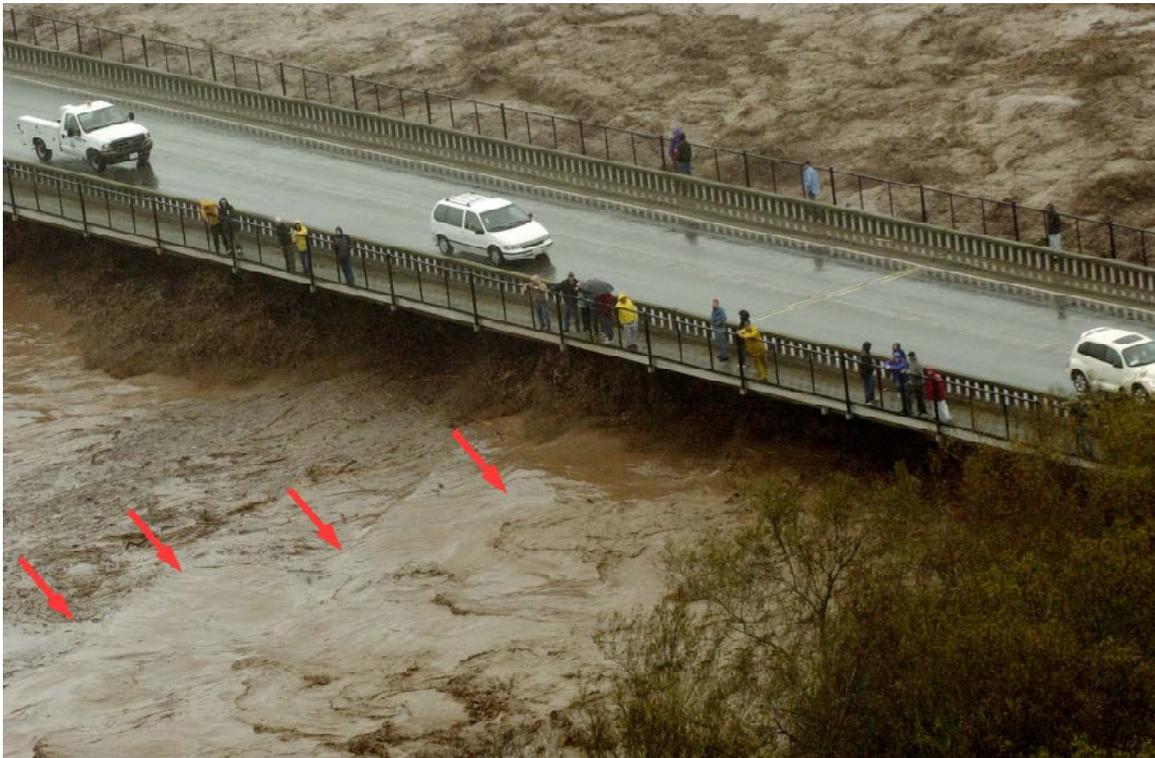
Fig. 9. Stormflows in the Santa Clara River at the Harbor Ave Bridge just over ½ mi from the Pacific Ocean. There is a silvery oil sheen (red arrows) on the water surface. A significant amount of this oil is proposed to have originated from natural seeps in the vicinity of Thomas Aquinas College, near the confluence of Sisar and Santa Paula Creeks. Photo courtesy Gary Phelps, Ventura County Star, 10 Jan, 2005).

Photographic evidence (**Fig. 9**) supports that proposition that oil flowed down the Santa Clara River into the Pacific Ocean on 10 Jan. 2005.

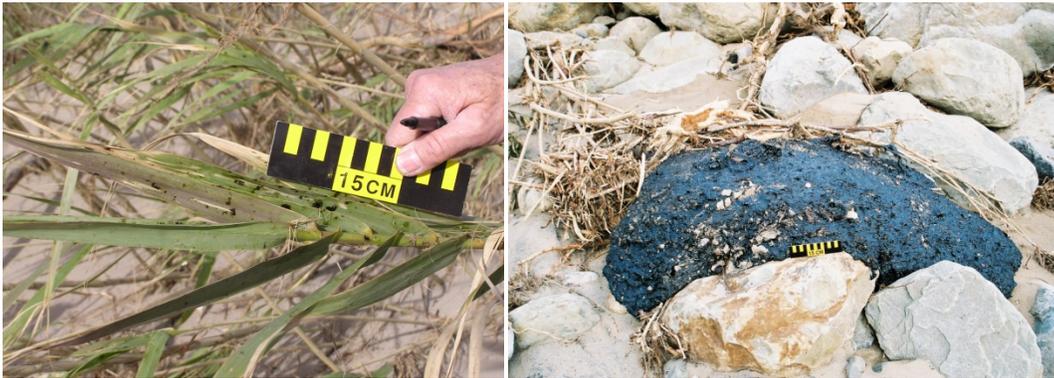
Fig. 12 Left. Image showing trace oil deposits on a giant cane plant in the SCR. This oil was ‘similar’ to the oil on the bird feathers. **Right.** The right image is a 1-meter diameter chunk of semi-plastic asphalt conglomerate deposited in Santa Paula Creek just below Steckel Park. Many large tar patties (semi-plastic asphalt) were observed stranded in the bed of SPC. For example, a 1-meter diameter tar patty was observed ~2.4 miles downstream of our study area.

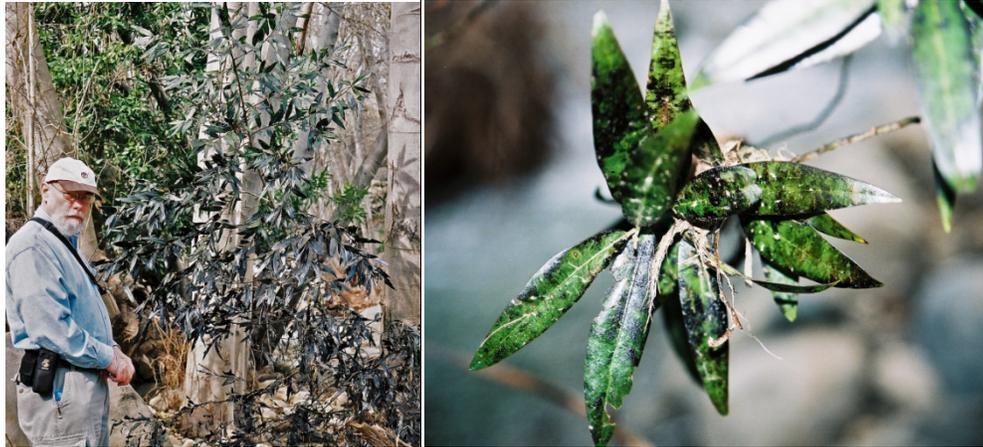
Fig. 13. Left. California laurel tree showing oil staining up to several meters above ground. This tree was located high on the bank of Sisar Creek, ~15 to 20 feet above the streambed, near its confluence with Santa Paula Creek, approximately $\frac{1}{4}$ mile upstream of the study area. CDFW Chemist Bob Todd in image. **Right.** Close-up image of oiled leaves.

Investigators found traces of oil on vegetation and on the bed of the SCR upstream to, but not beyond, Santa Paula Creek (**Fig. 13**). Samples from several known significant terrestrial oil seeps located in tributaries to the SCR were analyzed to determine possible oil sources. These included several in SPC and in its major tributary, Sisar Creek; sources in Sespe Creek, a tributary to the SCR near Fillmore, CA, located upstream and east of Santa Paula; and seeps in from Wheeler Canyon arising from Unocal's abandoned oil tunnels just downstream of Santa Paula. Oil samples also were collected from eleven oil producers in the SPC watershed to eliminate the possibility of spills from oil production facilities.

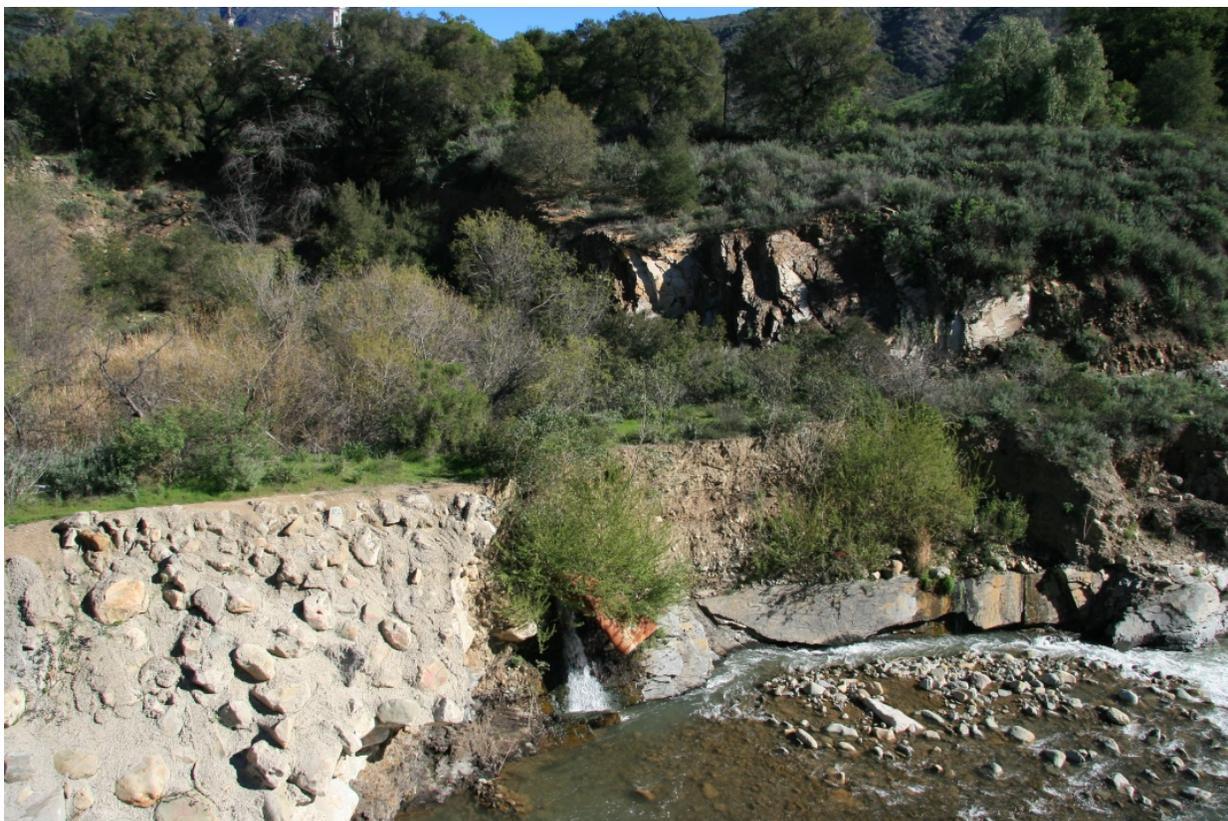
Fig. 18. Northeast of the Culvert Seep Area (foreground), the Thomas Aquinas Oil Pool is in the upper left quadrant of the photo and may be recognized as the light straw-colored vegetation behind the concreted rock rip-rap bank protection. The damaged culvert and soil bank downstream of the rip-rap were heavily eroded by the Jan. 2005 storms. (Photo taken 26 Feb. 2008).

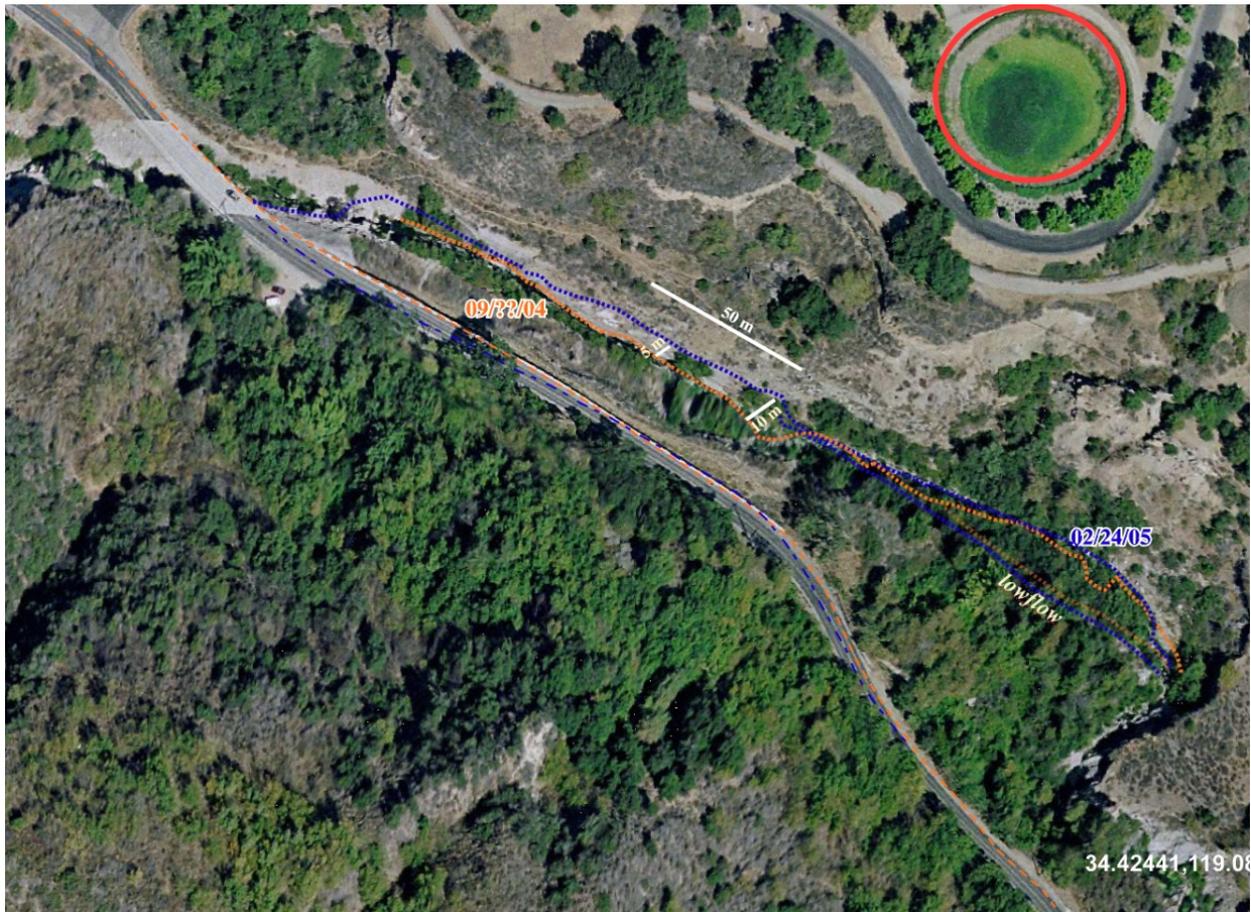
Fig. 19. Study area image from Google Earth. Orange dotted line represents the toe of slope of Santa Paula Creek on Sept. 2004 and Blue dotted line the toe of slope on Feb. 2005 showing post erosion bank line. CalTrans Bridge (No. 52-105) is in the upper left corner of the image. Note, red circle and blue and orange lines along Highway 150 were for aligning images only and have no other significance.

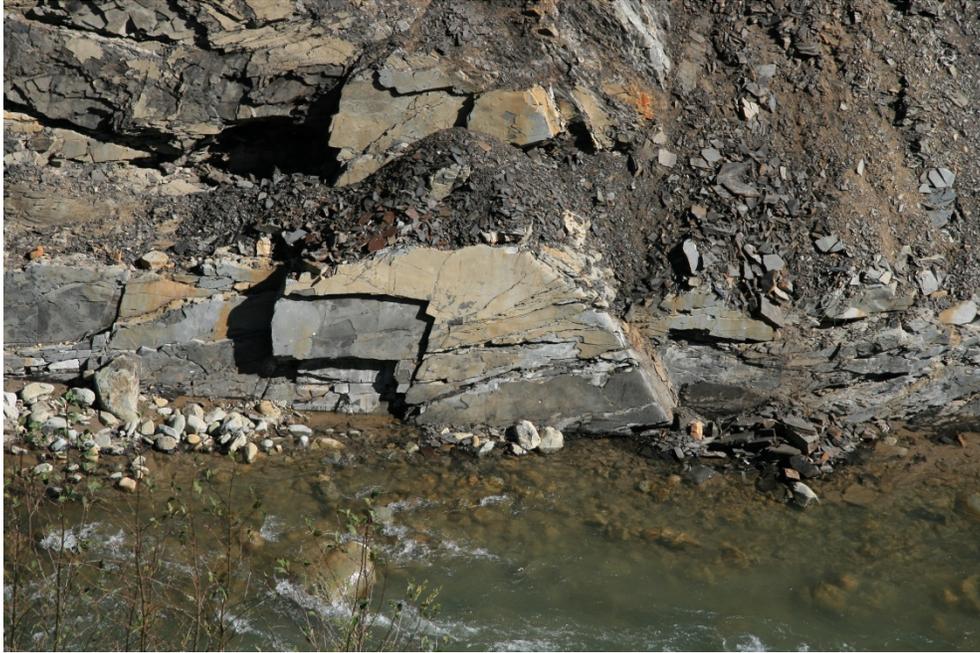
Fig. 20. Raven's Head Seep was venting underwater in this Feb. 2008 photo. The seep is located just to the left of photo center. Though inconspicuous, brown and black droplets are floating on the water surface.

This is a small oil seep that vents at the interface of the fracturing shale cliff-face and the streambed (**Fig. 20**). Brown and black oil droplets may be seen upon close examination at the front of the Raven's neck at water level, just to the left of photo center. As the stream flows diminished, oil flowed through the cobbles and vented in the streambed alluvium in the lower left quadrant of the photo. This oil seep did not form large pools due to the streambed configuration.

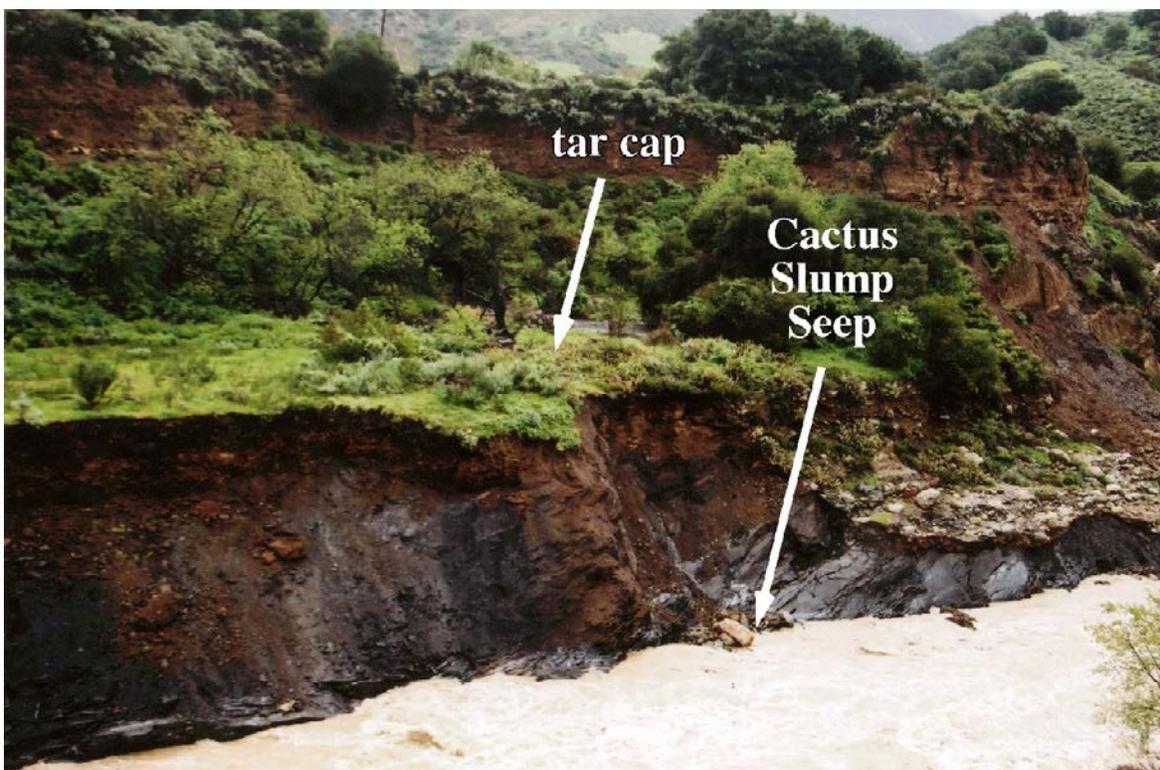
Fig. 22. January 2005 photo of Santa Paula Creek near, but below, flood stage. The dark cliff face between the Cactus Slump Seep and the photo's left edge is proposed to be the remnant of the oil-saturated soil that washed away on 10 Jan. 2005. The tar cap and Cactus Slump Seep Area are identified on photo. See **Fig. 25** for 2008 photos. Future Dead Duckling Oil Pool below Cactus Slump Seep. Photo courtesy of CDFW.

An extensive tar cap tens of meters across was noted on this terrace and was bordered by cacti on the streamward (southwest) side (**Figs. 22 to 24**). Below this tar cap were instream oil seeps we named the Cactus Slump Seeps. The cap's central area was mostly un-vegetated, with two large dead trees standing in the middle. The surface of the petroleum comprising tar cap was asphaltized and somewhat flexible (i.e., could not be walked on), suggesting liquid oil and/or water underneath, with fresh oil seepage noted at one or two locations. The tar cap had no sediment overburden for a diameter of tens of meters, beyond which it is sediment covered. In the direction of the stream (south), this sediment overburden extends right to the terrace's edge. The tar is far more plastic in the summer than winter, while the absence of dirt over the central

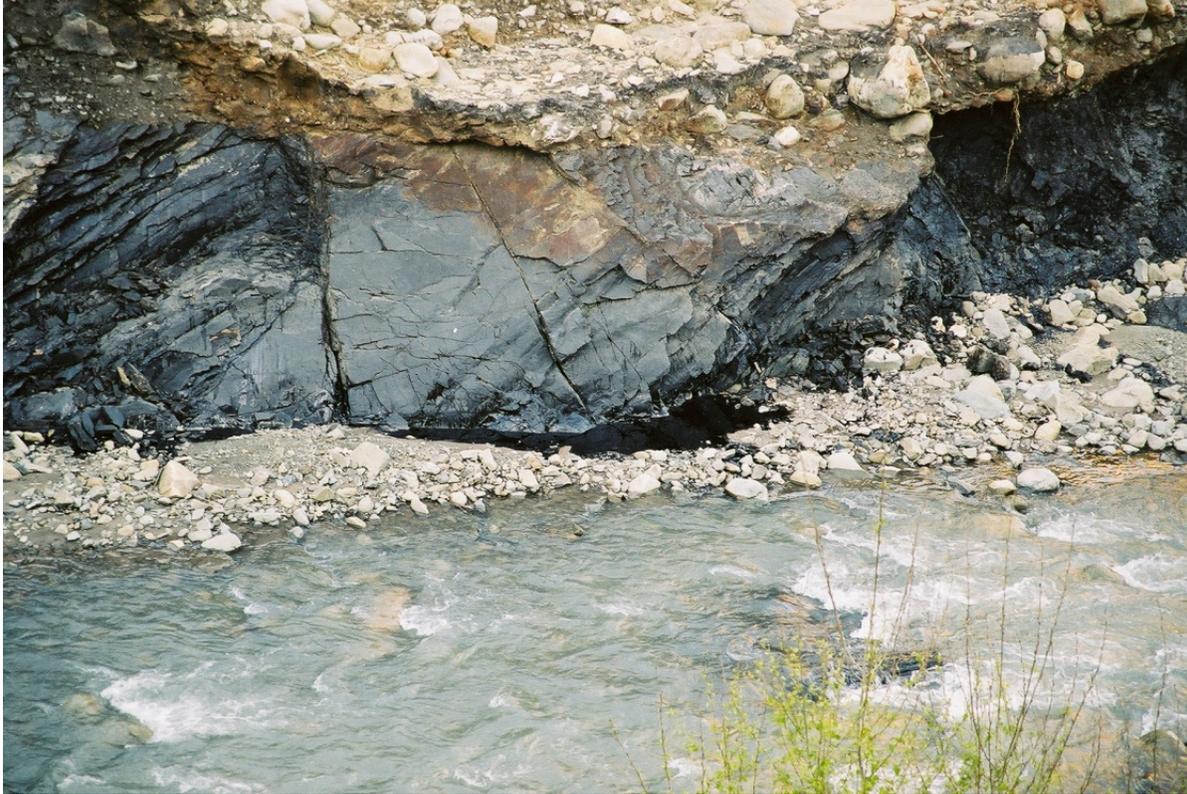
Fig. 25. By the end of Jan. 2005, a large oil pool formed in the streambed of Santa Paula Creek as the floodwaters began to recede. The area in the lower right quadrant of the photo will become the site Dead Duckling Oil Pool (DDOP) will form in 2008 approximately 3-m streamward of the oil pool at photo center. See **Figs. 26** and **27**.

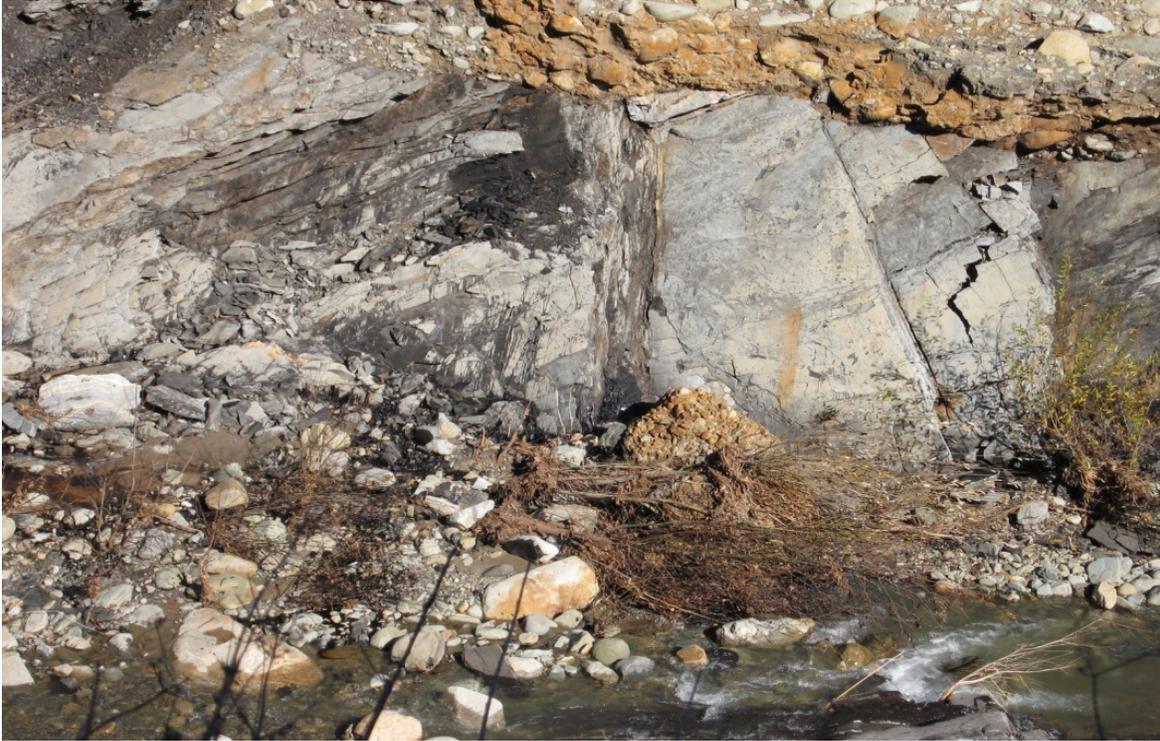
Fig. 26. This Jan 2008 shows where DDOP formed as water levels began to recede and the secondary stream channel braid was isolated. Submerged bedrock outcropping in lower right corner of photo formed the streamward boundary of the pool in May 2008. Also note conglomerate boulder below contorted shale and dislodged tree in **Fig. 21**.

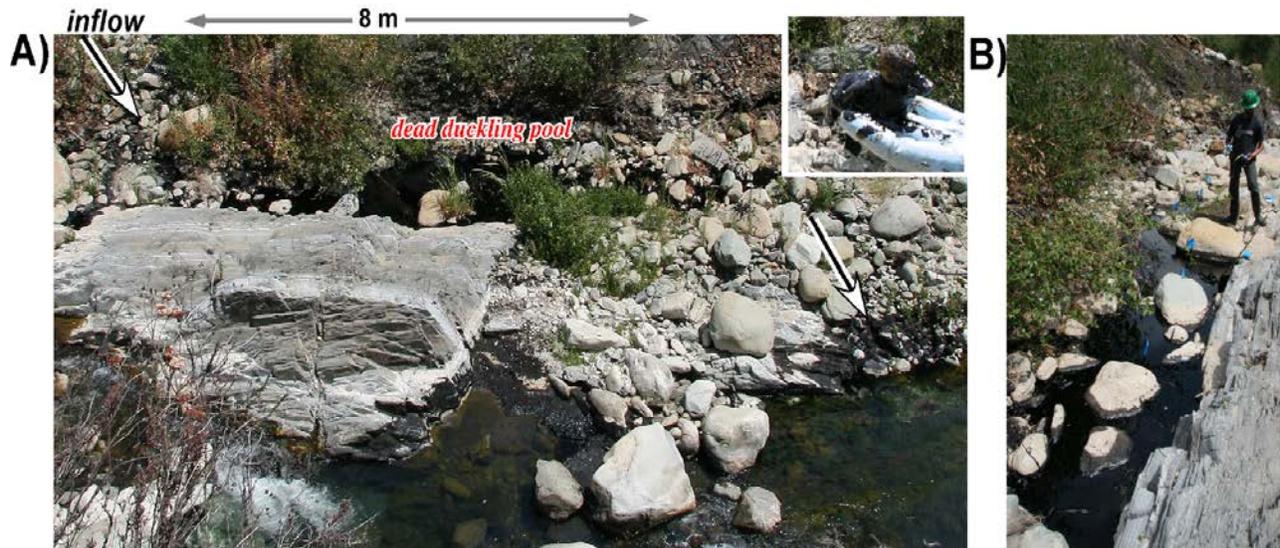
Fig. 27. A. Photo of Dead Duckling Oil Pool, located under Cactus Slump Seeps, at the edge of the Santa Paula Creek. Inset shows an oiled duckling. **B.** East view, showing flags located (and held upright by the oil viscosity) every 1 m. Photo from Jul. 2008.

Based on these observations, we drafted proposed recommendations for mitigating future oil effects on wildlife. In May 2008, a large seasonal oil pool developed in the study site that was observed to have killed five ducklings (**Figs. 16 and 27**). Upon release, during the first flushing flows of the 2008-2009 high flow season, oil from this pool was proposed to have created a significant oil slick on the SPC which threatened downstream fauna.

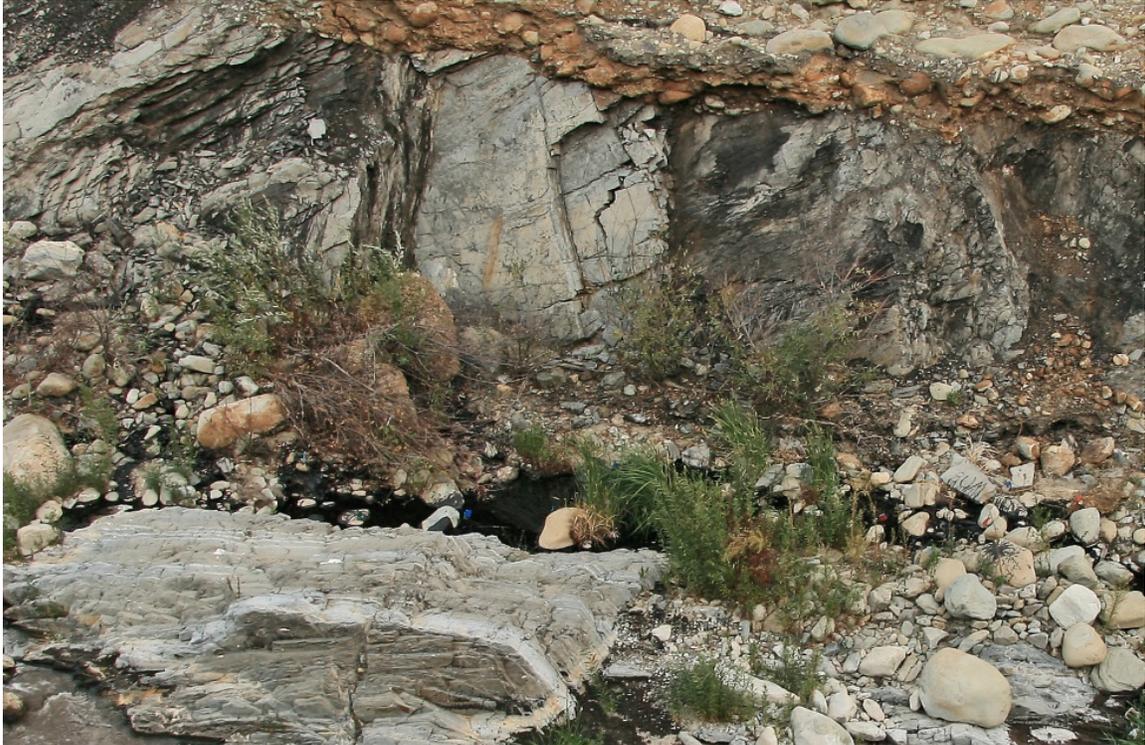
Fig. 28. On 24 Nov. 2008, under low water conditions, Dead Duckling Oil Pool (DDOP) was 10.4-m long by 2.1-m wide (maximum) 0.22-m thick at location of maximum thickness.

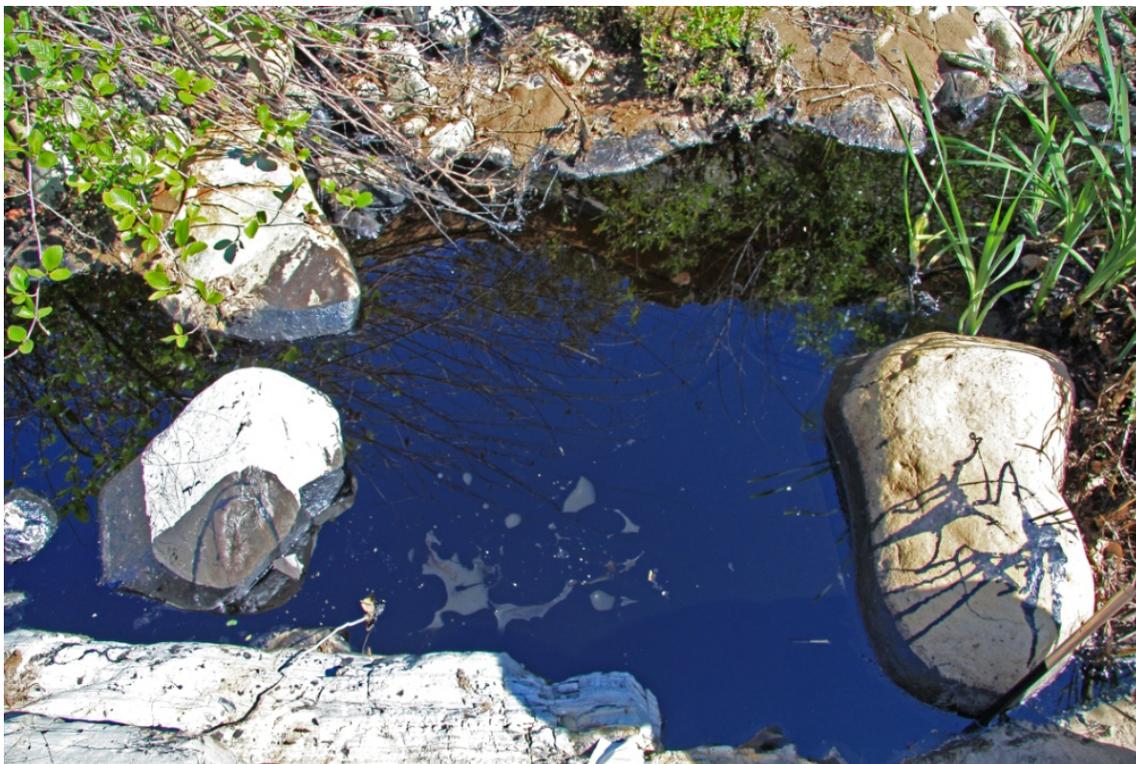
Fig. 29. In Mar. 2009. Oil surface was disturbed bringing some of the water underlayer to the surface. Water will resettle to the bottom. As the lighter components volatilize and the oil becomes denser, water and oil form layers.

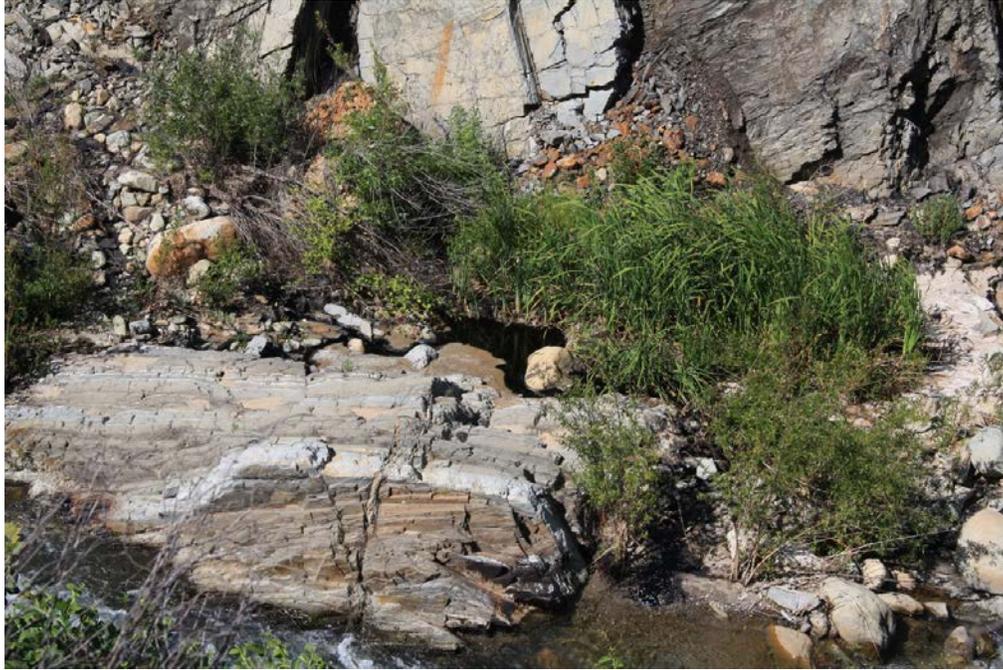
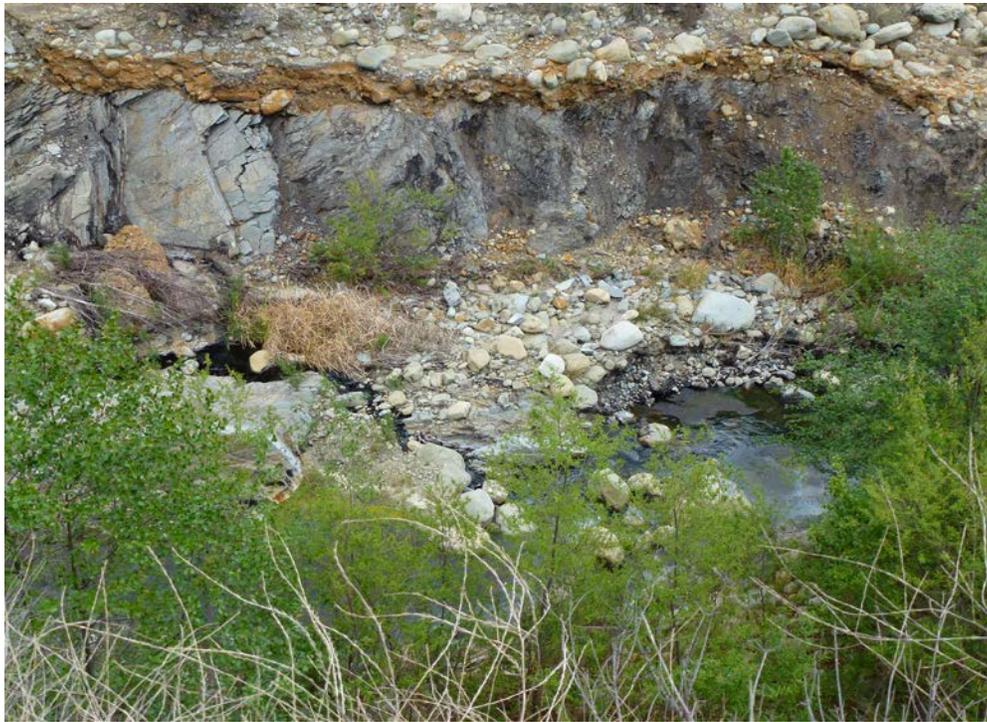
Fig. 30. The DDOP decreased markedly in footprint and volume between Mar. 2009 (**Fig. 29**) and May 2010 (upper image). Note sand fills much of the pool, oil is emptying just downstream of the bedrock outcropping, and talus and vegetation at the cliff-face in comparison with **Figs. 26** and **27**. Larger area view Mar. 2012 at the center of left 1/3 of photo (bottom image).

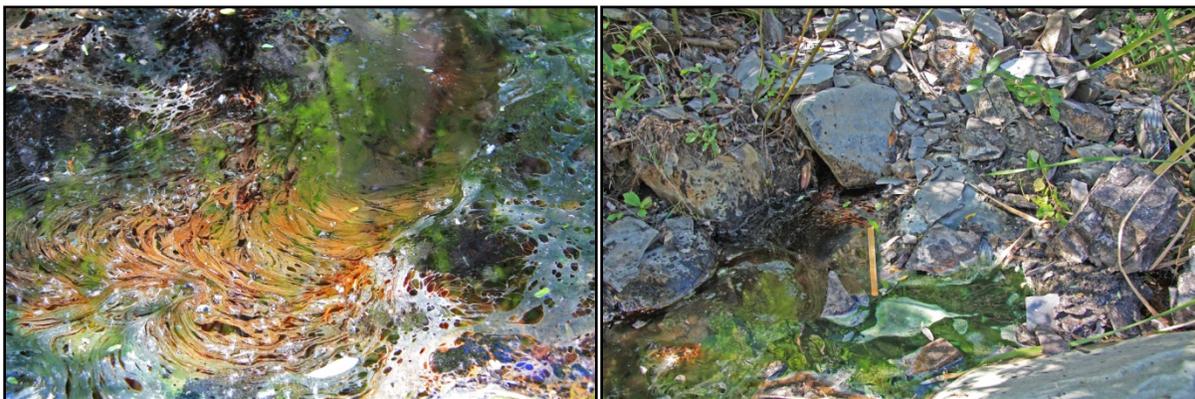
Fig. 33. Left - Cattail oil pool highly weathered oil and whitish bacterial mats. **Right** - Image of one of the sulphur water springs that feeds the pool – note oil splattering on rock suggests there are gaseous discharges from the spring. Photo Mar. 2009.

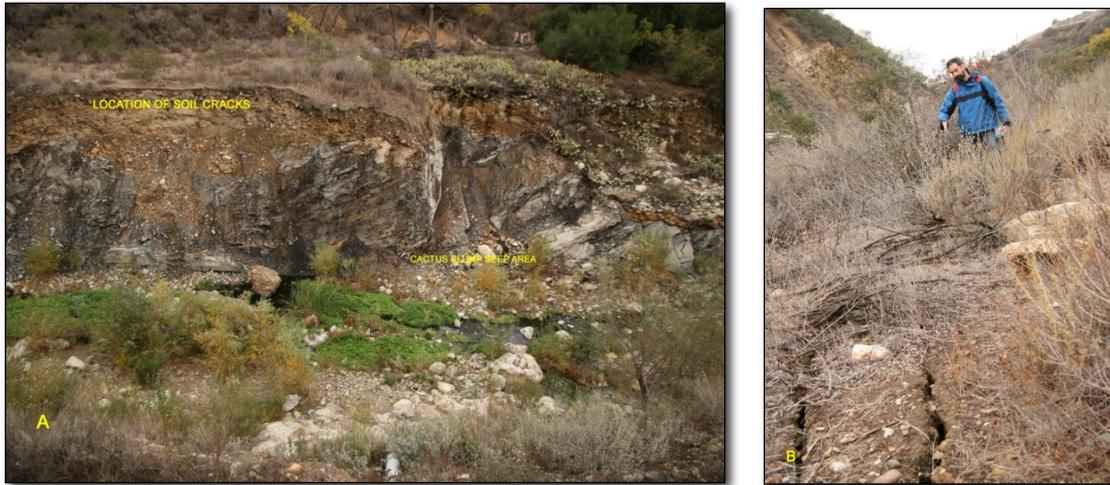
Fig. 35. Left) Location of unstable soil and cracks. **Right)** Examples of soil fissures at top of bank just upstream of the Cactus Slump Seep Area.

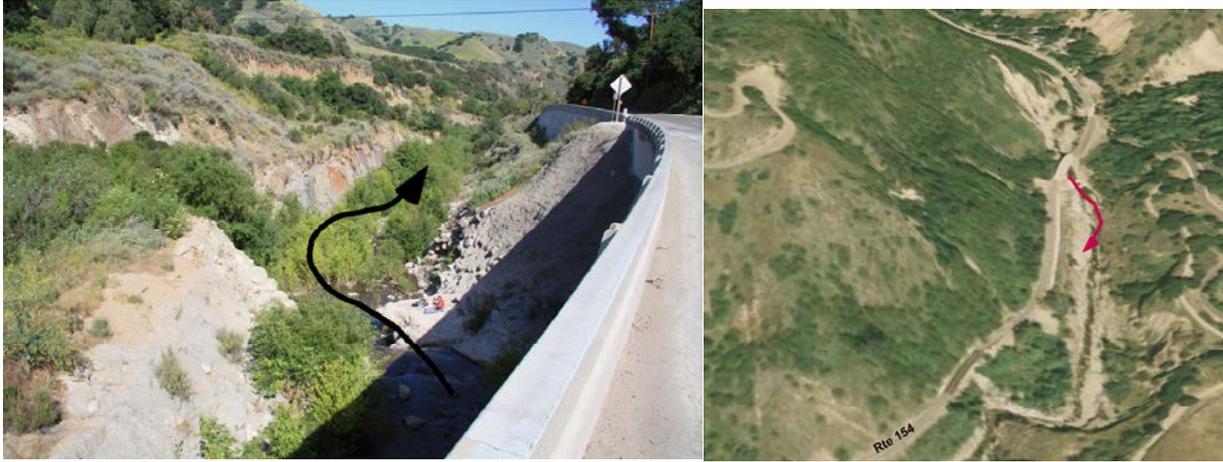
Fig 37. Left. East-southeast-looking photo from the Hwy 150 bridge showing the channel alignment is directed toward the North bank. The upstream end of Thomas Aquinas Oil Pool lies behind the rip-rap to the left. Most of the North bank is unprotected. **Right.** East-Northeast looking Google Earth overview of valley showing proposed stream water flow during storms.

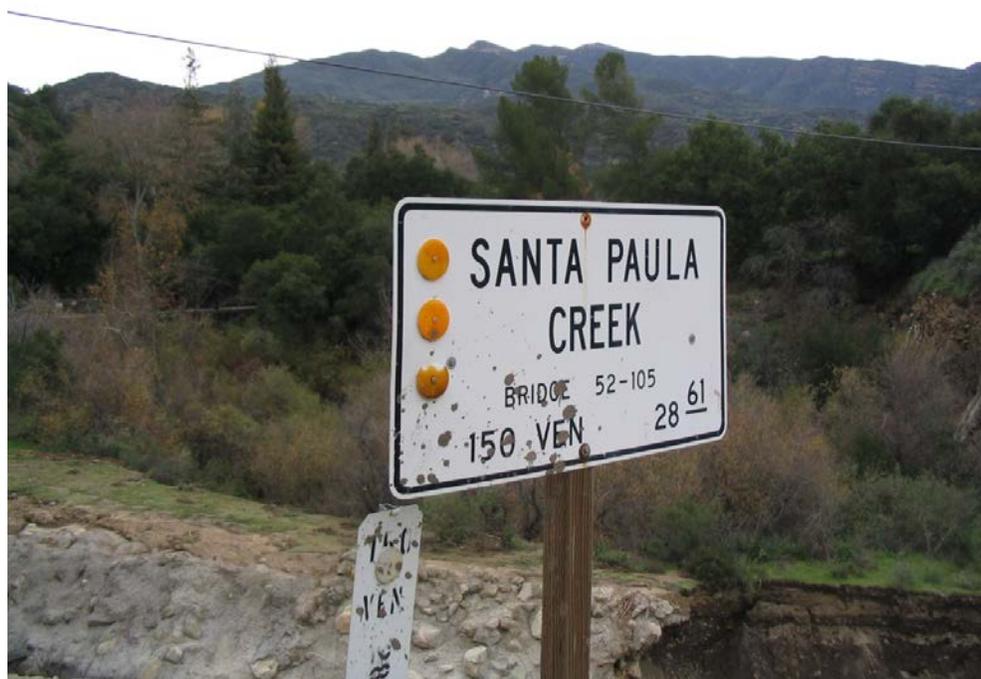
Fig. 38. Silt in grass along top of bank behind the rip-rap and the line of vegetative debris at photo left provides evidence that flood flows overtopped the boulder riprap on the Hwy 150 bridge possibly flushing free oil from the TAOP into the SPC. Photo courtesy of Glen DeSanno, CalTrans-Fillmore Office.

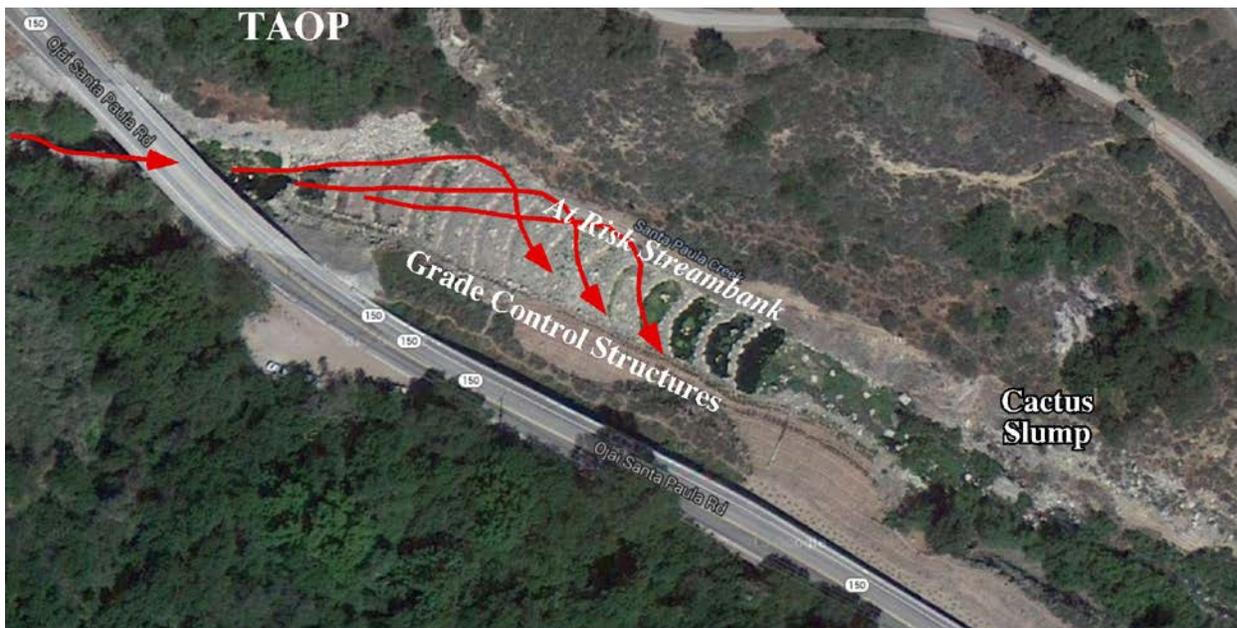
Fig. 39. Google Earth image of study site in 2013, showing recent CalTrans riverbed modifications. Arrows show schematically the high flow direction (which extended further downstream than shown). TAOP – Thomas Aquinas Oil Pool.
