FULL RESEARCH ARTICLE

## **An innovative temporary escape ramp for deer and other wildlife**

Temporary wildlife escape ramp engineering design for five original ramp locations in canal at North Fork, California.

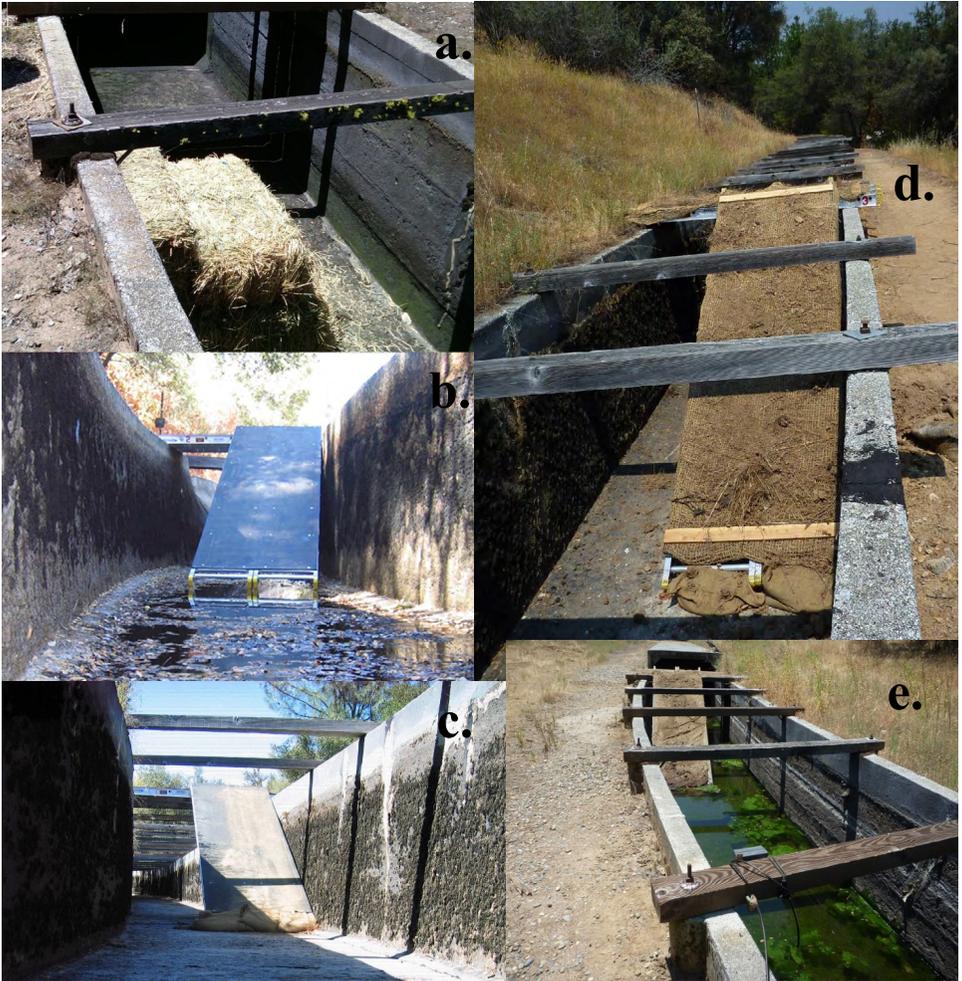
**Figure 2.** Different iterations of temporary escape structures used from 2011–2018 in canal located in North Fork, California: (a) Hay bales arranged in step configuration (2011), (b) Aluminum platforms covered with rubber sheets (2012), (c) Aluminum platforms covered with rubber sheets and sandbags installed at base of ramp (2012), (d) Aluminum platforms covered with rubber sheets, sandbags deployed at base of ramp, and jute netting and debris utilized (2013), (e) Aluminum platforms covered with rubber sheets, sandbags deployed at base of ramp, jute netting and debris utilized, and camera trap attached to canal crossbeam (2017).

We required an escape ramp that met the following criteria: 1) easy to deploy and remove during/after the annual summer maintenance period; 2) would not affect the structural integrity of the canal; and, 3) economical (inexpensive to construct, deploy, and maintain). Initially in 2011, hay bales were stacked in a step configuration within the canal (Fig. 2). Four to six wheat hay bales were stacked at each site.

Due to the lack of successful results the previous year, in 2012 we used a different temporary escape structure designed specifically for the canal. The design consisted of aluminum stage platforms covered in neoprene rubber sheets that were 0.64 cm thick by 50.8 cm wide and secured to the canal with galvanized steel hardware to increase traction (Fig. 2; Appendix I). At each of the five sites, we used two 3.66 m by 0.56 m aluminum stage platforms that were placed side by side to serve as the ramp. At three sites that did not have existing bridges, we placed two 2.44 m by 0.56 m aluminum stage platforms side by side to create a bridge. The platforms were secured together with 0.95 cm steel bolts with washers. The ramps were secured to the bridges with 1.27 cm-diameter U-bolts. The assembly was secured to the canal walls using steel bolts and locked to deter theft. At two sites, wood/iron supports were removed on top of the canal sides to install the ramps. The ramp angles ranged from 27° to 32°. These angles were hypothesized to avoid attracting deer into the canal, while providing a means to exit the canal. From 2013–2018 we added jute netting and debris (i.e., dirt, plant material) on top of the rubber sheets to create a more natural appearance, and sandbags with native fill at the bottom of each ramp to eliminate any gaps that might be visible to wildlife (Fig. 2). Wooden slats were placed horizontally along sections of ramps in 2013 but were not attached in subsequent years. The entire ramp assembly was constructed with materials purchased from a local hardware store for under \$1,000 per site; this met our economical criterion.

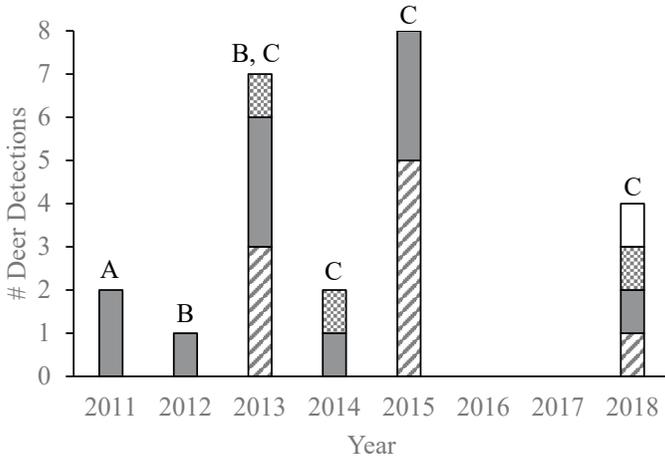
**Figure 3.** Number of deer detections inside canal located in North Fork, California for all sites from 2011–2018. Temporary escape structure designs: A = hay bales, B = aluminum, rubber covered ramps; C = aluminum, rubber, jute netting and debris covered ramps.

■ Fawn Ramp Use      ■ Fawn No Ramp Use  
 ■ Adult Ramp Use      □ Adult No Ramp Use

We did not detect any animals using the stacked hay bales to exit the canal in 2011. Although fawns were detected in the canal in 2011 and 2012, they did not use the temporary escape structures to exit the canal (Fig. 3). We detected mule deer fawns and adults using temporary escape ramps to exit the canal in 2013, 2014, 2015, and 2018 (Figs. 3 and 4). We recorded the highest amount of ramp use in 2015 (62.5% of deer detected in the canal used ramps), followed by 2013 (57.1% of deer detected in the canal used ramps) and 2018 (50.0% of deer detected in the canal used ramps; Fig. 3). There were no detections of deer in the canal using the temporary escape structures to exit until after the installation of jute netting and debris onto the surface of the ramps in 2013 (Fig. 5). No deer were recorded using the ramps to enter the canal throughout the monitoring period.

We documented more mule deer in the canal during years of higher deer activity (2013, 2015, and 2018) compared to other years (Fig. 3). We did not observe mule deer in the canal during the monitoring period in 2016 and 2017 which also coincided with low deer activity around the canal (Fig. 6). By using the mule deer activity in and around the canal as an index, we felt that we were able to effectively detect deer activity in the canal.

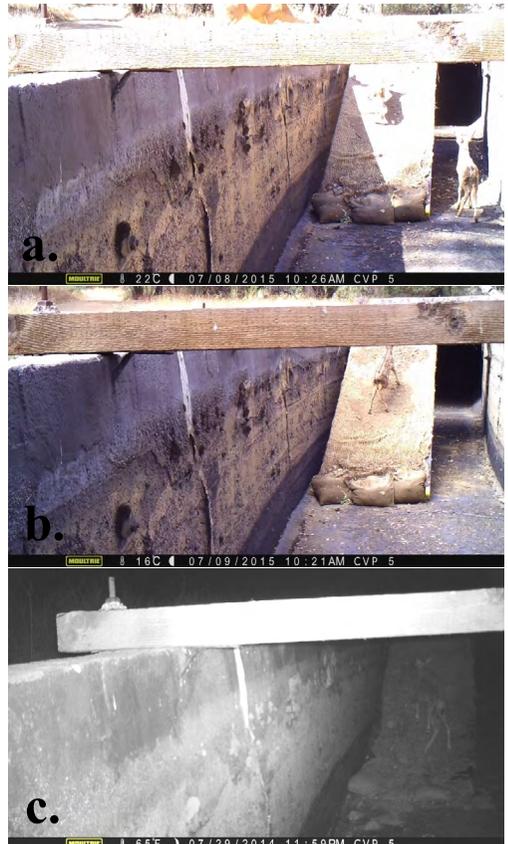
**Figure 4.** Examples of mule deer utilizing the temporary escape ramps to exit the canal from 2014–2015 in canal located in North Fork, California: (a) and (b) pair of trapped fawns use ramp to exit canal as mother doe observes from above (2015), (c) mule deer using ramp to exit canal at night (2014).

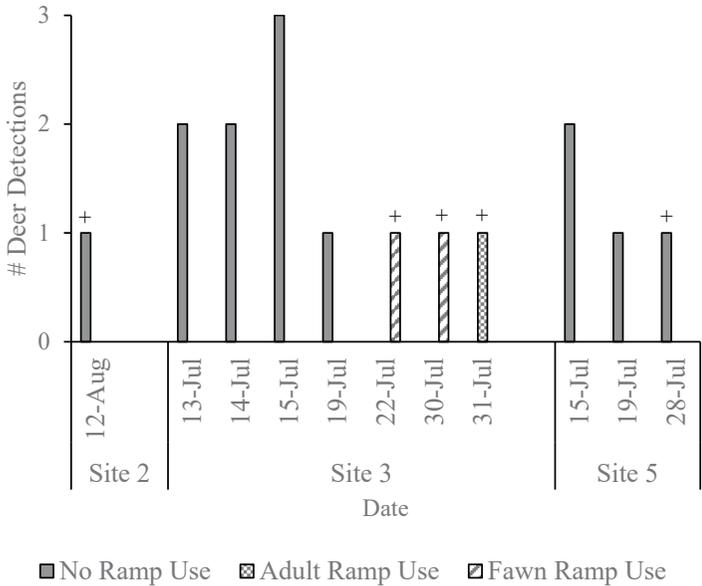
**Figure 5.** Number of deer detections inside canal located in North Fork, California by site compared with timing of jute netting and debris installation onto temporary escape ramps in 2013. Plus sign (+) indicates post installation of jute netting and debris.

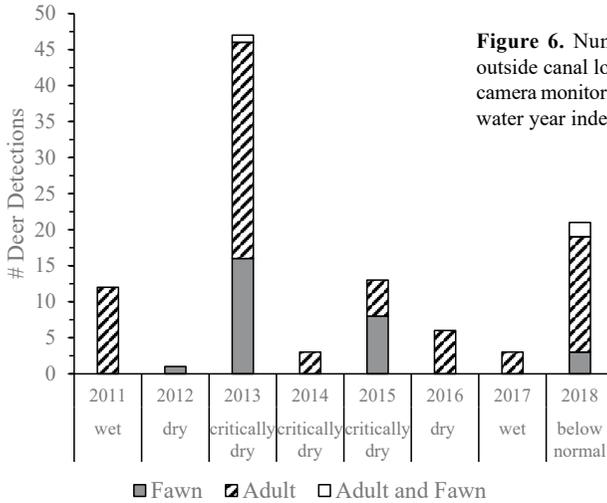
**Figure 6.** Number of deer detections inside and outside canal located in North Fork, California at all camera monitoring sites from 2011–2018 compared to water year index (<https://cdec.water.ca.gov>).

in 2013, 2014, and 2018 (n = 4; Fig. 3). Overall deer activity varied by year. We detected the highest levels of mule deer activity in and around the canal in 2013 and 2018 (n = 47 and 21, respectively), followed by moderate activity in 2011 and 2015 (n = 12 and 13, respectively; Fig. 6). We recorded the greatest number of deer detections in critically dry and below normal water years, but this pattern was not consistent among years (Fig. 6). We detected other wildlife using the ramps to enter or exit the canal from 2012 to 2018 (Table 3 and Fig. 7), with a general increase in use over monitoring years.

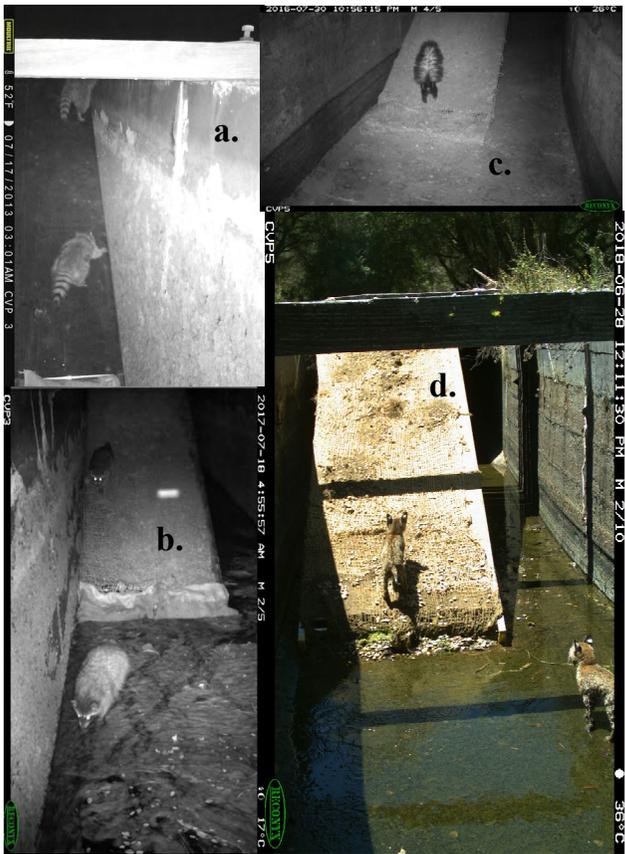
**Figure 7.** Examples of wildlife utilizing the temporary escape ramps to either enter or exit the canal from 2013–2018 in canal located in North Fork, California: (a) Raccoons using ramp to exit canal with no jute netting or debris installed (2013), (b) Raccoons using ramp to enter canal with jute netting and debris installed (2017), (c) Skunk using ramp to exit canal with jute netting and debris installed (2016), and (d) Bobcat kittens using ramp to exit canal with jute netting and debris installed (2018).

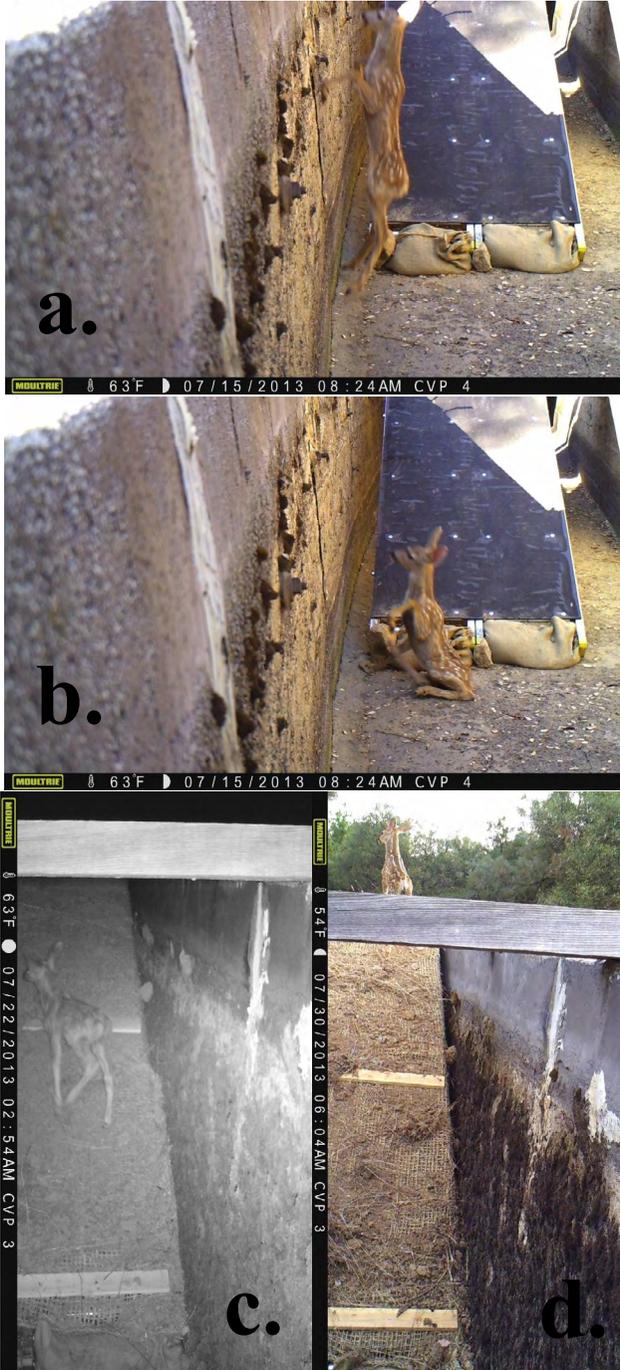
**Figure 8.** Example of adaptive modification of ramp design based on monitoring data at canal in North Fork, California: (a) and (b) Mule deer fawn attempts to jump vertically to exit canal while ignoring temporary escape ramp (15 July 2013). On 19 July 2013, jute netting and debris are added to the ramps. (c) and (d) mule deer fawns use ramp to exit canal on 22 July 2013 and 30 July 2013.
