# San Luis Rey River Basin Assessment

**April  
2010**

# San Luis Rey River Watershed Assessment

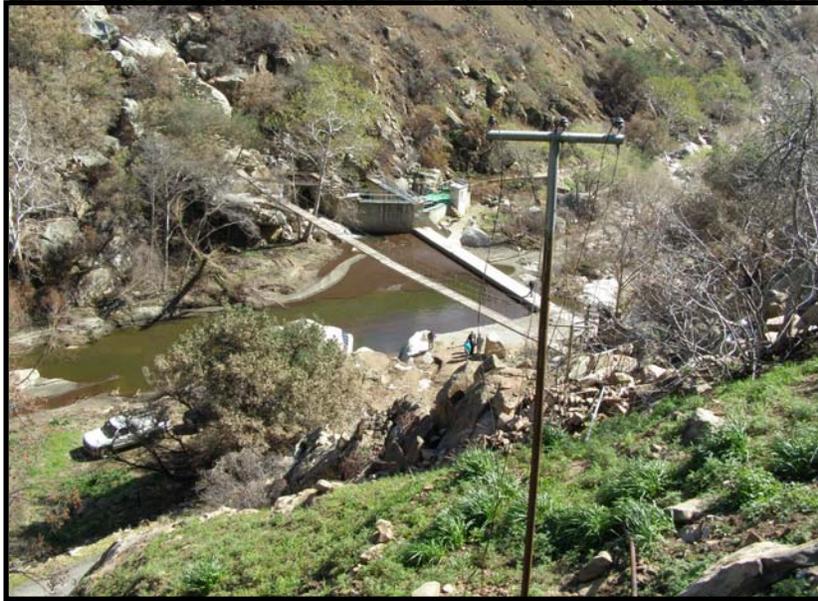
Figure 24. Photo of Escondido Canal dam diversion in Southern Subbasin.

Impacts to SLR River water flows are not limited to the Henshaw Dam and the Escondido Canal diversion in the Upper and Southern subbasins, respectively. Several shallow alluvial aquifers exist in the SLR River Basin, which contribute groundwater used throughout the watershed for agricultural, industrial, and municipal supplies (Figure 6). This groundwater is extracted through the numerous wells located throughout the watershed. For example, more than 100 wells are present in a five mile stretch between the Old Bonsall Bridge and I-15 (Helm 2008 Draft) and over 600 wells exist along the river channel in the Middle Subbasin (Hazel et al. 1975). These wells and other wells located in the Coastal, Southern and Northern subbasins are largely unregulated. As the uncertainty and costs of obtaining outside water supplies rise, demands will increase on utilizing local water resources.

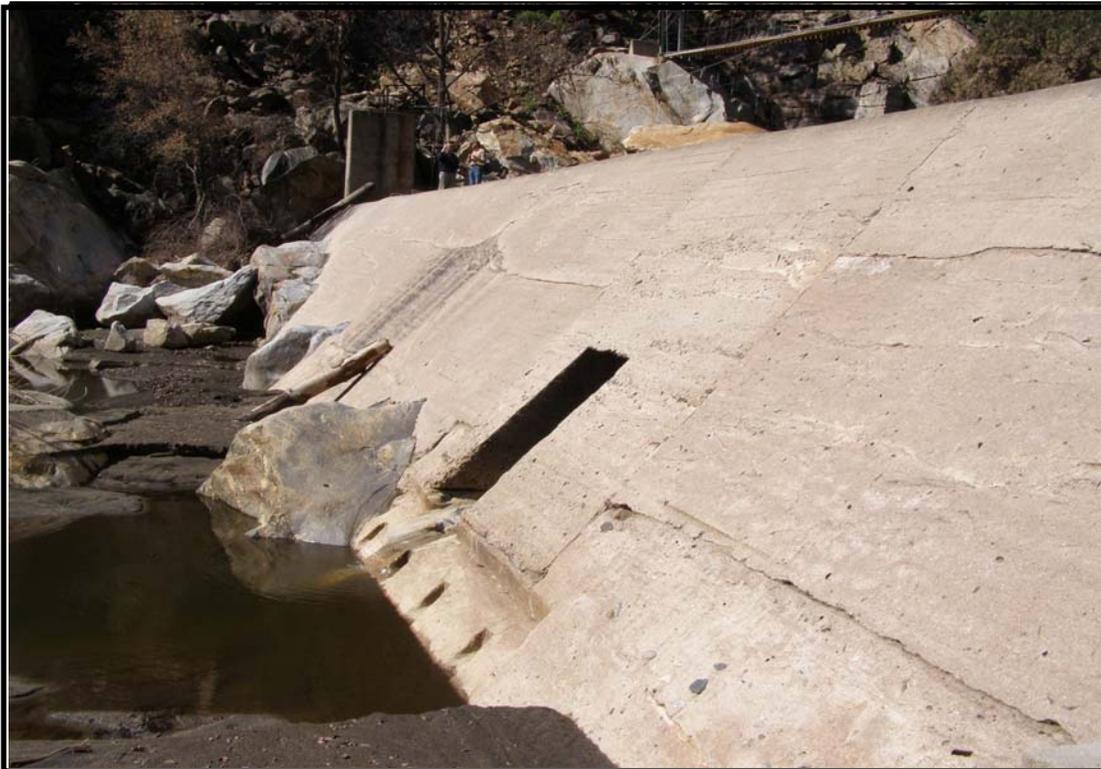
Figure 5. Escondido Canal diversion dam (RM 40).

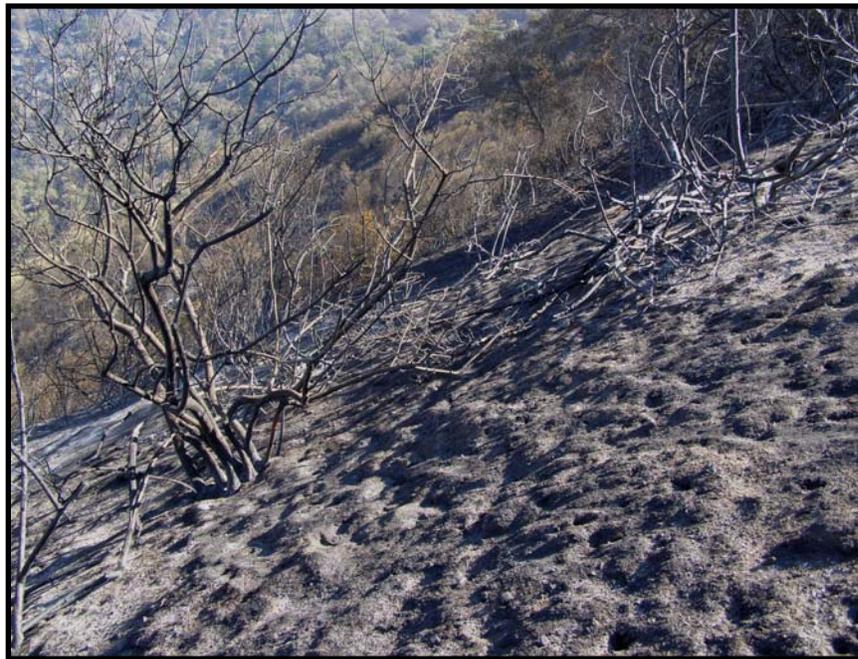
Figure 4. Post-Poomacha Fire (fall of 2007) photo of exposed hydrophobic soil on a steep slope within the Northern Subbasin.
