**REVISED FOCUSED SPECIAL STATUS FISH SPECIES
HABITAT ASSESSMENT AND IMPACT ANALYSIS
SANTA CLARA RIVER AND TRIBUTARY
DRAINAGES WITHIN NEWHALL RANCH**

**NEWHALL RANCH
RESOURCE MANAGEMENT & DEVELOPMENT PLAN
LOS ANGELES COUNTY, CALIFORNIA**

Project No. 3109006

**JUNE 2010
~~February 23, 2009~~**

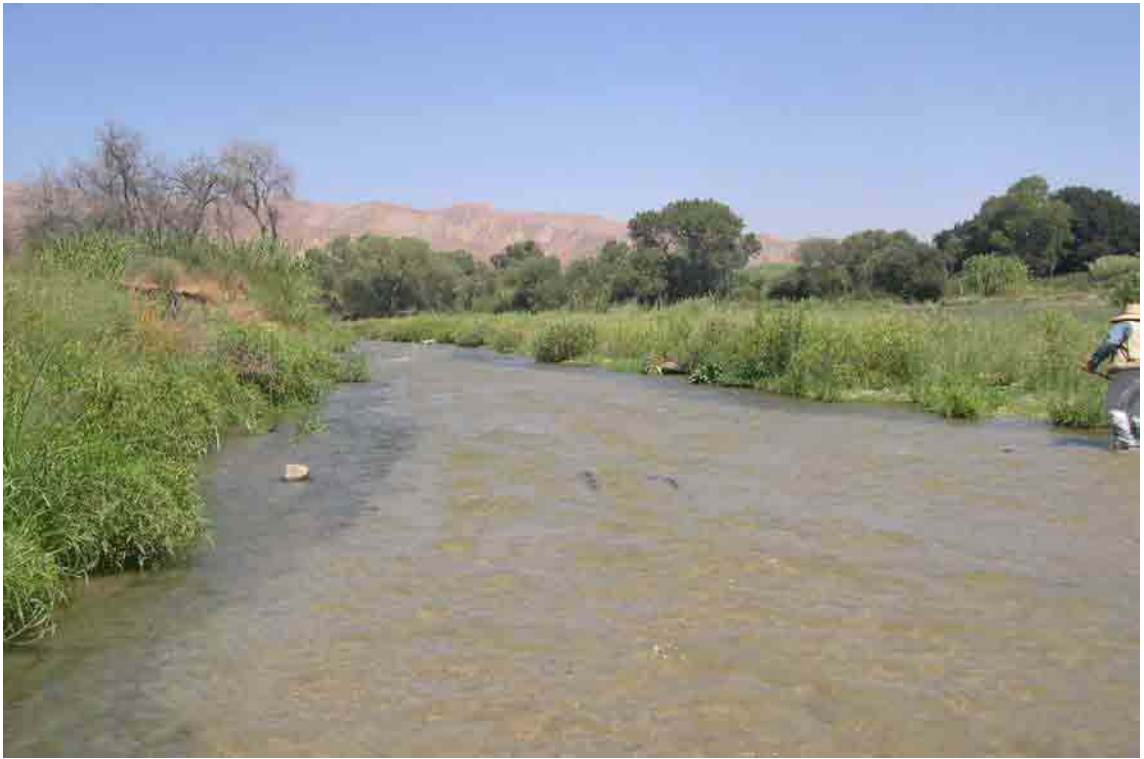
Representative run habitat (Reach A).

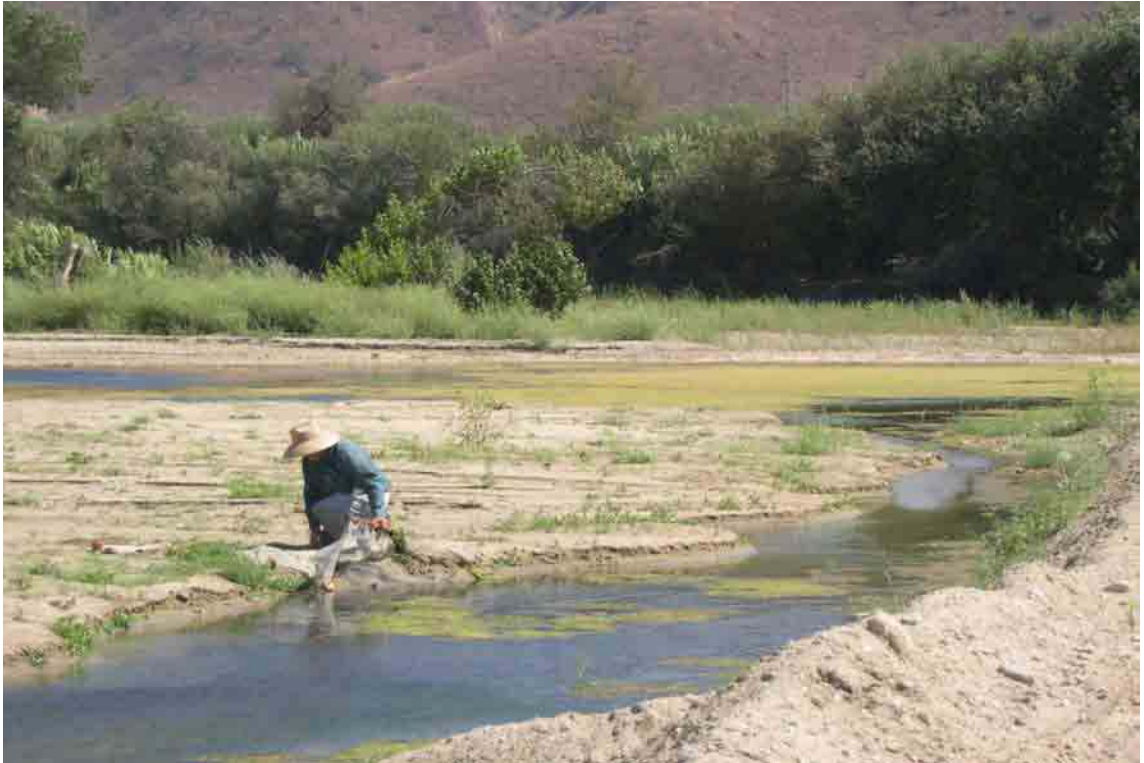
Backwater habitat sampled (Reach A).

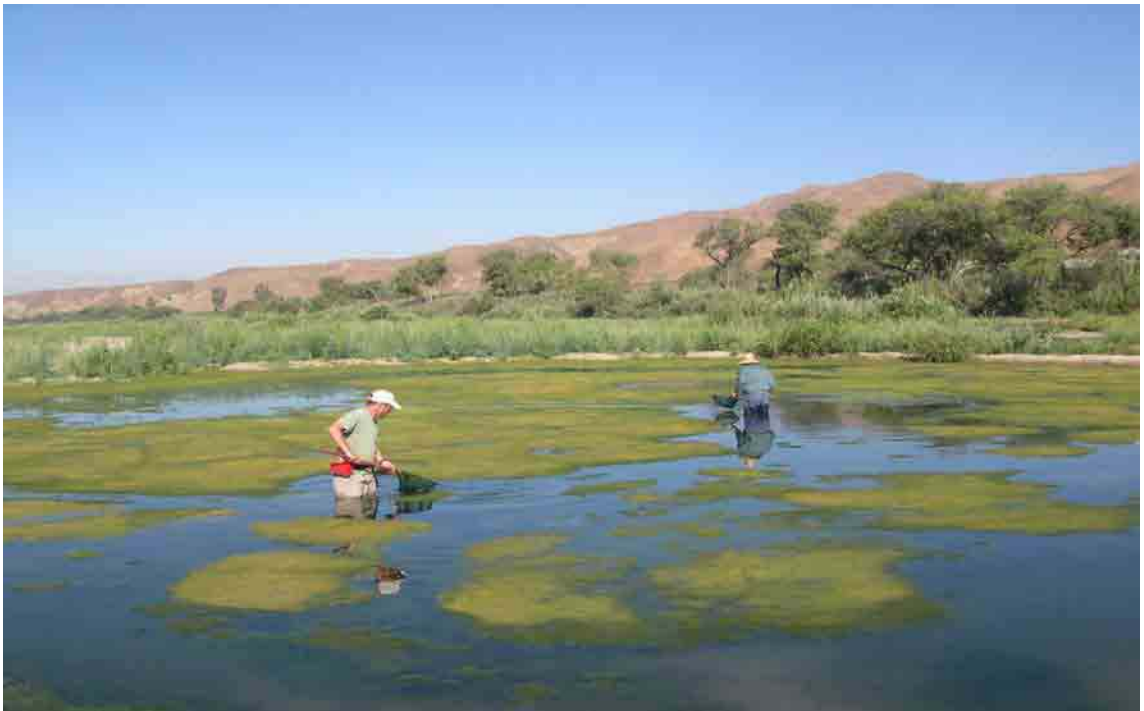
Isolated pool sampled at culverted crossing (Reach B)

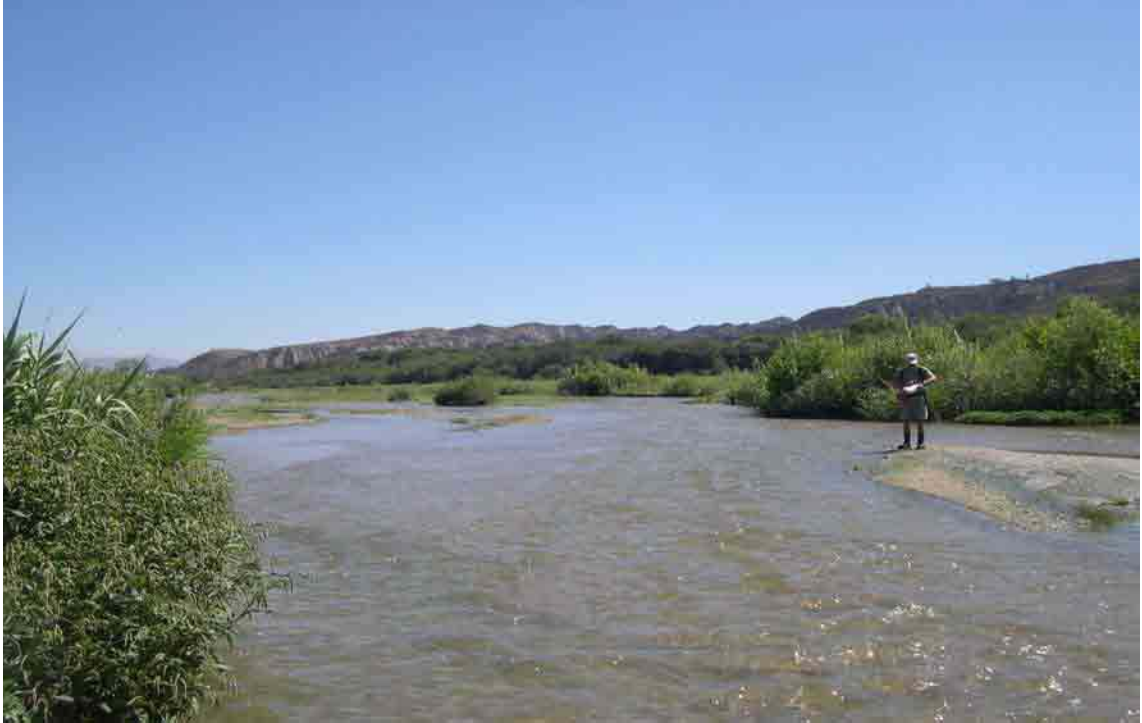
Representative fast flowing braided run habitat (Reach C)

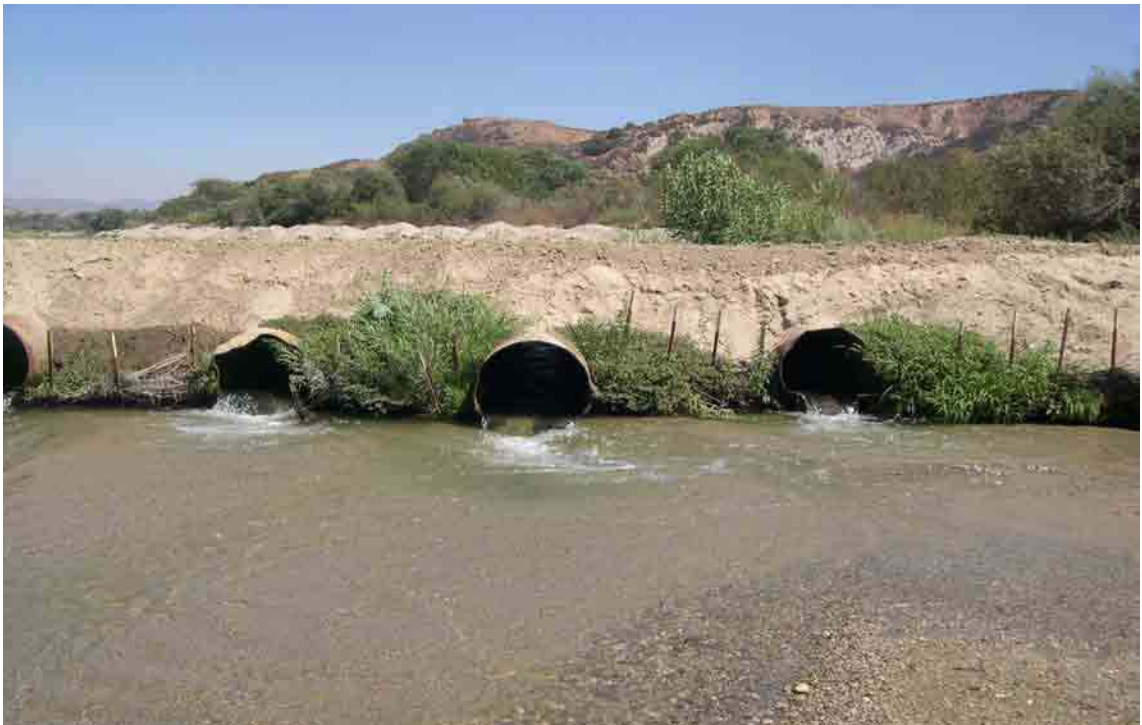
Culverted crossing with good sucker habitat (Reach C)

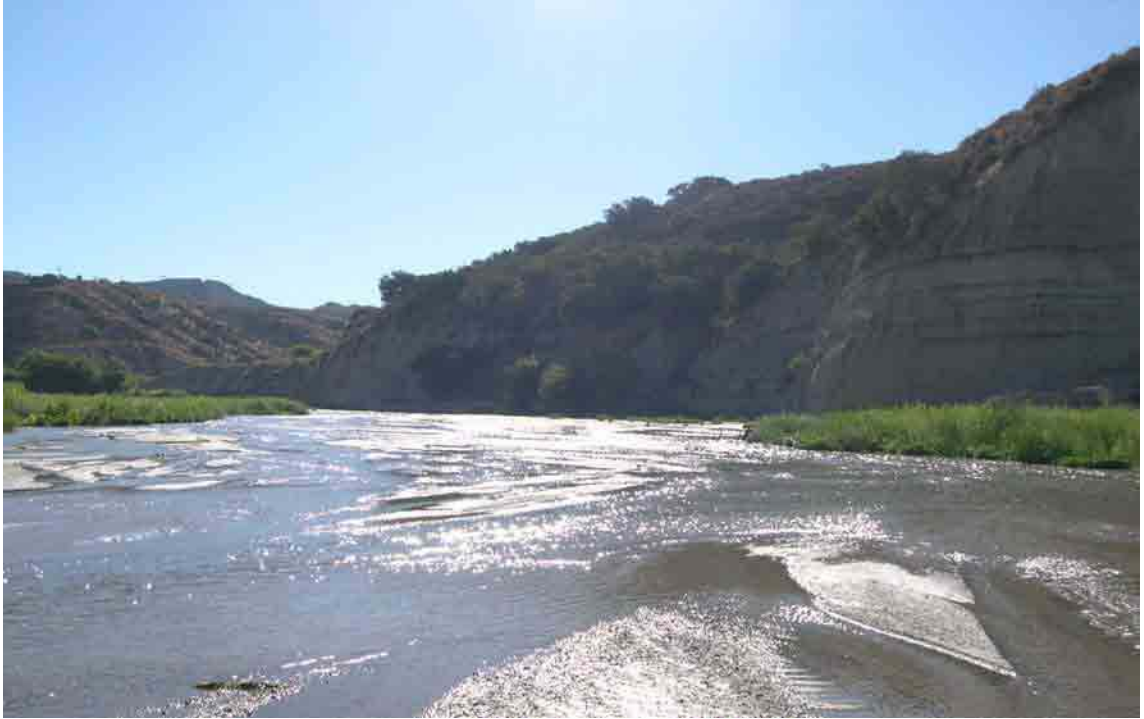
Representative shallow run/glide habitat (lower Reach D)

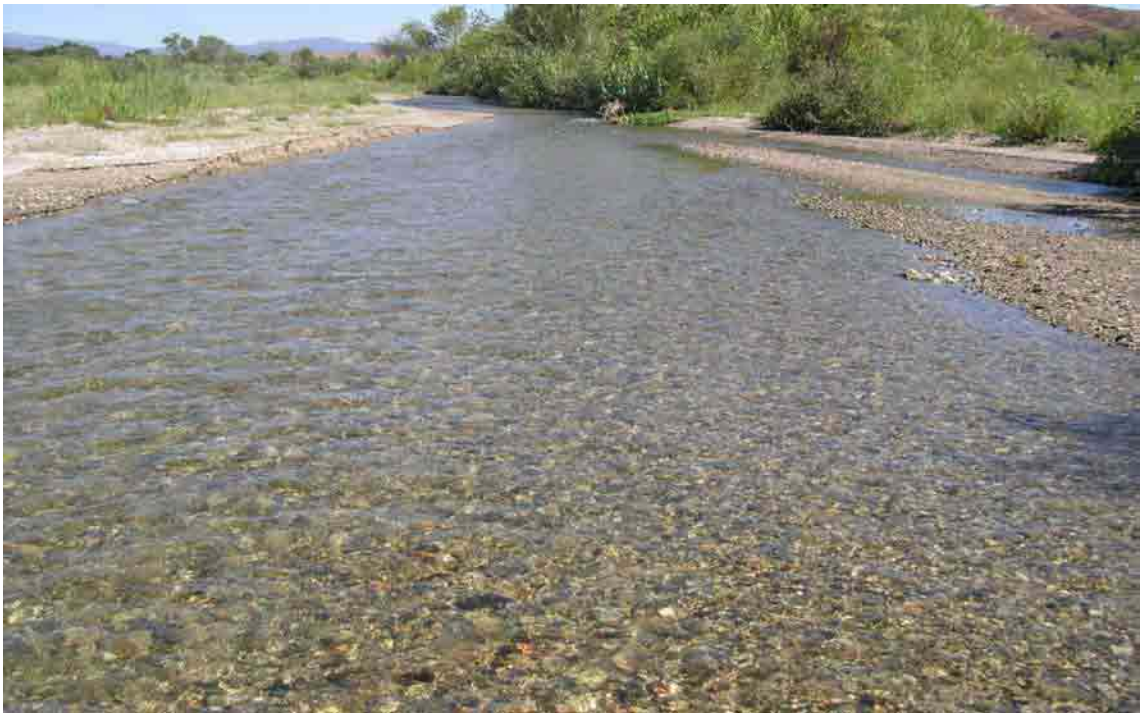
Representative gravel substrate (Reach D)

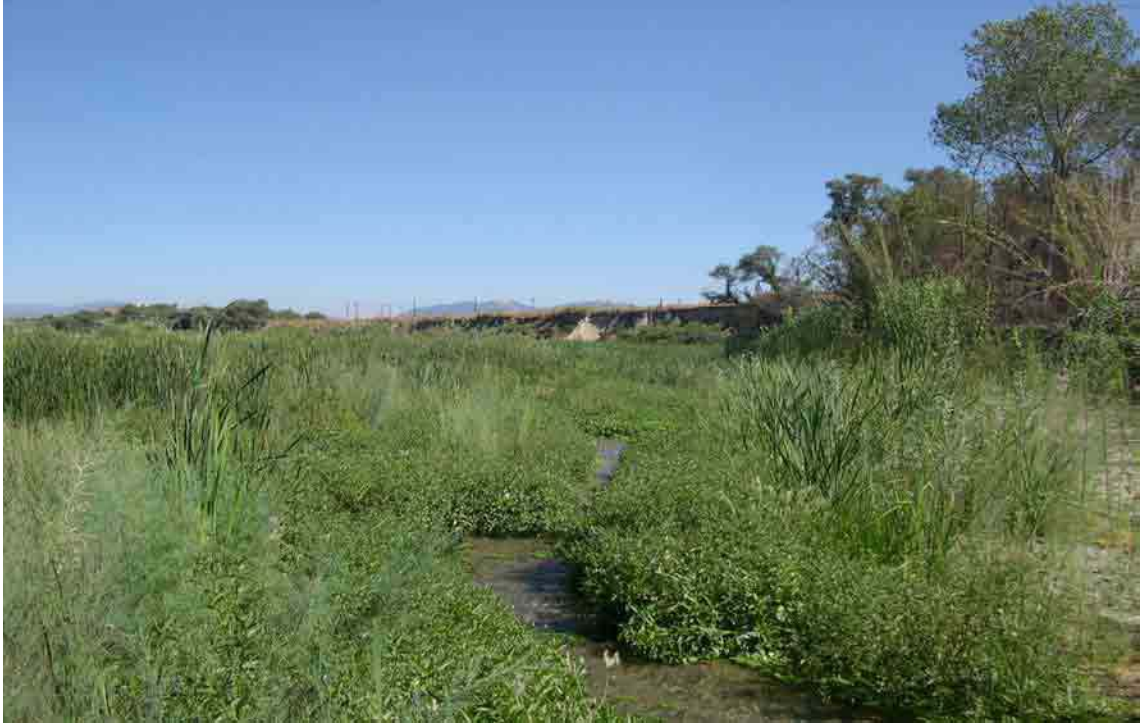
Spring-fed channel where stickleback were collected (Stickleback refuge Reach D)

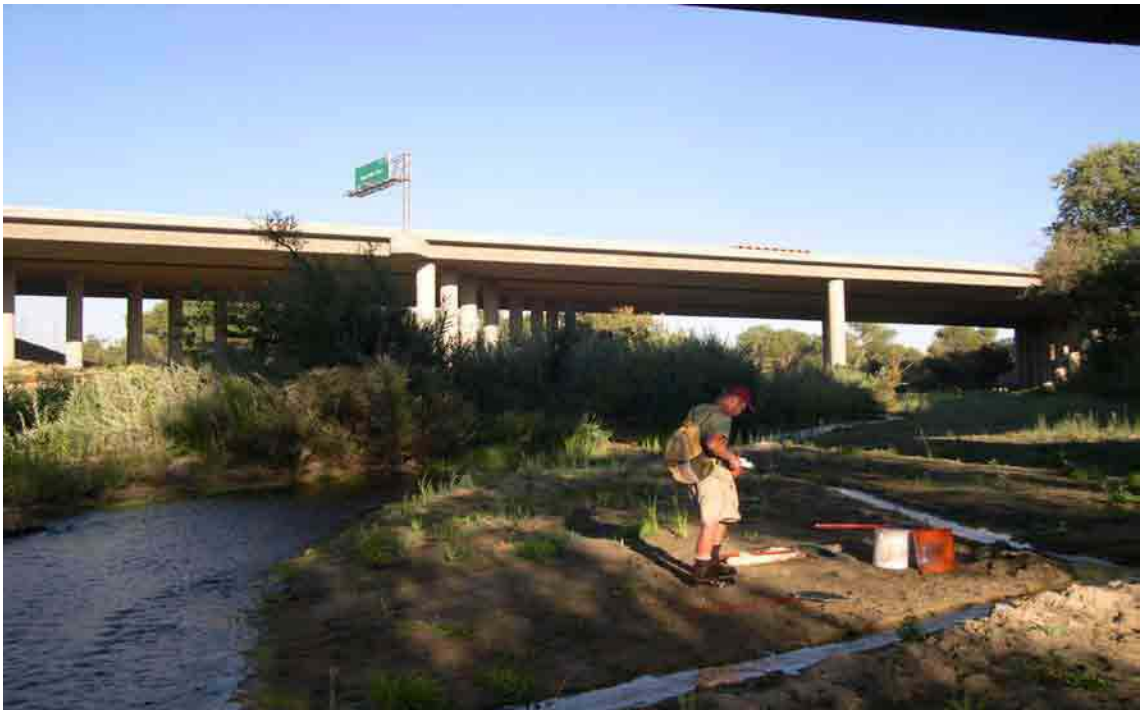
Representative run habitat at Interstate 5 (Reach E)

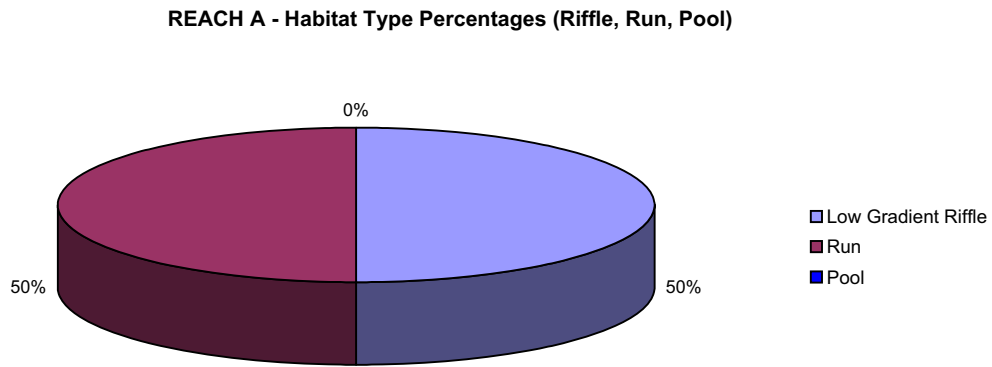
Figure 1. Reach A (Salt Canyon to Potrero Canyon) Habitat Type Percentages

This section summarizes the results of the Santa Clara River fish survey conducted on September 2, 5 and 7, 2005. Figures 1 through 18 that summarize these results can be found in Appendix B.

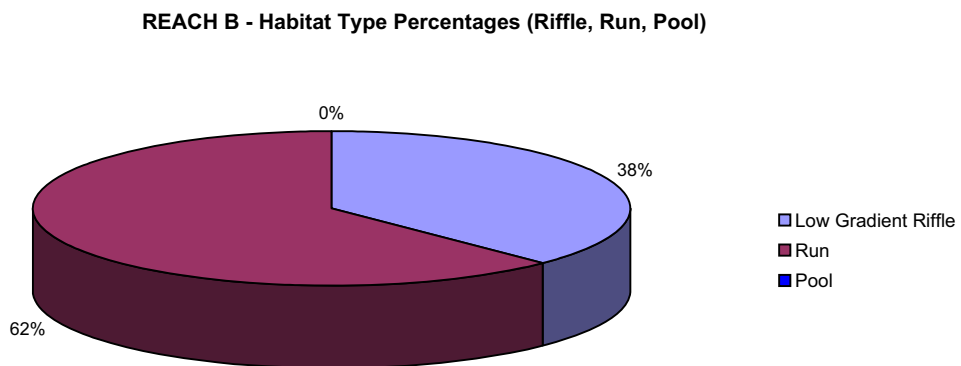
Figure 2. Reach B (Potrero Canyon to Chiquito Canyon) Habitat Type Percentages

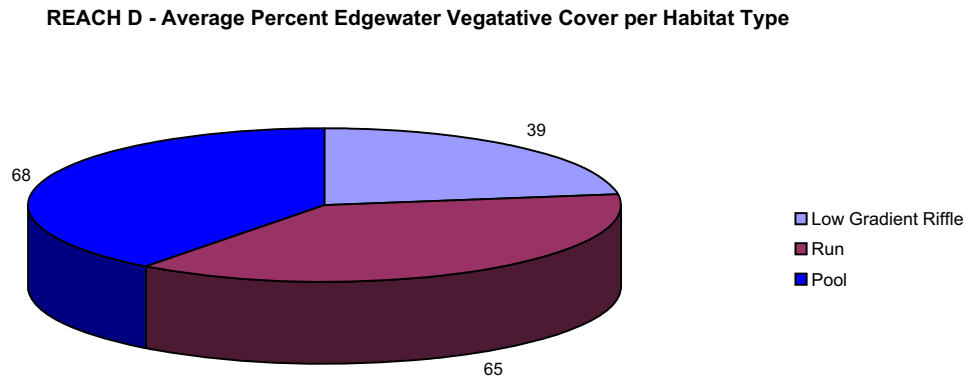
Figure 16. Reach D (Castaic Creek to Effluent Channel) Average Percent Edgewater Vegetation per Habitat Type

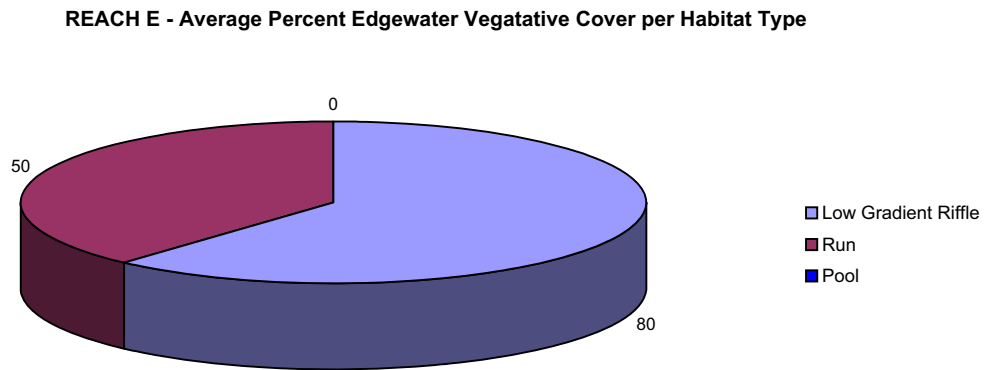
Figure 17. Reach E (Effluent Channel to Old Road) Average Percent Edgewater Vegetation per Habitat Type

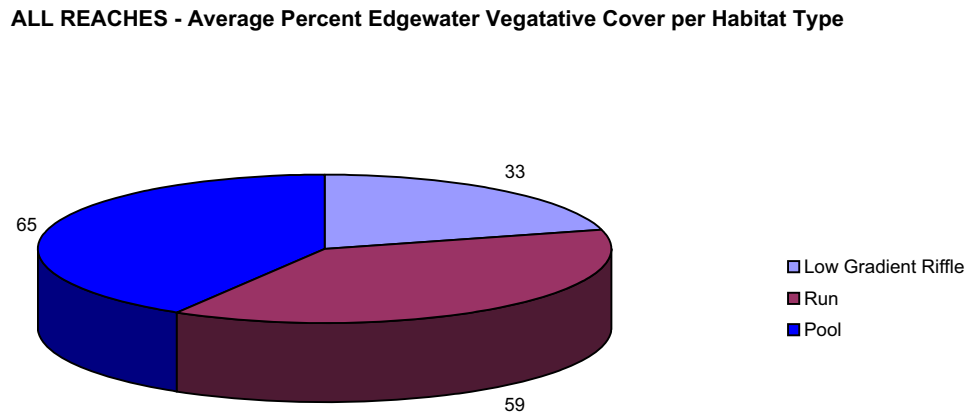
Figure 18. All Reaches (Salt Canyon to Old Road) Average Percent Edgewater Vegetation per Habitat Type

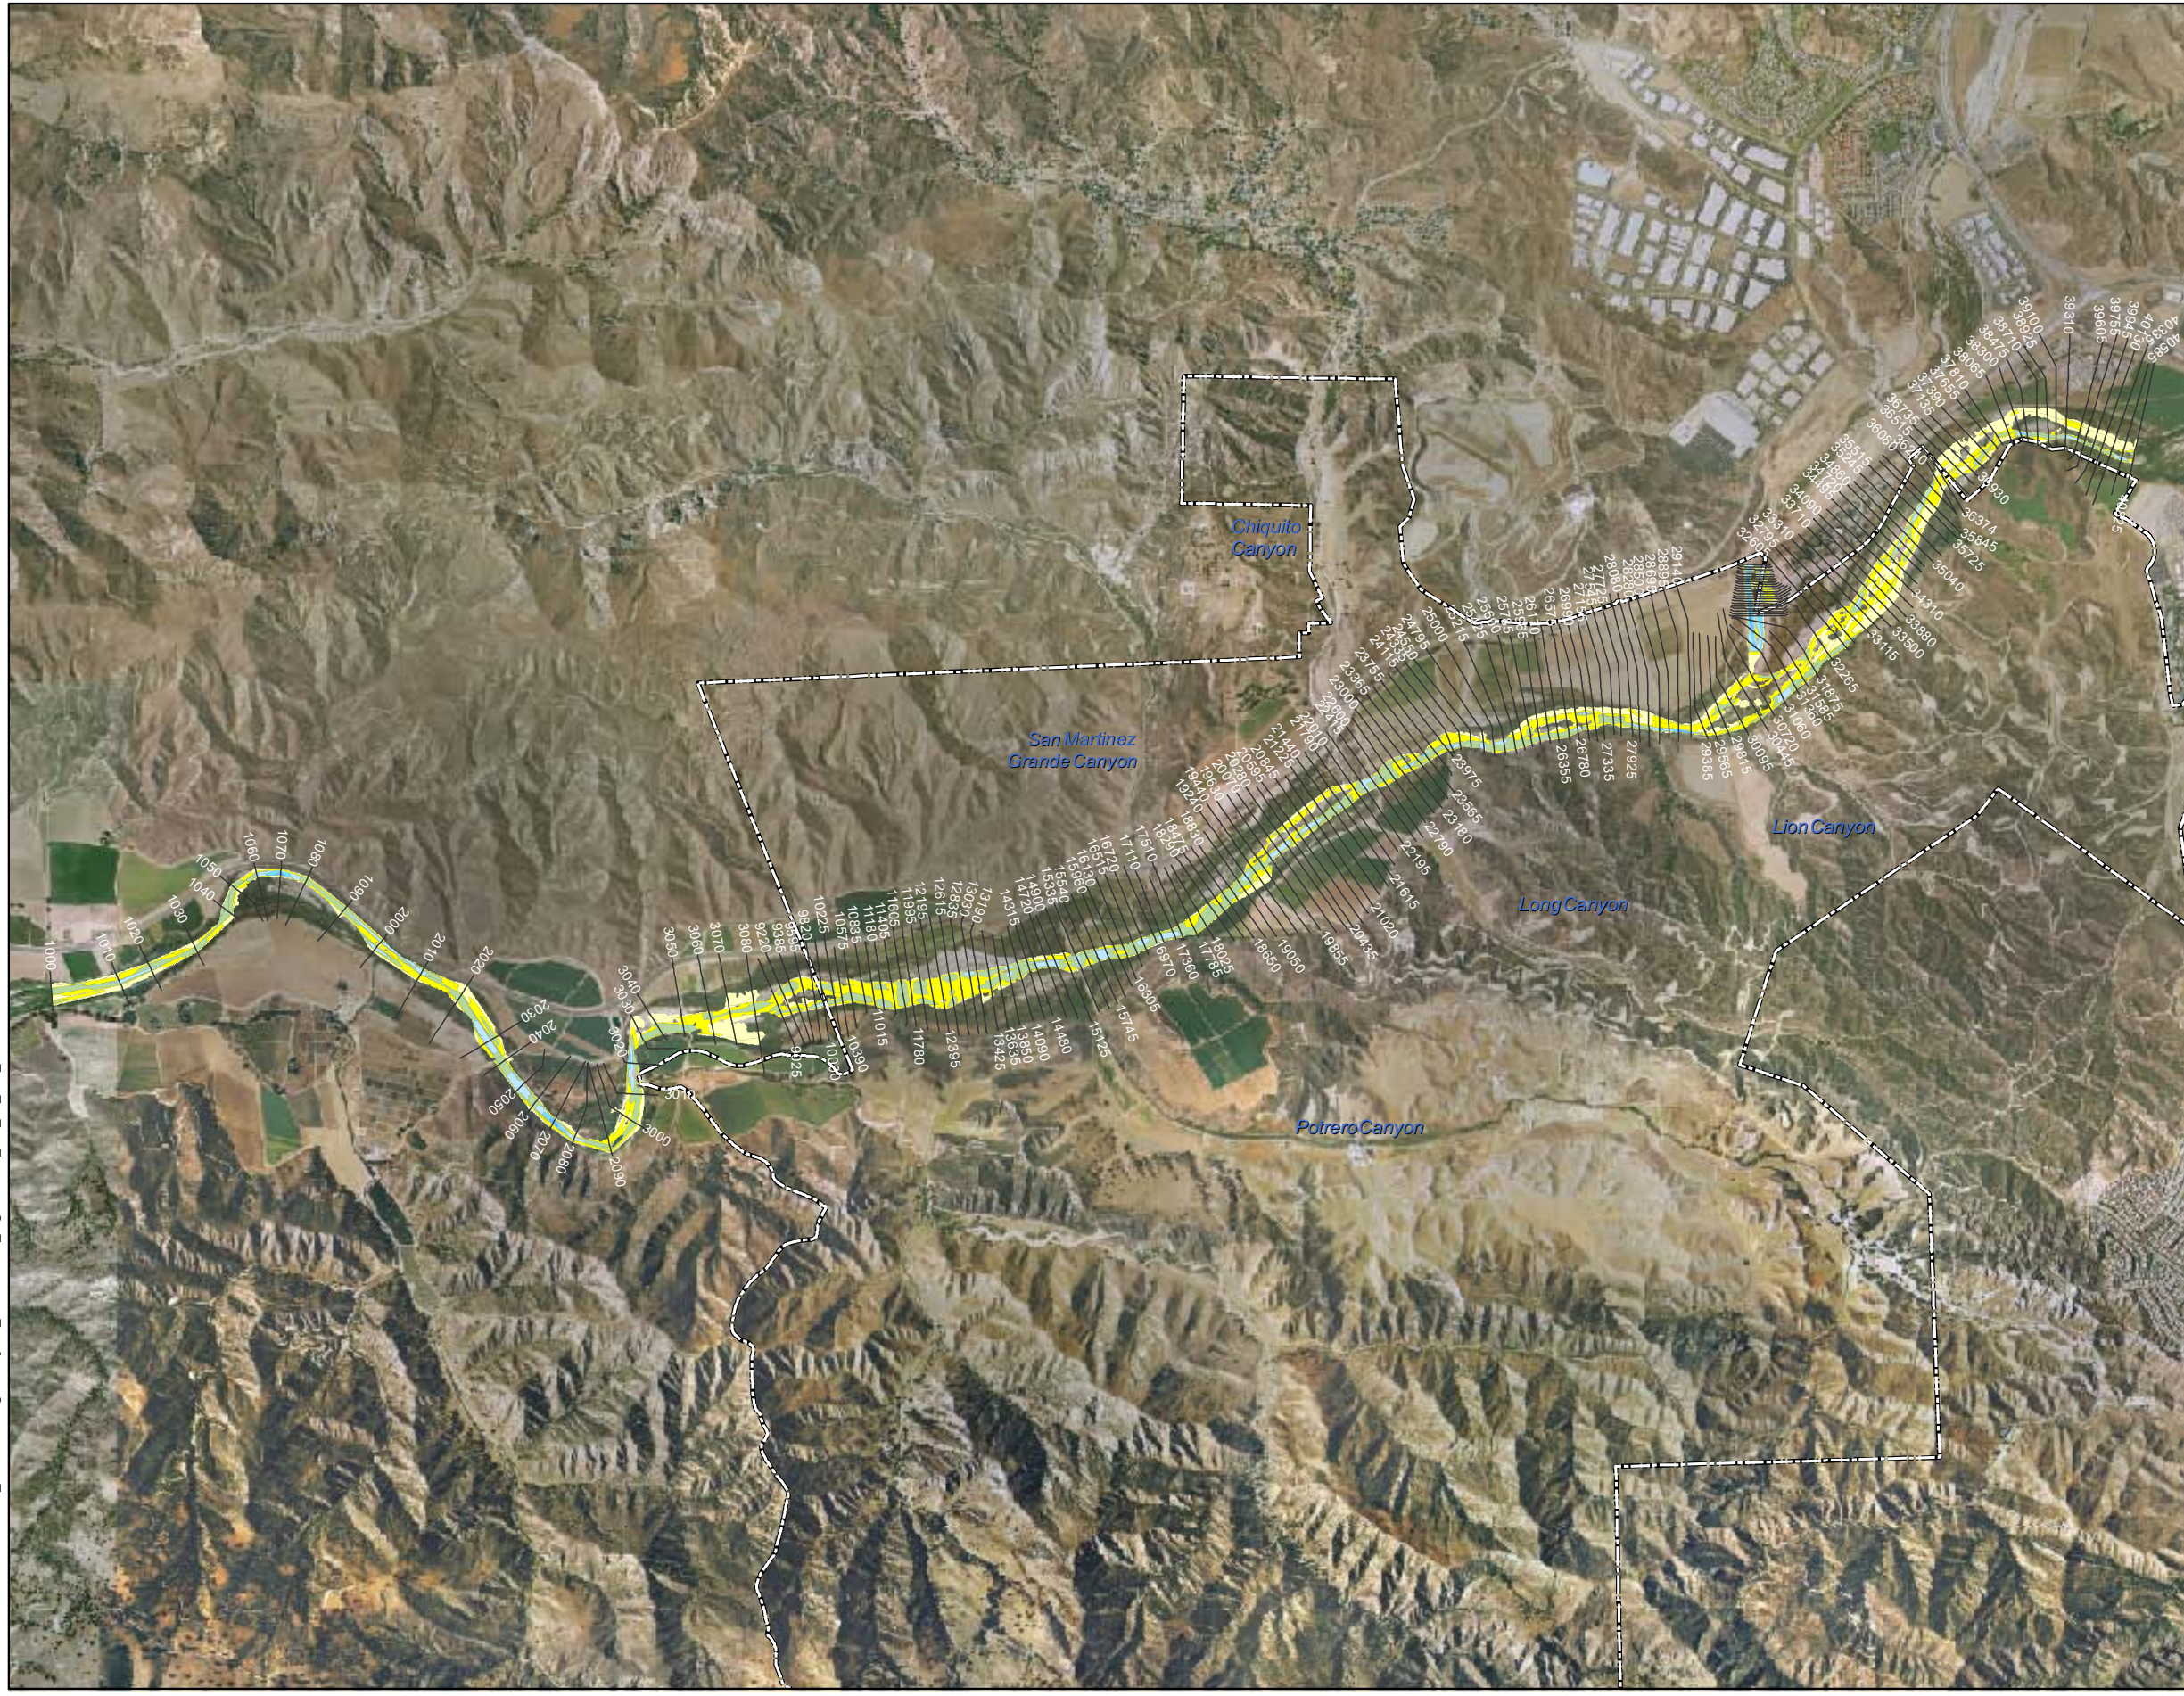
Figure 5.1b
EXISTING PRECONDITION
2 YEAR FLOOD EVENT VELOCITY
SANTA CLARA RIVER

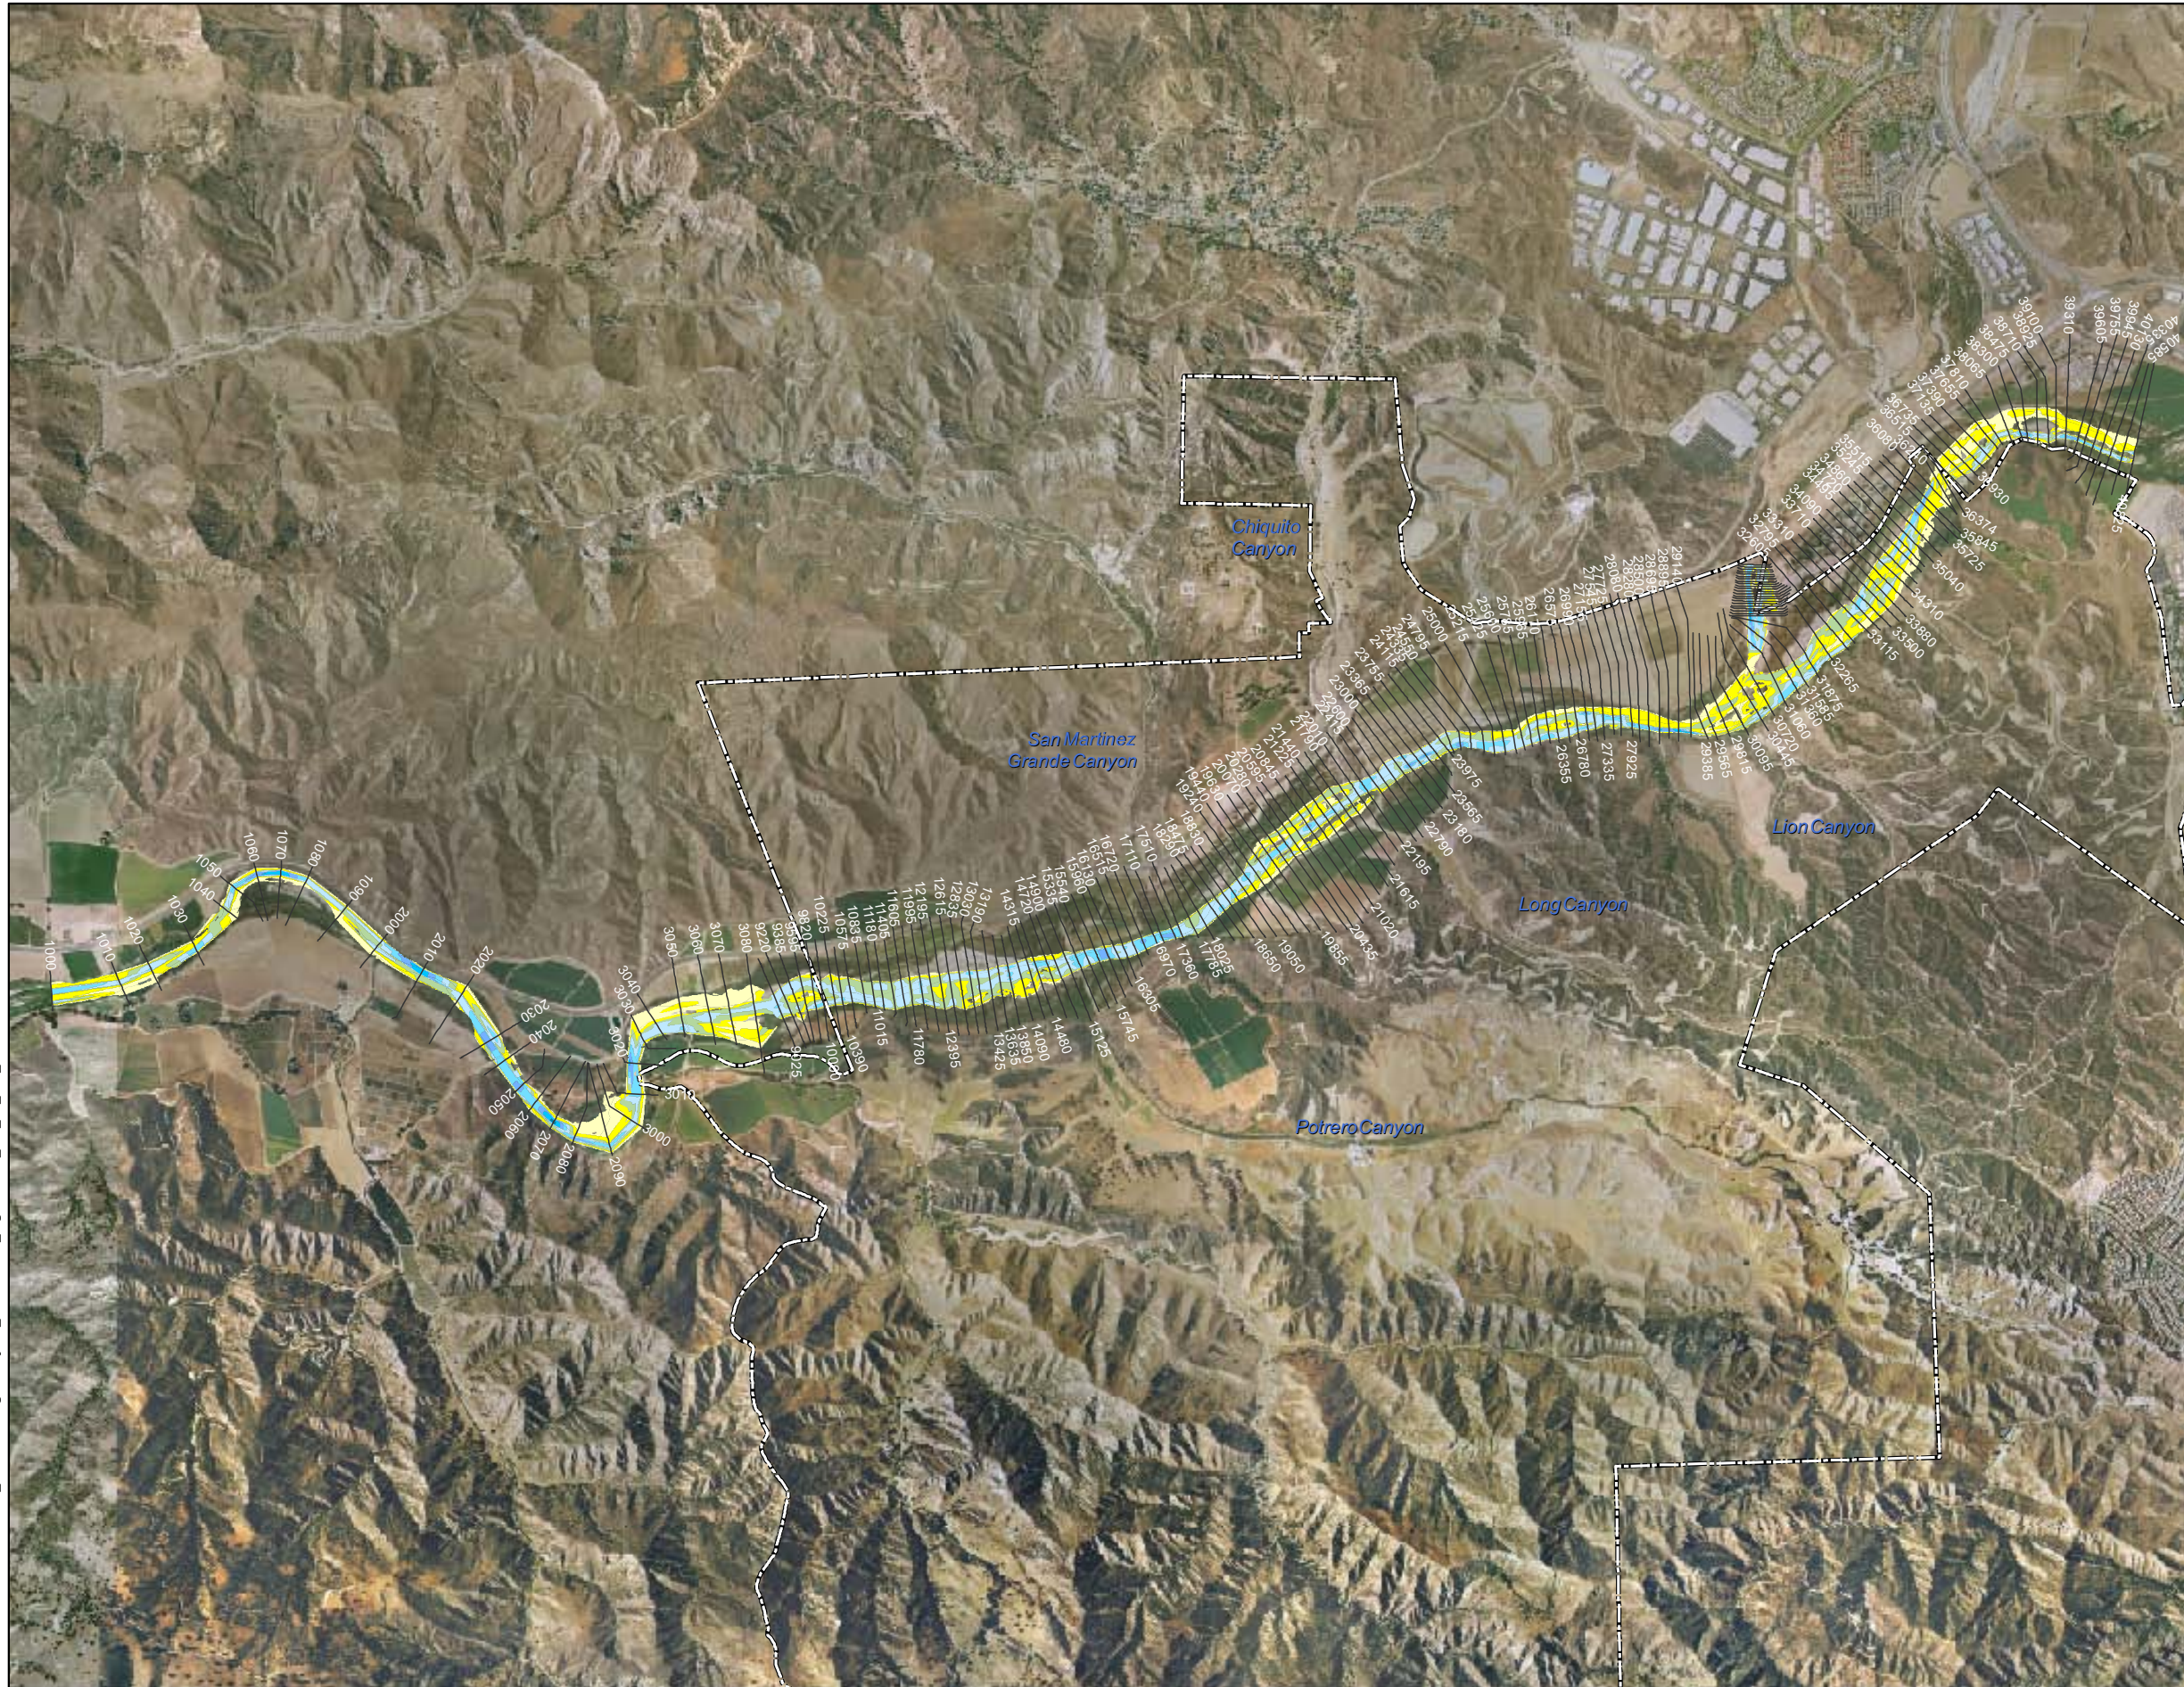
Figure 5.1c
EXISTING PRECONDITION
5 YEAR FLOOD EVENT VELOCITY
SANTA CLARA RIVER

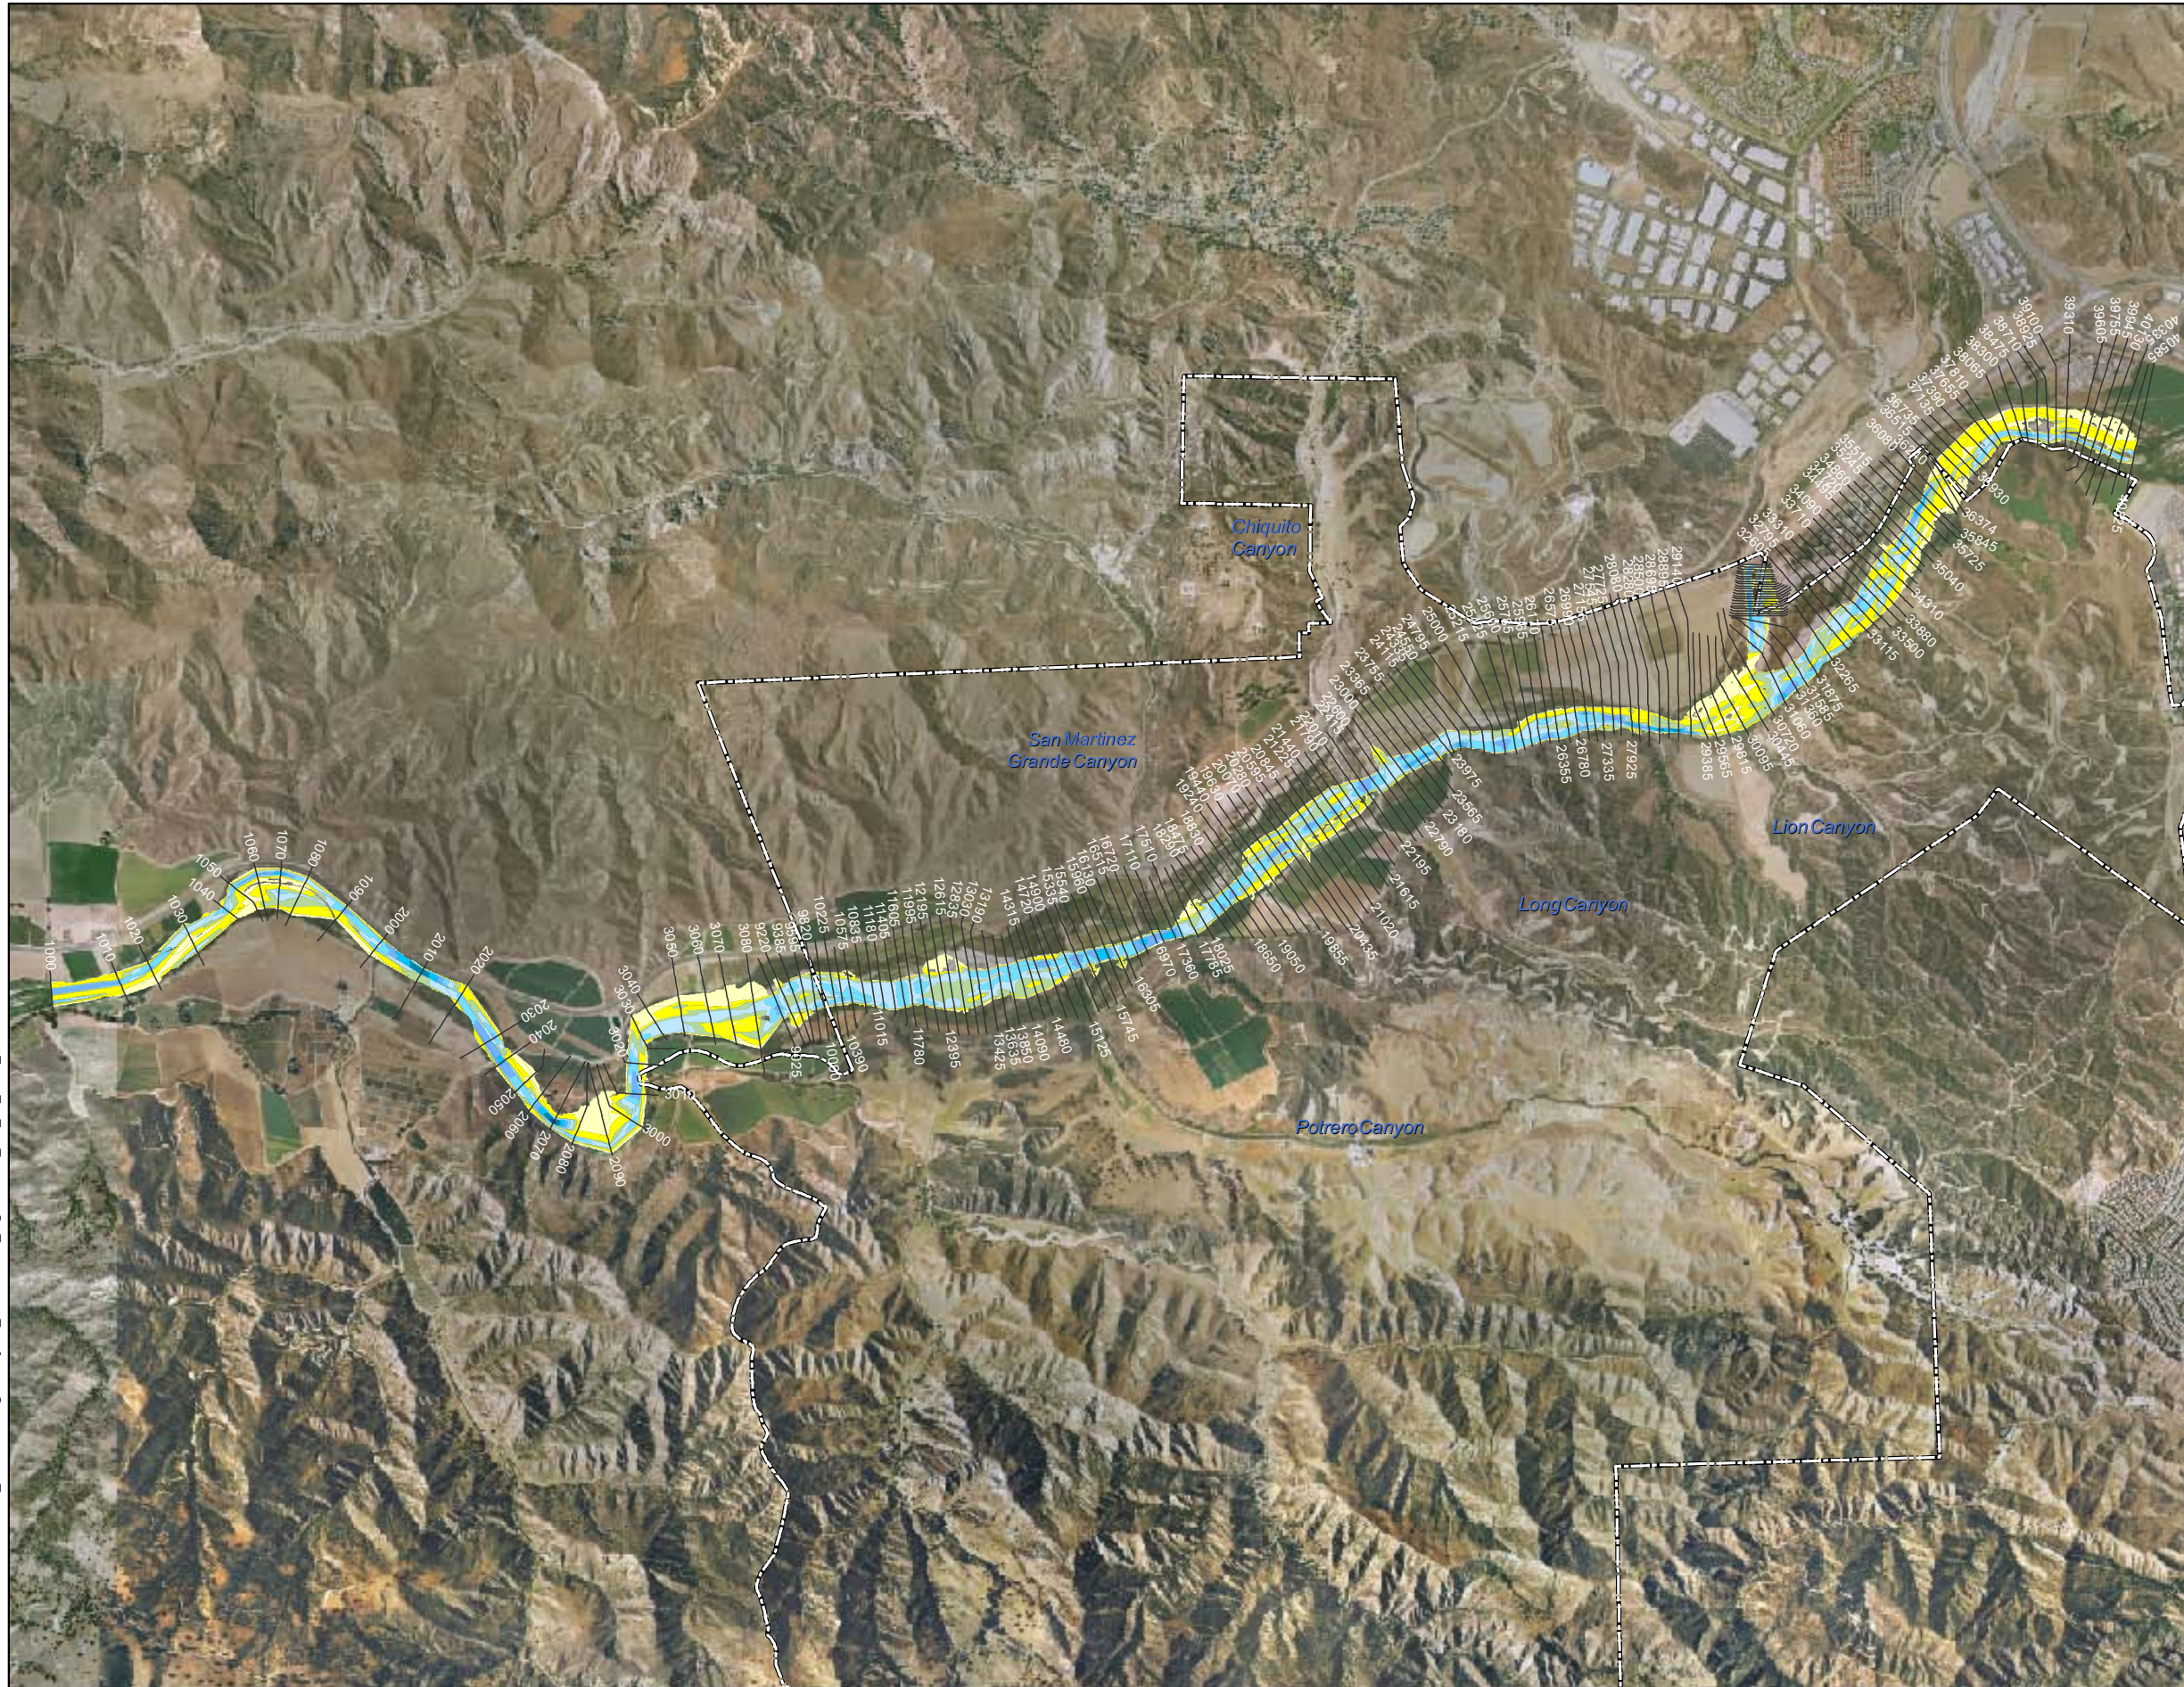
Figure 5.1d
EXISTING PRECONDITION
10 YEAR FLOOD EVENT VELOCITY
SANTA CLARA RIVER
