**REVISED FOCUSED SPECIAL STATUS FISH SPECIES
HABITAT ASSESSMENT AND IMPACT ANALYSIS
SANTA CLARA RIVER AND TRIBUTARY
DRAINAGES WITHIN NEWHALL RANCH**

**NEWHALL RANCH
RESOURCE MANAGEMENT & DEVELOPMENT PLAN
LOS ANGELES COUNTY, CALIFORNIA**

Project No. 3109006

**JUNE 2010
~~February 23, 2009~~**

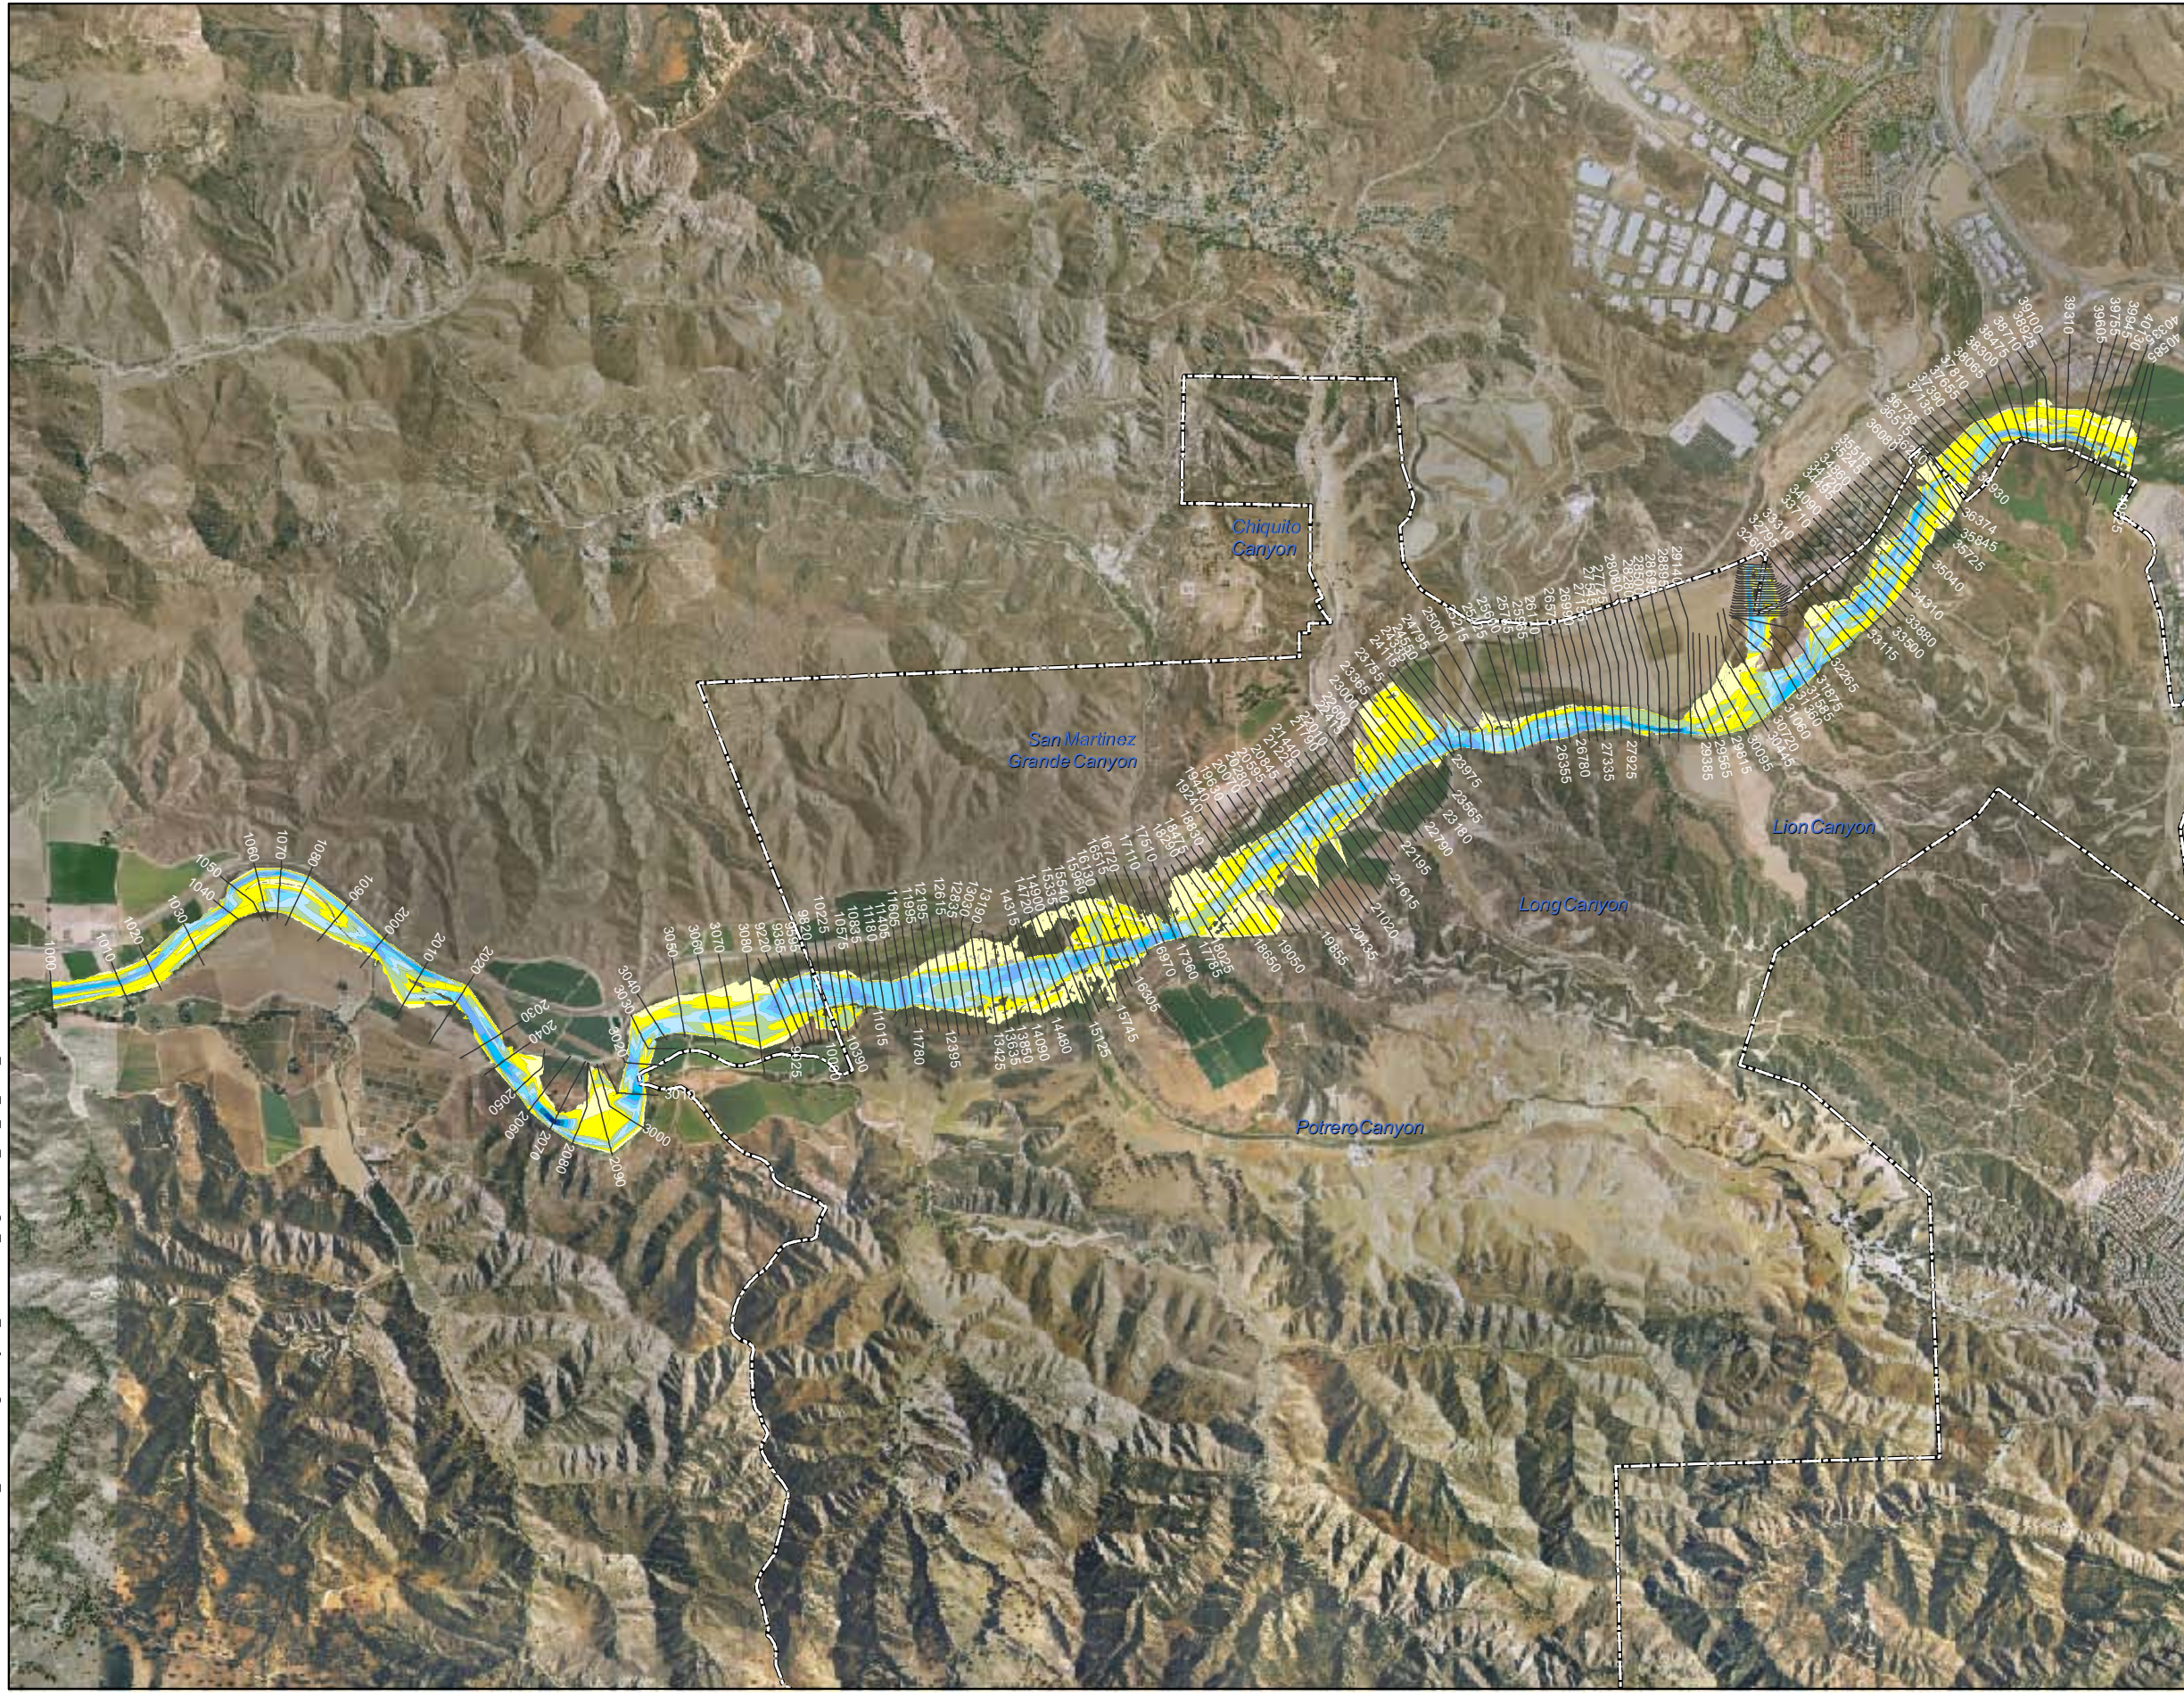
Figure 5.1e
EXISTING PRECONDITION\
20 YEAR FLOOD EVENT VELOCITY
SANTA CLARA RIVER

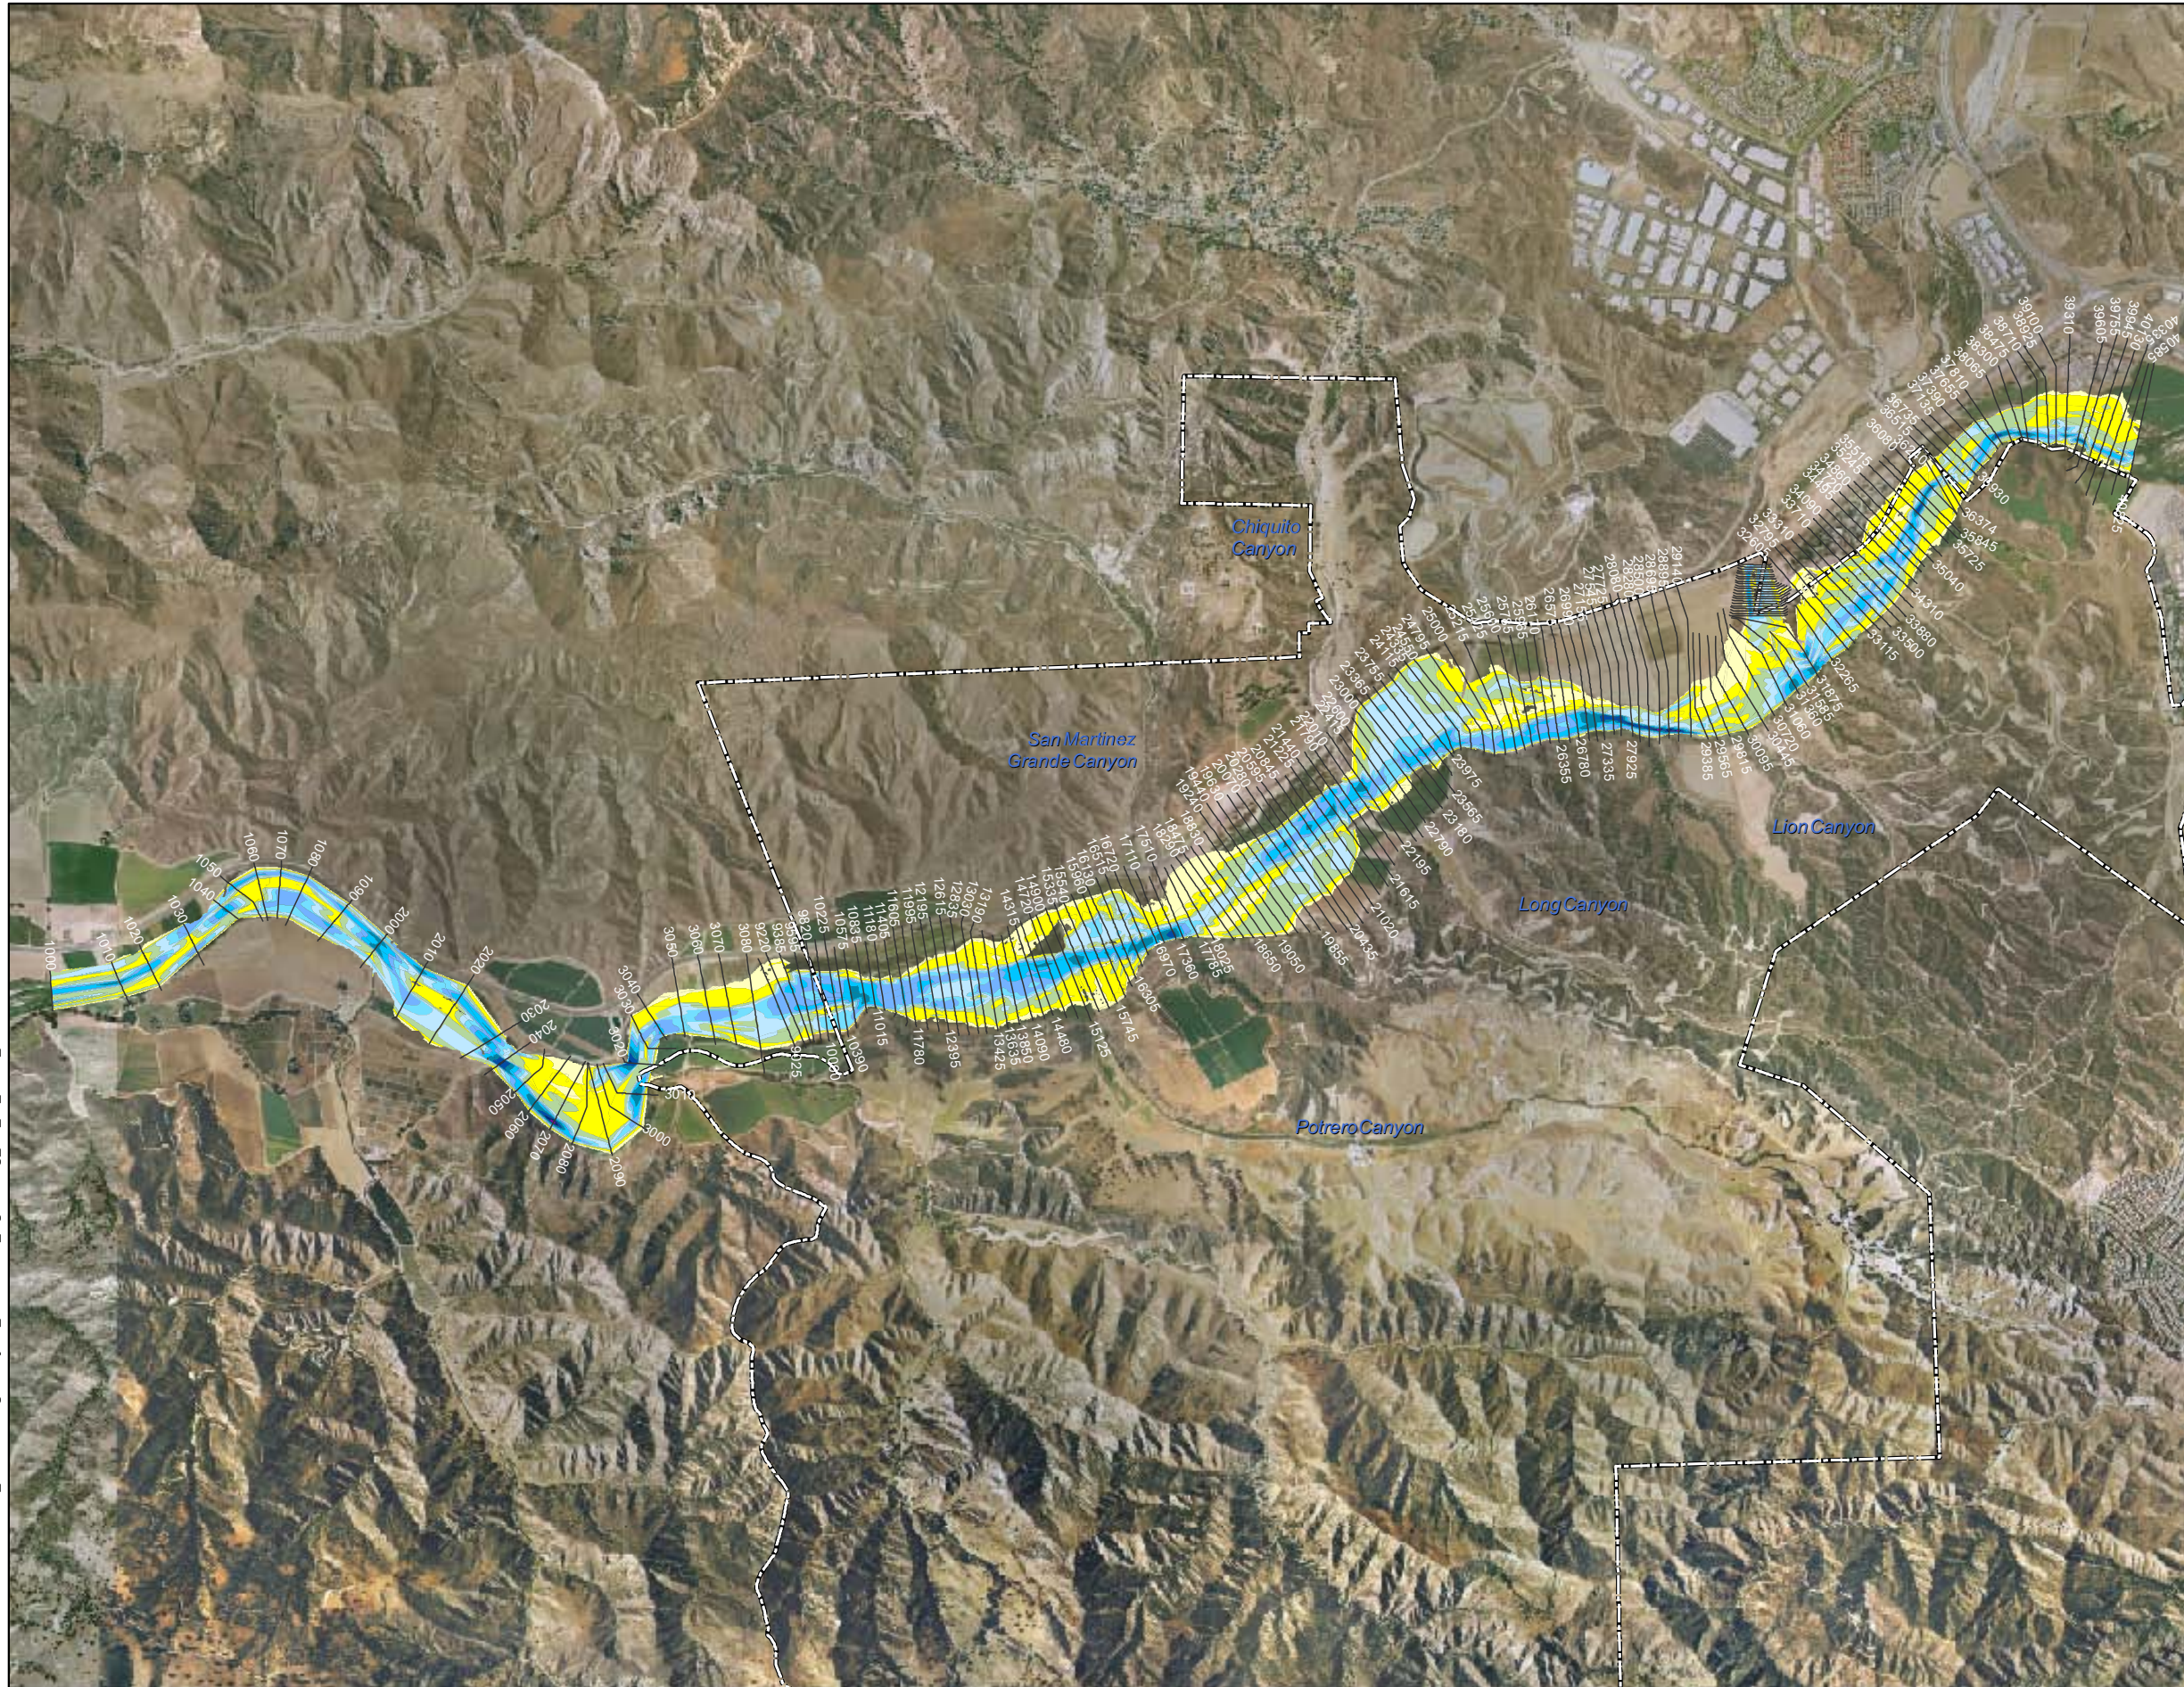
Figure 5.1g
EXISTING PRECONDITION\
100 YEAR FLOOD EVENT VELOCITY
SANTA CLARA RIVER

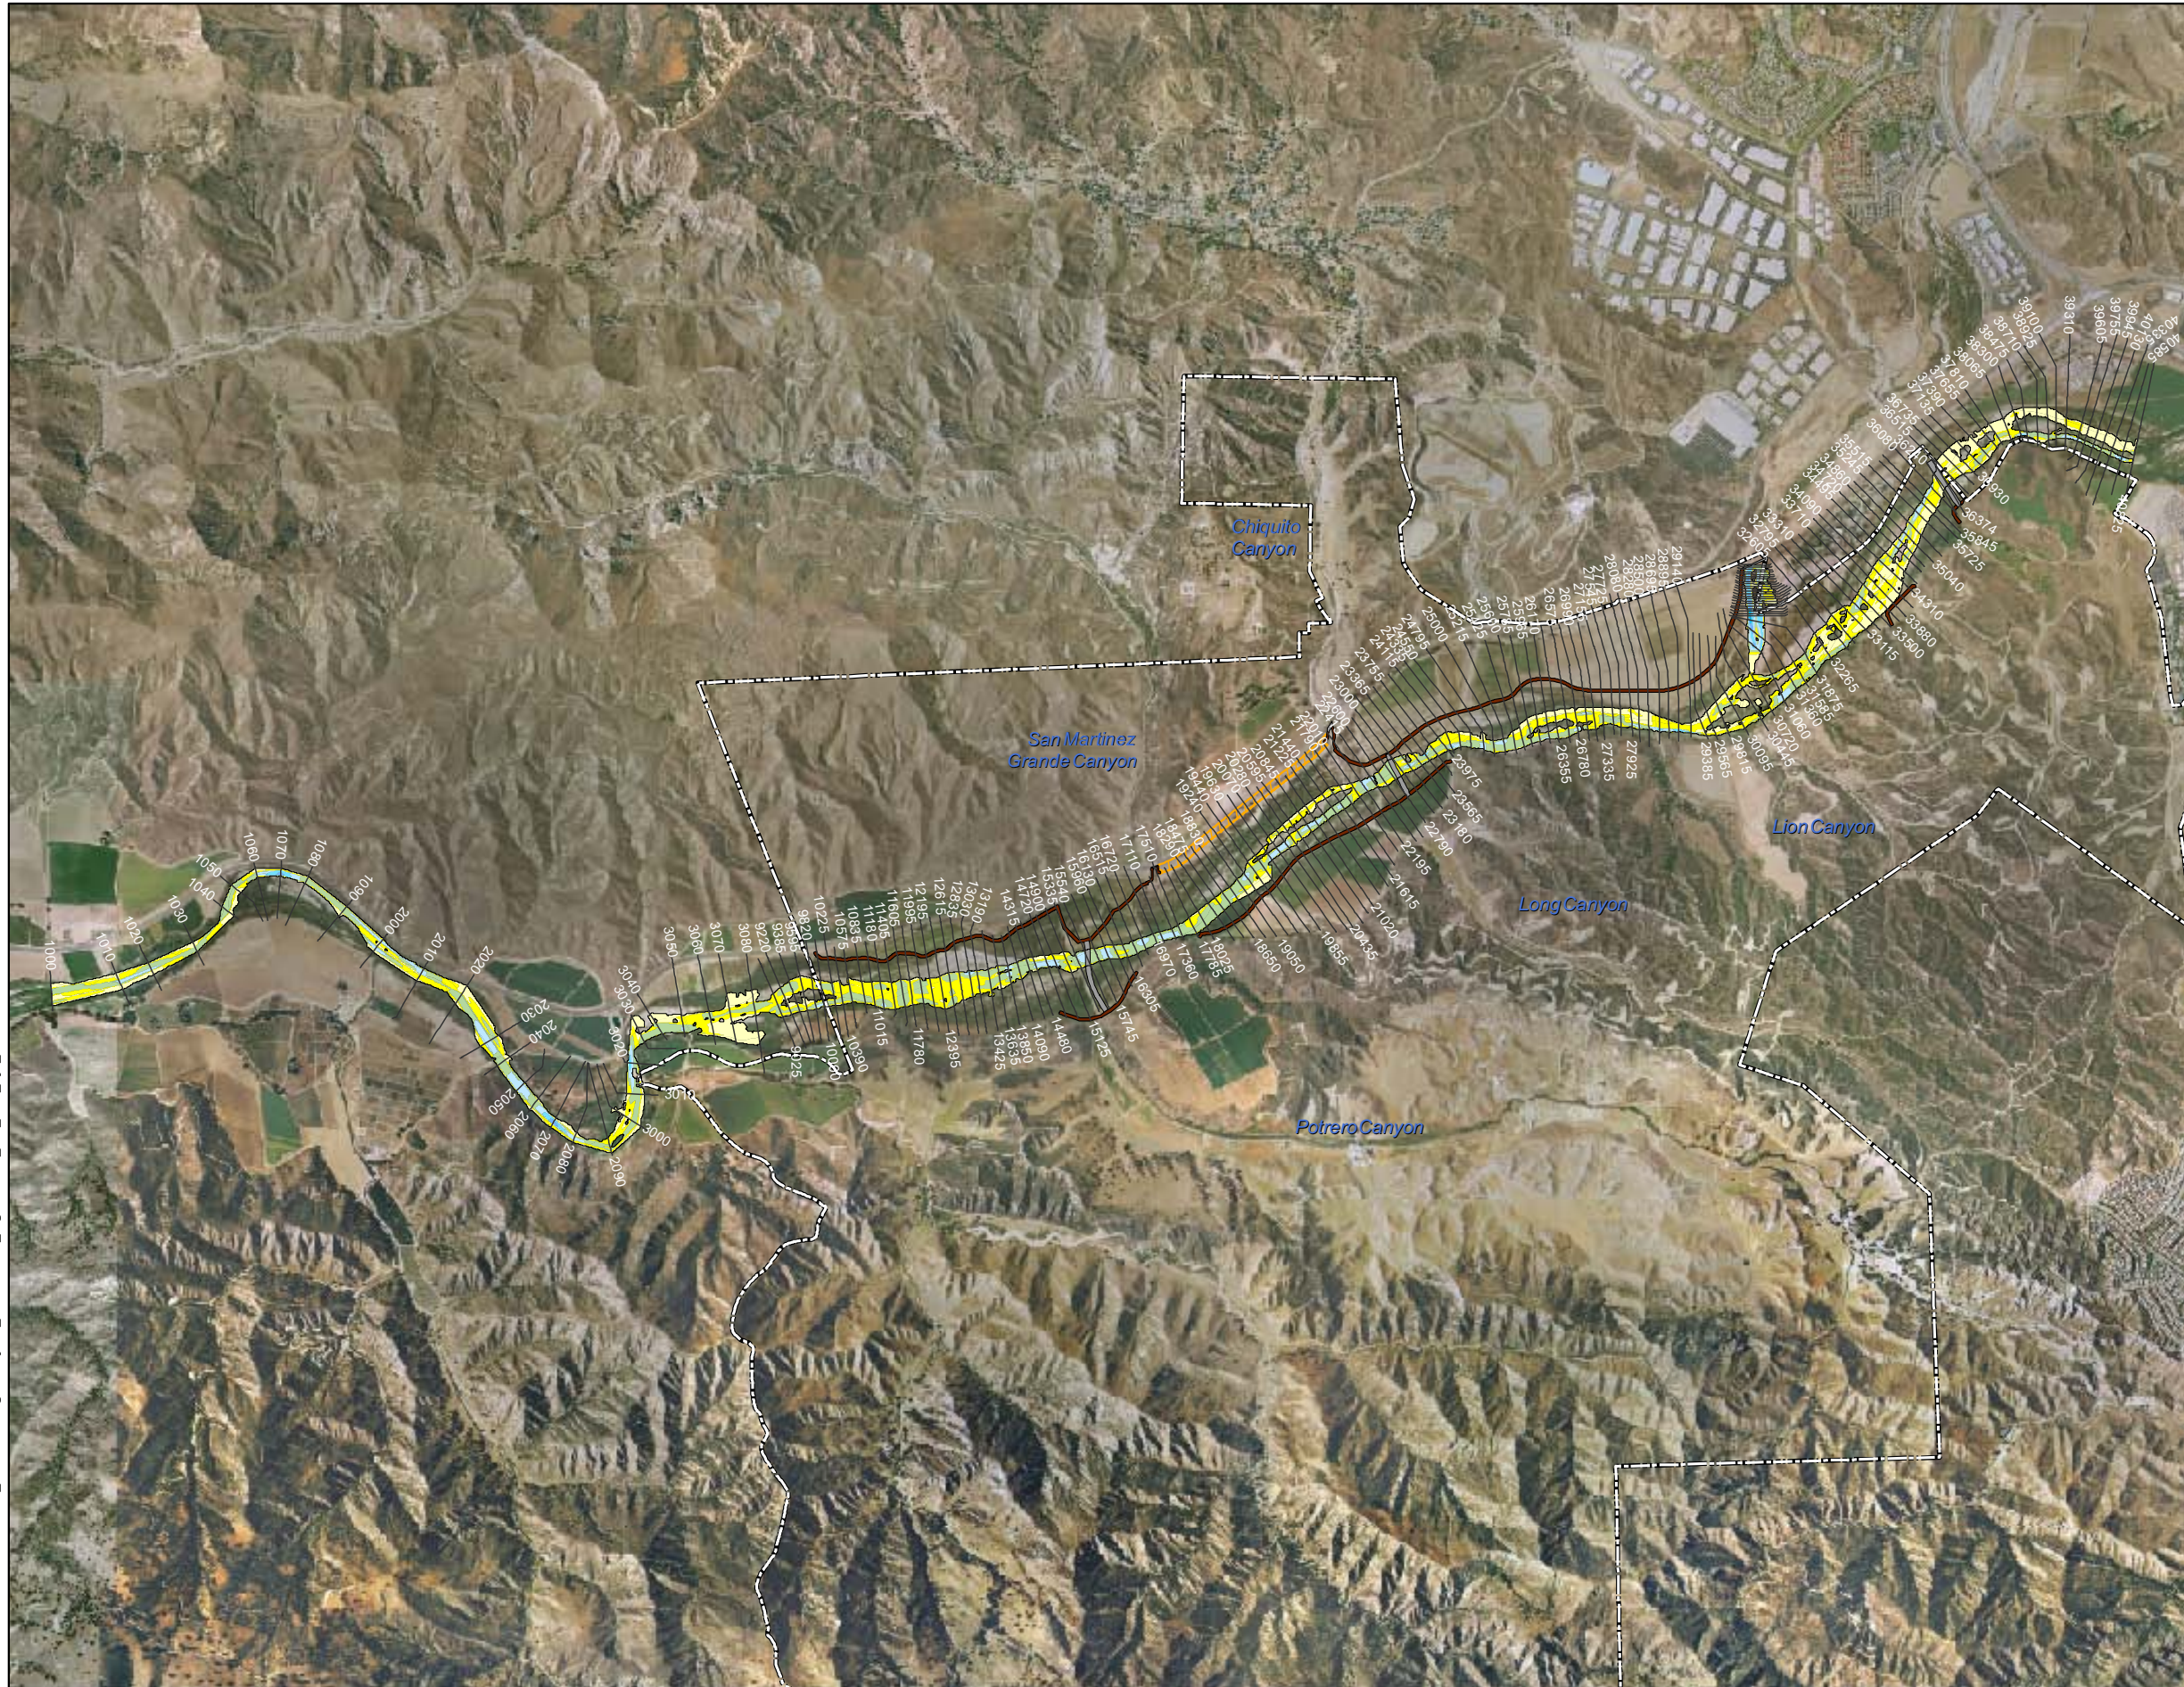
Figure 5.2b
ALTERNATIVE 2
2 YEAR FLOOD EVENT VELOCITY
SANTA CLARA RIVER

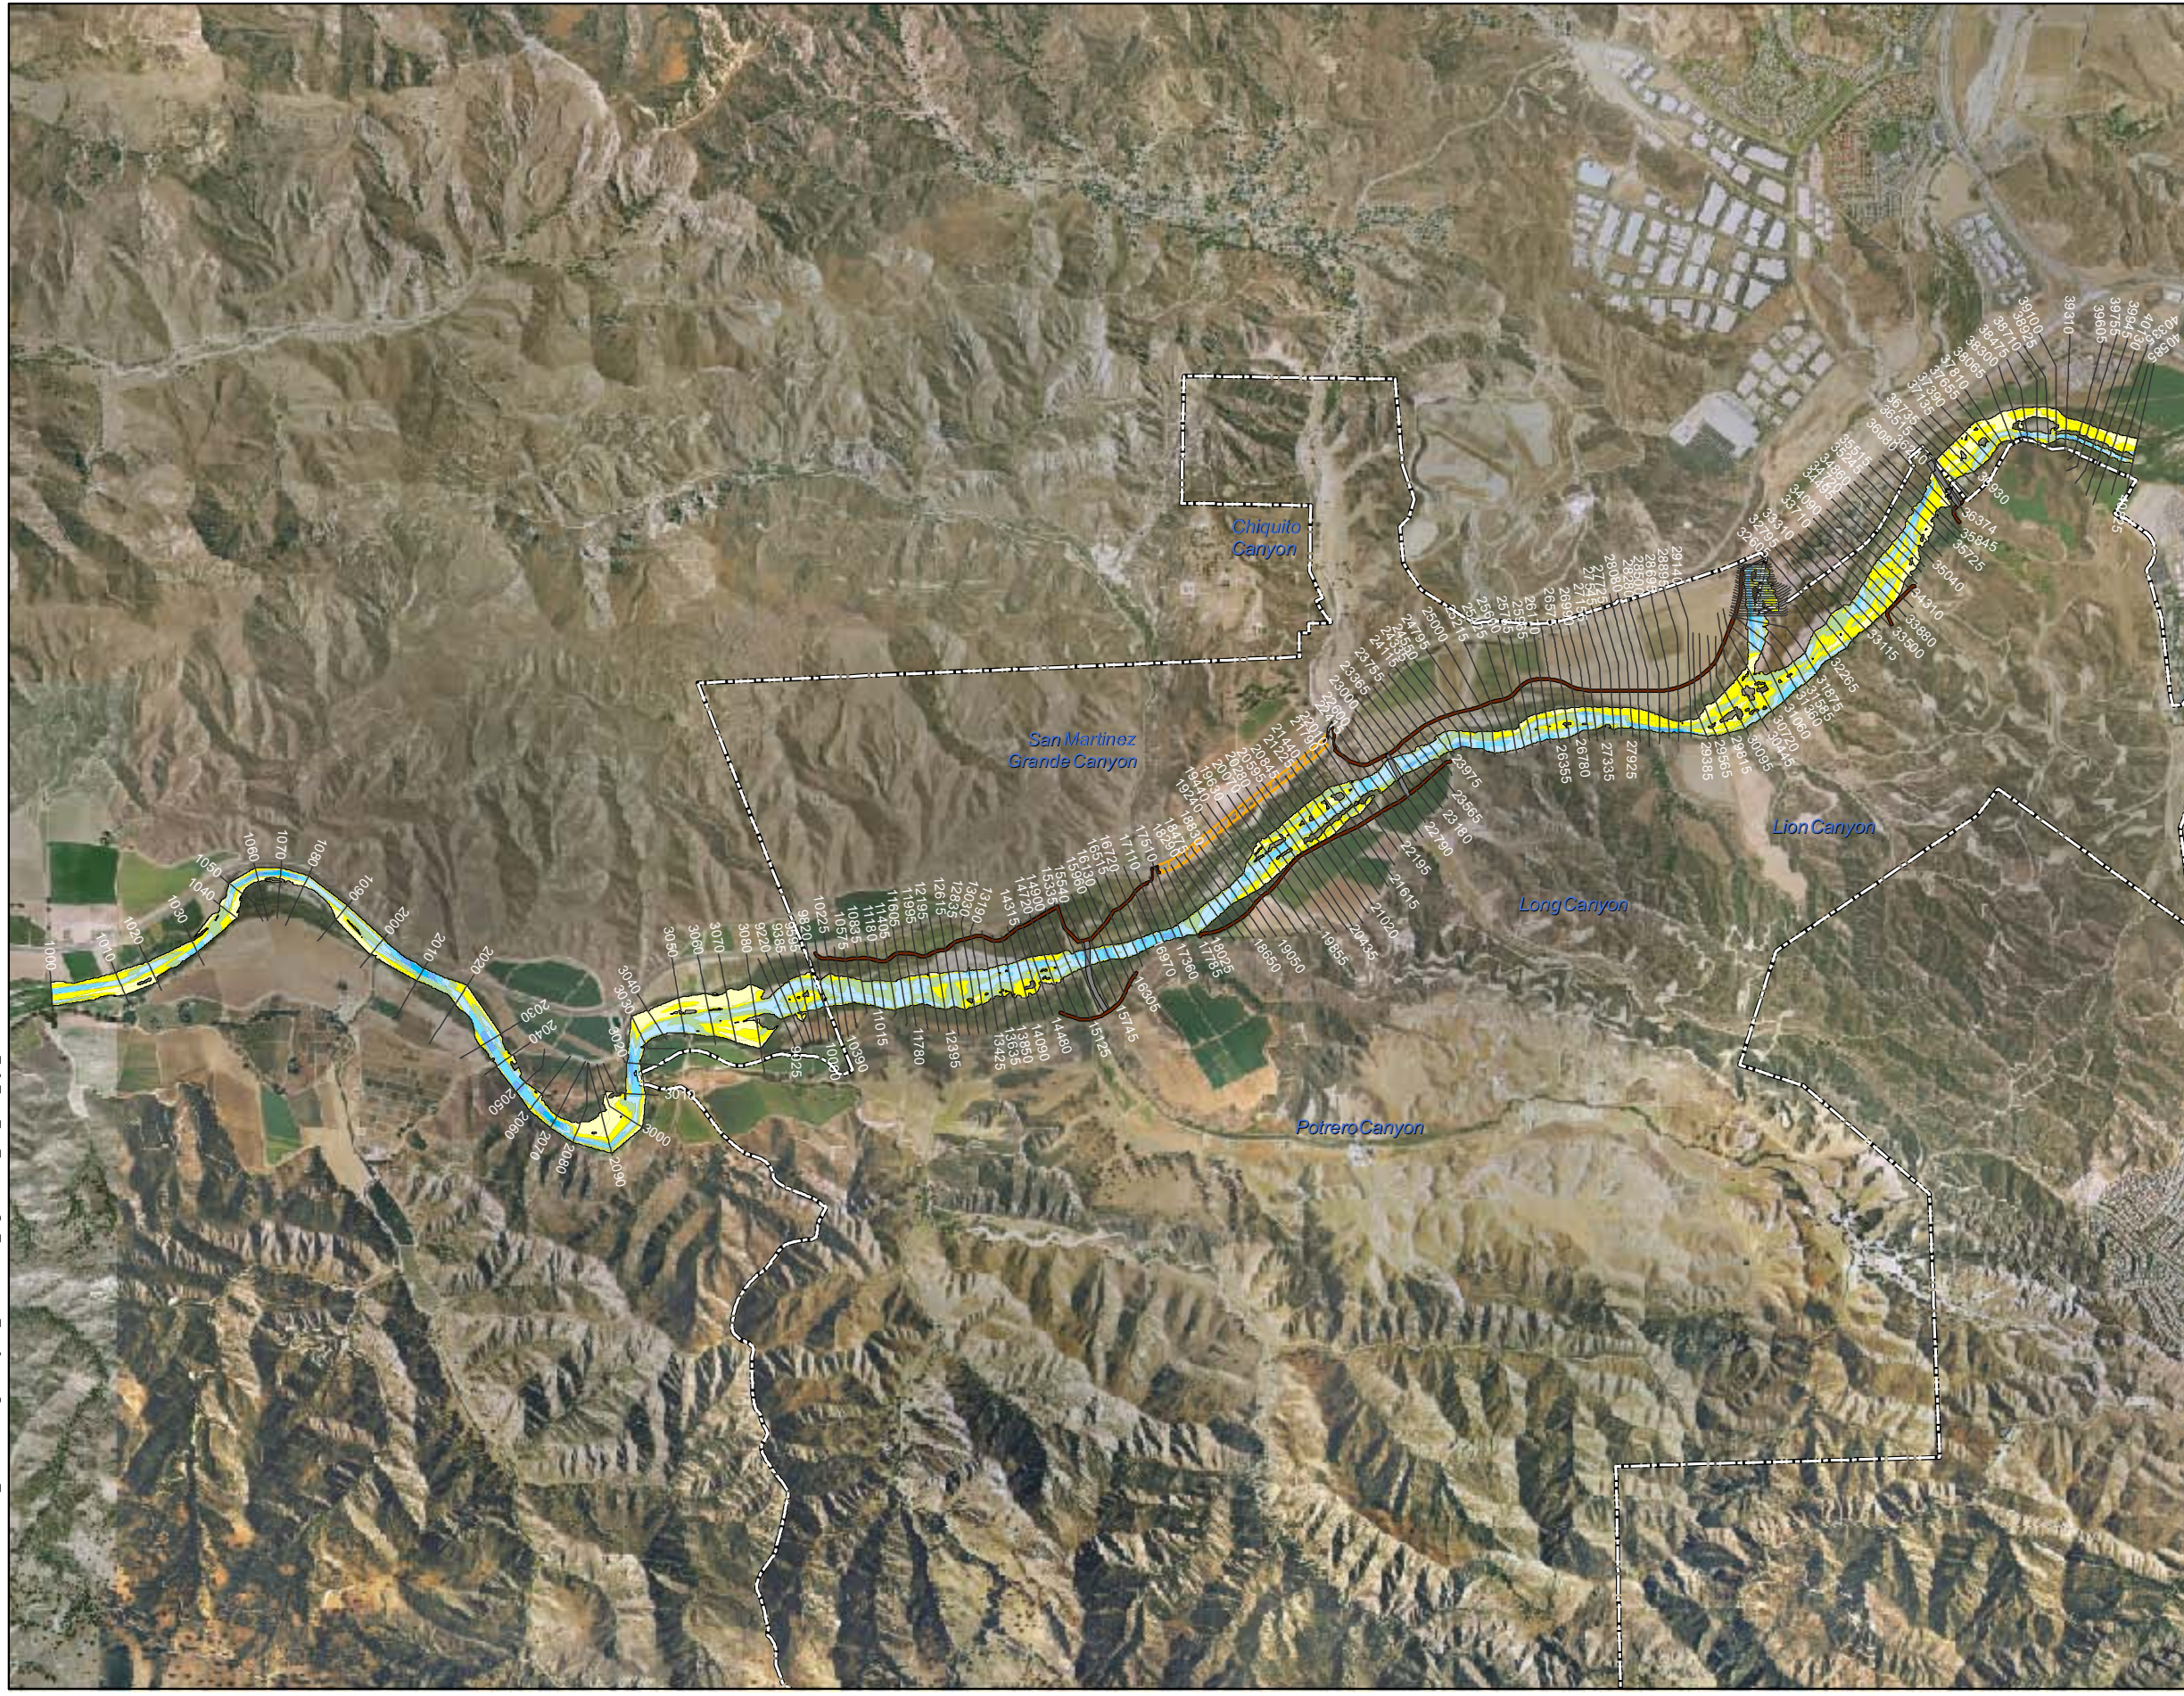
Figure 5.2c
ALTERNATIVE 2
5 YEAR FLOOD EVENT VELOCITY
SANTA CLARA RIVER

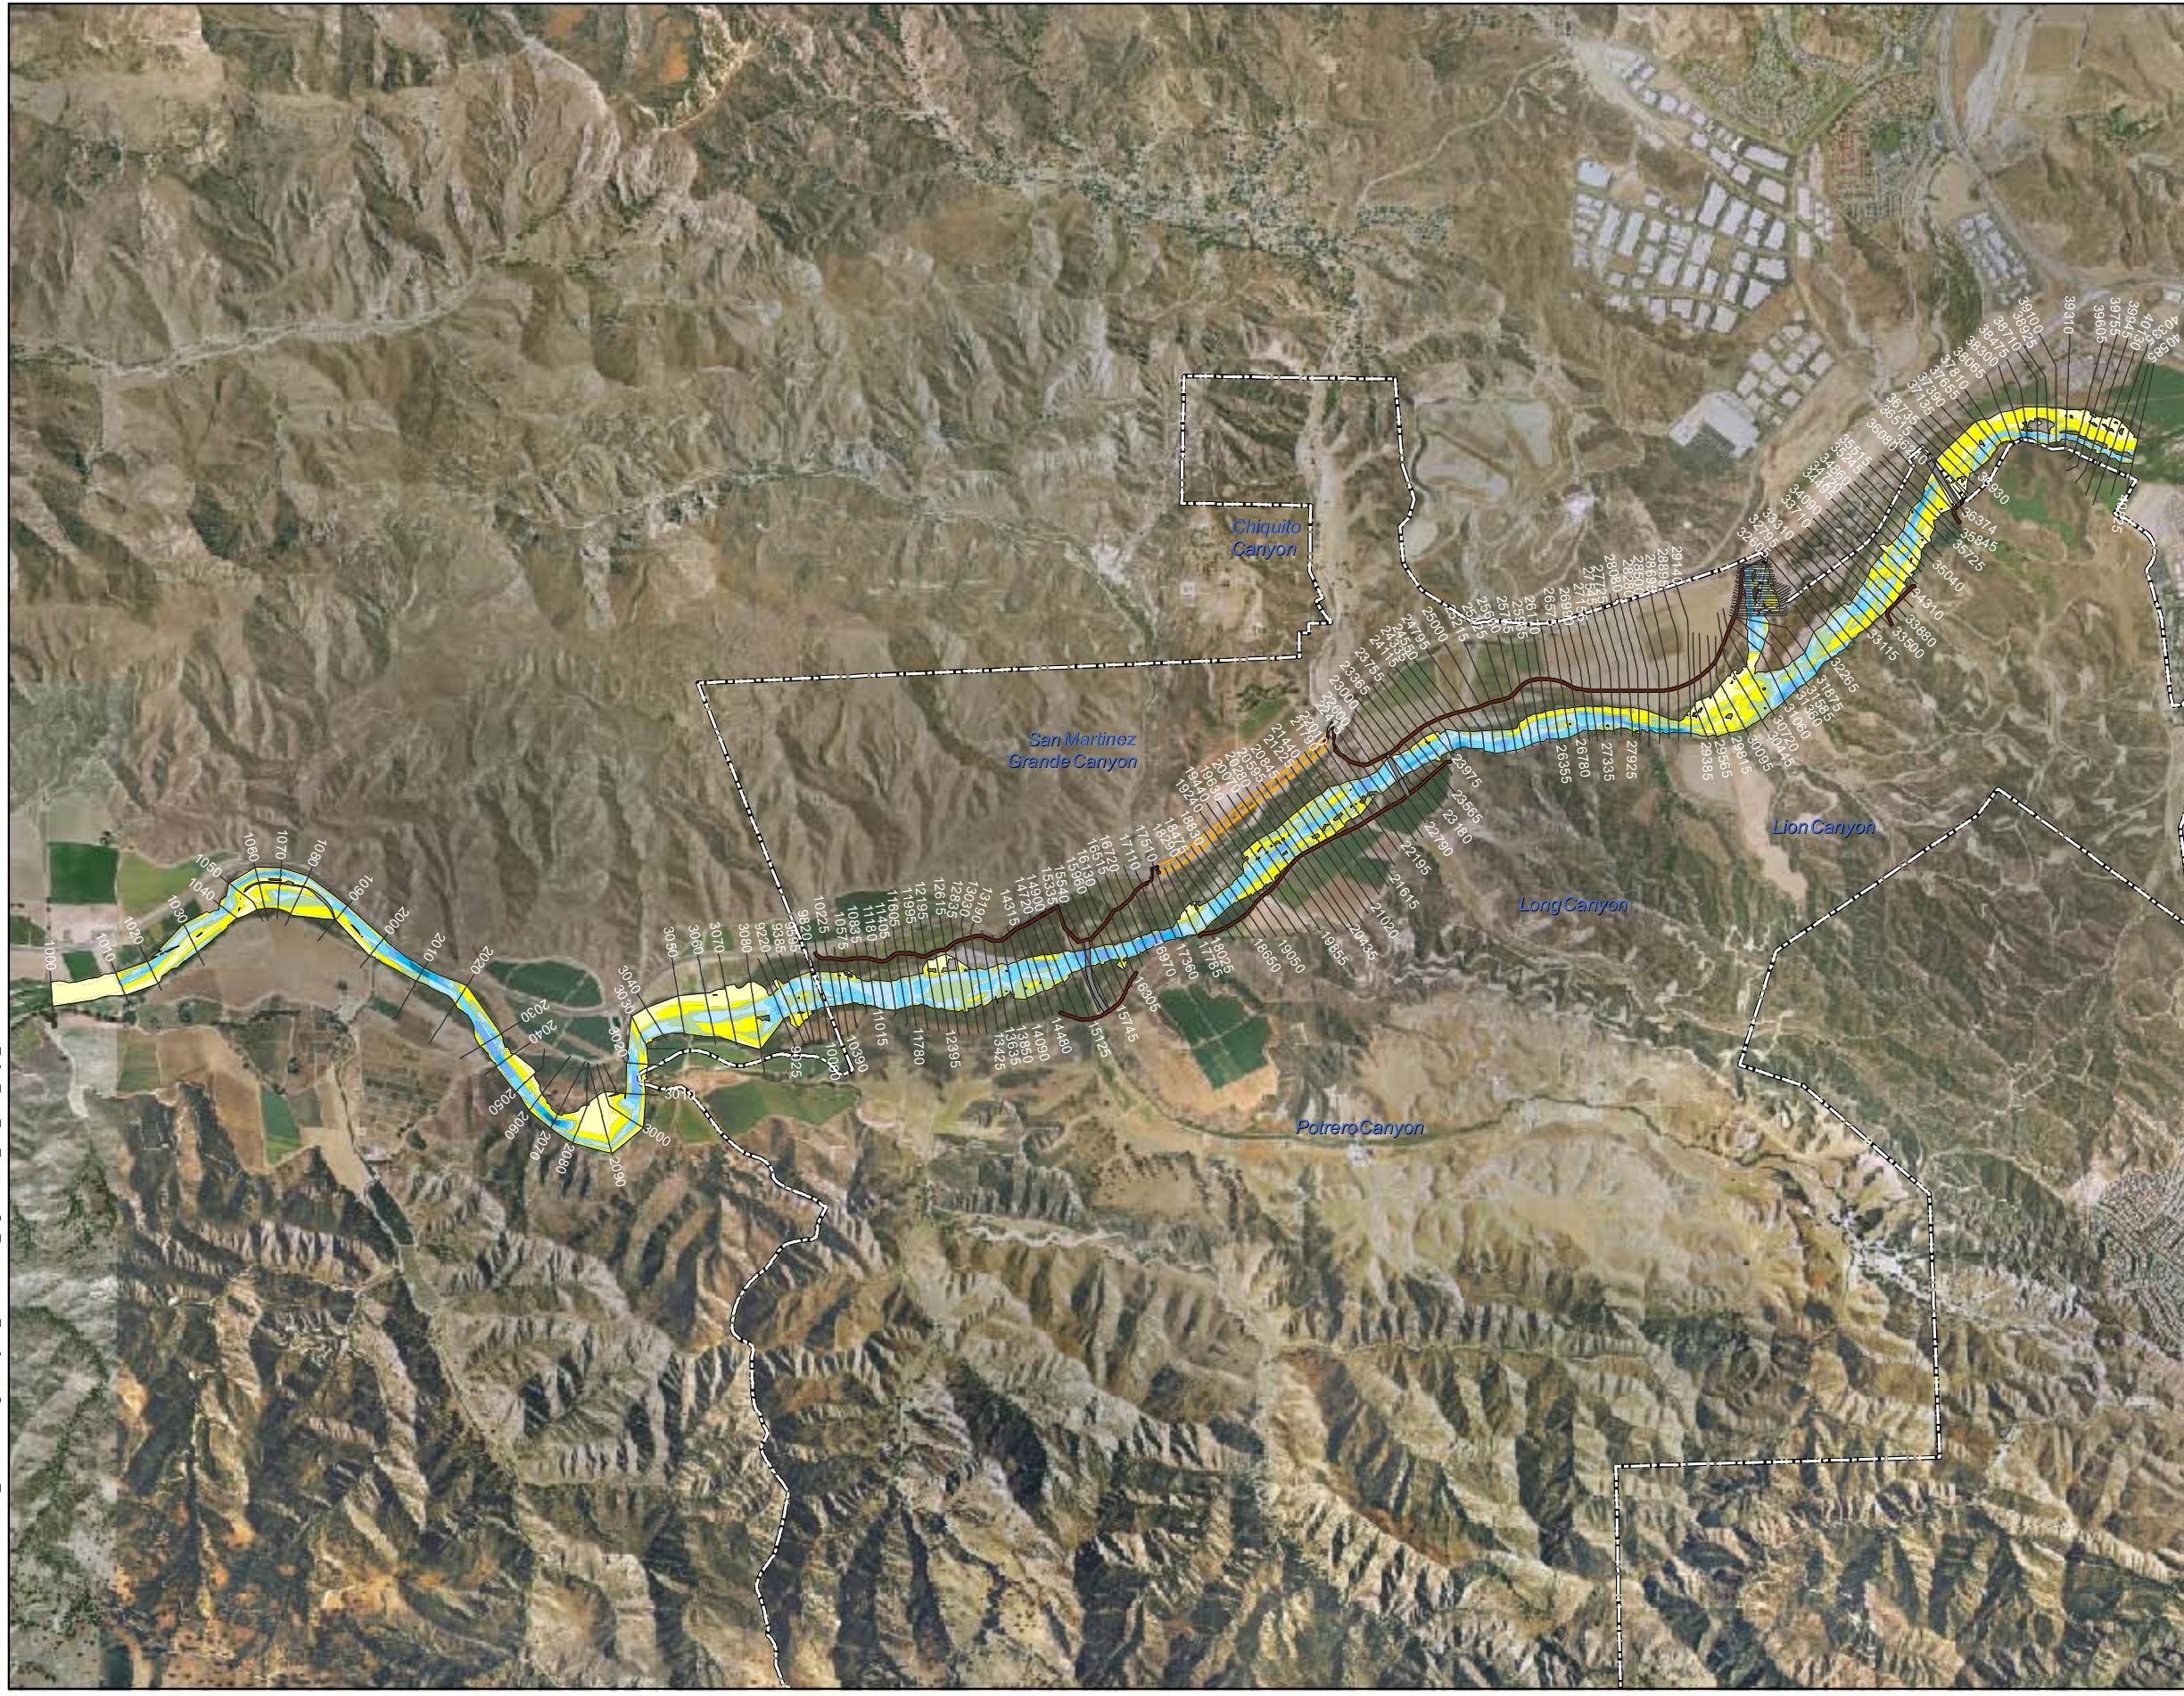
Figure 5.2d
ALTERNATIVE 2
10 YEAR FLOOD EVENT VELOCITY
SANTA CLARA RIVER

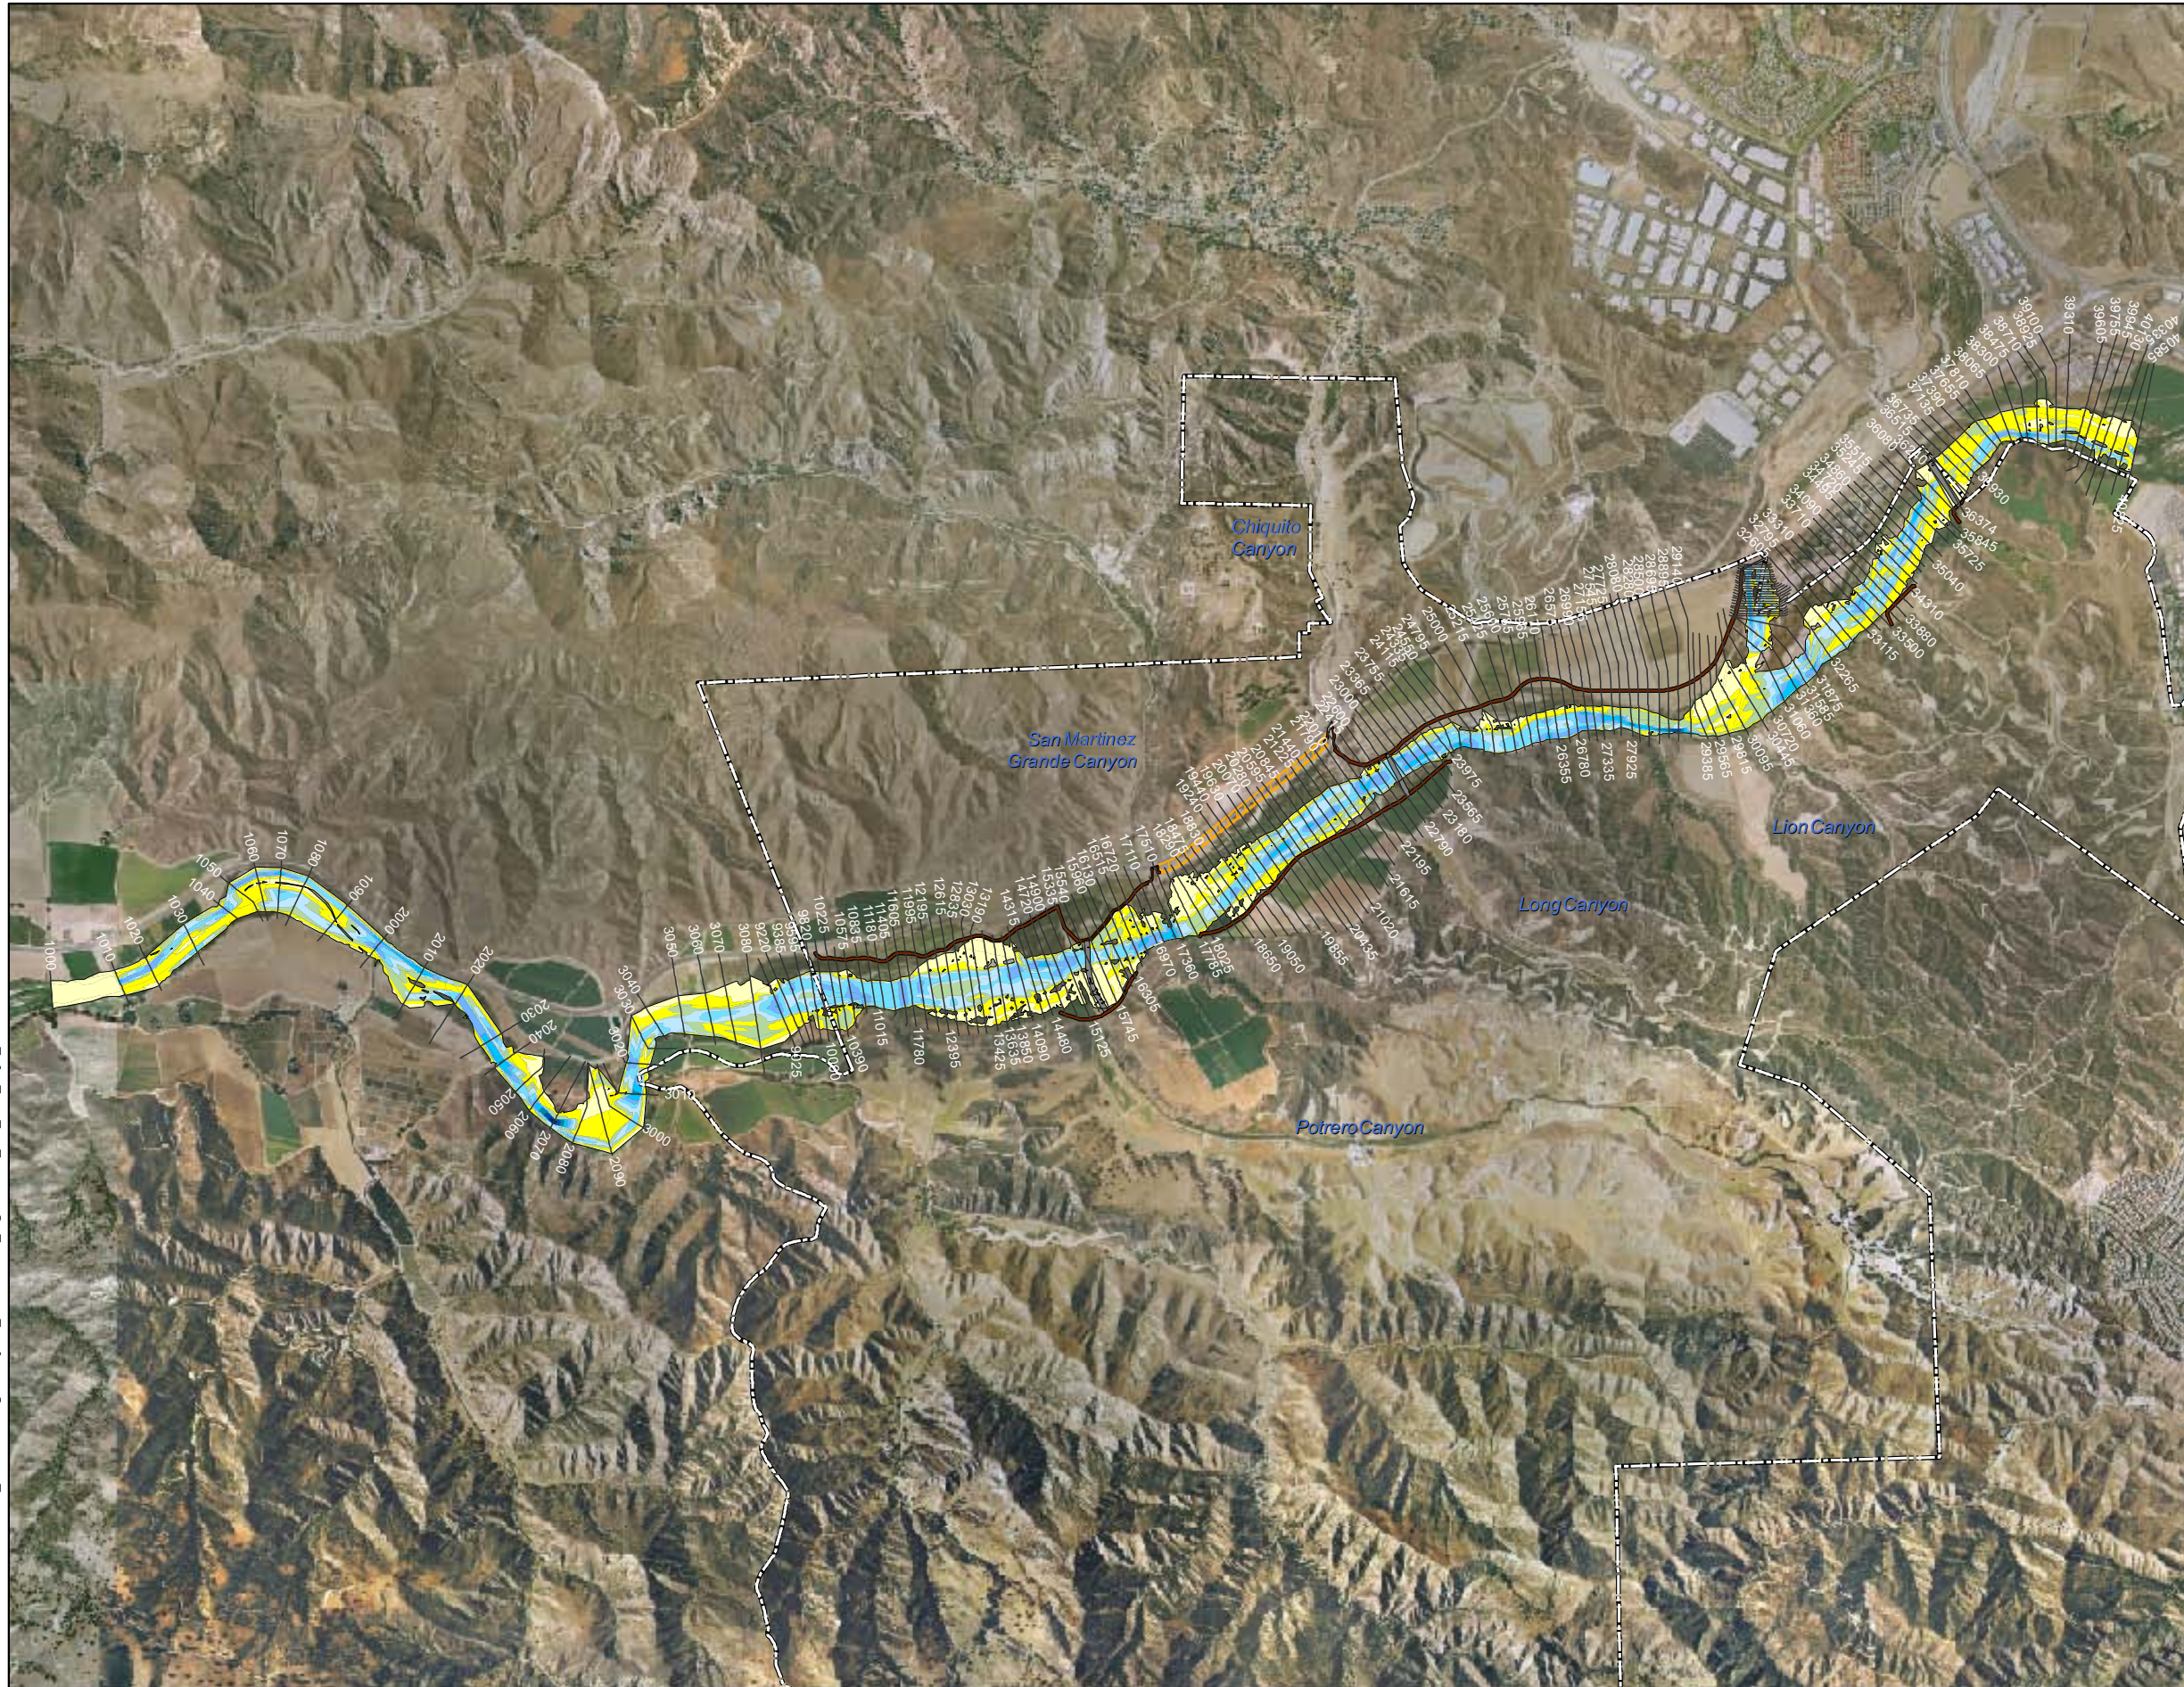
Figure 5.2e
ALTERNATIVE 2
20 YEAR FLOOD EVENT VELOCITY
SANTA CLARA RIVER
