**REVISED FOCUSED SPECIAL STATUS FISH SPECIES
HABITAT ASSESSMENT AND IMPACT ANALYSIS
SANTA CLARA RIVER AND TRIBUTARY
DRAINAGES WITHIN NEWHALL RANCH**

**NEWHALL RANCH
RESOURCE MANAGEMENT & DEVELOPMENT PLAN
LOS ANGELES COUNTY, CALIFORNIA**

Project No. 3109006

**JUNE 2010
~~February 23, 2009~~**

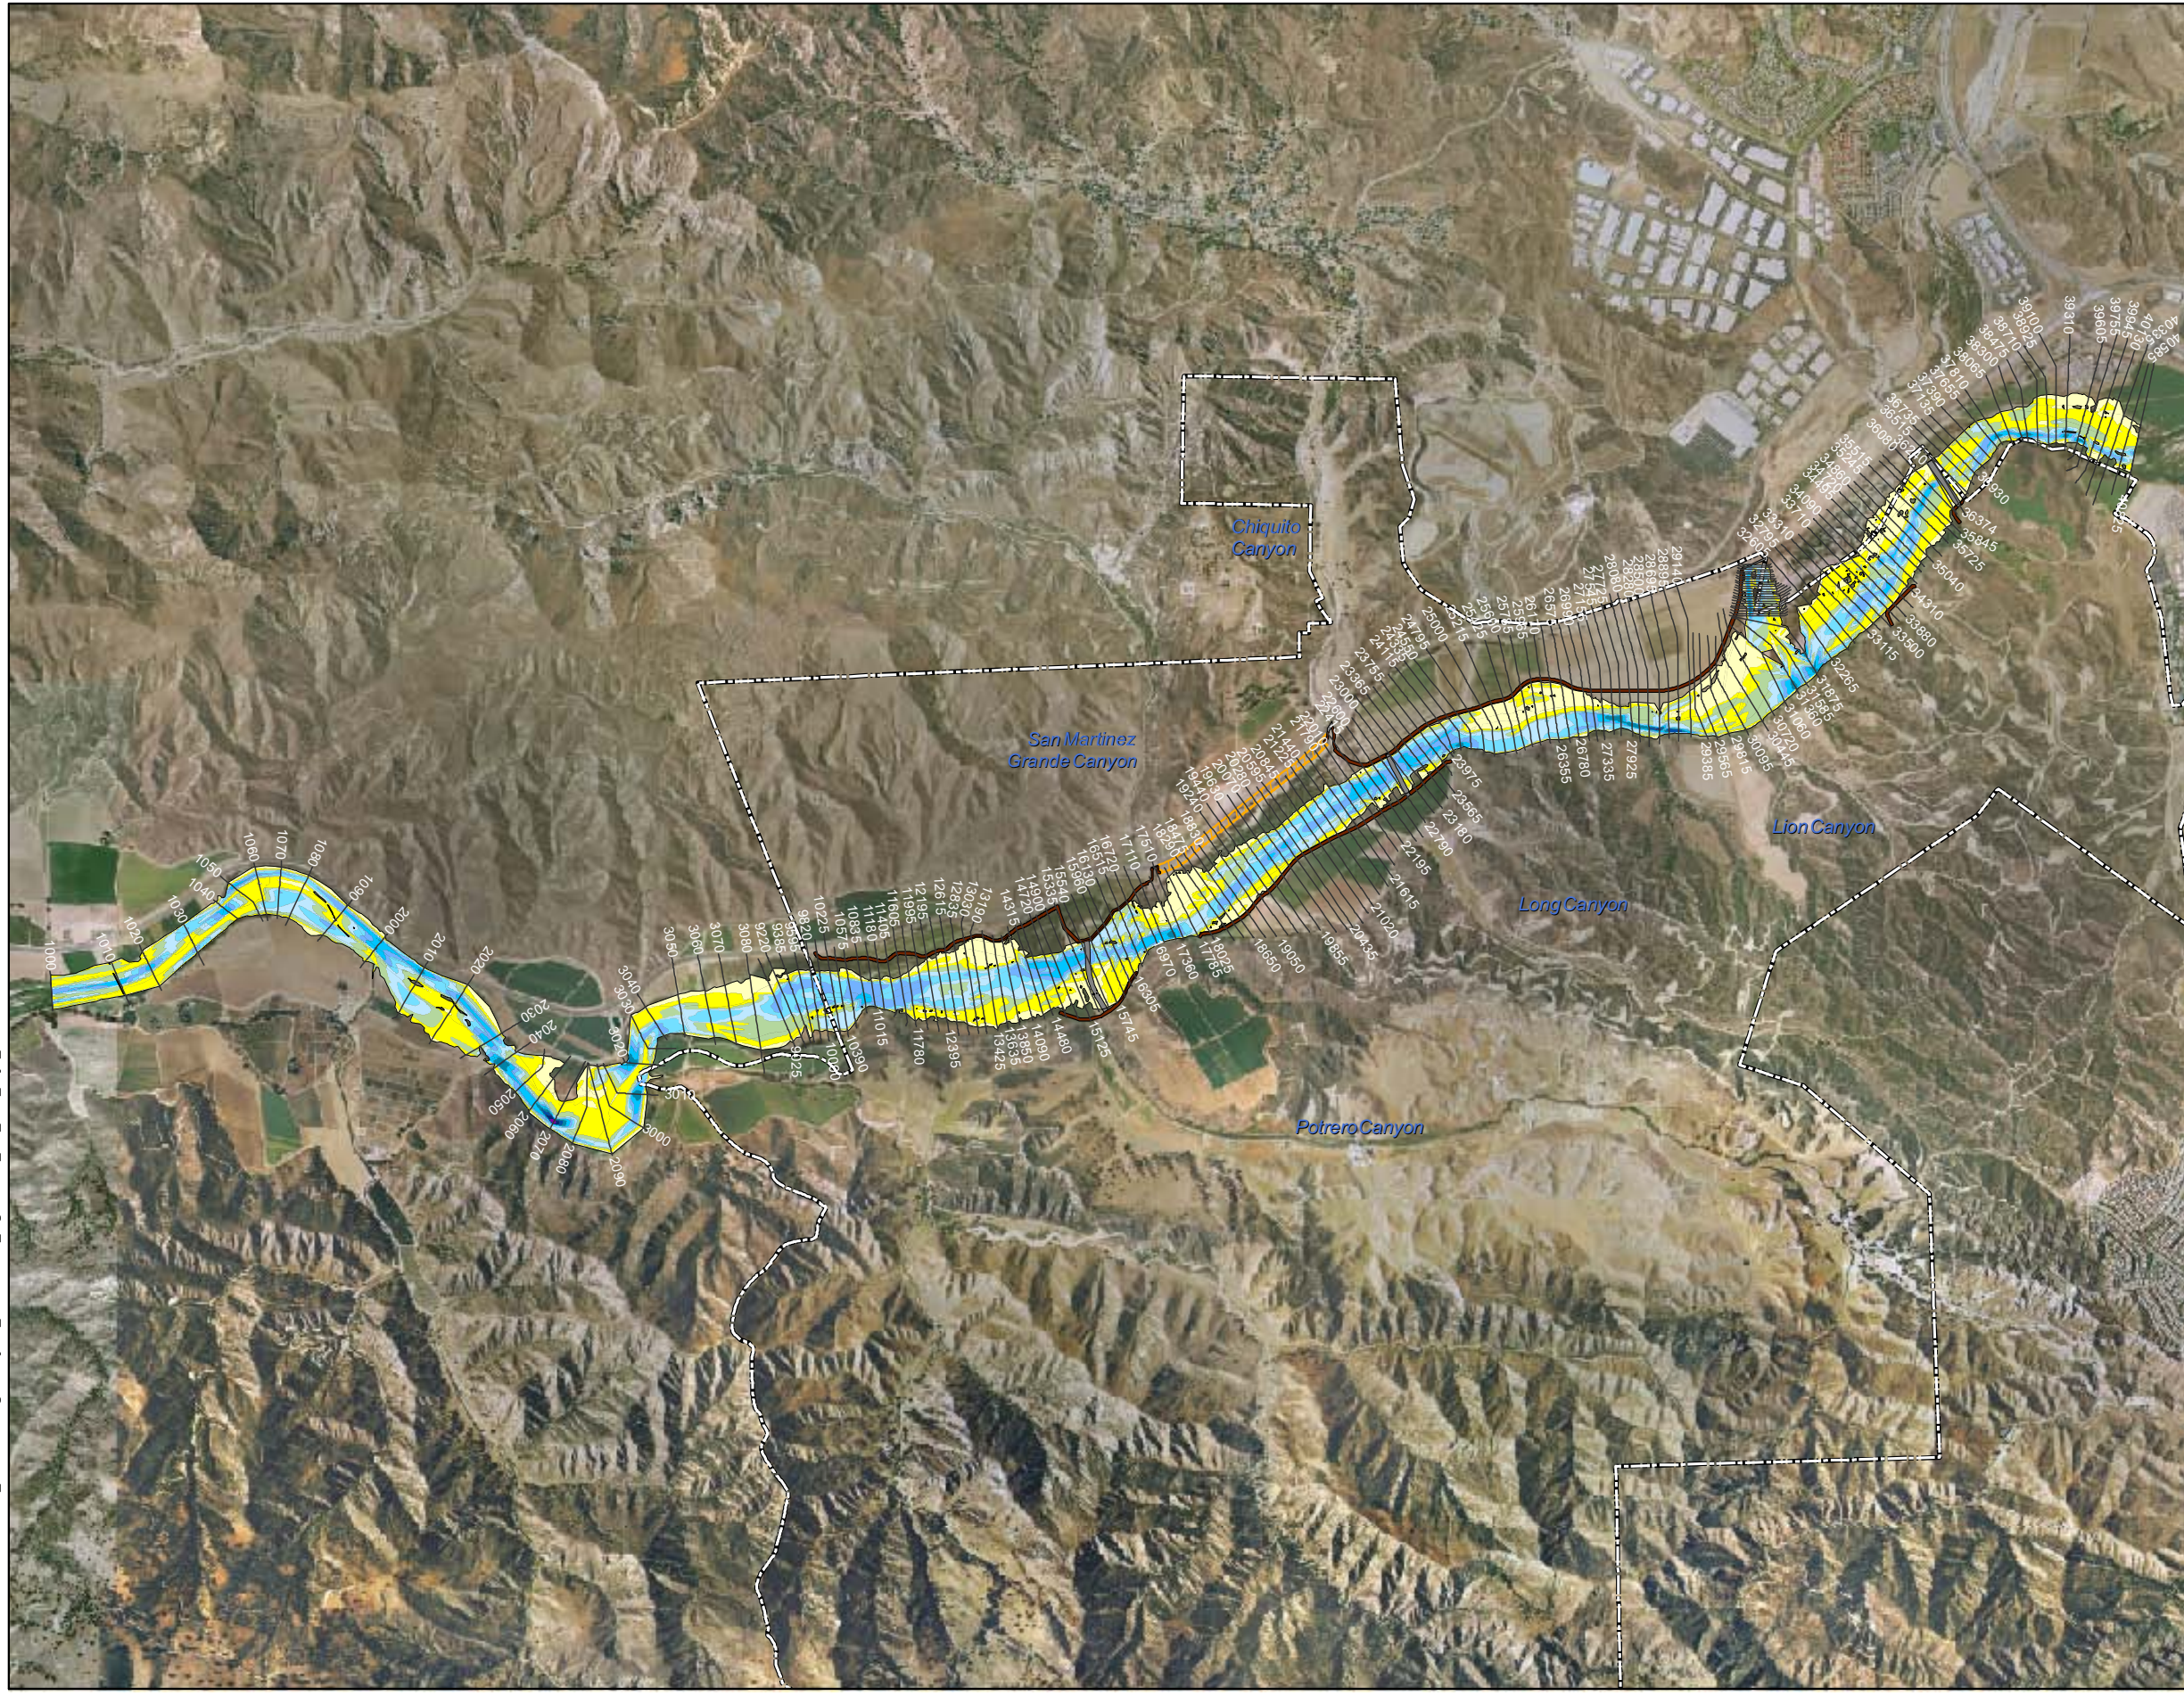
Figure 5.2f
ALTERNATIVE 2
50 YEAR FLOOD EVENT VELOCITY
SANTA CLARA RIVER

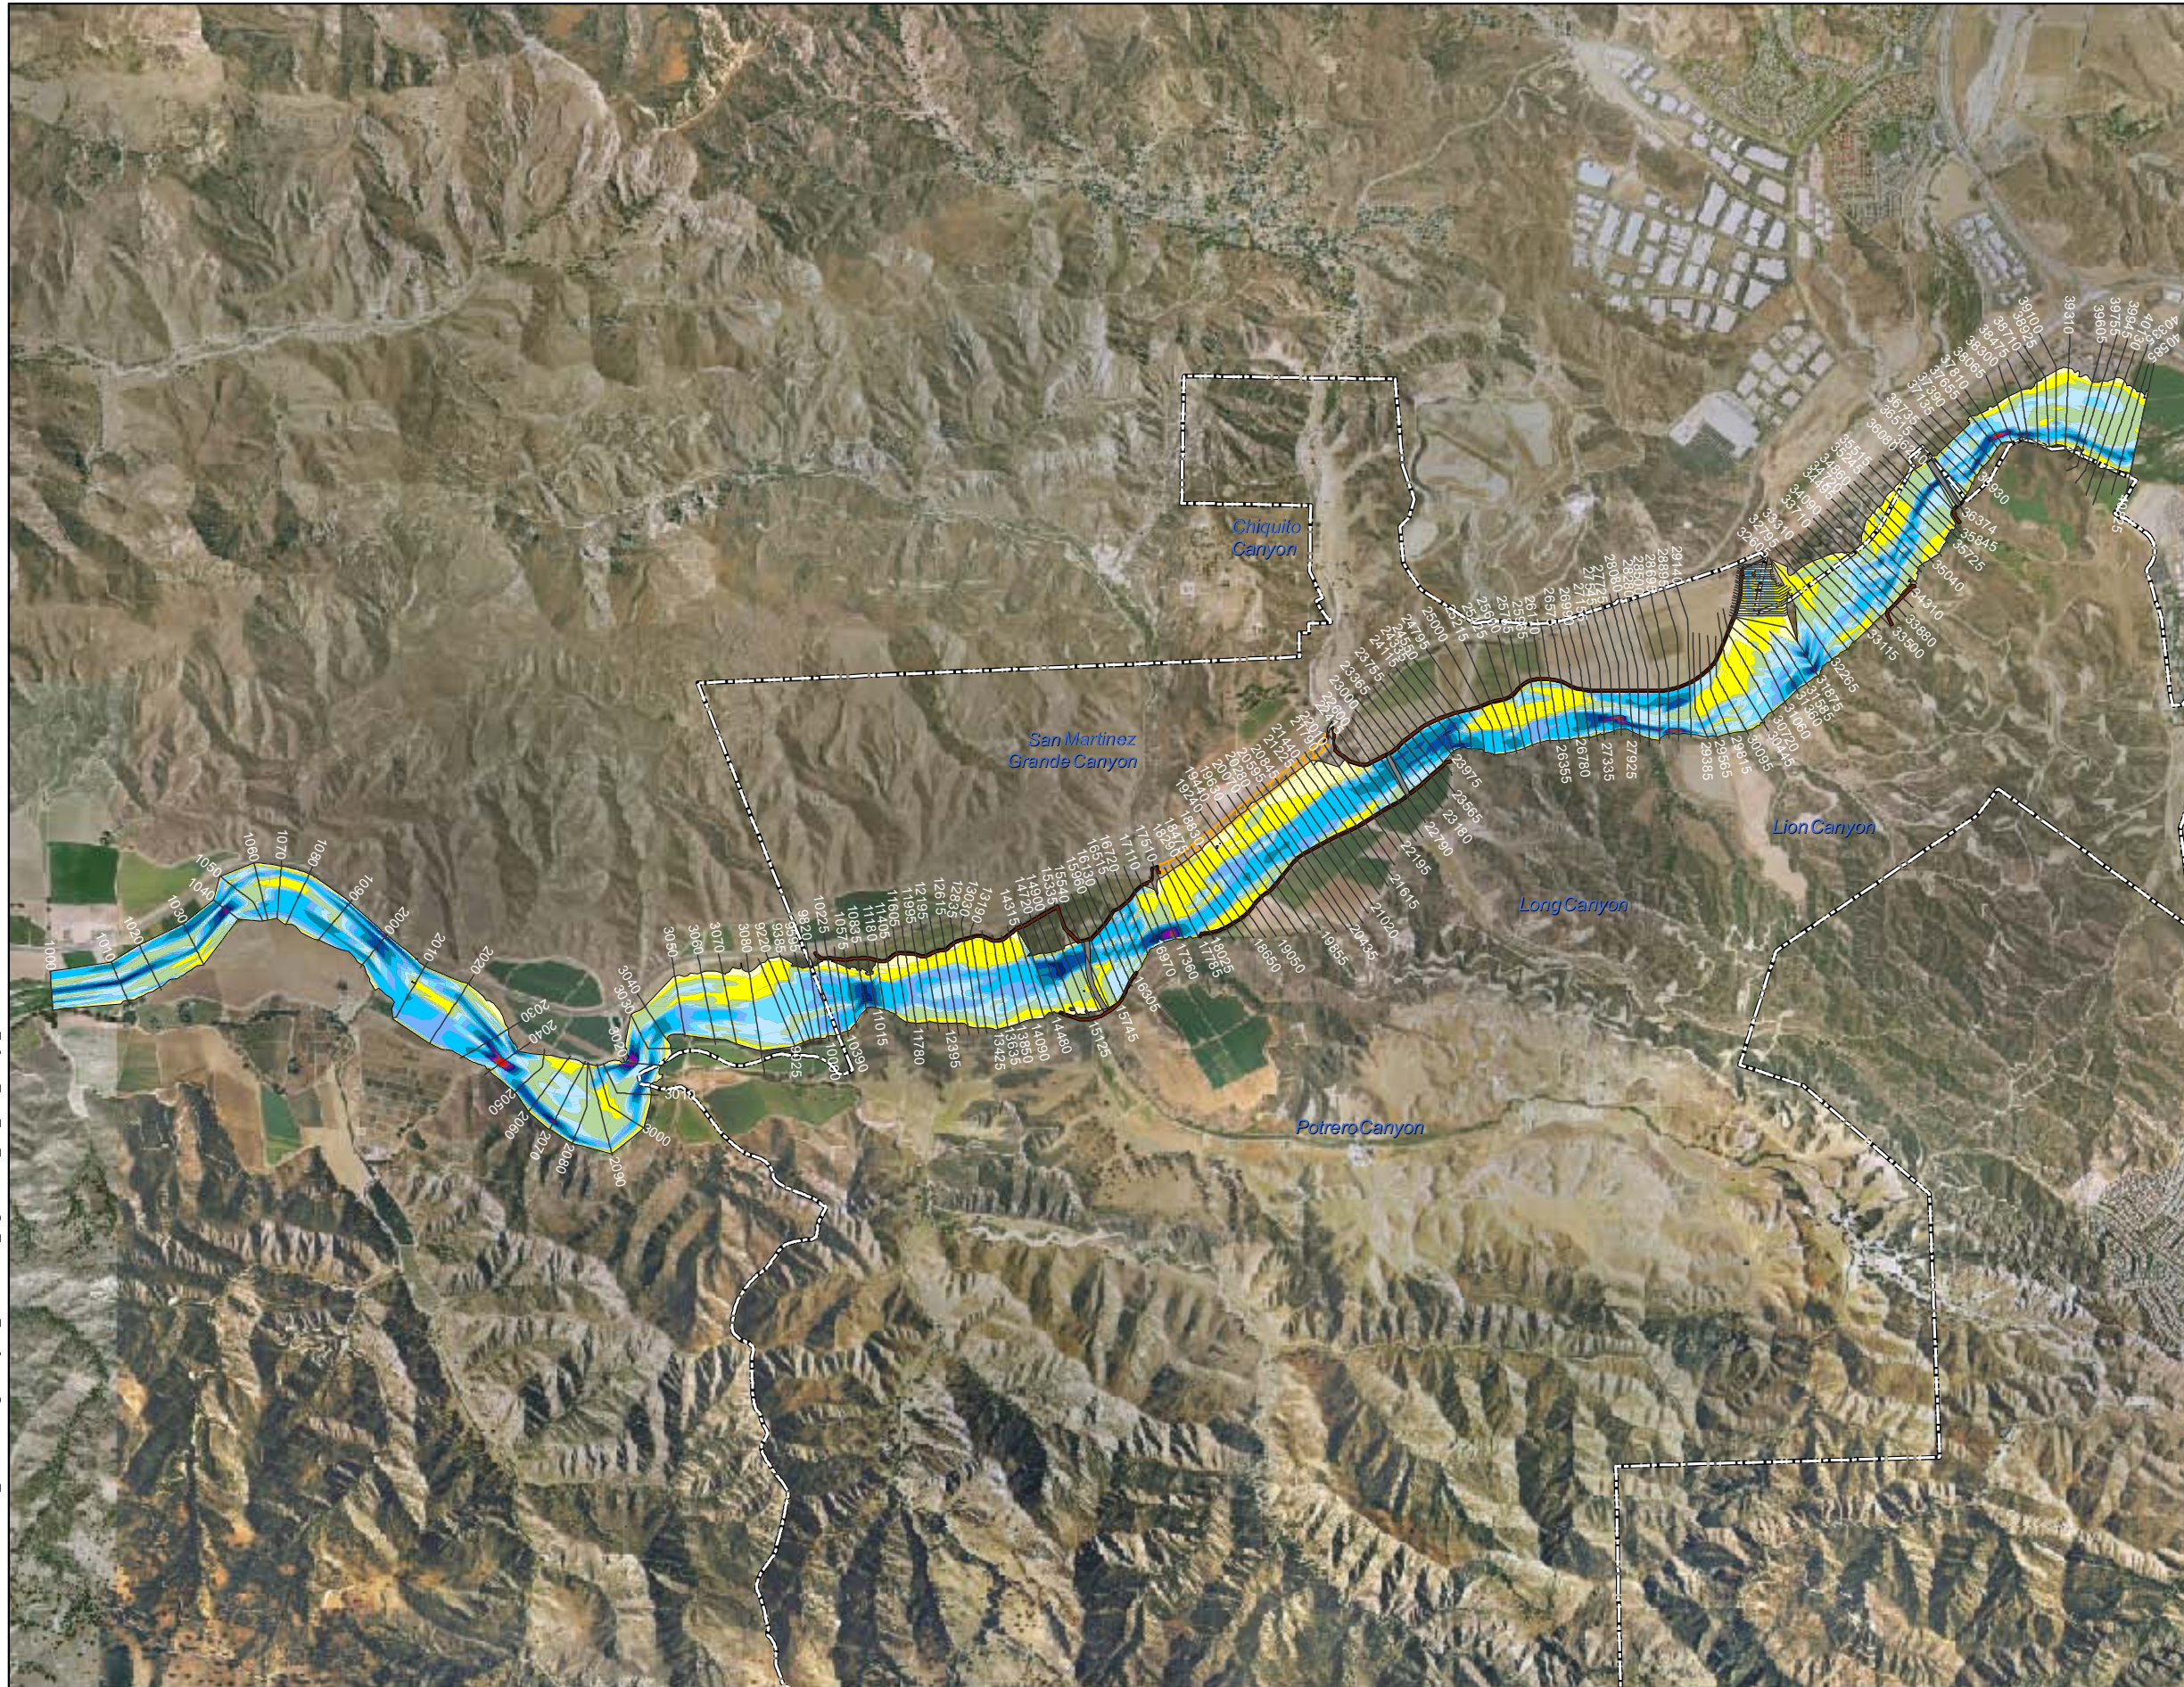
Figure 5.2h
ALTERNATIVE 2
CAPITAL FLOOD EVENT VELOCITY
SANTA CLARA RIVER

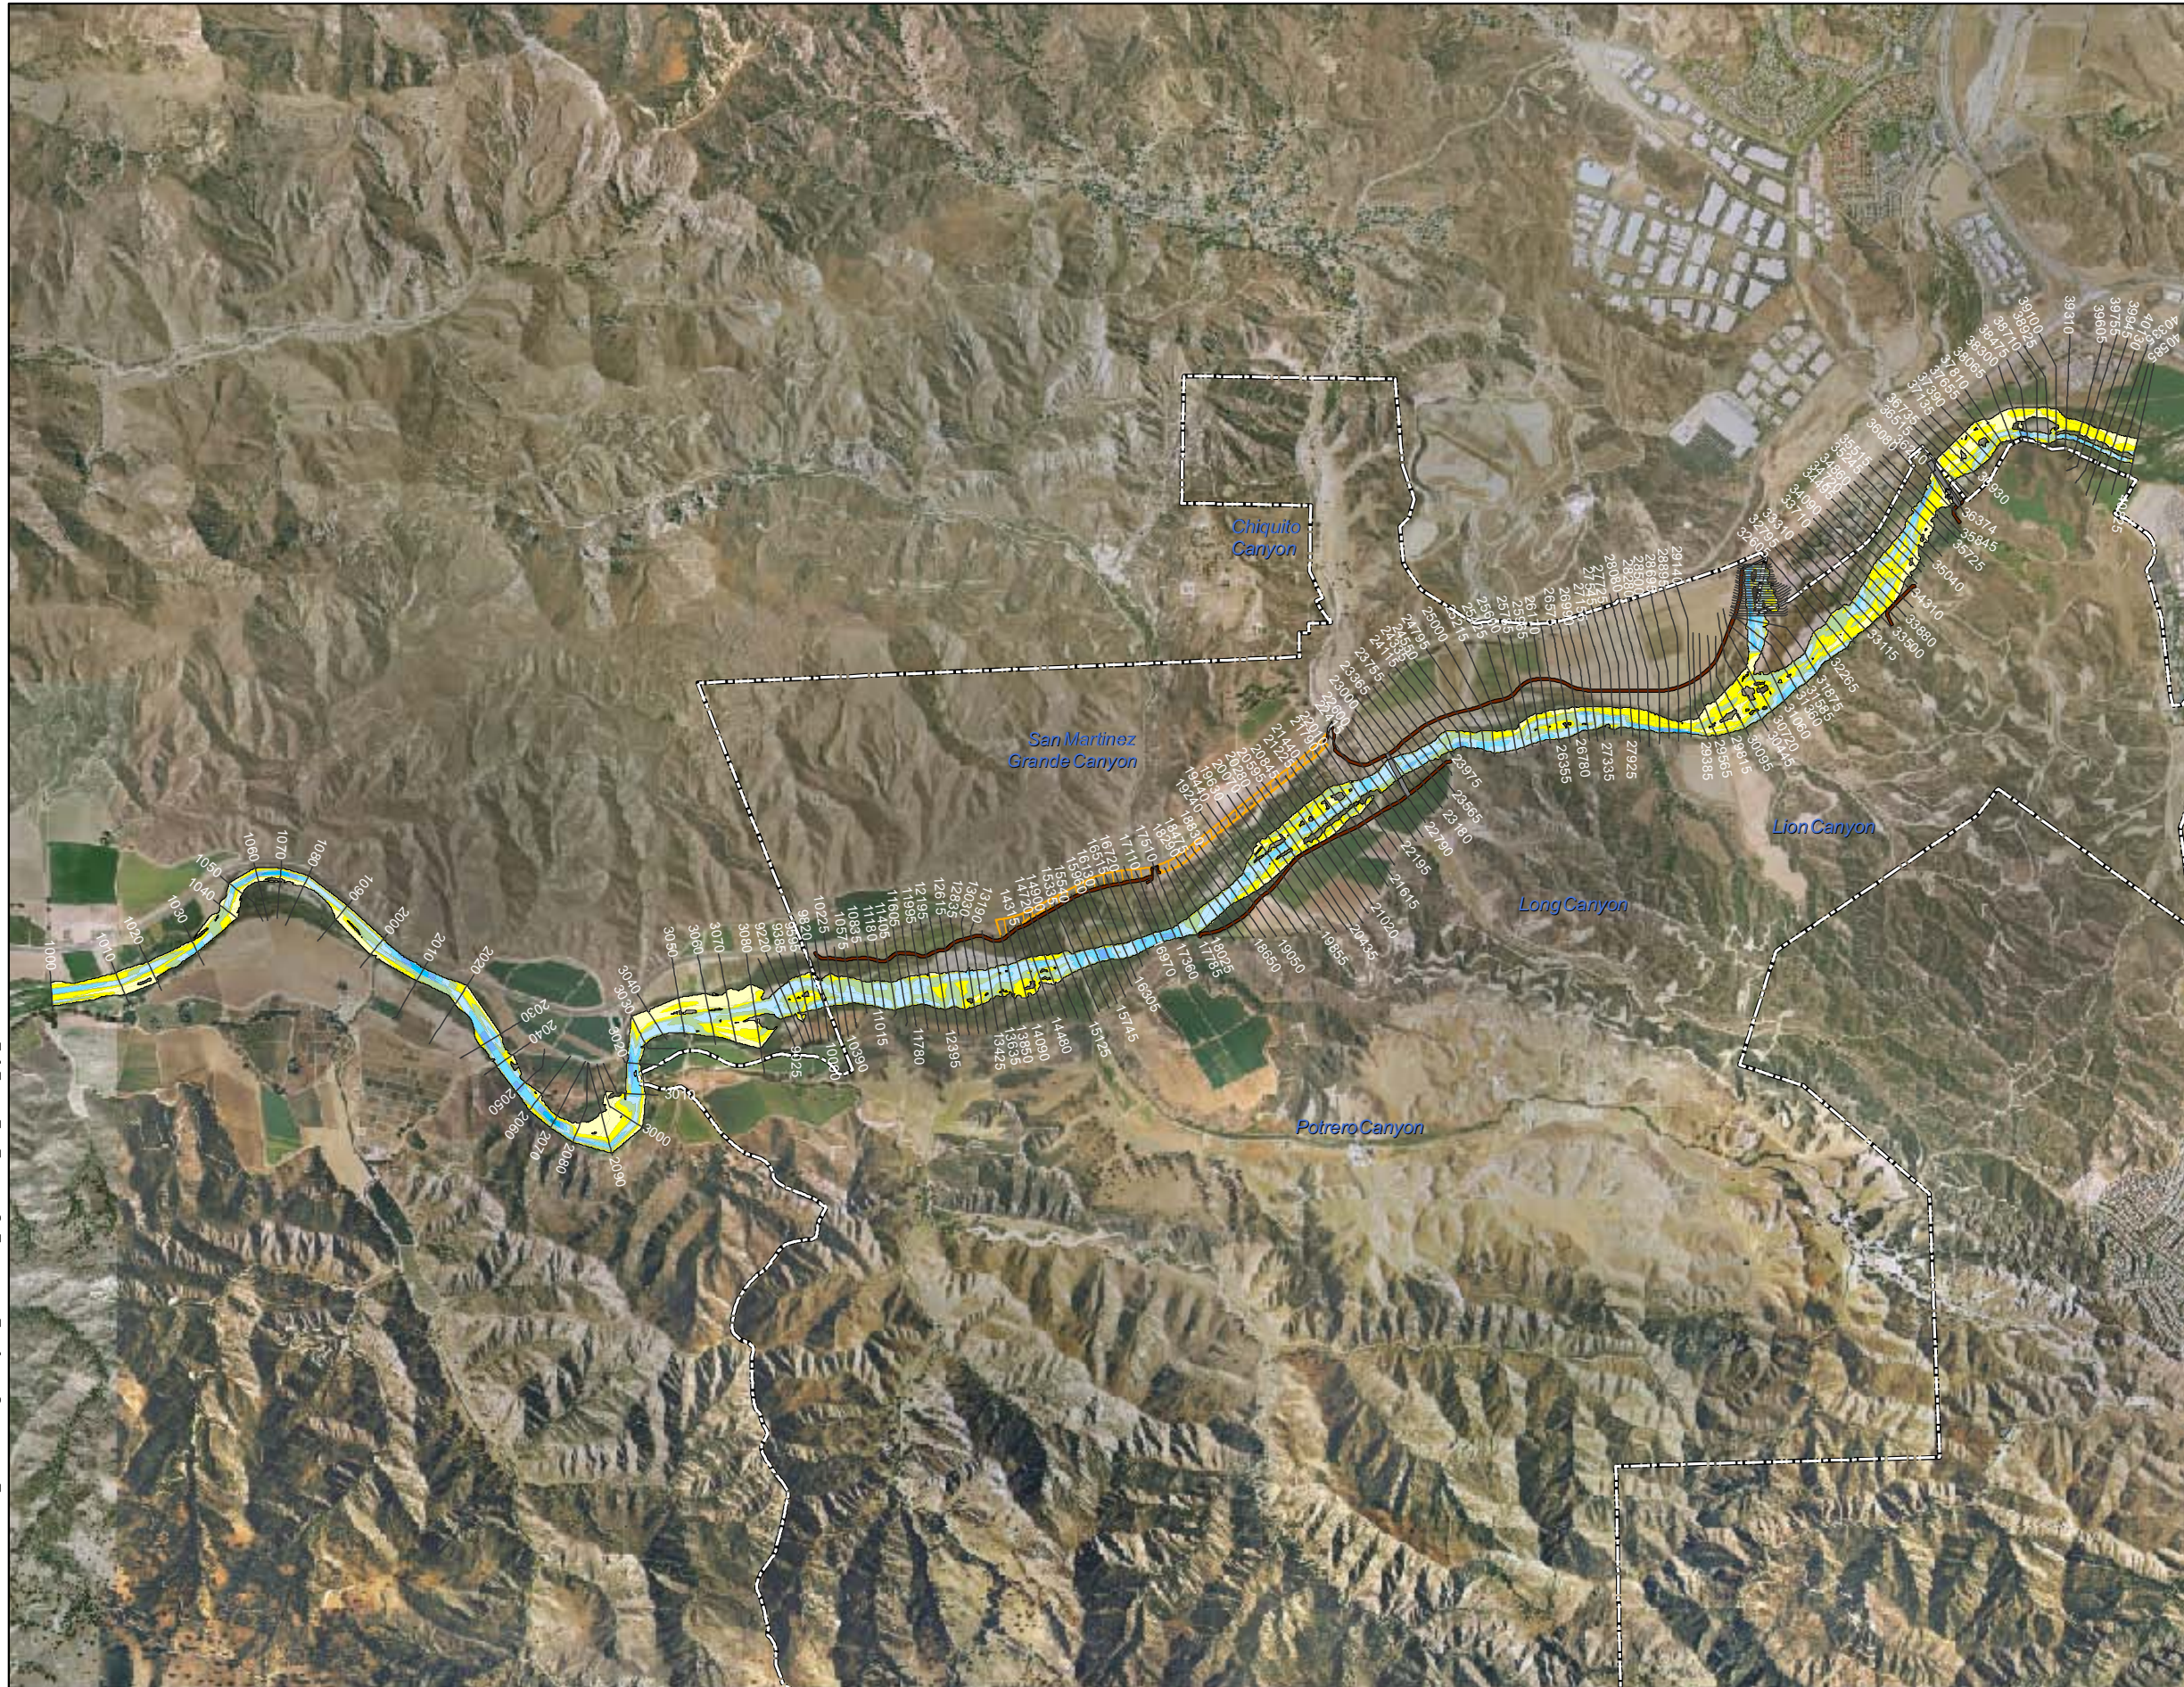
Figure 5.3c
ALTERNATIVE 3 & 4
5 YEAR FLOOD EVENT VELOCITY
SANTA CLARA RIVER

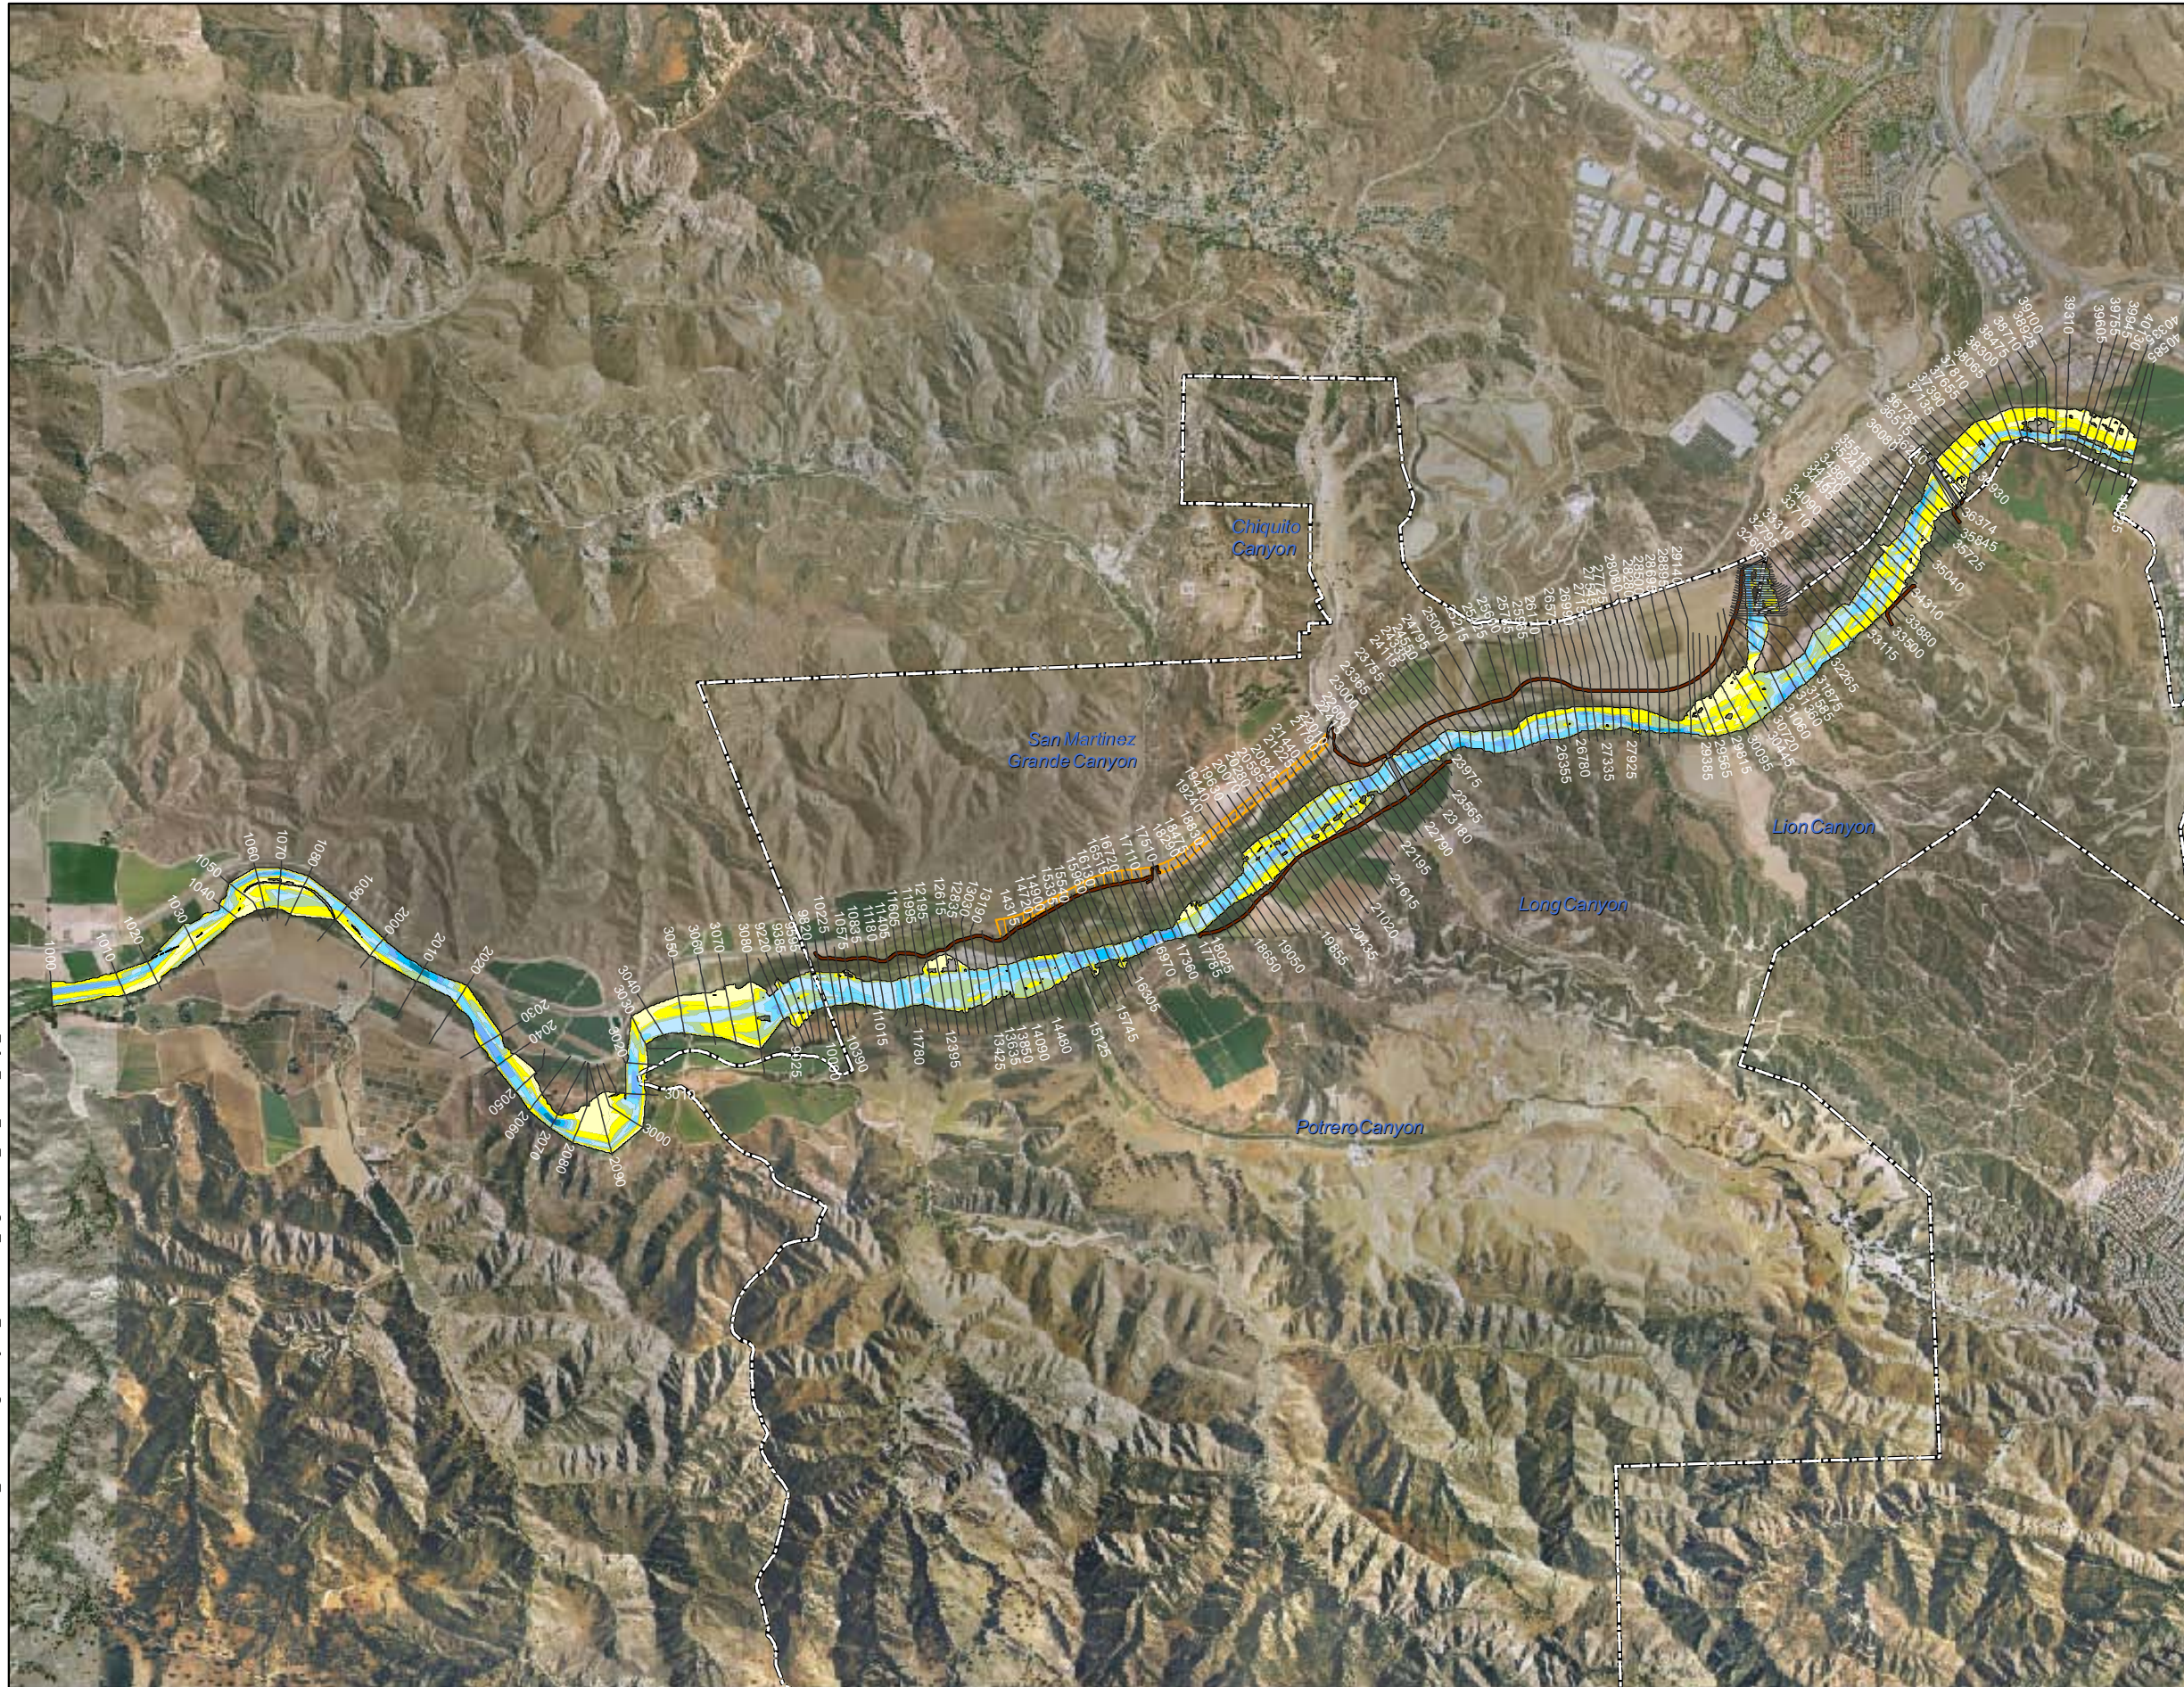
Figure 5.3d
ALTERNATIVE 3 & 4
10 YEAR FLOOD EVENT VELOCITY
SANTA CLARA RIVER

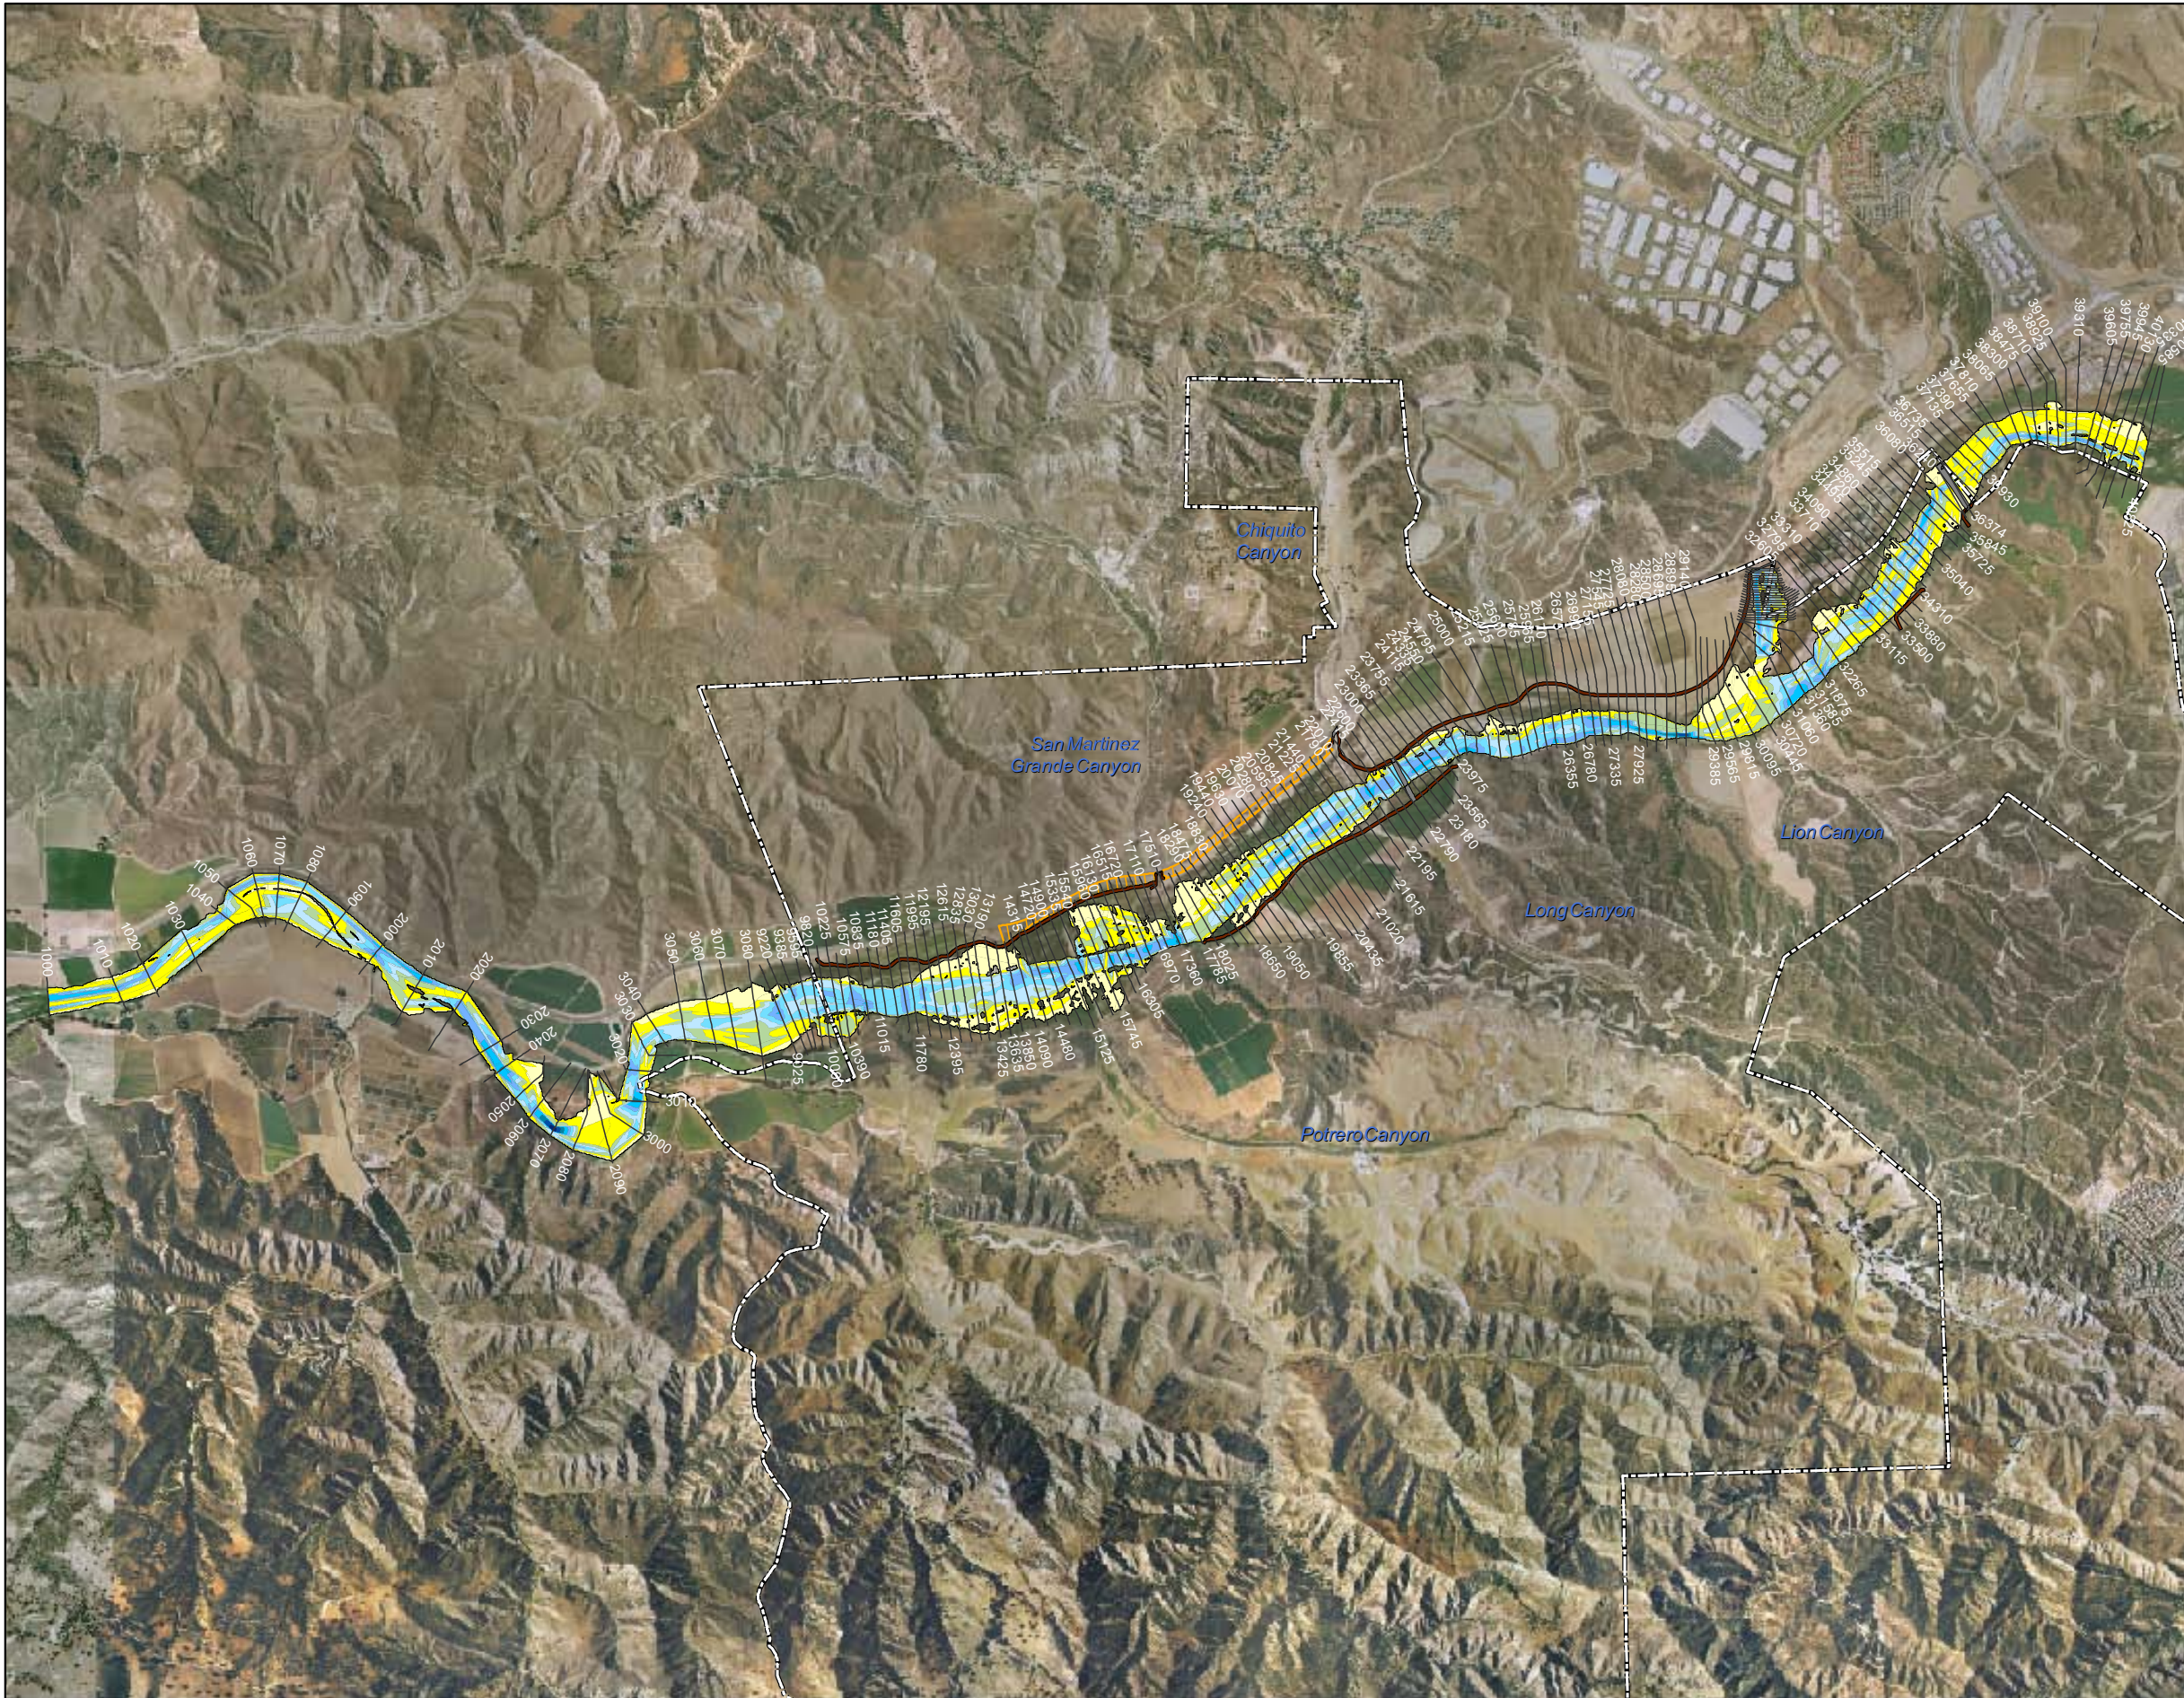
ALTERNATIVE 3 & 4
20 YEAR FLOOD EVENT VELOCITY
SANTA CLARA RIVER

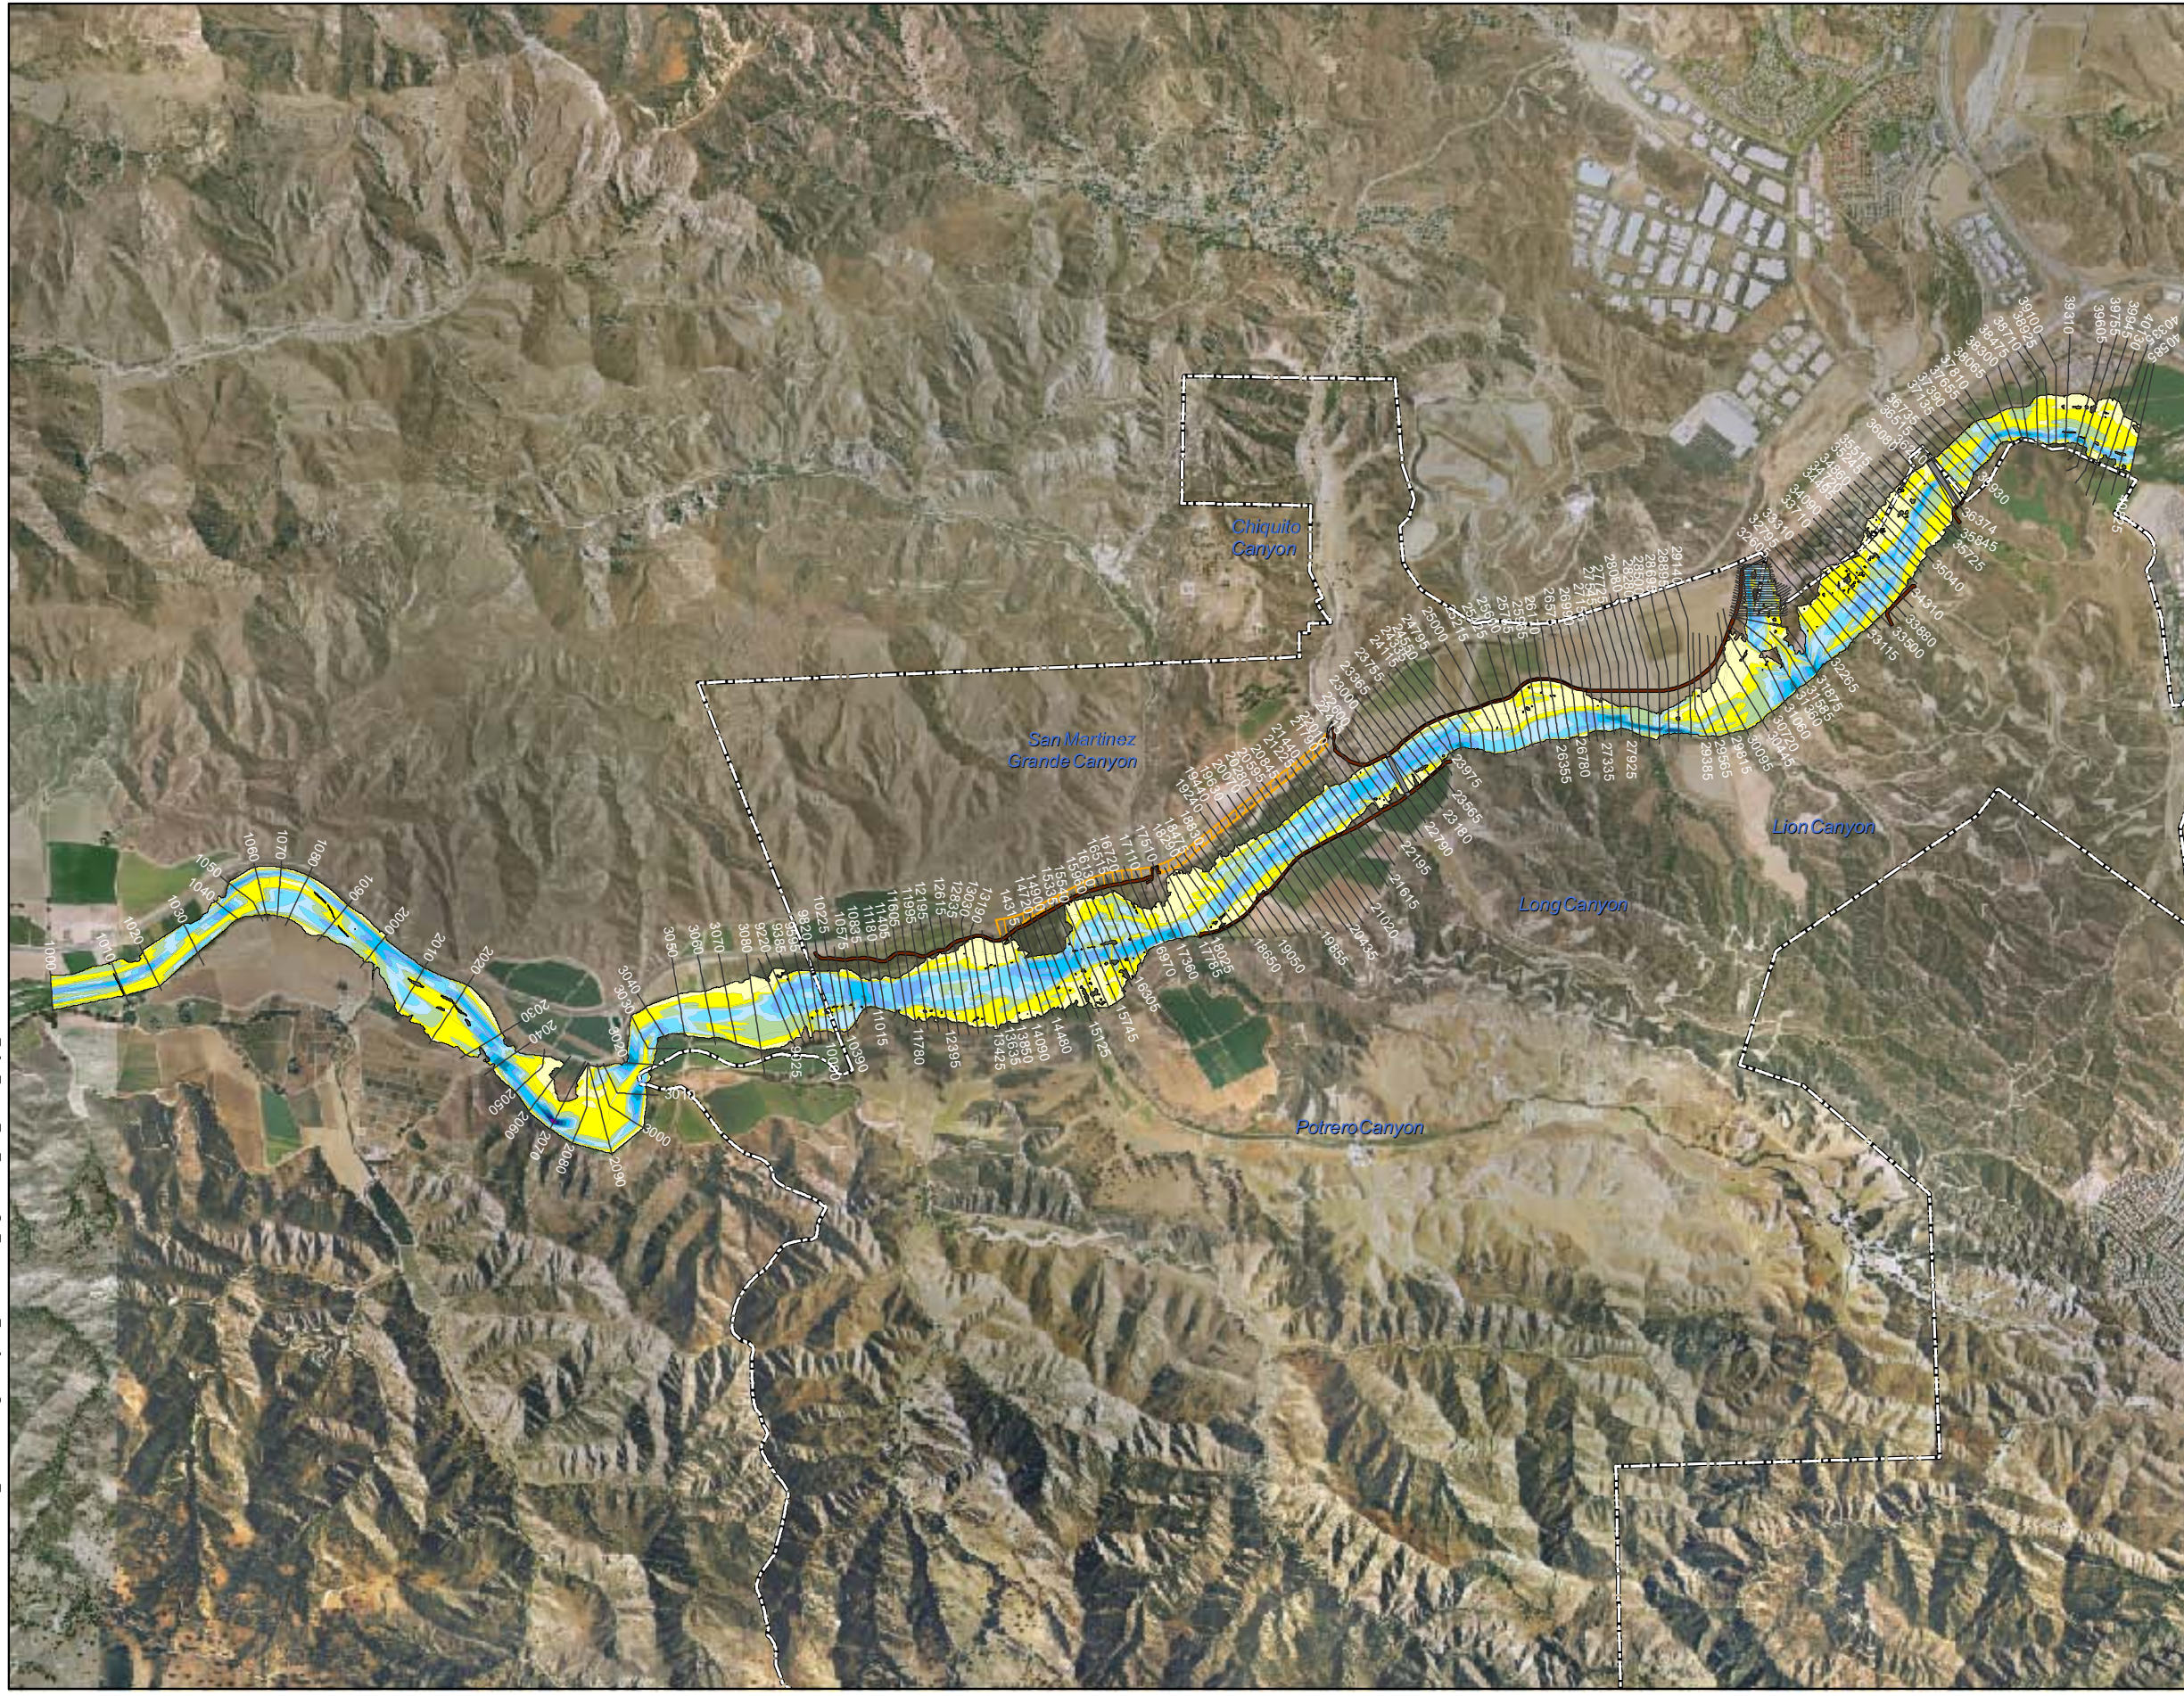
Figure 5.3f
ALTERNATIVE 3 & 4
50 YEAR FLOOD EVENT VELOCITY
SANTA CLARA RIVER
