**REVISED FOCUSED SPECIAL STATUS FISH SPECIES
HABITAT ASSESSMENT AND IMPACT ANALYSIS
SANTA CLARA RIVER AND TRIBUTARY
DRAINAGES WITHIN NEWHALL RANCH**

**NEWHALL RANCH
RESOURCE MANAGEMENT & DEVELOPMENT PLAN
LOS ANGELES COUNTY, CALIFORNIA**

Project No. 3109006

**JUNE 2010
~~February 23, 2009~~**

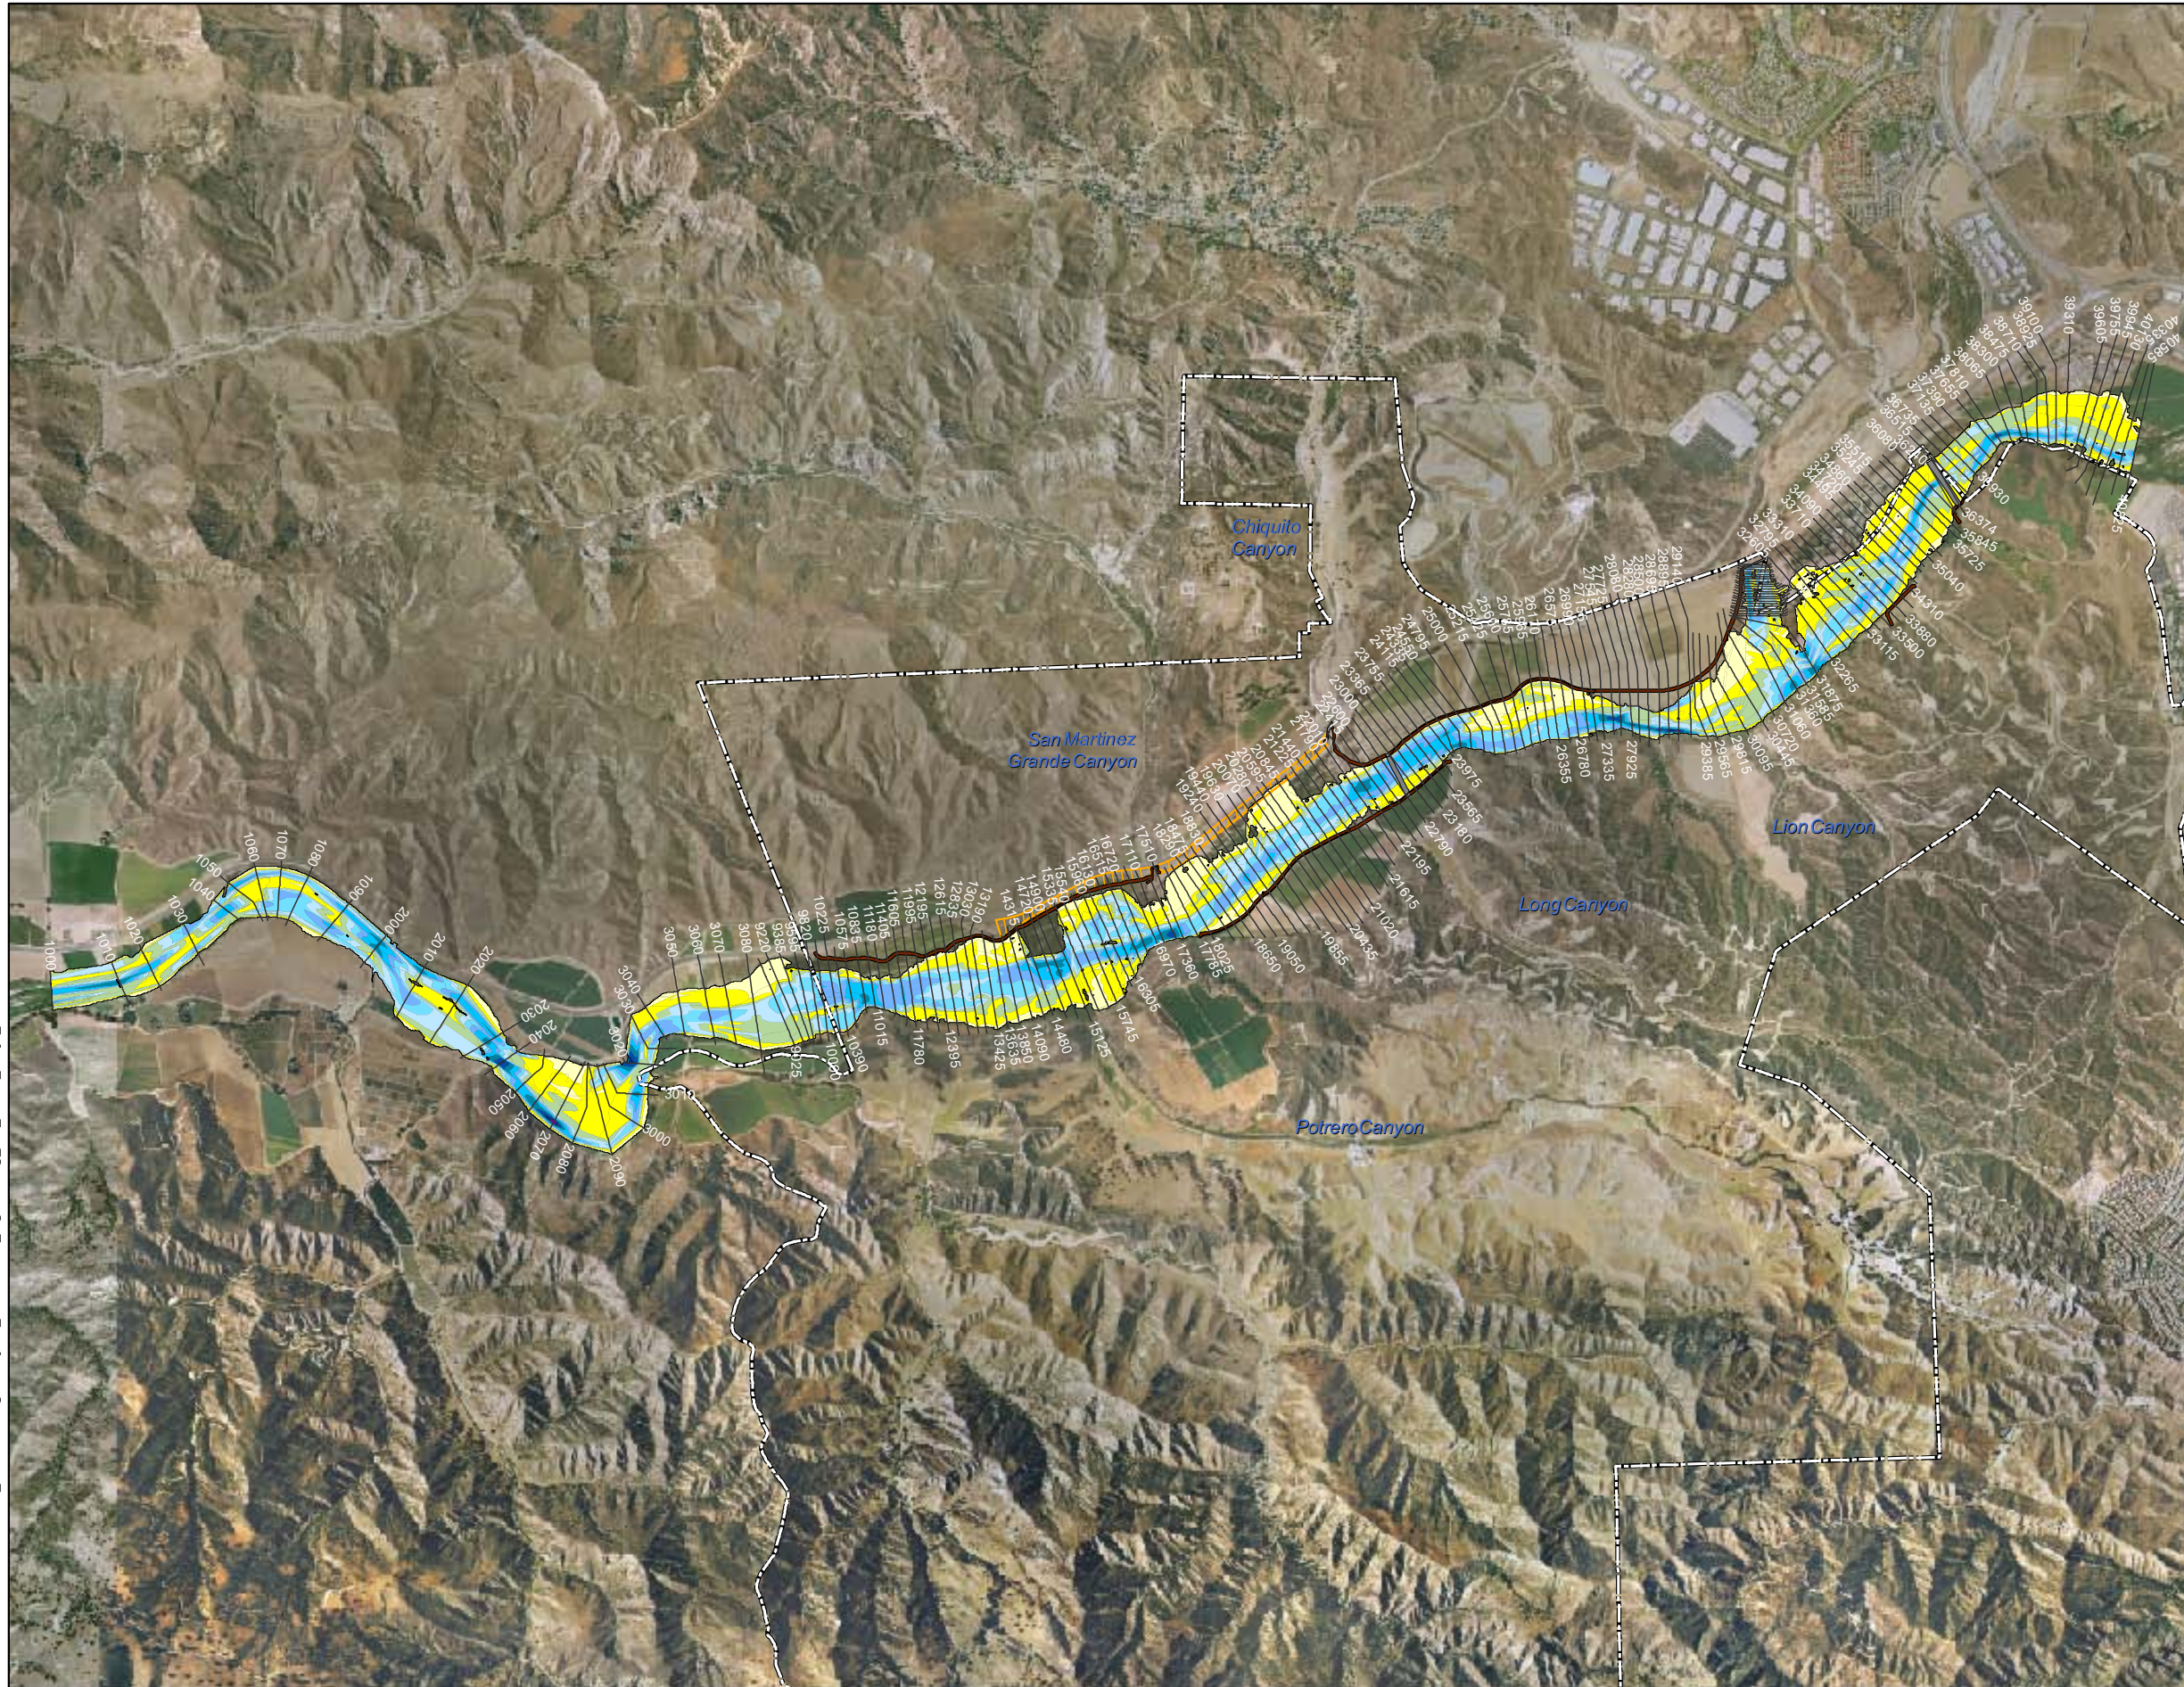
Figure 5.3g
ALTERNATIVE 3 & 4
100 YEAR FLOOD EVENT VELOCITY
SANTA CLARA RIVER

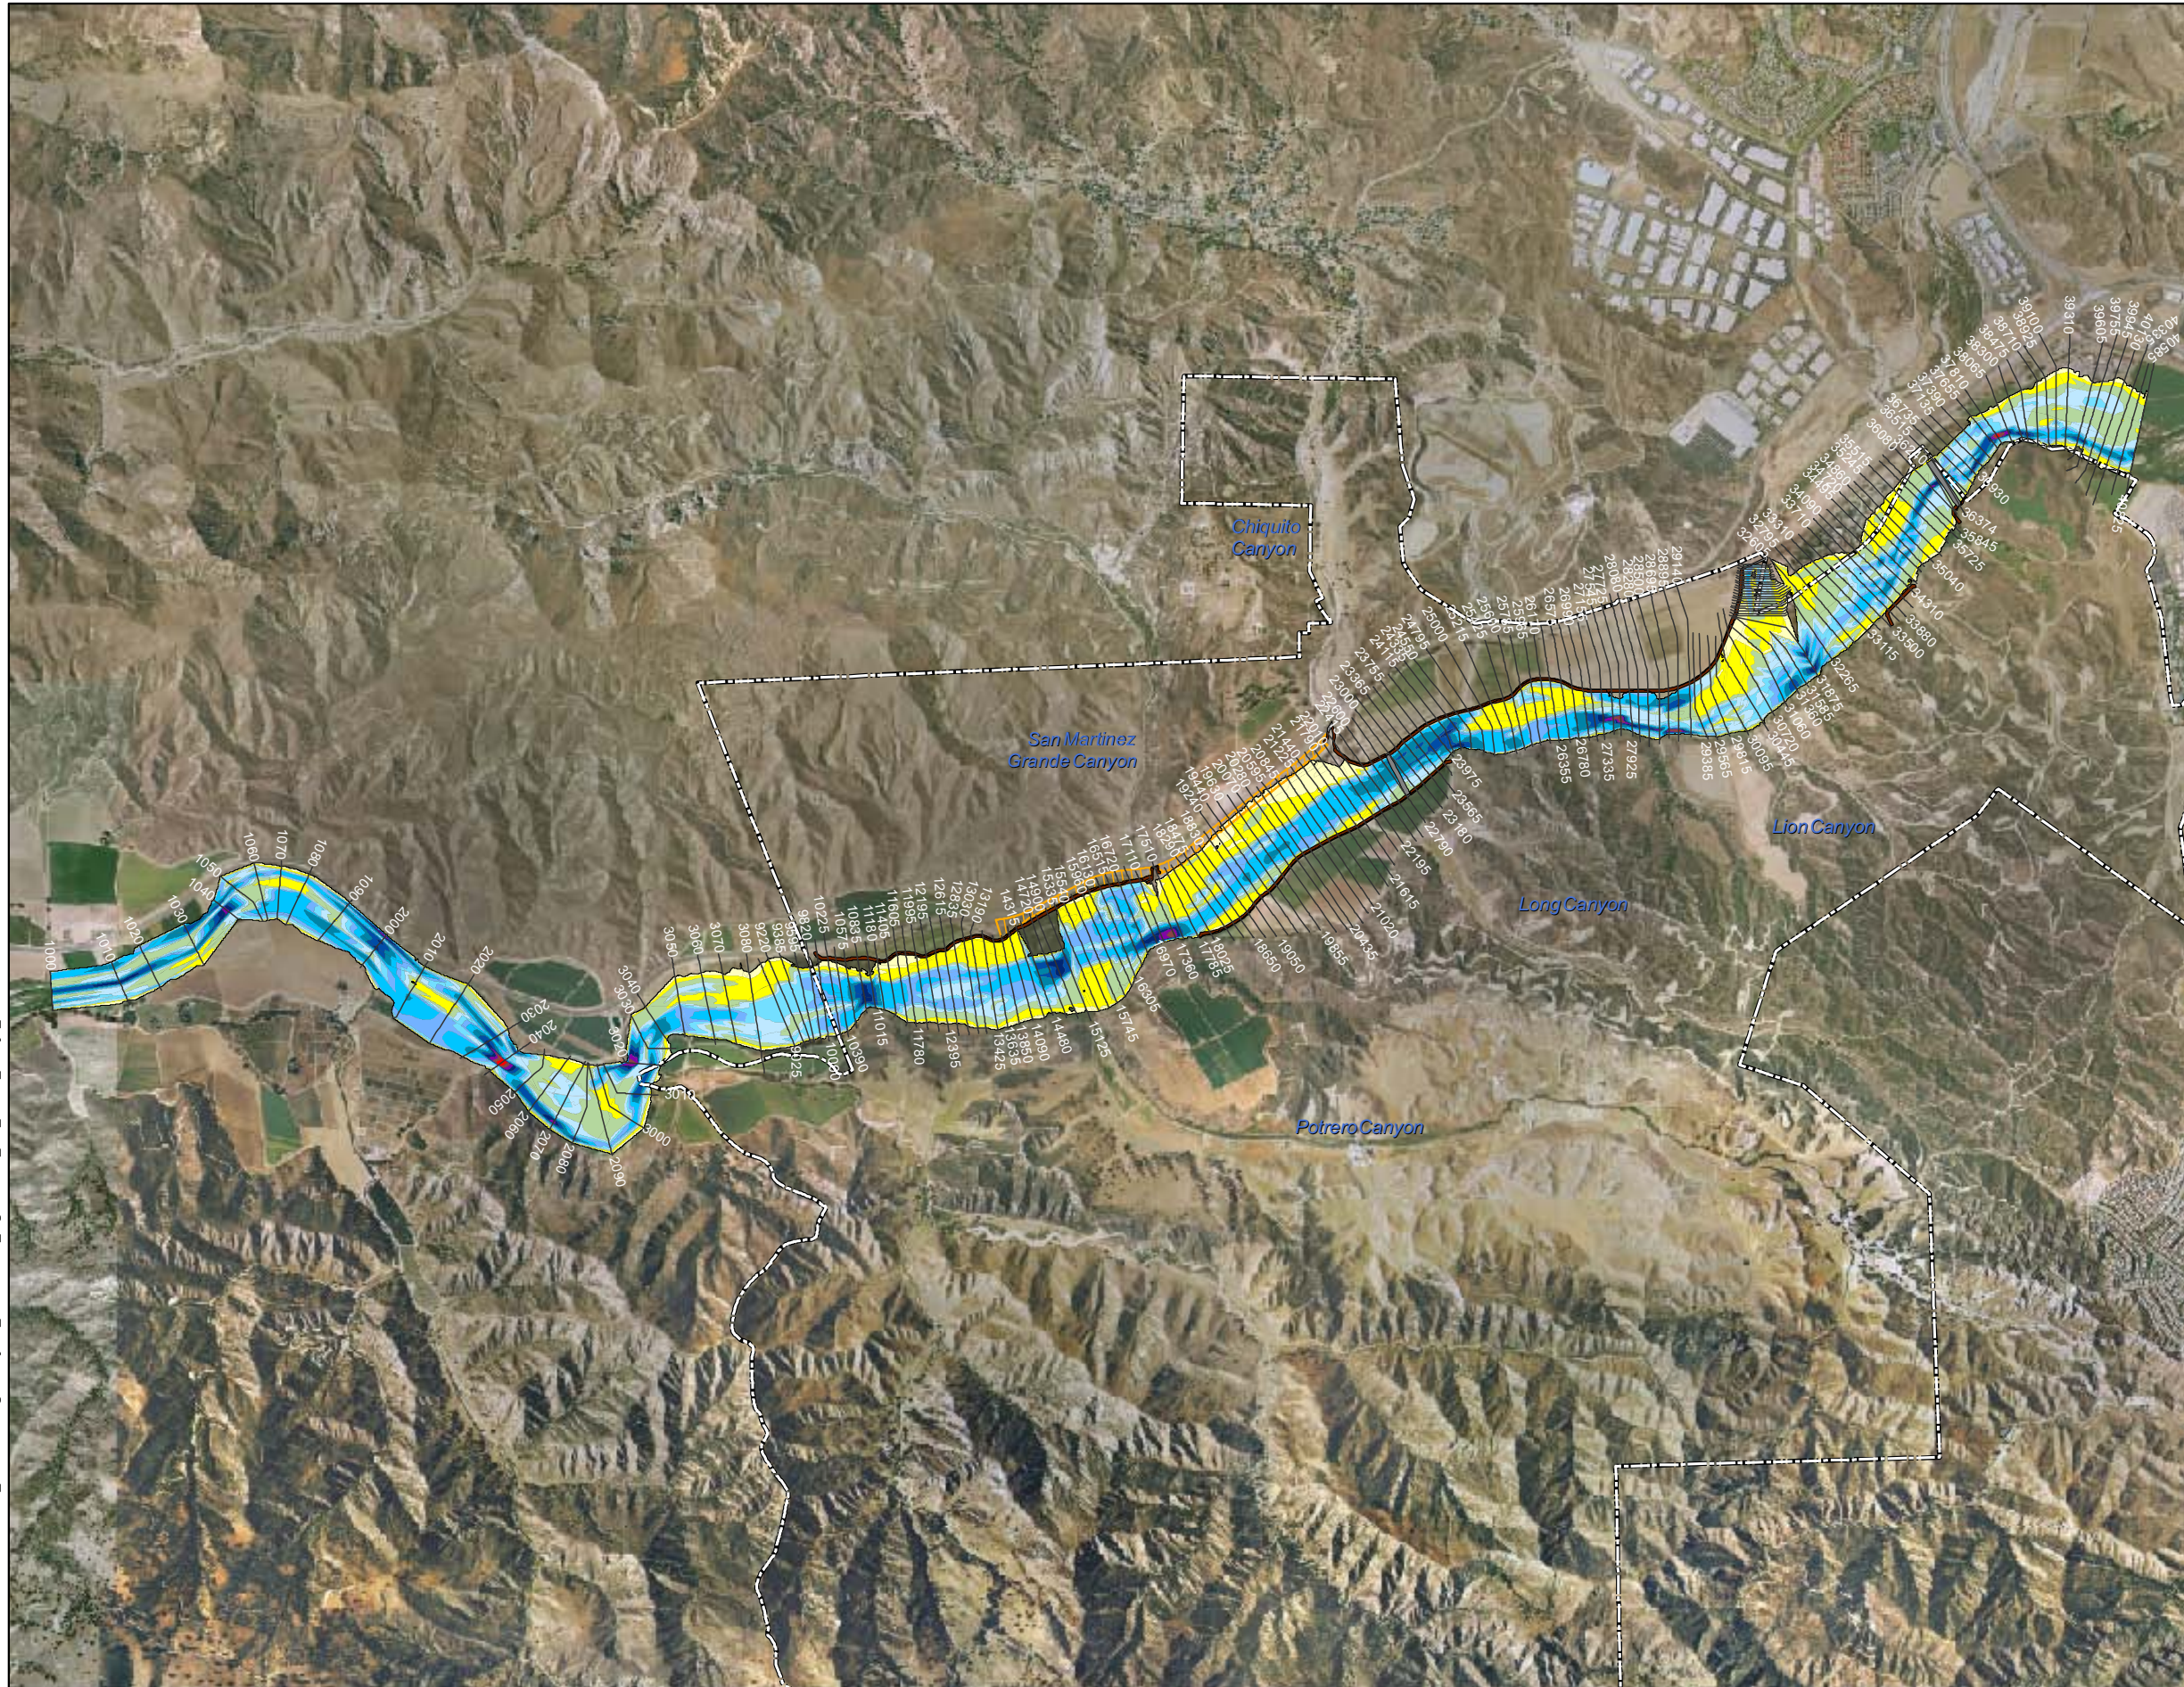
Figure 5.3h
ALTERNATIVE 3 & 4
CAPITAL FLOOD EVENT VELOCITY
SANTA CLARA RIVER

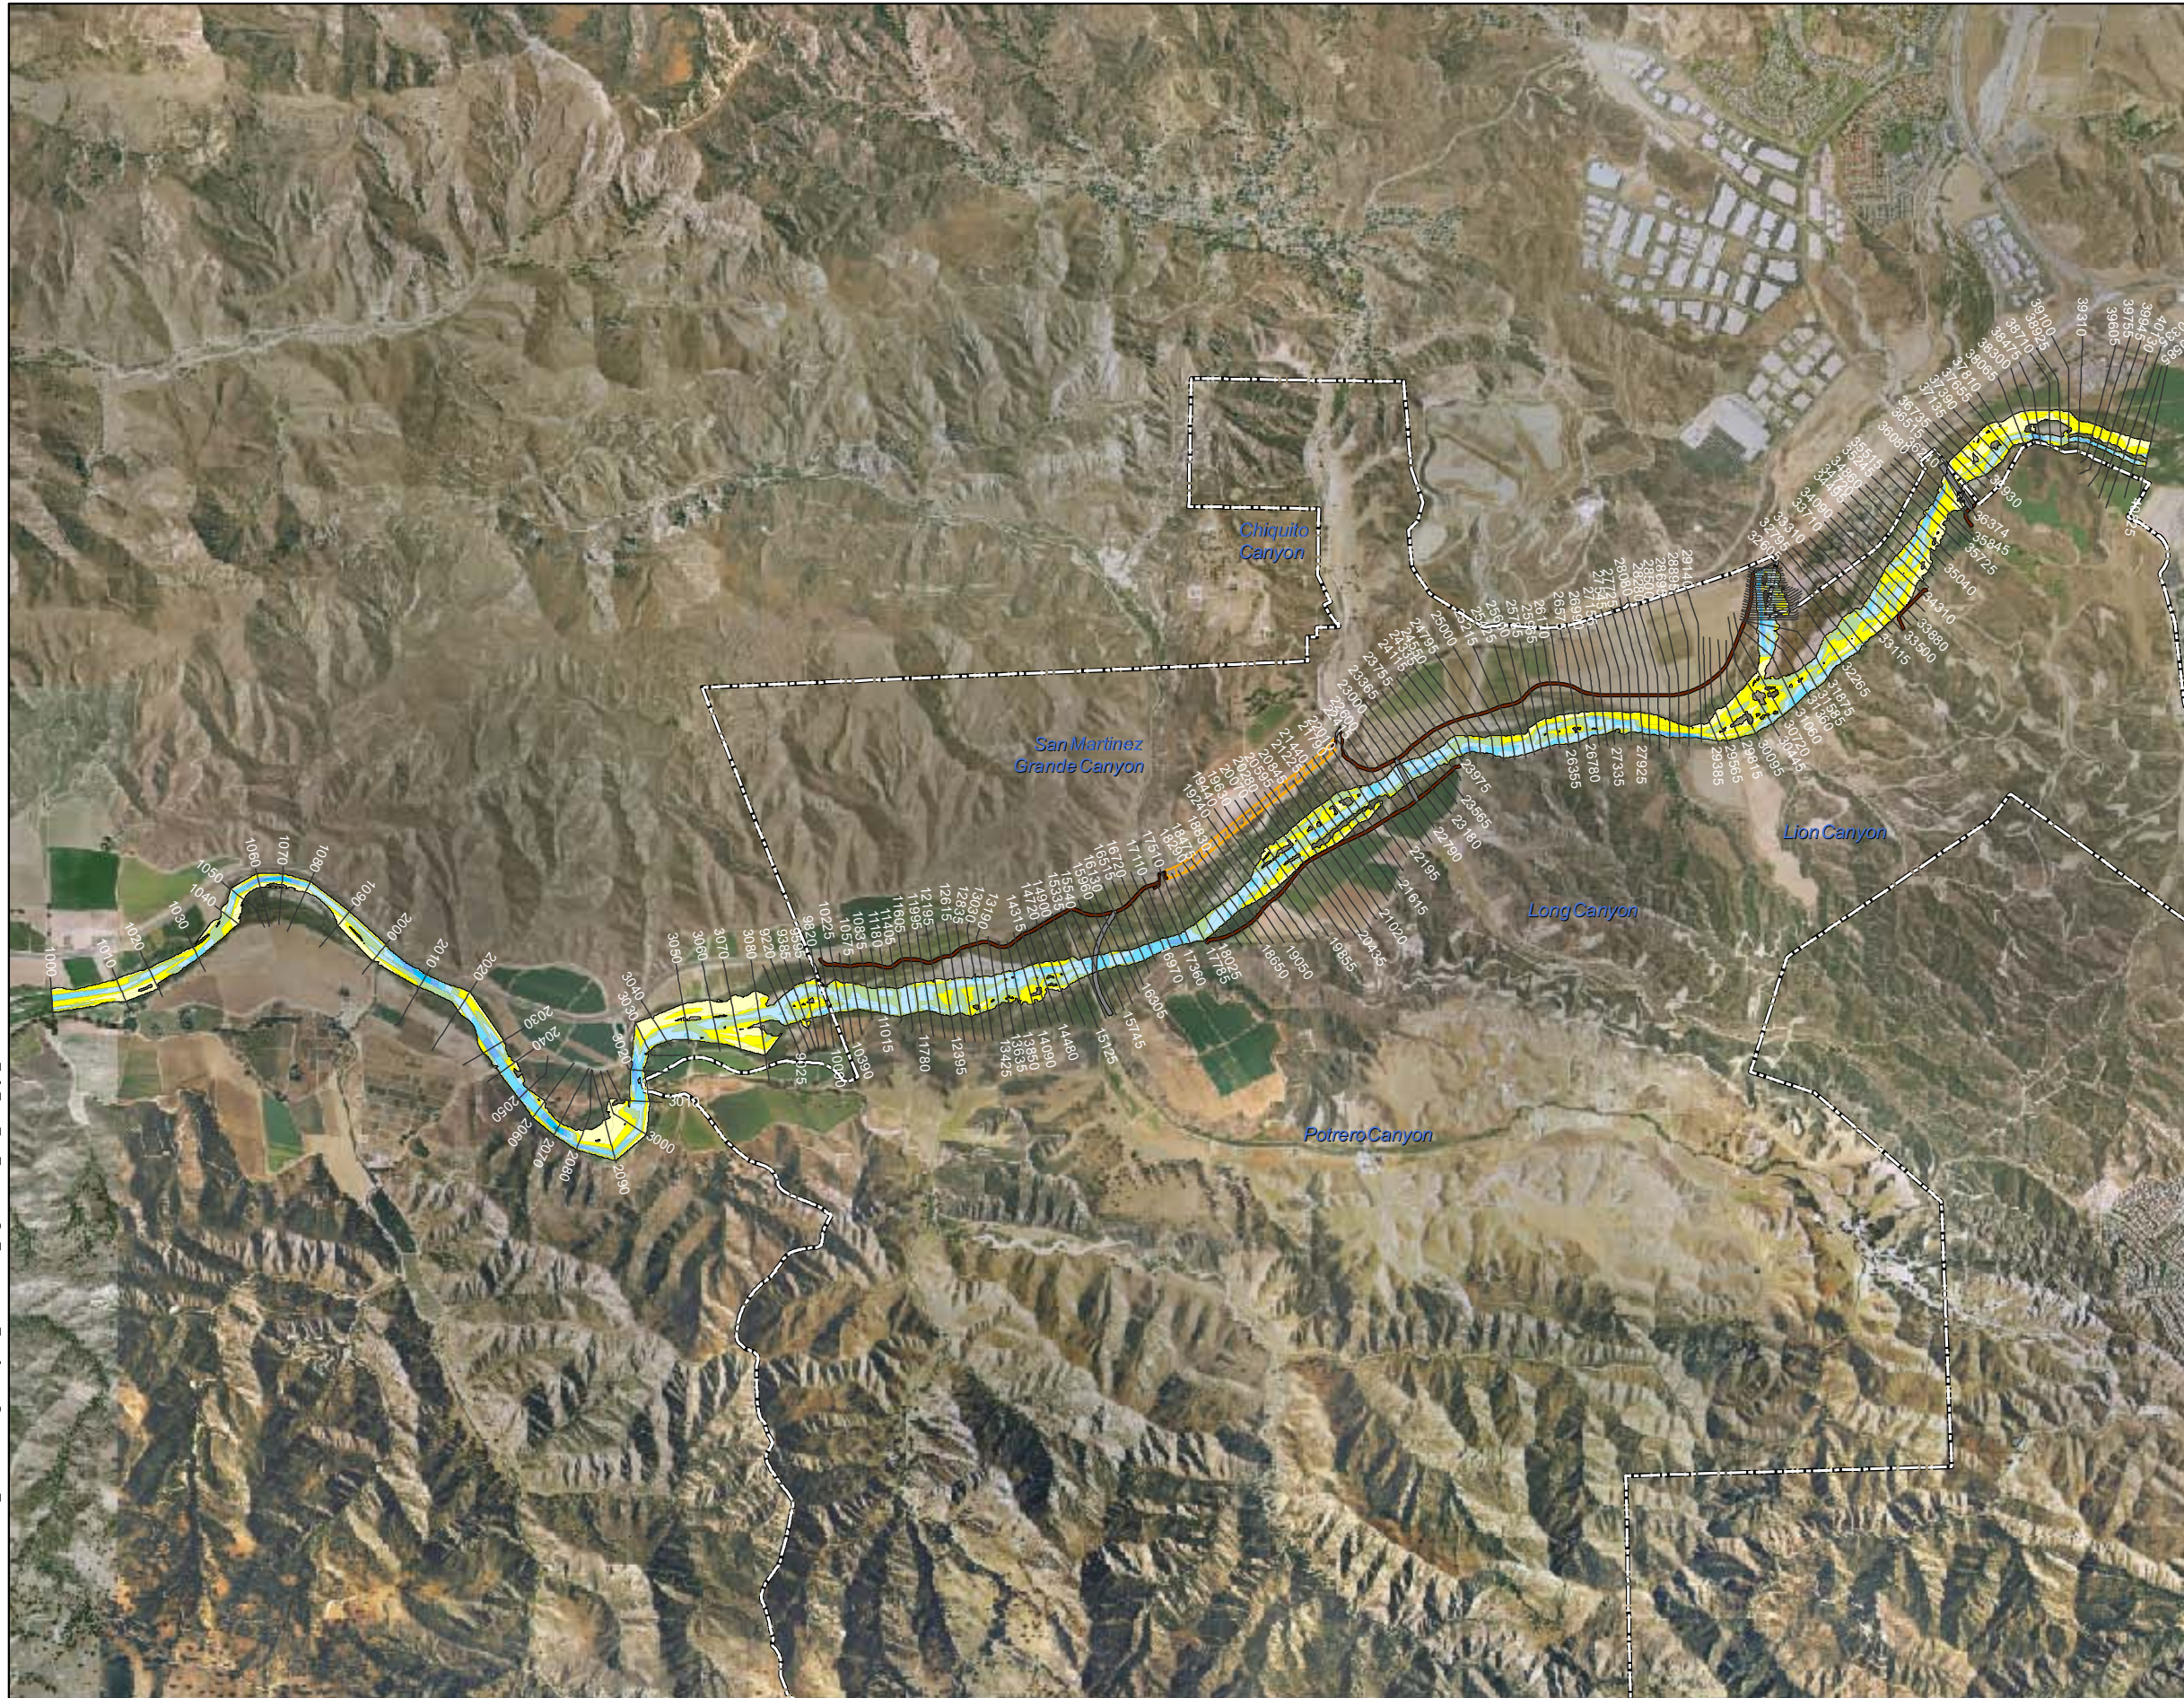
Figure 5.4c

ALTERNATIVE 5
5 YEAR FLOOD EVENT VELOCITY
SANTA CLARA RIVER

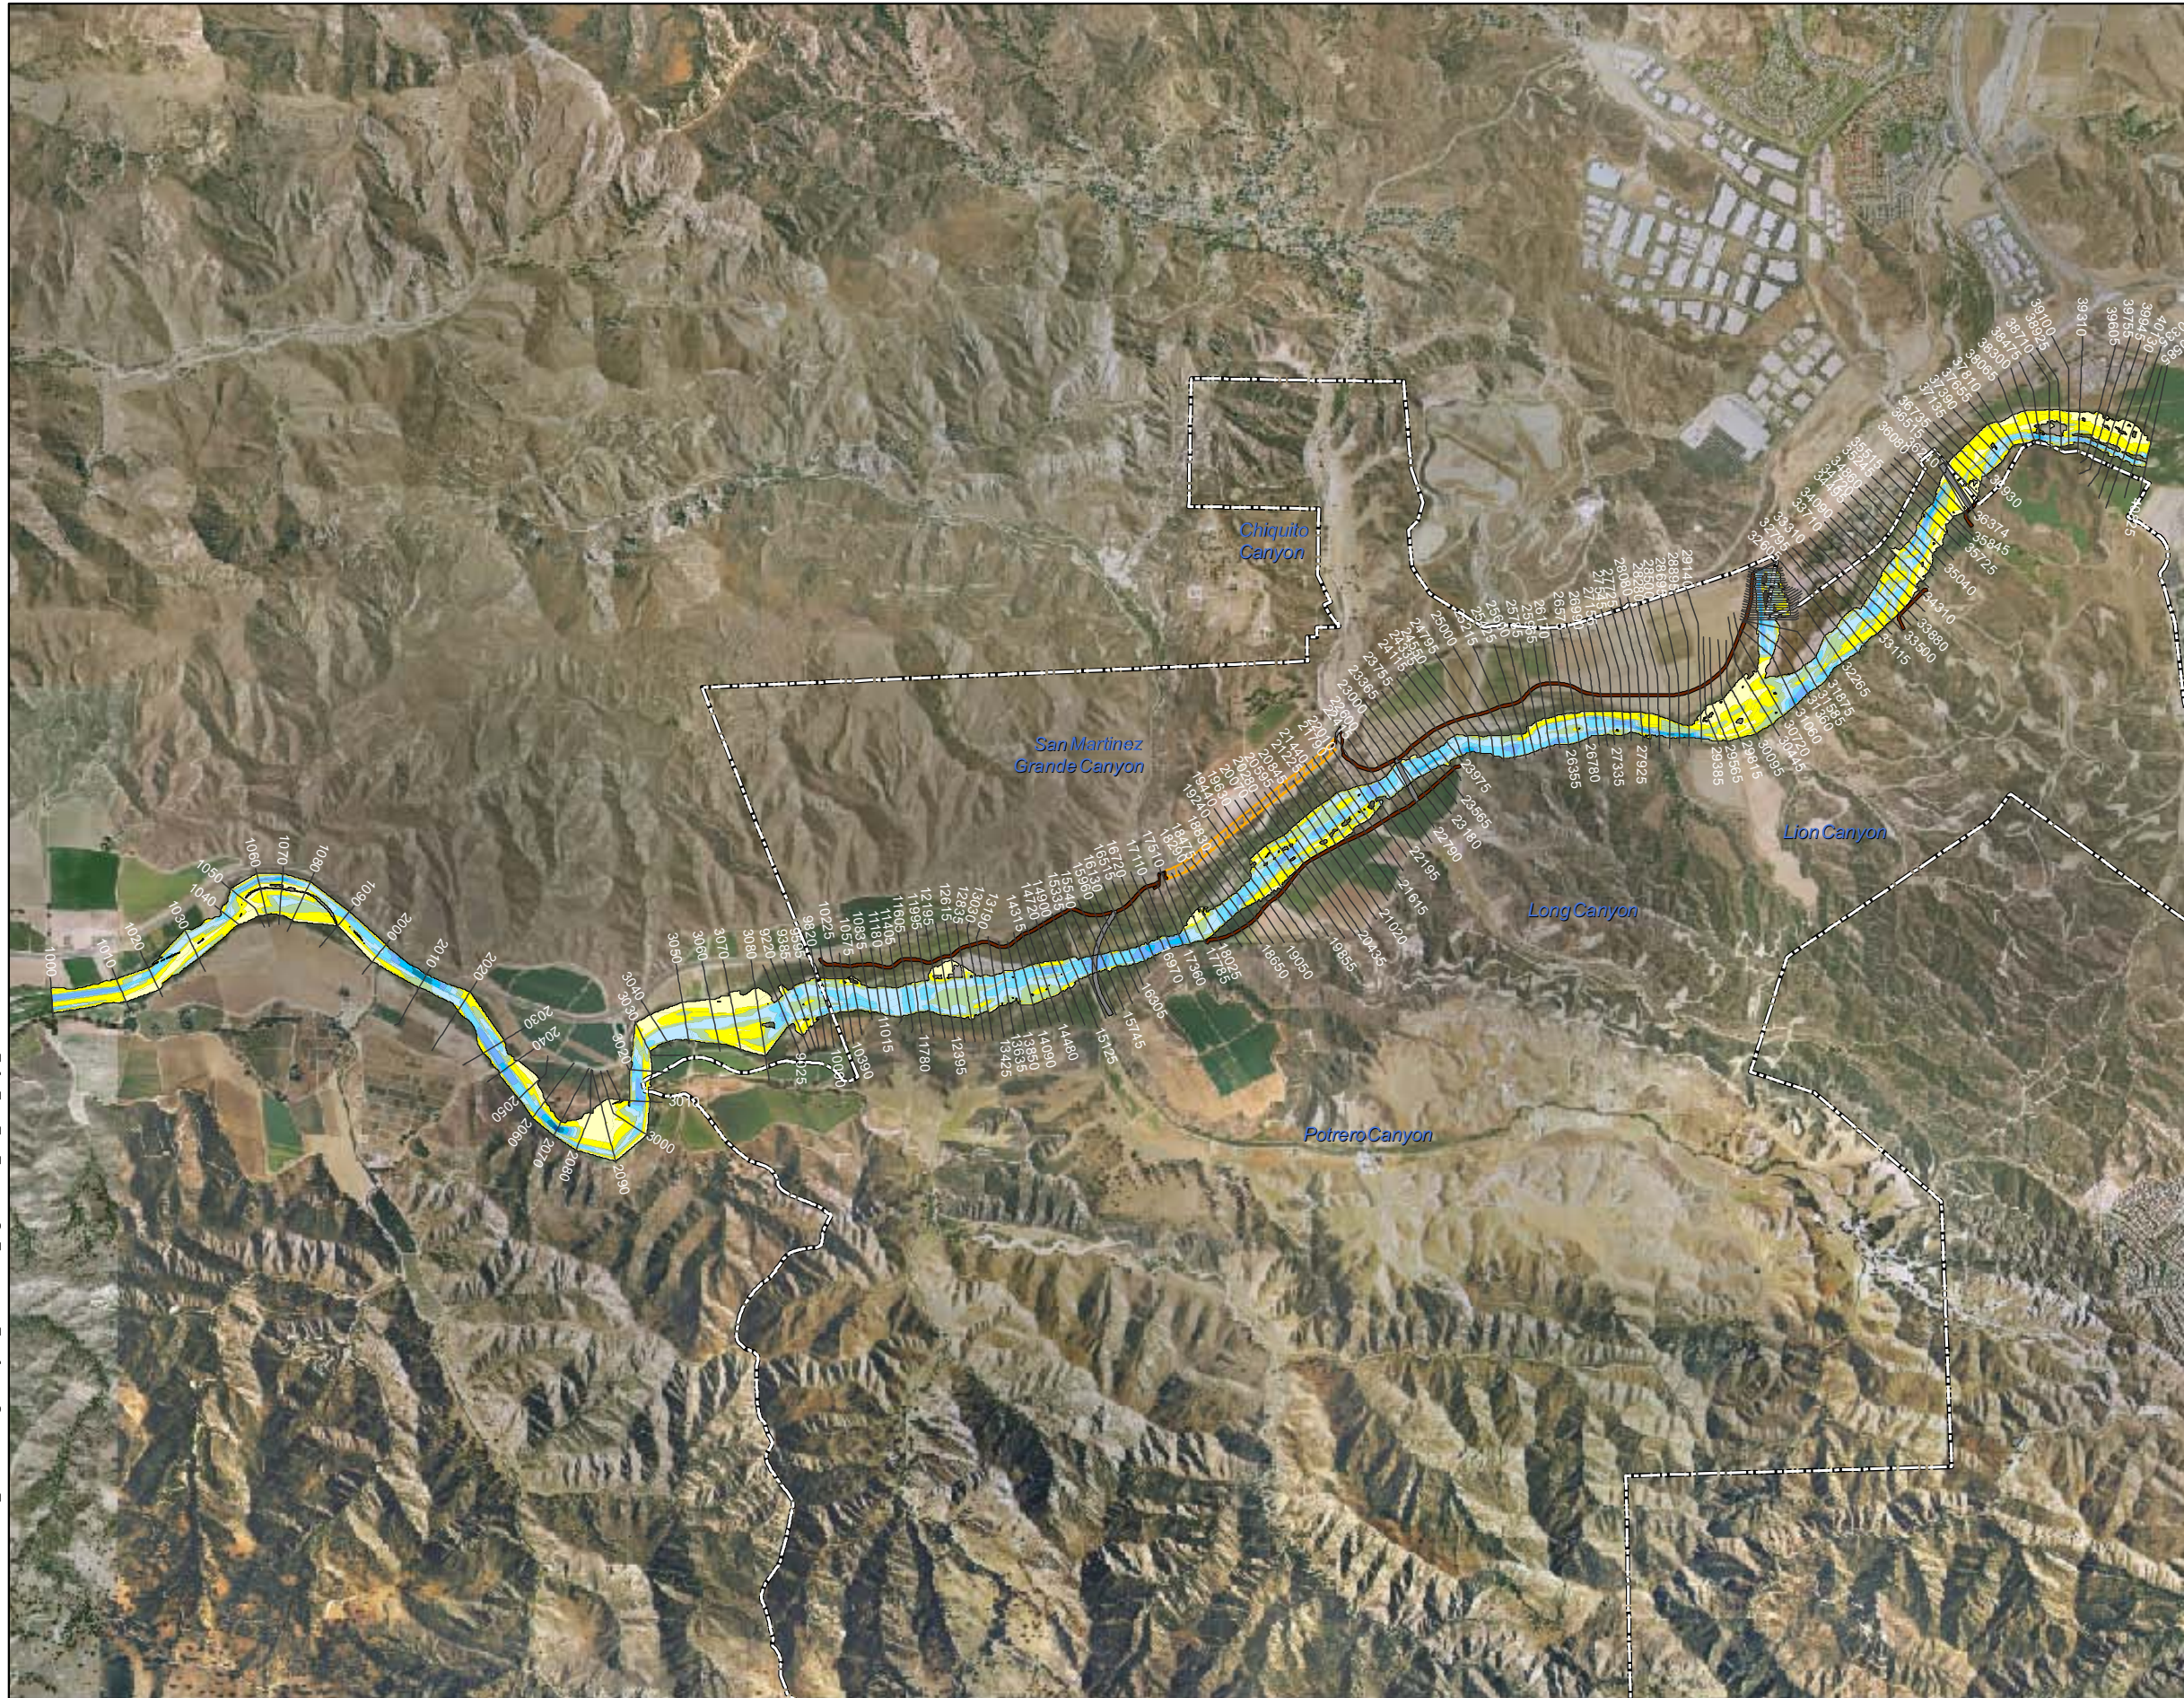
Figure 5.4d
ALTERNATIVE 5
10 YEAR FLOOD EVENT VELOCITY
SANTA CLARA RIVER
