Lugo-Victorville 500-kV Transmission Line Remedial Action Scheme Project

California Endangered Species Act
Incidental Take Permit Application

December 2022

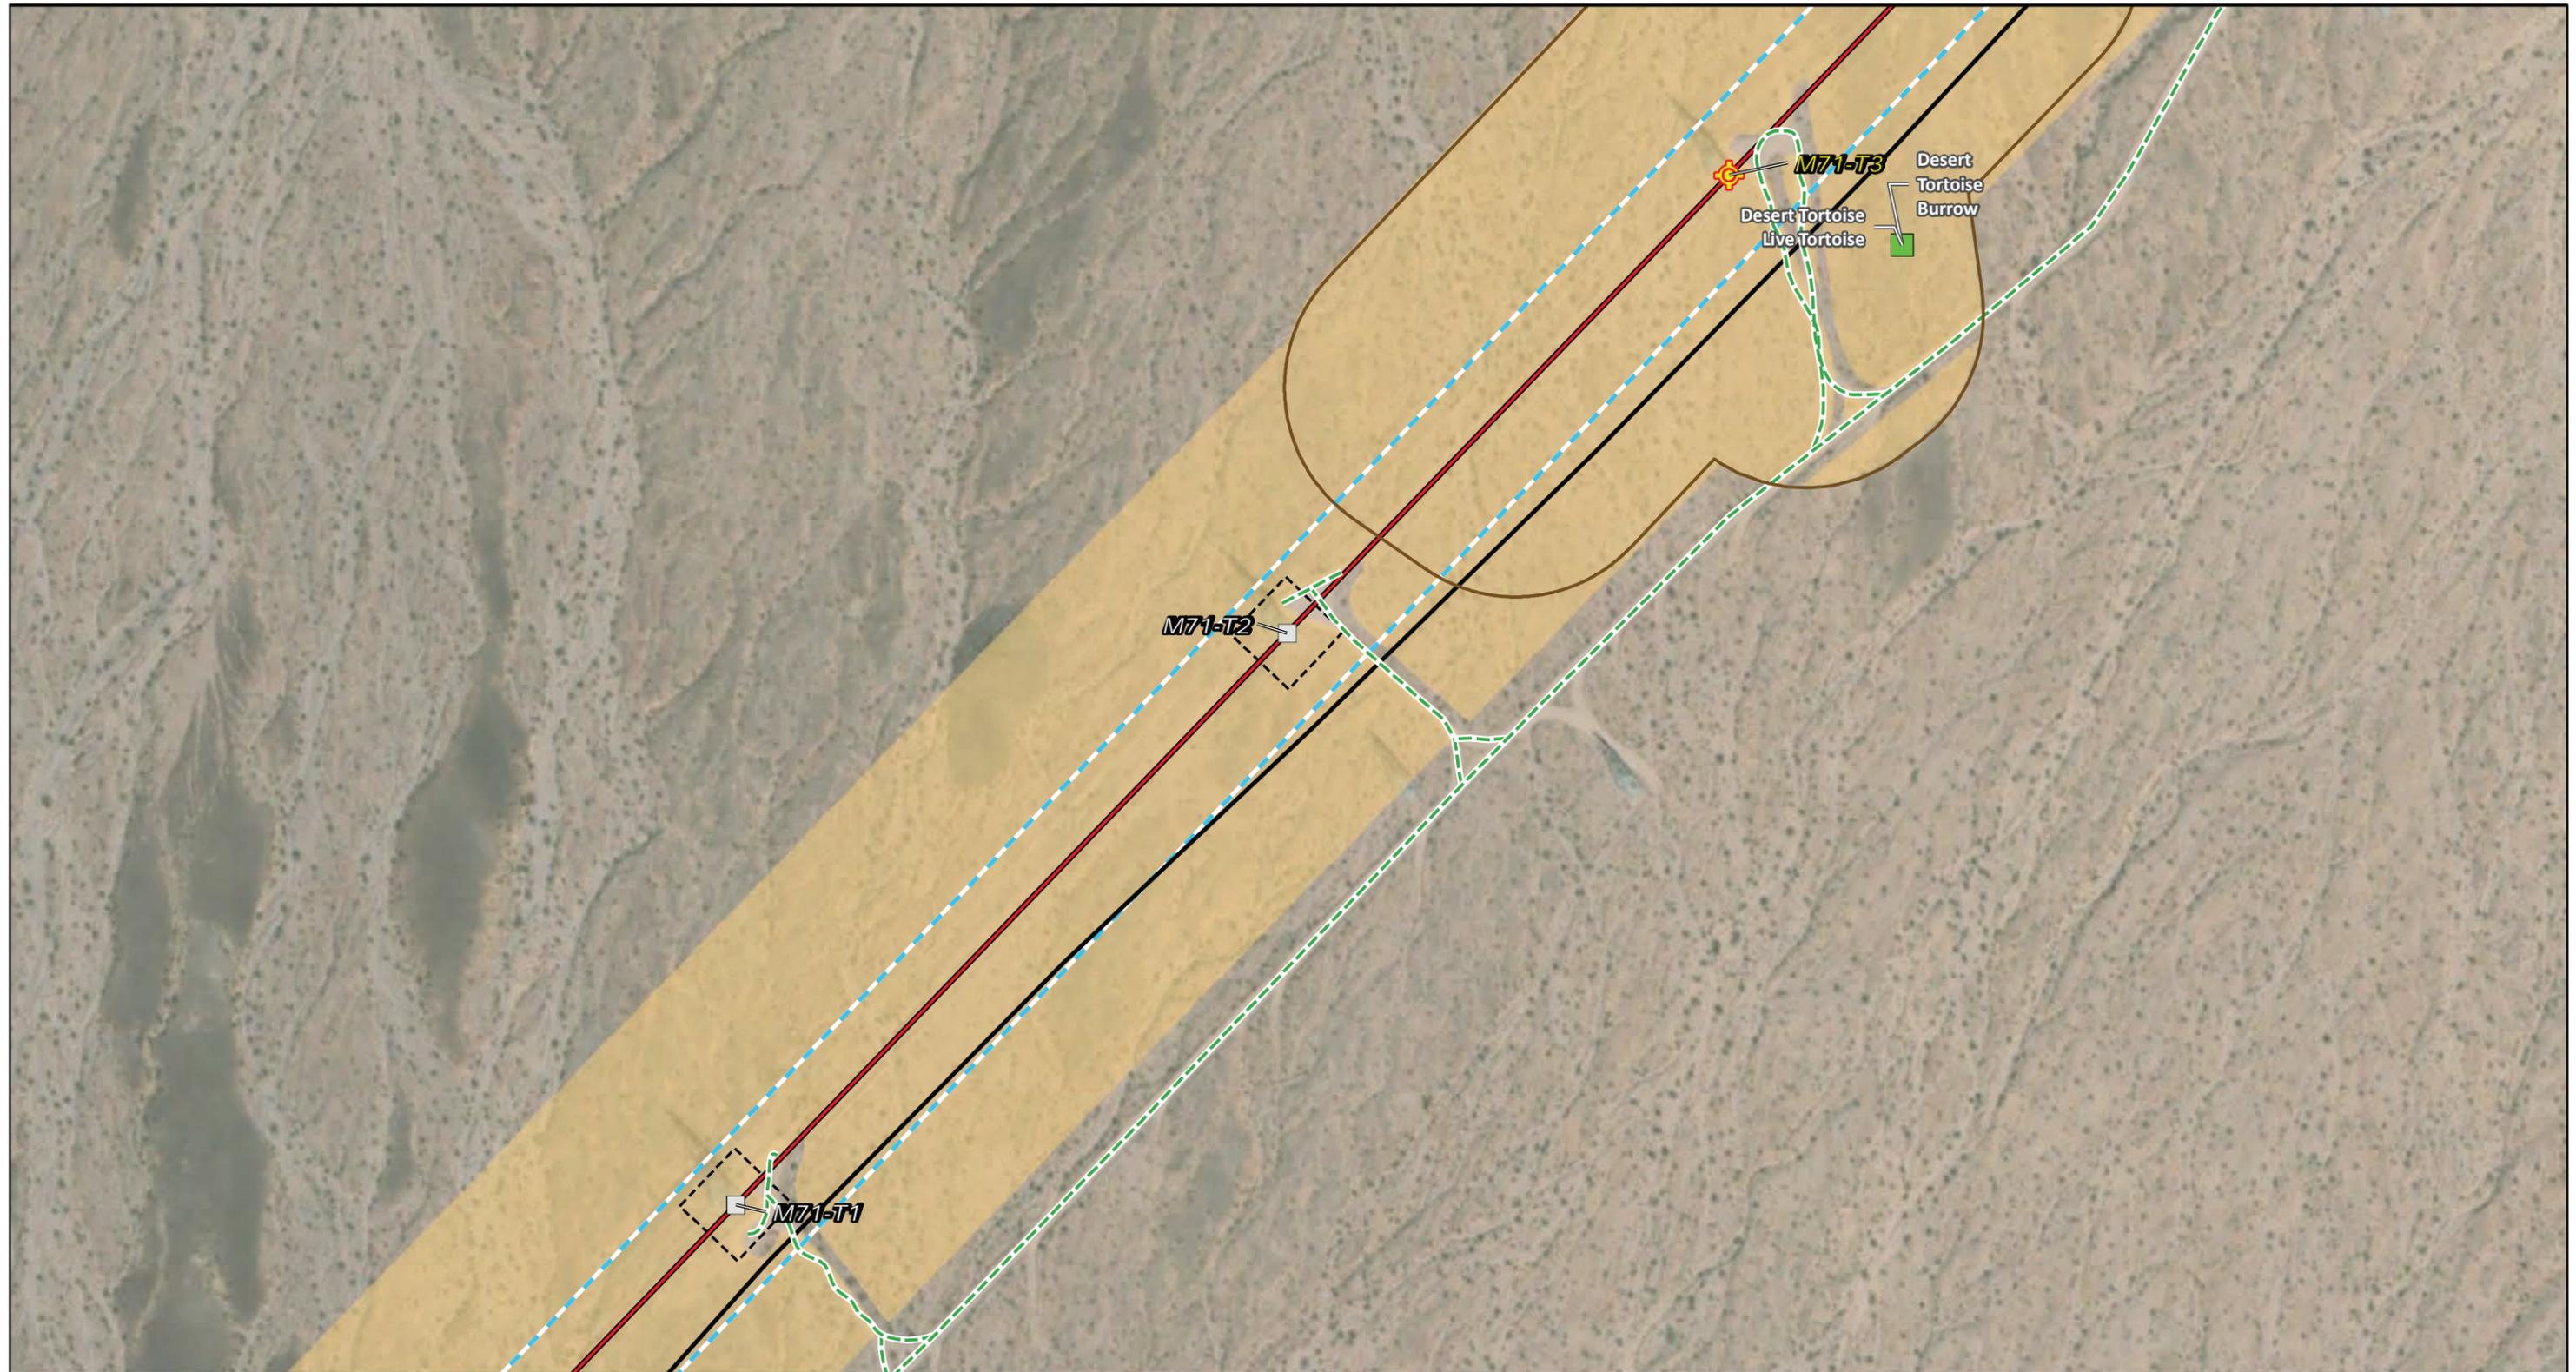
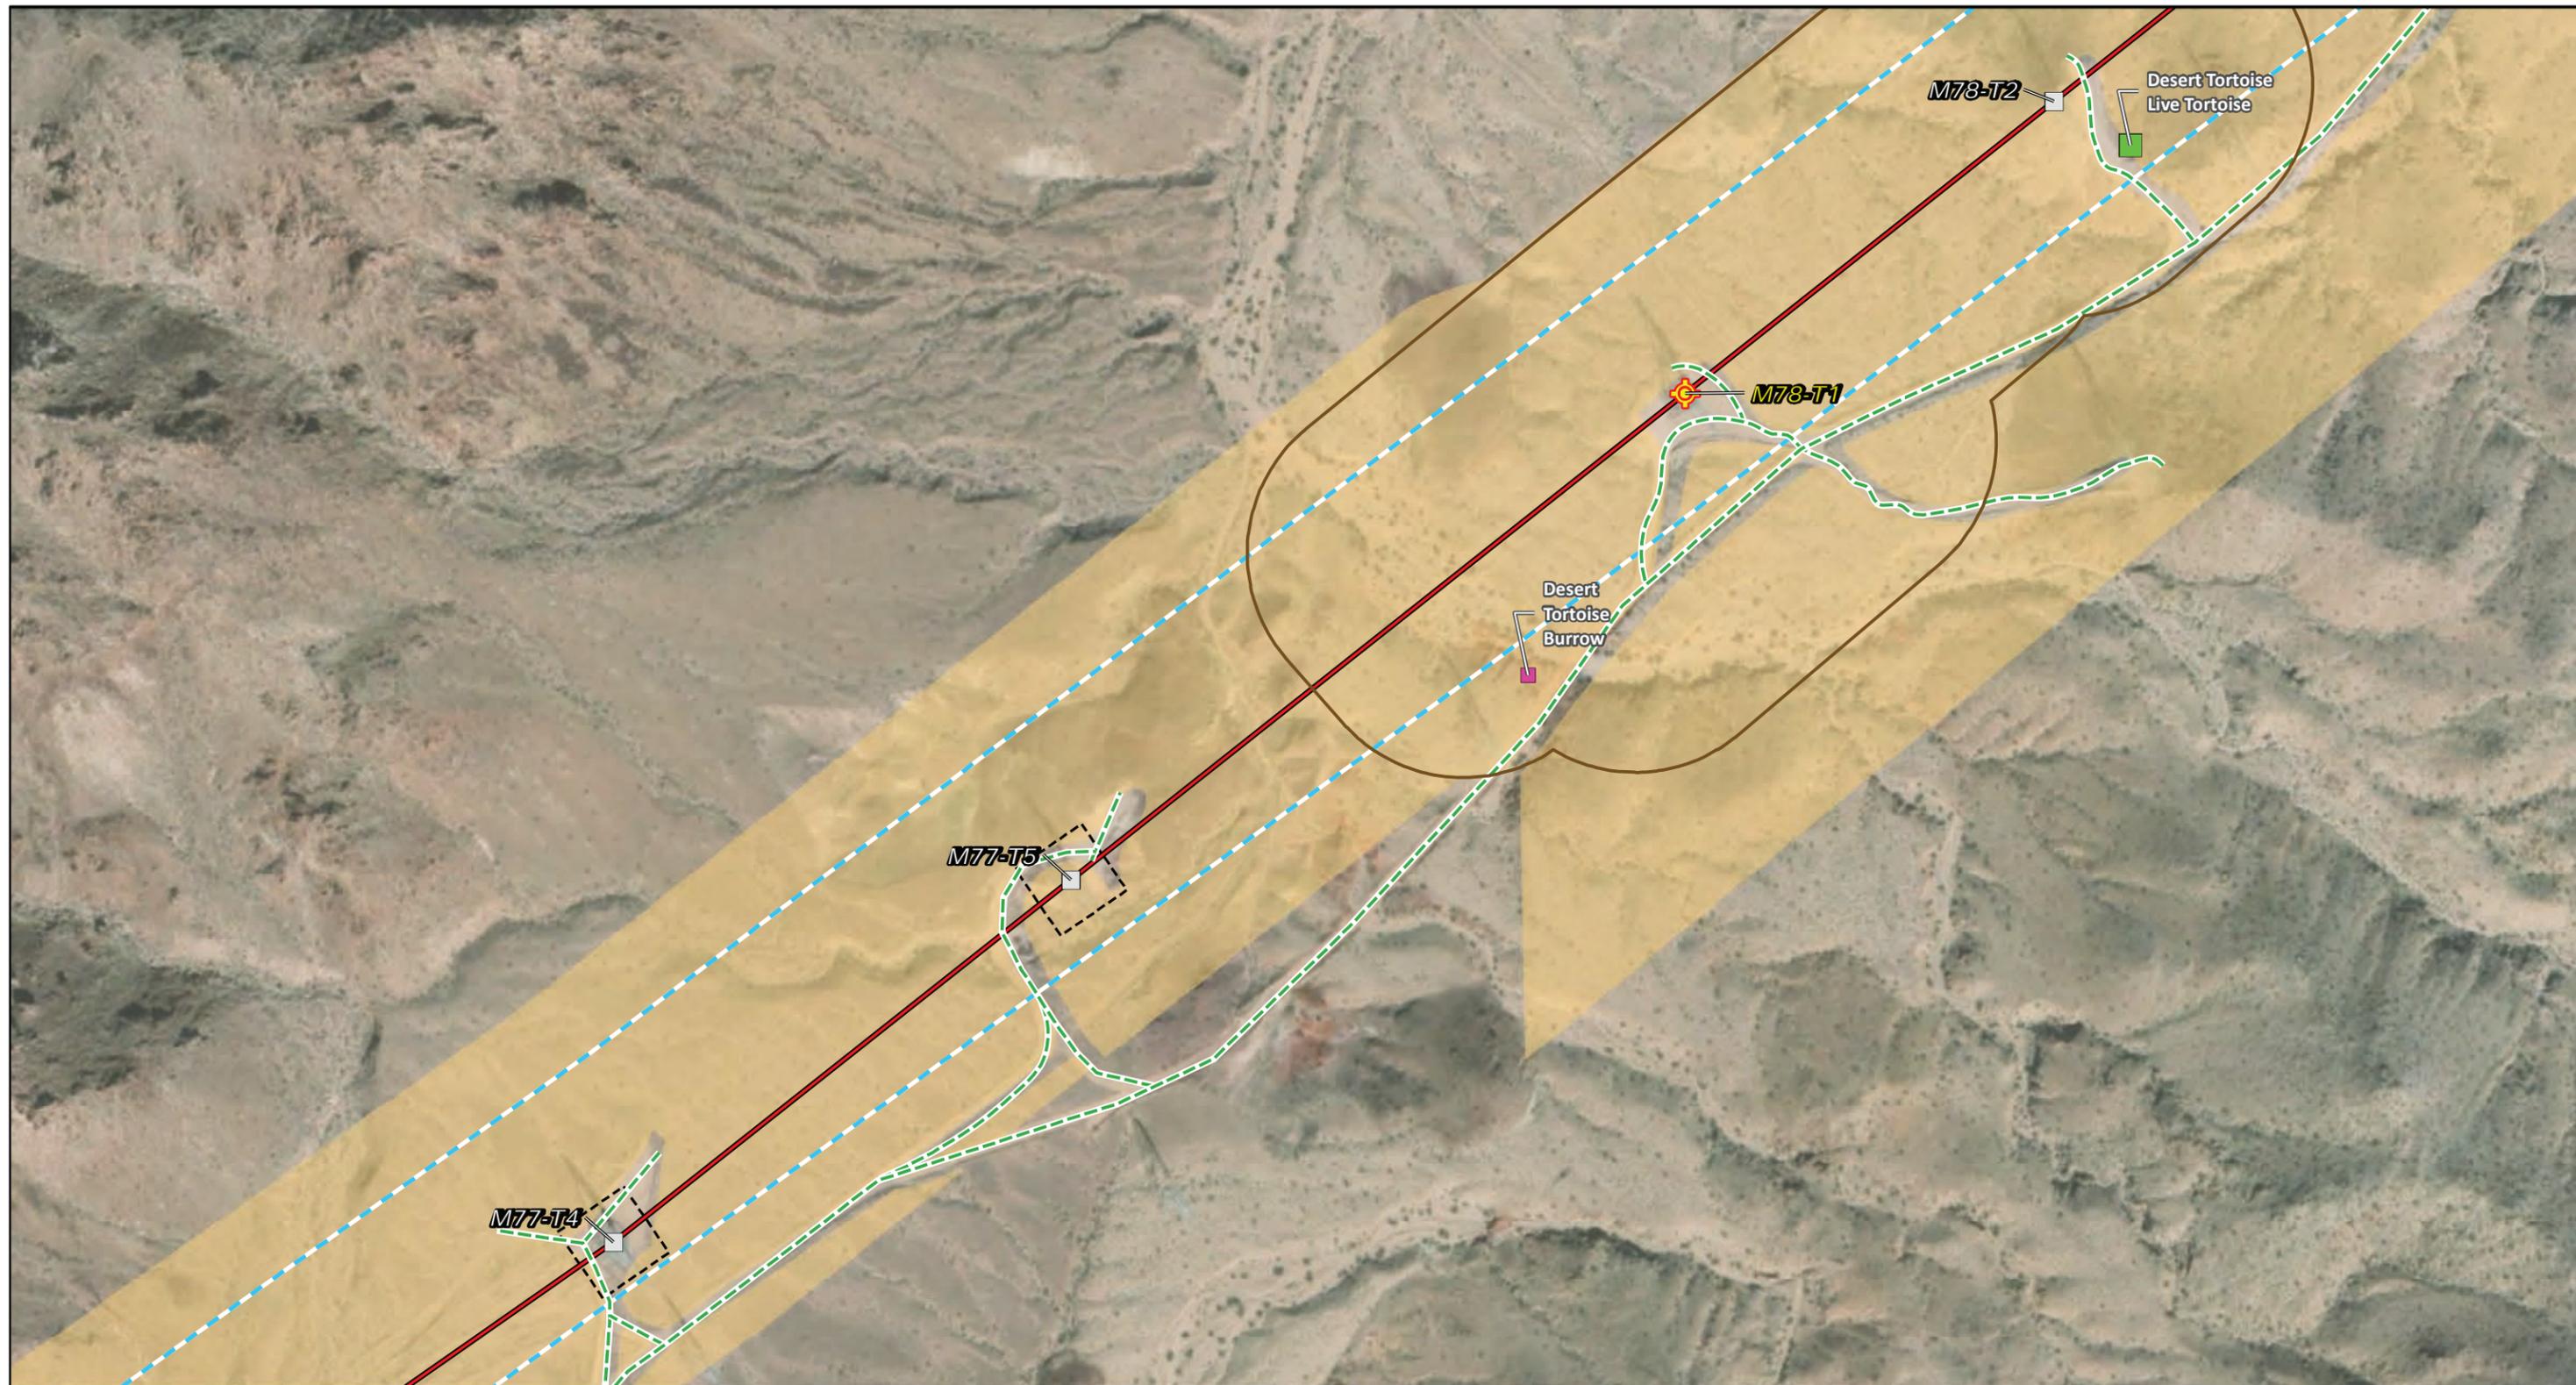
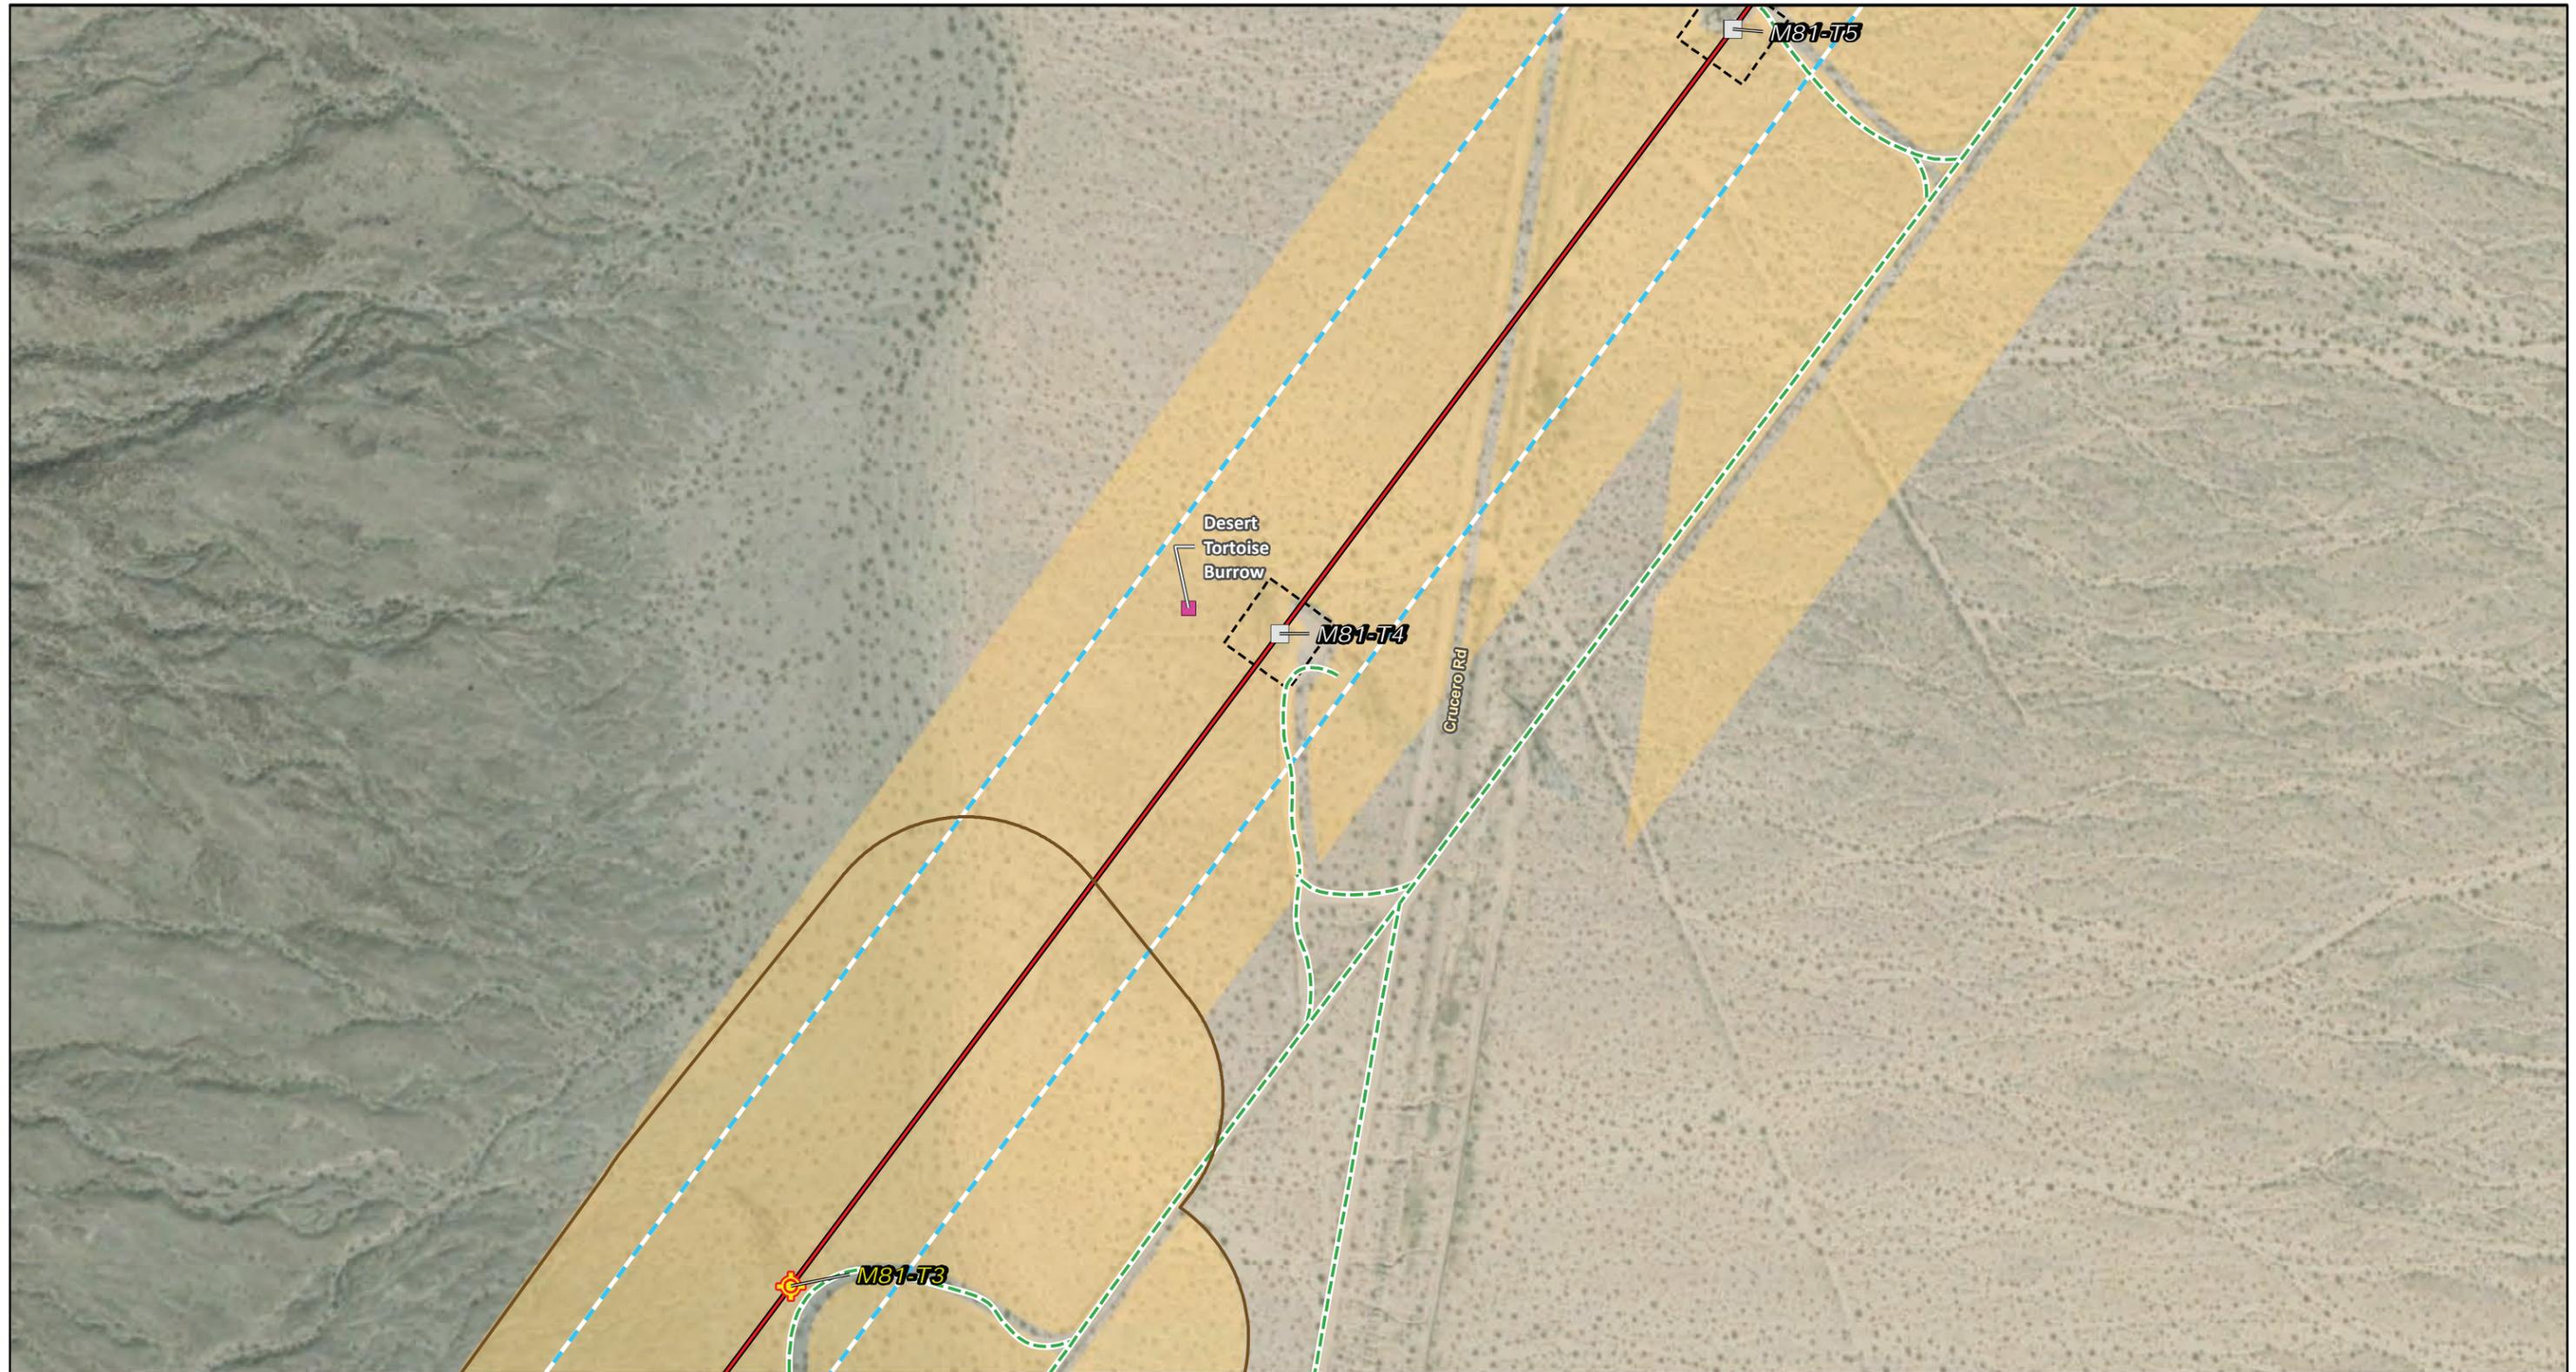
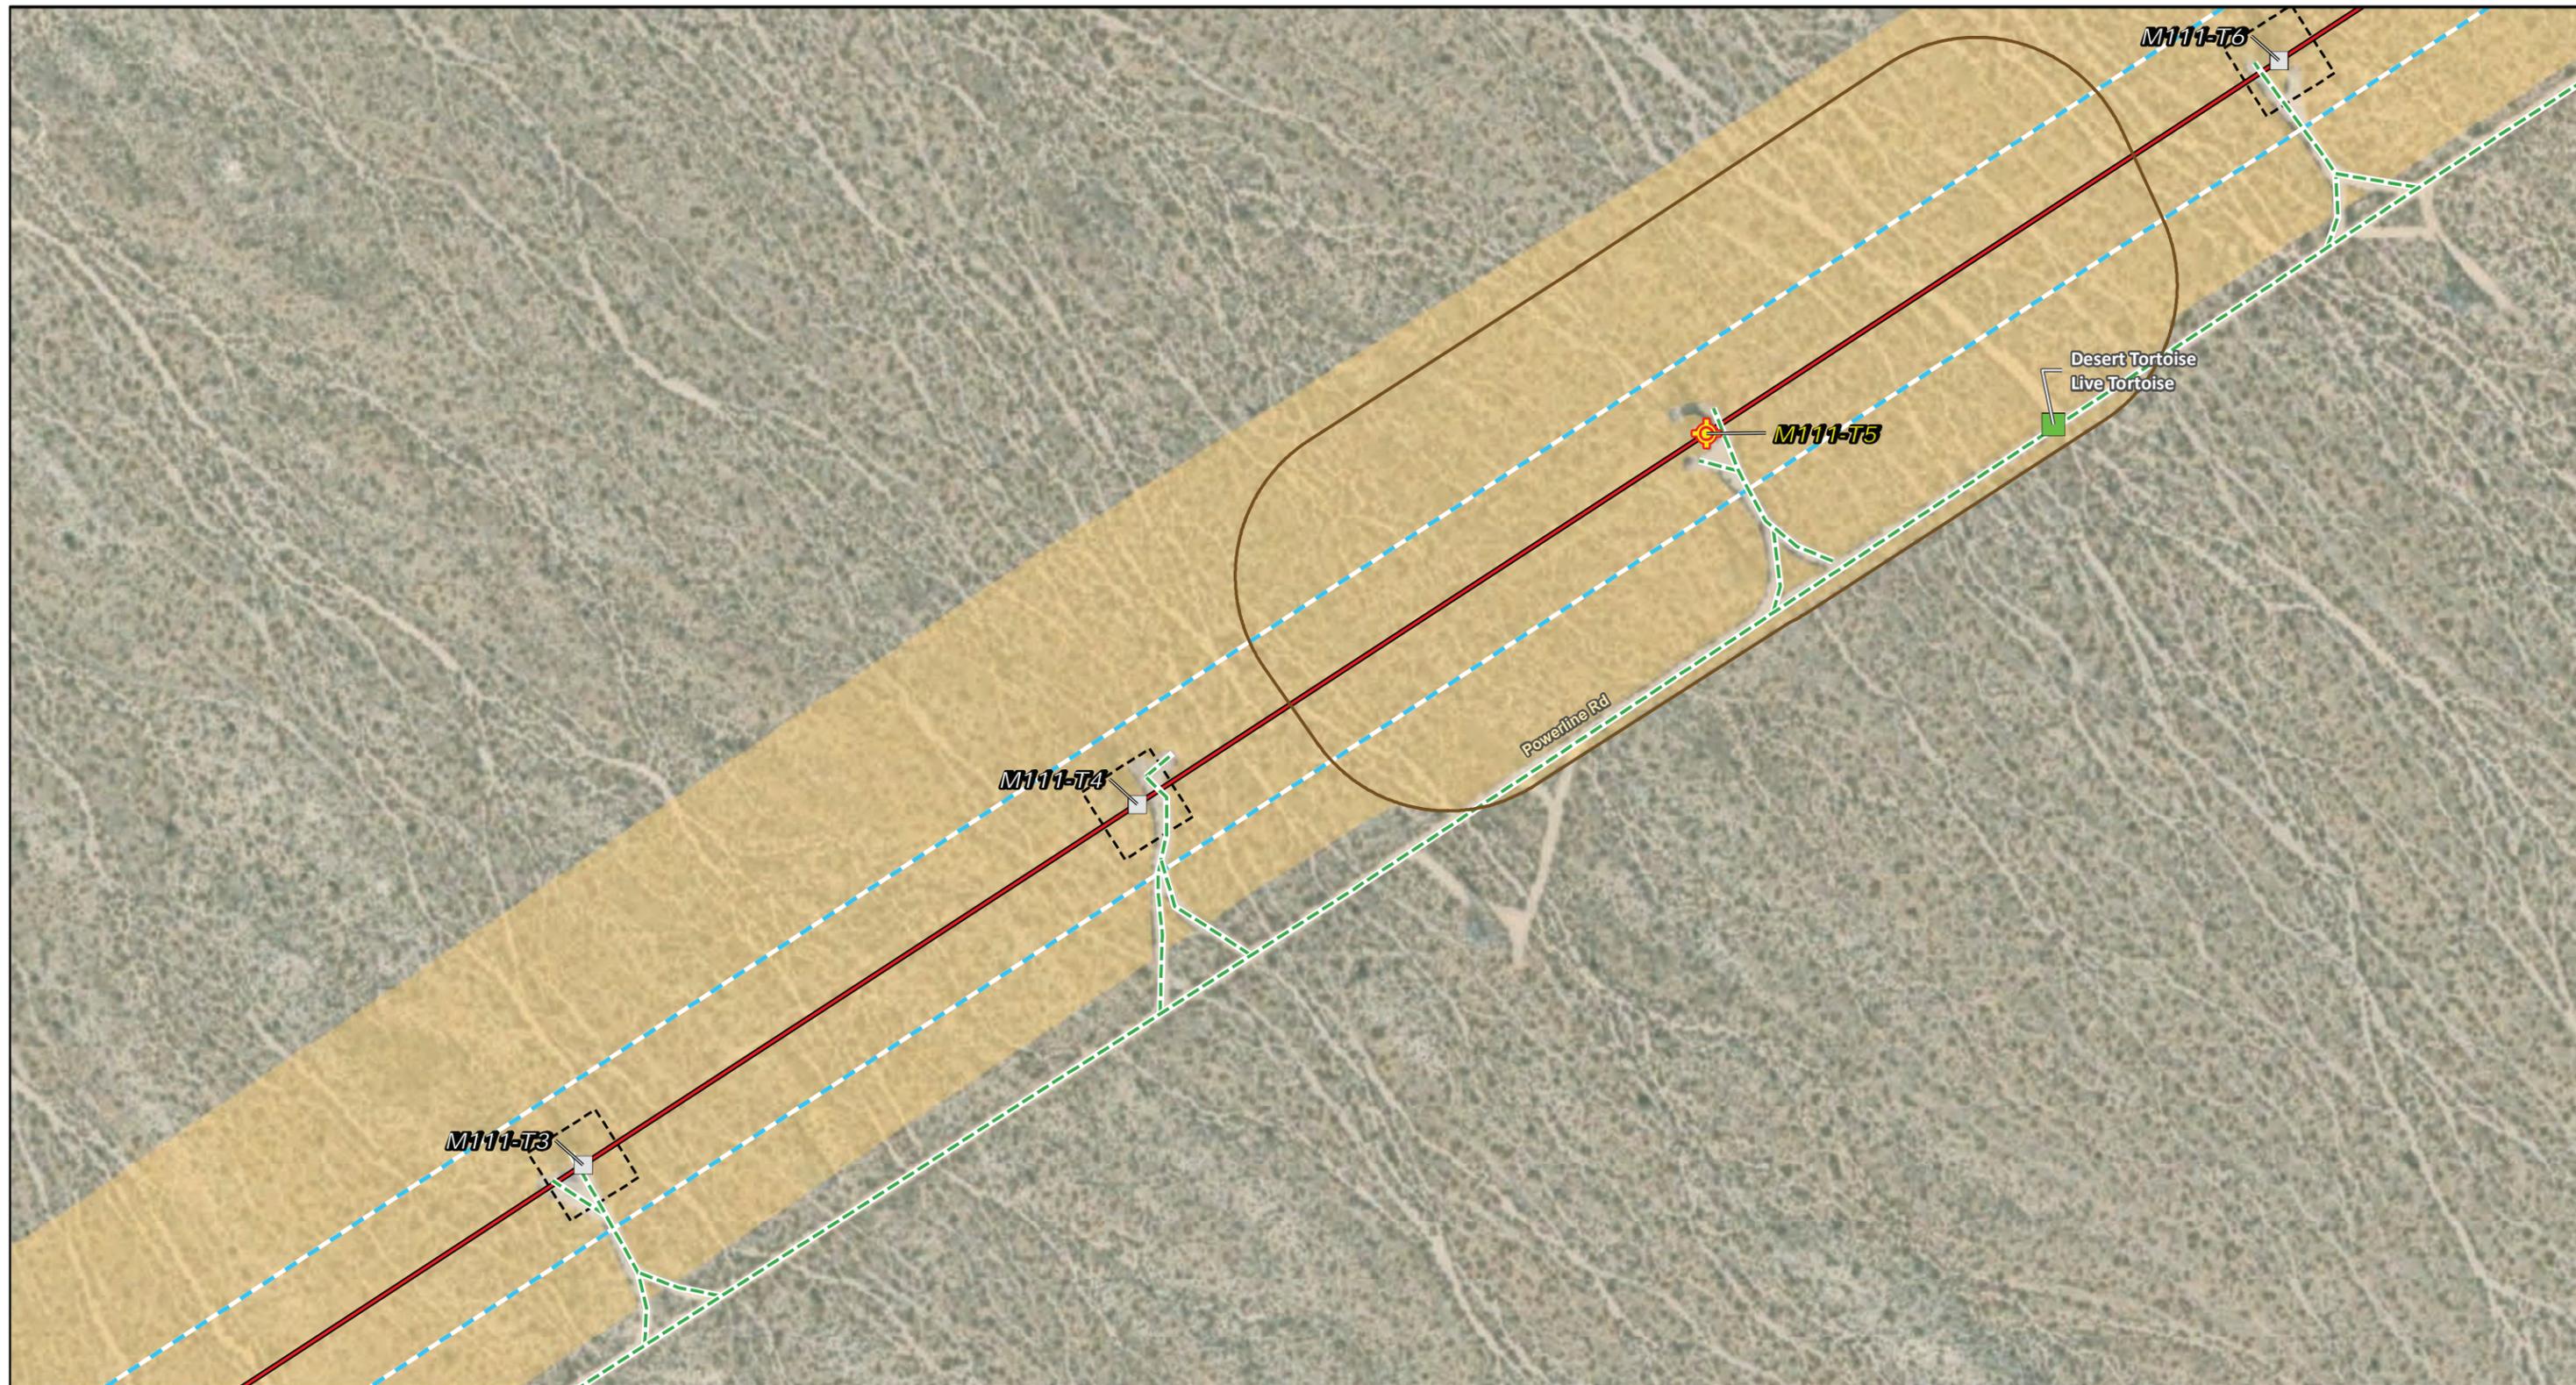
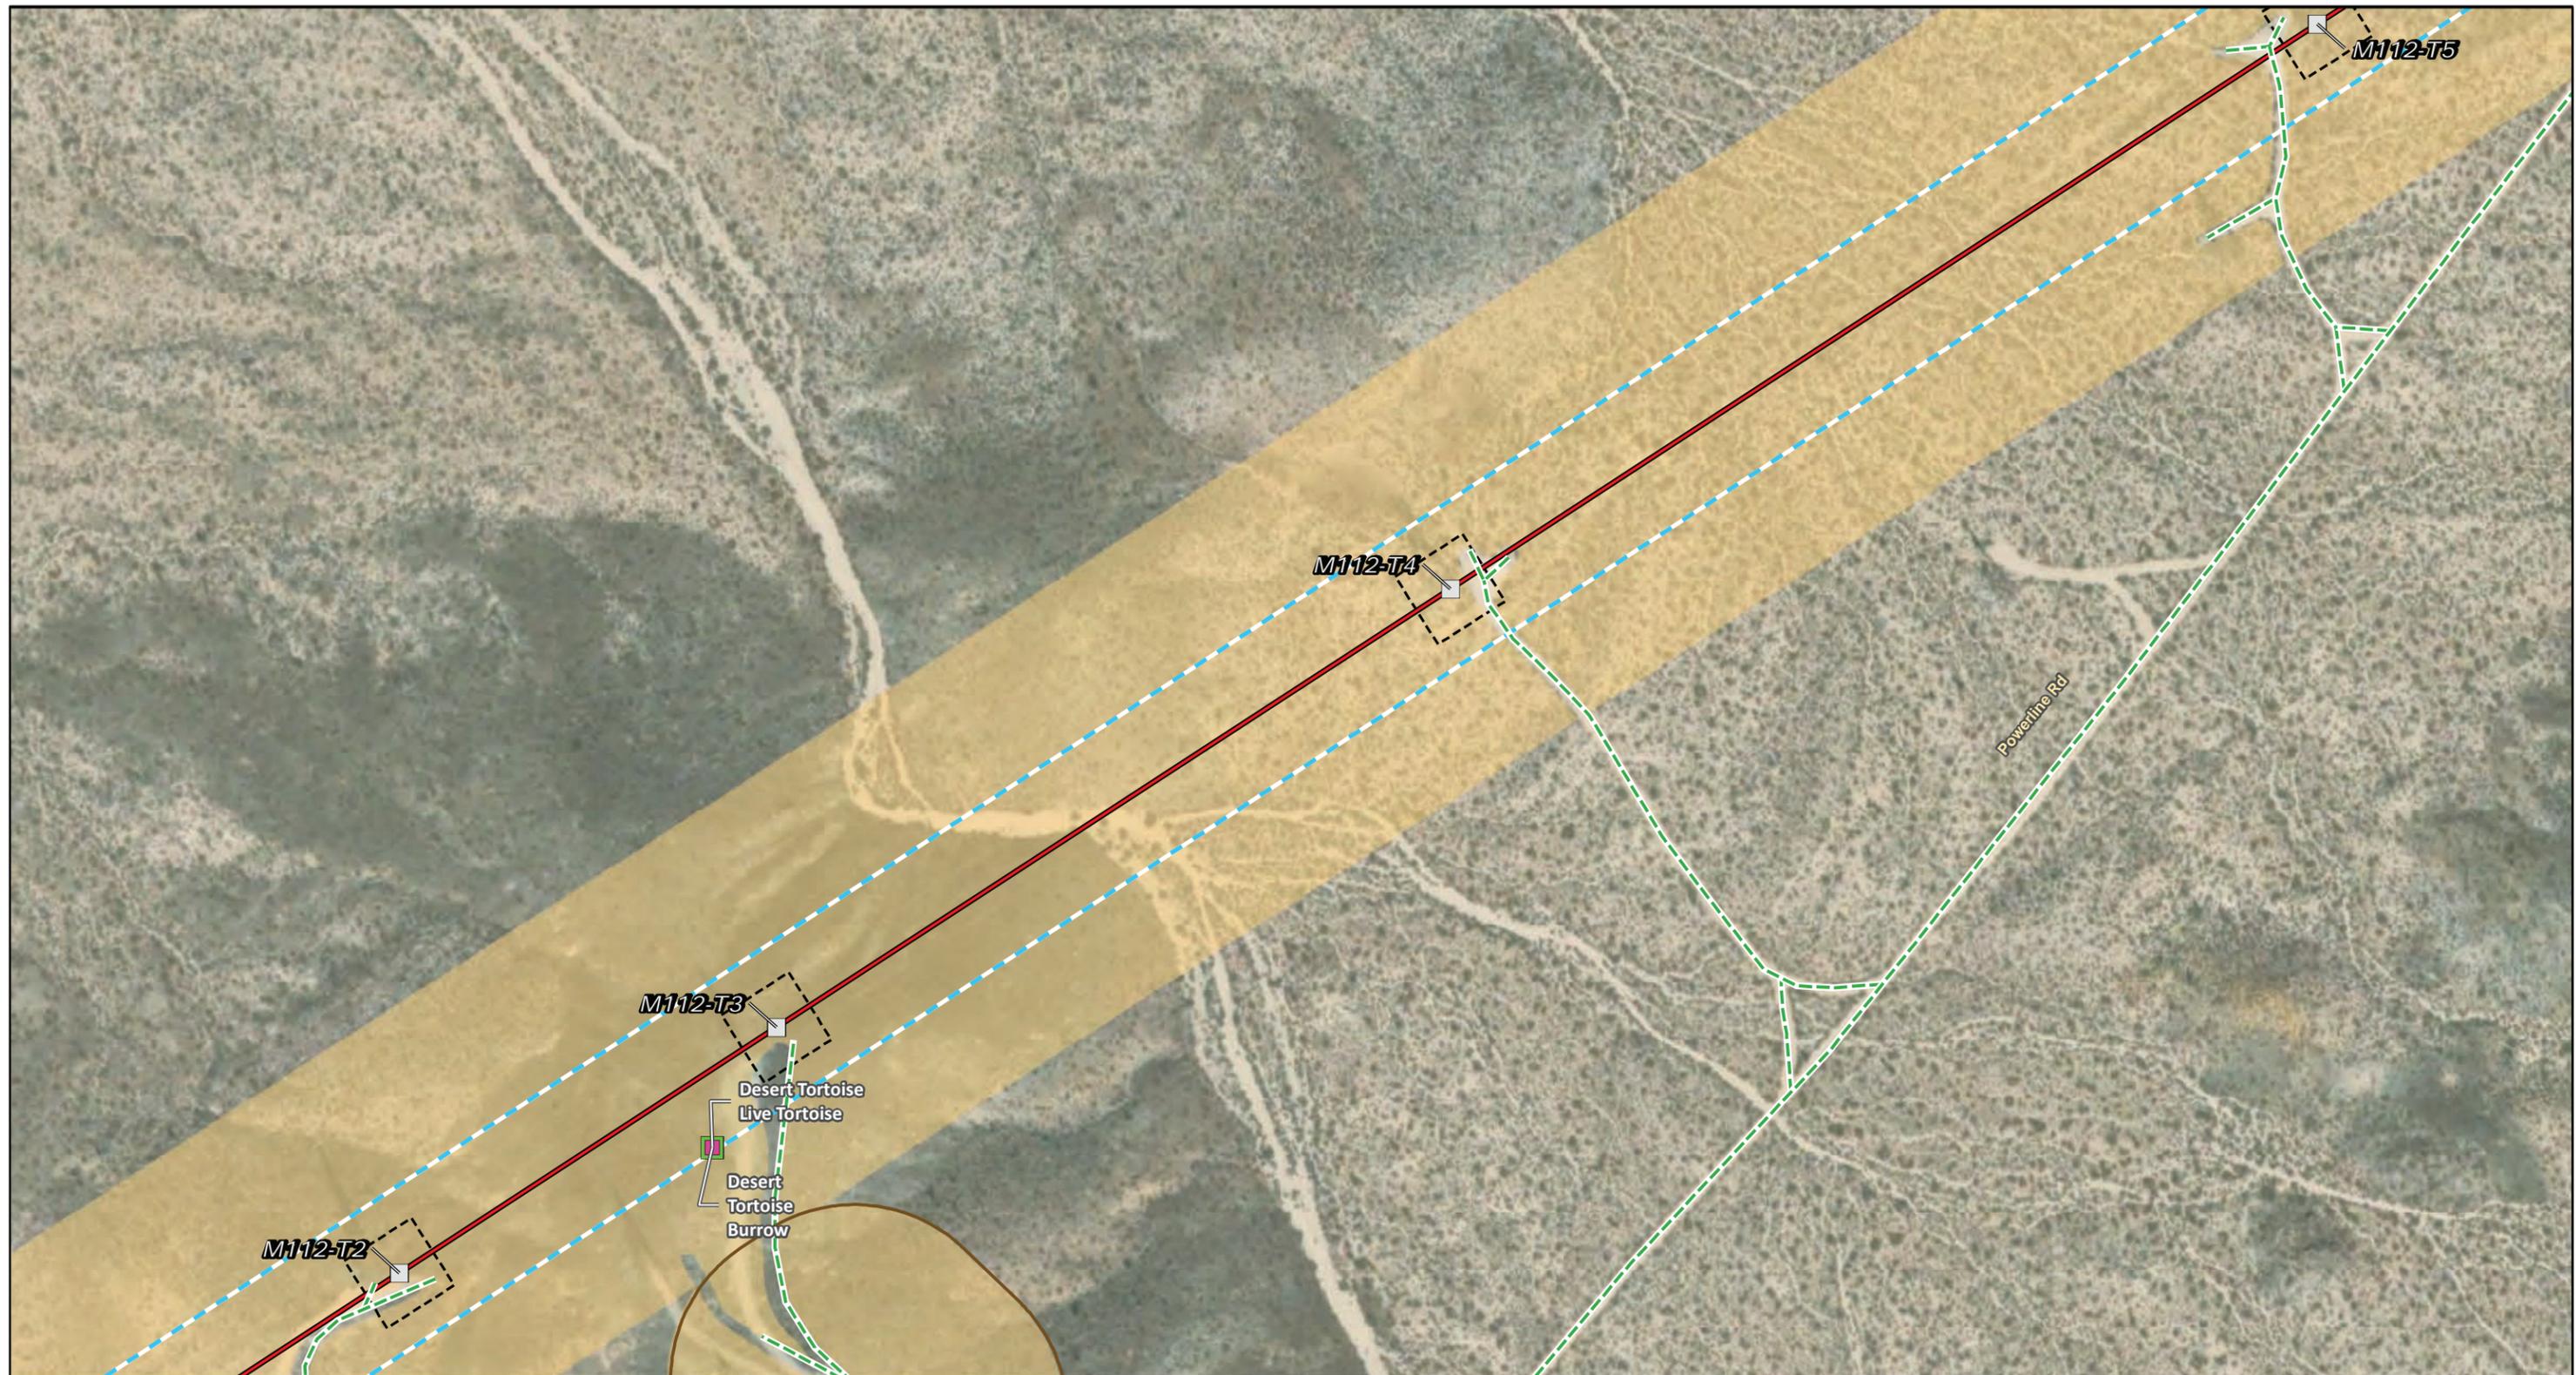
FIGURE 3
Desert Tortoise Survey Results

No desert tortoises or sign were identified in Segment 1 during the 2017 protocol surveys. Thirteen live desert tortoises were observed in Segment 2 during the 2016 and 2019 protocol surveys (Appendix D, Figure 3). The 13 live desert tortoises observed in Segment 2 included 10 adult/sub-adult tortoises with a maximum carapace length greater than 6.3 inches (160 millimeters) and one juvenile tortoise with a MCL less than or equal to 6.3 inches. Two desert tortoises found deep in burrows that could not be measured were assumed to be adult/sub-adult for the purpose of population calculations. Eleven of the 13 live desert tortoises observed were associated with a burrow (found in burrow or at entrance). Two desert tortoises were observed in the open, one of which was an adult with an identification tag (#N92043). In addition to live desert tortoises, other signs observed in Segment 2 included 215 desert tortoise burrows, 28 burrows with desert tortoise tracks, 185 pallet burrows, seven pallet burrows with desert tortoise tracks, 140 desert tortoise scat, 35 desert tortoise carcasses, and five locations with desert tortoise eggshell fragments.
