LUGO-VICTORVILLE 500-KV
TRANSMISSION LINE REMEDIAL
ACTION SCHEME PROJECT
AQUATIC RESOURCES DELINEATION

LUGO-VICTORVILLE 500 KV TRANSMISSION LINE
 REMEDIAL ACTION SCHEME PROJECT
 2022 NOXIOUS WEED SURVEY REPORT

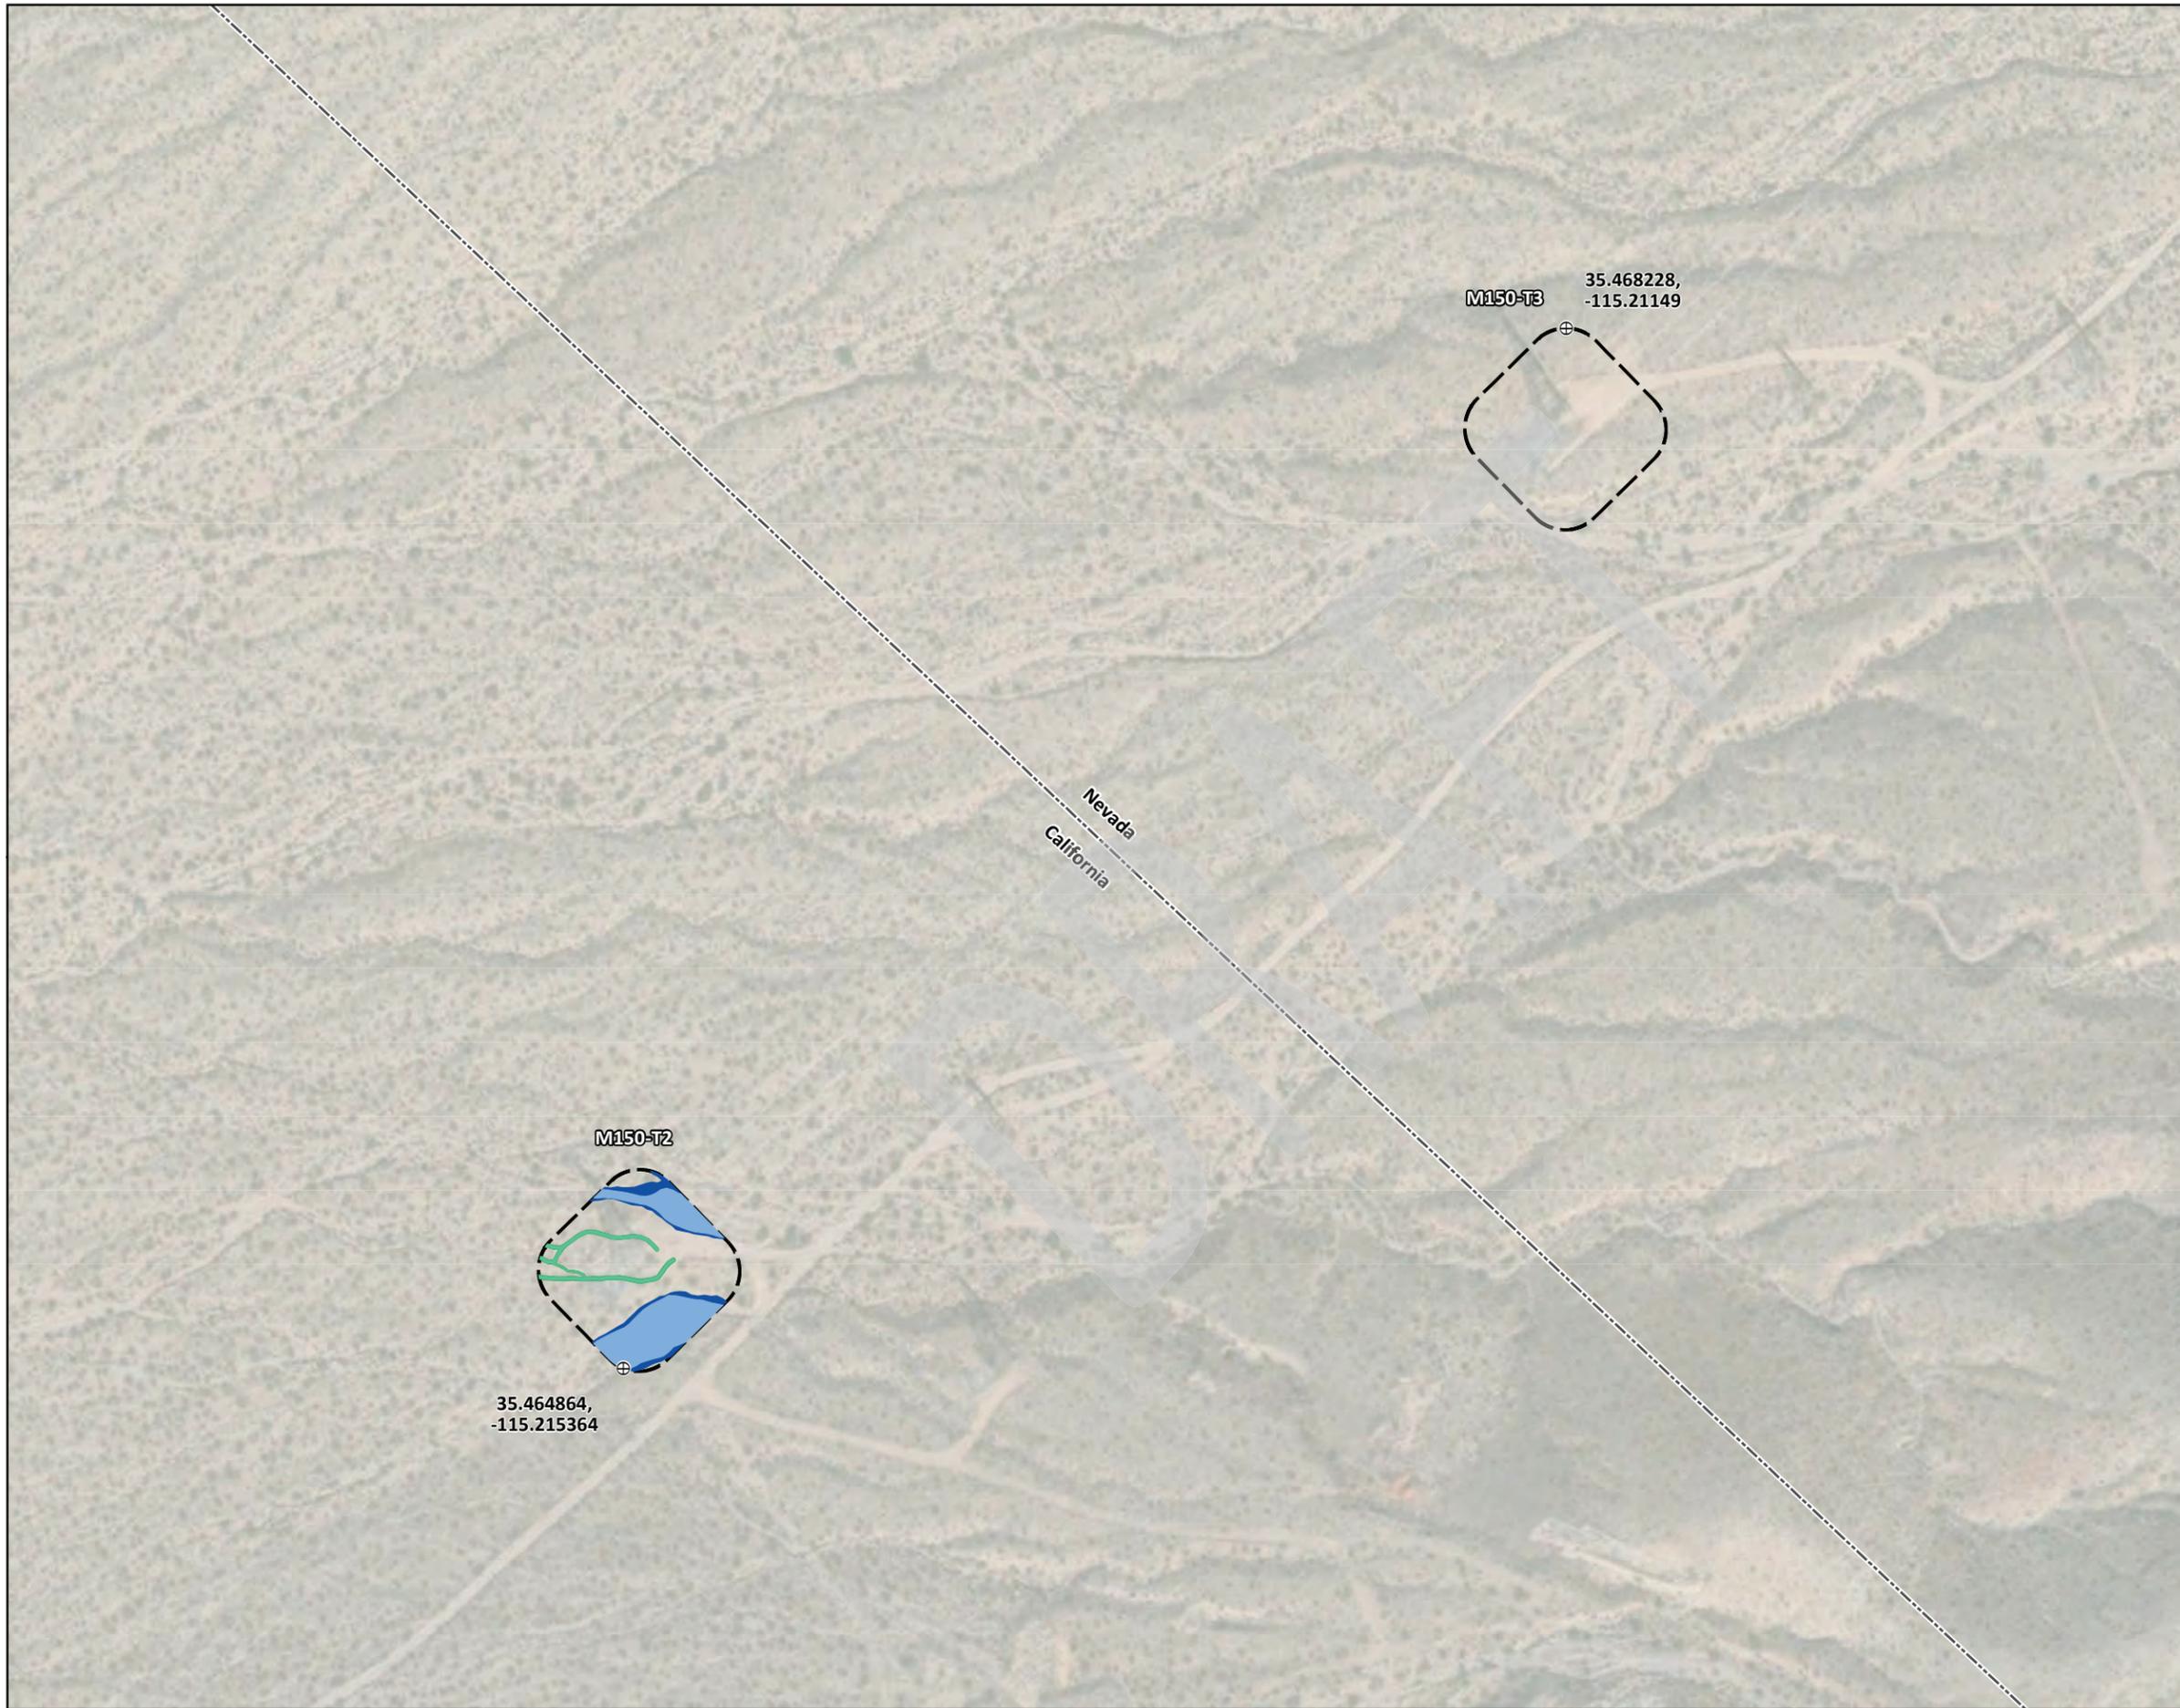
Figure 9, Page 189 of 189

CDFW Aquatic Resources Survey Results

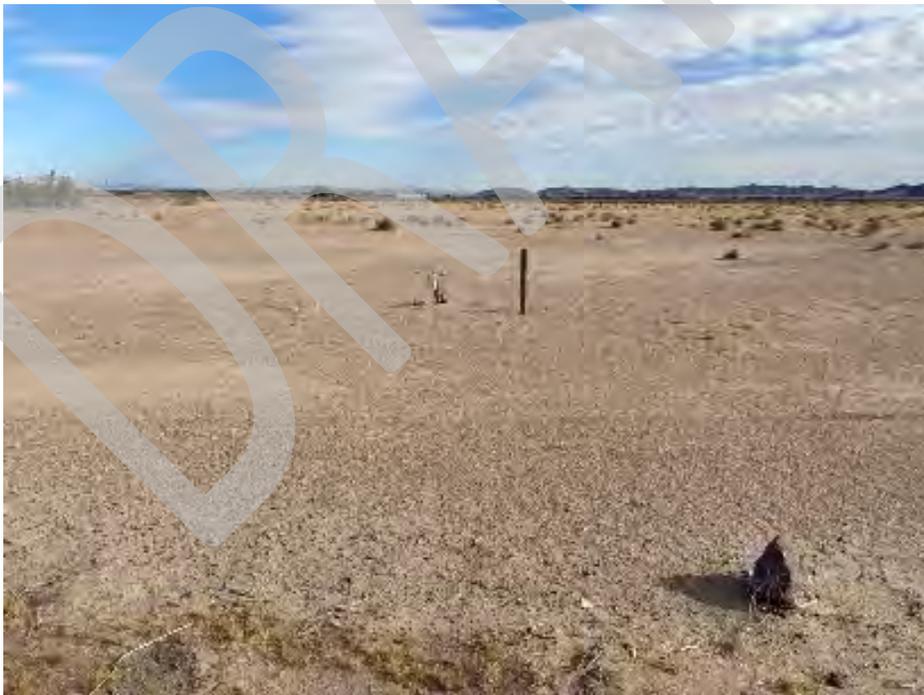
Photo 6. Degraded and pebbly soil in Segment 1, looking north.

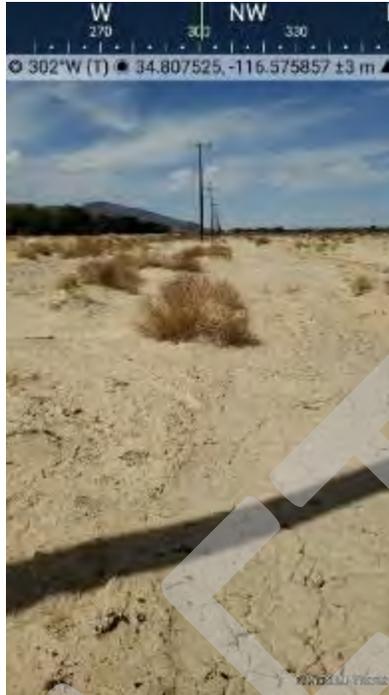
Photo 7. Playa amongst *Suaeda nigra* community in Segment 1, looking west (Datasheet OHWM_LVRAS-S1-ATG-Playa 3).

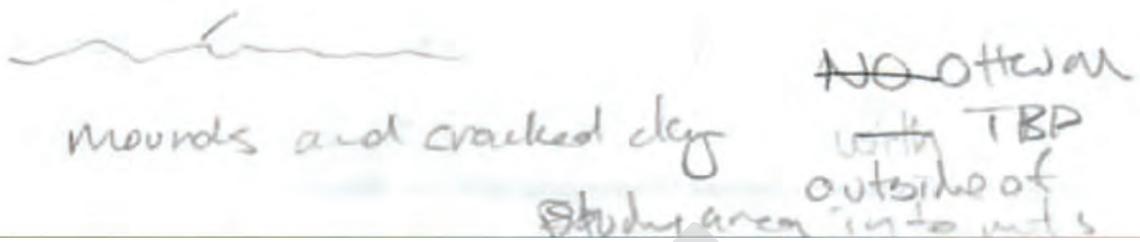
Above unknown
Clay silt cracked dry soil

Cracked dry, driflines, soft soils

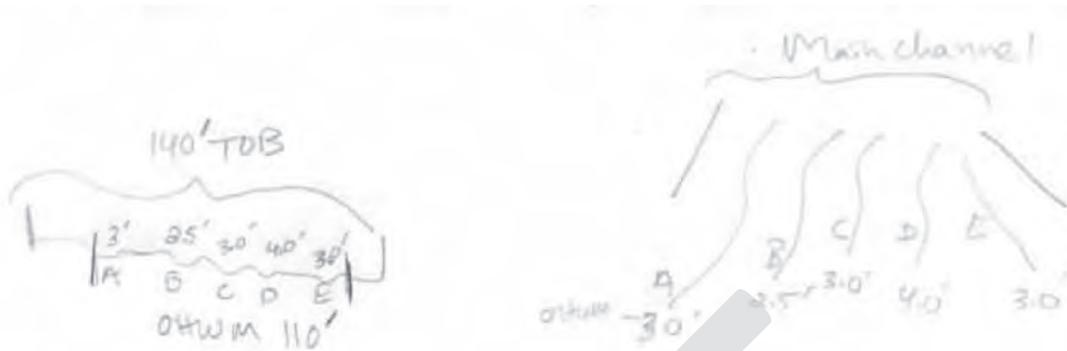
Above: *Larrea tridentata* shrubs dominant in upland with *Ambrosia dumosa* and *Schismus* in under-story. Under: Channels lined with *Schismus sp.*, *Larrea tridentata* and *Ambrosia dumosa* found intermittently.

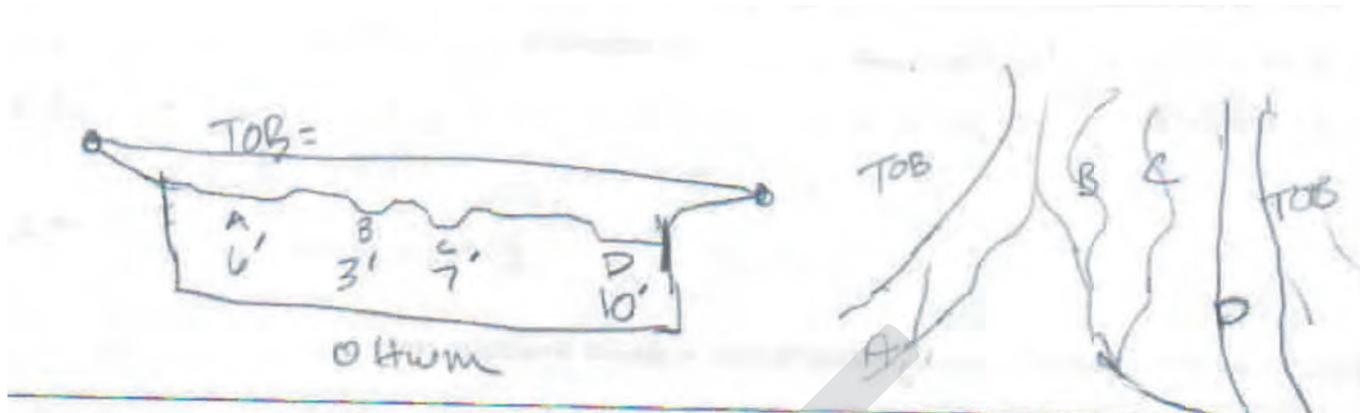
Above OHWM boulders, cobbles, mound around shrubs
Gravel found around herbaceous plants
Large boulders create bare areas
