# Final Mission Creek Habitat Restoration Project Biological Technical Report

**Southern California Edison  
Environmental Services Department**

**SWCA Environmental Consultants**

# MISSION CREEK HABITAT RESTORATION PROJECT BIOLOGICAL TECHNICAL REPORT

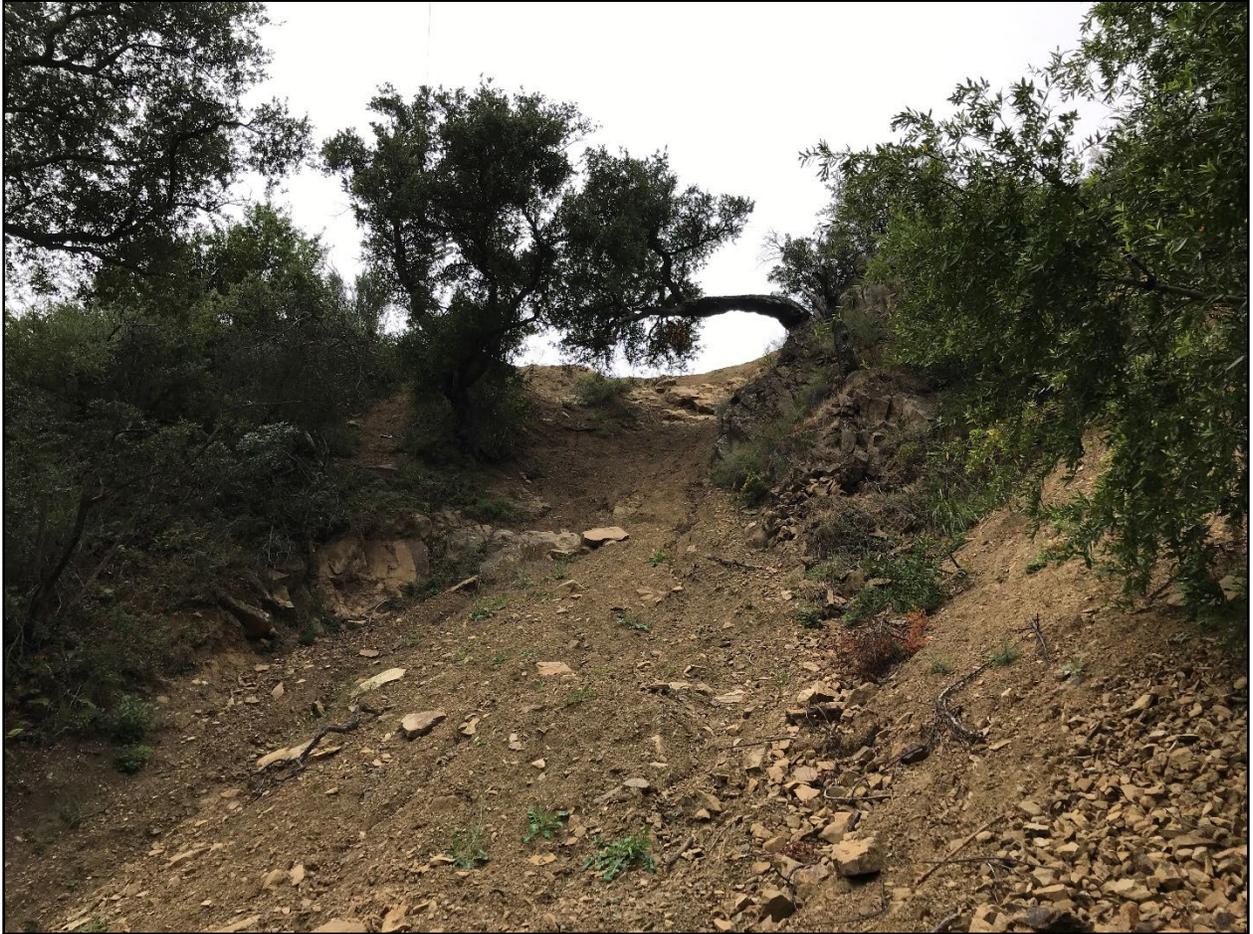
**Photograph B-3. Side-casts along the west bank of Mission Creek south of the bridge. Note the intact portions of the bank that support healthy individuals of Santa Barbara honeysuckle (*Lonicera subspicata* var. *subspicata*) and Plummer's baccharis (*Baccharis plummerae* ssp. *plummerae*); photograph taken June 2020.**

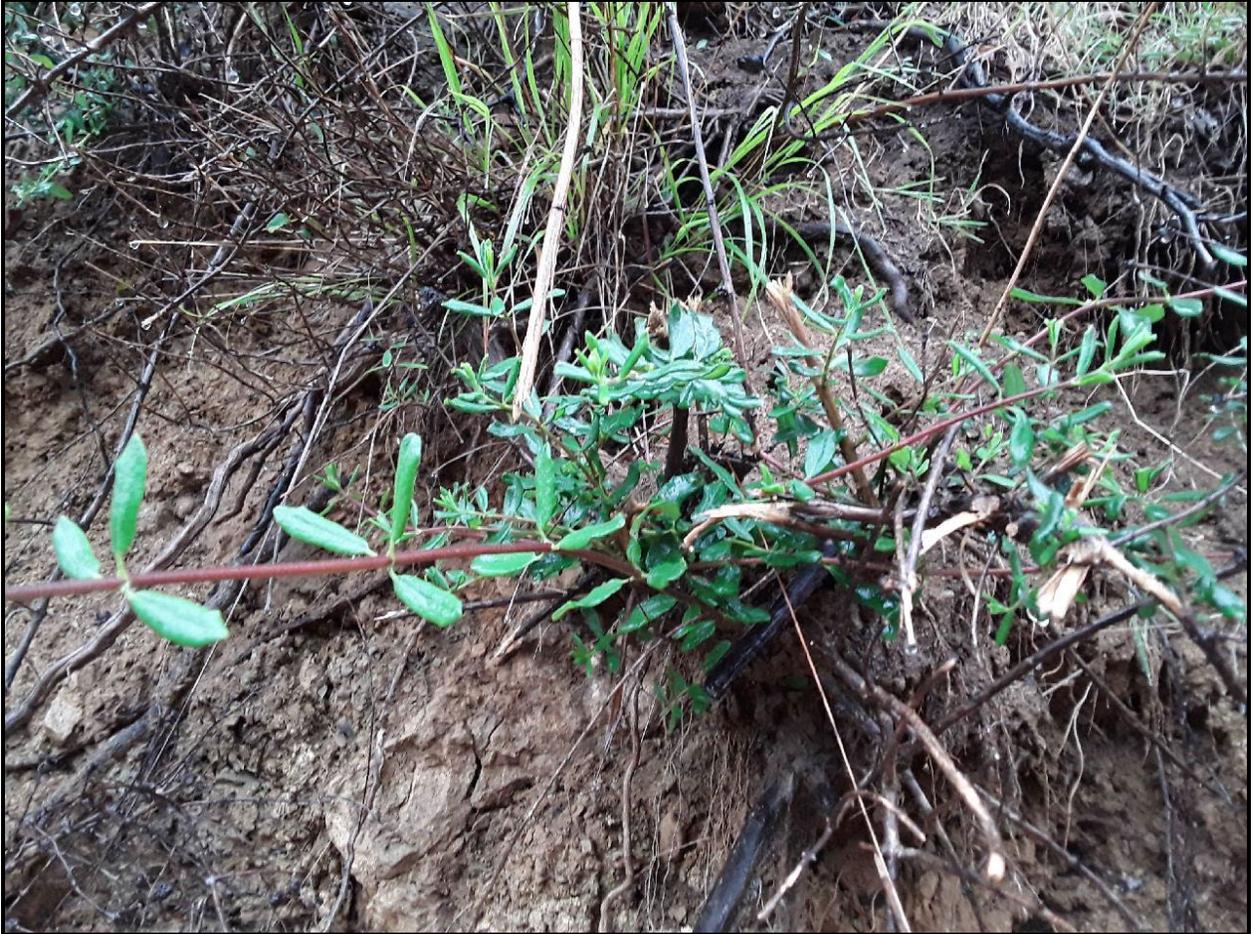
**Photograph B-9. Santa Barbara honeysuckle (*Lonicera subspicata* var. *subspicata*) hanging by roots on cliffside on Spyglass Ridge Road less than 0.5 mile from gate entrance.**

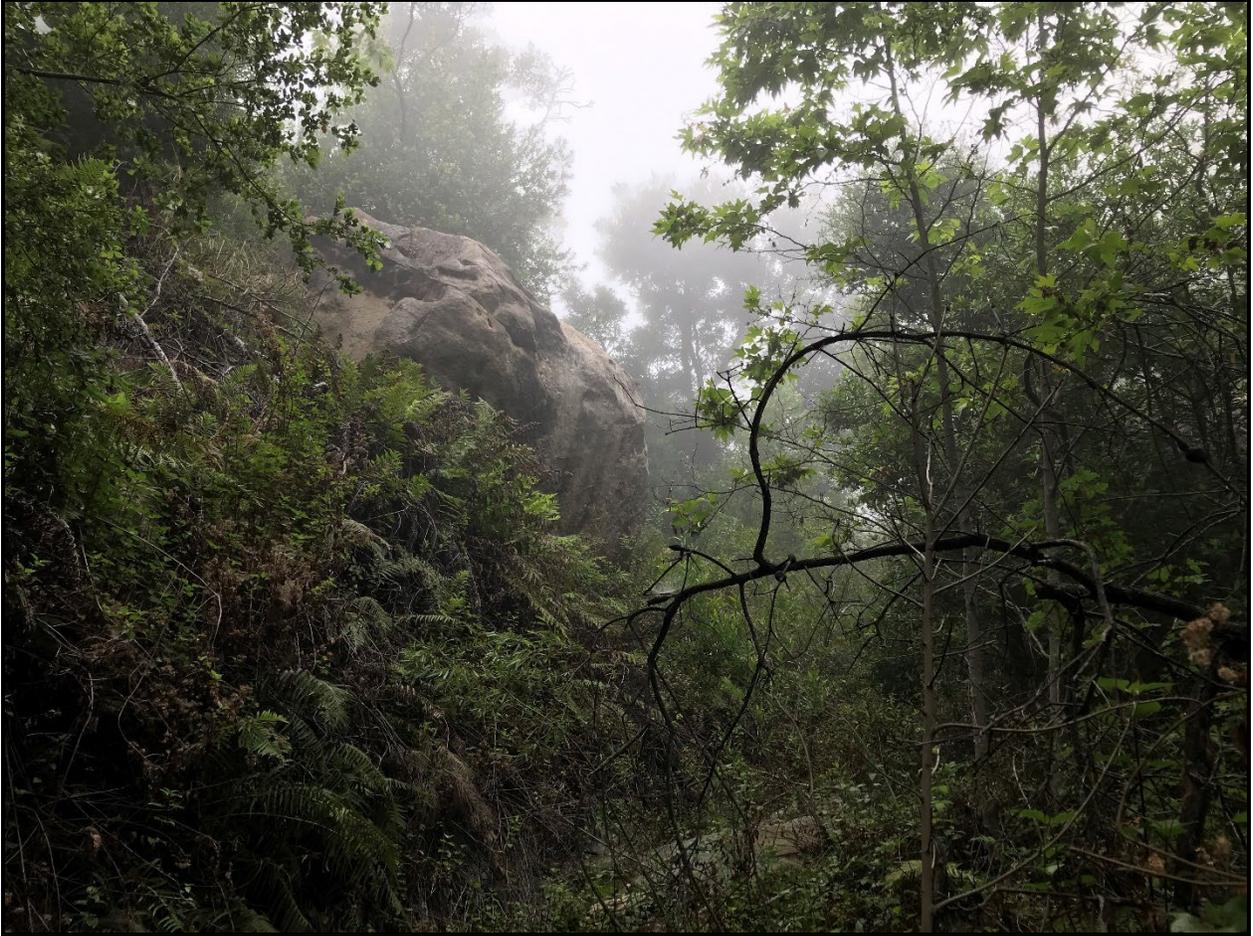
**Photograph B-18. One of several steelhead trout barriers observed along Mission Creek south of Mission Creek Bridge and upstream of the fish observations; photograph taken April 2020.**

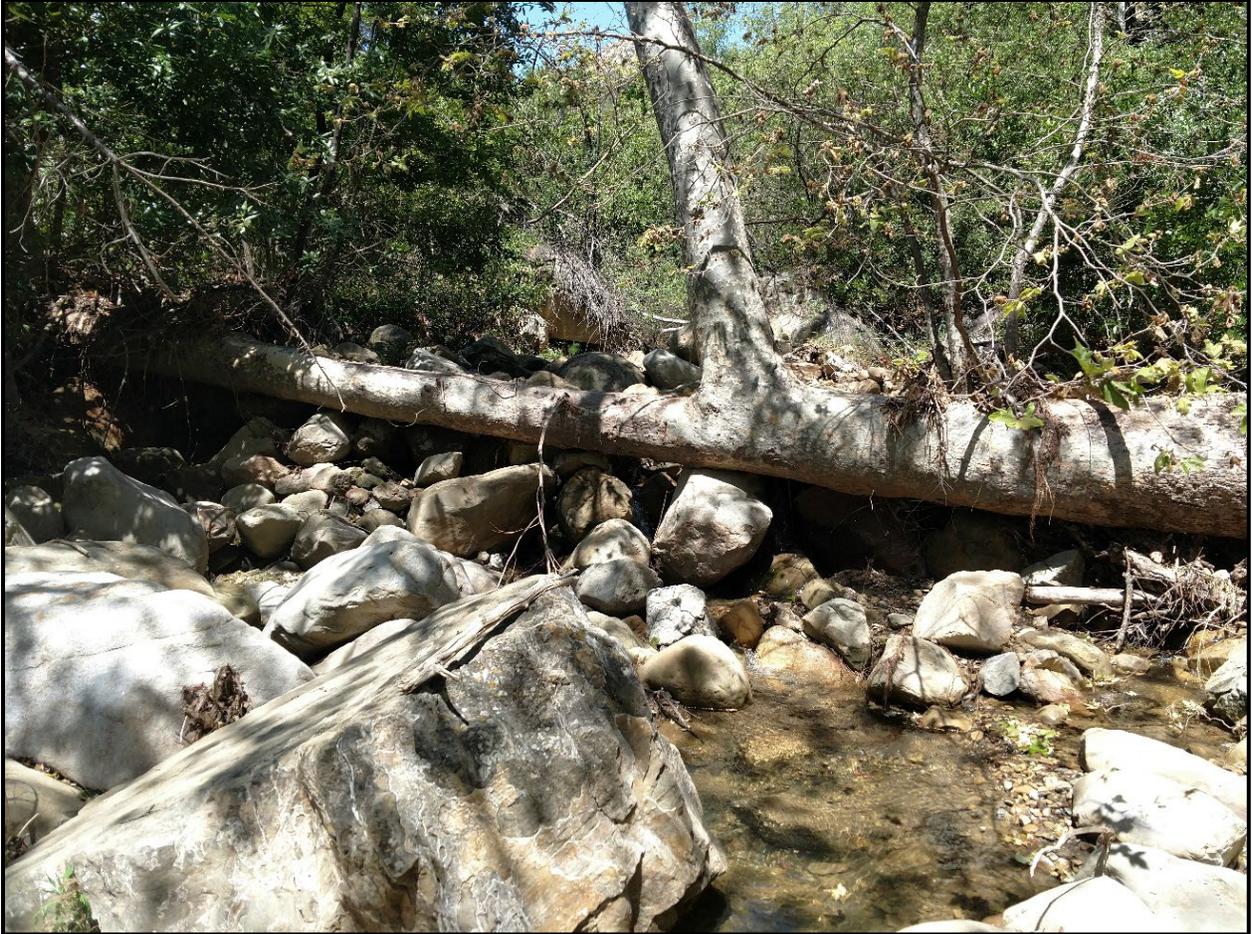
**Photograph B-19. Example of several steelhead trout barriers observed along Mission Creek south of Mission Creek Bridge and near the fish observations; photograph taken April 2020.**

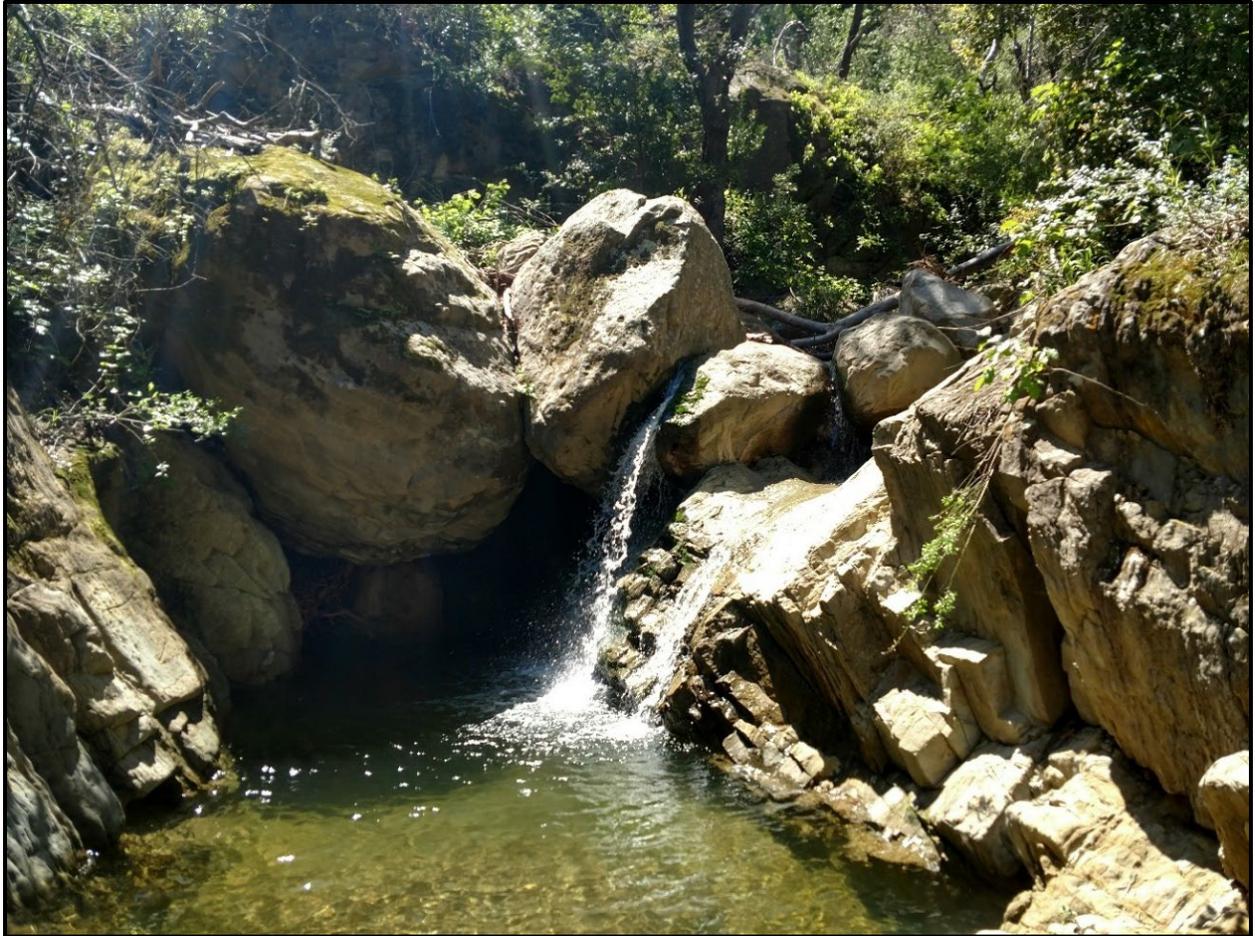
**Photograph B-20. One of the human-made barriers observed along Mission Creek south of Mission Creek Bridge and downstream of the fish observations; photograph taken April 2020.**

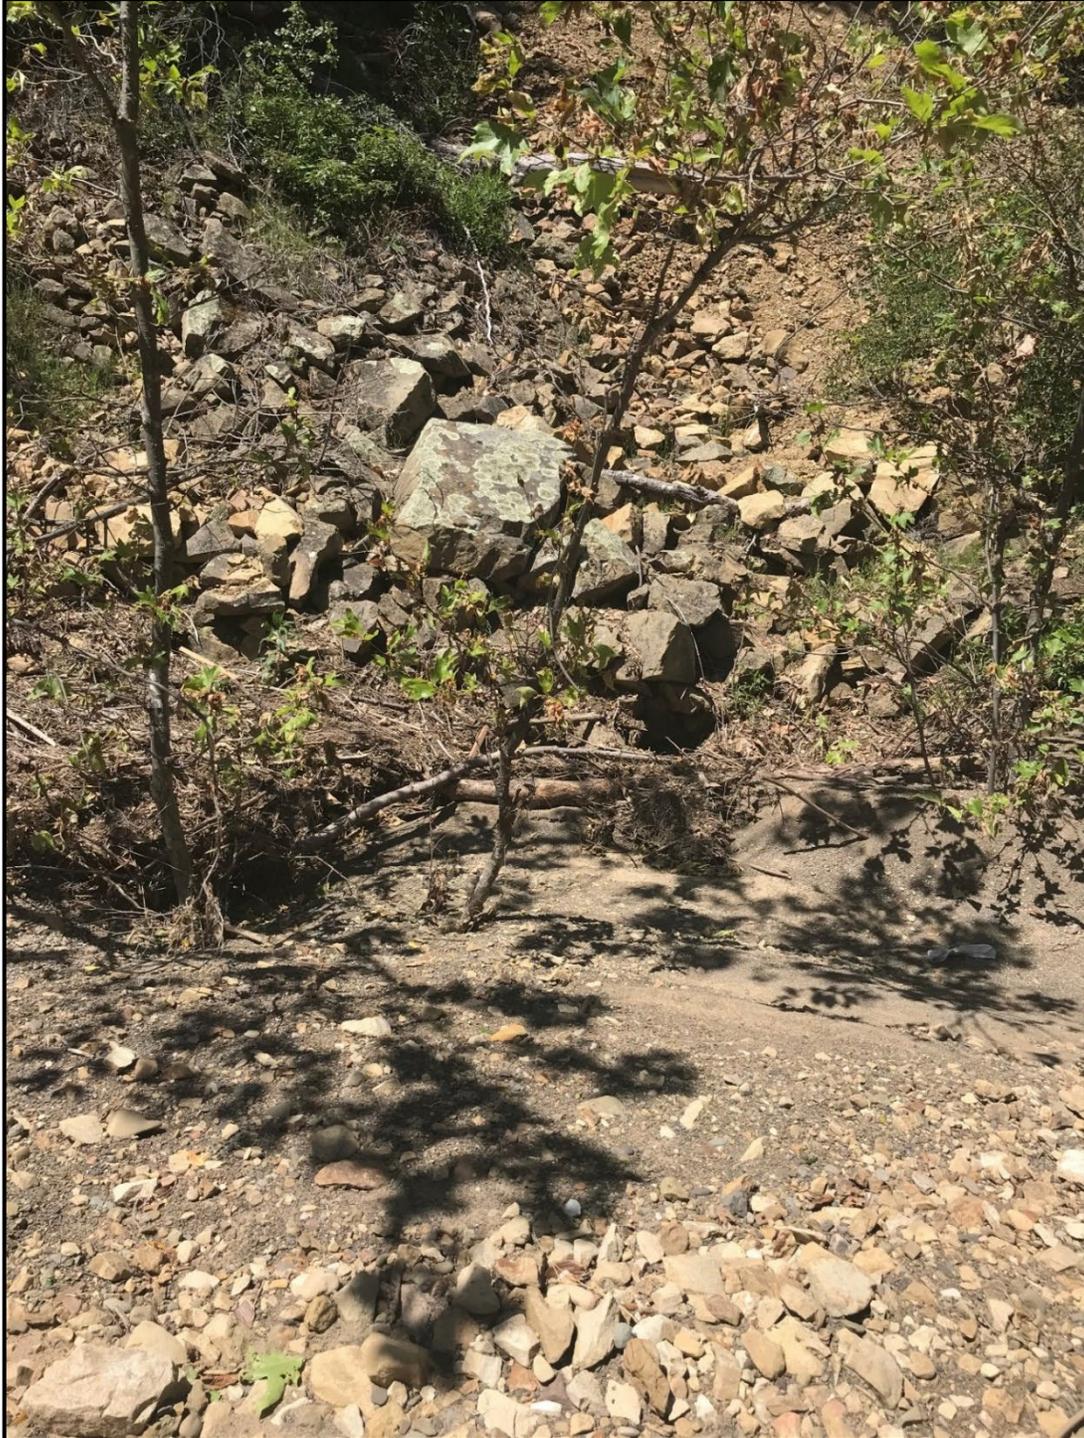
**Photograph B-26. Impacted habitat downstream of Creek Site 3 and 4, facing west toward slide; no surface flow evident in this section of stream because of project impacts; photograph taken April 2020.**

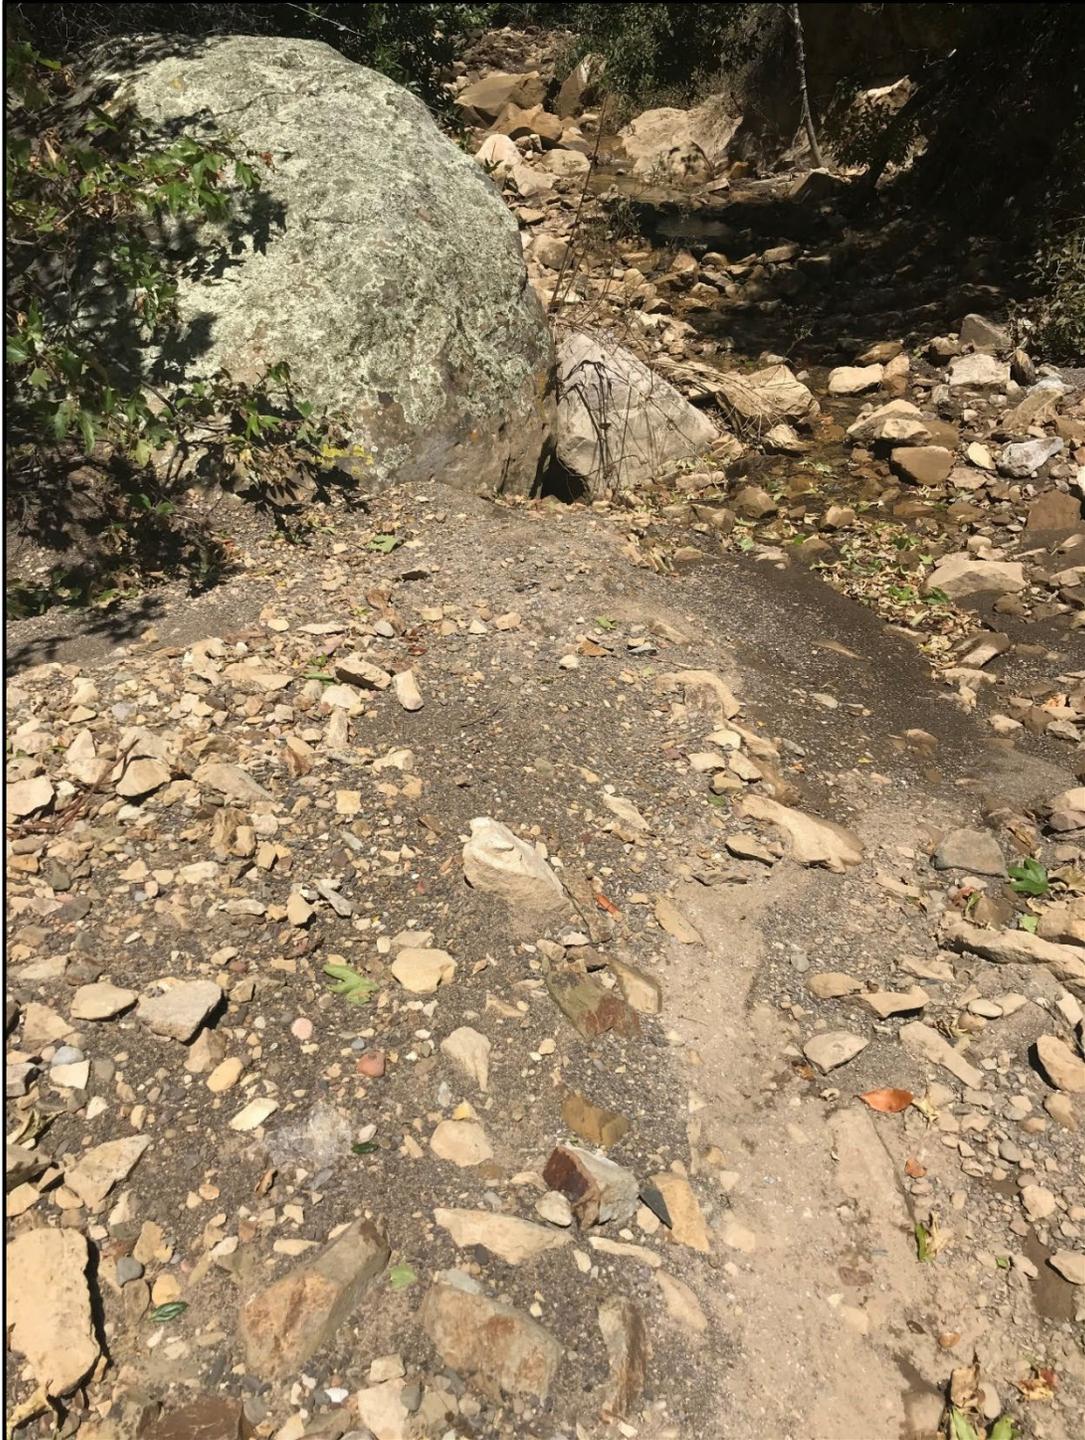
**Photograph B-27. Impacted habitat downstream of Creek Site 3 and 4, facing north toward bridge; surface flow going underground upstream of project impacts; photograph taken April 2020.**

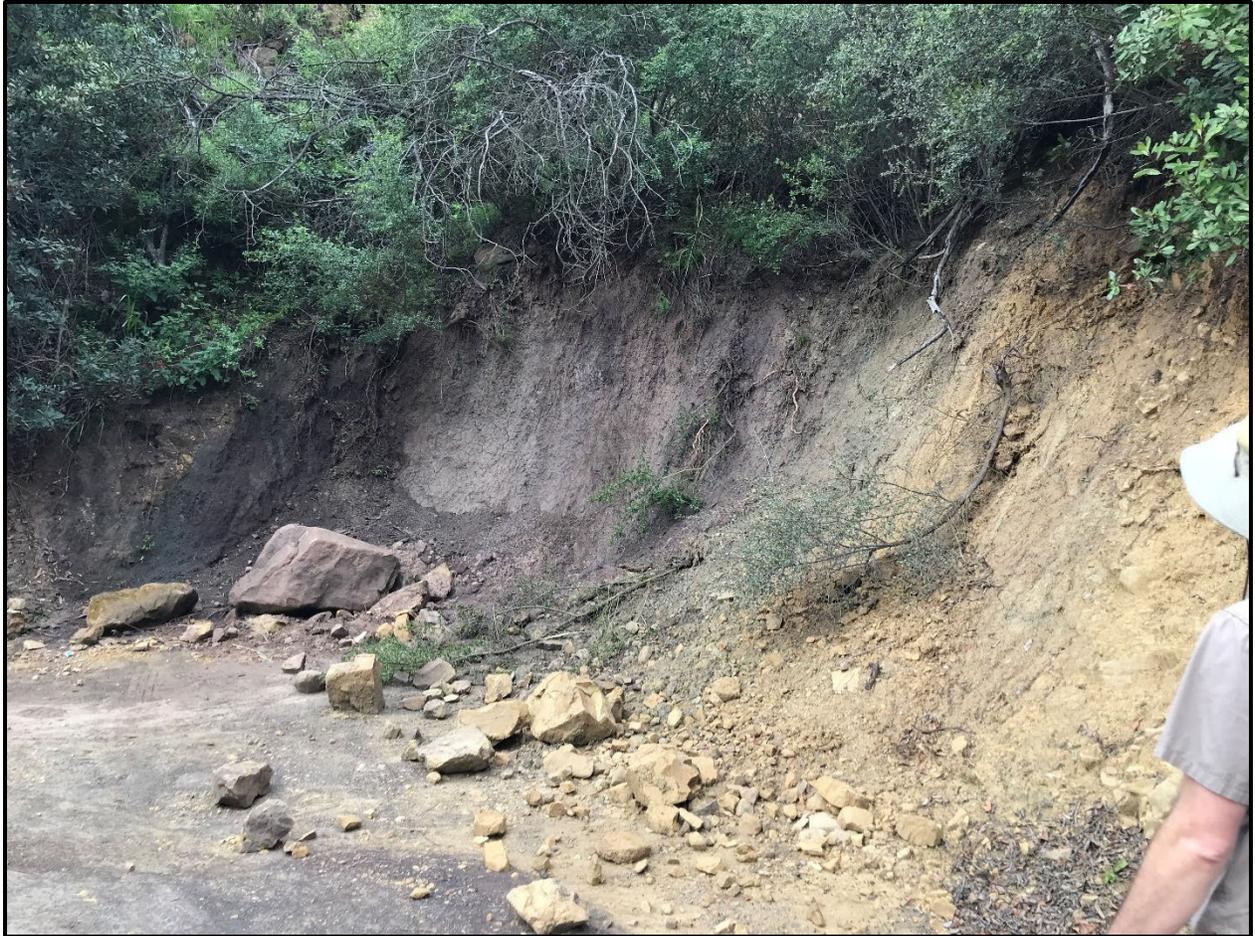
**Photograph B-29. Fallen shrubs, rock debris, and topsoil; vulnerable to further erosion due to an unstable cut rock wall; photograph taken April 2020.**

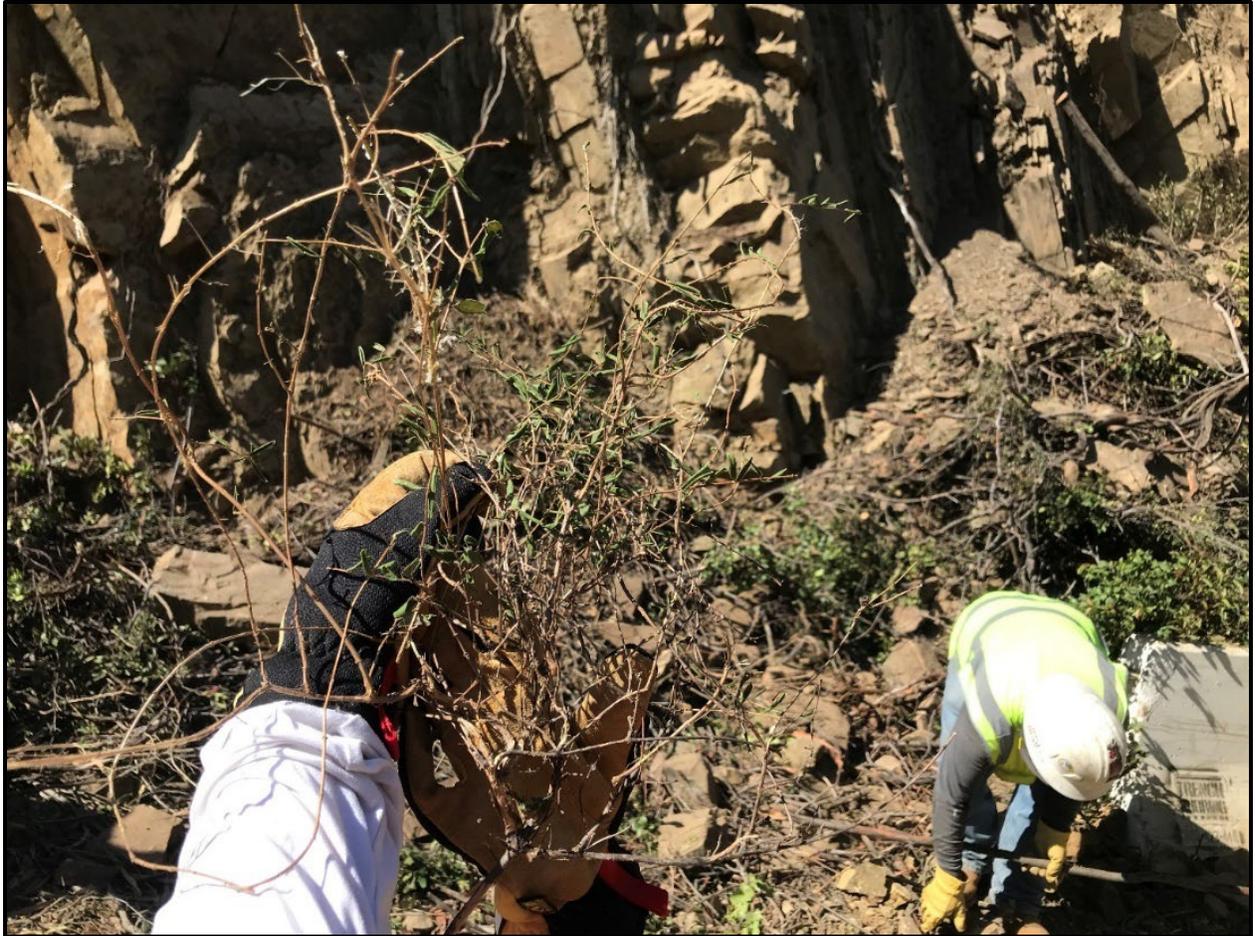
**Photograph B-30. A Santa Barbara honeysuckle individual inventoried as part of a pile of vegetation downed from the rock wall.**

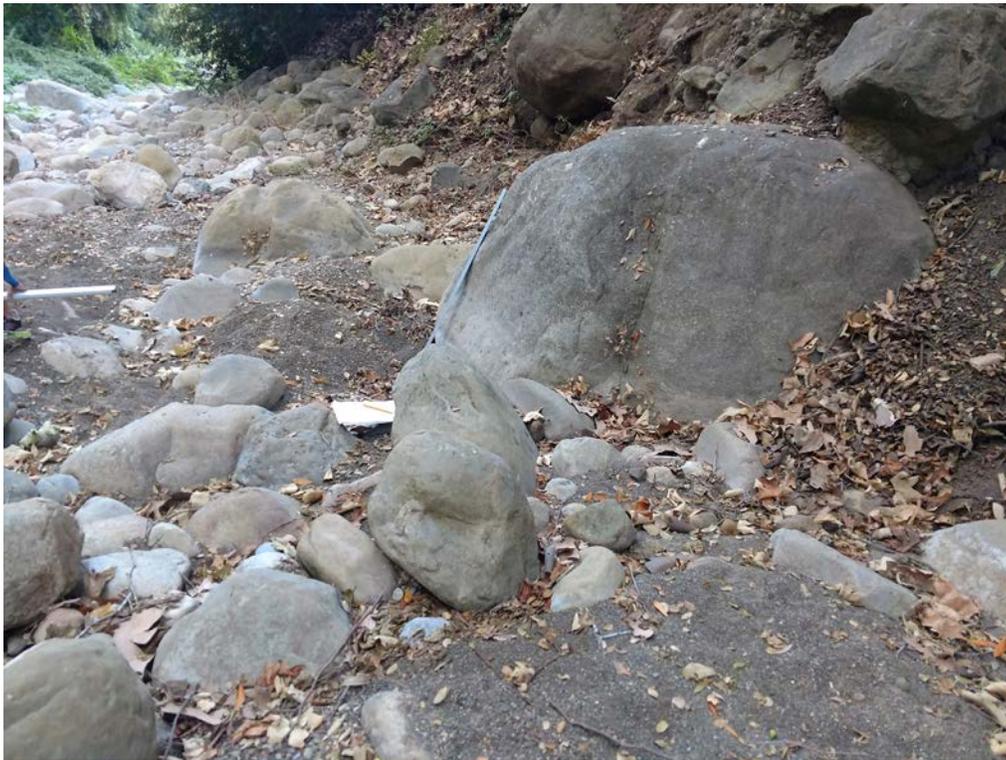
Photo 1. Habitat unit #3, boulder formed scour pool. Sidecast sediment visible in D/S end of pool. Photo facing D/S.

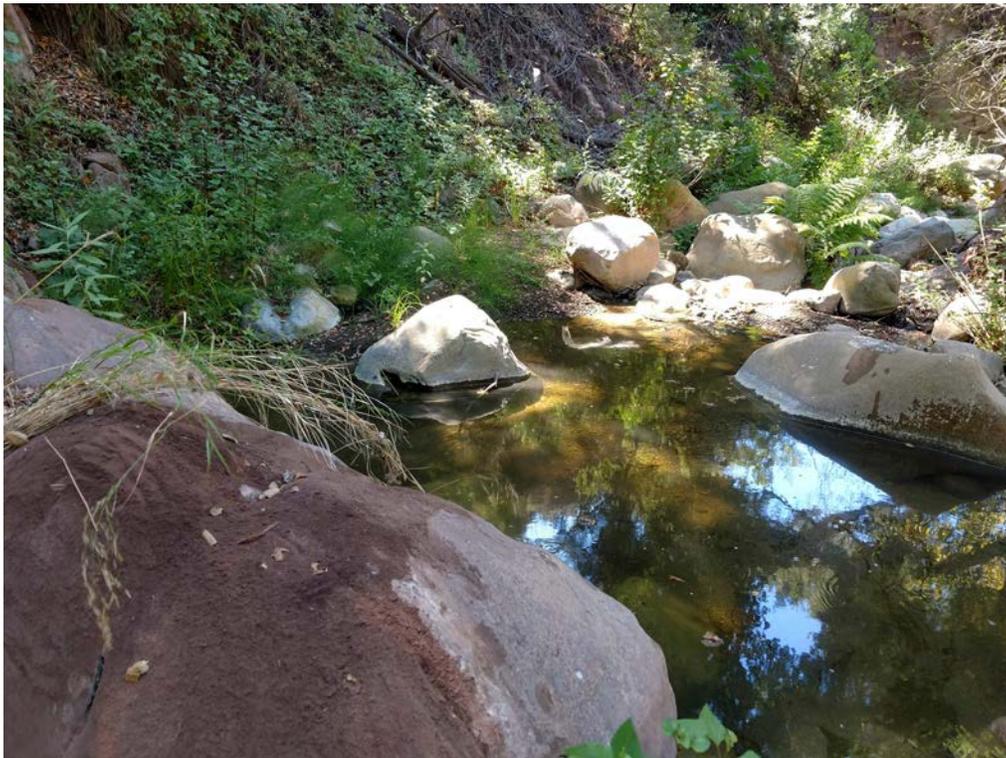
Photo 2. Habitat unit #36, bedrock formed scour pool. No sidecast sediment. Photo facing D/S.

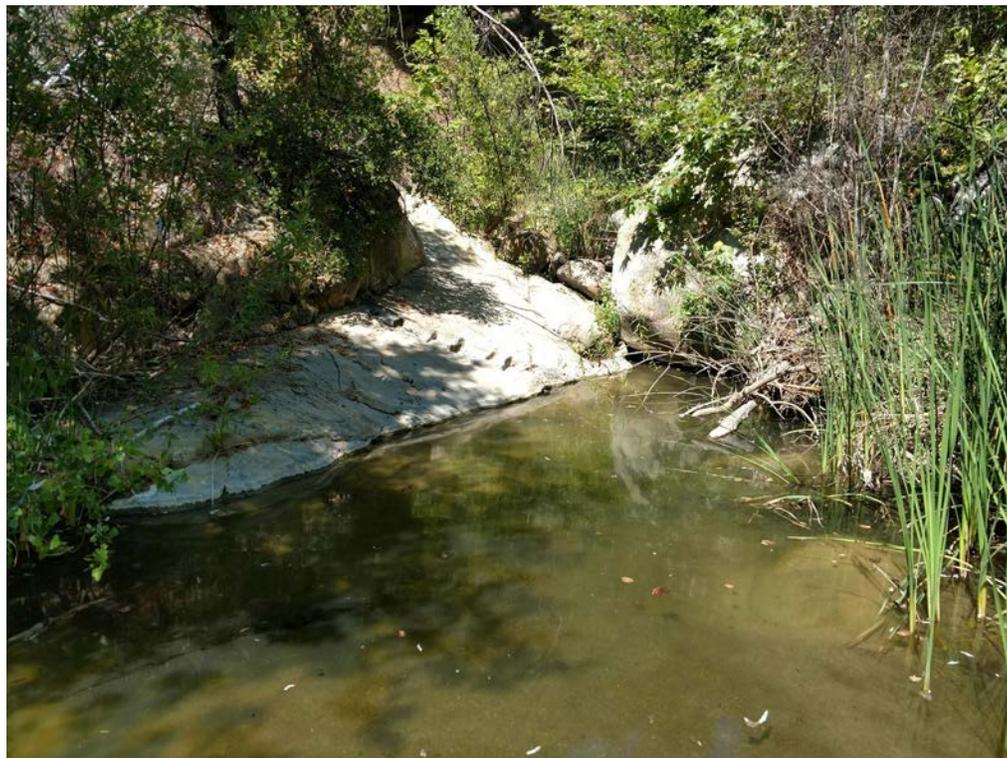
Photo 3. Habitat unit #81, mid-channel pool. No sidecast sediment. Photo facing U/S.

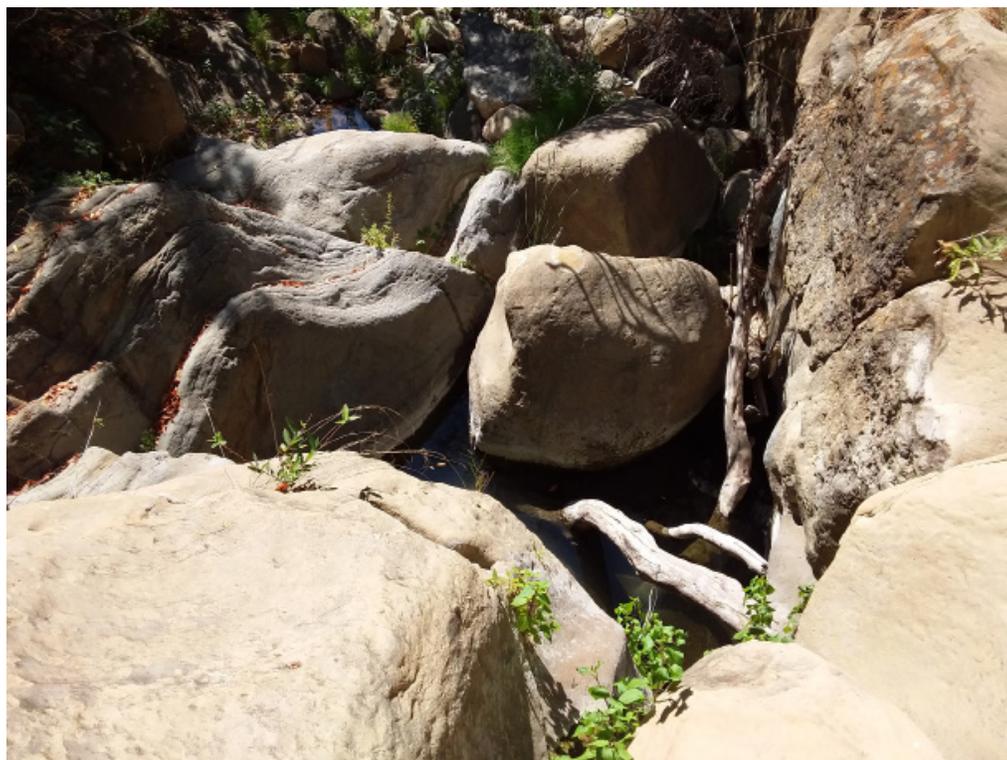
Photo 4. Habitat unit #96, plunge pool at base of waterfall. No sidecast sediment. Photo facing D/S.

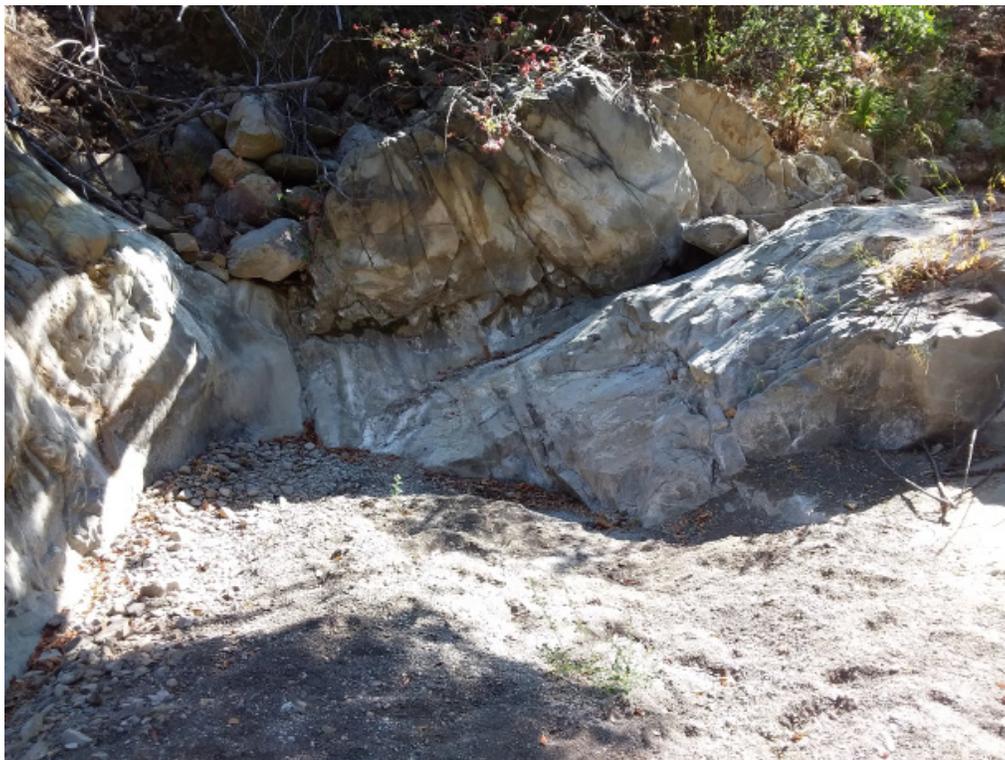
Photo 5. Habitat unit #110, bedrock formed scour. Sidecast sediment visible U/S end of pool (R edge), base of pool, and D/S end of pool (L edge). Photo facing U/S.

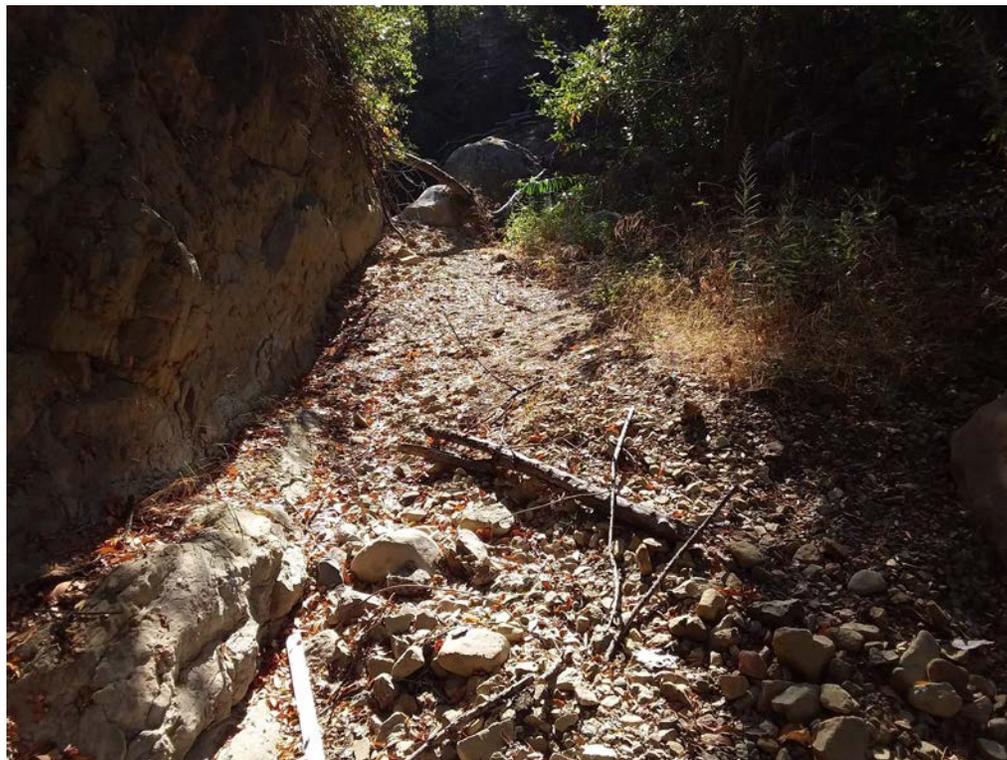
Photo 7. Habitat unit #117, bedrock formed scour pool/corner pool. Sidecast sediment visible in center of pool bottom and small cobbles and boulders on the outer edges. Photo facing D/S.

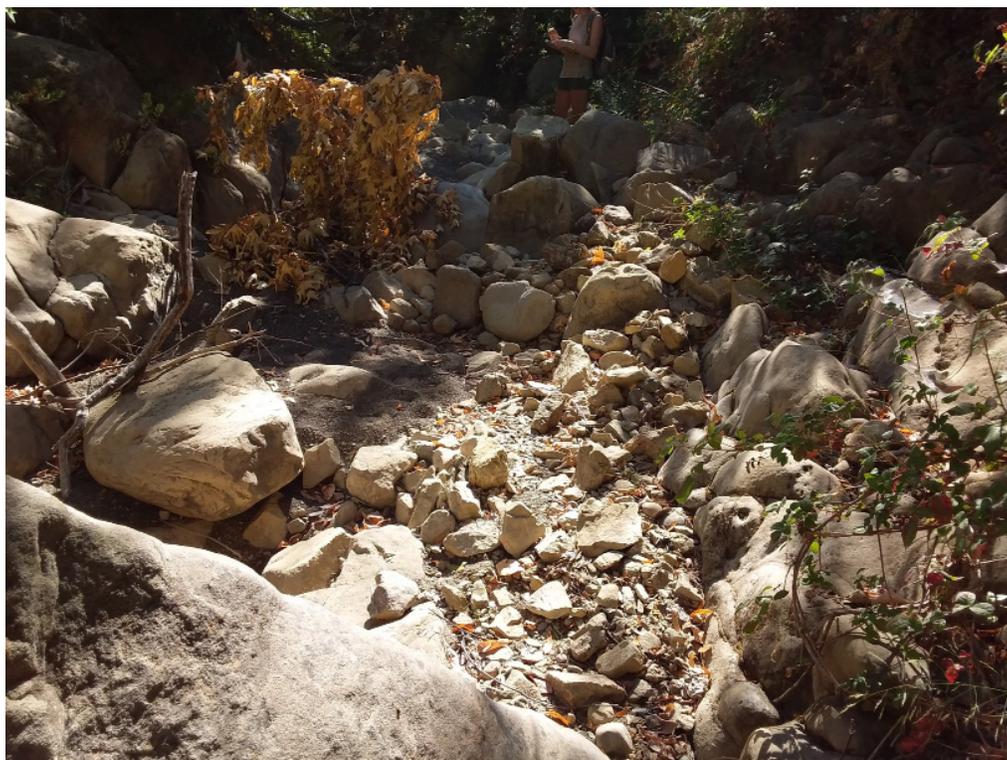
Photo 8. Habitat unit #120, plunge pool. Sidecast sediments, cobbles, and small boulders visible in center (R side) of pool. Photo facing D/S.

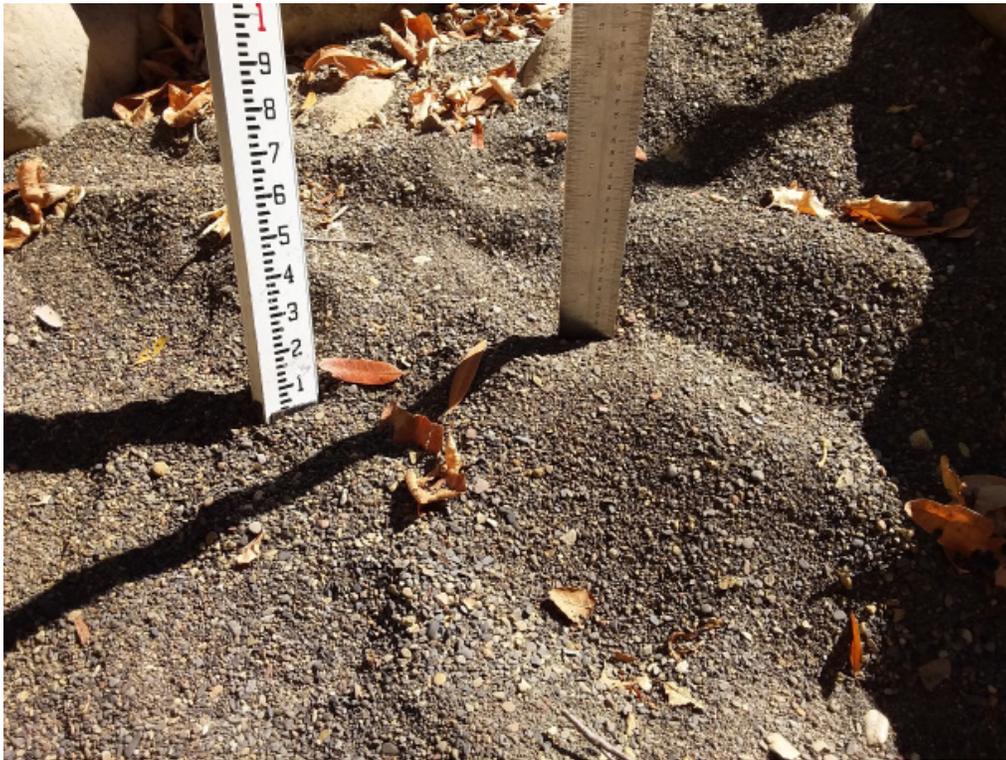
Photo 9. Habitat unit #120, closeup of sidecast fines and gravels measurement at base of pool. Photo facing U/S.

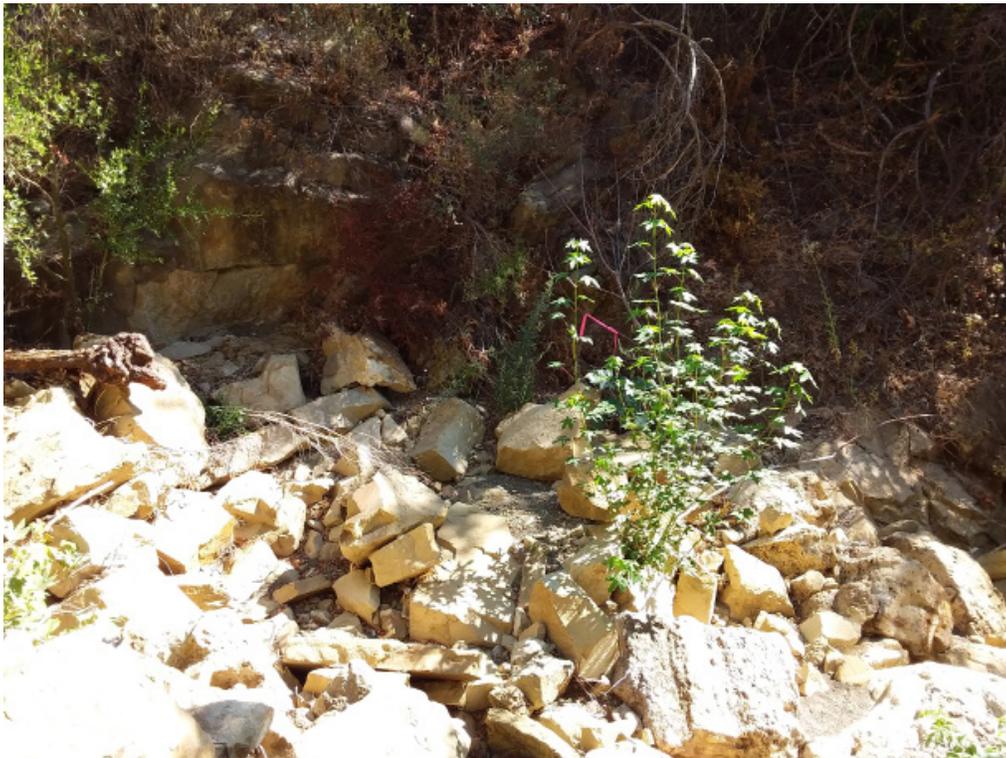
Photo 10. Habitat unit #122, cascade habitat at base of Creek Site 1. Sidecast boulders visible in creek. Photo taken from R bank looking across creek.

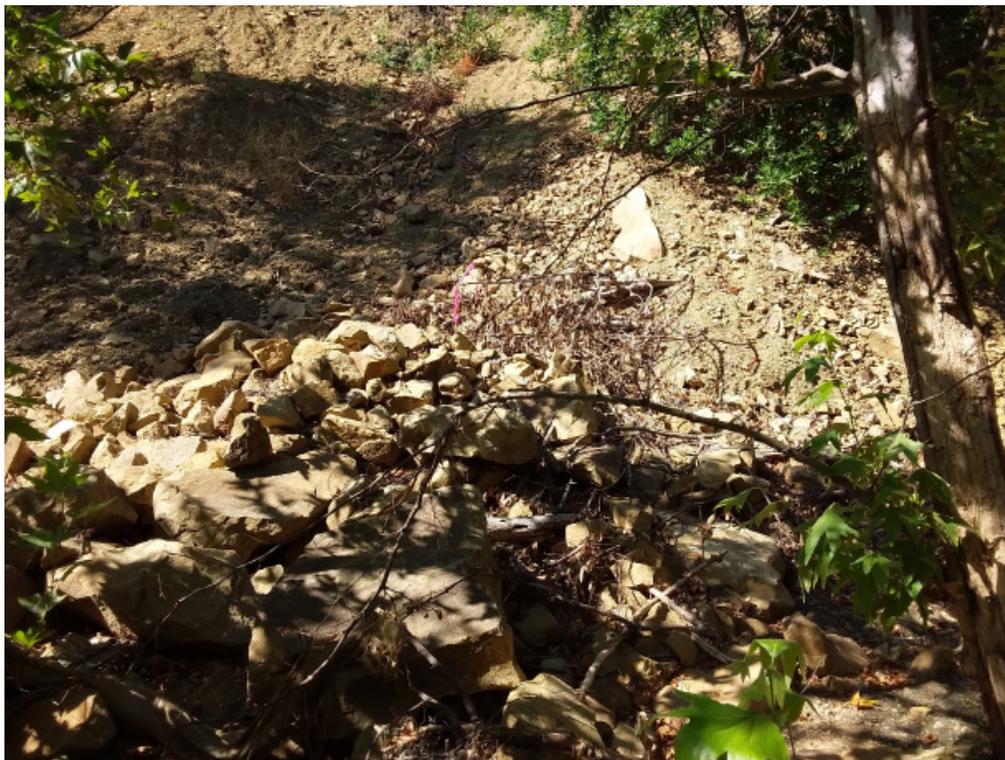
Photo 11. Habitat unit #122, Creek Site 1 transect 2 location. Sidecast boulders, cobbles, gravels, and fines on the R bank above the creek. Photo taken from creek looking at the R bank.

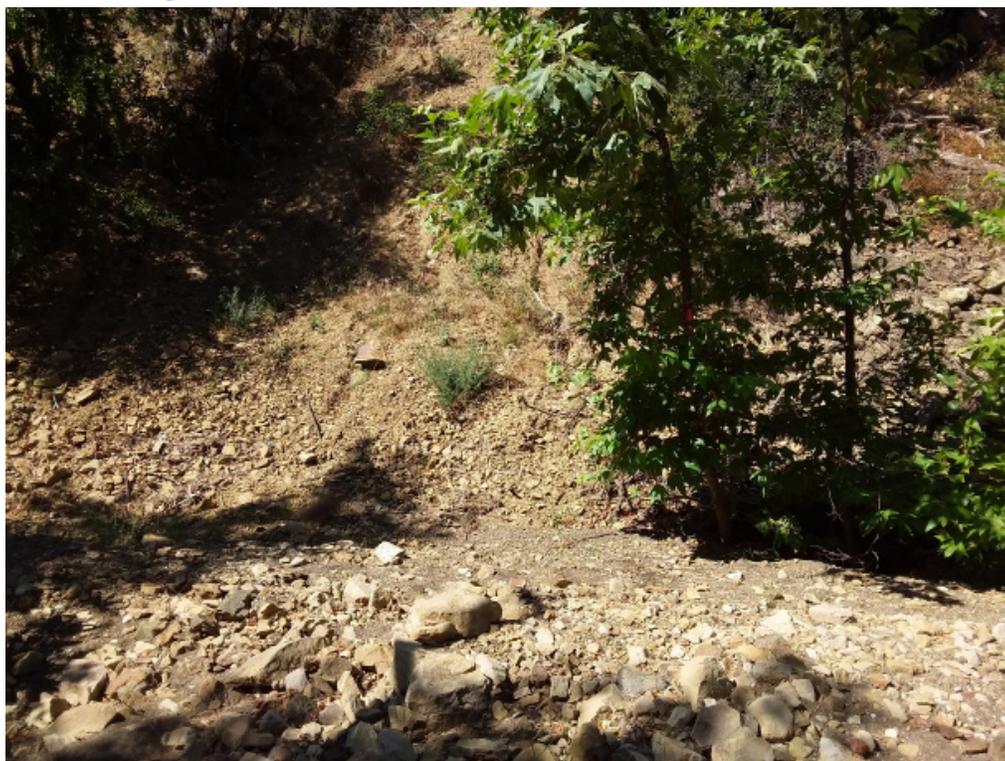
Photo 12. Habitat unit #123, run habitat at base of Creek Site 2. Sidecast fines, gravel, cobble, and small boulders visible in creek. Photo taken from L bank looking across creek.

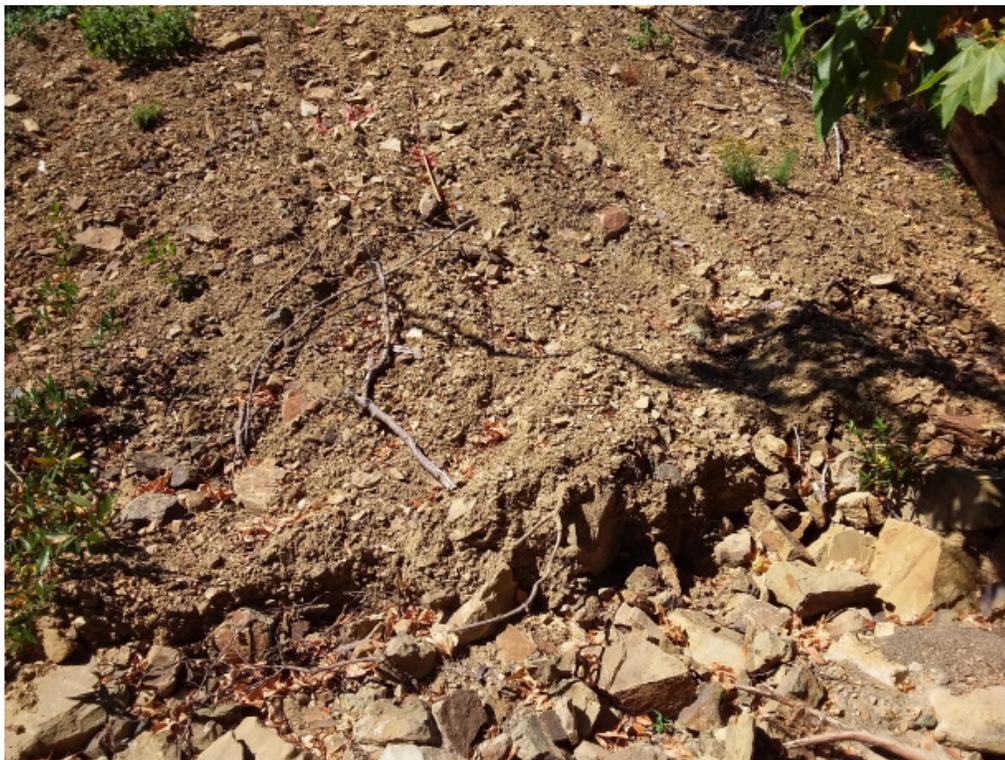
Photo 13. Habitat unit #123, Creek Site 2 sidecast deposit transect 3 location. Sidecast fines, gravel, cobble, and small boulders on the R bank. Photo taken from creek looking at R bank.

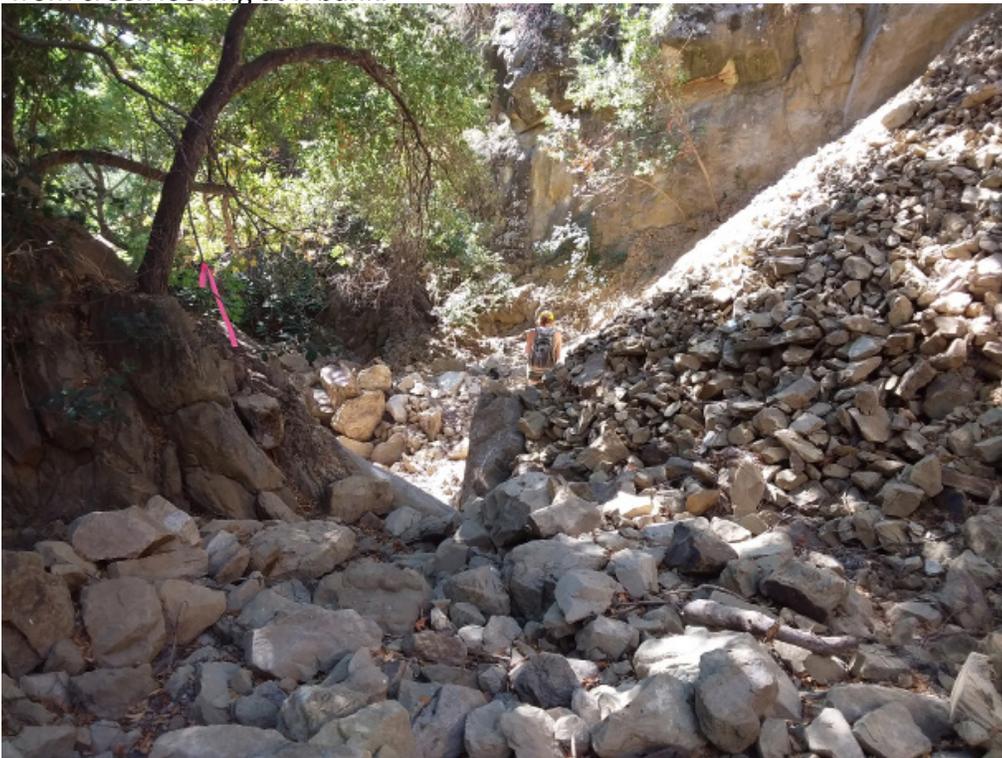
Photo 14. Habitat unit #124, low gradient riffle habitat at base of Creek Site 3, transect 4. Sidecast cobbles and boulders in creek. Photo facing D/S.

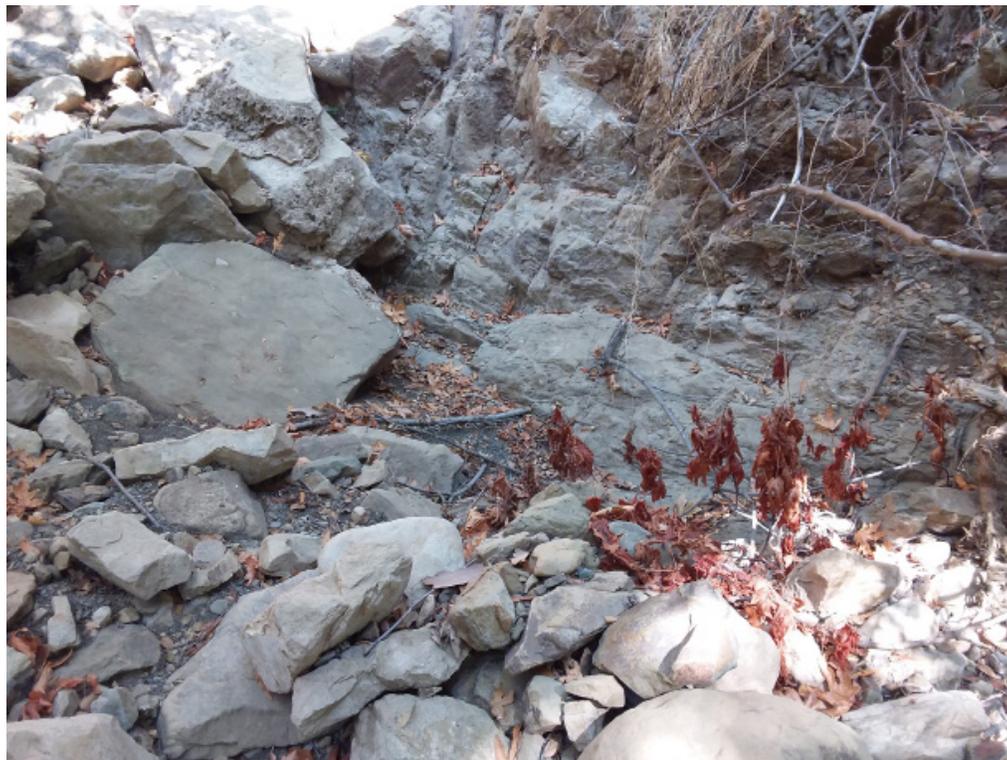
Photo 15. Habitat unit #125, first of two pools formed due to large sidecast boulders and cobbles dam. Photo facing U/S.
