# Final Mission Creek Habitat Restoration Project Biological Technical Report

**Southern California Edison  
Environmental Services Department**

**SWCA Environmental Consultants**

# MISSION CREEK HABITAT RESTORATION PROJECT BIOLOGICAL TECHNICAL REPORT

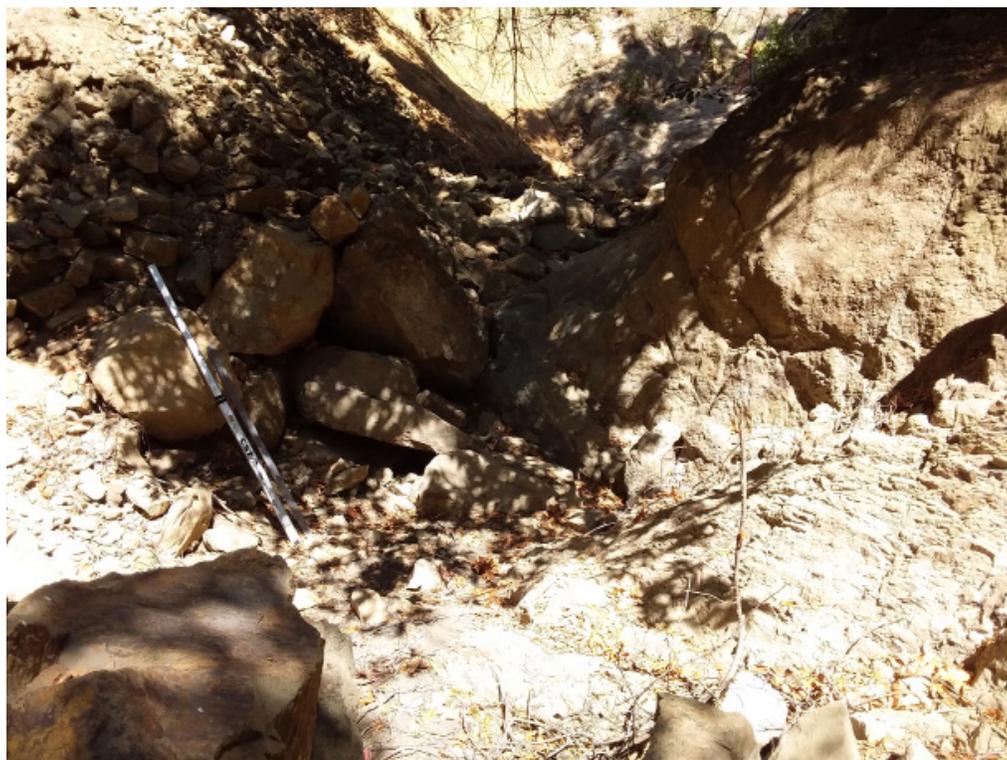
Photo 16. Habitat unit #126, second of two pools formed due to large sidecast boulders and cobbles dam. Photo facing D/S.

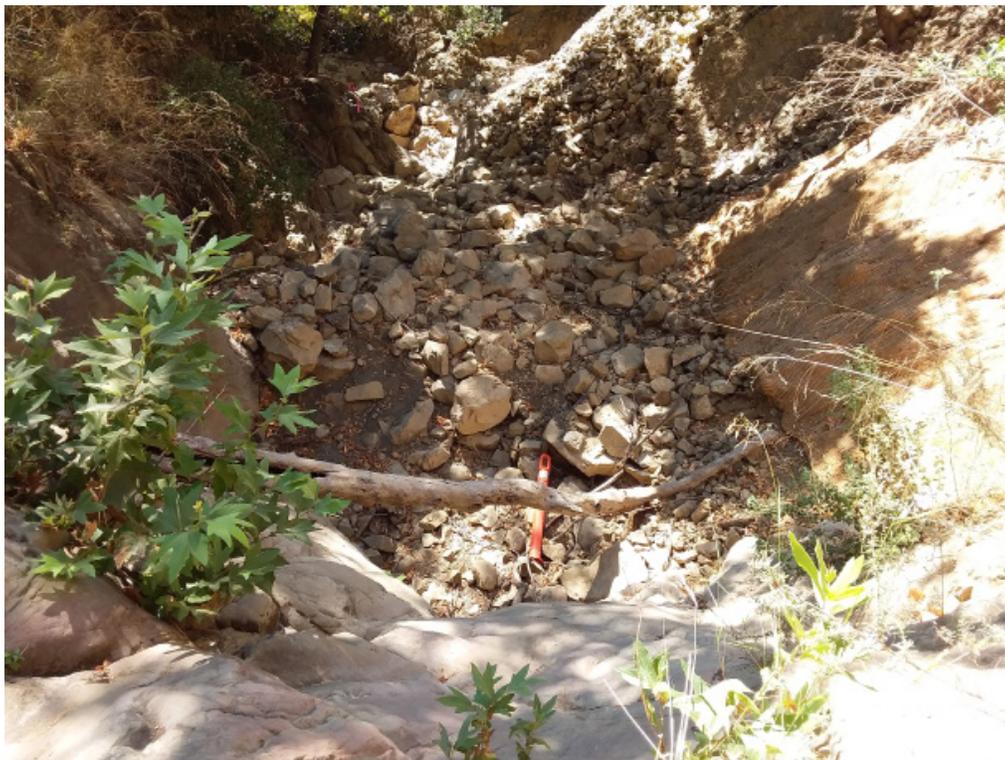
Photo 17. Habitat unit #127, plunge pool at base of Tunnel Road Falls, Creek Site 3. Large sidecast boulders, cobbles, gravels, and fines visible at bottom and outer edges of pool. Photo facing D/S.

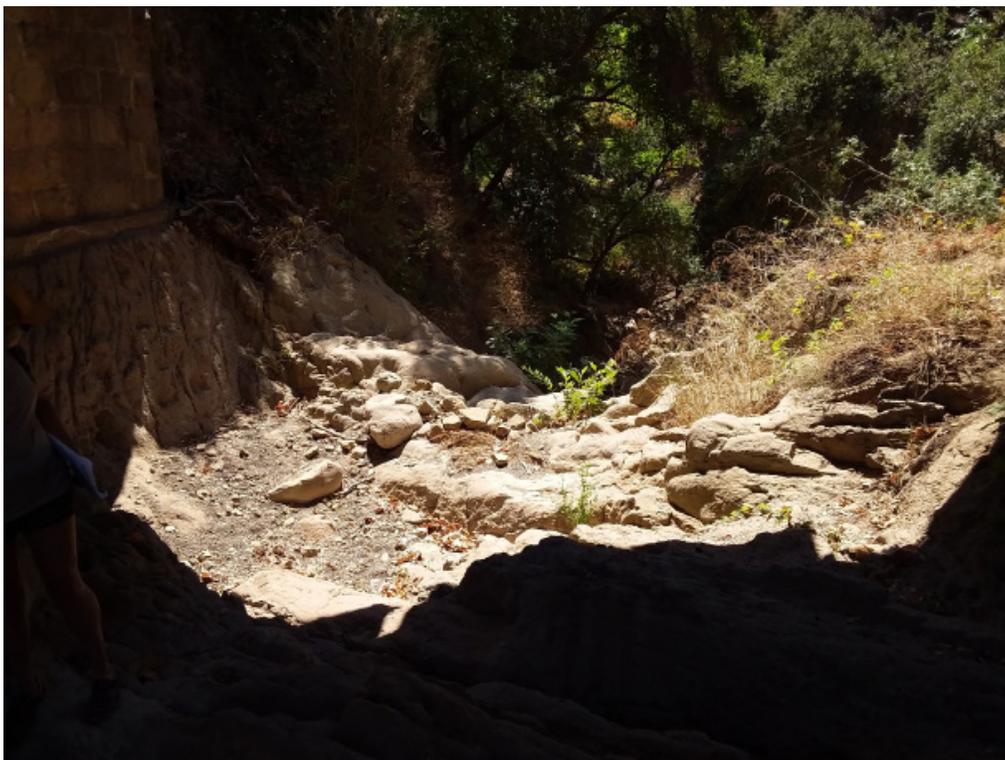
Photo 18. Habitat unit #128, plunge pool underneath bridge. Sidecast boulders, gravels, and fines visible toward outer edges of pool. Photo facing D/S.

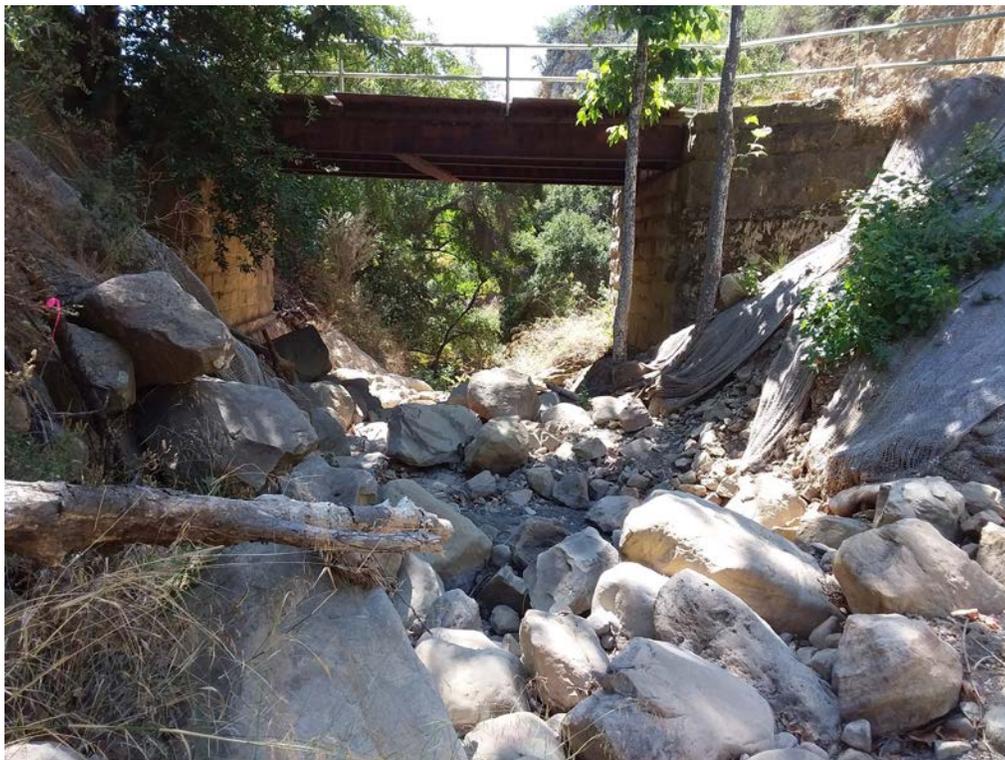
Photo 19. Habitat unit #129, step pools at the base of Creek Site 4. Sidecast boulders, cobbles, gravels and fines visible throughout creek. Photo facing D/S.

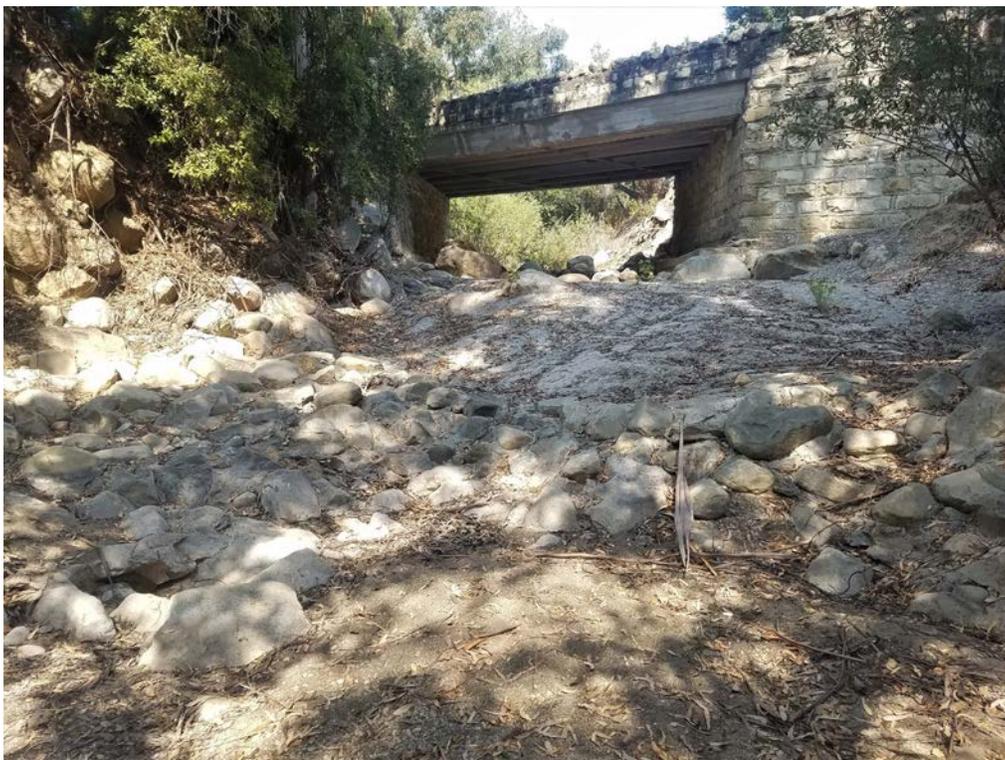
Photo 20. Highway 192 Bridge, Compensatory Mitigation Option 1 on Mission Creek. Photo facing U/S.

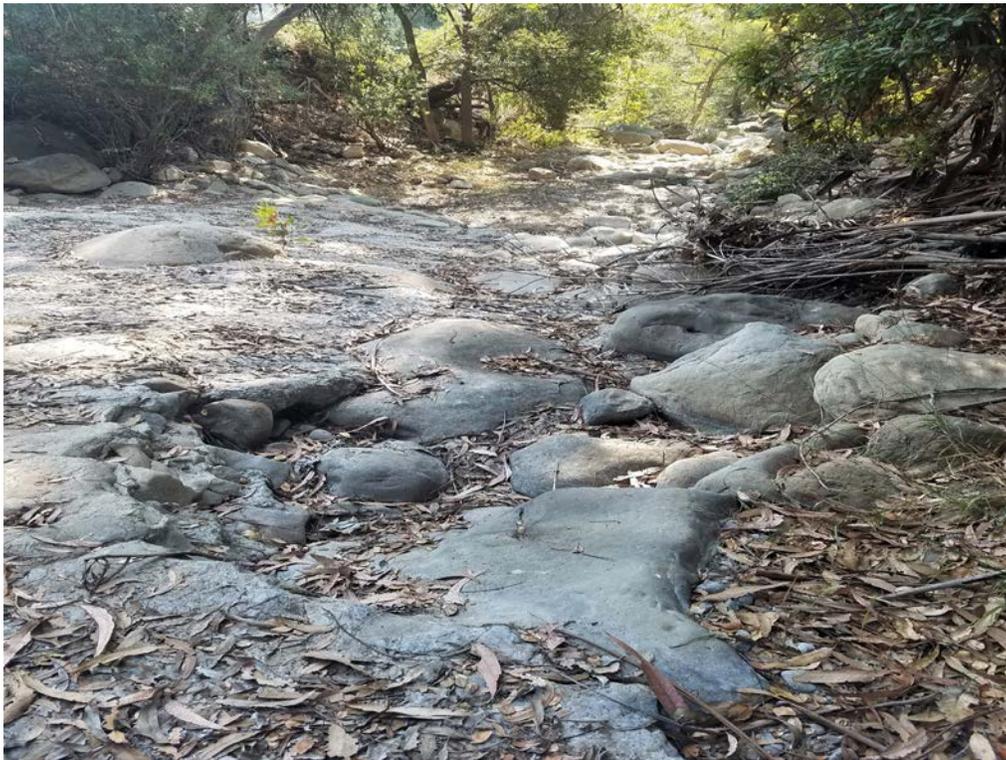
Photo 21. Wear on R side of concrete apron of the Highway 192 Bridge, Compensatory Mitigation Option 1. Photo facing D/S.

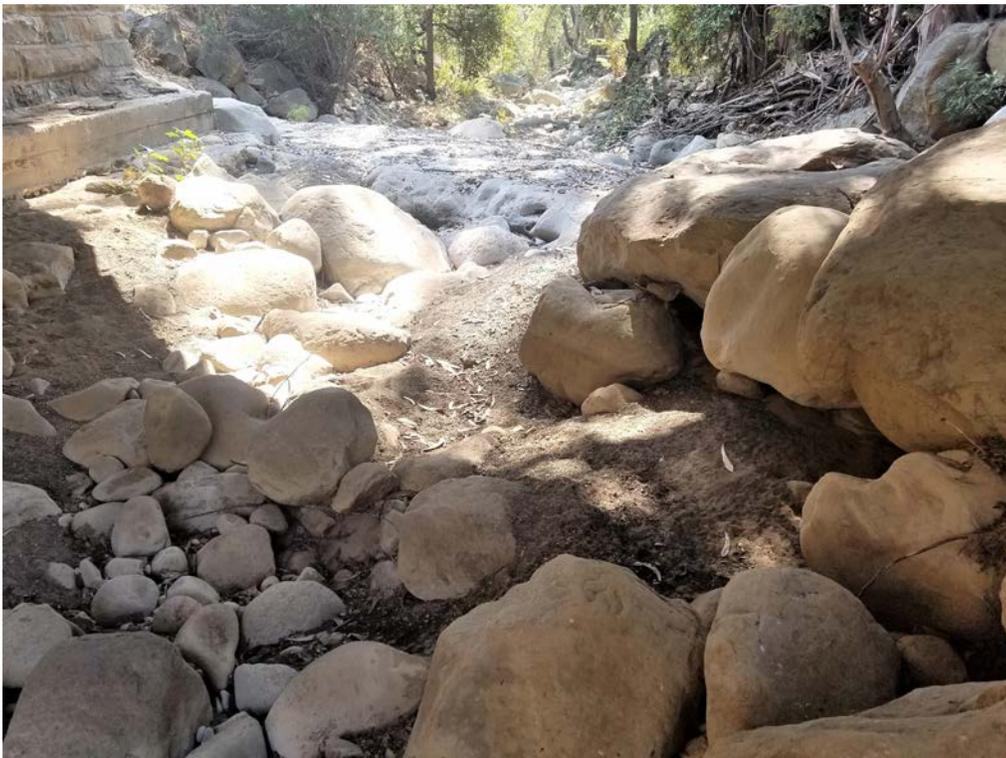
Photo 22. Scour pool habitat and boulders underneath Highway 192 Bridge, Compensatory Mitigation Option 1. Photo facing D/S.

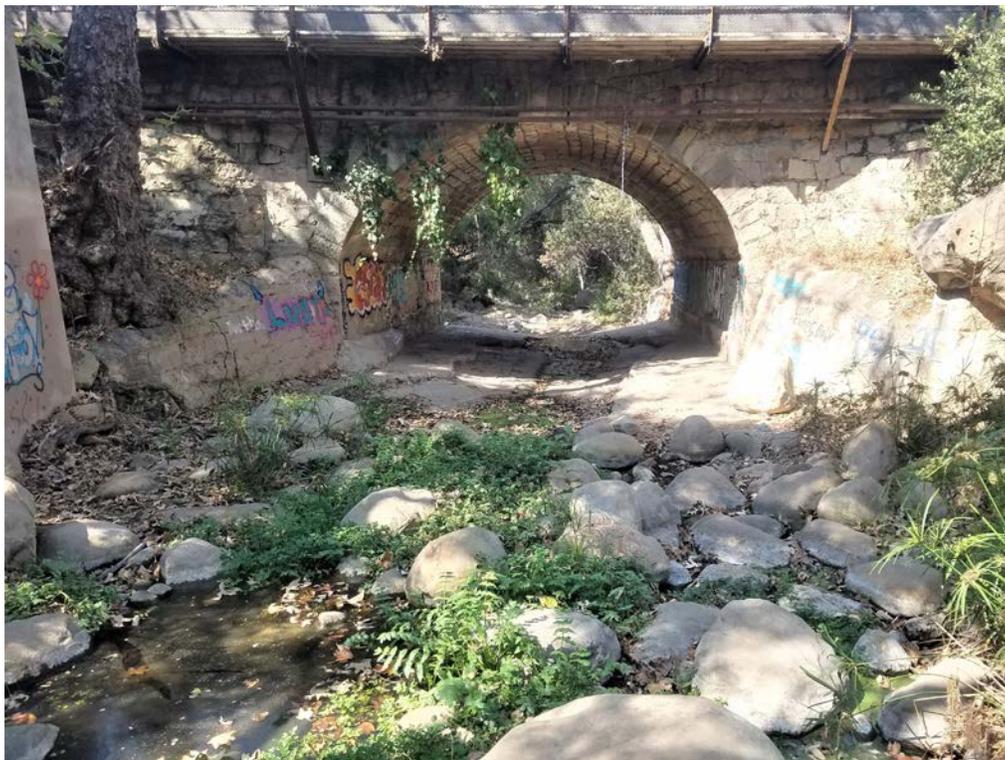
Photo 23. Mission Canyon Road Bridge, Compensatory Mitigation Option 2 on Mission Creek. Photo facing D/S.

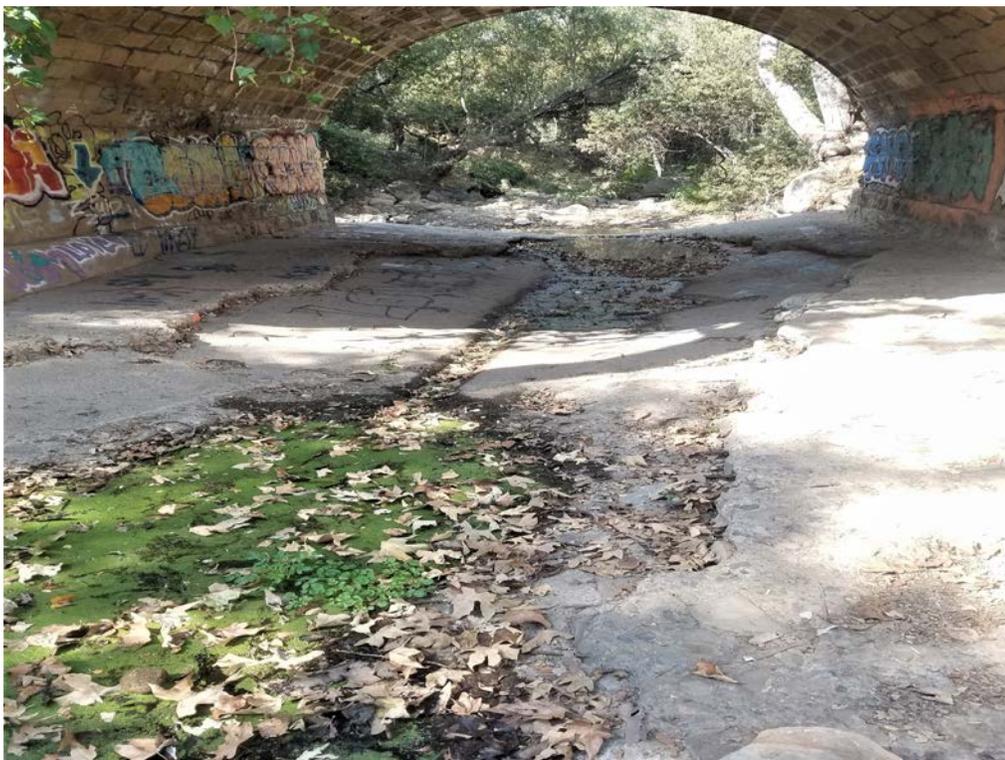
Photo 24. Concrete slough underneath Mission Canyon Road Bridge, Compensatory Mitigation Option 2 on Mission Creek. Photo facing D/S.

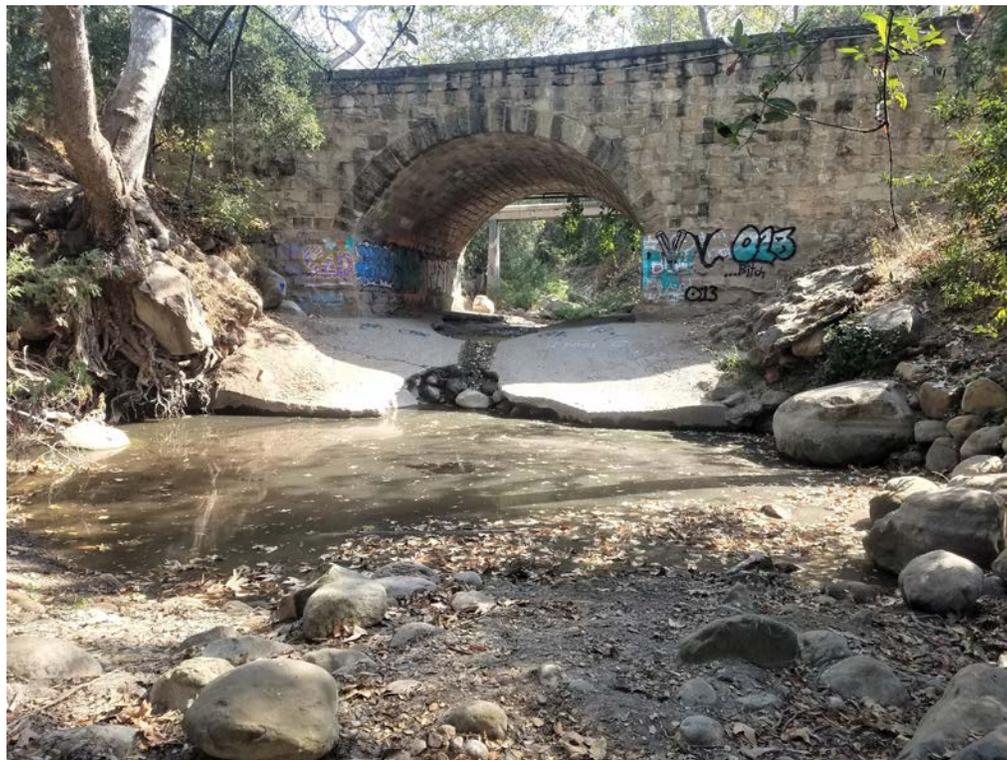
Photo 25. Plunge pool habitat and eroded apron on D/S end of Mission Canyon Road Bridge, Compensatory Mitigation Option 2 on Mission Creek. Photo facing U/S.

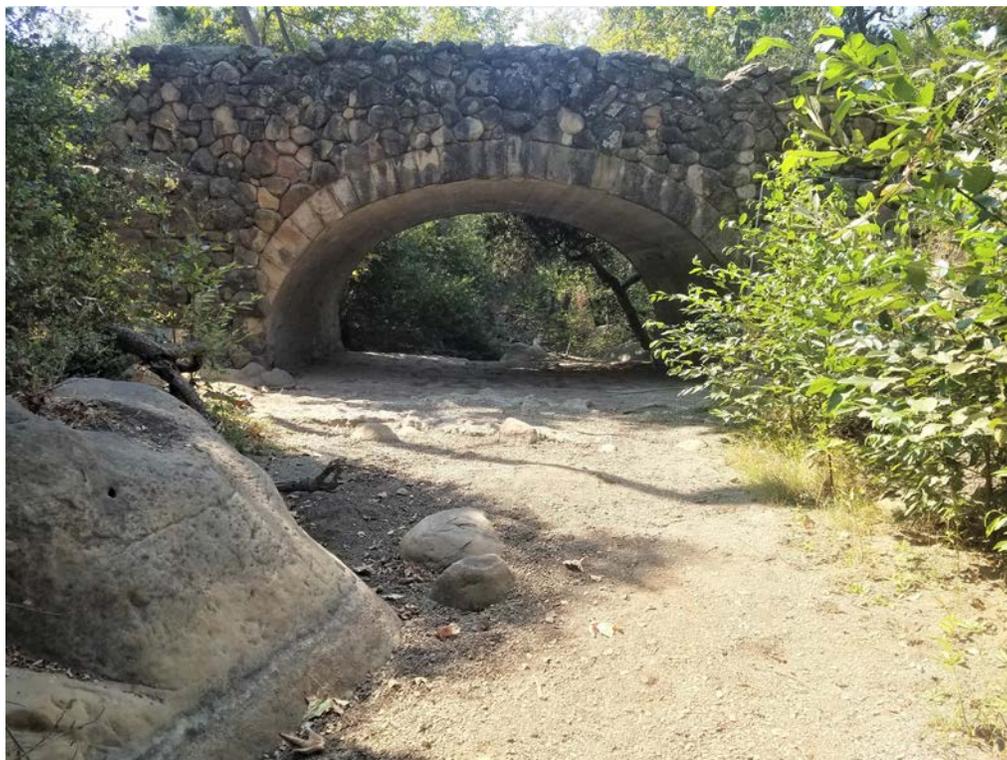
Photo 26. Las Canoas Road Bridge, Compensatory Mitigation Option 3, on Rattlesnake Creek. Photo facing D/S.

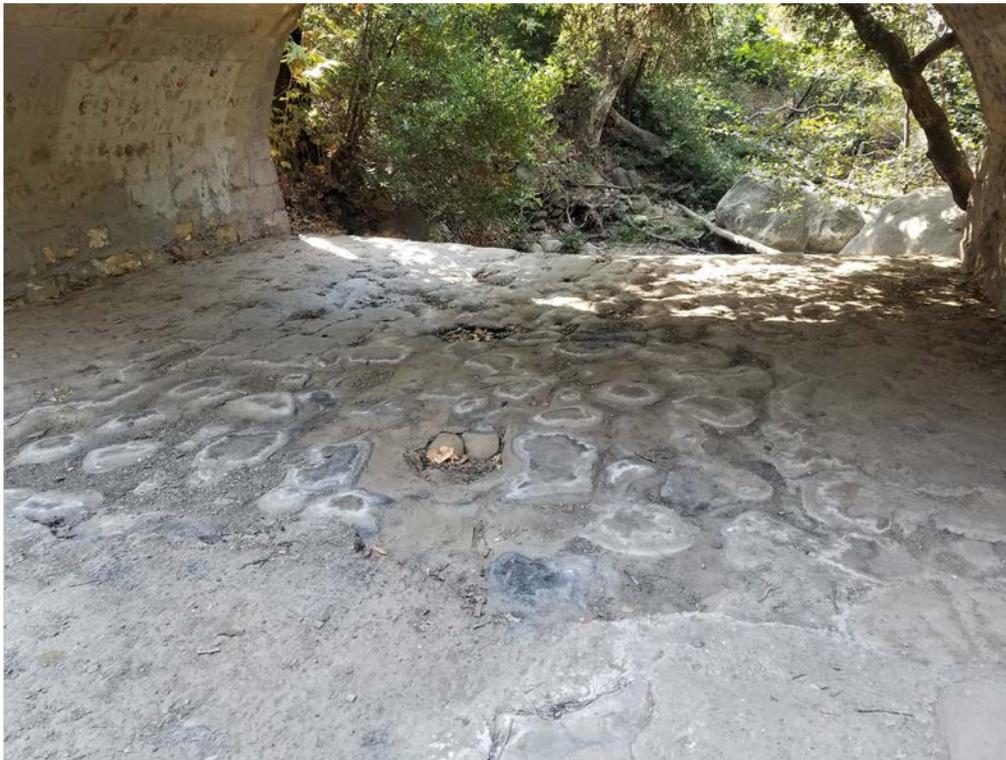
Photo 27. Flat concrete apron underneath Las Canoas Road Bridge, Compensatory Mitigation Option 3, on Rattlesnake Creek. Photo facing D/S.

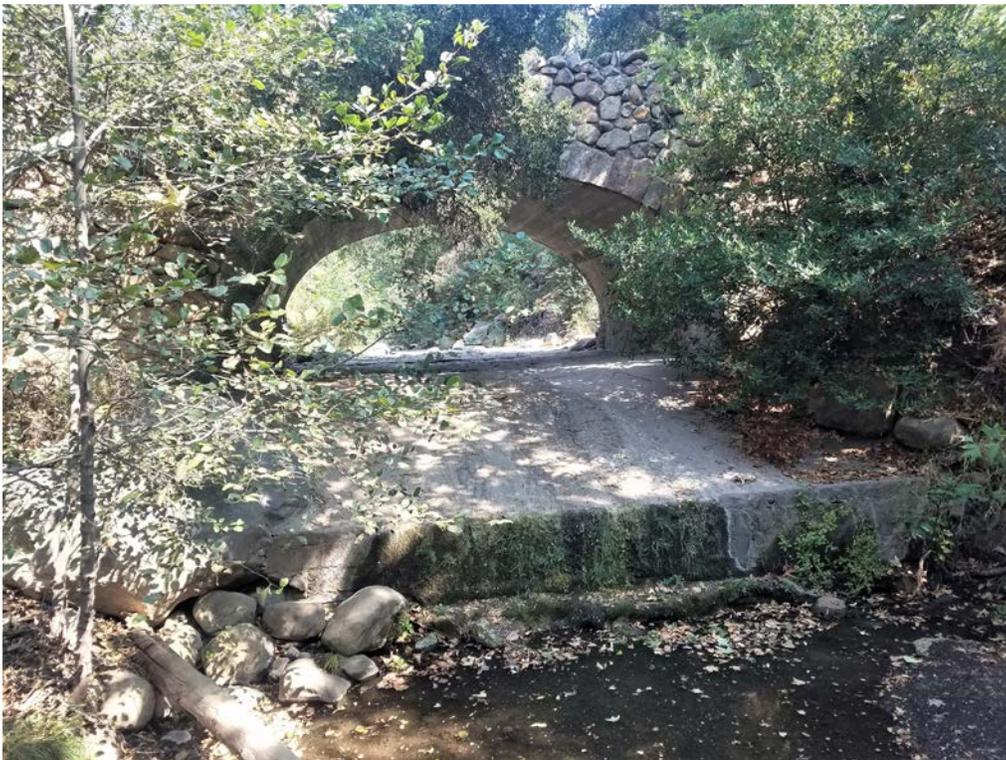
Photo 28. Plunge pool habitat and sloping apron of Las Canoas Road Bridge, Compensatory Mitigation Option 3, on Rattlesnake Creek. Photo facing U/S.

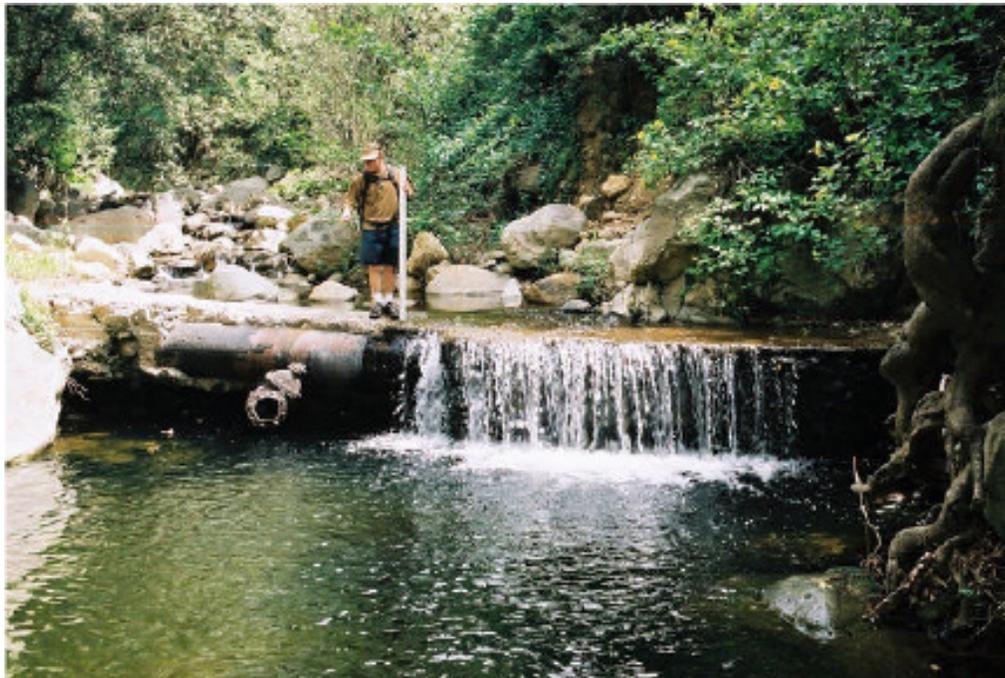
Photo 29. 20-inch Pipeline Crossing, Compensatory Mitigation Option 4, on Rattlesnake Creek. Photo from Stoecker 2002.
