Restoring Coastal Dune Ecosystem Health and Resilience at Salinas River State Beach

Final Restoration & Monitoring Report

January 2024

Coastal Conservation and Research

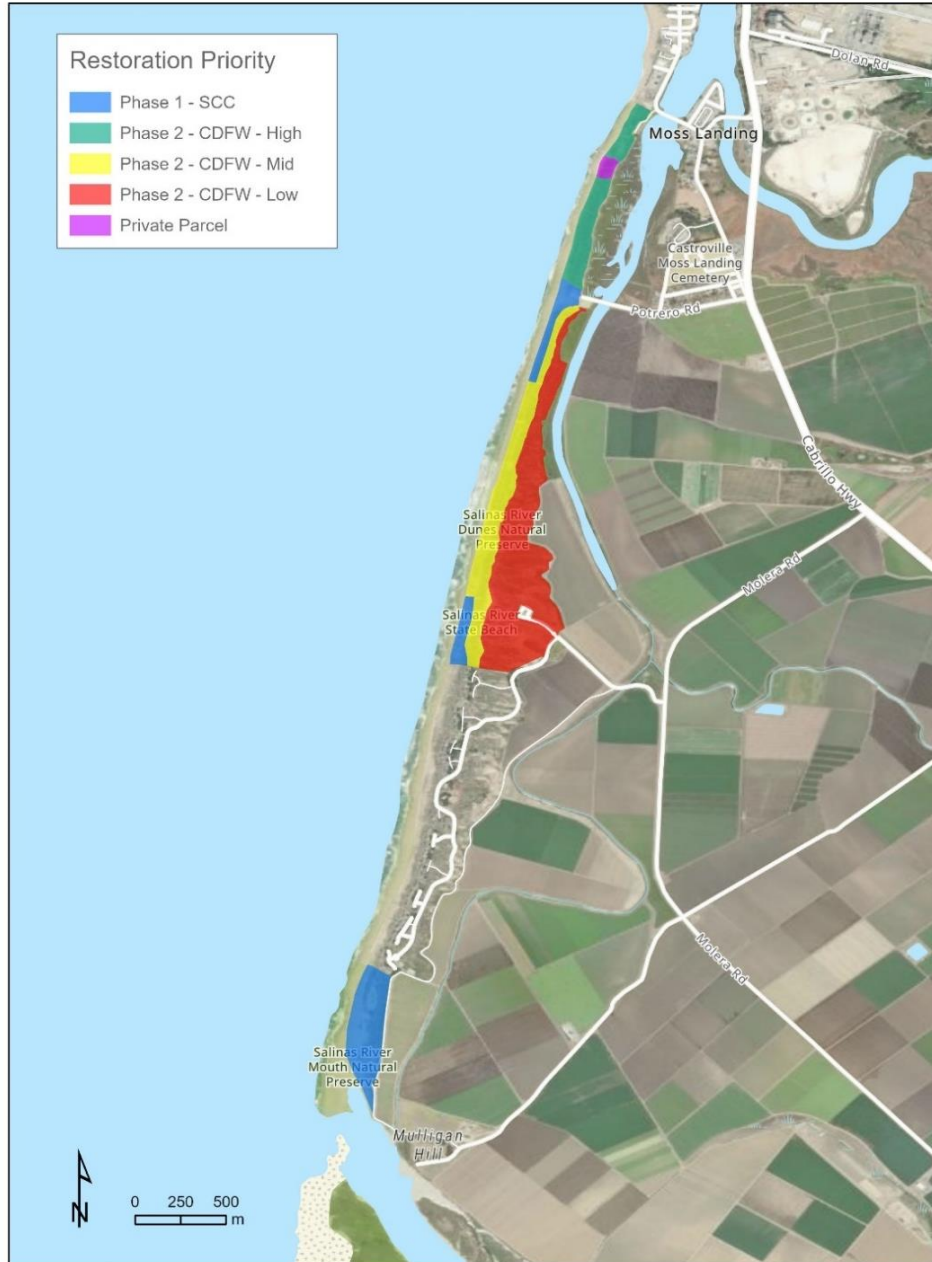
Figure 2. SRSB dune locations prioritized for restoration

The dune section located between the northern boundary of SRSB and the Potrero Rd access was identified as a high priority restoration area because it helps link previous restoration areas together into a large natural complex, provides valuable habitat for snowy plovers and other dune species, and contains key beach access trails. This section of dunes is relatively narrow (about 75 meters in width), is heavily covered by ice plant, and provides critical coastal resilience functions for the community of Moss Landing and Moss Landing Harbor. Funding from CDFW (Environmental Enhancement Fund grant provided in 2019) was secured to restore this section of dunes and became the focus area of the dune restoration project.

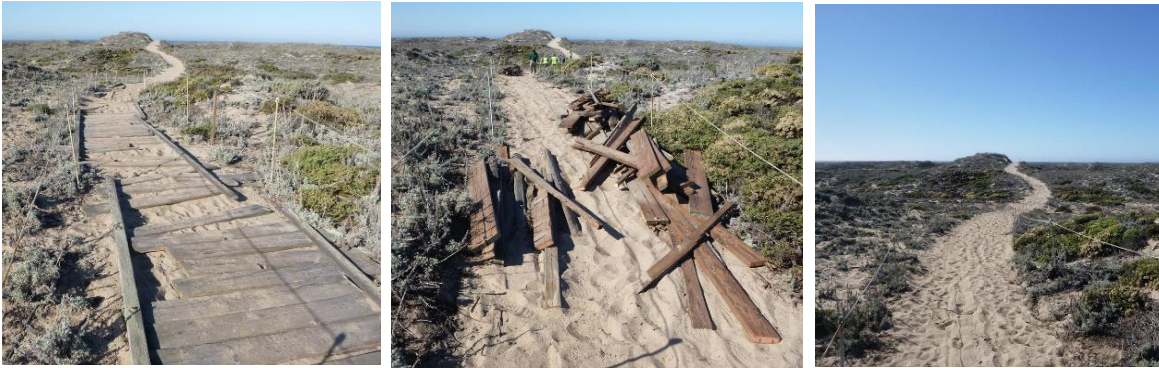
Figure 5. left: trail with boardwalk, center: trail in the process of boardwalk removal, right: trail with boardwalk removed.

The Molera beach access trail consists of two paths that branch from the parking lot and lead to the beach. However, the boardwalk on one of these paths had deteriorated and posed safety concerns. State Parks initiated the process of decommissioning this trail, and the first step was to remove the boardwalk, which was completed in October 2022 (Figure 5).

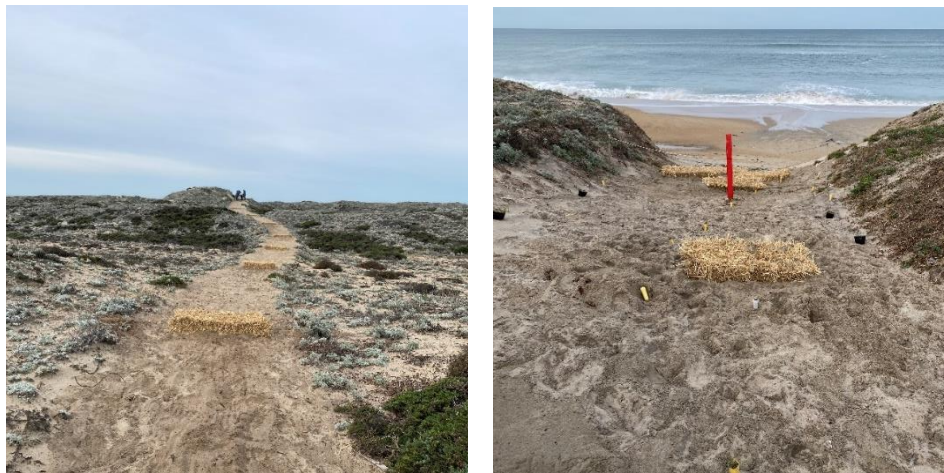
Figure 6. Haybales were placed along the Molera access trail to deter trail use, help capture sand, and provide wind barriers for newly planted plants.

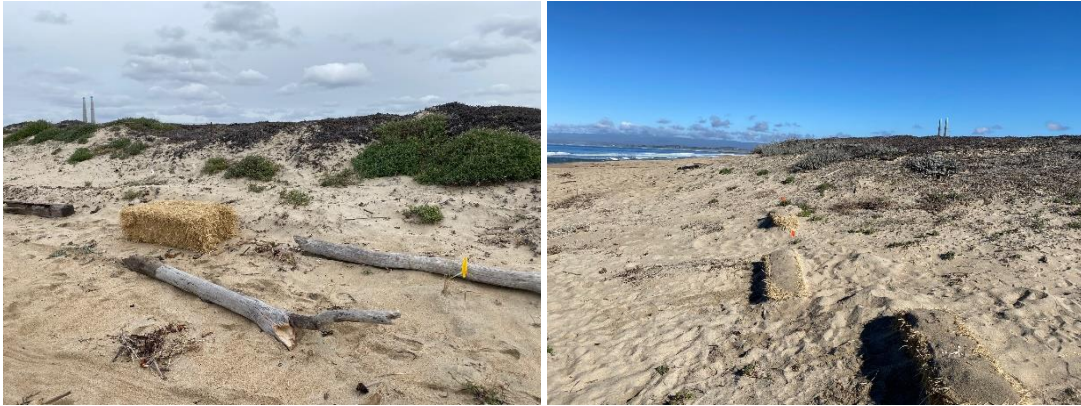
Figure 7. Haybales and drift wood places along toe of foredune and buried ~1/3 of the way into the sand

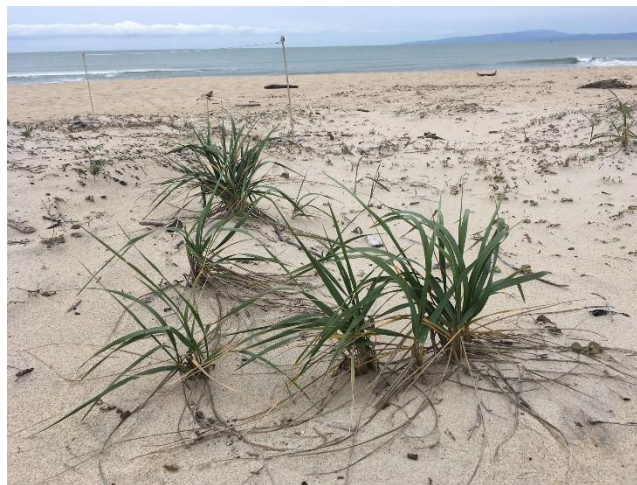
Figure 8. Native dune grass helps capture sand in the foredune.

while continuing to help capture sand and add to foredune roughness. Dune grass was planted on the foredune around the haybales and driftwood to enhance foredune resilience (Figure 8).

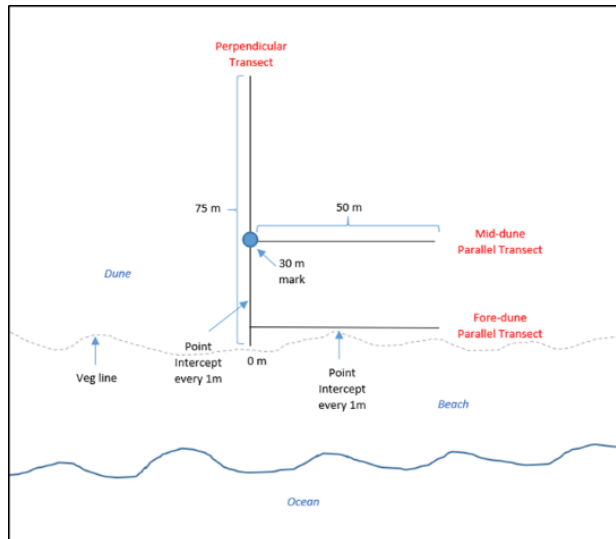
Figure 9. Vegetation transect layout

In November 2019, CCWG staff conducted pre-restoration vegetation surveys within the Sandholdt project focus area. Eight transect locations were established, with six being within the restoration area and two within the Private parcel, which was used as a no action control area. Each of the eight locations included three transects: 1) a 75m transect perpendicular to beach and 2) two 50m transects parallel to beach, one along the fore-dune and one along the mid-dune (Figure 9). Along the perpendicular transects, it was also noted where the transect transitioned from fore-dune to mid-dune. Line-Point Intercept method was used along transects to quantify cover of specific species, native and non-native cover, and species diversity. At every meter on the transect line, a pin flag was used to determine cover type, based on the plant or abiotic feature that it intersected first. Native and non-native plants were identified to the species level whereas abiotic cover was defined as bare sand, litter, dead ice plant, or trash. Litter was defined as loose material, whereas dead ice plant was defined as ice plant material that was dead or in the process of dying, but still rooted.

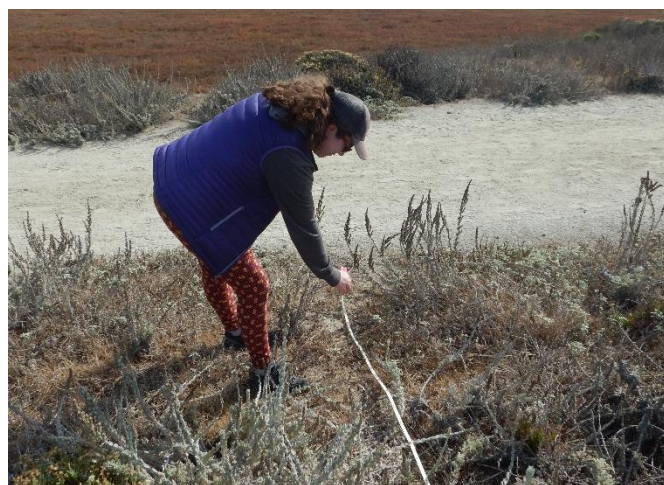
Line-point intercept vegetation surveys were used to characterize the vegetation community located within the restoration areas and to document vegetation changes over the course of the project. Information collected during surveys included percent cover of native and non-native or invasive plants, and abiotic features. Presence of ice plant during monitoring was noted for spraying or hand removal. The results of these surveys help provide information on the success of restoration activities.

CCWG staff using line-point intercept method along a transect in the Sandholdt Restoration dune section

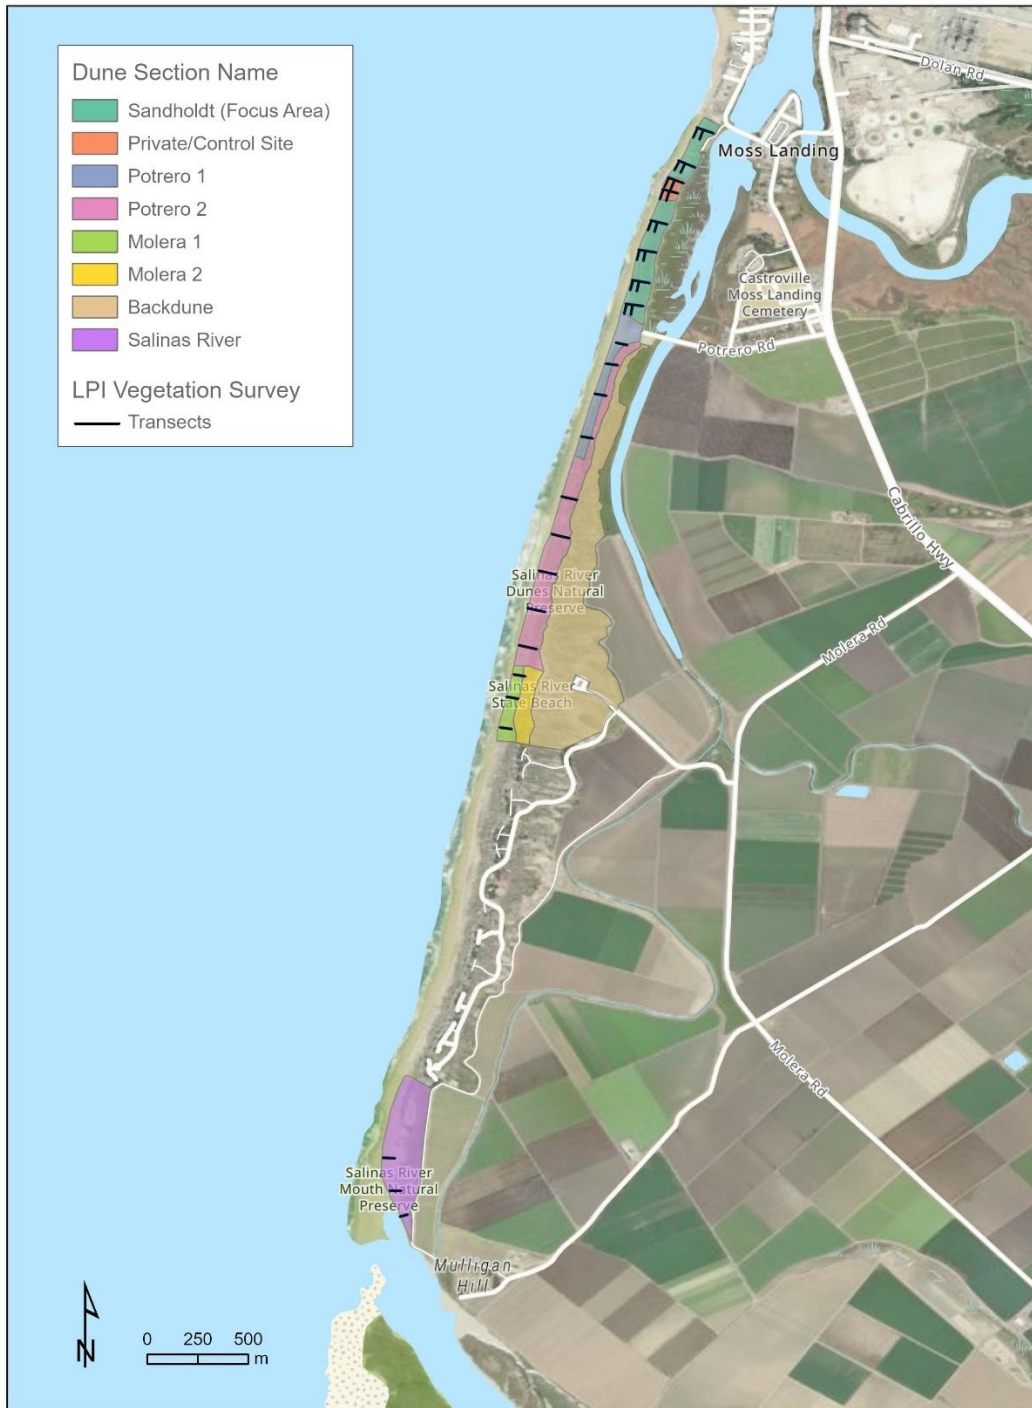
Figure 10. Locations of vegetation transects within the project area. Vegetation transects within Phase 1 dune sections (Potrero 1, Molera 1, and Salinas River) were established in 2016. Vegetation transects within Phase 2 restoration areas were established in 2019 (Sandholdt) and 2020 (Potrero 2). The orange area on the Northern portion of the restoration area is a private inholding and has not been treated or restored, however it was used as a control area for surveys. Vegetation transects were established there in 2019.

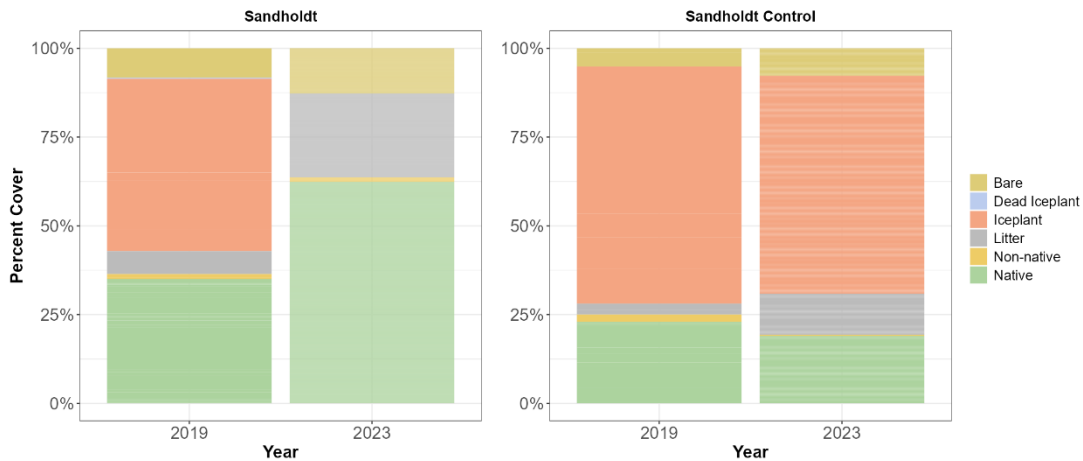
recent October 2023 survey. The Sandholdt Control area, where no restoration activities have taken place, saw a slight decrease in native cover from 23% to 19% and ice plant cover from 67% to 61% between the pre-restoration survey in Fall 2019 to the most recent Fall 2023 survey (Figure 11).

Figure 11. Vegetation survey results comparing pre-restoration (Fall 2019) to post-restoration (Fall 2023) for the Sandholdt Restoration and Sandholdt Control.

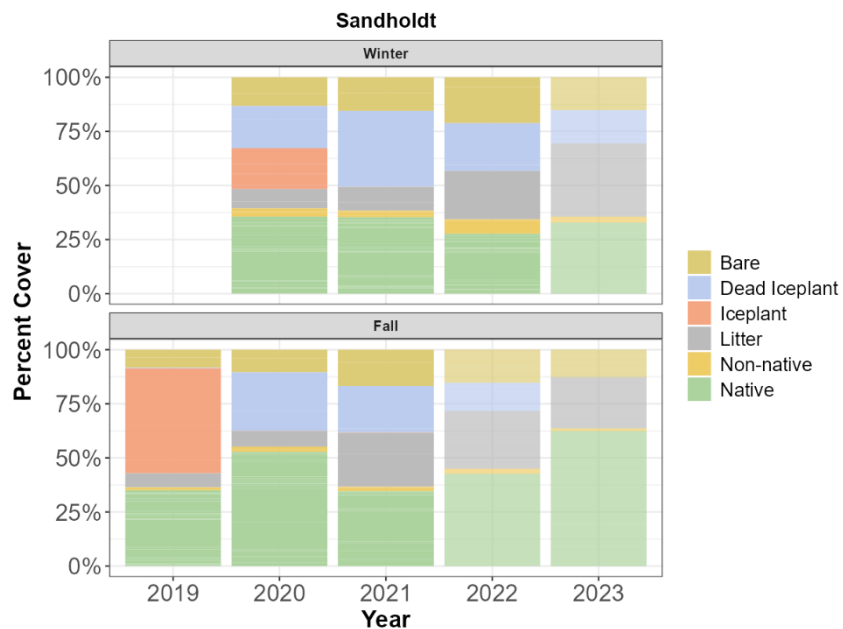
Sandholdt Restoration - Winter vs Fall: Results show that surveys conducted in Winter generally had lower percent cover of native vegetation and slightly higher percent cover of bare sand than the Fall surveys (Figure 12).

Figure 12. Vegetation survey results comparing Winter vs Fall for the Sandholdt Restoration area.

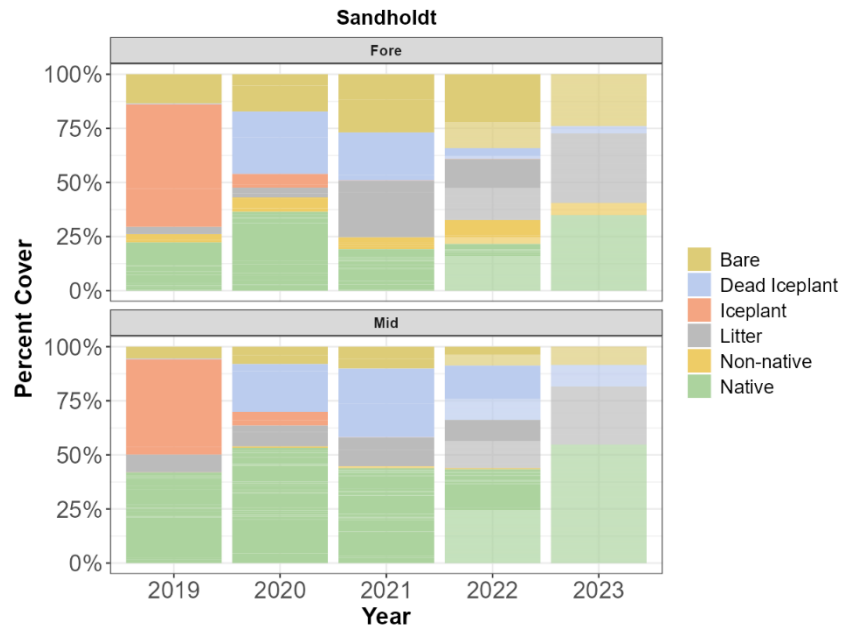
Sandholdt Restoration - Fore dune vs Mid Dune: Results show that the Sandholdt foredune overall has lower cover of native vegetation and higher cover of bare sand throughout the project period than the mid-backdune area. However the foredune also had higher cover of ice plant (at project initiation compared to the mid-backdune area (Figure 13).

Figure 13. Vegetation survey results comparing Fore dune to Mid dune for the Sandholdt Restoration area.

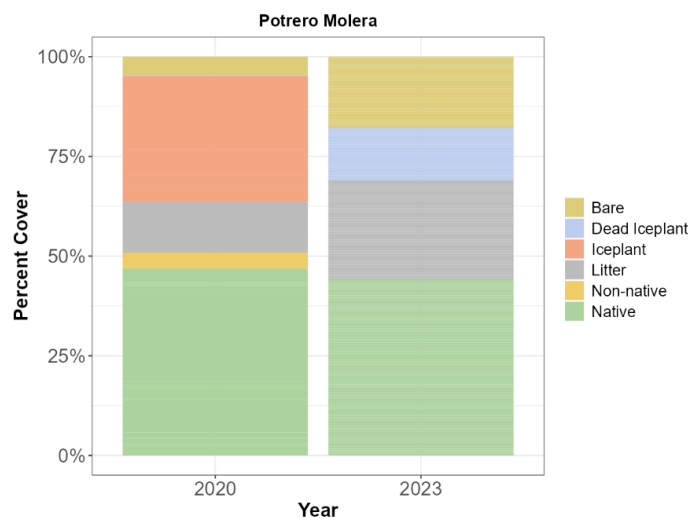
Potrero-Molera Pre and Post. The Potrero-Molera restoration area is showing an overall significant decrease in invasive ice plant cover from 32% to 0%, and a slight decrease in native cover from 47% to 44% between Fall 2020 and February (Winter) 2023 (Figure 14).

Figure 14. Vegetation survey results comparing pre-restoration (Fall 2020) to post-restoration (Winter 2023) for the Potrero-Molera area.

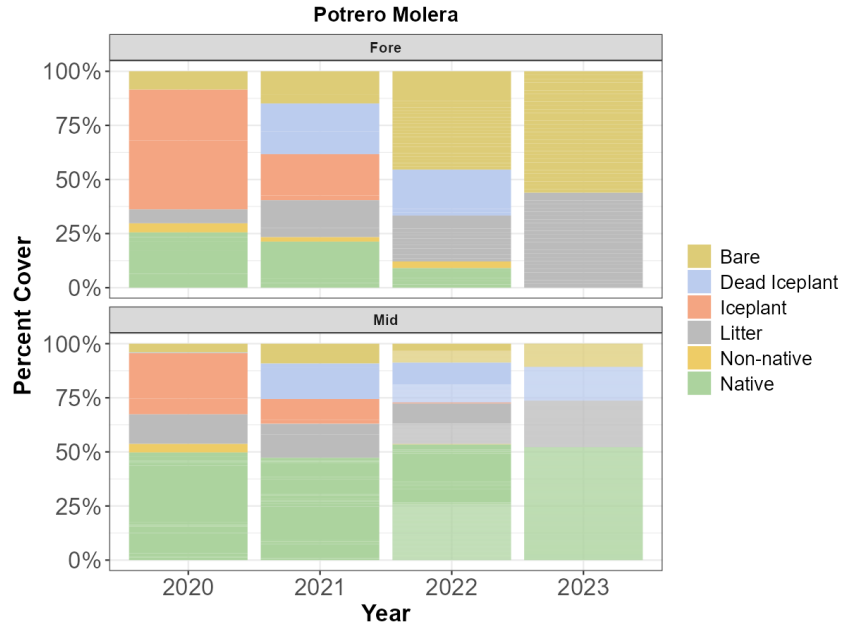
Potrero-Molera Foredune vs Mid Dune: Results show that the Potrero-Molera foredune has lower cover of native vegetation and higher cover of bare sand in the foredune throughout the project period than the mid-backdune area. However the foredune also had higher cover of ice plant at project initiation compared to the mid-backdune area (Figure 16). Steep/thin foredune area along this segment, and data collection methods (no parallel transect completed) are likely driving the low native plant cover estimates.

Figure 16. Vegetation transect results compare Fore dune to Mid dune for the Potrero-Molera Restoration area.

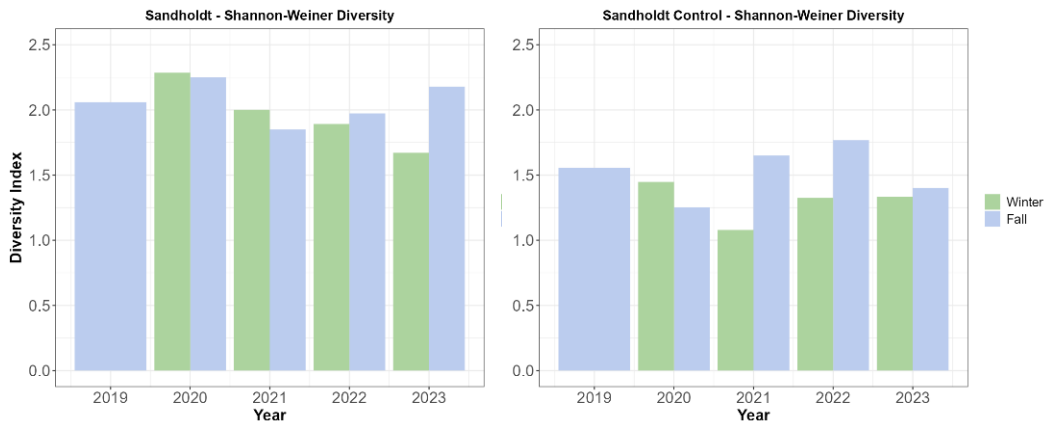
Results of plant diversity are shown in Figure 17 for the Sandholdt Restoration and Control areas. The diversity index decreased during the Winter surveys and fluctuated during the Fall surveys, with the index from the final Fall 2023 survey at the Sandholdt Restoration area being slightly higher than the Fall 2019 survey. The diversity index was consistently lower in the Control area.

Figure 17. Diversity index of Sandholdt Restoration area compared to Sandholdt Control

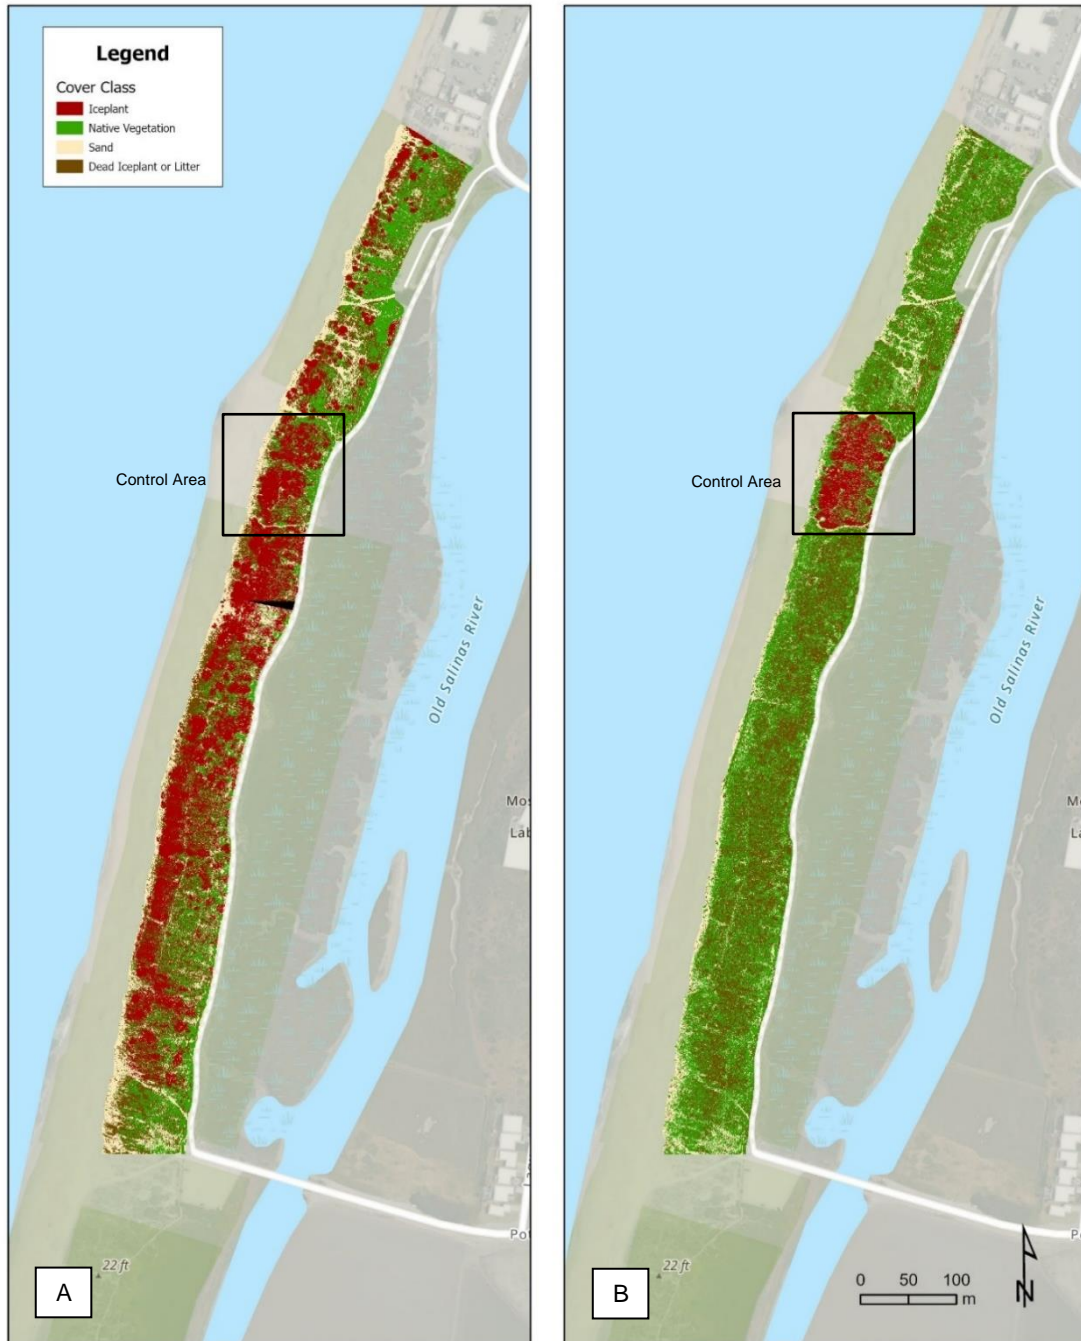
The map in Figure 18 displays the results of the image classification. A comparison of results between the GIS image classification and on-the-ground survey are presented in Figure 19 and Table 6.

Figure 18. A) Aerial analysis of UAV photography in February 2020 prior to herbicide spraying and B) November 2023 after several years of ice plant removal efforts.

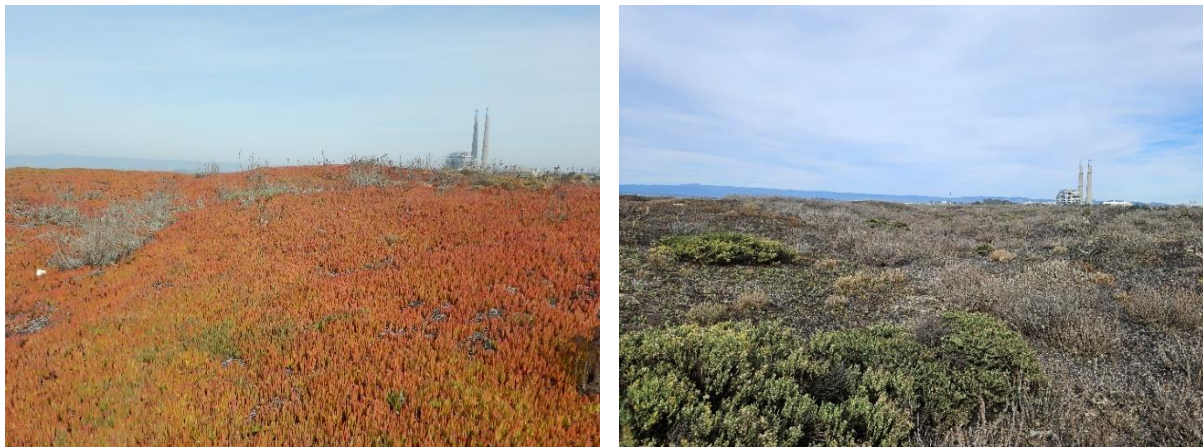
Figure 20 shows pre and post restoration photos from a mid-dune transect within the Sandholdt Restoration dune section. See Appendix B for photos from more transects.

Figure 20. Sandholdt Transect 5 photo monitoring: November 2019 (left) and November 2023 (right). Photo taken on the middune facing North.

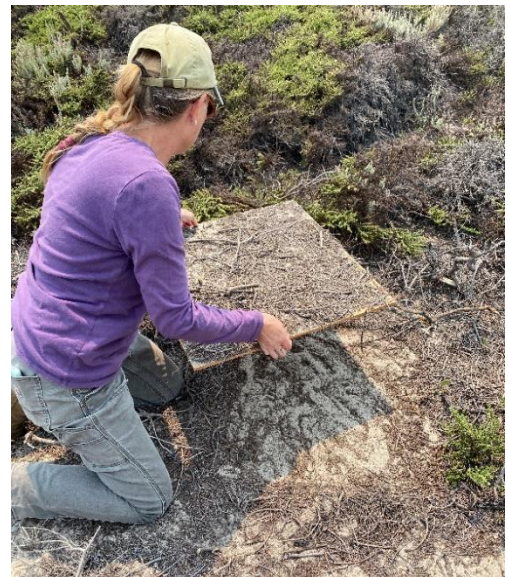
Figure 23. Quietly removing a coverboard during a legless lizard survey.

set aside (Figure 23). The sand was then gently raked with fingers, multiple times in each direction. This typically reveals if a legless lizard is present within the first 5-8 cm of the surface. When a legless lizard was found, the raking stopped to allow it to return under the sand surface. The coverboard was then gently returned to its location and partially covered with sand.

Surveys for Northern legless lizards were conducted with the use of coverboards. In April 2021, forty-one (60 cm x 60 cm) coverboards were distributed throughout the Sandholdt restoration and Control sections of dunes as well as part of the Potrero dune area, at a density of approximately 5 coverboards per hectare. Coverboards were surveyed throughout the Spring and Summer months in 2021, and opportunistically during rare plant surveys in 2022 and 2023. In 2021, surveys were conducted under optimal conditions which require some level of sunlight during the day and sand surface temperatures exceeding 35° C. Sand temperatures were measured at each coverboard location with an infrared thermometer. At each location the coverboard was quietly lifted and

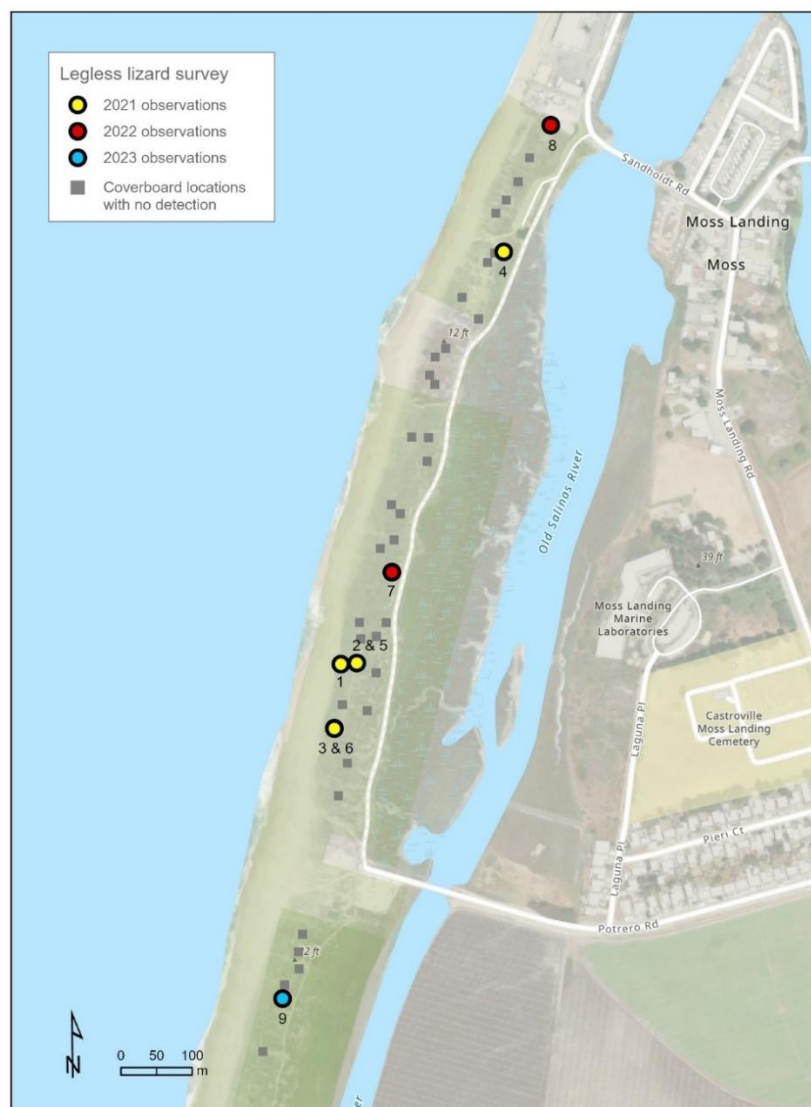
A total of nine Northern legless lizards were found, eight of which were found under coverboards with one additional found incidentally during a restoration planting (Figure 24 and Table 9). In 2021, surveyors found six legless lizards, with two of the coverboards having two separate observations on different dates. During the opportunistic surveys in 2022 and 2023, there were two observations in 2022 and one and in 2023. No legless lizards were found under coverboards placed in the unrestored Control section of dunes.

Figure 24. Detections of legless lizards at coverboards during 2021, 2022, and 2023 surveys.

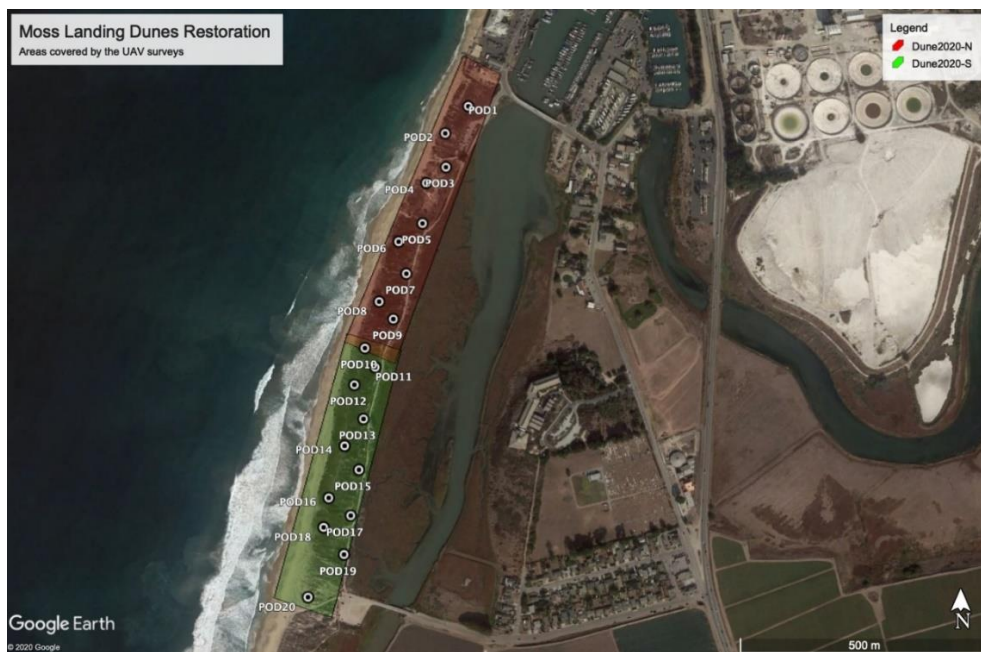
Figure 25. UAV Study area. The colored polygons outline the two separate survey areas. The label identifies the GCPs used for the surveys.

Beginning in 2020 the SRSB dunes were surveyed twice a year using a UAV flown over an area of 0.12 km² (about 0.18 km wide and 1.2 km long), extending from the Moss Landing Marine Laboratories (MLML) Shore Lab at the north end of the project area, to the parking lot at Potrero Road at the south end of the project focus area. Preliminary 2D/3D surveys were conducted on 1/13/2020 to test the best UAV flying conditions, and to create the first

photomosaic to use as baseline to both visually assess the treated areas as well as to find the best locations for the Ground Control Points (GCPs) for future surveys. Based on the results of the preliminary surveys in January 2020, the photogrammetric surveys with the UAV were carried out to manage resolution quality and flight time. For optimal results, the study area was broken into two separate survey areas of similar size, outlined by the red and the green colors in Figure 25. The survey extents overlap to ensure a seamless integration of survey results.

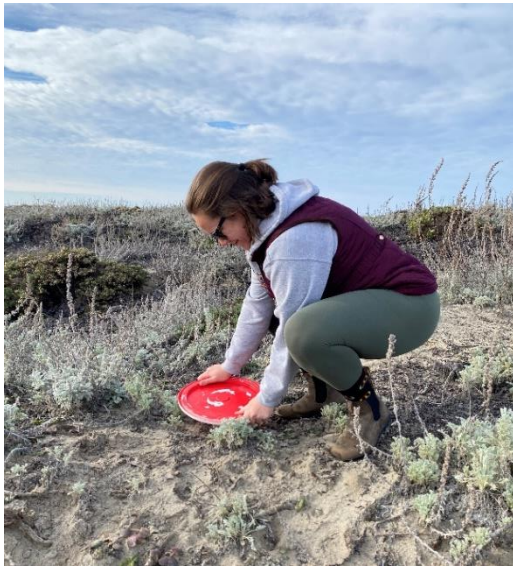
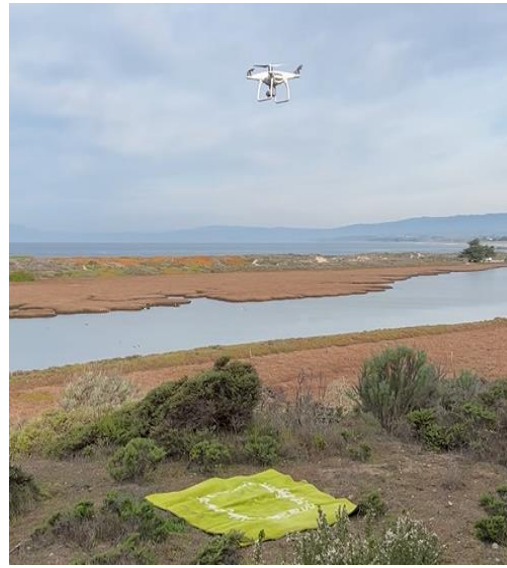
Left: Bucket lids being put on ground control points before the UAV /survey. Right: UAV departing Moss Landing Marine Labs for survey at SRSB

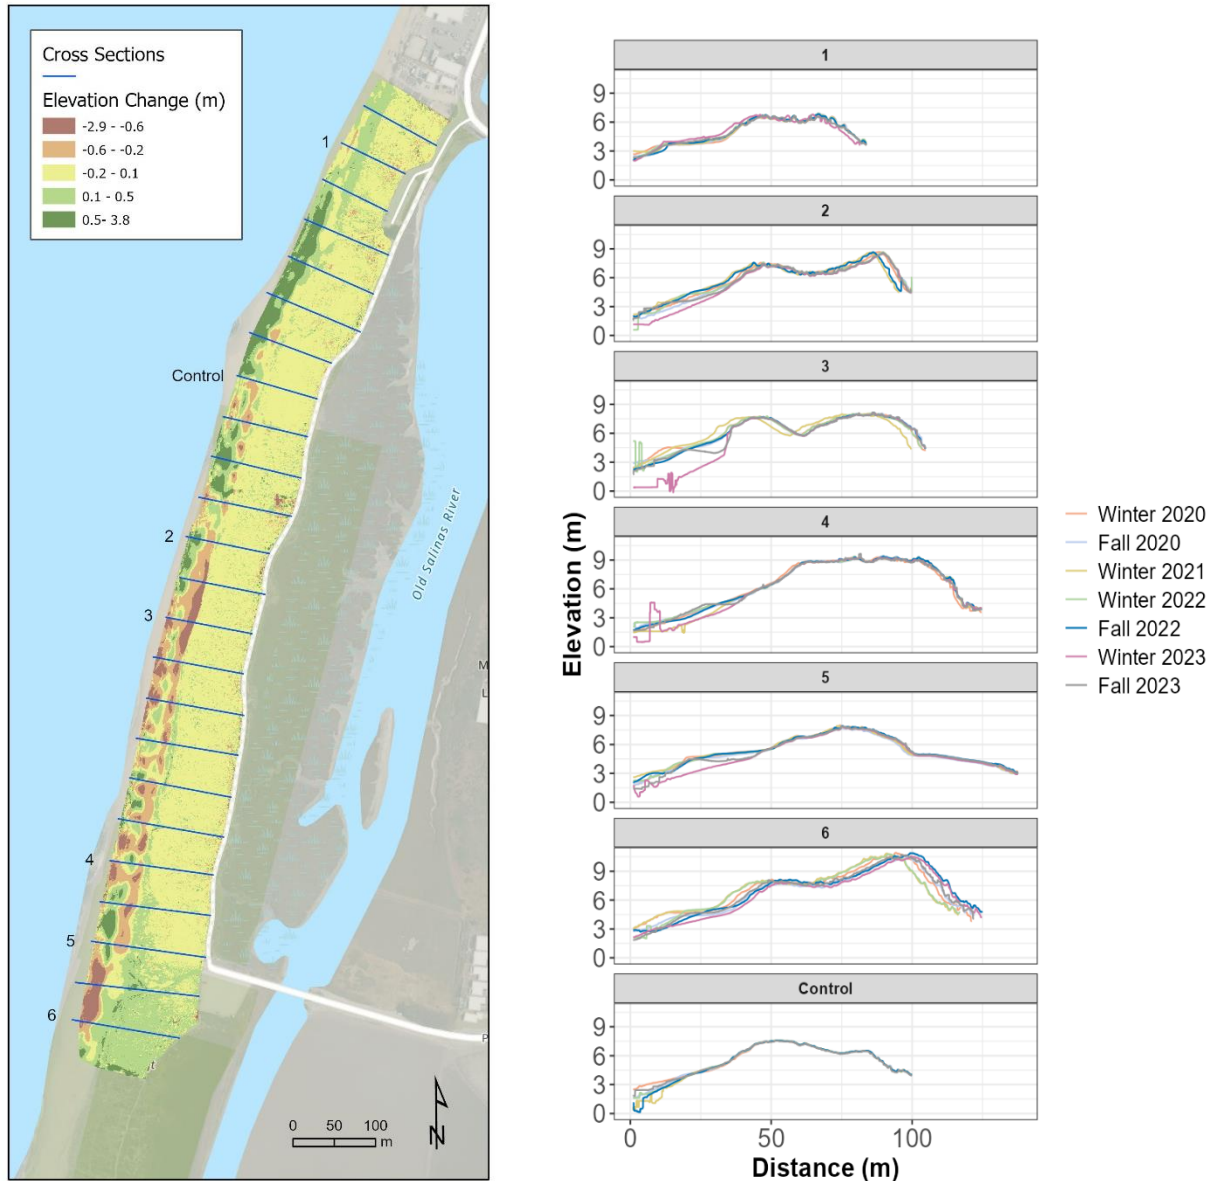
Figure 27. Digital Surface Elevation map depicting raster changes in elevation associated elevation cross sections showing fluctuations in dune height.

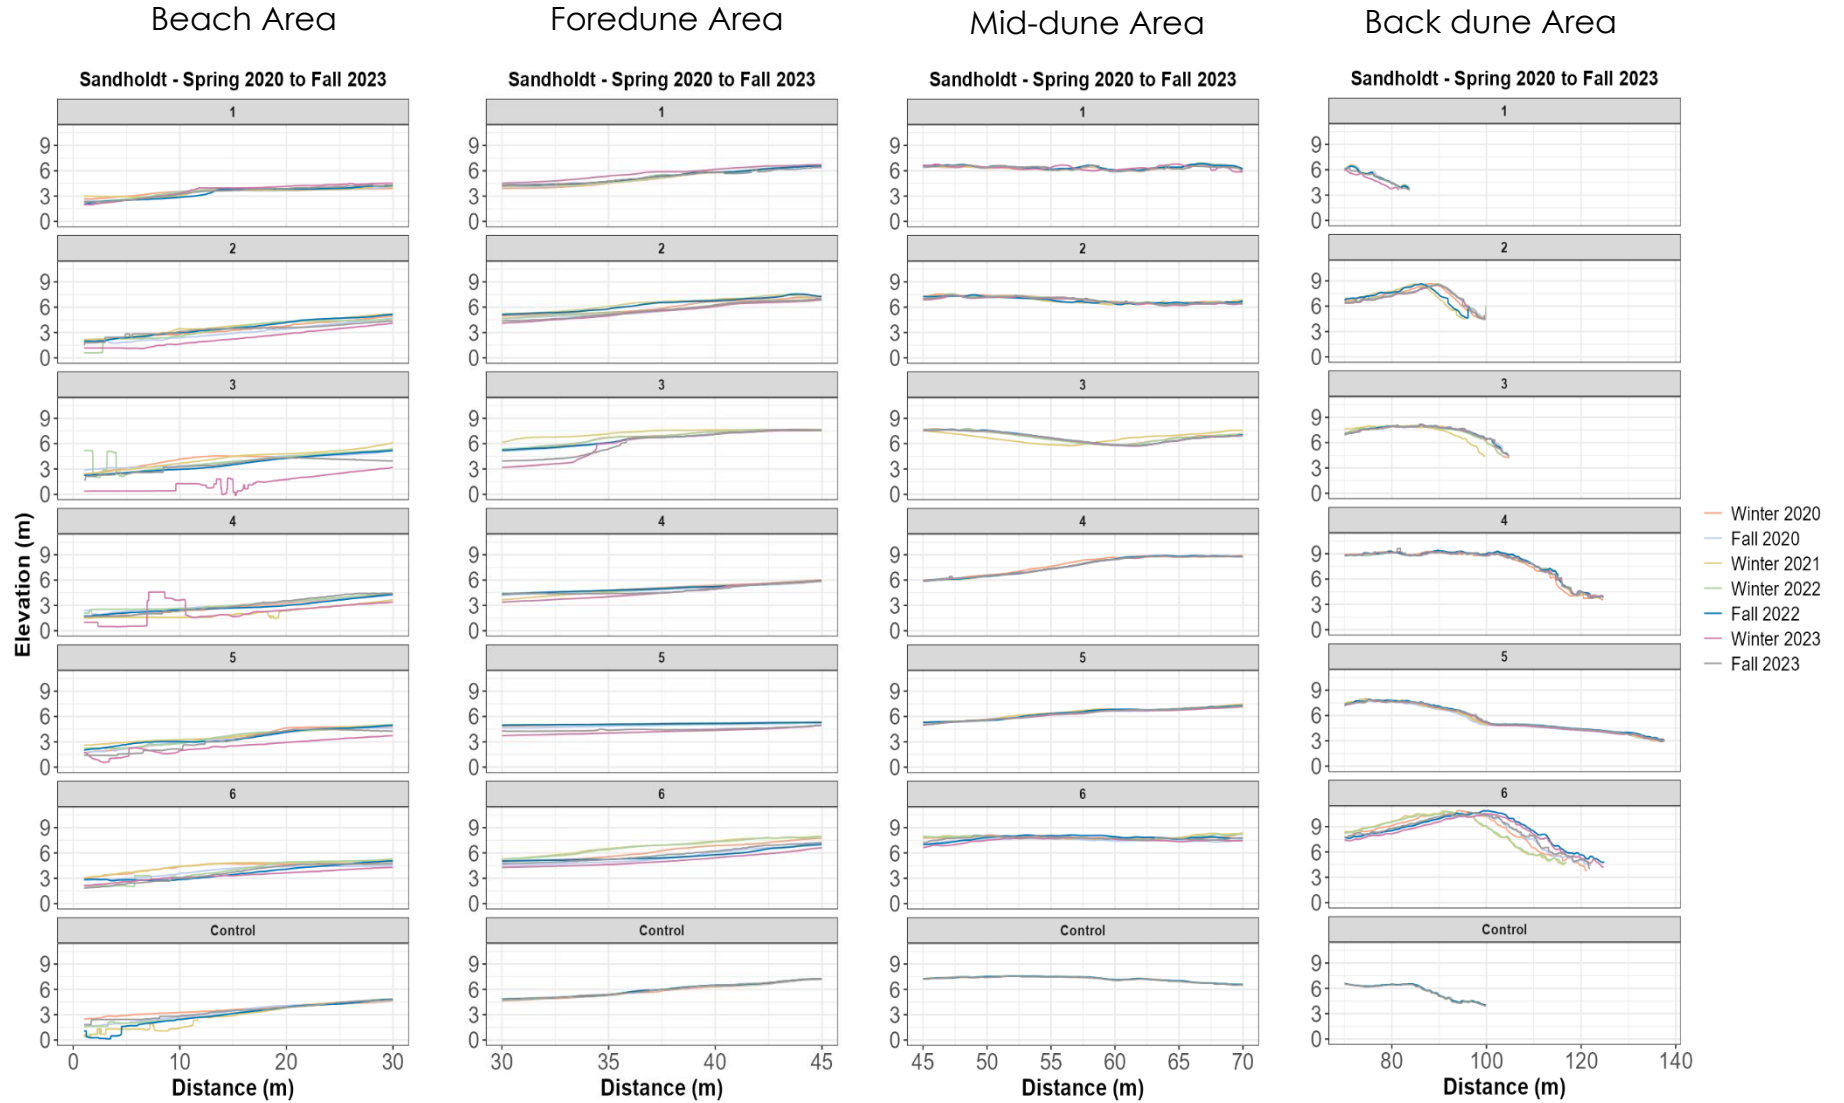
Figure 28. Cross sectional elevation changes for 6 linear transects and a control transect within each dune zone area

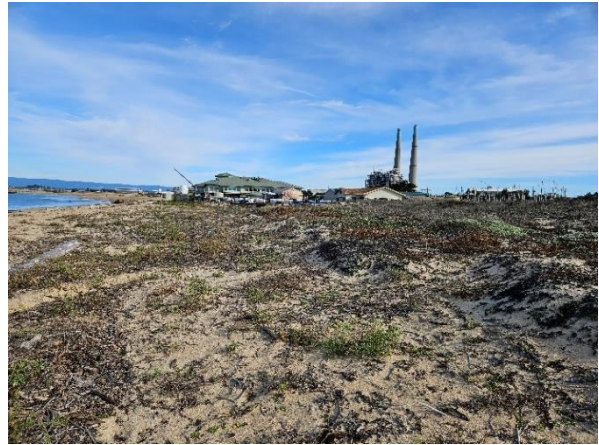
Sandholdt Transect 1: November 2019 (left) and November 2023 (right). Photo taken on the foredune facing North

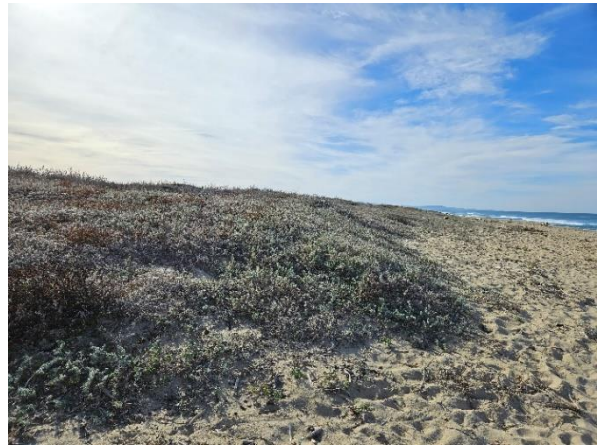
Sandholdt Transect 2: November 2019 (left) and November 2023. Photo taken on the foredune facing South

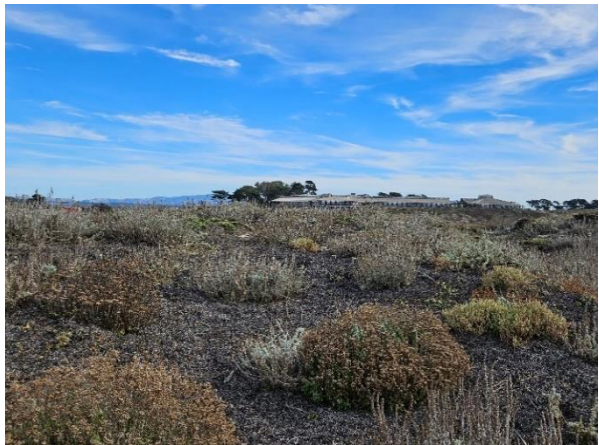
Sandholdt Transect 5: November 2019 (left) and November 2023 (right). Photo taken on the middune facing east.

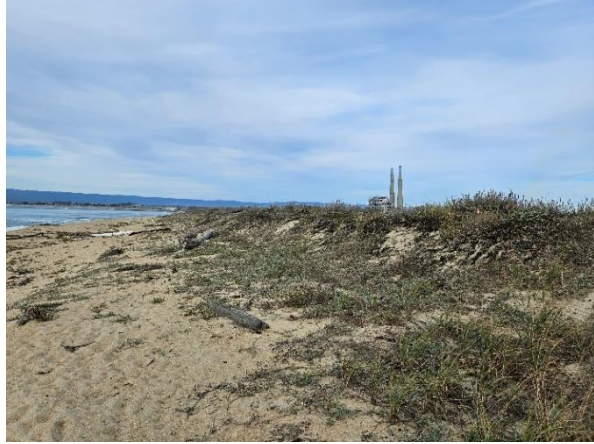
Sandholdt Transect 7: November 2019 (left) and November 2023 (right). Photo taken on the foredune facing north.

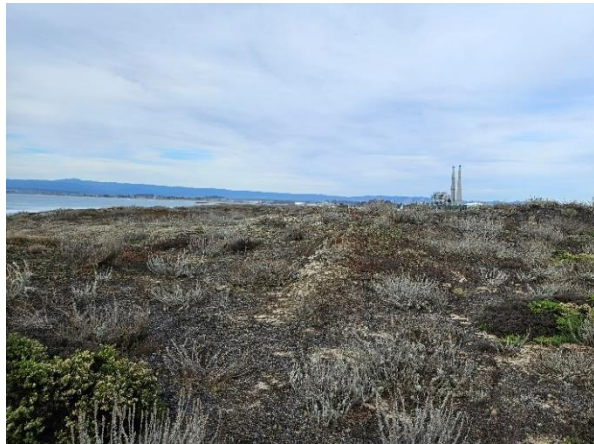
Sandholdt Transect 8: November 2019 (left) and November 2023 (right). Photo taken on the middune facing north.

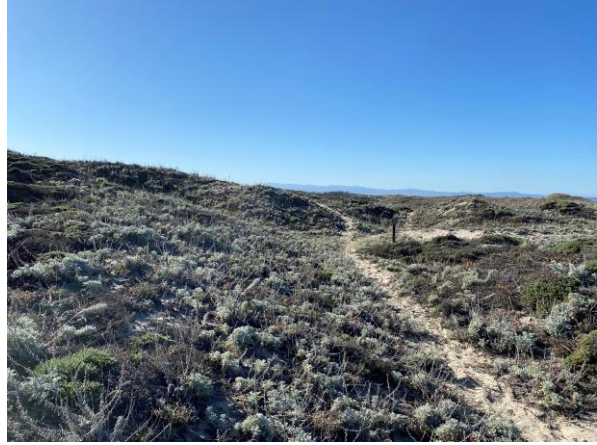
Potrero-Molera Transect 2: October 2020 (left) and February 2023 (right). Photo taken on the middune facing South.

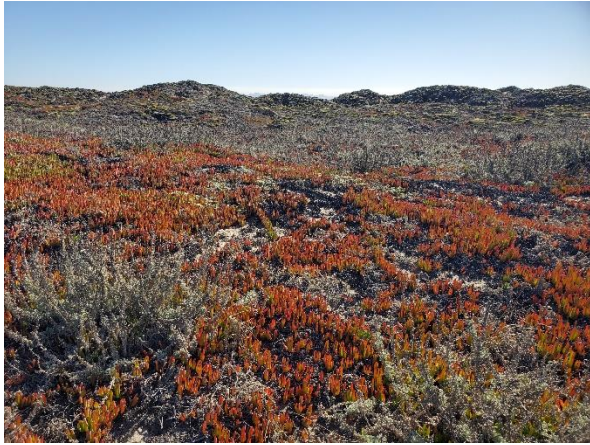
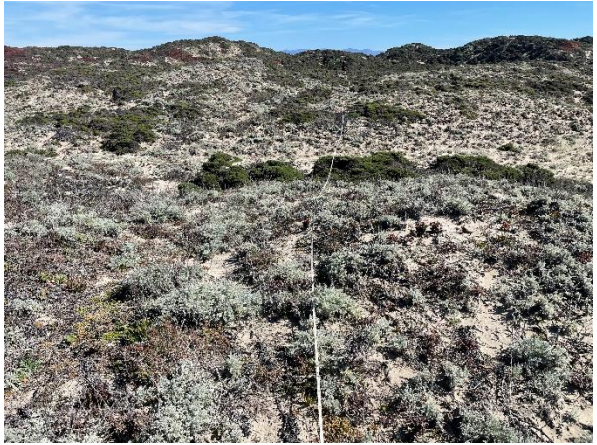
Potrero-Molera Transect 3: October 2020 (left) and February 2023 (right). Photo taken on the middune facing East.

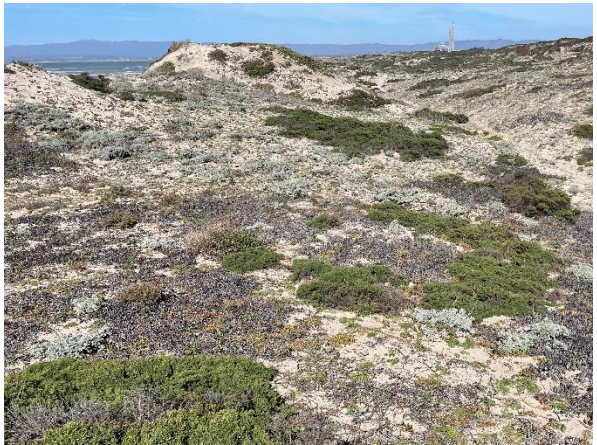
Potrero-Molera Transect 4: October 2020 (left) and February 2023 (right). Photo taken on the middune facing North.

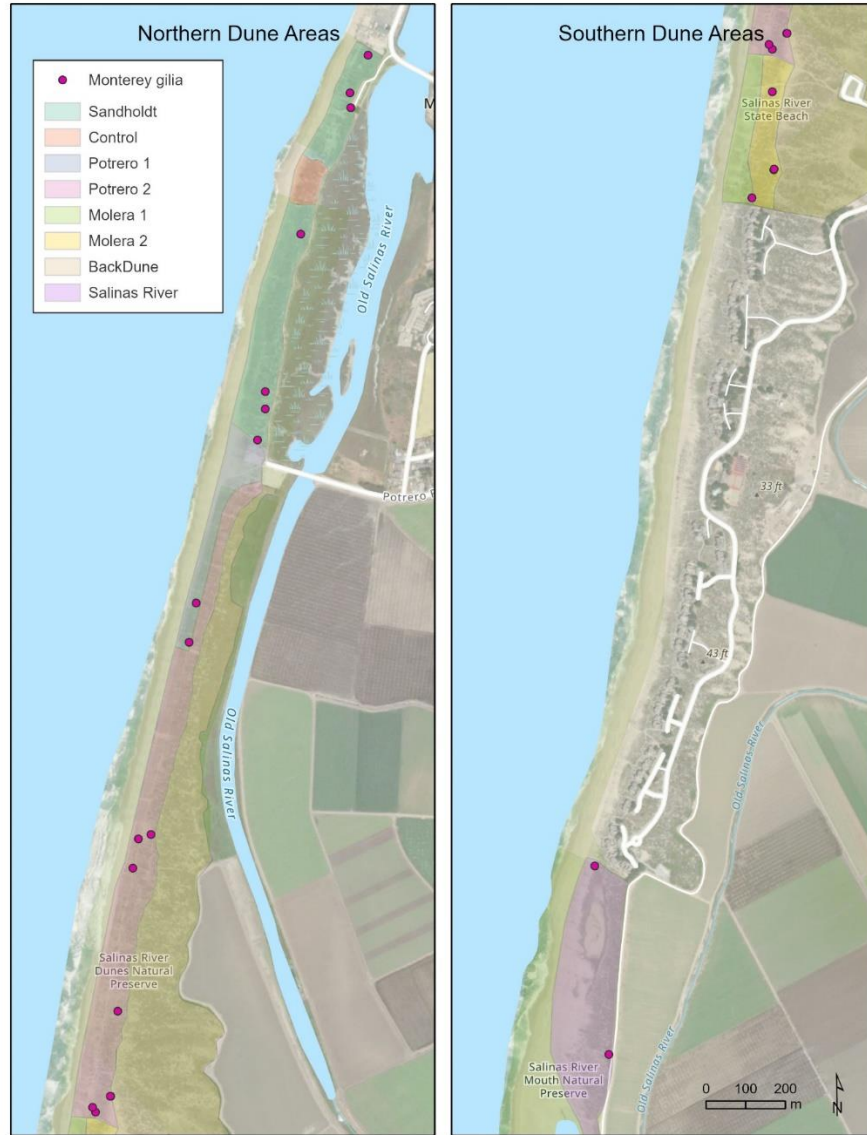
Figure 2. Locations of Monterey gilia during expanded 2022 rare plant survey
