Hill Slough Tidal Marsh Restoration Project

Final Report to the Natural Resource Trustee Council Representatives

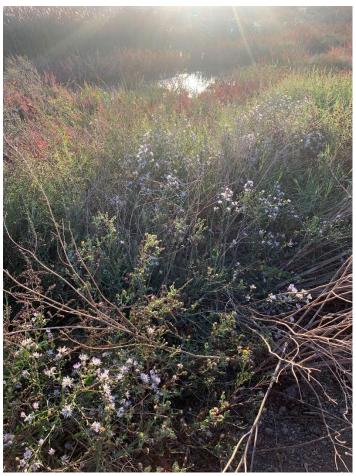
Photo 1: Relocated Suisun Marsh aster near breach W3 at Hill Slough, October 5, 2022, one year post-relocation.

Task 1. Mobilization, site preparation, and vegetation removal. In 2021, prior to levee lowering and breaching, vegetation was removed/reduced using blade trimmers or mowers, or by flooding. Suisun Marsh Aster (*Symphyotrichum lentum*), California Rare Plant Rank 1B.2, plants occurring at breach sites were relocated elsewhere on site using an excavator (photo 1).

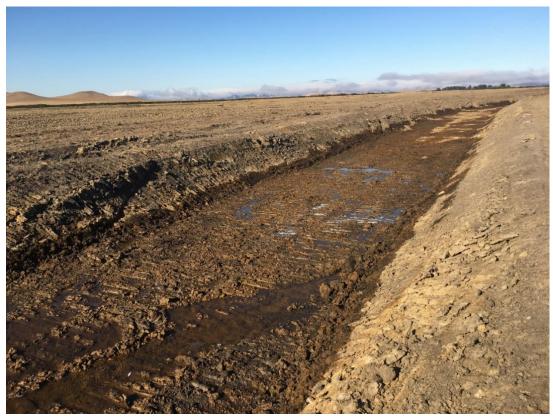
Photo 2: Excavated swale in Pond 4.

Task 3. Earth moving. Two ponds required interior recontouring (photo 2). The excavated soil was used on site for other aspects of the project where higher ground was required for upland refugia, such as for a habitat levee on the west side of the project.

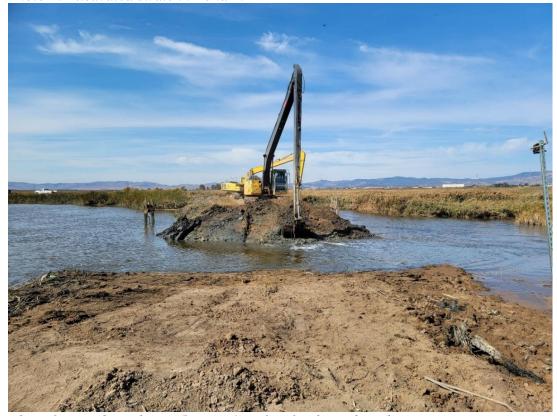
Photo 3. First breach at W5, near Grizzly Island Road Bridge.

Task 5. Levee breaches and levee lowering. Some levees were lowered and the soil used on site as part of the project. Levees were breached in 12 locations (photo 3).

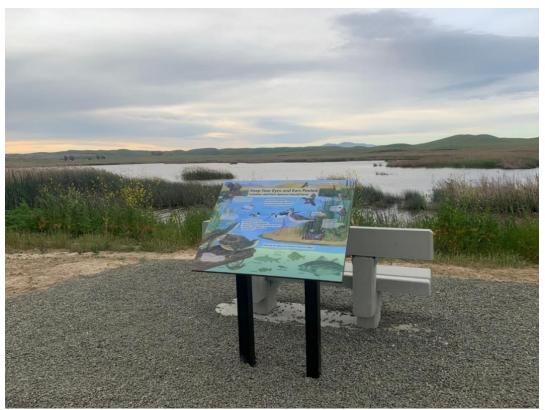
Photo 4: Sign and bench at Hill Slough Restoration Pond 6.

In 2022, a loop trail connecting to Suisun City's Grizzly Island Trail was completed along with three interpretive signs, bench, and trash receptacle (photos 4 and 5).
