2014-2022 MONITORING REPORT
Cosco Busan Trustee Council
Eelgrass Restoration and Monitoring Services
Cosco Busan DARP
San Francisco Bay, California

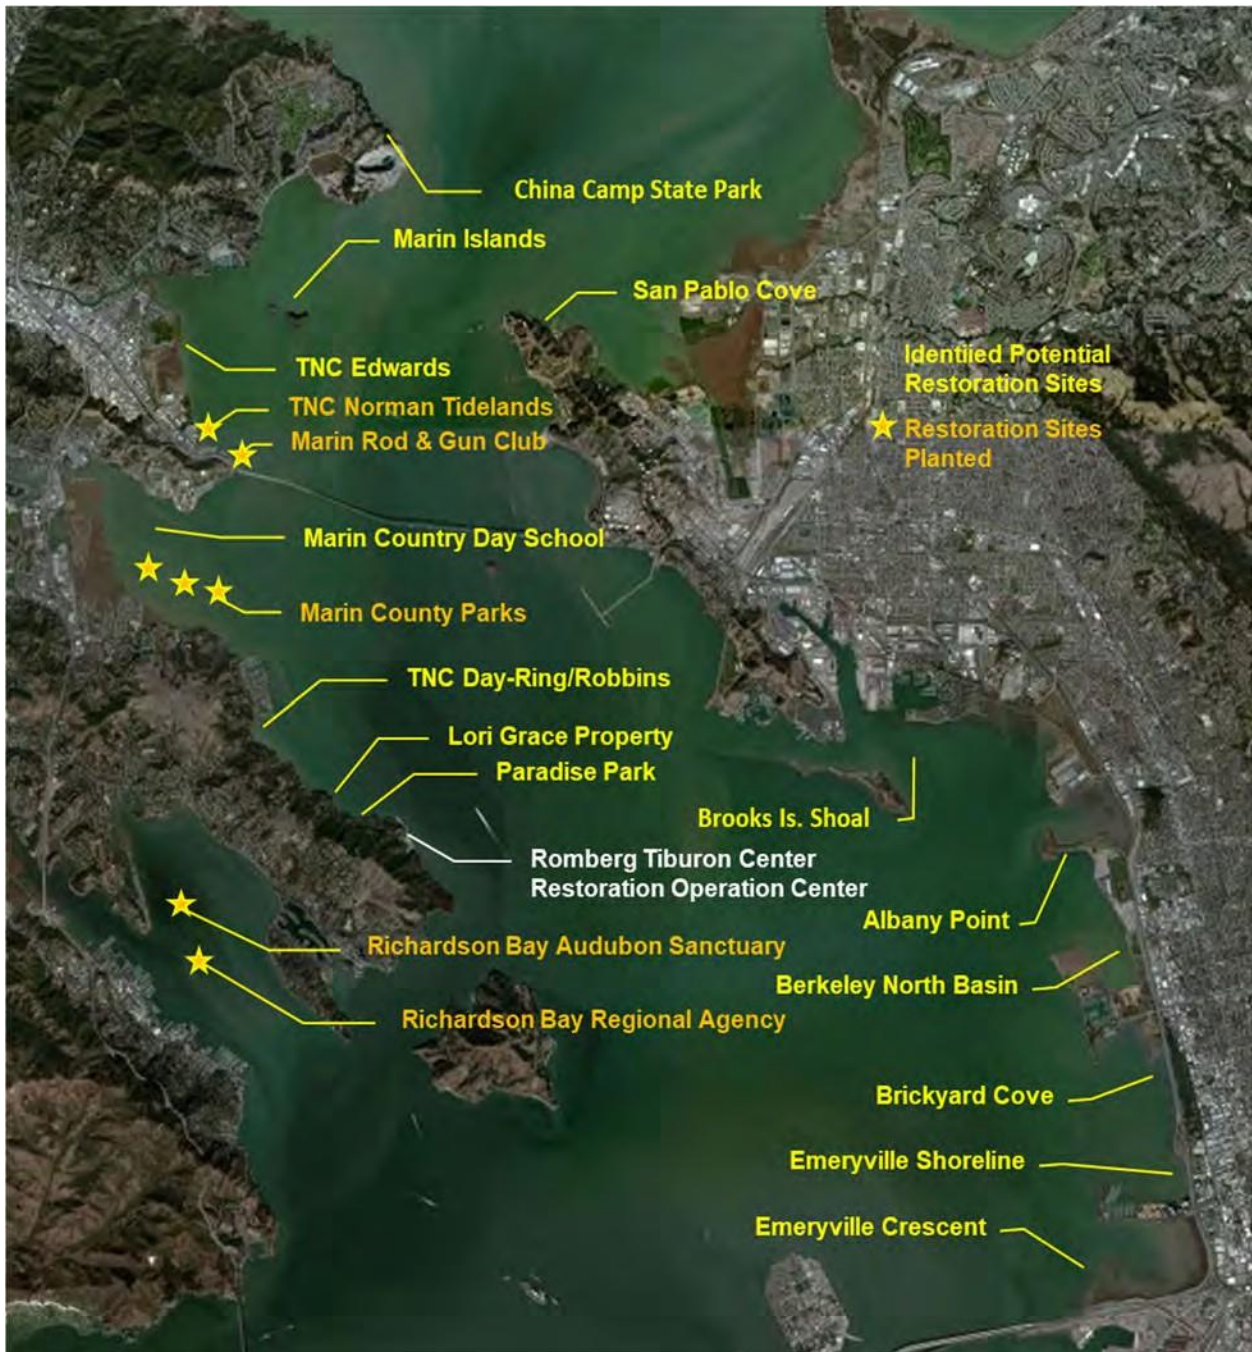
Figure 2. Restoration Sites Considered and Those Selected for Planting from 2014 through 2022 Planting Seasons

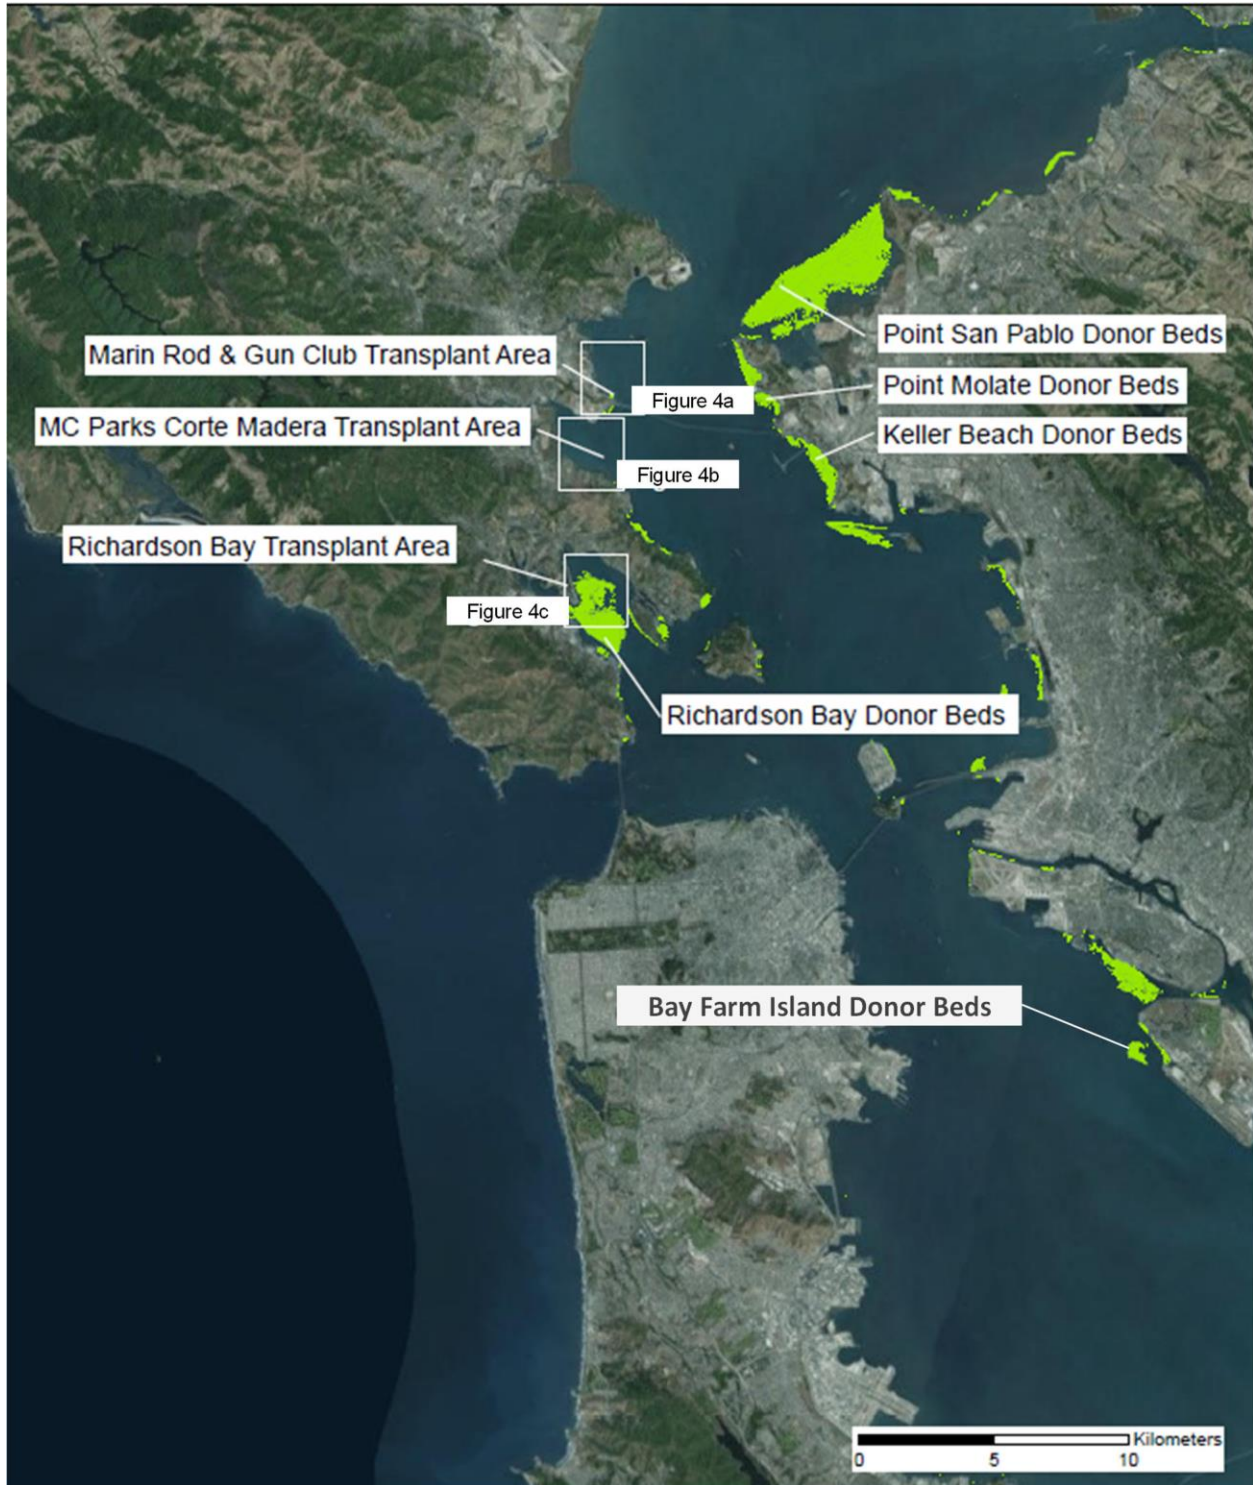
Figure 3. Eelgrass Transplant Regions and Donor Site Beds Used in Eelgrass Restoration Program

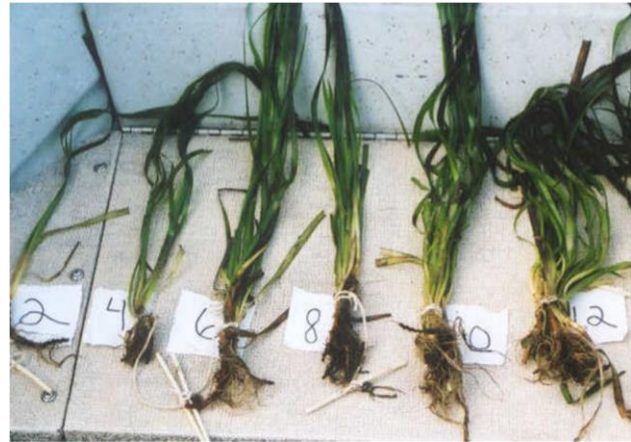
Multiple turion Merkel planting units tested

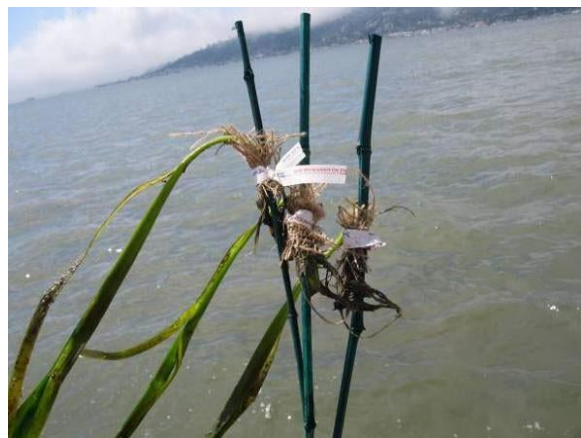
Bamboo stake (Kiriakopolos) transplant units

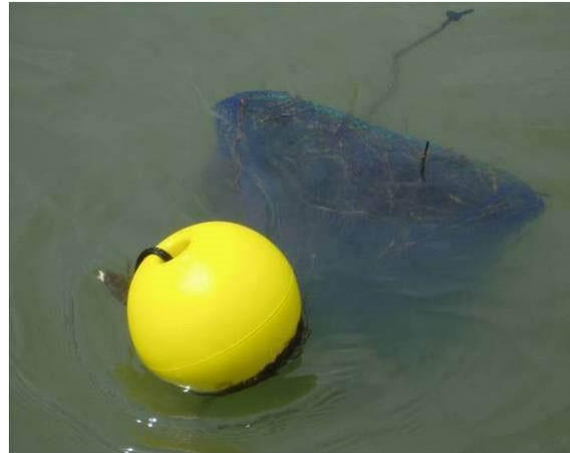
Seed buoy eelgrass transplants at Marin Rod & Gun Club, San Francisco Bay

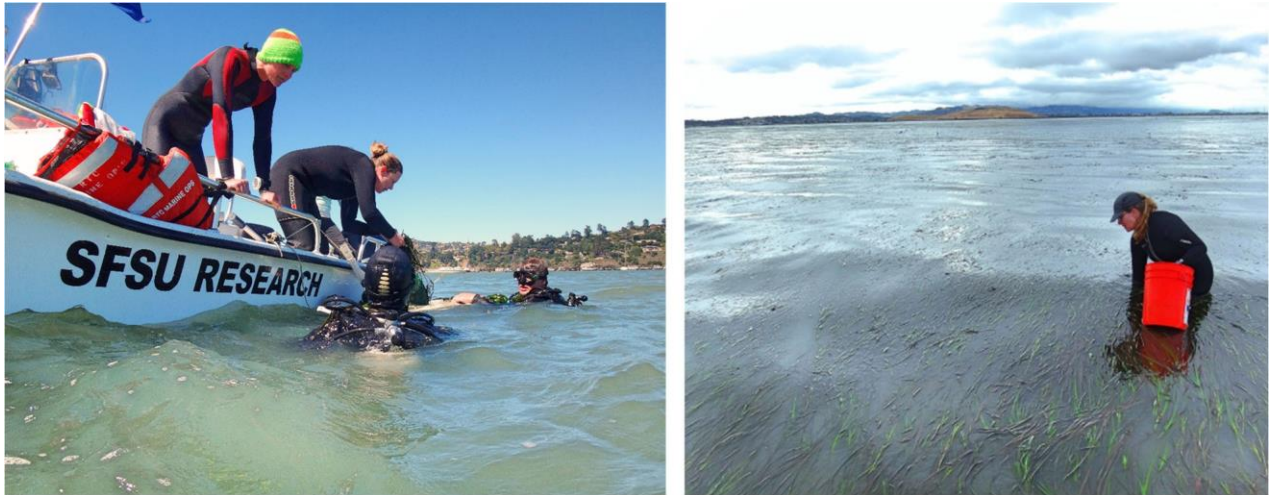
Harvesting of material from subtidal areas of Richardson Bay and intertidal areas at the Point San Pablo/Point Pinole donor sites by Merkel & Associates and SFSU project team members.

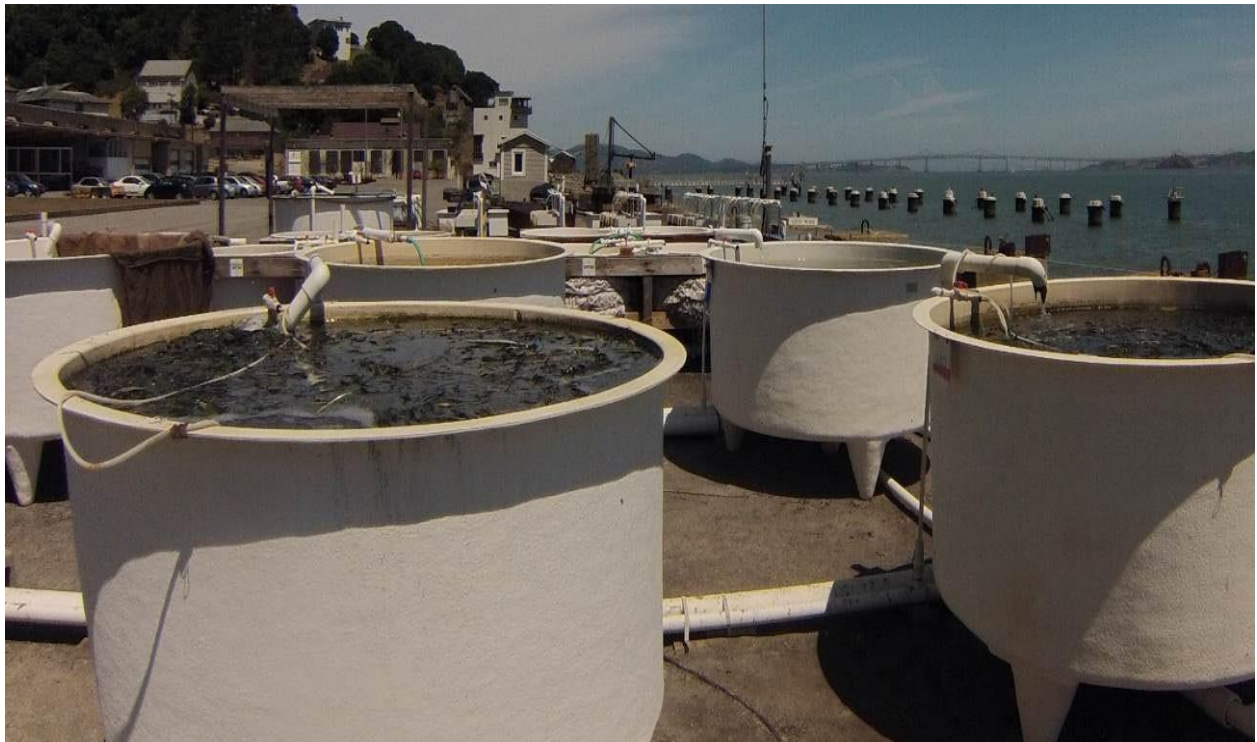
Flow-through seawater tanks used to store eelgrass from donor sites until processed into planting units. Tanks were then used to store processed planting units until they were planted at the transplant receiver sites.

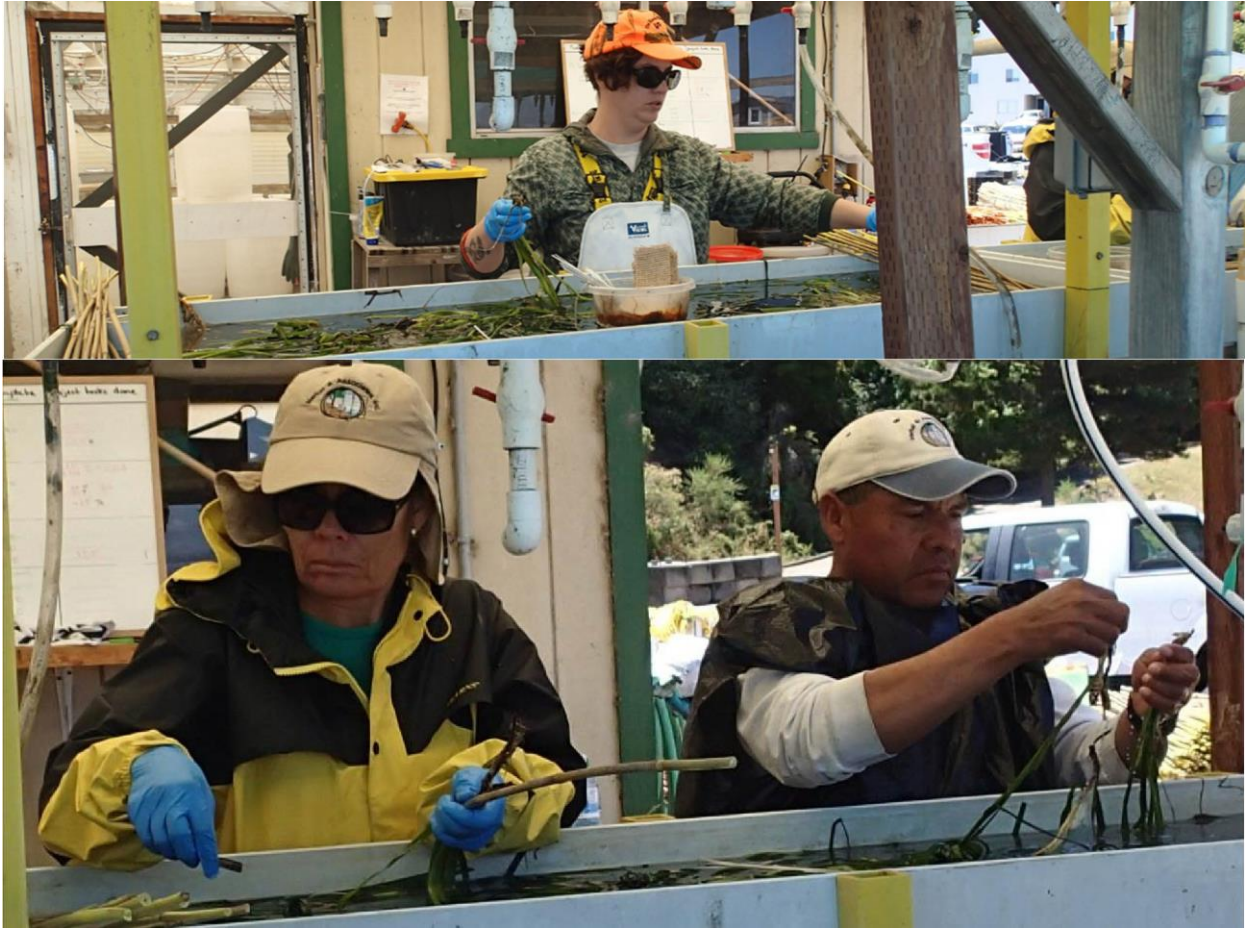
Water-tables used to process donor eelgrass into bare root units. The eelgrass units being prepared in the photograph are Kiriakopolos bamboo stake units from the Keller Beach donor site as indicated by the painted yellow ends of the bamboo stakes.

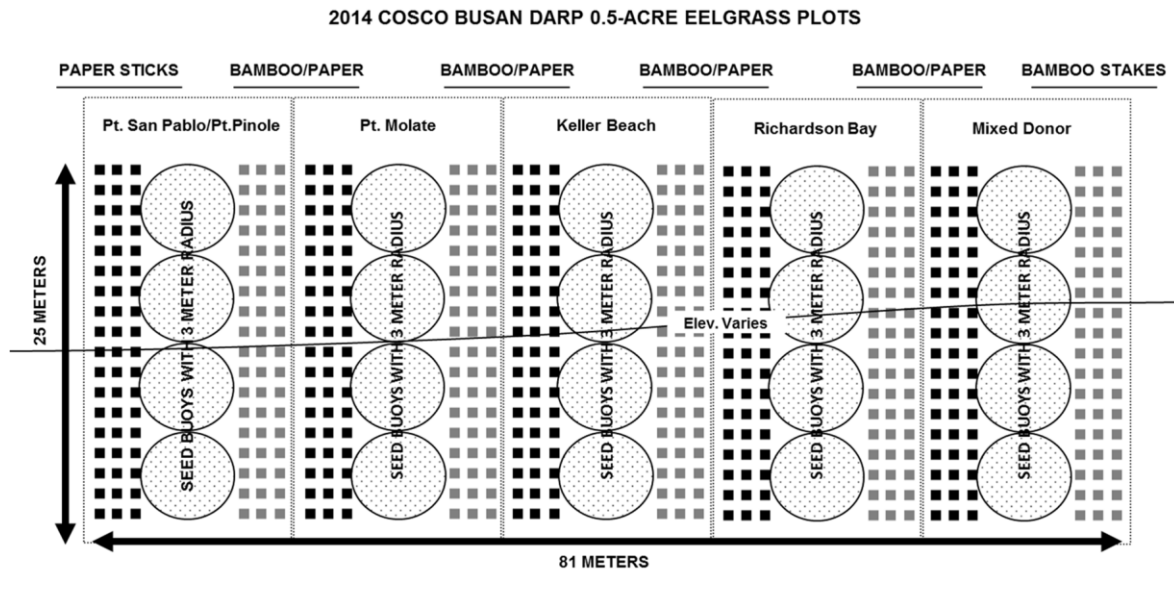
Figure 6. Typical Planting Array for the Cosco Busan DARP Eelgrass Restoration (2014, 2015-2016, 2019, and 2021 Planting Seasons)

The planting program used half-acre plots as well as the smaller test plots. These half-acre plots were 81 meters long and 25 meters wide. Plots were planted in rows defined by planting unit type and donor site (Figure 6). Gaps were left between donor sites in order to accommodate plant performance tracking, seedling recruitment monitoring, and/or seed buoy deployment to facilitate infill of the planting areas. Plots used in 2014 and those used in 2015–2016 and 2019–2021 had the same general layout, but plantings varied between 2014 and the other planting years. In 2014, an equal ratio of bamboo stakes to paper stick units were planted in the plot with each of the four donor beds being independently planted in groups and a fifth treatment of mixed donor plant materials was also used. For field logistical reasons, the arrangement of all donors and treatments within the half-acre planting plots were maintained across all plots that were installed (Figure 6). This prevented potential for confusion in donor source within the plots during performance monitoring and analyses.

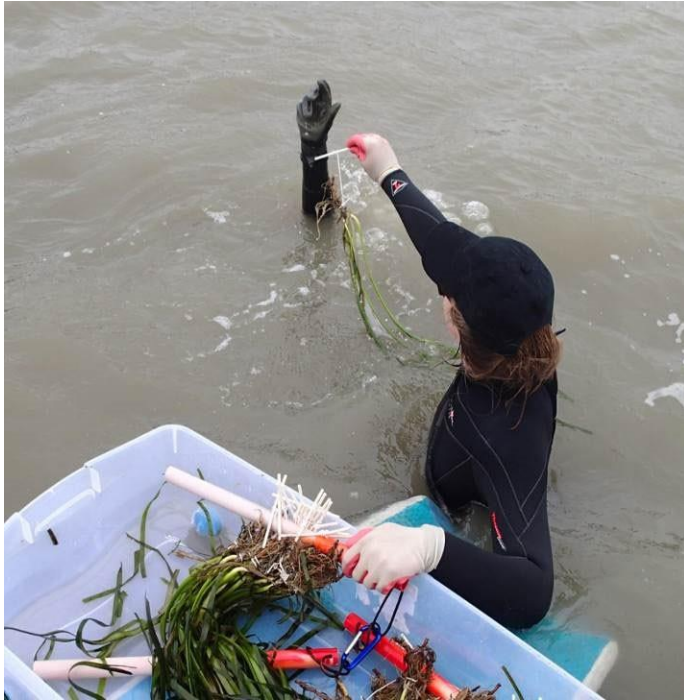
Eelgrass planting at Corte Madera Bay, Marin Rod & Gun Club, and Richardson Bay Audubon Sanctuary. Planting varied from subtidal planting by divers to intertidal planting by wading. Temporary guidelines and corner stakes were set prior to planting and removed following the planting efforts.

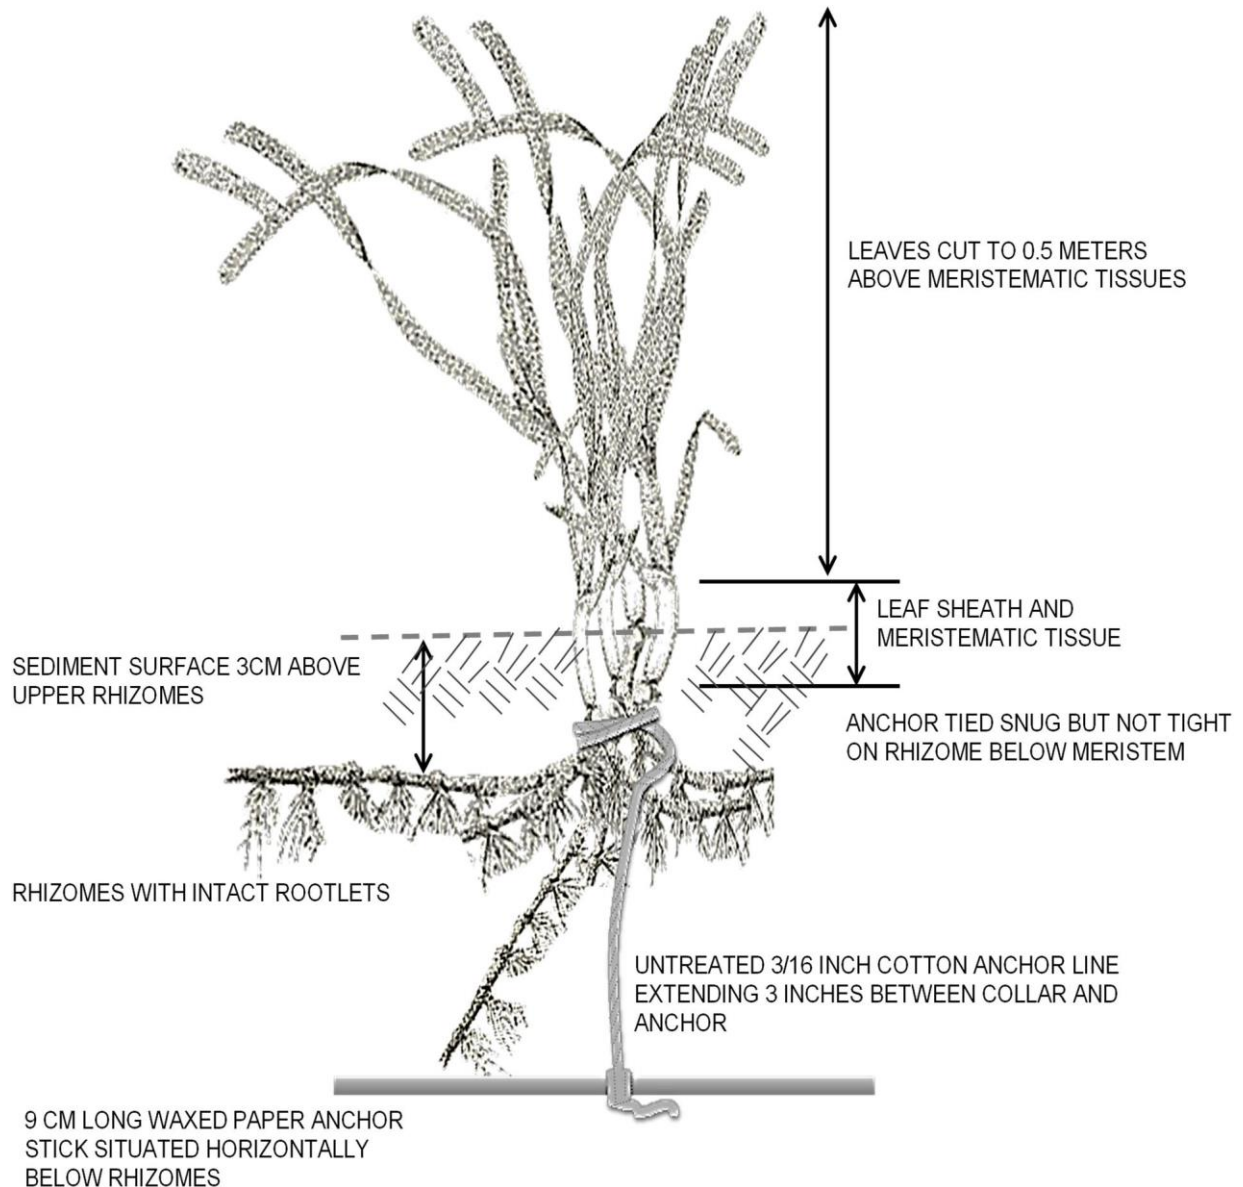
Typical bareroot planting for the Cosco Busan DARP restoration program using the Merkel paper stick anchor methods.

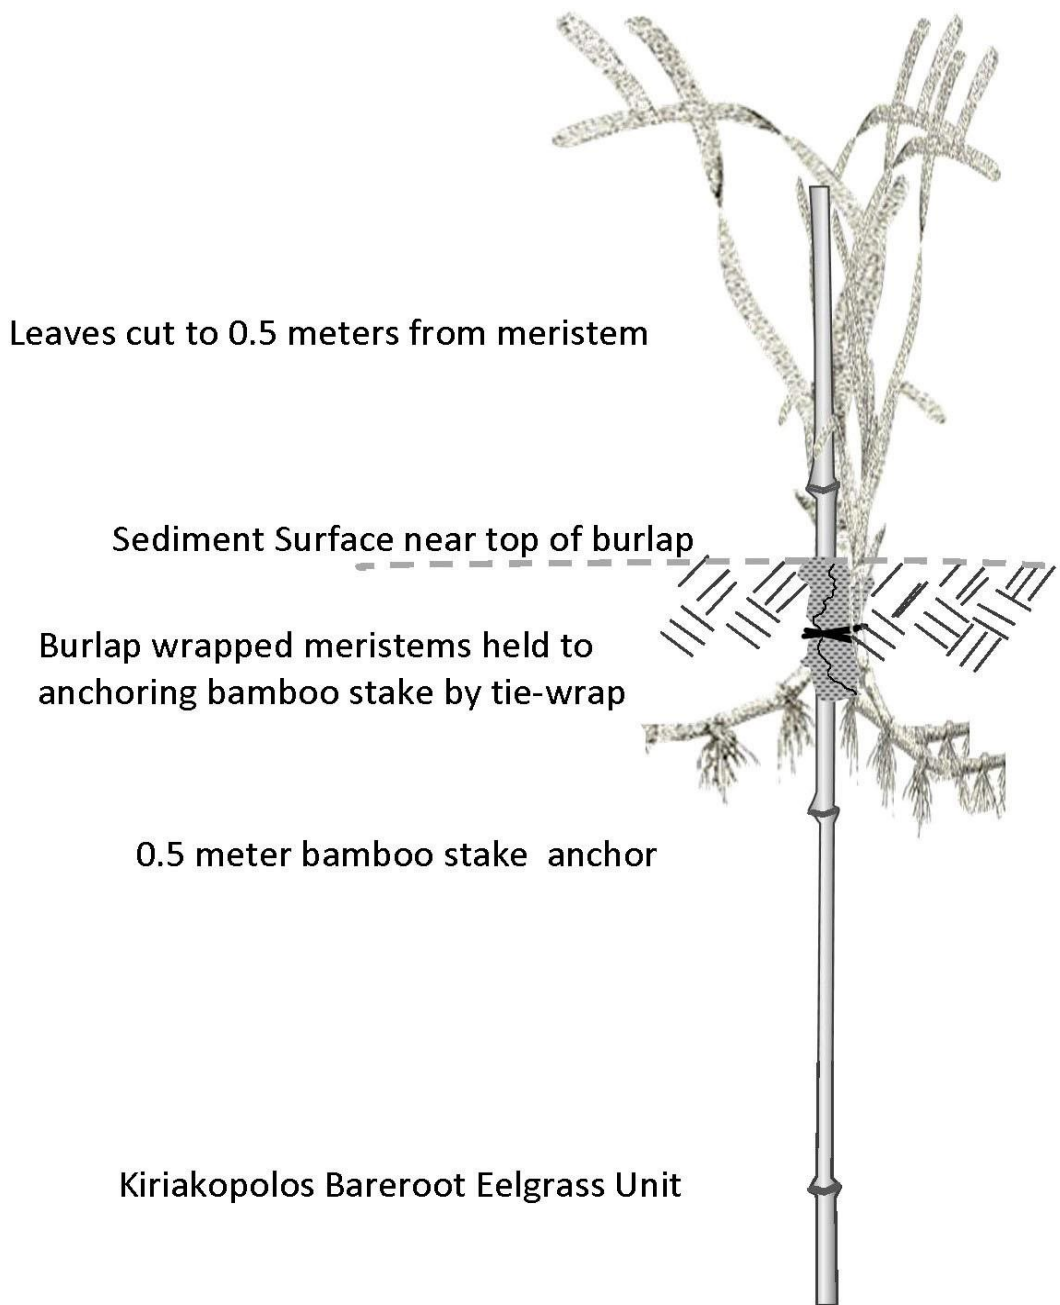
Typical bareroot planting for the Cosco Busan DARP restoration program using the Kiriakopolos bamboo stake anchor methods.

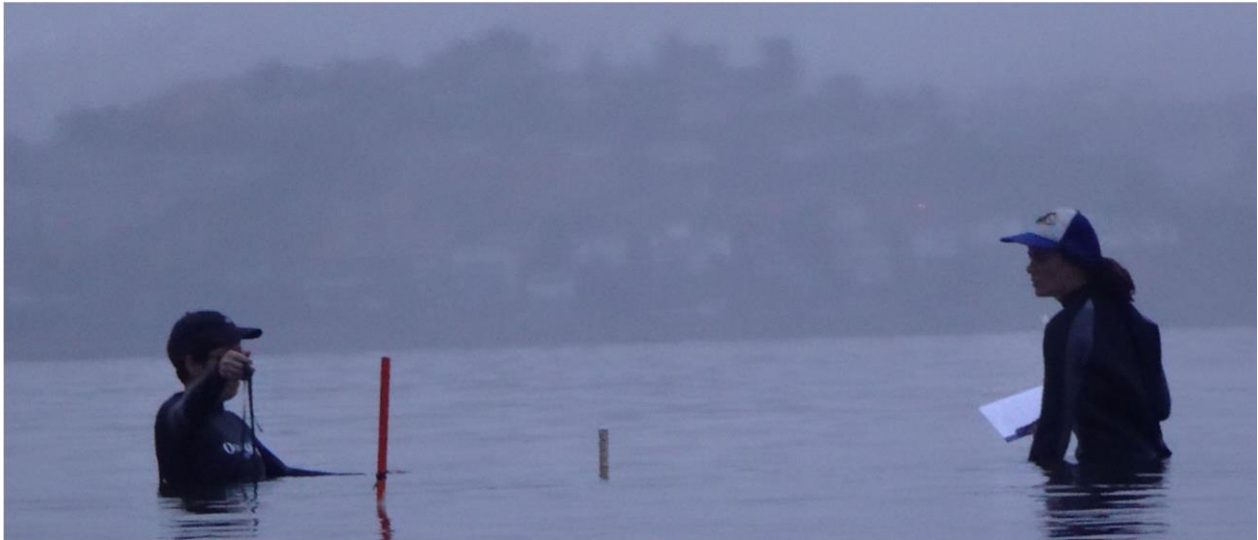
Early morning low tide monitoring was conducted on August 29, 2015 in Richardson Bay. Plant survival, growth, and height were assessed for plants installed in June of the same year.

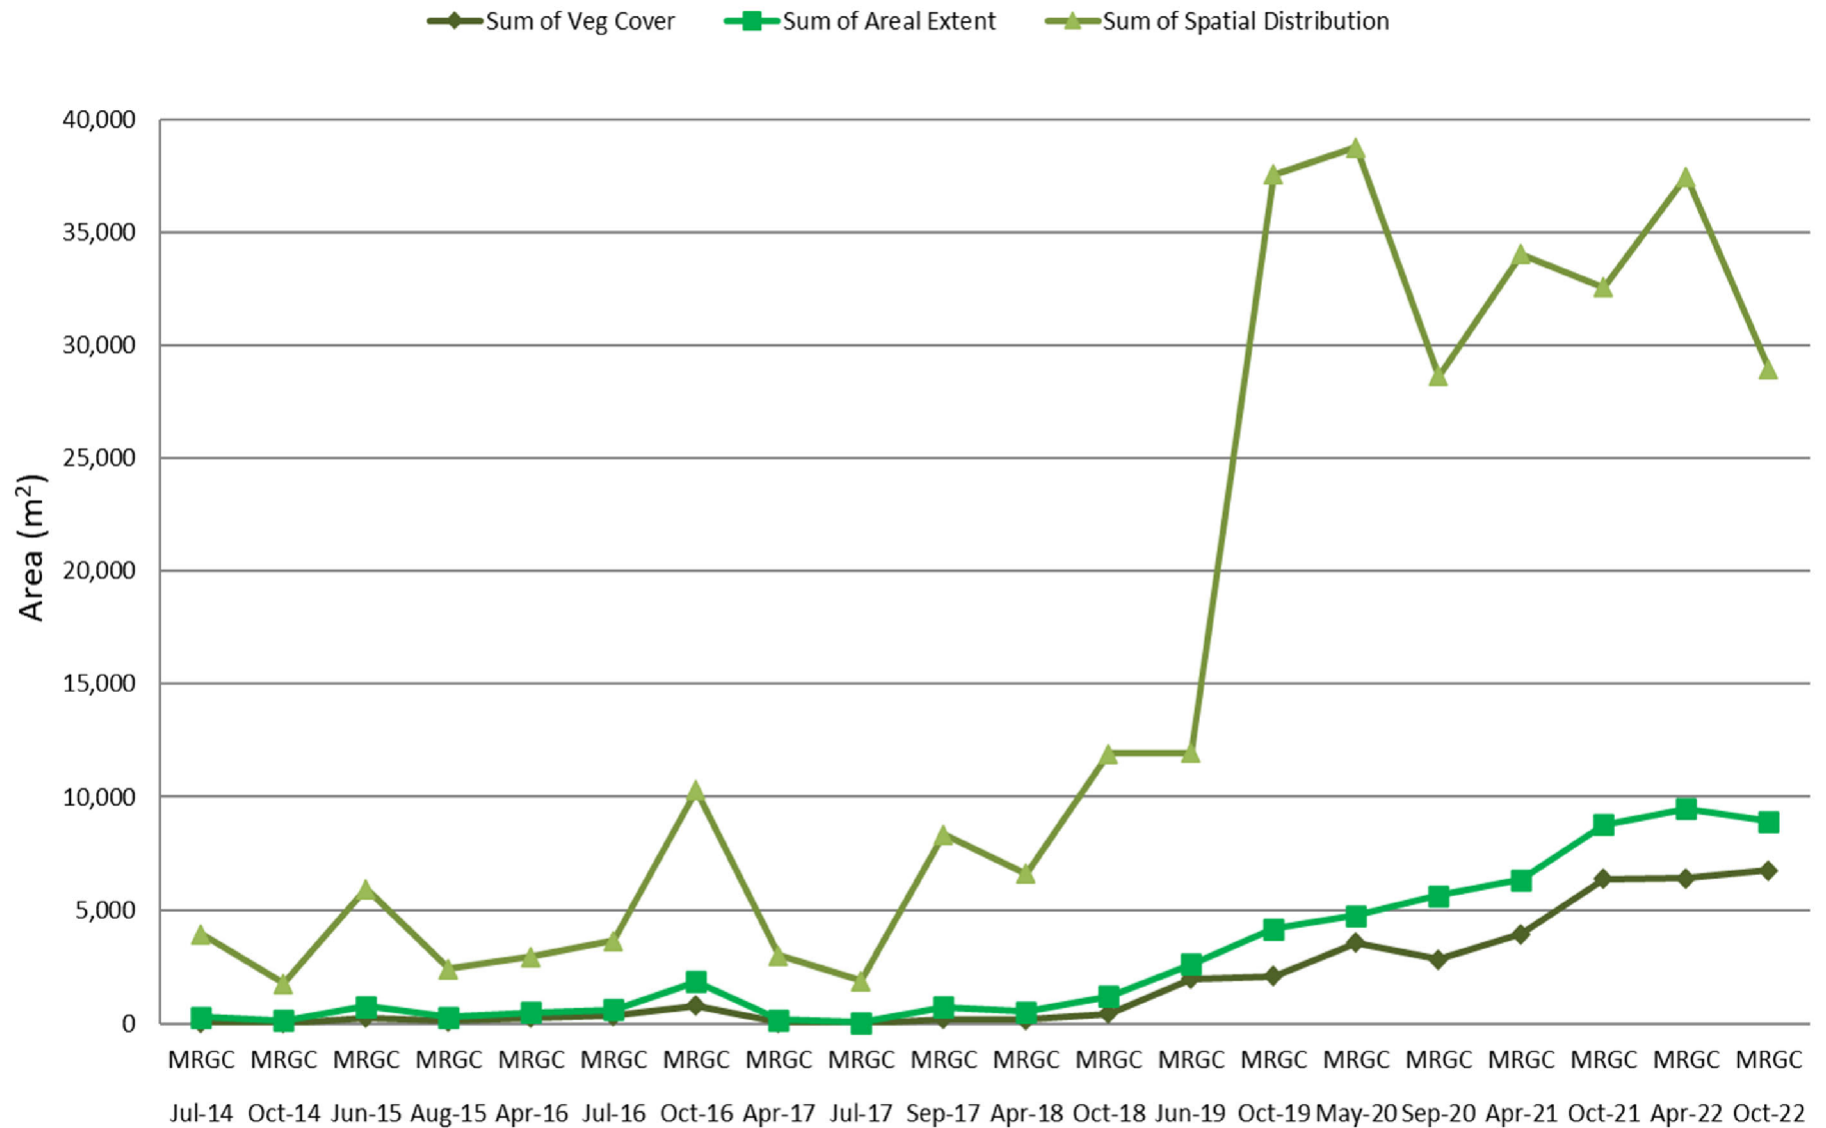
Figure 7. Change in Eelgrass Extent within Cosco Busan Transplants from 2014-2022 at Marin Rod & Gun Club

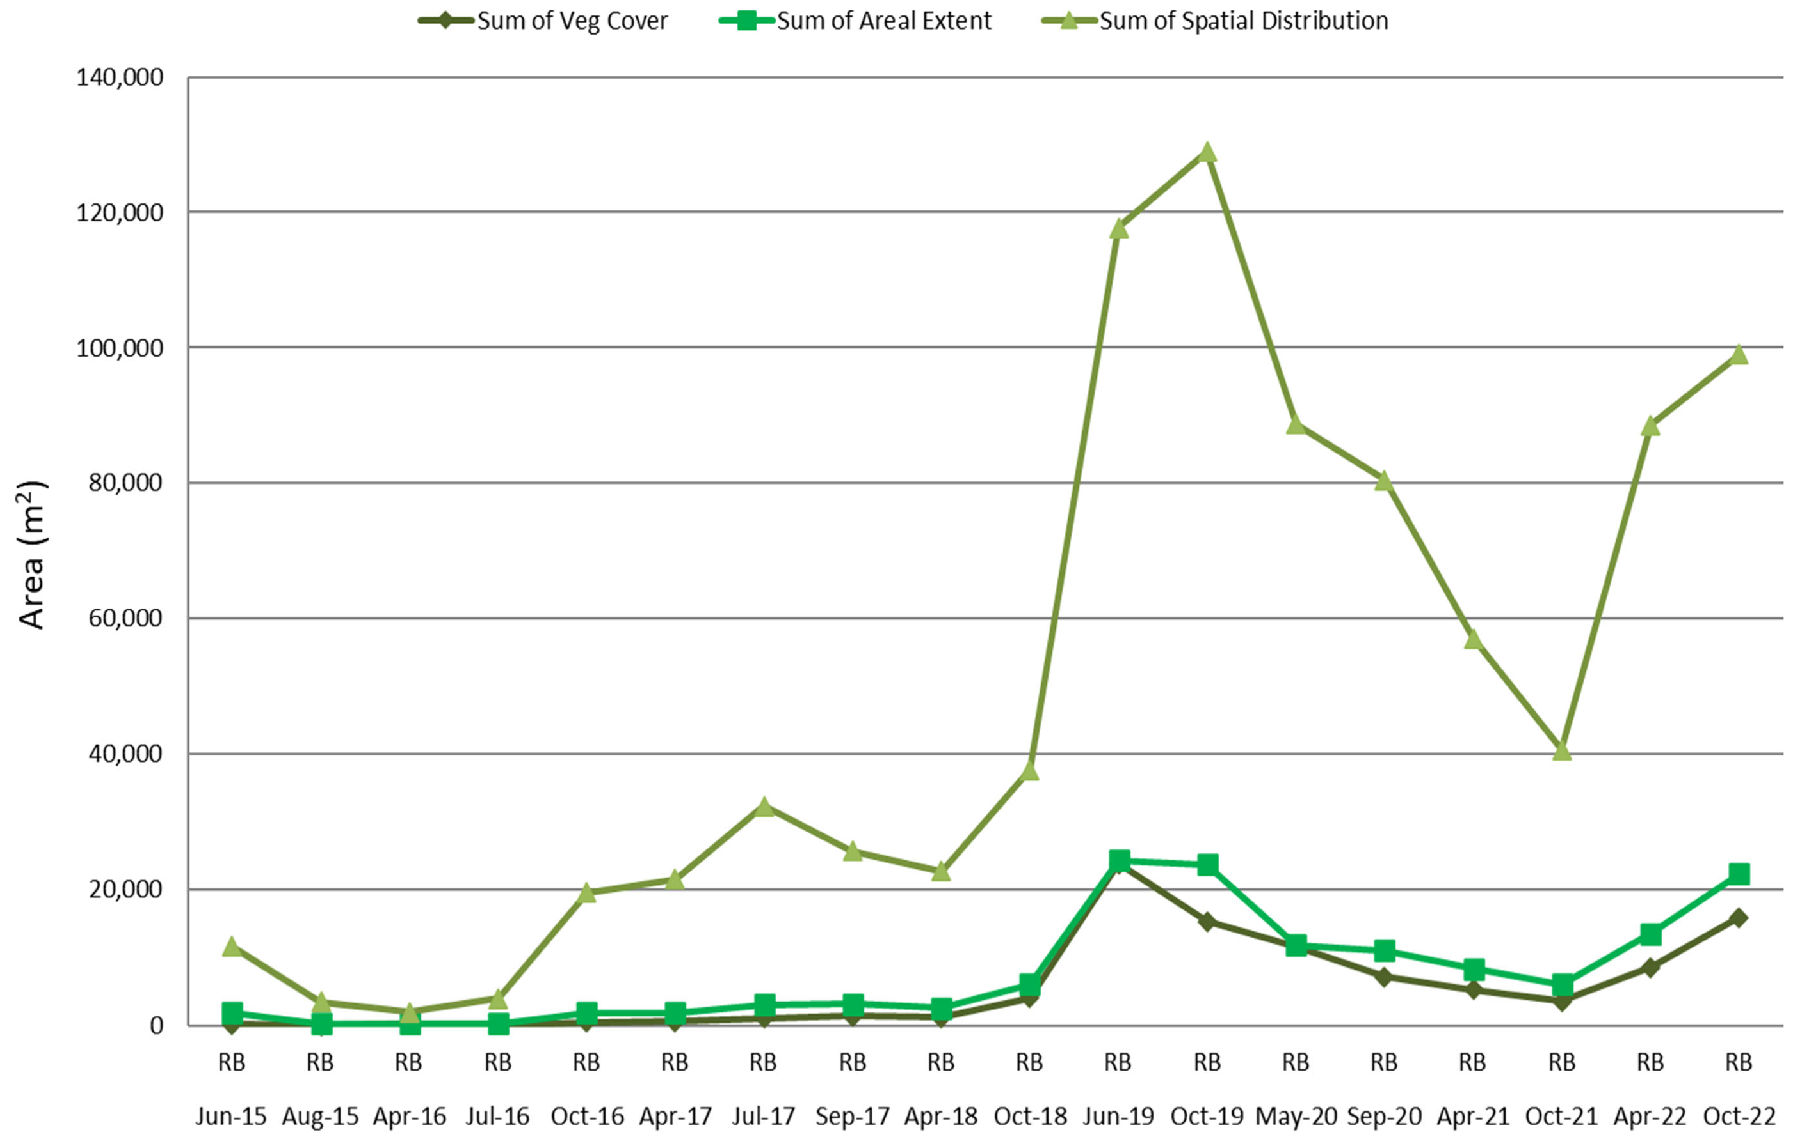
Figure 11. Change in Eelgrass Extent within Cosco Busan Transplants from 2014-2022 at Richardson Bay

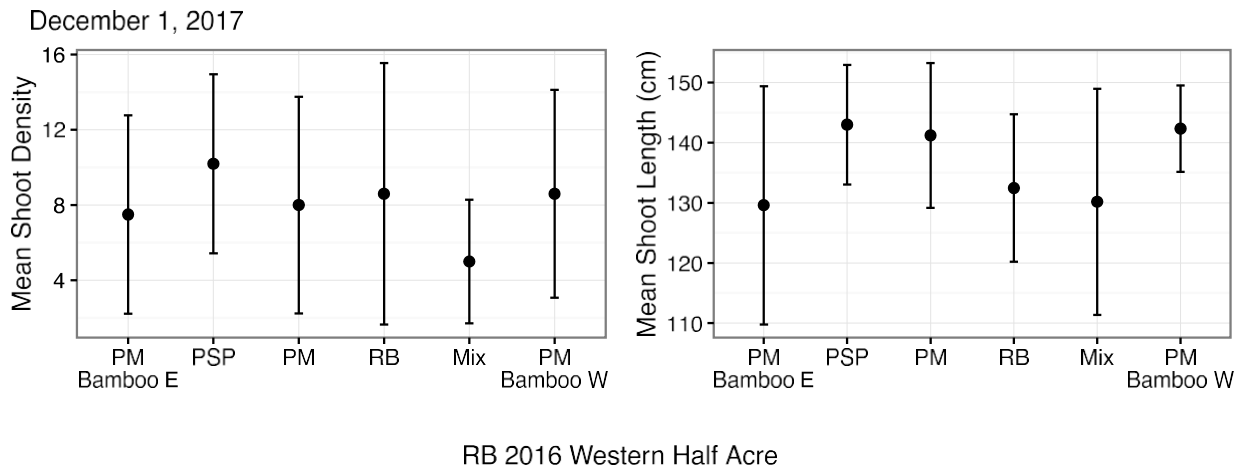
Figure 24. Mean Vegetative Shoot Density and Shoot Height ($\pm 95\%$ CI) Per 0.25 m² Quadrat in the 2016 Western Half-acre Plot at Richardson Bay (December 2017)

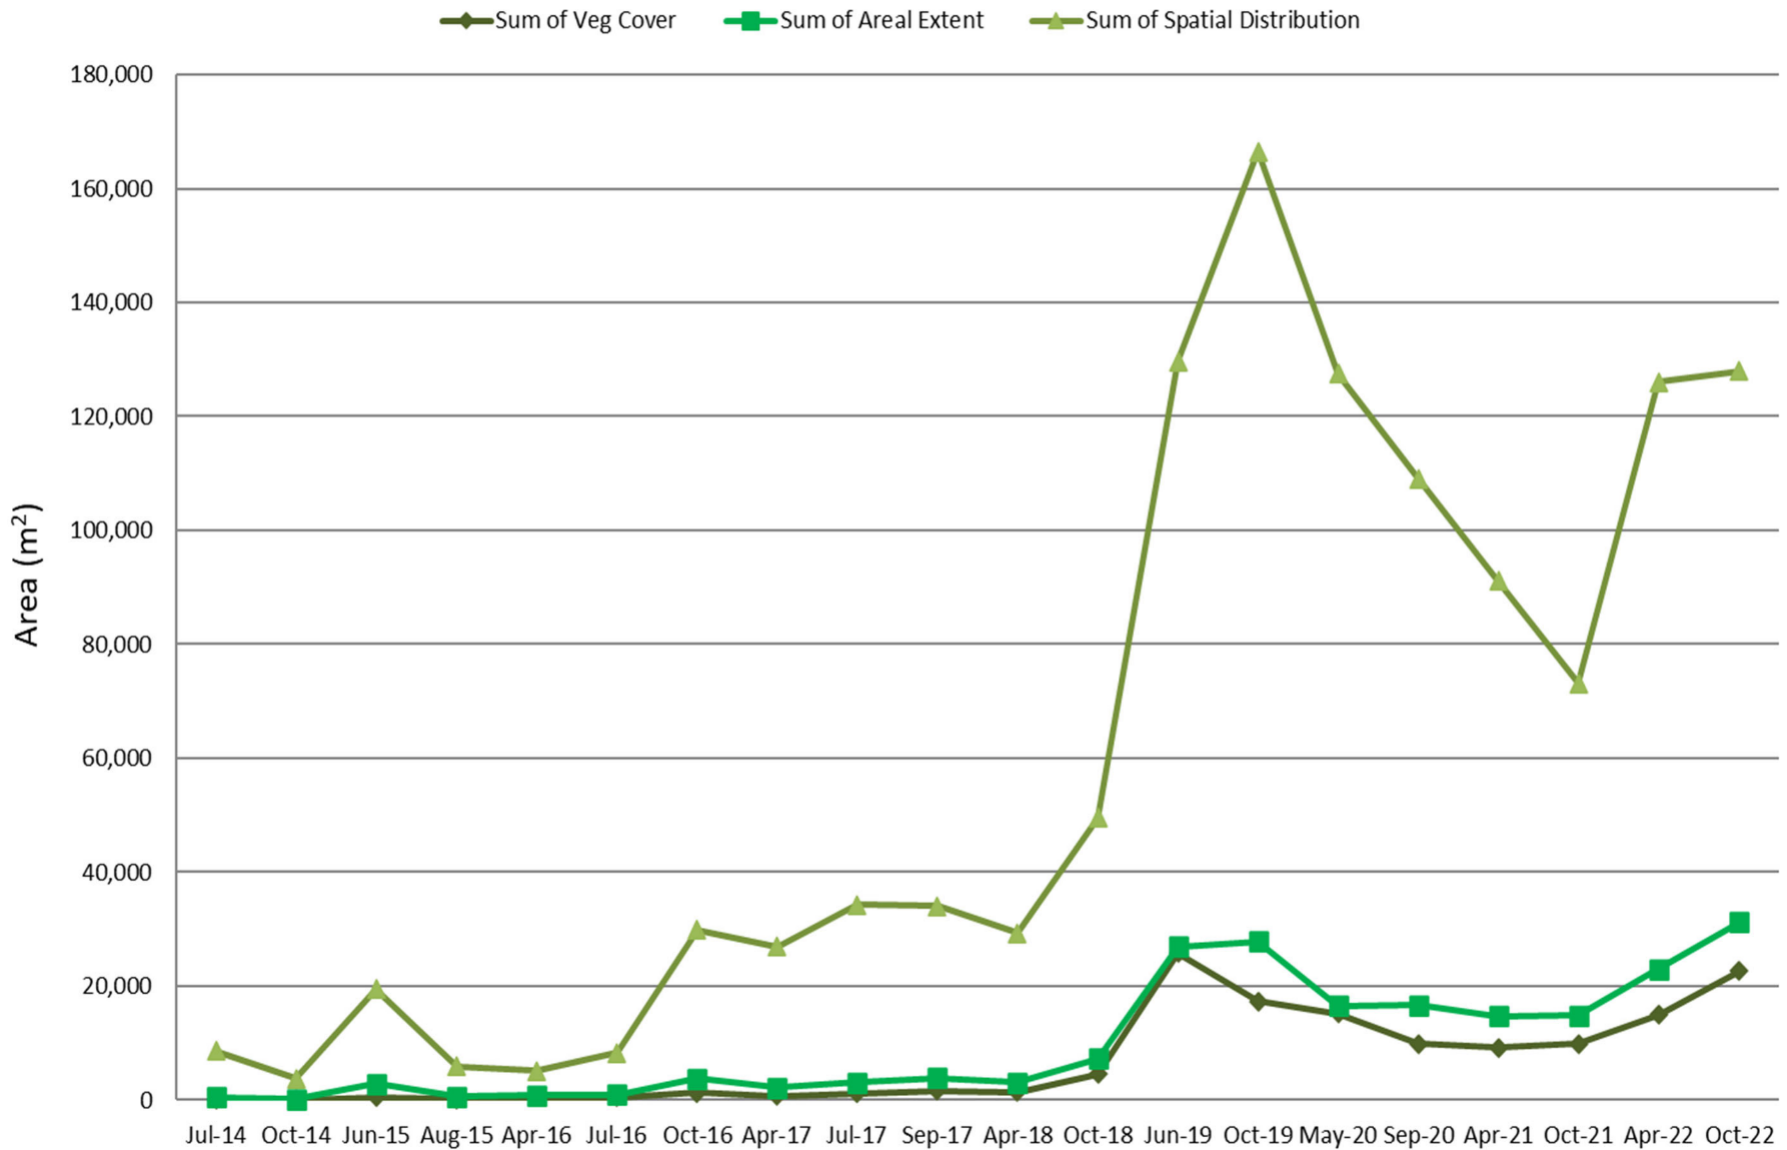
Figure 29. Cumulative Eelgrass Extent within Cosco Busan Transplants from 2014-2022
