**California Department of Fish and Wildlife
Environmental Enhancement Fund Grant Program
FINAL PROGRESS REPORT
Anderson Creek Instream & Riparian Habitat Restoration Project**

Project Title: Anderson Creek Instream &
Riparian Habitat Restoration Project
Grantee: Sanctuary Forest, Inc.

Anderson Creek Instream and Riparian Habitat Restoration Project

Monitoring Report

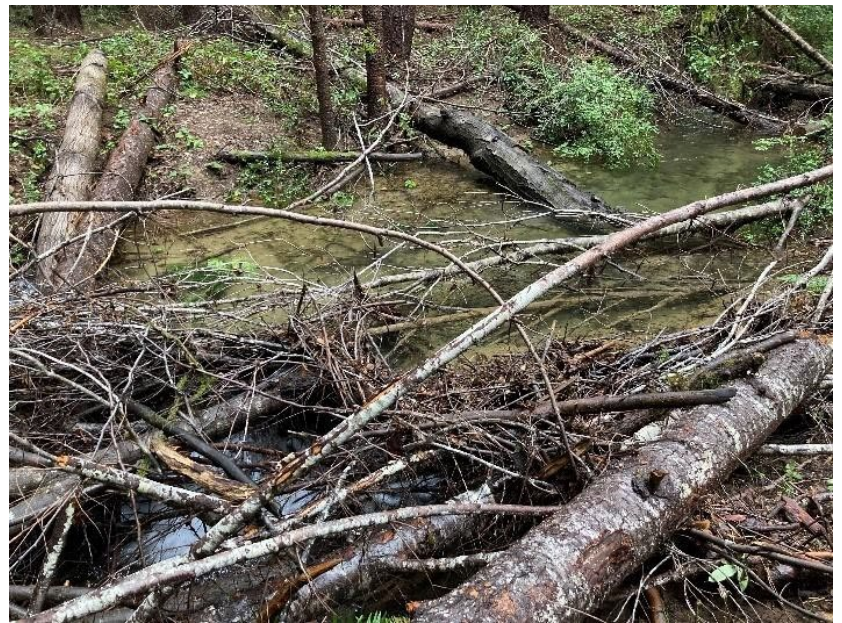
Instream LWD installed in Anderson Creek in 2022, floodplain reconnection and plunge pool formation following 2023/2024 winter high flows

Are the structures performing as per design objectives? As of early spring 2024, most of the structures are performing as per design objectives, sometimes exceeding expectations. The four log-and-boulder weirs have persisted through two winters with their clay seal intact. Many of the

wood jams have captured other woody debris and stream bedload, reconnecting floodplains upstream of the jams and creating plunge pools on the downstream side. The structures that were built with both large and small wood appear to be the most effective (see cover photo). The structures with only large pieces did not capture as much material and did not significantly change stream morphology.

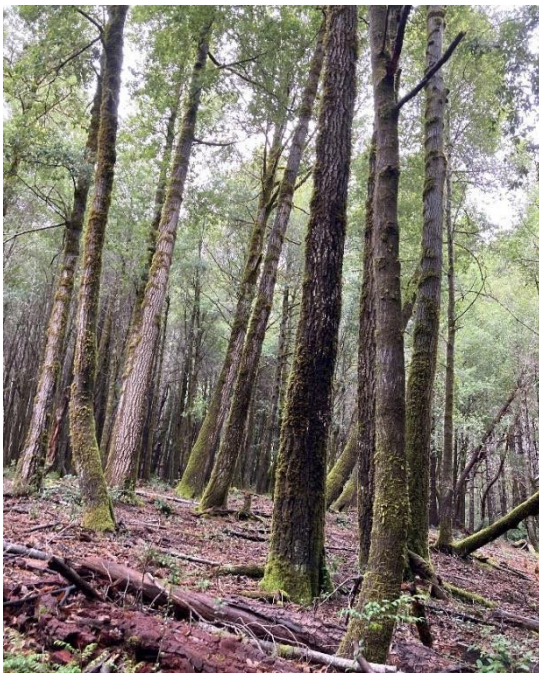
Riparian forest thinning in Anderson Creek, post-project photo shows lop and scatter mulch on the ground and wider spacing between trees in the foreground where thinning took place.

The forest thinning component benefits are also being achieved and include improved forest health, reduced fire hazard and increased forest stand diversity. We used lop and scatter and chipping of slash to help build up the mulch layer and to promote rainwater infiltration. The combined benefits of increased rainwater infiltration along with reduced evapotranspiration will help contribute to increased summer flows.

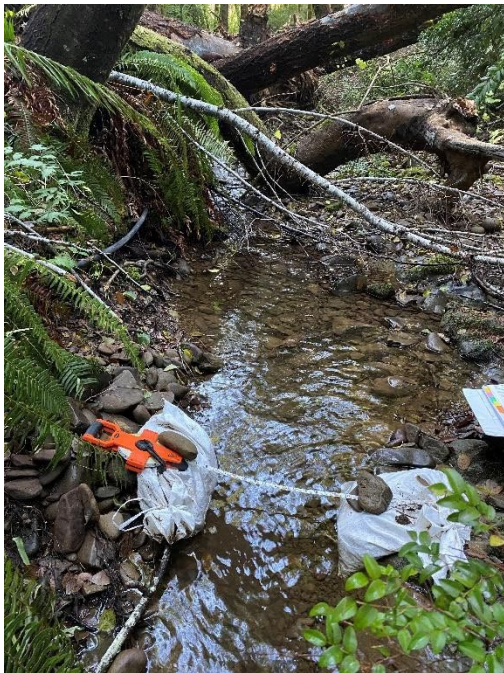
Anderson Creek streamflow measurement cross-section, post-project. Large wood installation is visible just upstream of the site.

Seasonal streamflow monitoring was performed at one established monitoring site downstream of the project reach for one pre- and one post-project dry seasons. The monitoring site is located ~8-10' feet downstream of the lowermost structure now installed within the project reach. The method of measuring discharge consisted of the following: installation of a cross section wherein sandbags are placed on both sides of the channel to square up the edges; a Marsh McBirney (pre-project) now using Hach (post-project) flow meter is used to measure depth and velocity when these are sufficient. When flows or depth are too low for the digital meter, a volumetric or “bucket and stopwatch” method is used at a location further downstream from the meter cross section, near the confluence with the mainstem of the Mattole River. This volumetric flow measurement site is within a bedrock cascade several feet above the confluence. *See images below.*

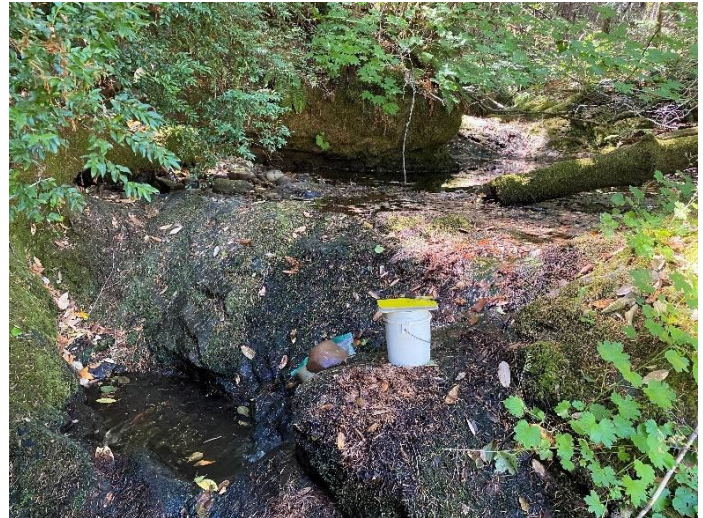
Anderson Creek volumetric streamflow measurement site. Dissolved oxygen is measured in the pool above the cascade.

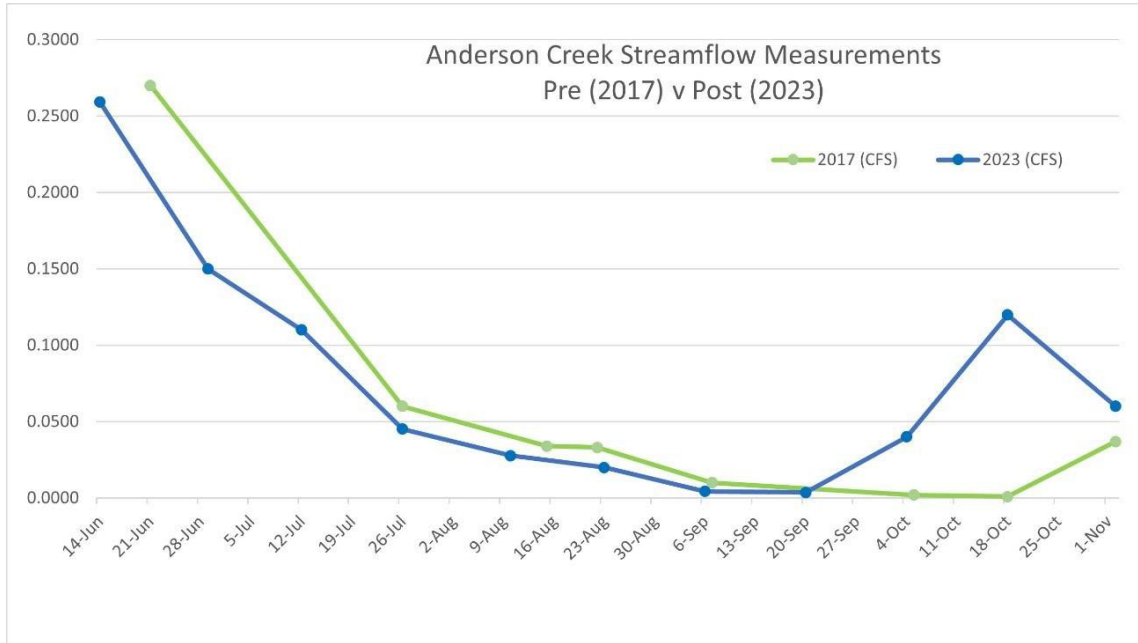
Figure 2.1 Anderson Creek Pre- and Post-Project Streamflow Measurements (full data set represented)

Figures 2.0, 2.1 and 2.2 (*below*) show streamflow data measured during pre- and post-project dry seasons for Anderson Creek and the mainstem of the Mattole River. Data show that in 2023 (post-project) there was less surface flow measured in both Anderson Creek and the Mattole River during the early months of the dry season than in 2017 (pre-project). In October, this trend shifts in both streams, with greater flow measured post-project than before. This could be in part due to a rain event (see Figure 3) or other weather-related factors (temperature, winds, humidity, smoke, etc.). One of the challenges in making determinations based on streamflow measurements alone is the presence of uncontrolled variables associated with weather and natural changes in streambed morphology from year to year. In this way, the weather can ultimately obscure or override project outcomes.

It should also be noted that, depending on local circumstances (valley width, soil/gravel depth, porosity, etc.) it could take several years to build up a depleted aquifer, so there could be more definitive conclusions after another year or two of monitoring.
