Nipomo Creek Watershed Management Plan

The Guadalupe-Nipomo Dunes Restoration Subcommittee

Central Coast Salmon Enhancement

December 2005

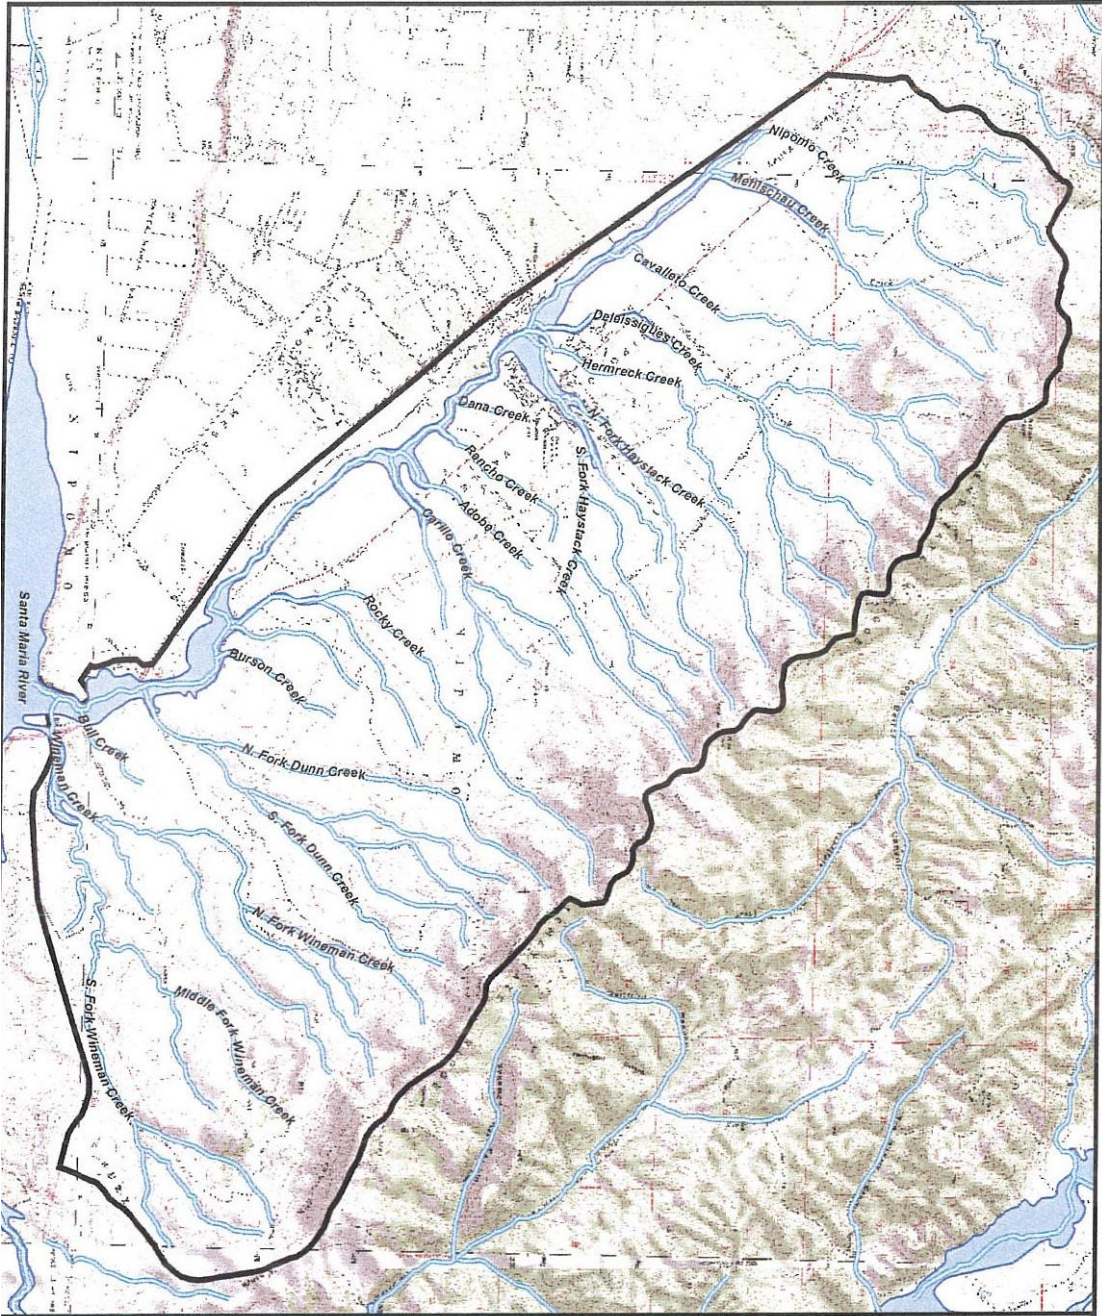
Nipomo Creek Watershed Delineation

The upper reaches of the main stem and tributaries primarily collect water from steep grazing lands on the west side of Temettate Ridge. By the middle elevations, the stream channels become more defined and the land uses are mixture of avocado and citrus trees,

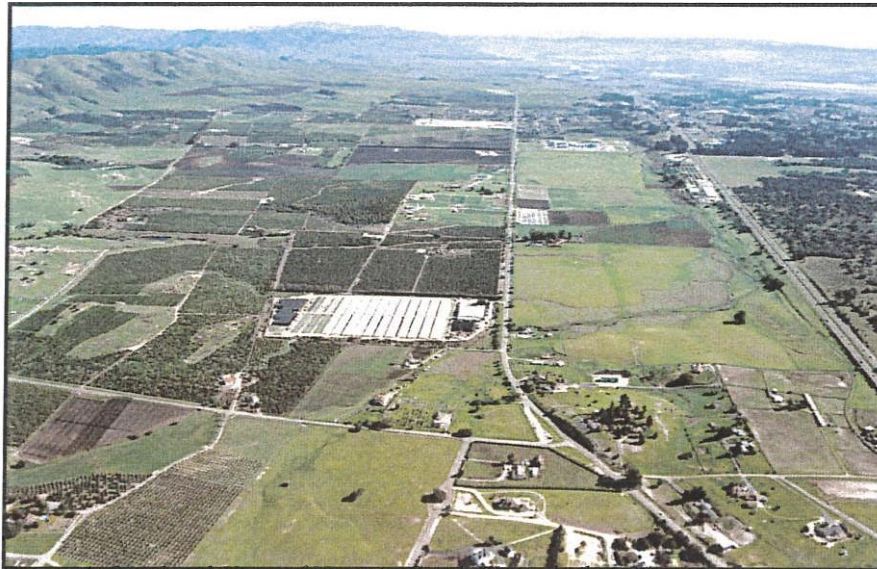
Figure 4: Overhead View of Nipomo Creek Watershed

greenhouses, and residential. The tributaries join the main stem in the lower elevation Nipomo Valley where land uses include irrigated and dry land farming, residential ,

commercial, and public facilities in and around Olde Towne Nipomo, and then more grazing and other agricultural uses before the creek passes the commercial and industrial areas found near the confluence with the Santa Maria River.

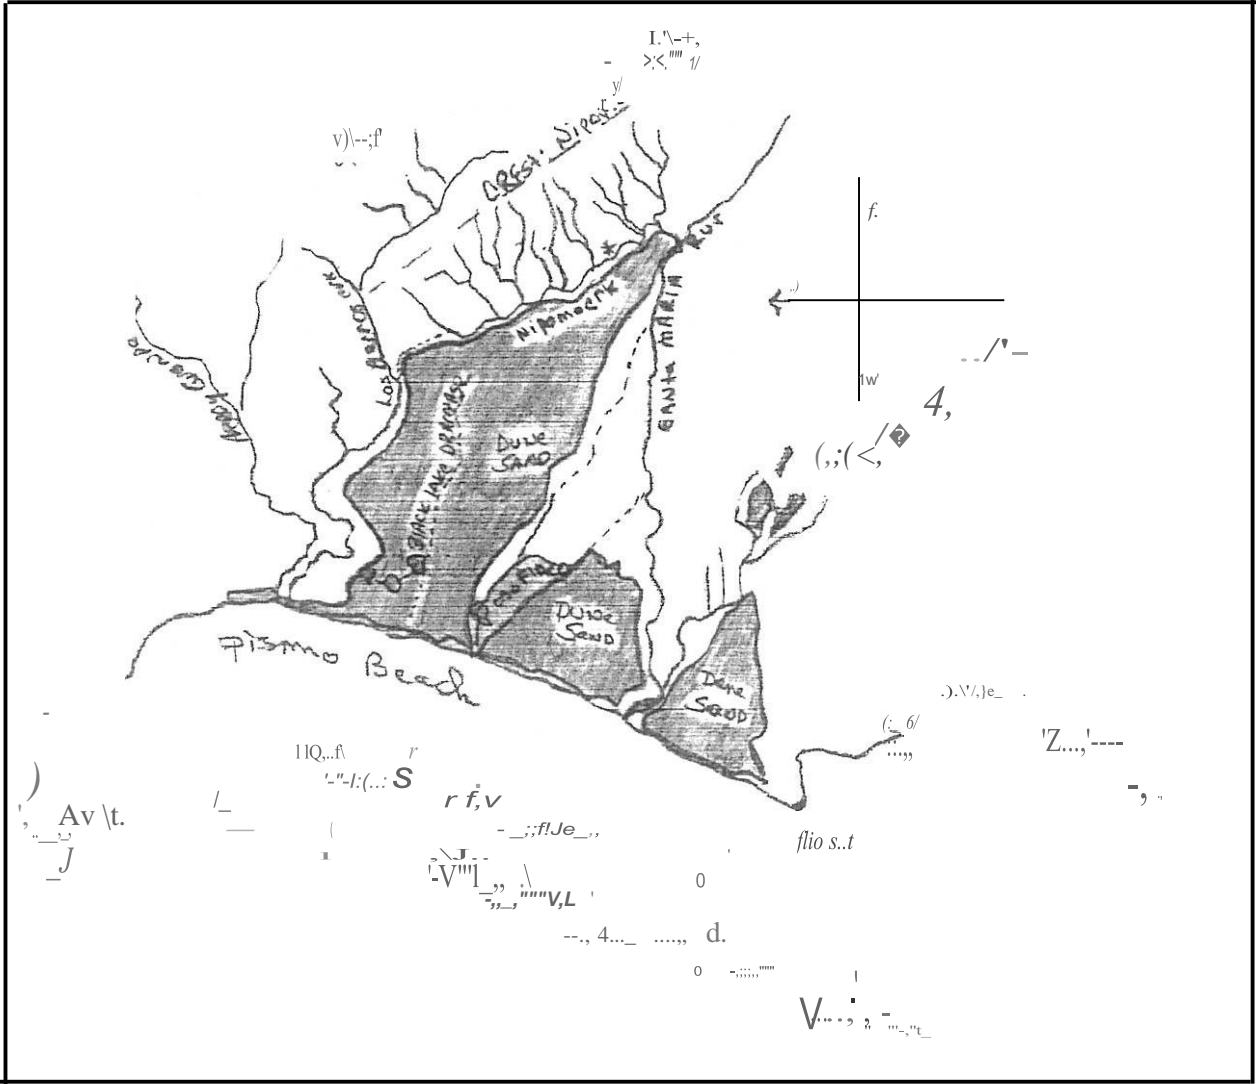
Figure 10: Nipomo Creek Watershed, Present Day (Credit: Ralph Bishop)

Further encroachment of wind driven sand eventually blocked this direct seaward exit of Nipomo Creek. The subsequent build up of water in Nipomo valley found its weakest point to exit through a southern route. At this point, Nipomo Creek became a tributary of the Santa Maria River Watershed (Ardoin/Bishop 2004).

Today, the Nipomo Mesa, a large stabilized sand dune overlying an elevated Pleistocene terrace, is located to the immediate west of the main stem of Nipomo Creek and defines the westerly edge of the Nipomo Creek Watershed (Spanne, 1981). The interface of the adobe and sandy soils is a unique geological feature, and defines certain hydrological characteristics within the Nipomo Creek Watershed.

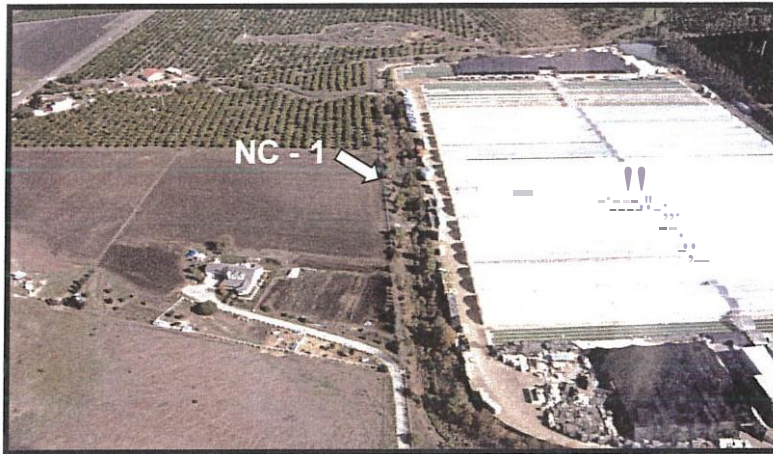
NC - 1: This reach is the uppermost section of the main stem. It begins in an area dominated by new, rural-estate subdivisions with lots ranging between 5 and 15 acres.

The topography is gently rolling. There is little to no riparian vegetation along this reach, with small willows representing what does exist. This reach primarily has the appearance of a swale. At the downstream terminus

of this reach, the creek has been straightened in order to accommodate a large greenhouse complex. This particular area is significantly degraded and features some rock fill.

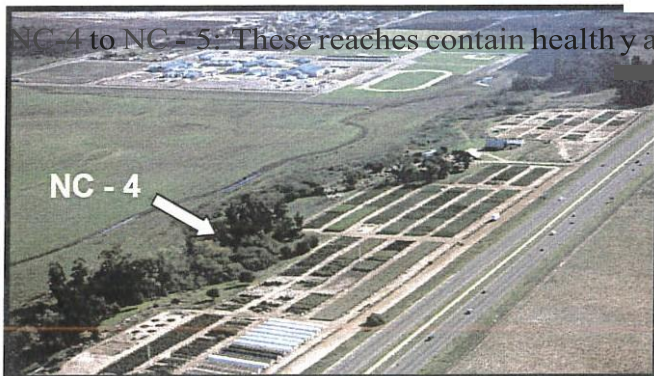
NC - 4 to NC - 5: These reaches contain healthy a

d abundant vegetation comprised of a mature tree canopy and understory associates. Non-native invasive vegetation also exists. Stream channels are shallow with sloped banks at some points and are deep with steep, eroded banks at other points.

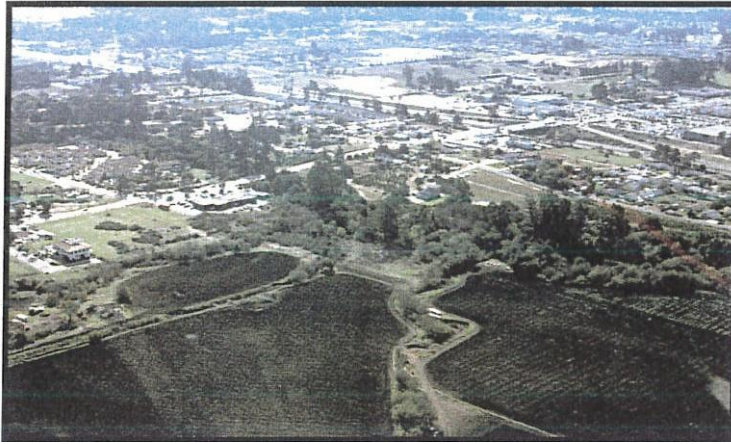
NC - 6: This reach continues with the mature tree canopy and under story associates.

Non-native invasive vegetation also exists. This reach is host to three important confluence areas immediately upstream of the Old Towne Nipomo area. Stream channels are shallow with sloped banks at some points and are deep with steep,

eroded banks at other points. There are frequent debris dams present due to the proliferation of willows.

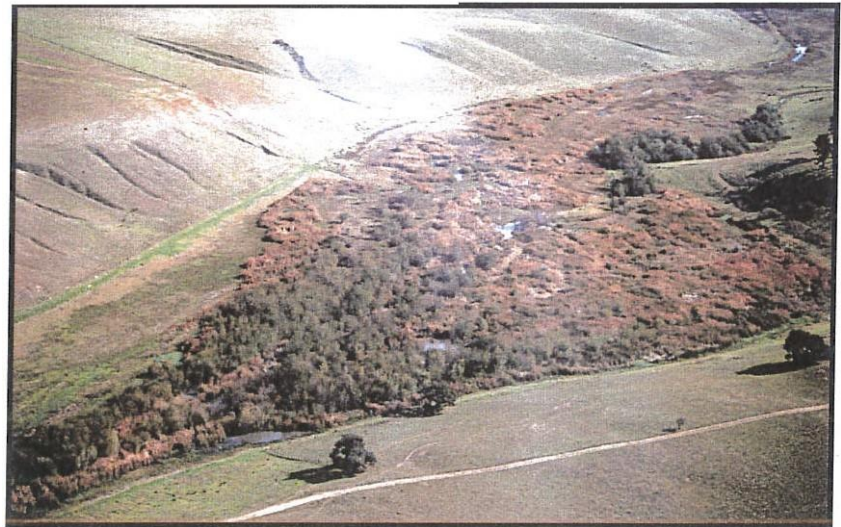
NC - 9 to NC - 11: In these reaches the creek widens out and flows into broad perennial wetlands and pools in several locations. These wetlands provide excellent wildlife

habitat, but are threatened by sedimentation transfer from upstream locations. Outside of the wetlands areas, there is little riparian vegetation and the channels are often deeply incised.

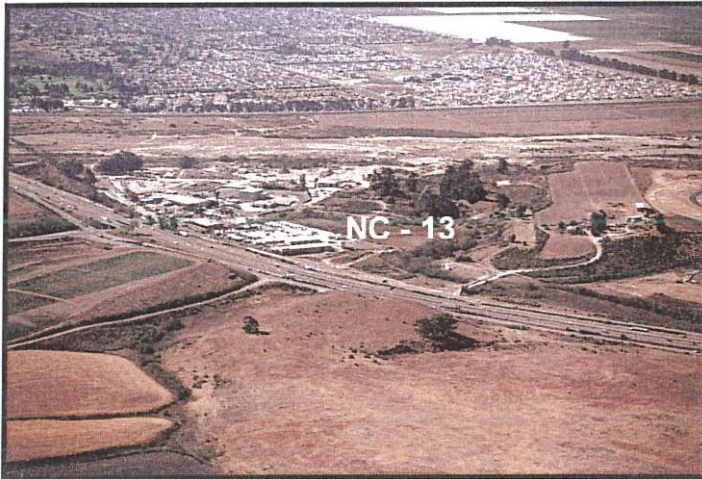
NC - 12 and NC- 13: These reaches also historically contained wetlands, but they are currently in a somewhat degraded state. There are several substandard bridges and

"Arizona" style crossings. The channels are mostly deeply incised with eroding banks. There is some riparian vegetation in places, but it is primarily absent. NC - 13 passes through various commercial and industrial developments.

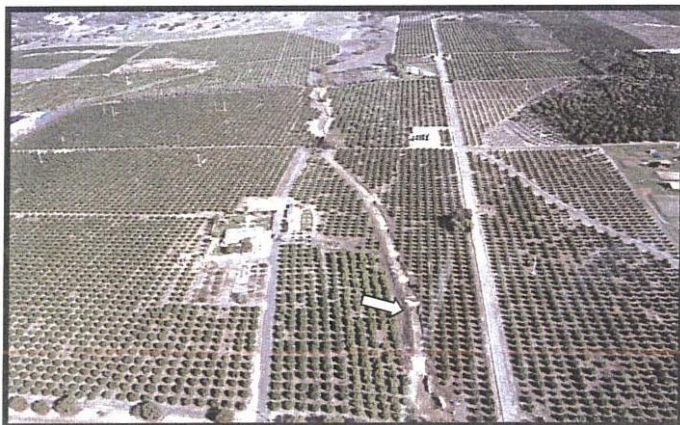
MC- 2: This reach does not offer much in the way of native vegetation. There are some sparse, intermittent willows in the upper half of this reach. There is also a retention pond that has been built into the creek channel. At the lower half of this reach, the creek

travels through orchards where there is no vegetation at all. Near the end of the reach, at Thompson Road, there is a series of concrete steps that stretch across the entire stream channel. It appears that their purpose is for gradient control.

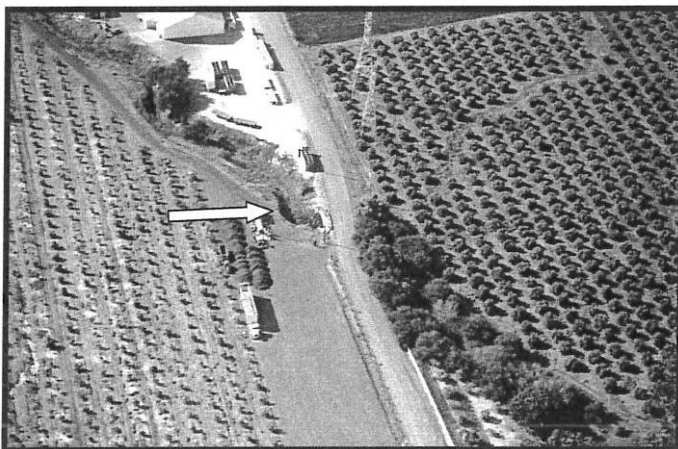
DLC-2: Near the beginning of this reach the creek passes underneath Mehlschau Road. Immediately at the downstream side of the bridge the creek is forced to make a ninety-

degree turn. At this location there is a massive erosion problem with the left bank (when looking downstream) being approximately twenty feet high. The right hand bank is filled with riprap. There is no vegetation as the ground cover has been entirely graded for agricultural purposes. After this

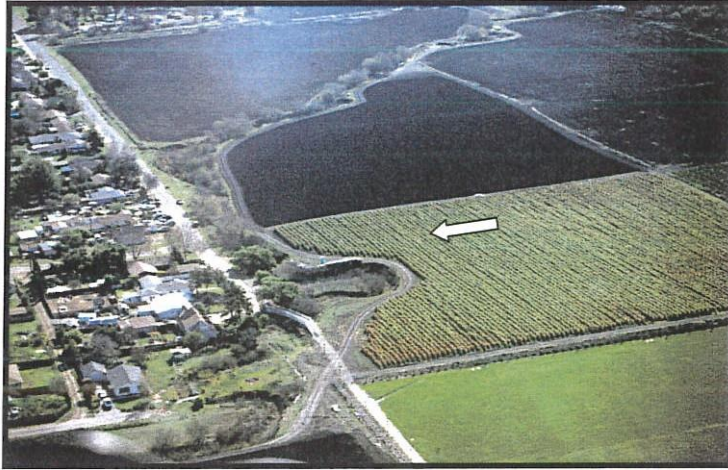
DLC- 3: This reach is one of the more problematic in the entire watershed.

Immediately after crossing under Thompson Road, the creek interfaces with residential

development. Several inadequate flooding solutions have been tried here. The creek then continues for a short, undisturbed period where some intermittent riparian vegetation is present before it again passes by residential development.

There is a sharp bend in the creek that is immediately followed by an even sharper bend that forms a horseshoe shape. This area appears to have been one of the causes of flooding damage suffered by the aforementioned residences in March 2001. The creek continues to flow adjacent to these residences for a stretch before turning right towards the confluence with Nipomo Creek. There is both native and exotic vegetation present and intermittent tree canopy, including some nice oaks. The confluence zone offers rich vegetation and tree coverage. There are frequent debris dams located here due to the thick willows that are present.

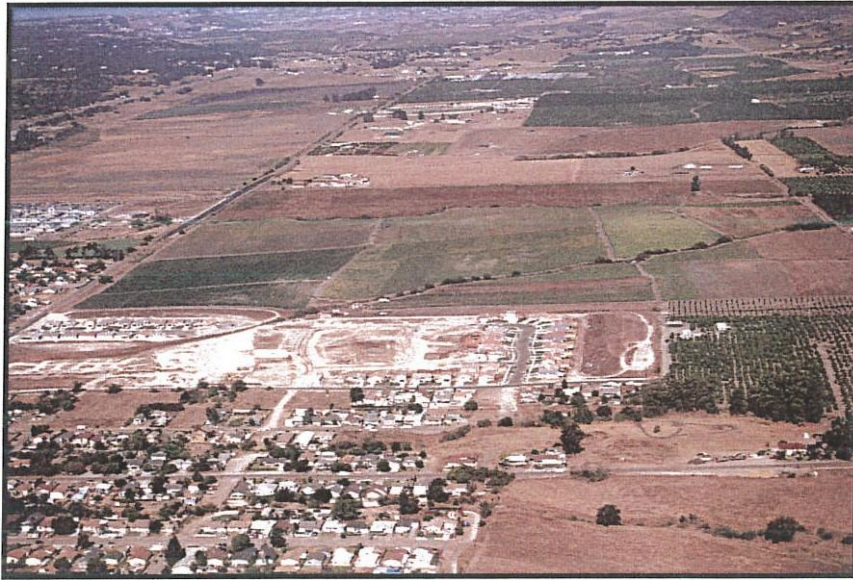
HMC - 1: This reach starts out either flowing through, or adjacent to, orchards and other agriculture. There is little or no vegetation in this area. After this, the creek flows through a graded agriculture field and features some intermittent vegetation. The channel is incised and often has steep, eroded banks. Following this, the creek travels through a new residential subdivision of approximately 100 homes. Currently, the first phases of construction have been completed. Where the creek flows through, the banks have been fenced off under an Army Corp permit condition to avoid sedimentation filling while construction is under way. The channel has been widened and the banks have been

graded back. There is a drainage weir installed at the end of this section right before the creek crosses under Thompson Road. Continuing downstream, the creek flows through

an underground culvert beneath residential development for two city blocks. Upon seeing daylight, the final section of this reach offers little riparian vegetation until right at the confluence area with

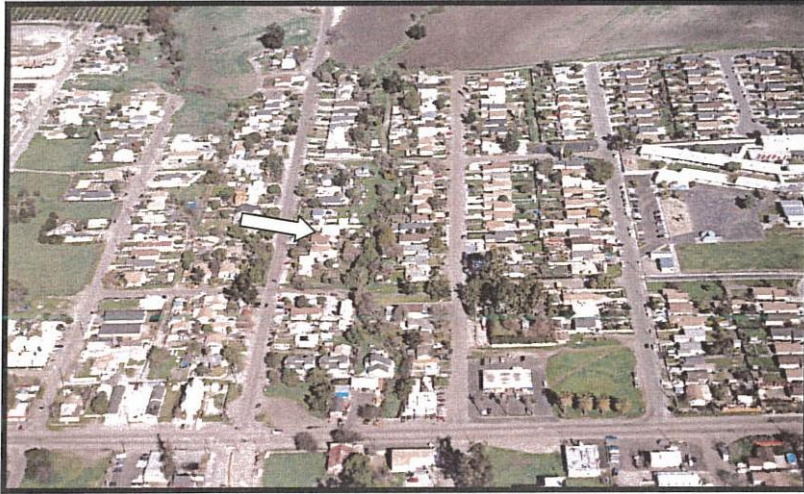
NHC - 2: After the above described confluence zone, the vegetation and canopy coverage remains dense for a stretch before reaching more orchards where there is little or no vegetation. The stream banks and channels range from good condition to fair condition. Beyond this, the creek flows through residential and commercial development located in the Olde Towne Nipomo area. In this stretch the vegetation is intermittent and dominated by non-natives. The banks are often eroded and the channel is incised. Many

residents have attempted makeshift erosion and flood control efforts over the years in order to protect their properties. This reach should be considered a problem spot, although the multiple small lot ownership pattern of this

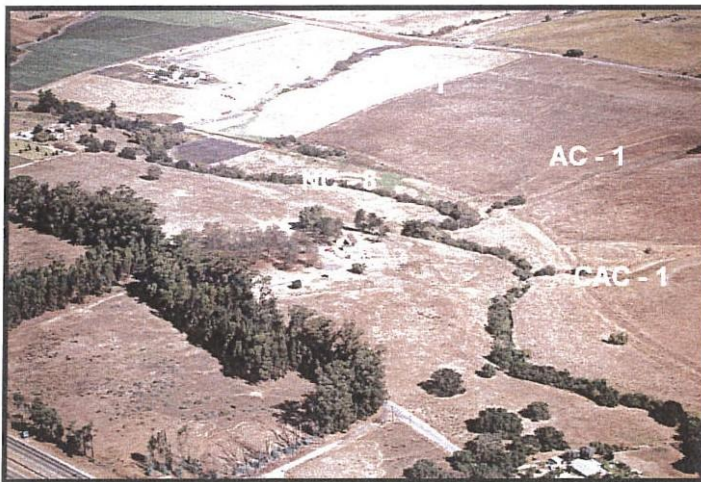
RAC - 1: This reach begins in an orchard where there is no vegetation or tree coverage.

After this it cross under Thompson Road and featured some intermittent riparian vegetation and willow coverage until illegal grubbing activities were undertaken in the fall of 2004. An enforcement case ensued thereafter.

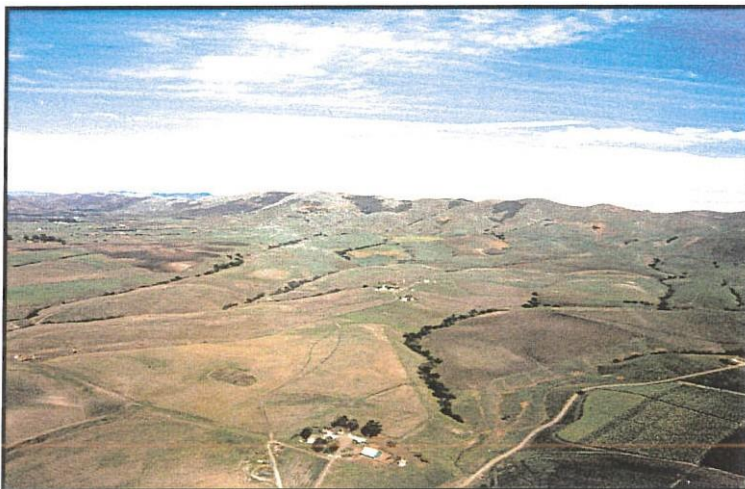
WC - **3:** This final reach collects the north fork, middle fork, and south fork of Wineman Creek. Surprisingly, it appears as a relatively minor section of creek. There are a few

trees and some riparian vegetation present. This reach is primarily incised to a depth of about two feet. The channel is about three feet across and the banks are vertical. There are several dirt roads crossing over the creek.

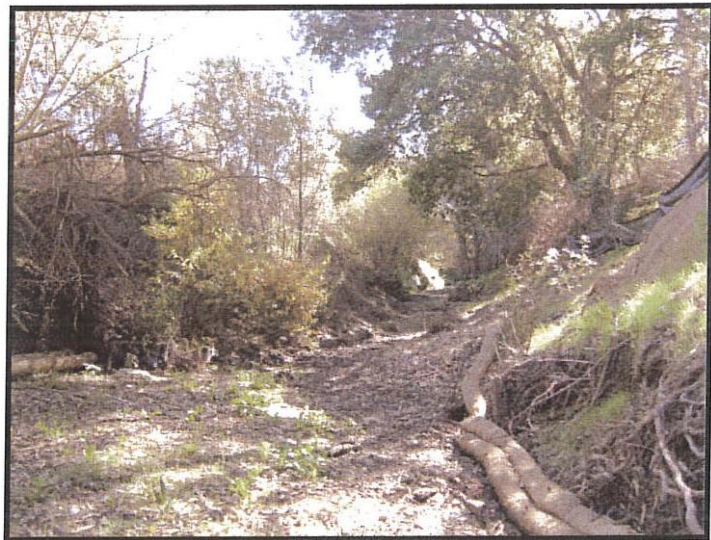
Figure 16: Bank Stabilization Efforts at Adobe Plaza

The stream channel at Adobe Plaza is approximately 20 feet wide and 25 feet high. Standing water appears to be seasonal because no water was found during the winter 2004 survey. The stream banks in many parts of the corridor are extremely eroded.

Many locations along the banks have exposed soil (no under story) and exposed tree roots. Efforts to stabilize the stream banks and redirect water flow have begun in the stream channel. Bio-logs are currently being used to divert water flow. In the future, efforts need to be
